***South Shore Coastal Infrastructure Inventory
and Assessment Demonstration Project
Coastal Hazards Commission***

Town of Scituate

February 28, 2007

**Presented by:
Bourne Consulting Engineering
Franklin, Massachusetts**

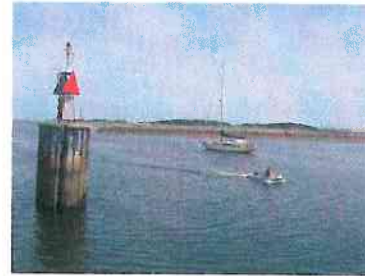
Placed rip rap jetty with 1 to 2 ton stones and flat top.

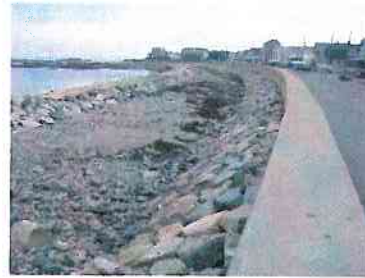
This structure is a vertical seawall with a fronting stone revetment along the toe. There is also a rubble mound structure approximately 50 feet in front of the seawall which runs parallel to the wall for its entire length.

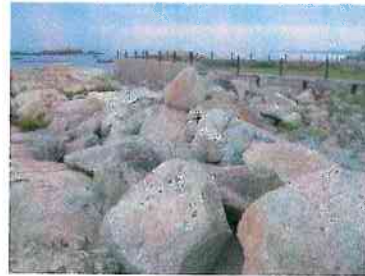
This is a small stone revetment of random placed stone, fronted by bedrock. Much of the stone is not interlocked.

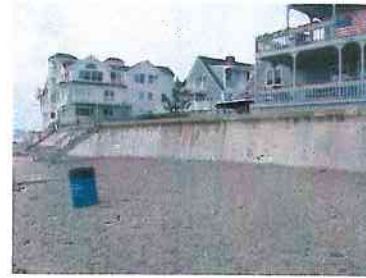
This is a vertical concrete seawall with a wave return face. All aspects of the structure are like new.

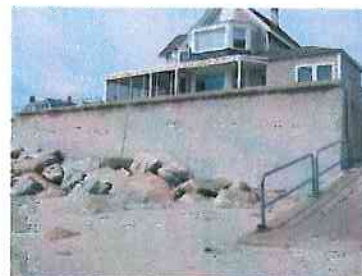
This structure is a vertical concrete seawall with a wave return face. The wall is fronted by a stone revetment.

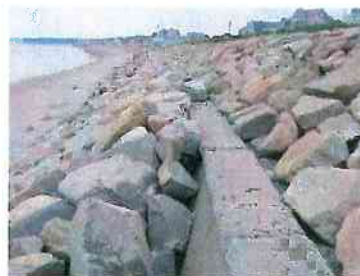
This structure is a stone revetment which covers a vertical concrete wall. The wall crest is visible in some areas but otherwise is completely enclosed in the revetment. The armor stone is weathered and has come dislodged in some sections.

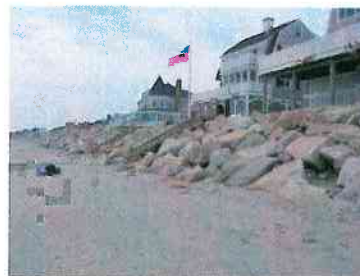
This structure is a stone revetment. Approximately 25% of the armor stones have become dislodged.

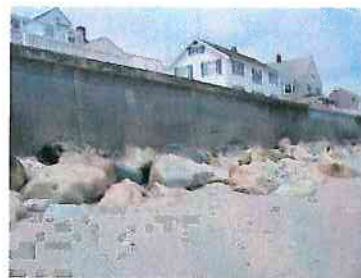
This structure is a concrete seawall with a wave return face cap and riprap at the toe. Strong weathering and discoloration are evident. Some sections of the crest exhibit minor displacement forward. There is steel sheetpile driven at the toe which has started to become exposed in some sections.

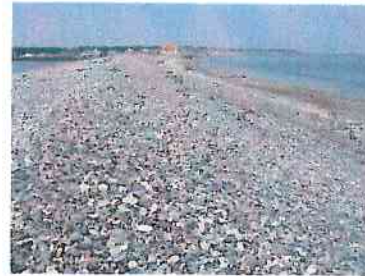
This structure is a cobble berm, located back from the normal surf zone where it functions as storm protection. The majority of this berm fronts Musquashicut Pond. A typical 2-tiered cross section is evident. The crest is even and wide for the length of the structure. Some overwash occurs as evidenced by areas of slight reduction of crest elevation and bulge of cobble material along the back slope of the berm.

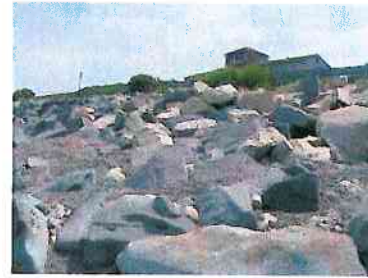
This structure is a revetment of dumped and random placed stone. The side slopes and structure crest vary considerably along the length of the structure. There is little to no interlocking between the armor stone. Slumping/movement is apparent along approximately 50% of the structure.

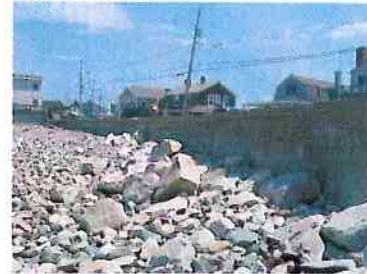
This structure is a concrete seawall with a recurved cap and riprap placed along the toe. The wall shows significant cracking and spalling throughout.

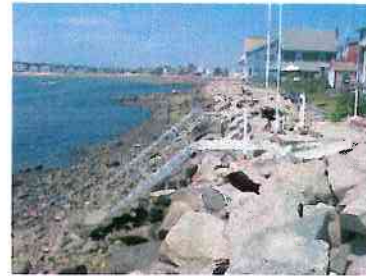
This structure is a stone revetment which runs along the northern edge of Scituate Harbor. The armor stones exhibit normal weathering and some have become displaced in small sections.

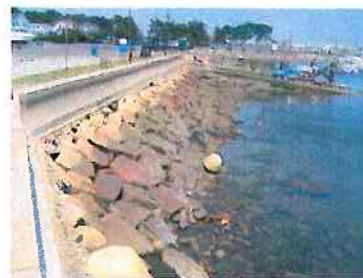
This structure is a concrete seawall with a wave return face and stone revetment at the base. The wall and stone are in good condition.

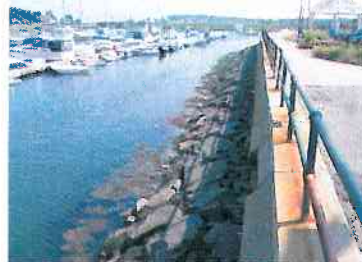
This structure is a concrete seawall with railing fronted by a stone revetment. The revetment shows weathering and cracked stone with some slumping evident. The wall is cracked and spalled and the railing is bent and rusted in sections.

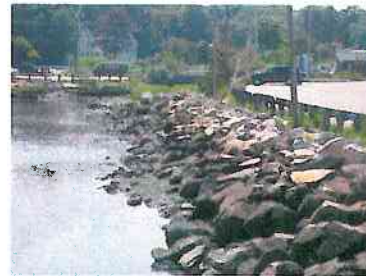
This structure is a revetment of random placed and dumped stone along the backside of a parking lot. The stone is weathered and slumping.

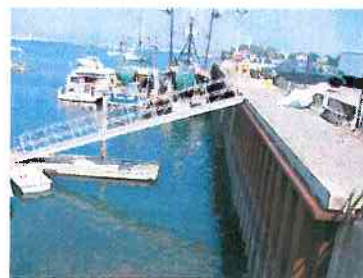
This is a sheet pile pier. The sheetpiling and wooden piles around the perimeter look weathered but sound. The toe/foundation of the pier is not accessible to be rated as it is under water.

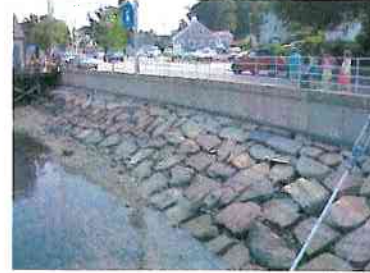
This structure is a concrete seawall with a railing and a stone revetment at its base. Both the wall and revetment are in good condition. There is minor cracking along the wall crest.

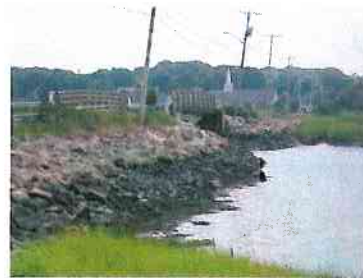
This is a revetment of random placed and dumped stone along the East side of the bridge along Edward Foster Road/Bridge Avenue. The revetment is weathered and shows some minor slumping.

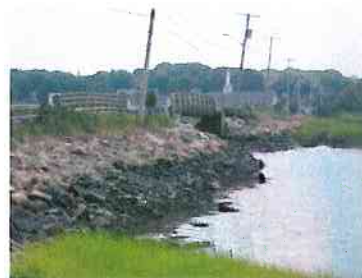
This is a revetment of random placed and dumped stone along the West side of the bridge along Edward Foster Road/Bridge Avenue. The revetment is weathered and shows some minor slumping.

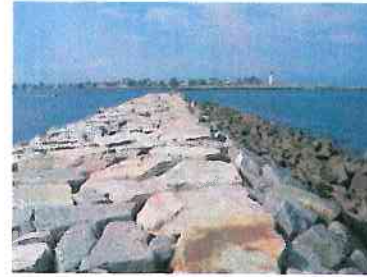
This is a rubble mound jetty at the south side of the entrance to Scituate Harbor. The crest and side slopes are consistent elevation and slope. There is also a stone apron at the seaward toe which wraps around the head of the structure. This apron is also in good condition. There are a few armor units which have cracked and at least which has been displaced.

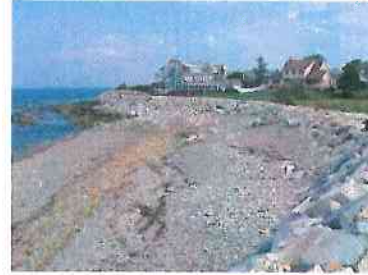
This structure is a rubble mound revetment around the perimeter of First Cliff. Some of the armor stone is cracked and there are sections which are beginning to unravel.

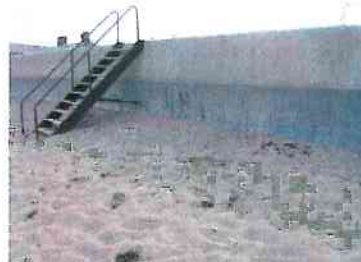
This structure is a concrete seawall. It is a continuation of the adjacent structure but without the fronting revetment and now with a approximately 3feet high concrete cap block along the crest. The wall is in decent shape and shows only minor weathering.

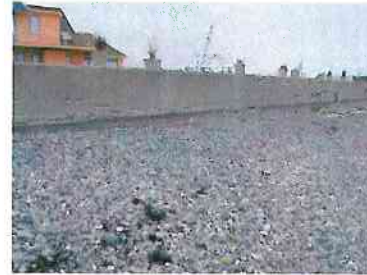
This is a concrete seawall with a 3feet high concrete cap placed on the crest. This section is a continuation of adjacent structure but is in worse condition. Cracking and spalling is evident throughout.

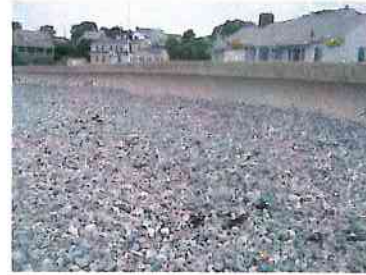
This is a concrete seawall with a wave return face fronted by a cobble beach. The wall shows minor cracking and spalling and is generally in good condition.

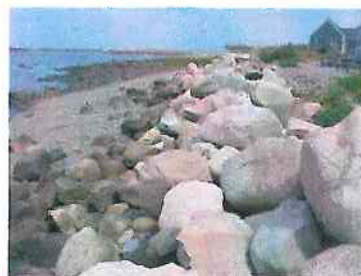
Dumped rip rap slope (45 degrees) with no defined toe or top. Erosion thru and inshore of rip rap. 1 to 2 ton stones typical. Some movement of stones.

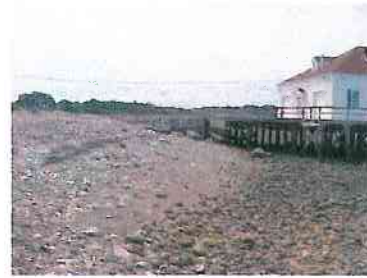
Timber bulkhead forming filled wharf with revetment on south side (500 to 1000 lb. stone). North side has concrete blocks and cobble beach. Pile supported building and pier outshore of bulkhead.

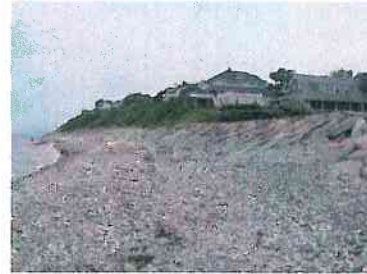
This structure is a rubble mound revetment along the base of Second Cliff. The revetment is in good shape on the whole, but there are 3 to 4 large areas which have slumped and become unraveled from toe to crest. These failing areas threaten the stability of the surrounding good sections and should be repaired before further damage spreads.

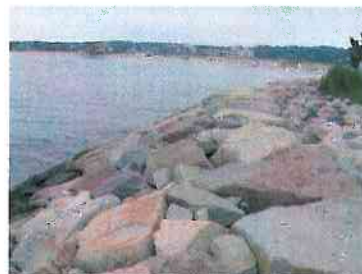
This is a stone revetment which covers the end of Second Cliff as it loses elevation and transitions into Peggotty Beach. The revetment side slopes and crest appear in good condition but close examination of the side slopes revealed large voids between armor stones, some voids reaching 3 to 4 feet.

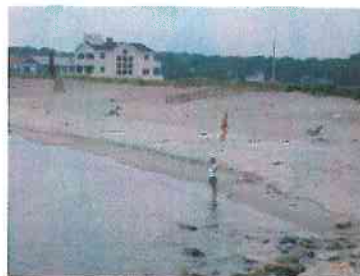
This structure is a stretch of sandy shoreline know as Peggotty Beach. The beach width is narrow and the high water rack line is onto the road (Town Way Ext.) suggesting that the beach is highly eroded.

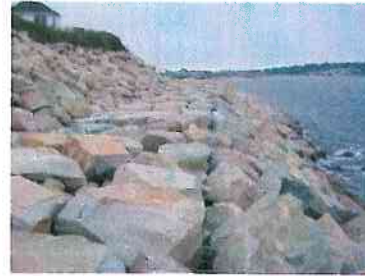
This structure is the stone revetment which lies along the base of Third Cliff. One section of major slumping exists near the middle of the revetment. In general the structure looks to be in good condition, however isolated areas do show significant armor stone movement. These sections should be repaired before the damage can spread and be monitored after storms until repairs can be made.

Condition**C****Rating****Fair****Level of Action****Moderate****Description**

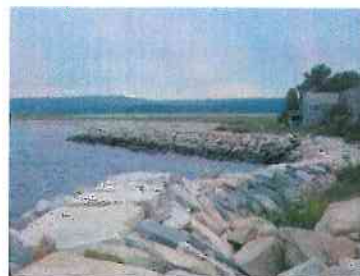
This structure is a stone dike at the terminal (southern) end of the revetment around Third Cliff. The structure shows armor stone slumping and failure at two locations and also at the head.

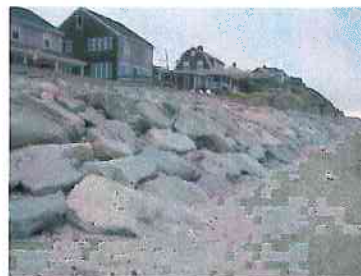
This structure is a stone revetment at the northeastern end of Humarock, immediately south of the military land. The stone is unraveled in many sections, with areas where the revetment is slumped and not functional. Certain sections of the cliff above the revetment have been armored and grouted.

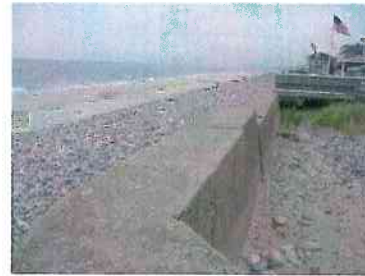
This structure is a short concrete seawall that runs along Humarock beach from Newell Street south to Marshfield Avenue. Most sections of the wall have seen the cobble beach pushed back up to the crest of the wall. There are some surface cracks evident and displacement of the wall in sections. The fact that the wall is buried by the cobble beach in most sections makes inspection difficult.

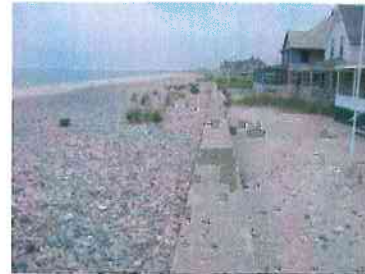
This structure is a short concrete seawall that runs along Humarock beach to the south, starting from Marshfield Avenue. Most sections of the wall have seen the cobble beach pushed back up to the crest of the wall. Surface cracking and spalling are evident throughout.
