SOUTH SHORE WATERSHEDS

South Shore Watersheds

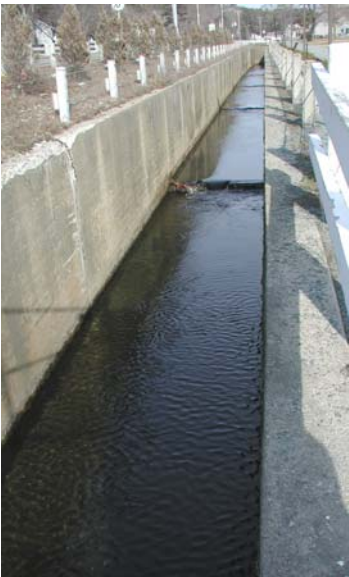
Lower section of fishway to Herring Run Motel Pool

| Notched weir-pool | Concrete with metal slots and wooden baffles | 364.0 | 8.1 | 10 | 7 | 1.4 | ~2.5 | 59.5 | Fair Passable |

Long section of fishway

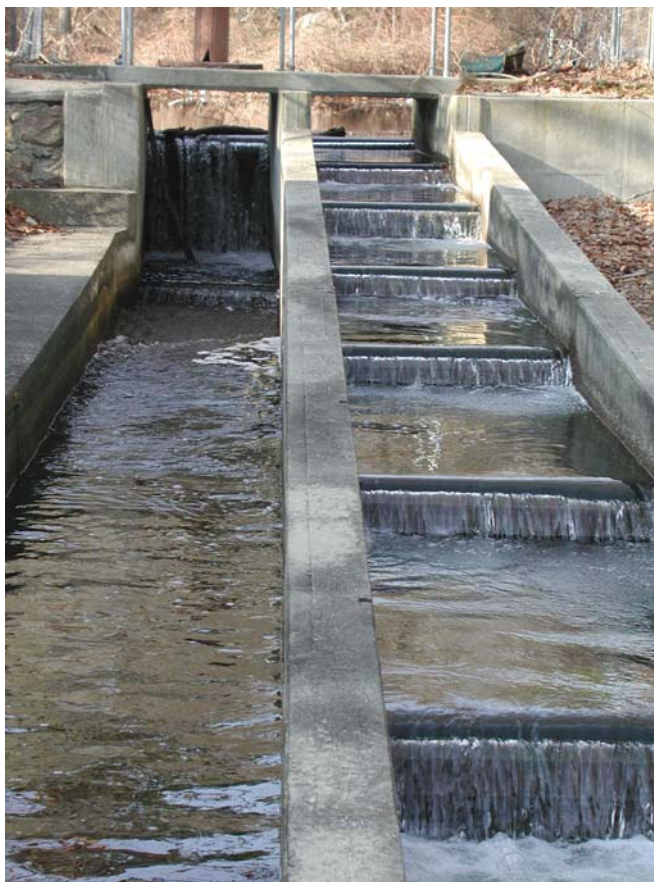
Benoit's Pond Dam (with ladder)

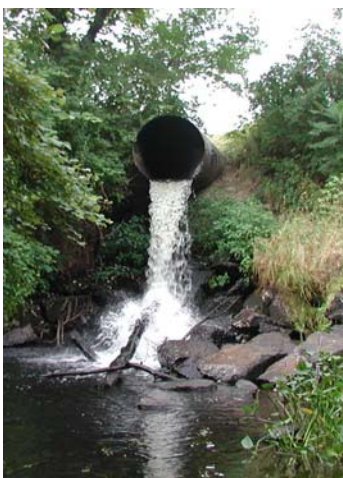
Hayden Mill Pond spillway

The primary spawning habitats on this stream are 20.5 acre Hayden Pond and 42.2 acre Russell Millpond. In 1980 a dilapidated fishway at Hayden Pond was replaced by DMF with a concrete and wooden Denil ladder. This ladder is in good condition and functions well. At Russell Millpond, however, a weir-pool fishway was allowed to be shut down at the request of the dam owner due to the possibility of further damage to the already unsafe dam. Since that time, the Town of Plymouth has planned repair work to both dams and has agreed to include fishway restoration in the plans. At this writing funds are being sought to construct a new ladder and provide access to the larger of the two impoundments.

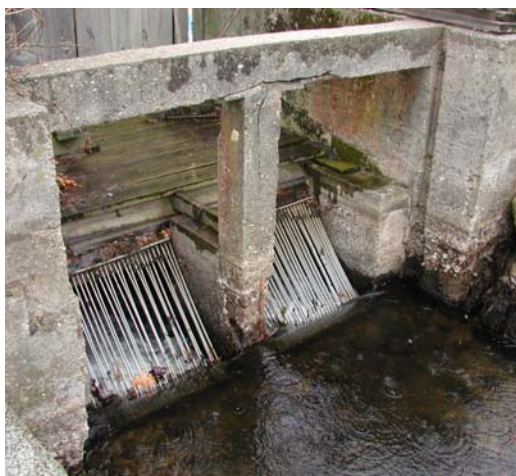
Russell Mill Pond Dam

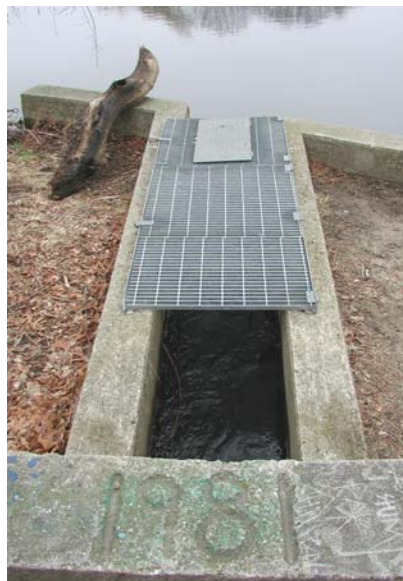
| Weir-pool | Concrete with wooden baffles | 78.0 | 2.0 | 3.6 | 4 | 1.4 | - | 6.0 | Fair Inefficient passage |

Upper fishway at Newfield Street

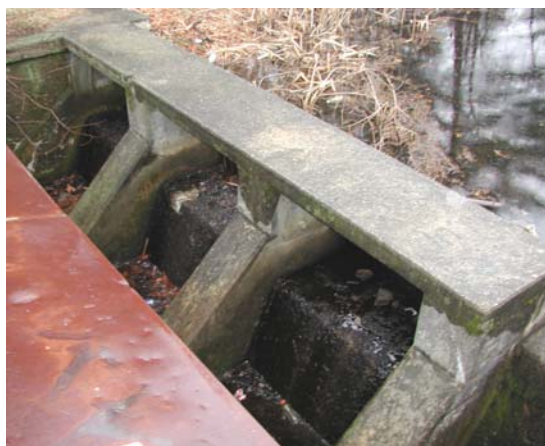
Silver Lake Dam

The Jones River has 640 acre Silver Lake as its headwater. Silver Lake is a water supply for the City of Brockton and very little if any water flows into the river. Consequently, the bulk of the system's river herring spawning occurs in its Furnace Brook tributary. Three obstructions including the Silver Lake dam impact fish passage. The first, at Elm Street in Kingston was formerly equipped with a deteriorating, obsolete notched weir-pool ladder. In 2001 this structure was fitted with an aluminum steep pass insert at the recommendation of DMF. River herring can now efficiently move beyond the dam. A second dam located at Wapping Road prevents any further movement up the Jones River and it is below this point that river herring turn into Furnace Brook.

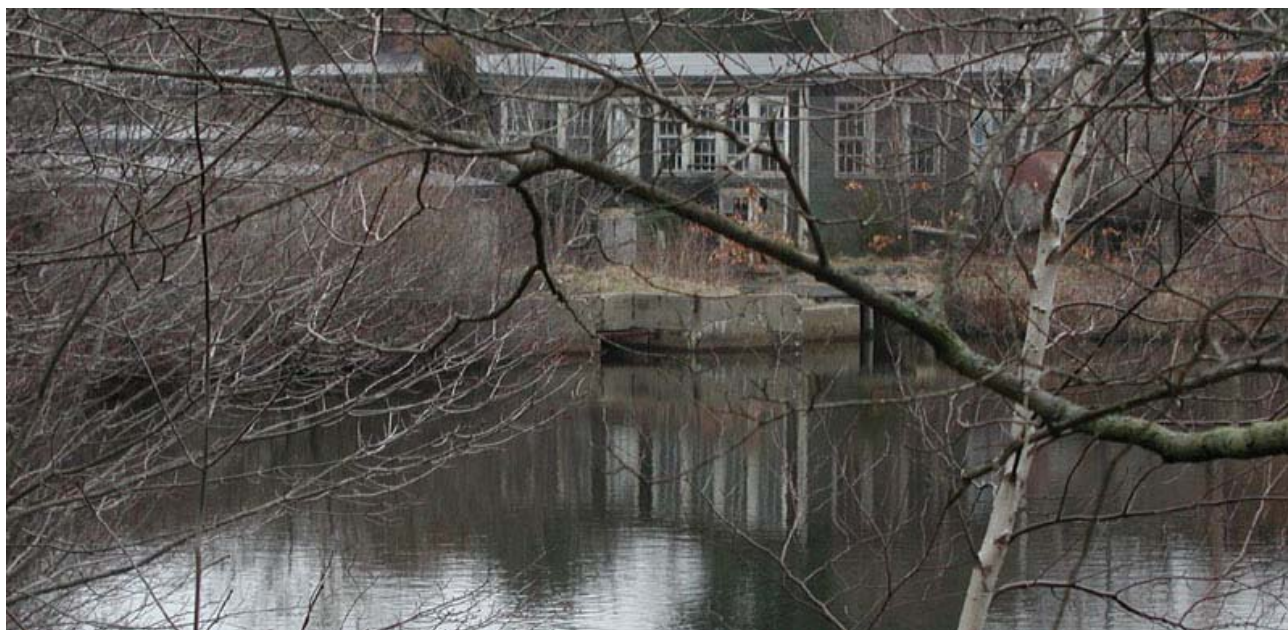
Foundry Pond Dam

Smelt Brook originates in 44 acre Smelt Pond and flows to the Jones River estuary forming 7.2 acre Foundry Pond along its course. Although Smelt Brook offers a significant amount of habitat, the industrial development along the upper stream and the difficulties which would be encountered in establishing passage at Foundry Pond present significant challenges for development. Smelt spawning is known to occur in the area of Rt. 3A.

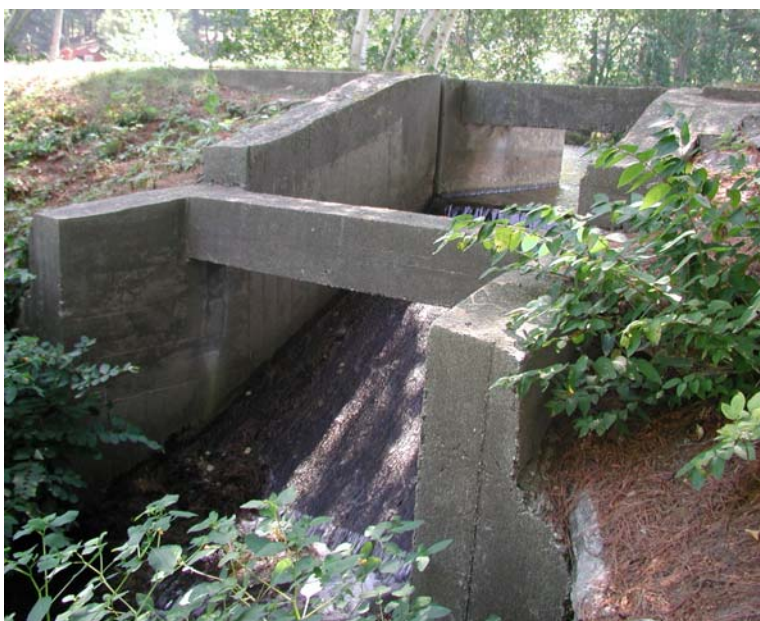
Lucas Pond Dam

This small stream drains 2.1 acre Lucas Pond. The pond is inaccessible to river herring. Small numbers of smelt have been observed spawning in the lower reaches of the stream.

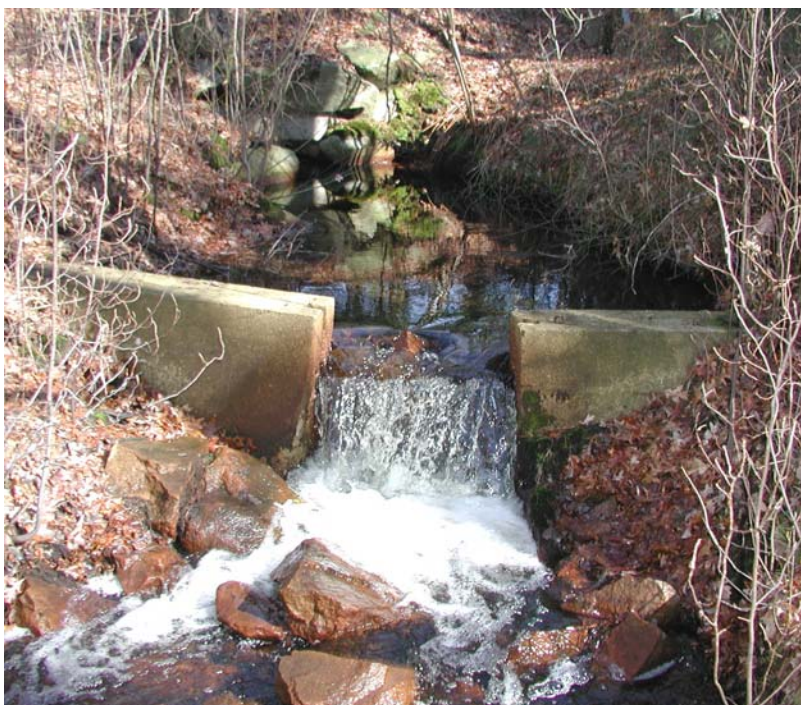
Island Creek Pond control structure

Three obstructions block fish passage on this Duxbury stream and a railroad embankment culvert may form a fourth when clogged with debris. The culvert, which is downstream of Rt. 3A, must be cleaned on a regular basis during the spawning season to insure passage. The first dam at Mill Pond is provided with a weir-pool fishway that has become deteriorated and no longer functions properly. Restoration of the ladder would provide access to the 7.1 acre impoundment. The second obstruction is a natural elevation change in the form of a steep, rock strewn streambed that creates a difficult passage problem. A 1.6 foot high dam at the outlet of Island Creek Pond is the third obstruction. Although the headwater pond provides 45 acres of potential habitat, the problems that would be encountered in establishing passage here make this an unlikely project. Rainbow smelt have recently been observed in the section of the stream below the first dam.

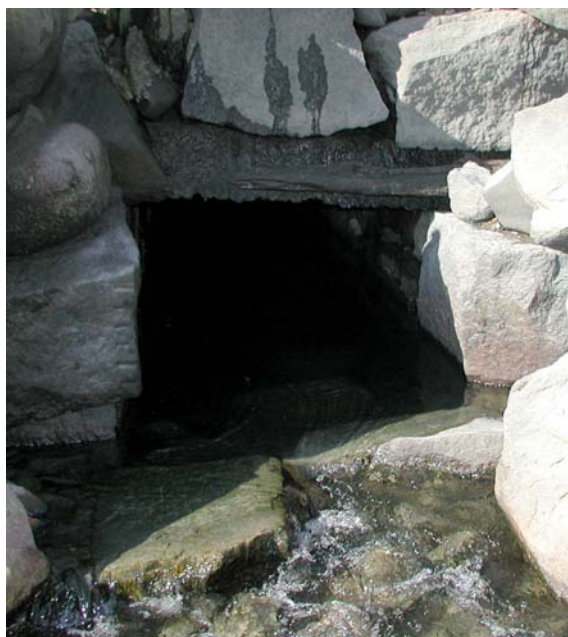
Downstream view of culvert at Damons Point Rd.

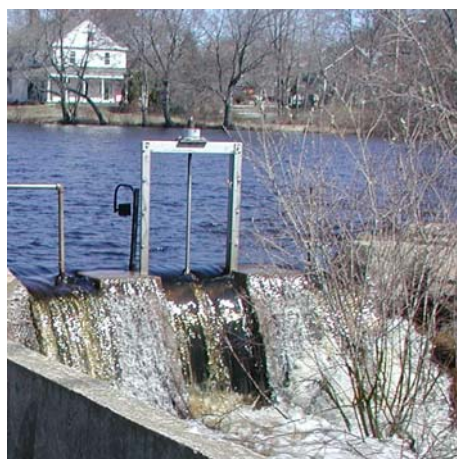
Old Oaken Bucket Pond Dam

The Town of Scituate uses this system extensively as a water supply. A weir-pool ladder at Old Oaken Bucket Pond provides access for spawning adult river herring to that impoundment. Low water levels in the fall due to withdrawals make downstream migration of juveniles unlikely and it is not known if a population still exists in the system. A second weir-pool ladder was installed at the second dam, built in 1969, and is not functional due to its poorly designed exit elevation. Rainbow smelt eggs have been observed in the stream below the first dam but no recent reports of smelt presence have been received.

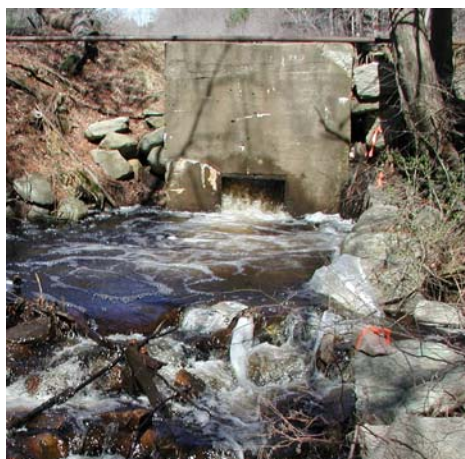
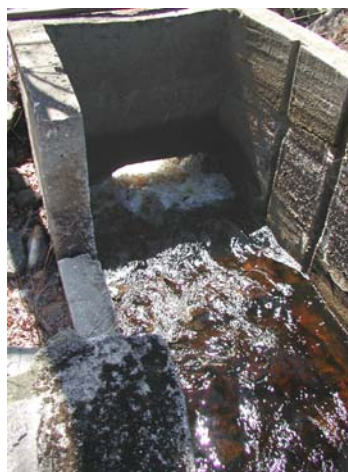
Mill Pond Dam downstream (left) and upstream (right)

This tributary to the North River has six obstructions to fish passage before its headwaters, 55 acre Jacobs Pond can be accessed. Although the second dam, at Mill Pond, is being considered for removal, the need for at least four fishways to provide passage to the headwaters reduce this system to a low priority site. Small numbers of smelt eggs have been observed in the stream just above its confluence with the North River.

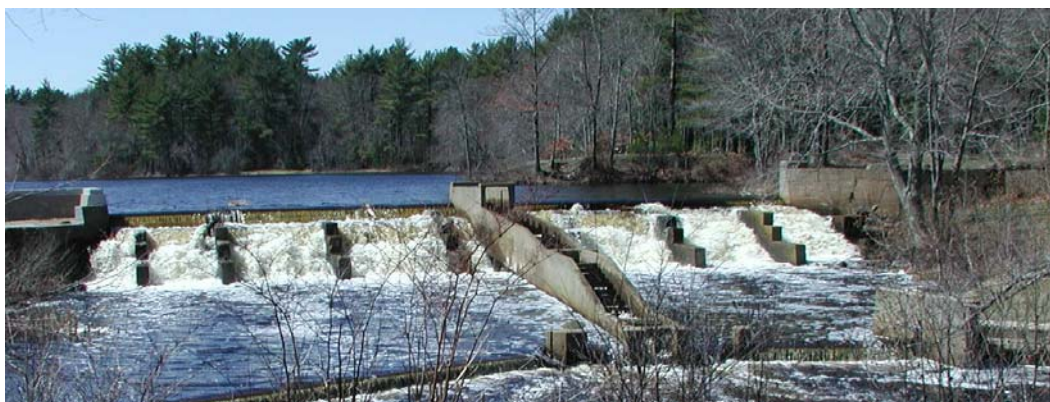
Elm Street Dam (fishway is in center of structure)

Furnace Brook provides the primary river herring spawning/nursery habitat for the Jones River system. With the 2001 restoration of the Elm St. fishway, the numbers of fish reaching the brook should increase significantly. Of the five fishways on the stream, three are in good condition and function adequately. The remaining two require repairs to maintain efficiency. The weir-pool ladder below Sylvia Place Road needs to have new baffles installed and the fishway at Russell Pond is badly deteriorated and must be completely replaced. To complicate matters, the Russell Pond dam is in poor condition and the question of removal has been raised. Since the 10.4 acre impoundment is the largest spawning area on the stream, removal could have a serious impact on this population.

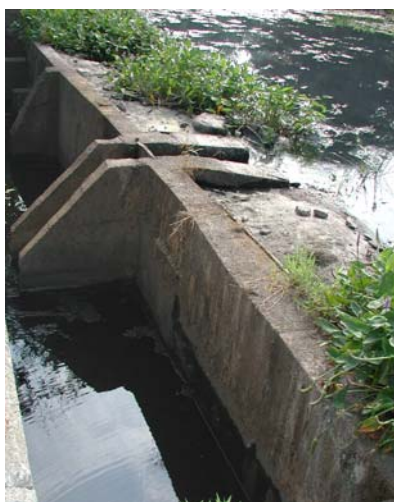
Hunters Pond Dam

Bound Brook is formed by the confluence of Aaron River and Herring Brook, which in turn flow from Aaron River Reservoir and Lilly Pond, water supplies for the Town of Cohasset. A poorly designed, deteriorating notched weir-pool ladder at Hunters Pond is impassable and should be replaced. Temporary modifications have been designed to provide some degree of function but have not been implemented to date. Relatively new fishways have been installed at the Beechwood St. dam and at Aaron River Reservoir, and should efficient passage be made available at the first dam, the river herring population has the potential to increase substantially. While DMF does not generally endorse the development of anadromous fish populations in public water supplies, the Town of Cohasset has expressed interest in maintaining such a herring resource in the reservoirs. In addition to river herring, rainbow smelt are known to spawn in the stream below Hunters Pond.

6. The fishway at Hunters Pond on Bound Brook should be redesigned and replaced.
7. The fishway below Sylvia Place Rd. on Furnace Brook in Kingston should be repaired.
