Manhole Inspection Report

MH# S2-2767

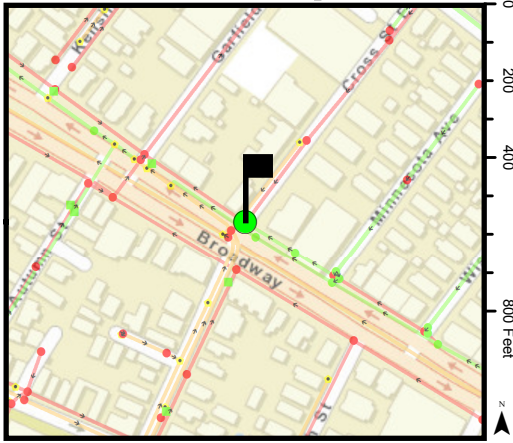
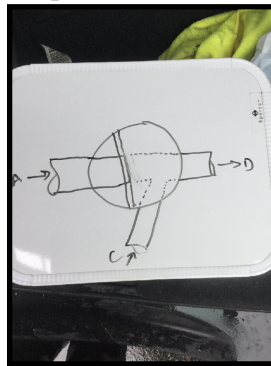
S2-2750

Pipe Size	Material	From / To MH#	Invert Depth (from rim)	Flow Depth (from invert)	Debris Depth (from invert)	Condition
A.	12"	Unknown	S2-2738	9.61'	2"	0"	Good
B.							
C.	10"	Unknown	S2-2312	9.71'	2"	0"	Good
D.	12"	VCP	S2-1927	11.08'	2"	0"	Good
E.							
F.							
G.							
H.

Recommendations- No Action

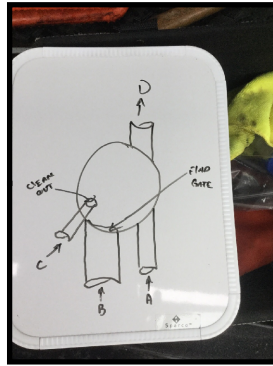
CA-2752

General Comments: Flap Gate in poor condition

Pipe Size	Material	From / To MH#	Invert Depth (from rim)	Flow Depth (from invert)	Debris Depth (from invert)	Condition
A.	18"?	Unknown	CA-450	13.51'	18"	1"	Fair
B.	24" Flap Gate	DI	CA-5278	12.45'	1"	0"	Poor
C.	6"	PVC	Unk	5.98'	1"	0"	Good
D.	20"	Unknown		14.01'	18"	0"	Fair
E.							
F.							
G.							
H.

Recommendations- Rebuild

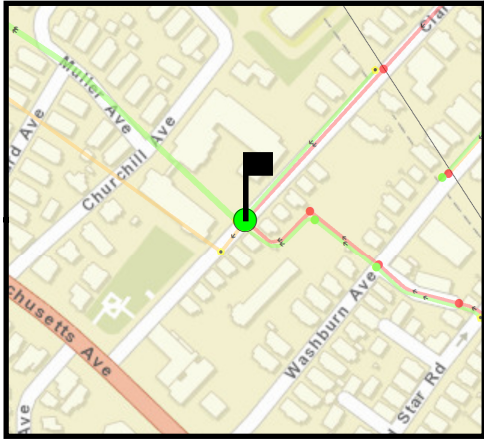
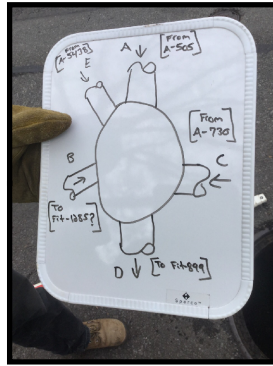
Paved- Cracked

Pipe Size	Material	From / To MH#	Invert Depth (from rim)	Flow Depth (from invert)	Debris Depth (from invert)	Condition
A.	10"	VCP	A-505	8.10'	6"	1"	Good
B.	10"	VCP	FIT-1285?	7.41'	1"-2"	0"	Good
C.	12"	VCP	A-730	7.97'	5"	0"	Good
D.	15"	VCP	FIT-899	8.37'	8"	0"	Good
E.	8"	VCP	A-5438	5.47'	<1"	0"	Good
F.							
G.							
H.

Recommendations- Clean/Remove Debris from invert

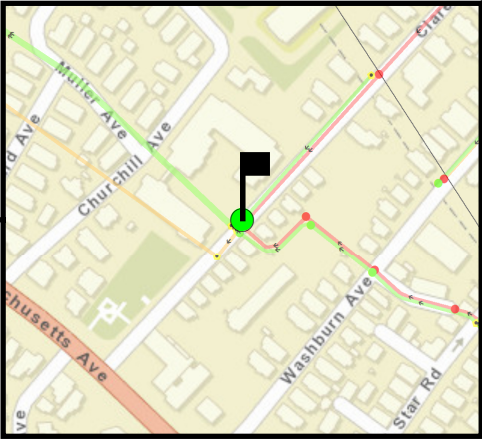
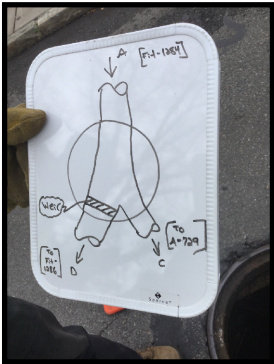
Weir- (Y/N): Y
Rim to top of weir: 4.18'
MH Channel- (Y/N): Y
MH Channel Condition: Good
Area Around MH Condition:
Paved- Cracked
MH Condition:
Good

Pipe Size	Material	From / To MH#	Invert Depth (from rim)	Flow Depth (from invert)	Debris Depth (from invert)	Condition
A.	15"	VCP	FIT-1284	4.70'	2"	0"	Good
B.							
C.	8"	VCP	A-729	4.71'	<1"	0"	Good
D.	15"	VCP	FIT-1286	4.70'	0"	0"	Good
E.							
F.							
G.							
H.

Recommendations- No Action

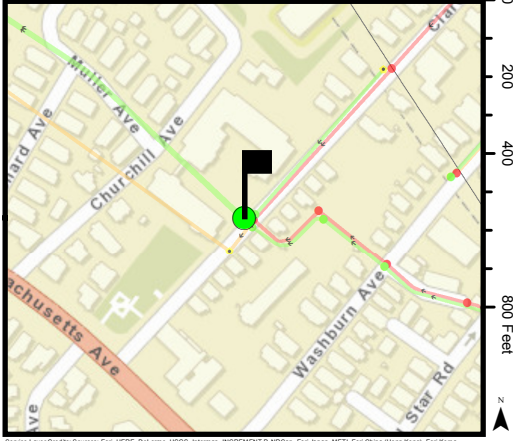
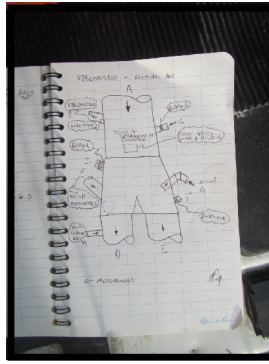
S78CMH9500

Pipe Size	Material	From / To MH#	Invert Depth (from rim)	Flow Depth (from invert)	Debris Depth (from invert)	Condition
A.	7.3'Wx4.1' - 4.4'H Conc Bot/Brick Top	Other		6.3			
B.	10"	VCP	Underflow to S78COM0210	6.8	2"	1"	
C.	8"	VCP	Bulkheaded	N/A	N/A	N/A	N/A
D.	54"	RCP		6.29	1"		
E.	54"	RCP		6.29	1"		
F.	15"	VCP	From D41DMH9965	5.3	0	0	
G.	8"	PVC		4.25	0	0	
H.	6"	VCP		3.1	0	0

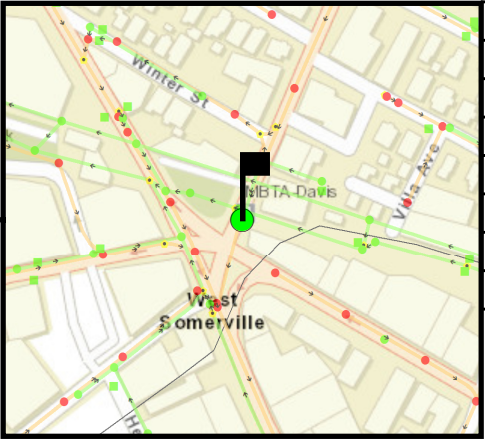
MH#CA-5916

Pipe Size	Material	From / To MH#	Invert Depth (from rim)	Flow Depth (from invert)	Debris Depth (from invert)	Condition
A.	5'W x 7'H Concrete Box Culvert	Other		15.27'		6-8"	
B.	30"	DI		9.77	1"		
C.	24" Corrugated Metal	Other		9.07			
D.	5'W x 7'H Concrete Box Culvert	Other		15.27'		6-8"	
E.							
F.							
G.							
H.

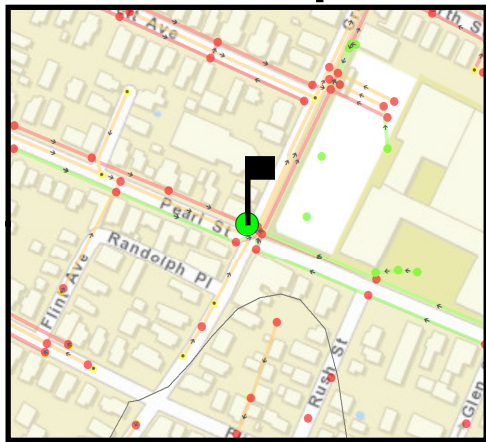
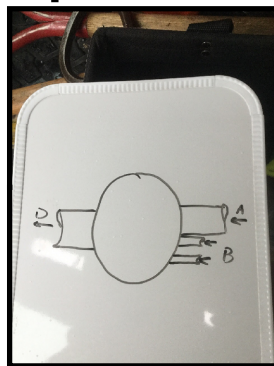
Pipe Size	Material	From / To MH#	Invert Depth (from rim)	Flow Depth (from invert)	Debris Depth (from invert)	Condition
A.	18"	VCP	S2-1441	14.83'	1"	0"	Good
B.	(2) 5"	VCP	CB	1.99	0"	0"	Fair
C.							
D.	18"	VCP	Unk; inline.?	16.77'	12"	0"	Good
E.							
F.							
G.							
H.

Recommendations- No Action

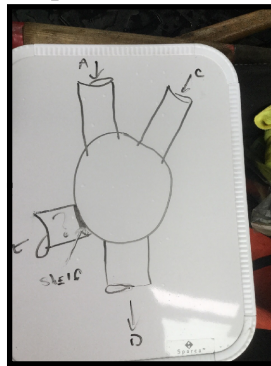
S2-1577

General Comments: No pipe observed from Pearl St (South) but could be weir; recommend CSE

Pipe Size	Material	From / To MH#	Invert Depth (from rim)	Flow Depth (from invert)	Debris Depth (from invert)	Condition
A.	36"Wx24"H	Brick	Cross St (West)	13.18'	10"	0"	Good
B.							
C.	24"Wx36"H	Brick	Pearl St (north)	13.25'	10"	0"	Good
D.	Unk	Brick	S2-2139	13.48'	10"	0"	Good
E.							
F.							
G.							
H.

Recommendations- No Action

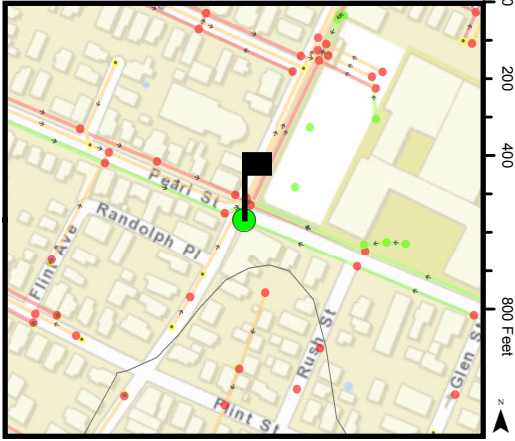
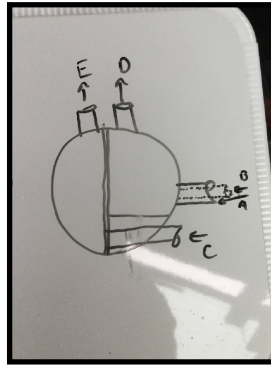
MH# S2-1578

Pipe Size	Material	From / To MH#	Invert Depth (from rim)	Flow Depth (from invert)	Debris Depth (from invert)	Condition
A.	10"	VCP	S2-1576	11.15'	2"	0"	Good
B.	10"	VCP	Unk	7.56'	0"	0"	Good
C.	8"?	Unknown	SS lateral?	6.38'	<1"	0"	Good
D.	10"	VCP	S2-2481	11.28'	2"	0"	Good
E.	8"	DI	S2-1566	11.06'	<1"	0"	Good
F.							
G.							
H.

Recommendations- No Action

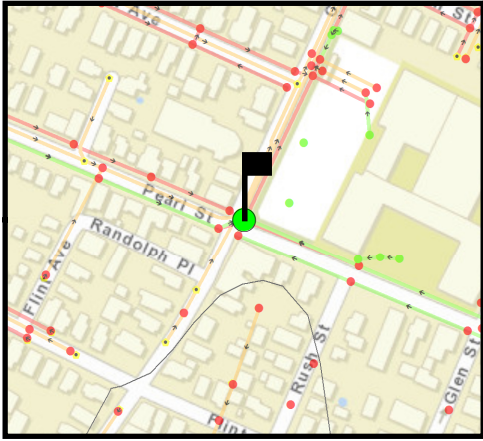
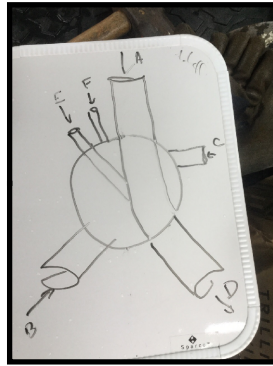
S2-2481

Pipe Size	Material	From / To MH#	Invert Depth (from rim)	Flow Depth (from invert)	Debris Depth (from invert)	Condition
A.	24"	VCP	Pearl St (North)	16.69'	8"-10"	3"-4"	Good
B.	12"?	Unknown	Pearl St (South)	16.26'	0"	0"	Good
C.	15"	Brick	Unk	14.90'	0"	0"	Good
D.	24"?	Unknown	S2-1621	16.33'	10"	1"	Good
E.	8"	VCP	Cross St (West)	15.71'	1"	0"	Good
F.	6"	VCP	Unk	12.20'	0"	0"	Good
G.							
H.

Recommendations- No Action

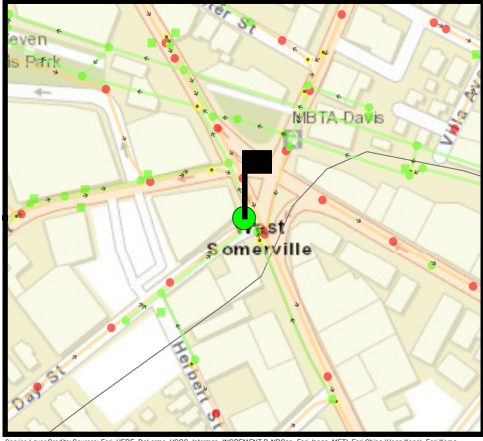
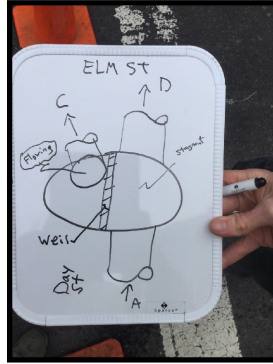
CA-3075

Pipe Size	Material	From / To MH#	Invert Depth (from rim)	Flow Depth (from invert)	Debris Depth (from invert)	Condition
A.	18"	Brick		8.49'	3"	2"	Good
B.							
C.	24"	VCP		11.42'	1"	0"	Good
D.	18"	Brick		8.53'	3"	1"	Good
E.							
F.							
G.							
H.

Recommendations- No Action

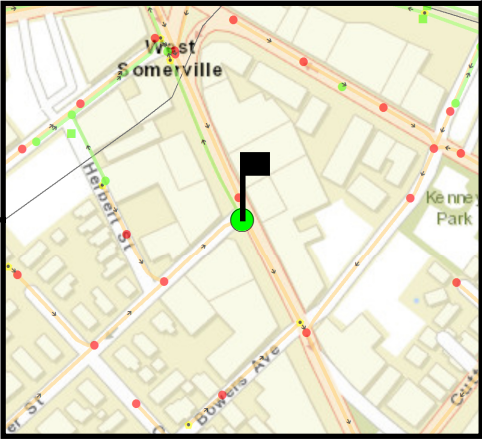
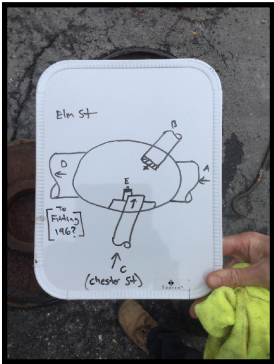
MH# 1-5026

Pipe Size	Material	From / To MH#	Invert Depth (from rim)	Flow Depth (from invert)	Debris Depth (from invert)	Condition
A.	Unknown	Brick		11.14'	0"	2"	N/A
B.	12"	DI		10.36'	Mechanical Plug		Fair
C.	24"H x 18"W (egg shaped)	RCP		10.45'	2"	0"	Fair
D.	30"	VCP		11.48'	3"	4"	Good
E.	6"	PVC		10.98'	Mechanical Plug	0"	Fair
F.							
G.							
H.

Recommendations- Clean/Remove Depris from invert

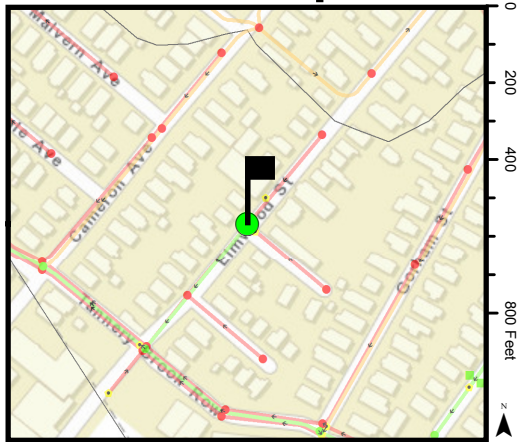
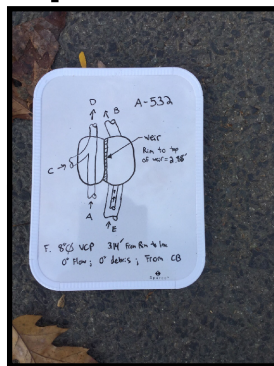
Pipe Size	Material	From / To MH#	Invert Depth (from rim)	Flow Depth (from invert)	Debris Depth (from invert)	Condition
A.	8"	VCP	A-531	6.28'	<1"	<1"	Good
B.	12"	VCP	A-5061	4.37'	0"	0"	Good
C.	8"	VCP	A-536	6.15'	0"	<1"	Good
D.	8"	VCP	A-533	6.42'	<1"	<1"	Good
E.	12"	VCP		4.27'	0"	0"	Good
F.	8"	VCP	CB	3.14'	0"	0"	Good
G.							
H.

Recommendations- Clean/Remove Debris from invert

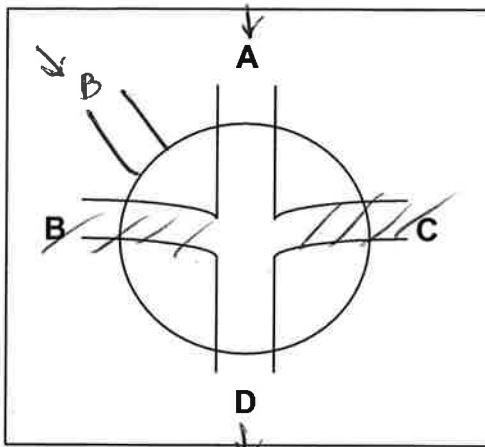
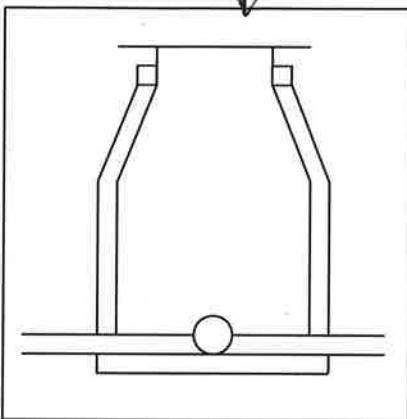
MH# C1-1354

5.65 to top of water

Pipe size	Material	From / To MH#	Invert Depth (from Rim)	Flow Depth (from Invert)	Debris Depth (from Invert)	Condition
A. 27" x 20"	Brick		6.40	0.75	1-2"	
B. 24" x (17") 20"	Brick	C1-1355	6.21	0.56	4-5"	
C.						
D. 30" x 21"	Brick		6.73	1.08	1-2"	
E.

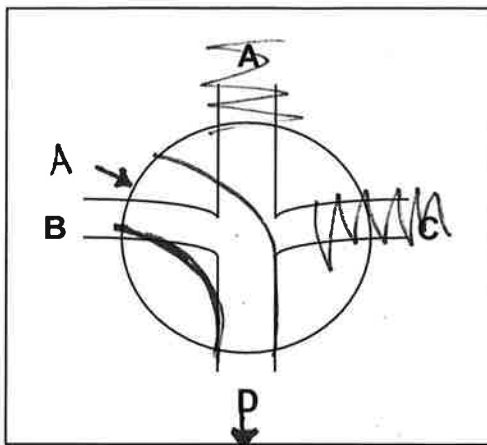
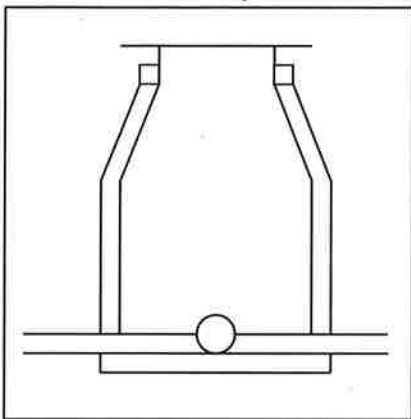
MH# C1-1355

Pipe size	Material	From / To MH#	Invert Depth (from Rim)	Flow Depth (from Invert)	Debris Depth (from Invert)	Condition
A.	<u>24" Ø</u>	<u>PVC</u>	<u>C1-5679B</u>	<u>5.88'</u>	<u>8" standing</u>	<u>~4"</u>	<u>Good</u>
B.							
C.							
D.	<u>24" Ø</u>	<u>PVC</u>	<u>C1-1354</u>	<u>5.92'</u>	<u>8" standing</u>	<u>~1"</u>	<u>Good</u>
E.

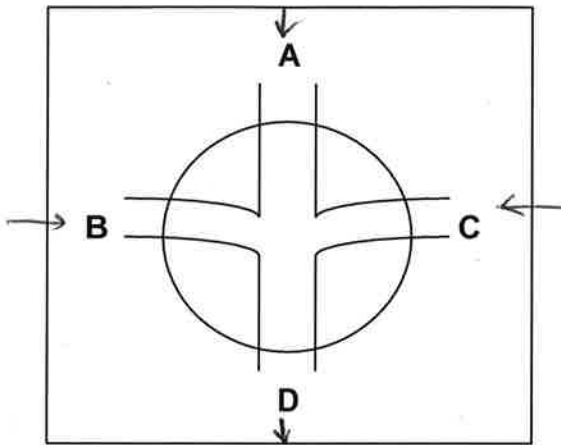
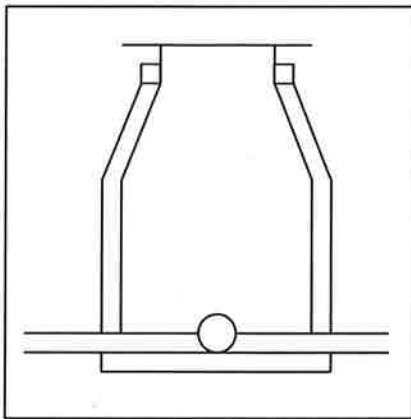
MH# C1-5679A

Note - Sound tested to DMH in b'ball court.

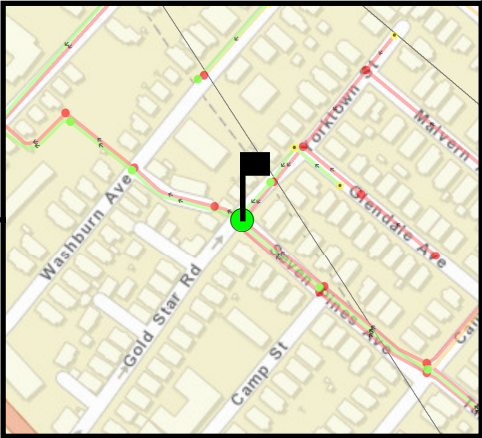
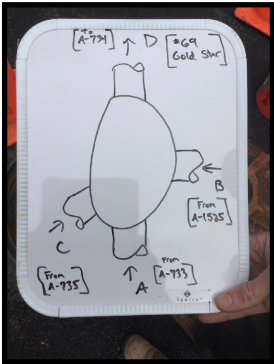
Pipe Size	Material	From / To MH#	Invert Depth (from rim)	Flow Depth (from invert)	Debris Depth (from invert)	Condition
A.	12"	VCP	A-733	8.09'	8"	1"	Good
B.	10"	PVC	A-525	7.92'	10"	1"	Good
C.	10"	VCP	A-735	8.06'	5"	1"	Fair
D.	12"	VCP	A-734	8.09'	8"	1"	Good
E.							
F.							
G.							
H.

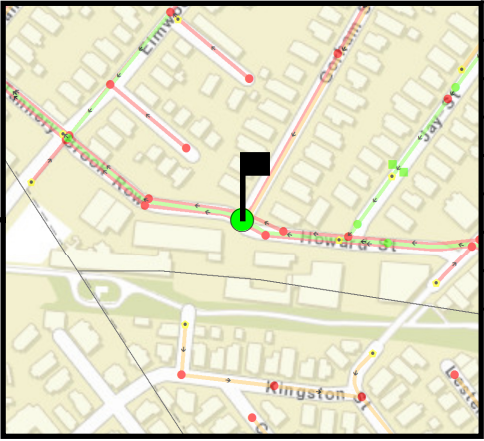
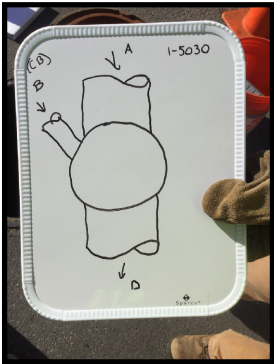
MH# 1-5030

Pipe Size	Material	From / To MH#	Invert Depth (from rim)	Flow Depth (from invert)	Debris Depth (from invert)	Condition
A.	48" x 52"	Unknown	FIT-16	8.85'	2"	0"	Good
B.	Unknown	Unknown	CB	8.21'	<1"	0"	Good
C.							
D.	48" x 60"	Unknown	1-5061	8.85'	2"	0"	Good
E.							
F.							
G.							
H.

Recommendations- No Action

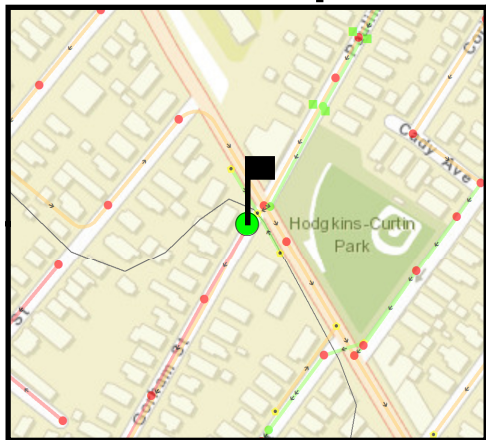
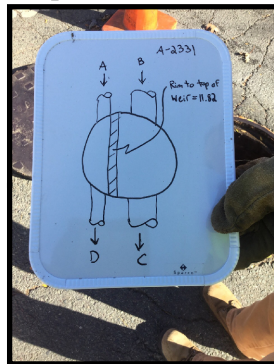
Pipe Size	Material	From / To MH#	Invert Depth (from rim)	Flow Depth (from invert)	Debris Depth (from invert)	Condition
A.	8"	VCP	CA-2397	17.21'	0"	0"	Good
B.	30"	Unknown	A-5353	14.97'	<1"	0"	Good
C.	30"	Unknown	Unknown	15.05'	<1"	0"	Good
D.	8"	VCP	Unknown	17.21'	0"	0"	Good
E.							
F.							
G.							
H.

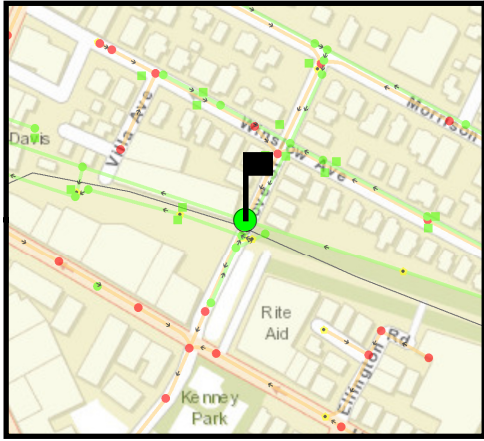
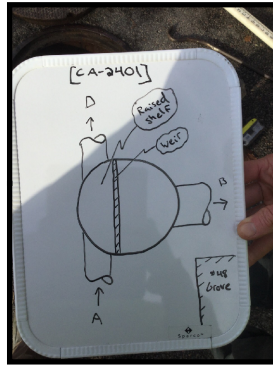
Pipe Size	Material	From / To MH#	Invert Depth (from rim)	Flow Depth (from invert)	Debris Depth (from invert)	Condition
A.	24"	Brick	CA-127	11.24'	8"	0"	Good
B.	30"	VCP	1-5280	13.21'	0"	1"	Good
C.							
D.	24"	Brick	C2-126	11.24"	8"	0"	Good
E.							
F.							
G.							
H.

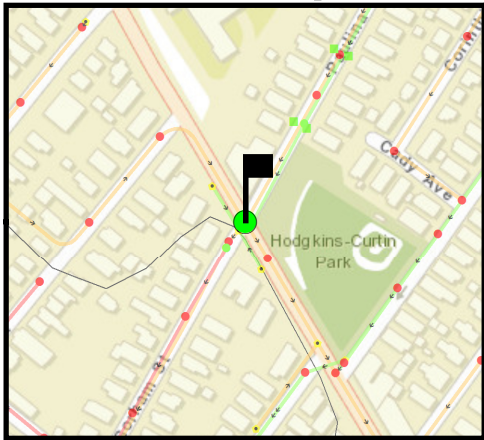
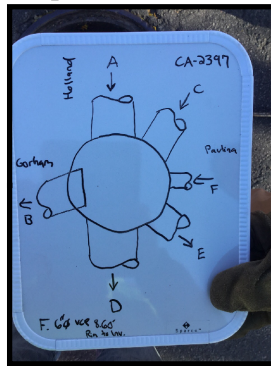
CA-2397

Paved- Cracked

Pipe Size	Material	From / To MH#	Invert Depth (from rim)	Flow Depth (from invert)	Debris Depth (from invert)	Condition
A.	30"	Brick	CA-398	14.34'	15"	0"	Good
B.	30"	N/A	Confirmed bulk- headed 12/20/18	12.54'	0"	0"	Good
C.	36"	Brick	CA-108	14.22'	12"	2"	Good
D.	36"	Brick	CA-399	15.35'	24"	2"	Fair
E.	30"	RCP	A-5353	9.84'	0"	0"	Good
F.	6"	VCP	UNK	8.60'	0"	0"	Good
G.							
H.

Recommendations- Clean/Remove Depris from invert

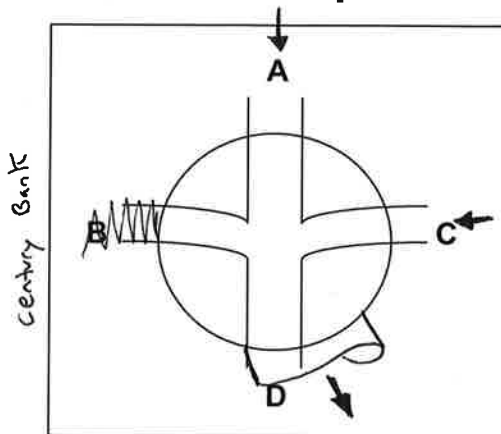
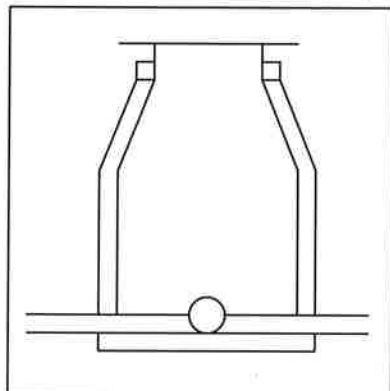
MH# 52-6086

Cracked

Pipe size	Material	From / To MH#	Invert Depth (from Rim)	Flow Depth (from Invert)	Debris Depth (from Invert)	Condition
A.	24"Ø	RCP	52-6085?	8.65'	<1" (orange)	0"	Good
B.							
C.	24"Ø	RCP	52-6245?	8.70'	0"	0"	Fair
D.	24"Ø?	RCP	UNK; could be connected to 52-3215	9.95'	<1" (orange)	0"	Fair
E.

Recommendations - No Action, Rebuild, Line Manhole Wall, Reset Frame, Clean / Remove debris from Invert

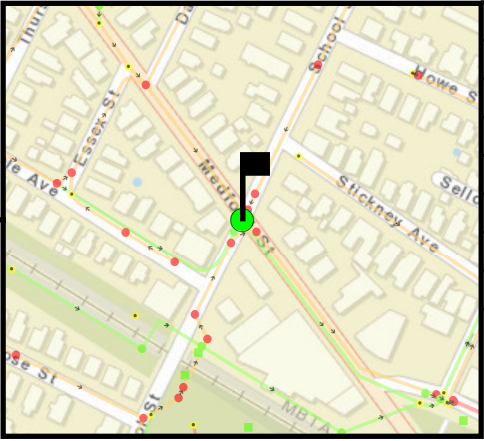
MH# 30-5112A

Pipe Size	Material	From / To MH#	Invert Depth (from rim)	Flow Depth (from invert)	Debris Depth (from invert)	Condition
A.	6"	VCP		8.80	<1"	0"	Good
B.	18"	VCP		6.59		0"	Good
C.	Unknown- Overflow to S2-2686	Unknown		6.69	<1"	0"	Good
D.	48"	Brick		8.61		0"	Good
E.	6"	VCP		8.8	<1"	0"	Good
F.							
G.							
H.

General Comments: Crack in manhole, 1.3' from top of weir to invert on other side of weir

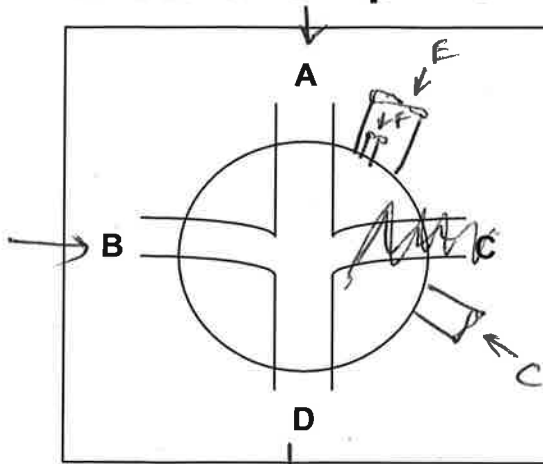
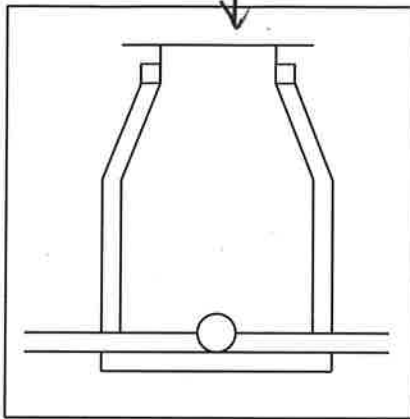
MH# 9-5186

Note - Sound test negative for adjacent SMH.

Pipe size	Material	From / To MH#	Invert Depth (from Rim)	Flow Depth (from Invert)	Debris Depth (from Invert)	Condition
F	4"	CI?	UNK.	5.34'	0"	0.1"	Good
A.	15"	VCP		5.81'	0"	0"	Good
B.	12"	VCP	CB?	5.67'	1"	0"	Fair
C.	12"	VCP	CB	4.71'	1"	0"	Fair
D.	20"	VCP		6.01'	1"	0"	Good
E.	12"	VCP	CB	4.43'	1"	0"	Good

Recommendations - No Action, Rebuild, Line Manhole Wall, Reset Frame, Clean / Remove debris from Invert

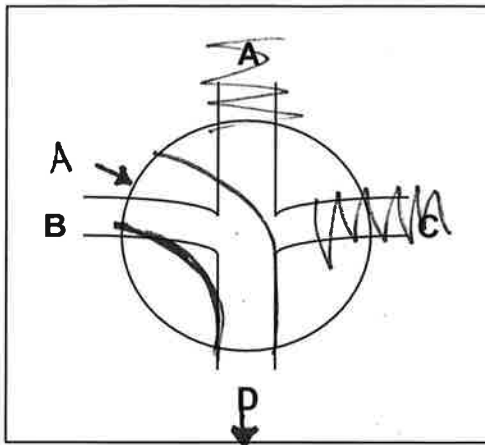
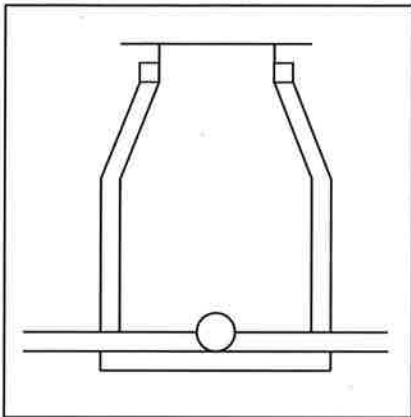
MH# C1-1355

Pipe size	Material	From / To MH#	Invert Depth (from Rim)	Flow Depth (from Invert)	Debris Depth (from Invert)	Condition
A.	<u>24" Ø</u>	<u>PVC</u>	<u>C1-5679B</u>	<u>5.88'</u>	<u>8" standing</u>	<u>24"</u>	<u>Good</u>
B.							
C.							
D.	<u>24" Ø</u>	<u>PVC</u>	<u>C1-1354</u>	<u>5.92'</u>	<u>8" standing</u>	<u>≈ 1"</u>	<u>Good</u>
E.

Recommendations - No Action, Rebuild, Line Manhole Wall, Reset Frame, Clean / Remove debris from Invert

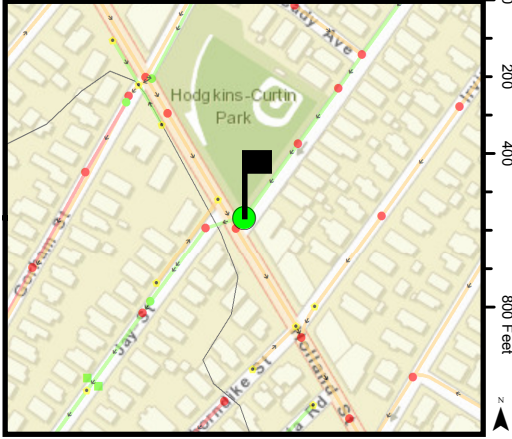
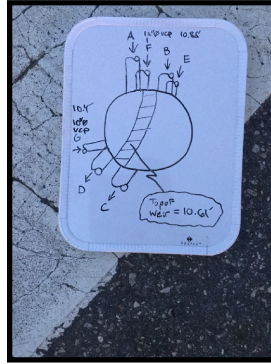
CA-2

Pipe Size	Material	From / To MH#	Invert Depth (from rim)	Flow Depth (from invert)	Debris Depth (from invert)	Condition
A.	15"	VCP		15.05'	1"	0"	Good
B.	8"	VCP		14.84'	4"	2"	Poor
C.	8"	VCP		14.84'	4"	2"	Good
D.	15"	VCP		15.05'	1"	0"	Good
E.	8"	VCP		12.08'	2"	0"	Fair
F.							
G.							
H.
