TAUNTON RIVER WATERSHED

Taunton River Watershed

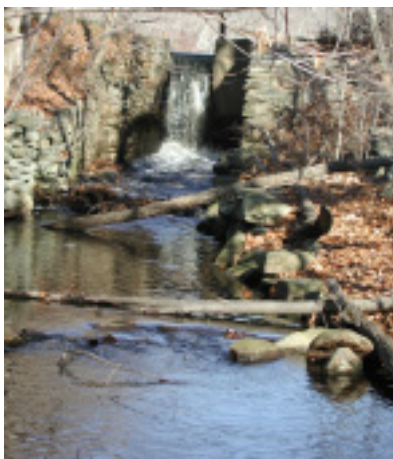
Western Spillway at Tisdale Pond

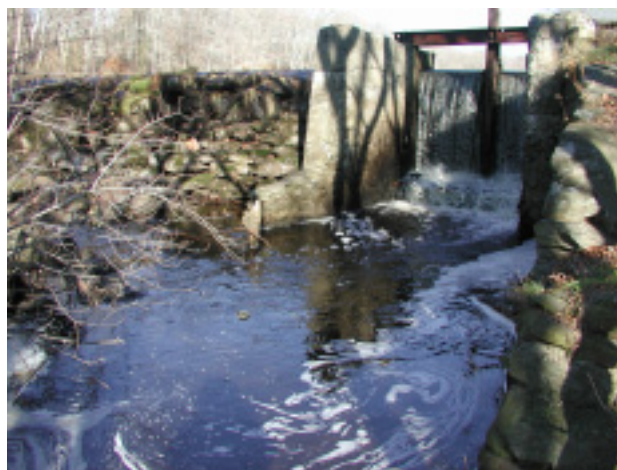
Eastern Spillway at Tisdale Pond

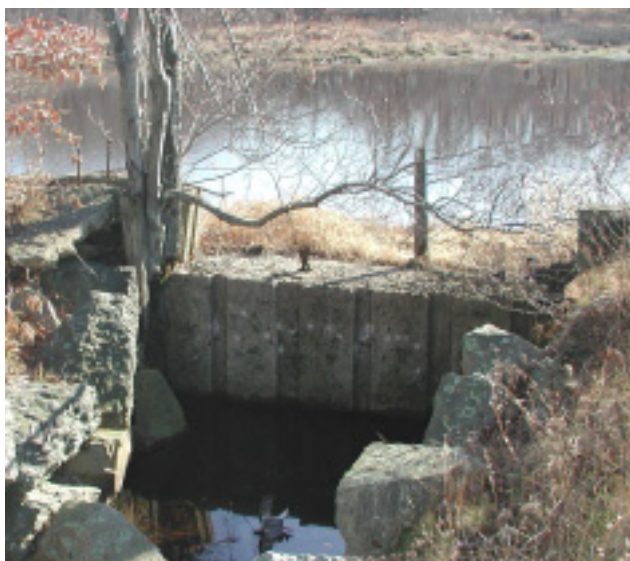
Bleachery Reservoir- Western Outlet

Rattlesnake Brook is a tributary to the Assonet River estuary. The stream is impounded at the Bleachery Reservoir. Although river herring and smelt have been observed just above the head of the tide, the impoundment's small size and the unusually low pH measured in the stream makes the brook a poor candidate for development. The existing spawning area below the reservoir should be protected and harvest of existing runs managed.

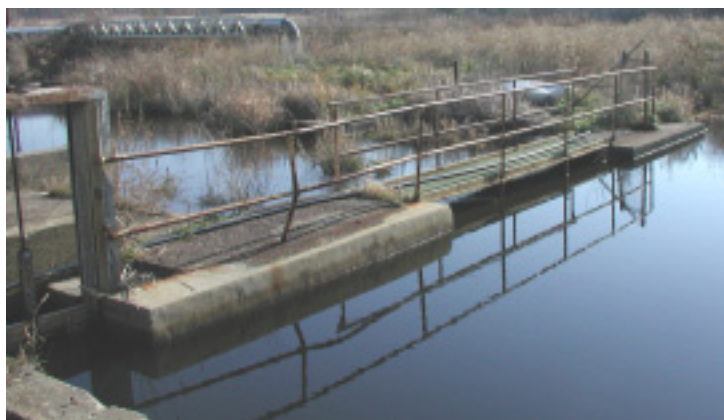
Dam on Zeneca Property

Muddy Cove Brook is a small tributary to the main stem Taunton River in Dighton. Several obstructions exist, two of which are passable at some tidal stages. The first, a tide gate at the stream mouth has deteriorated and allows fish to get by at higher tidal stages. The second is a concrete dam which has had its wooden stop logs removed and is passable under current water levels. A 17 foot dam blocks fish passage to a 23 acre impoundment. River herring have been reported to ascend to the base of that dam. The habitat available in the impoundment and the fact that the owner has expressed interest in installing fish passage facilities makes this system a good candidate for development.

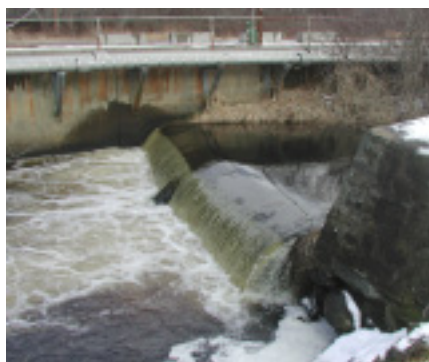
Dam above Harodite Factory

This tributary to the Taunton River forms the boundary between Dighton and the City of Taunton. The lower course is impounded by two currently impassable dams. The first, at the Harodite Company was equipped with a prefabricated, wooden Denil ladder. This structure was washed away by high water during the spring of 1998. The upstream impoundment has been stocked by DMF with blueback herring in anticipation of a replacement being installed. A more permanent structure has been designed for the site and is awaiting funding. A second dam at the Harodite location appears to be avoidable by way of a bypass channel a few yards from the spillway. A railroad trestle over the bypass channel, while not forming an obstruction itself, collects a large amount of debris which could impede passage and must be cleaned annually.

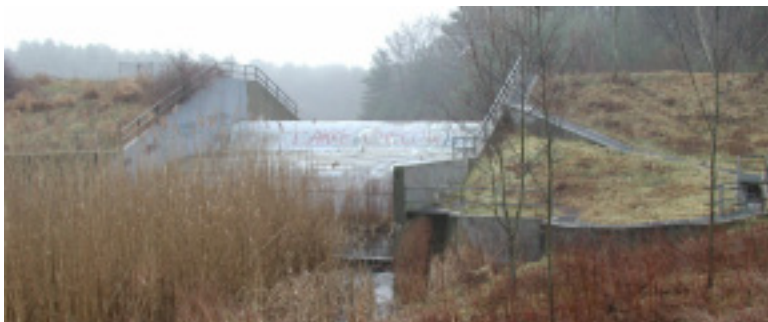
Lake Rico Dam

Design	Material	Length (ft)	Inside W (ft)	Outside W (ft)	# of Baffles	Baffle H (ft)	Notch W (ft)	Pool L (ft)	Condition/Function
Weir-pool	Concrete	170.0	2.0	4.0	20	Varied	-	Varied (6 – 8)	Good Passable

This stream flows for approximately one mile from Lake Rico to the Taunton River. The dam that creates Lake Rico was constructed by the Commonwealth's Department of Environmental Management in 1969. A fishway was installed at the time of construction but the inability to fill the impoundment to its design elevation caused the ladder to be nonfunctional. In 2000, DMF developed a design to retrofit the fishway with a new exit at the existing lake elevation. DEM funded the modifications and the fishway now passes river herring successfully. With proper maintenance and flow regulation, Lake Rico's 215 acres should support a sizeable population. Due to the low stream gradient, channel maintenance below the ladder and to the brook mouth is also an important priority.

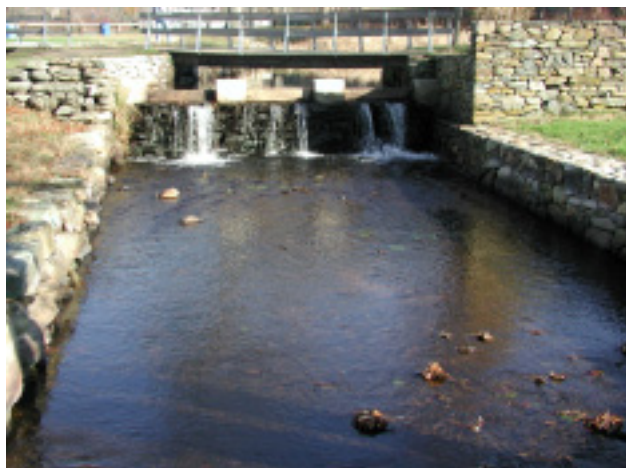
Two of the 7 spillways at Oliver Mills Dam

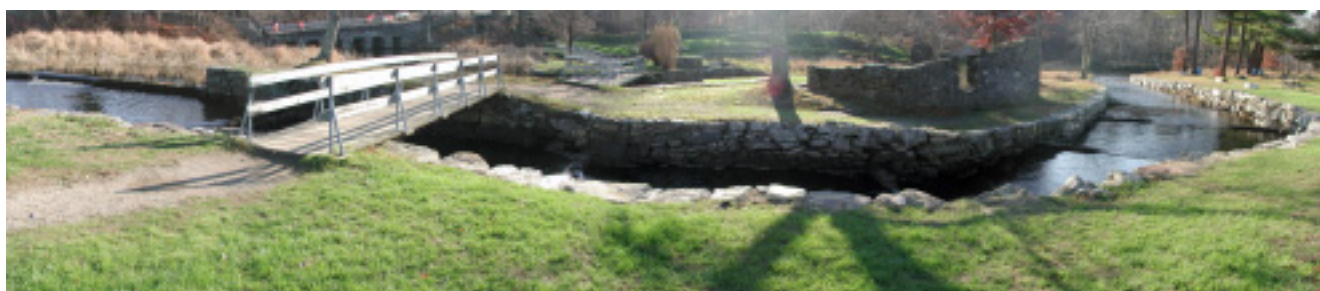
Oliver Mills Fishway

Design	Material	Length (ft)	Inside W (ft)	Outside W (ft)	# of Baffles	Baffle H (ft)	Notch W (ft)	Pool L (ft)	Condition/Function
Notched weir-pool	Stone and concrete	202.0	30-50	30-50	7	2.6	9	Varied (15-20)	Good Passable

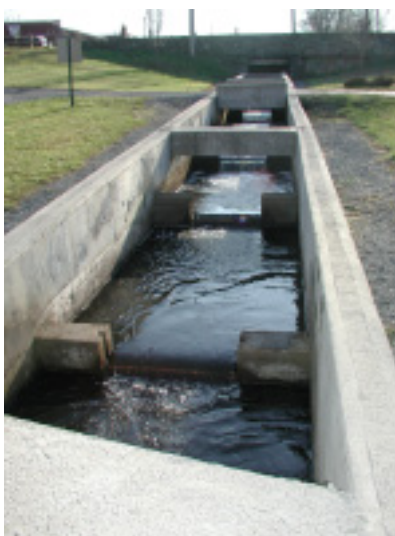
Wareham Street Fishway

Design	Material	Length (ft)	Inside W (ft)	Outside W (ft)	# of Baffles	Baffle H (ft)	Notch W (ft)	Pool L (ft)	Condition/Function
Notched weir-pool	Concrete with wooden boards	189.0	6.0	7.5	18	4.1	3.0	11.0	Excellent Passable

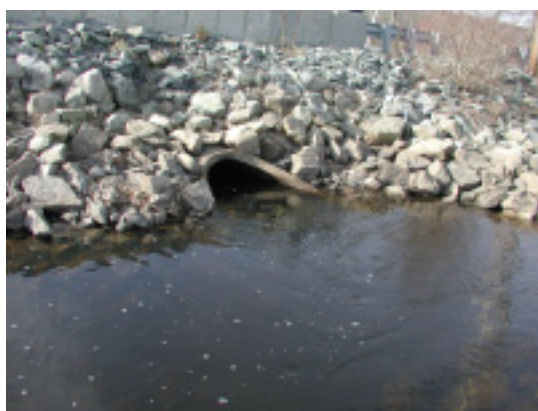
Smaller culvert under Route 18

Two other potential obstructions to passage may be encountered once fish have entered the lake system. A culvert at Route 18 which accommodates the connector stream between Assawompsett and Long Pond was replaced in 1993. The invert elevation of the culvert was too high for downstream migration of juvenile herring and as a result a second smaller culvert was added at a lower elevation. The effectiveness of both these culverts in passing fish has never been assessed. Since Long Pond represents a substantial portion of the total spawning habitat, such an assessment should be conducted.

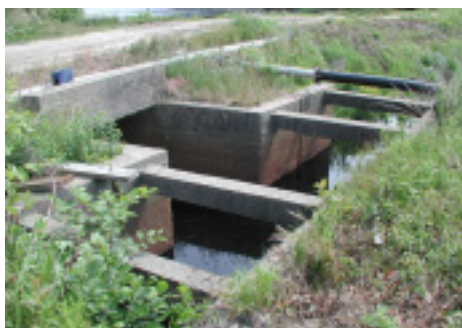
Bog T Control Structure

River Mile	Type	Material	Spillway W (ft)	Spillway H (ft)	Impoundment Acreage	Year Built	Owner	GPS
0.8	Bog sluice	Concrete with wooden boards	6.1	0.0	0.0	-	-	41° 59' 58.390" N 70° 54' 06.684" W

Fishway None

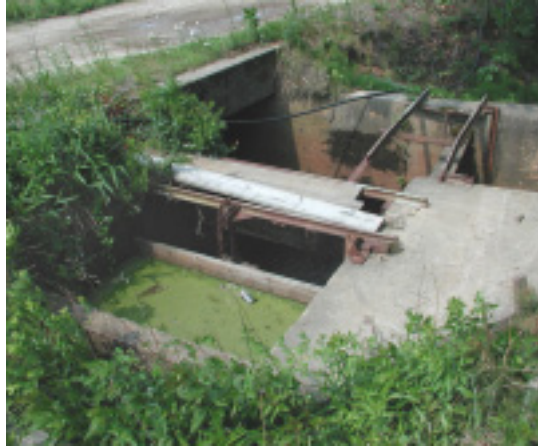
Bog Reservoir Dam

River Mile	Type	Material	Spillway W (ft)	Spillway H (ft)	Impoundment Acreage	Year Built	Owner	GPS
0.8	Bog sluice	Concrete with wooden boards	6.0	4.5	168.7	-	-	41° 59' 58.390" N 70° 54' 06.684" W

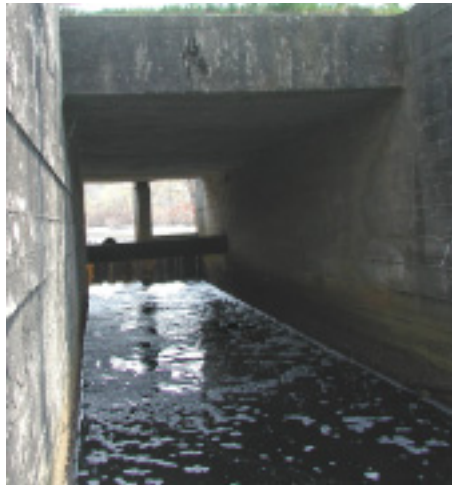
Dam at Furnace Street

River Mile	Type	Material	Spillway W (ft)	Spillway H (ft)	Impoundment Acreage	Year Built	Owner	GPS
1.4	Dam	Concrete with wooden boards	7.5	5.2	13.7	1917	Town of Halifax	41° 59' 54.991" N 70° 53' 15.949" W

Fishway None

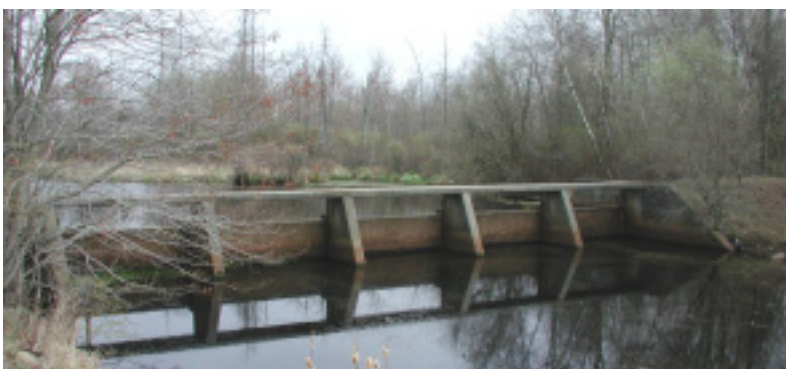
Stump Brook Dam

River Mile	Type	Material	Spillway W (ft)	Spillway H (ft)	Impoundment Acreage	Year Built	Owner	GPS
3.0	Dam	Concrete	67.5	4.6	0.0	1964 -1969	City of Brockton	42° 00' 48.570" N 70° 52' 10.213" W

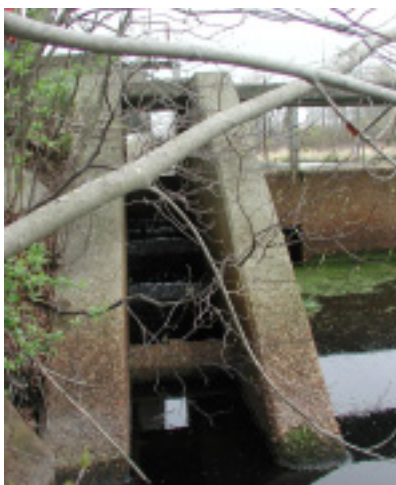
Fishway at Stump Brook Dam

Design	Material	Length (ft)	Inside W (ft)	Outside W (ft)	# of Baffles	Baffle H (ft)	Notch W (ft)	Pool L (ft)	Condition/Function
Weir-pool	Concrete	19.5	2.0	4.2	6	Varied (0.6-3.0)	-	3.5	Good Passable

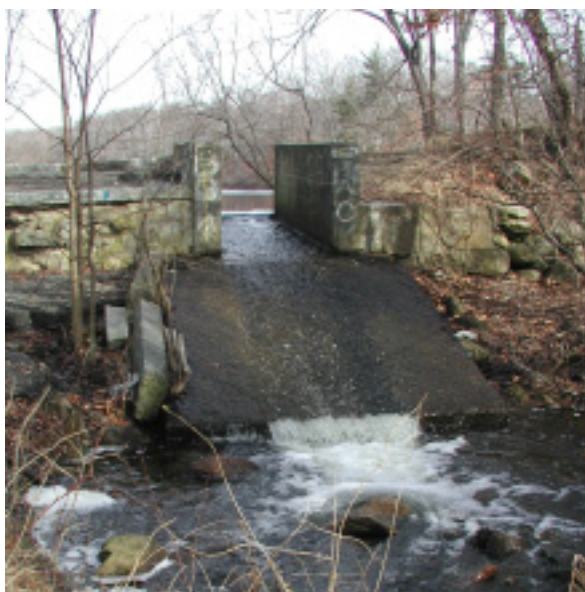
Hunts Pond Dam

River Mile	Type	Material	Spillway W (ft)	Spillway H (ft)	Impoundment Acreage	Year Built	Owner	GPS
5.4	Dam	Concrete spillway, earthen berm	4.0	5.5	5.3	1920	Cities of Brockton and Abington	42° 05' 43.384" N 70° 58' 30.901" W

Fishway	None
----------------	------

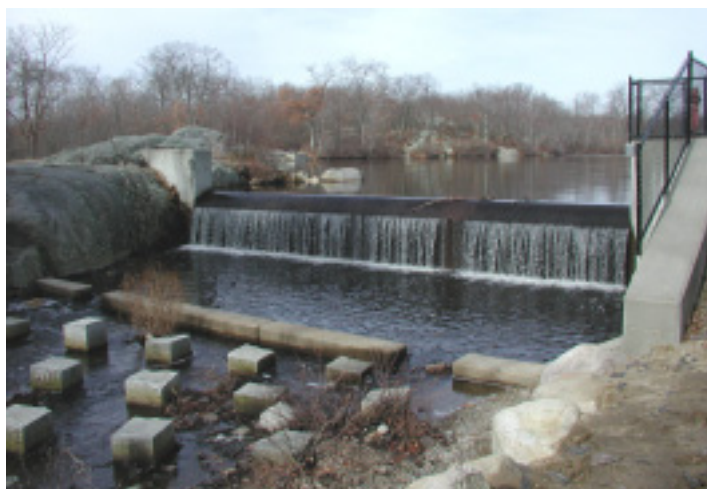
Cleveland Pond Dam

River Mile	Type	Material	Spillway W (ft)	Spillway H (ft)	Impoundment Acreage	Year Built	Owner	GPS
6.9	Dam	Concrete	43	6.0	100.0	Repaired 1992	Comm.- of Mass. - DCR	42° 06' 51.966" N 70° 58' 42.620" W

Fishway None
