TIDE Gateway

Tidegate Inventory and Data Evaluation Gateway

Final Report

April
2016

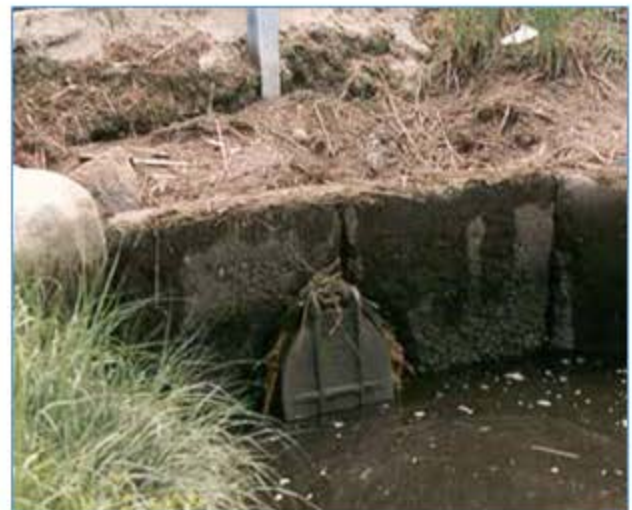
Photo of tide gate dated 6/25/2015

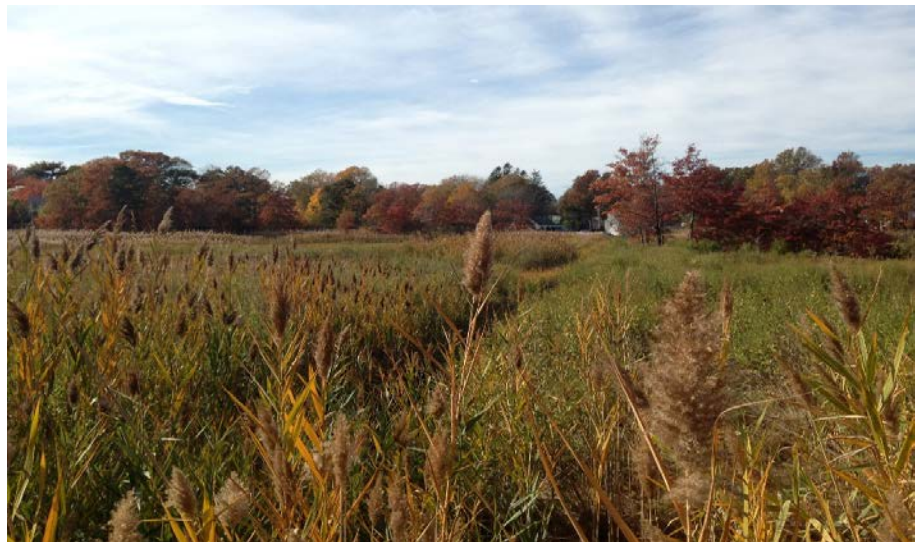
Site ID: Quincy-06

Comments: Flap gate limited all tidal flow. As a result, freshwater grasses and Phragmites were observed upstream. At the time of the site visit, no known restoration efforts had been undertaken. The upstream area was large and appeared to have significant restoration potential. A number of homes were observed adjacent to the impoundment which might limit restoration options due to potential flooding.

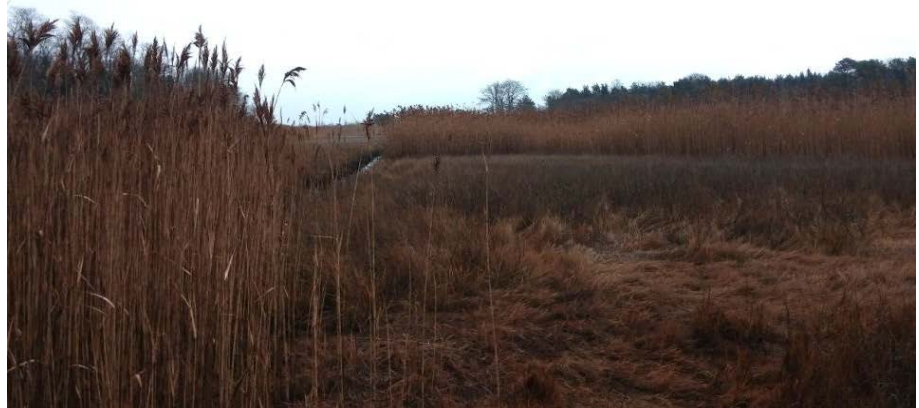
Site ID: 07

Comments: Phragmites dominated the upstream and downstream portions of the restriction. Small patches of high marsh were observed downstream of the restriction. The area appeared to have good restoration potential with minimal to no low-lying infrastructure observed. Note flap gate had been removed or fell off culvert at time of site visit (12/18/2015).

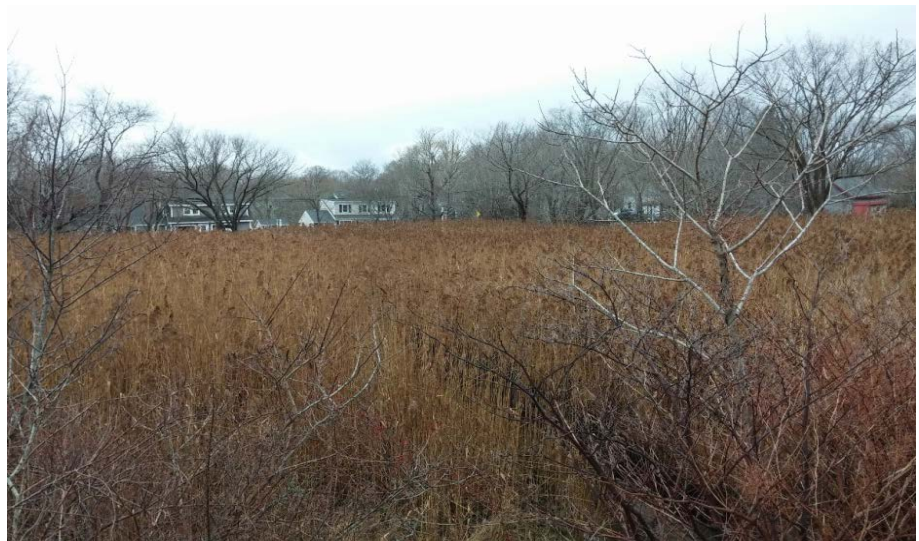
Site ID: Sandwich-01

Comments: The downstream portion of the marsh was comprised of a mixture of high marsh and phragmites while the upstream portion of the marsh was predominately phragmites. Upland vegetation was also observed along the railway embankment including wild cherry and sumac. The site appeared to have good restoration potential; however, upgradient infrastructure (i.e. houses) were observed.

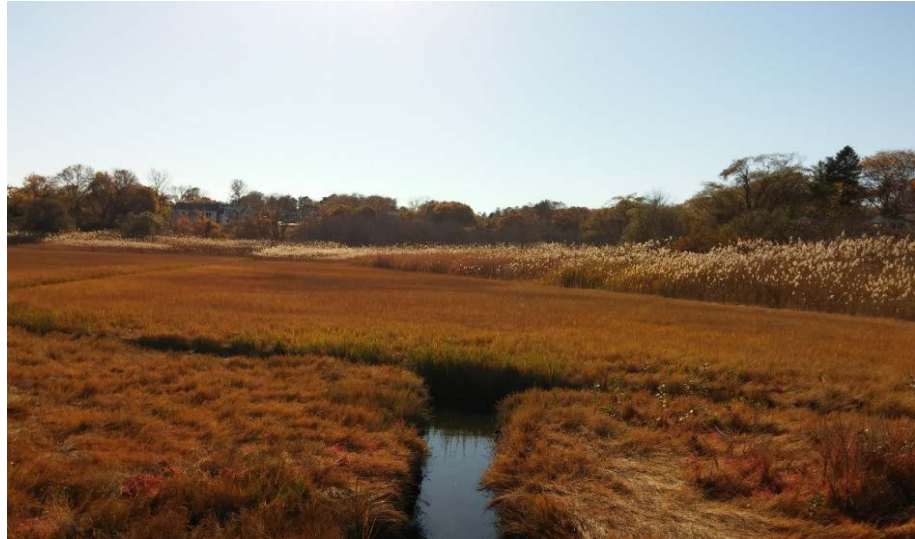
Site ID: 74

Comments: The impoundment was comprised primarily of high marsh and was fringed by phragmites. Houses were observed around the marsh; however, they appeared to be elevated.

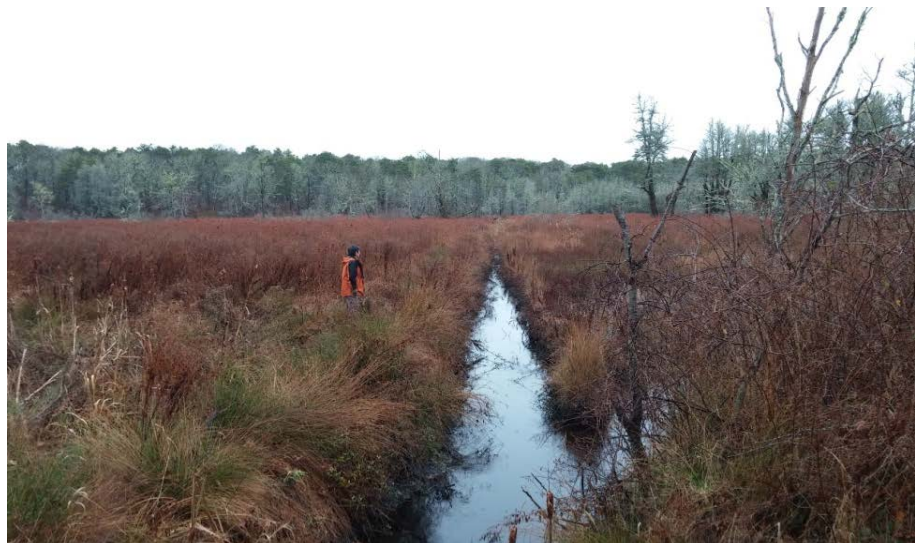
Site ID: Orleans-02

Comments: The upstream impoundment appeared to be an entirely freshwater system as evidenced by cattails, Atlantic white cedar, and freshwater sedge. The site had good restoration potential with minimal low lying infrastructure observed; however, restoration might be limited by the requirement to preserve Atlantic white cedar.

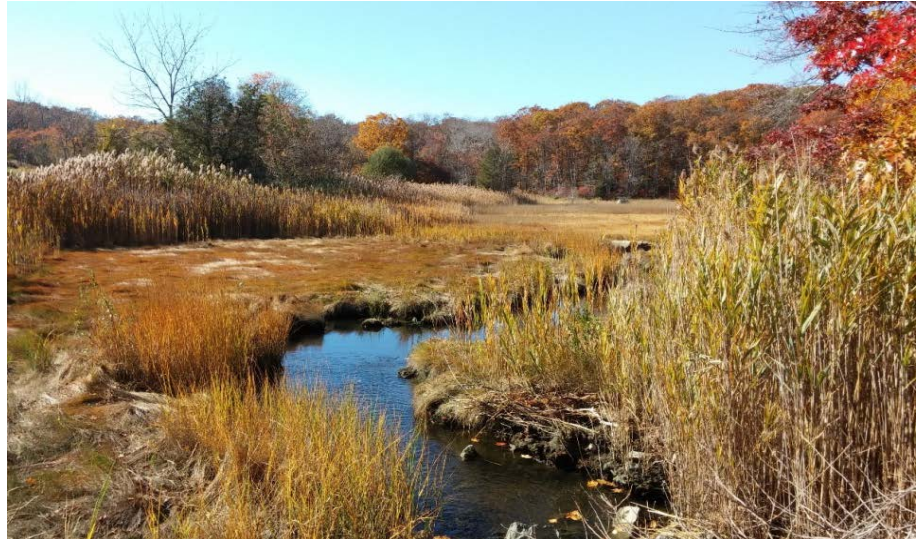
Site ID: Cohasset-02

Comments: The upstream impoundment was dominated by high marsh and was fringed with Phragmites. Unknown if any restoration efforts had been performed at the site. Future restoration considering upsizing the culvert would need to investigate low lying areas including adjacent farm land directly to the south of the impoundment.

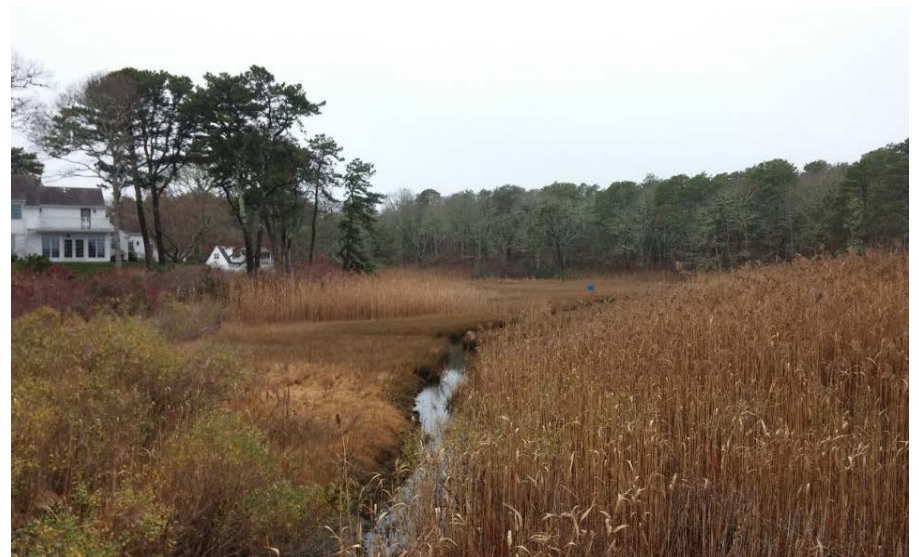
Site ID: Dennis-01

Comments: The upstream impoundment was mainly comprised of high marsh and was fringed with phragmites. Upland vegetation was also observed directly to the south of the upstream culvert opening. It appeared that the site would be a candidate for restoration; however, a potentially low lying barn and field was observed to the west of the restriction.

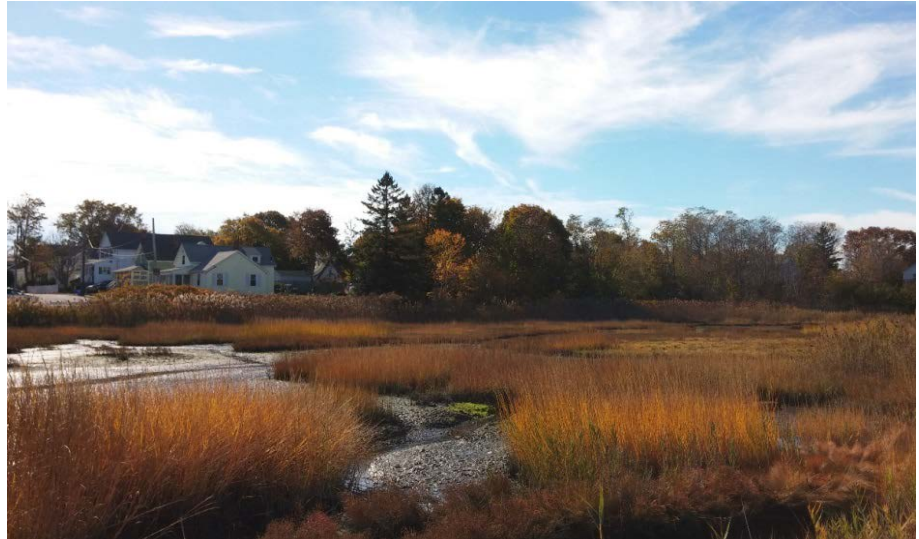
Site ID: Quincy-04

Comments: The upstream marsh had a mixture of *Spartina Alterniflora* and *Patens* and was bordered by *Phragmites*. The marsh was previously studied for potential restoration by MADER; however, it was concluded that low lying infrastructure would be a challenge. Future restoration would likely need to consider sizing culvert to accommodate the balance between stormwater outflows and tidal flushing.

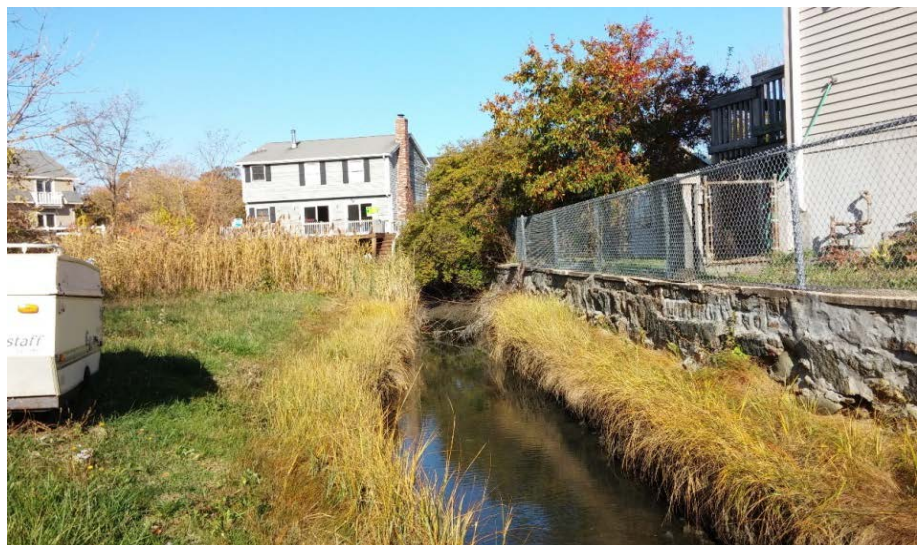
Site ID: Quincy-02

Comments: There was a narrow channel on the upstream end of the restriction lined with an approximately 2' wide layer of salt marsh grass. From there, the salt marsh grass transitioned into mowed grass and *phragmites*. It appeared that no restoration efforts had been made at this location. There was an abundance of low lying infrastructure located at the upstream end of the restriction including houses, deck stairways, and concrete retaining walls.

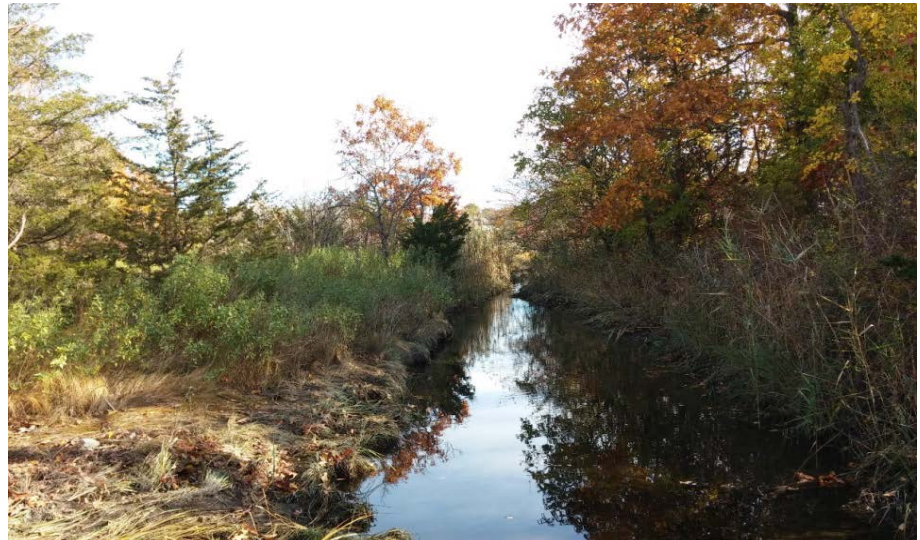
Site ID: Weymouth-02

Comments: Upstream area varied significantly. Phragmites, upland vegetation, and *Spartina Alterniflora* islands were observed. Vegetation was indicative of some level of salt water influence, but not enough volume to inundate the marsh top which was mainly comprised of upland vegetation. It appeared that the marsh had potentially subsided over time. Large upstream wetland area with good restoration potential. A marina worker indicated that upstream residents had complained of flooding in the past, but it was unclear if the flooding was a result of tidal inundation, stormwater influence, or a combination.

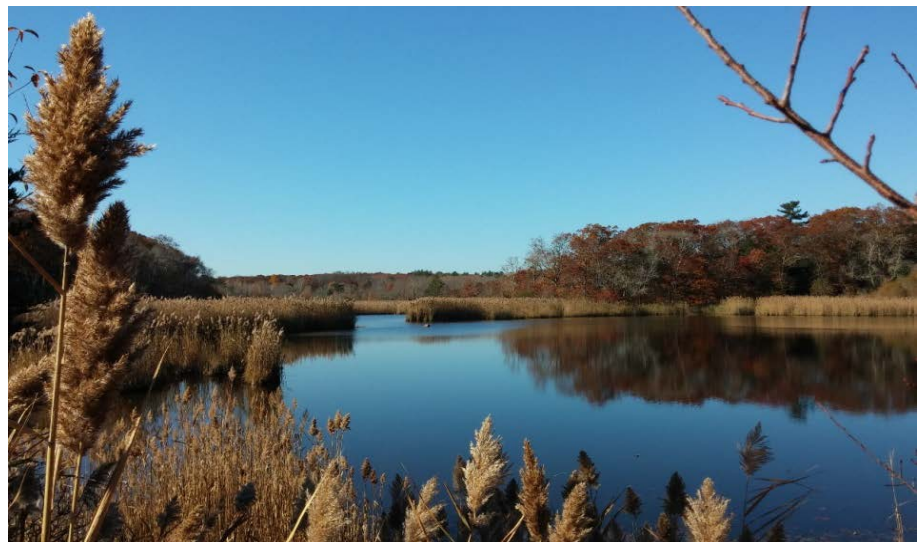
Site ID: Scituate-04

Comments: Upstream impoundment was predominately comprised of phragmites. Appeared that there was little to no tidal influence. Would potentially be a good restoration candidate - minimal low lying infrastructure was observed; however, upstream area is used by the town as a drinking water well field.

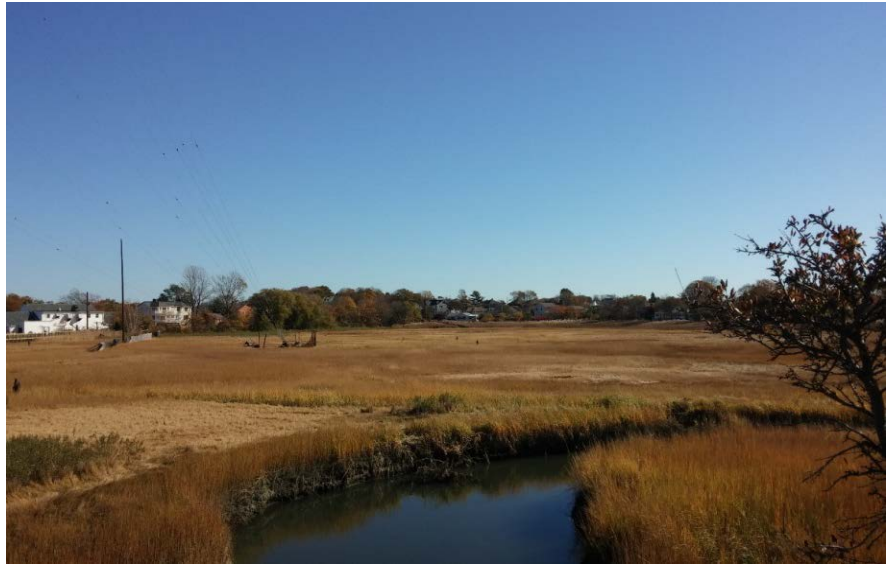
Site ID: Hull-02

Comments: Upstream marsh appeared to be relatively healthy with a mixture of low and high marsh species. Phragmites were observed at the fringes. Previous water level logging was performed determine the relative extent of upstream restriction. Low lying properties including a cellular tower and guy wires were observed within and around the impoundment.

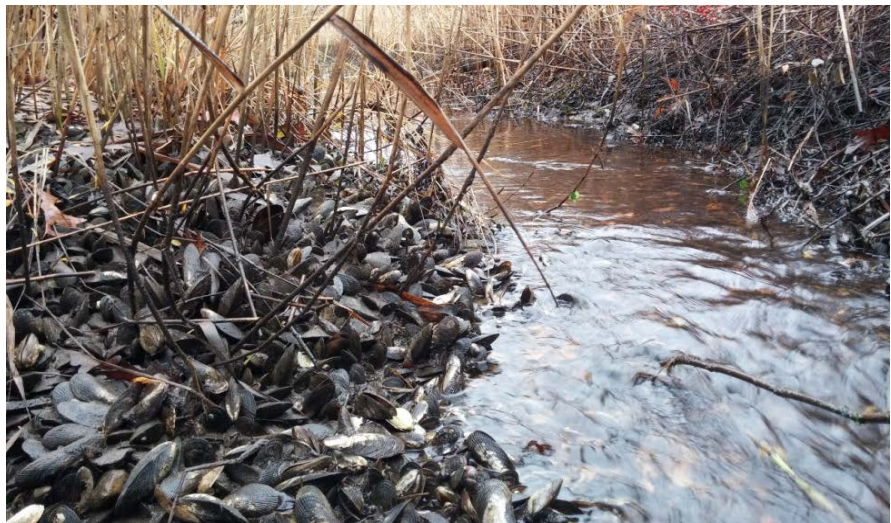
Site ID: Dennis-01

Comments: An abundance of live mussels was observed within the channel at the upstream end of the culvert.

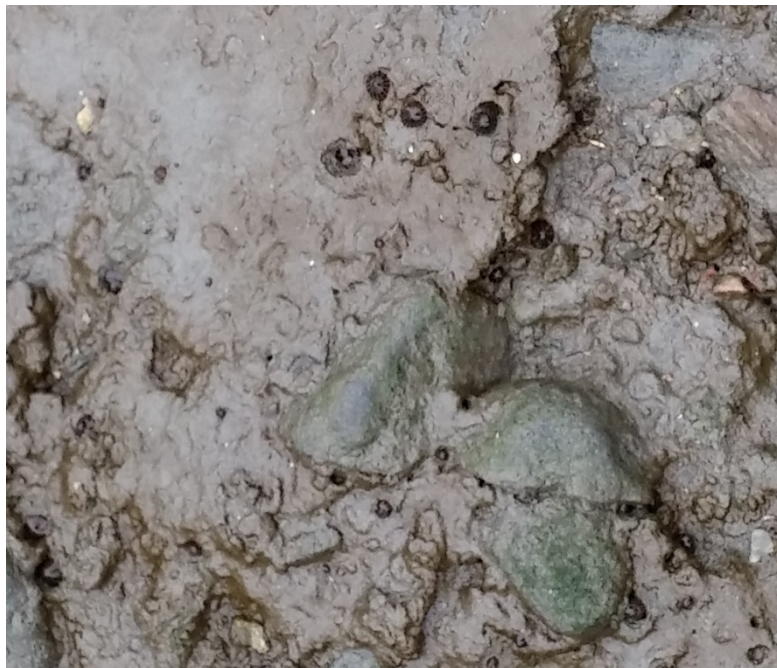
Site ID: Salem-01

Comments: Multiple invasive striped anemones were observed on the mudflat approximately 100 feet downstream of the downstream bridge opening.

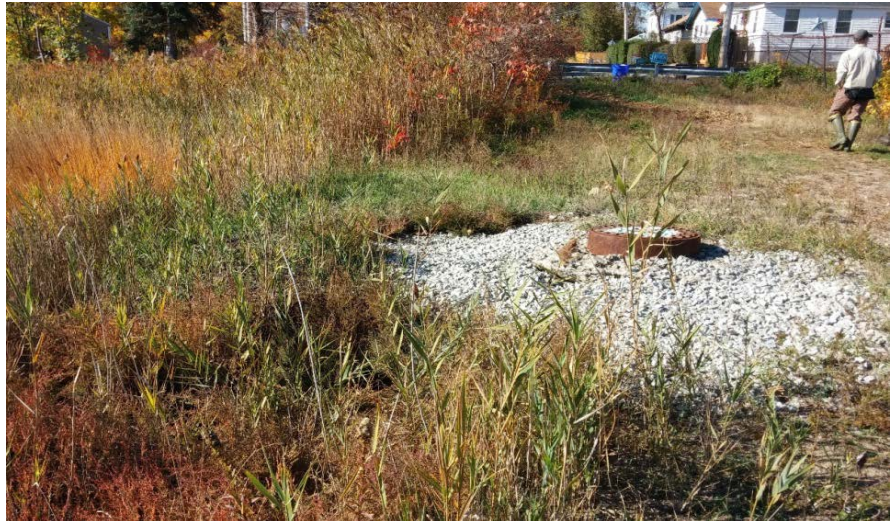
Site ID: Quincy-04

Comments: A sewer manhole was located adjacent to the upstream end of the culvert in the marsh. Gravel had recently been placed around the manhole and evidence of previous scour was observed suggesting a history of overwash and stormwater inflows.

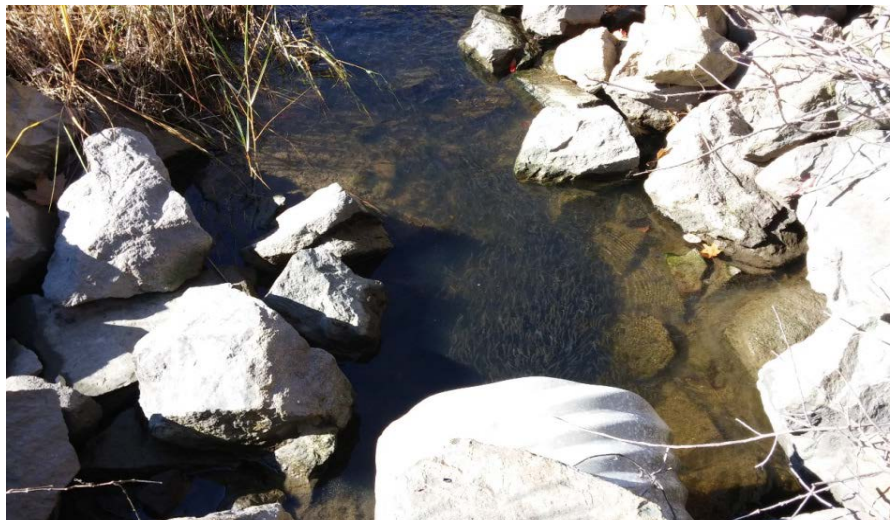
Site ID: Cohasset-02

Comments: The upstream channel was full of killifish.

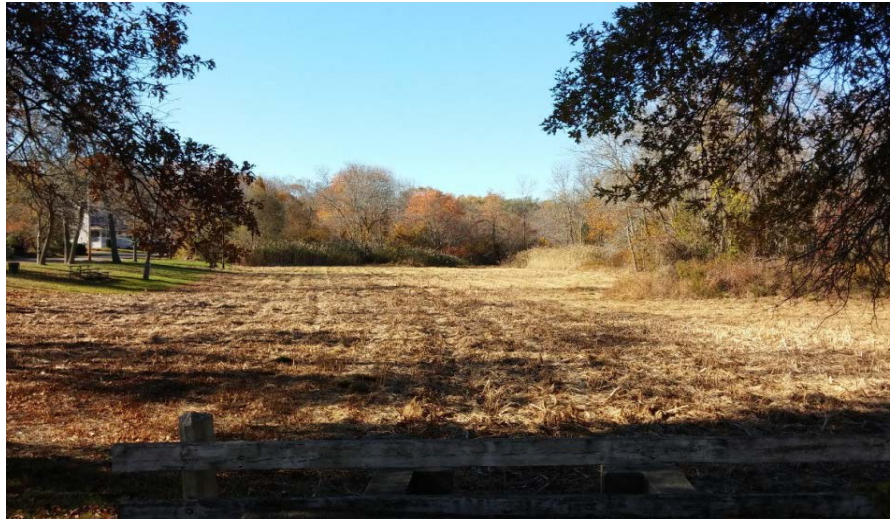
Site ID: Cohasset-04

Comments: Resident indicated that upstream impoundment used to be a pond; however, indicated that Town of Cohasset drains it for winter ice skating. Mowed cattails were observed throughout the upstream impoundment.

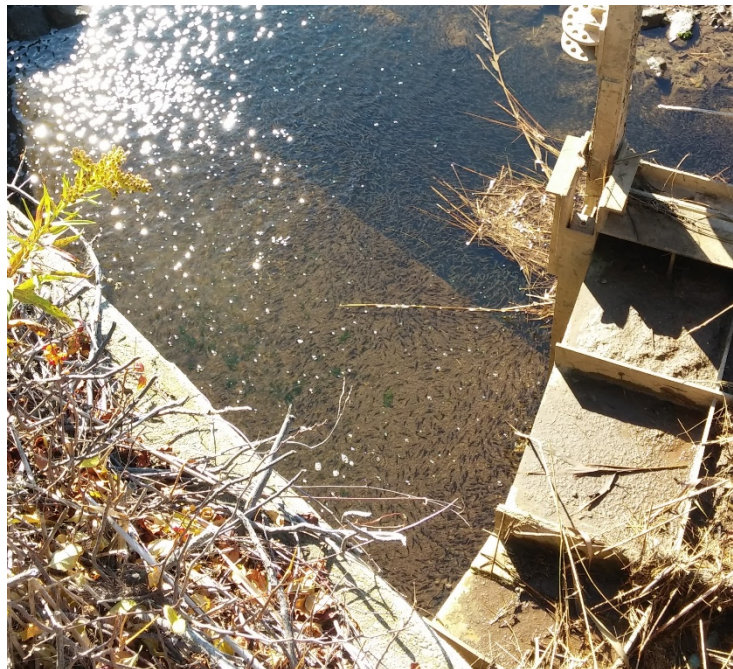
Site ID: Marshfield-02

Comments: Many killifish were observed on the downstream side of the tide gate.
