LAMPSON BROOK FARM BELCHERTOWN, MA

DEBRIS REMOVAL, REPAIR AND REMEDIATION

ASSESSMENT REPORT - JUNE 2022

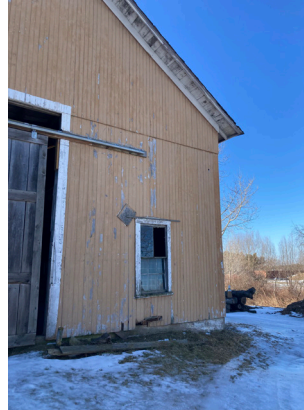
The main barn door facing North does not close fully and the window glazing is broken (left).

The building overall is in usable condition. The siding should be prepared and painted appropriately. The windows should be replaced throughout. And the sliding doors should be adjusted so they can close properly. The roof should be replaced and when it is, repair the roof sheathing as required. See below regarding structural repairs and information.

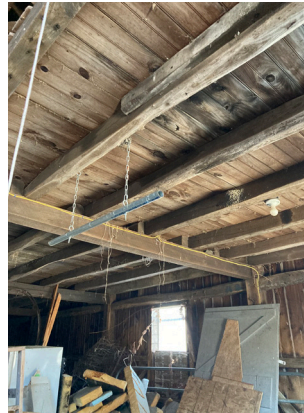
Wood post-and-beam framing is mostly sound and will require minimal restoration.

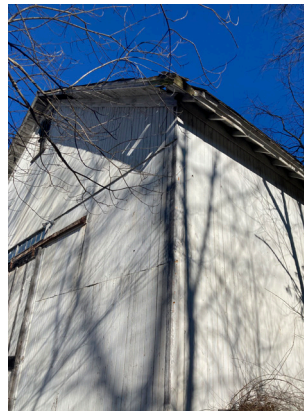
The asphalt shingle roof has holes in the plywood decking and is leaking (left). One of the central beams have split and collapsed (right).

Some rot was observed in localized areas in the roof and roof framing. No more than 20% of the existing framing should need to be replaced. Mezzanines appeared to be in adequate condition, as there were no signs of failure. Localized areas of deterioration were observed in the underside of the mezzanine deck, existing deteriorated boards should be replaced. High central storage mezzanine appeared to be failing and should be demolished. Some repairs to exterior paneling may be required as multiple areas of deterioration were observed. The roof will likely need to be replaced.

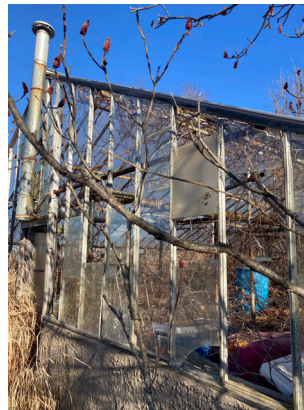
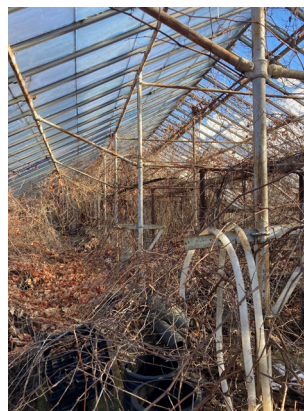
The greenhouse is composed of metal framing, glass panels, concrete curbing and a slab on grade. A majority of wall and roof glass panels are broken and exposing the interiors to climate vulnerabilities, accelerating degradation. The concrete curbing foundation walls are crumbling and rebar is exposed in multiple areas.

Based on the condition of the greenhouse, it is recommended that this structure should be demolished.

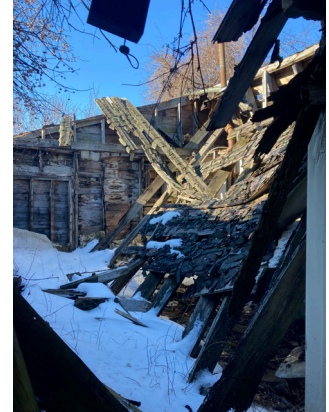
Small building portion with a concrete & metal fenced-in bull pen built off the back of the Milk Room.

Based on the conditions of the Bull Pen, it is recommended that this structure should be demolished.

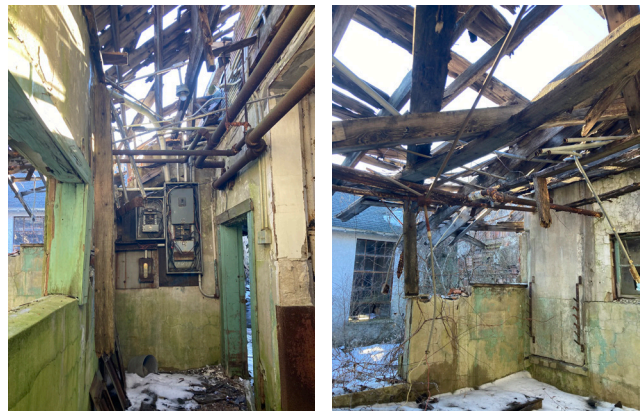
Looking through the front door (left) and along the side of the building (right), it is clear that the roof and wall framing are compromised and beyond repair.

Based on the conditions of the Milk Room, it is recommended that this structure should be demolished.

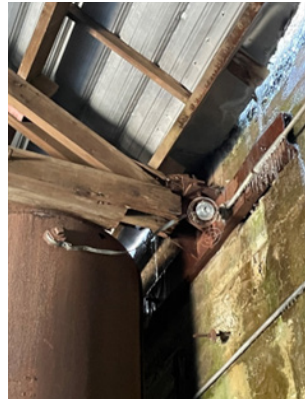
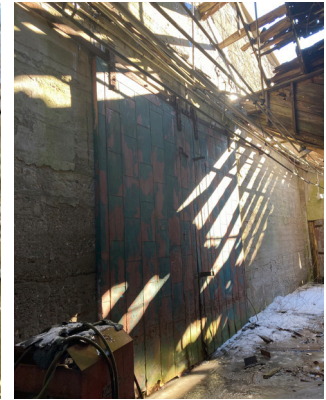
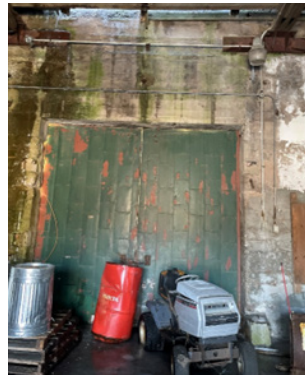
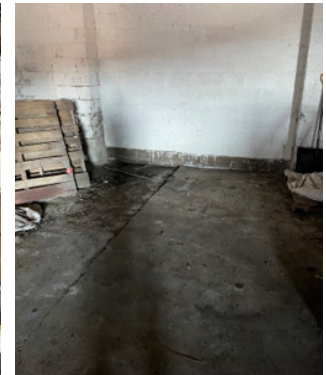
The metal roof deck appeared to be severely damaged in certain locations and will likely need to be completely replaced. The trusses bearing along the back wall at the steel ledger plate connection were observed to be failing in multiple locations. The steel ledger and truss bearing ends will need to be repaired and/or replaced. Several rafters spanning from the back wall to the roof purlins were observed to be deteriorated and will likely need to be replaced. Cracking was observed in both the masonry walls and the concrete back wall. Differential settlement was observed in the concrete floor causing significant cracking in multiple locations. Exterior roof edge beam was observed to be rotted/deteriorated in multiple locations. The concrete back wall is a shared wall with dairy barns 1 & 2. It is recommended that both dairy barns be demolished (refer to sections 9/10 in this report). Concrete wall shall be shored prior to demolition. Shoring shall remain throughout the life of the structure.

The metal roof deck should be replaced as daylight is showing where the previous demolished building was located. See below regarding the truss work that should occur prior to the roof replacement. There should be repointing work throughout. Replacement of the sectional and sliding barn doors scheduled. into the cost and repairs.

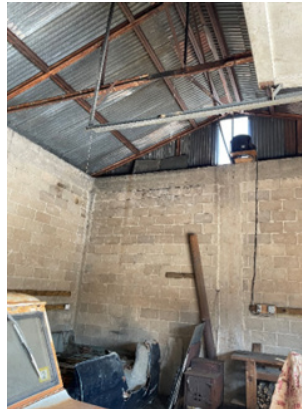
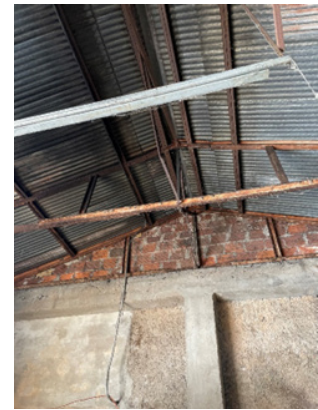
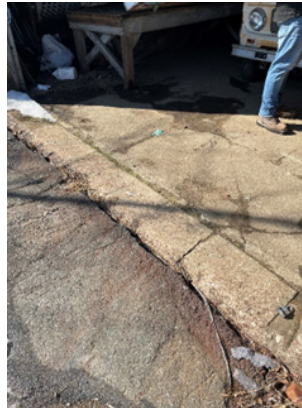
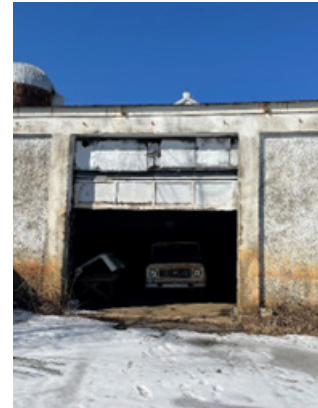
In general, the building appeared to be in adequate condition. Corrosion was observed on most of the roof framing members. There did not appear to be any failures observed in the roof deck. We recommend cleaning the existing roof framing from corrosion. Provide a protective coating to trusses such as epoxy paint or zinc rich primer to avoid steel section loss. The concrete beams and columns appeared to be in good condition, no deficiencies were observed. The concrete floor appeared to be cracked in some locations. Cracking was also observed in the foundation wall. The CMU walls appeared to be in good condition.

Overall, the building is in relatively good shape. Overall, the roof should be replaced for maintenance best practices. The sectional door should be replaced. And the cmu walls should have a repointing allowance to help stop potential future cracking.

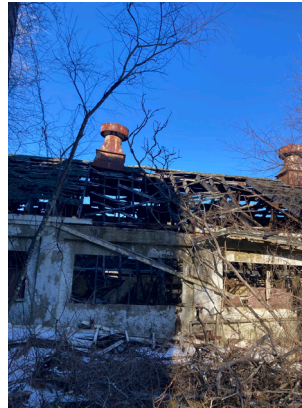
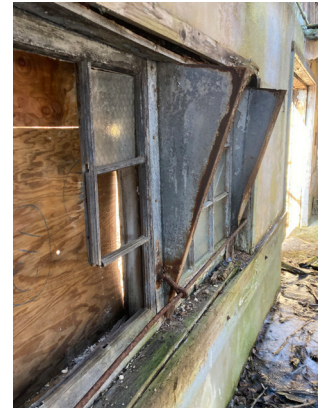
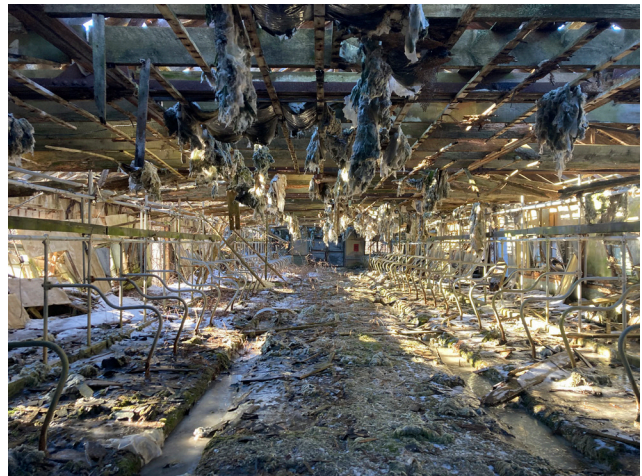
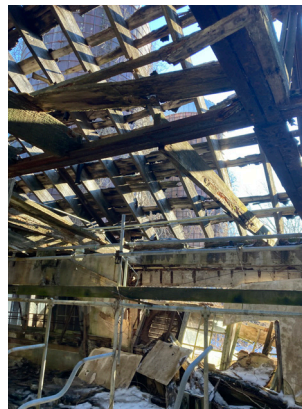
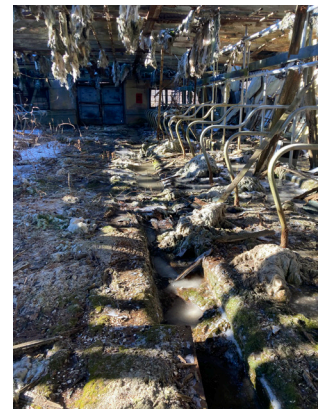
The structure has largely fallen in on itself.

There are remnants of milking stalls located on the interior.

Based on the conditions of the dairy barn 1, it is recommended that this structure should be demolished.

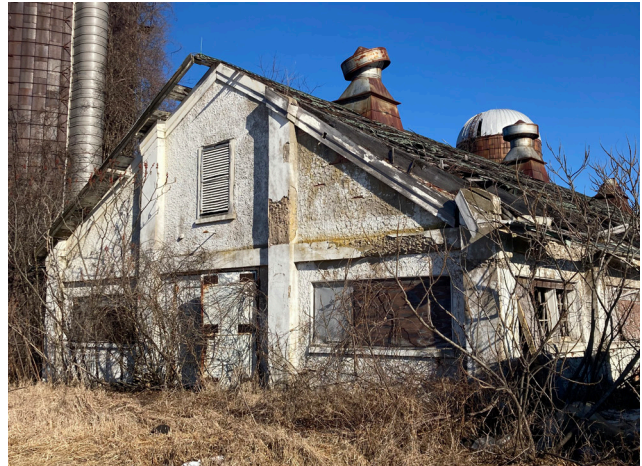
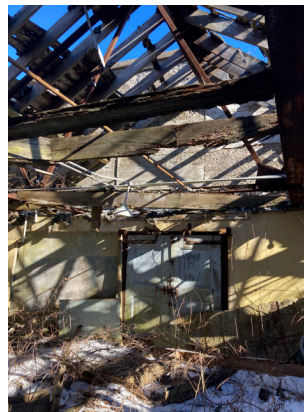
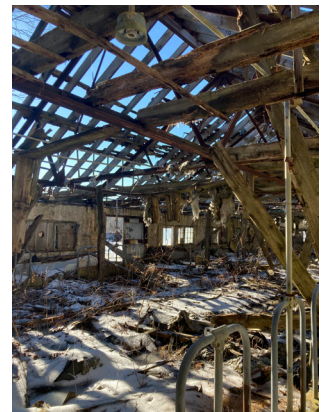
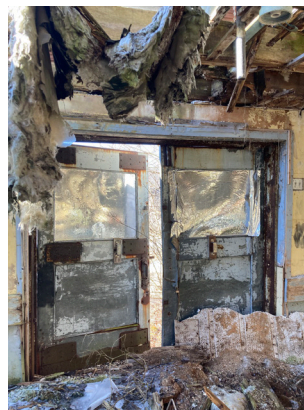
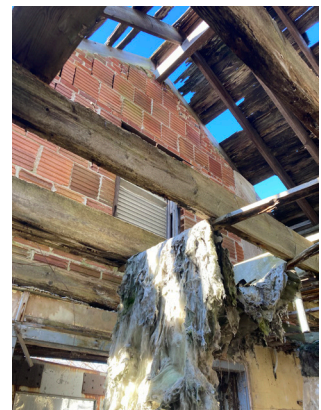
The structure has largely fallen in on itself and is exposed to the elements.

There are remnants of milking stalls located on the interior.

Based on the conditions of the dairy barn 2, it is recommended that this structure should be demolished.

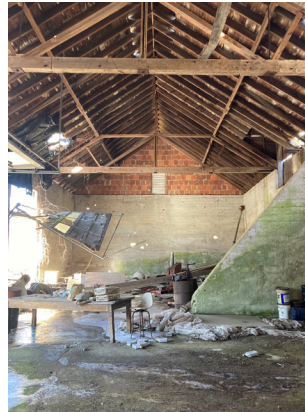
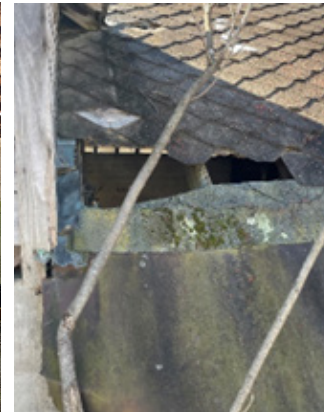
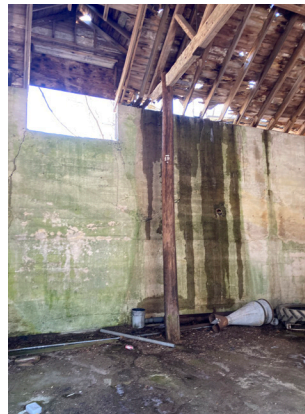
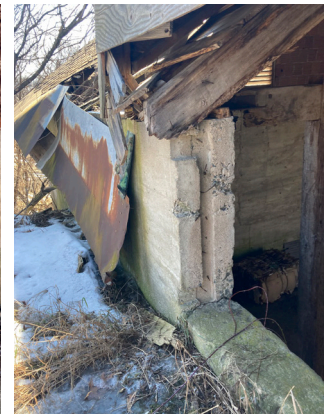
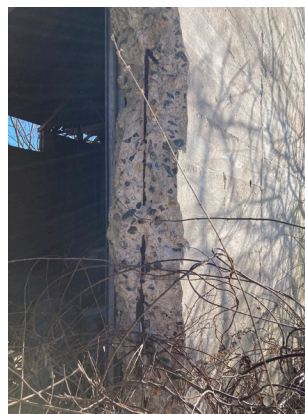
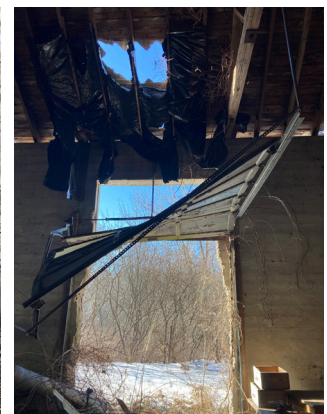
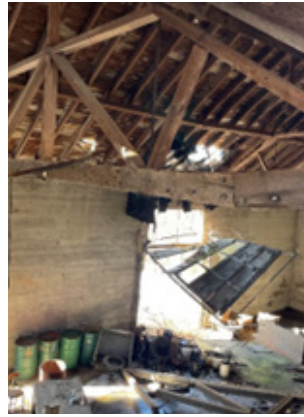
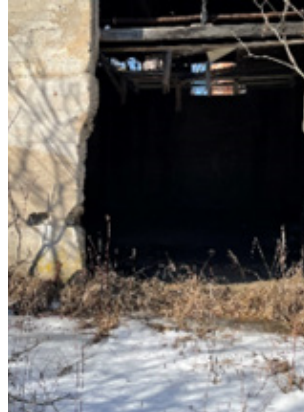
The building is a concrete wall with 2x wood roof joists and an asphalt shingle roof. A portion of the North wall is buried below grade and has dormer openings for manure to be pushed through onto the floor. There are multiple holes and openings in the roof. See below regarding the roof trusses and the temporary shoring provided for those trusses. The openings at the sectional doors have spalled and chipped concrete. The sectional doors for this building have failed and do not work.

The manure shed was observed to be framed by 2x timber rafters supporting a plywood roof deck with shingles. Four large hip trusses were observed at equal spacing within the building. The rafters bear on a continuous top plate fastened to the four-sided concrete walls. Brick infill was observed at each gable end from the top of concrete to the roof. The floor was observed to be a concrete slab on grade. It could not be determined from visual observations what the foundation of the building consisted of.

The existing plywood deck appears to be failing in multiple locations. Each hip truss appears to be completely failing. Truss #1 failed at the bearing end and was temporarily shored by a telephone pole. Trusses 2 and 4 appear to be failing at their splice connections, and truss 3 collapsed and is resting on the concrete slab. The concrete walls appear to be in reasonable condition, except at the overhead doors where significant spalling and cracking were observed, likely due to the failure of the overhead doors. Cracking in the masonry walls was observed at window openings as well. The concrete slab could not be fully inspected due to concerns about the stability of the roof. It appeared unsafe to enter the building.

We'd recommend replacing the roof after the truss and shoring recommendations provided below are completed. There will be sheathing / plank replacement once the demolition of the roof exposes the sheathing. The concrete openings at the sectional doors should be repaired prior to replacing the sectional doors. Once that work is completed, the sectional doors should be replaced.

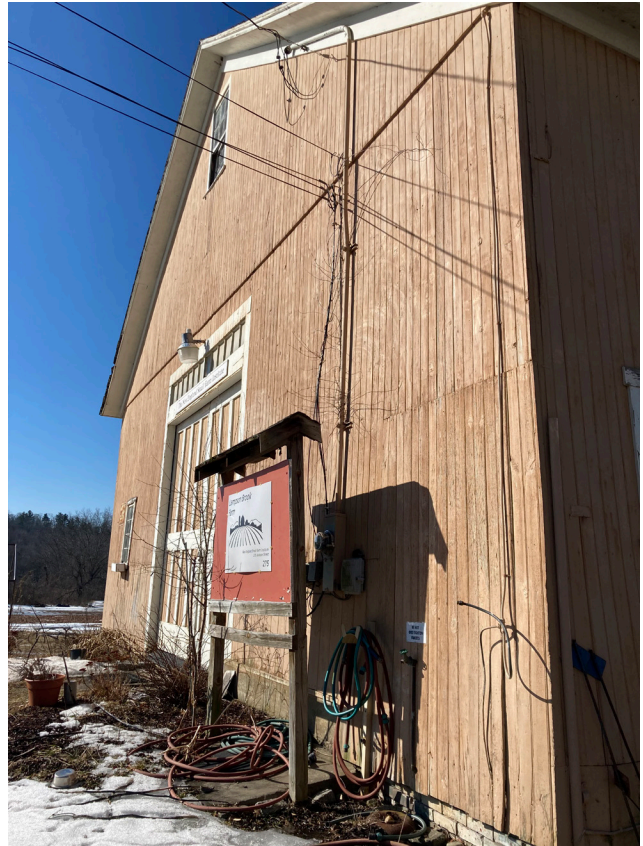
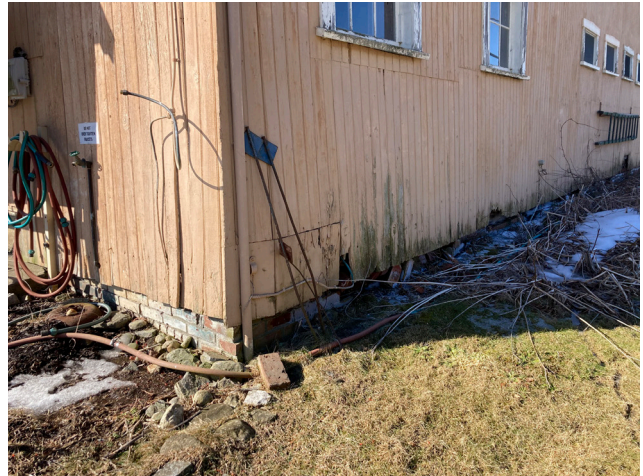
The community barn, is in good shape. Currently it is being used for offices, restrooms and general storage of some of the small farm institute materials. There is a second floor / mezzanine that houses library materials. The interior floor is poured concrete with posts. The interior of the community barn is in fairly good condition. The exterior wood siding paneling is deteriorating in multiple locations, mainly around the base perimeter. The barn does not have gutters or downspouts. The windows and sliding barn doors are in poor condition.

The follow work should occur to maximize the longevity of the community barn. The asphalt shingle roof, diamond style, should be replaced. Gutters and downspouts should be added to help alleviate the drainage issues and siding deterioration at the base of the barn. There may be some sheathing / plank replacement needed once the roof is demolished. The siding should be replaced in kind, where not repairable. The windows are in poor condition and should be replaced. The sliding barn doors could use adjustment and maintenance.

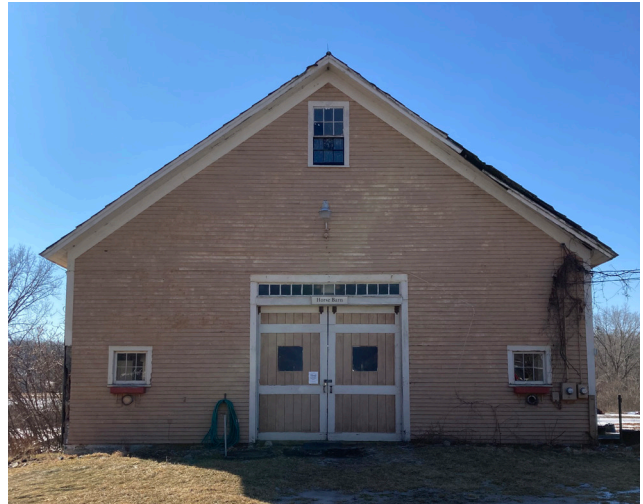
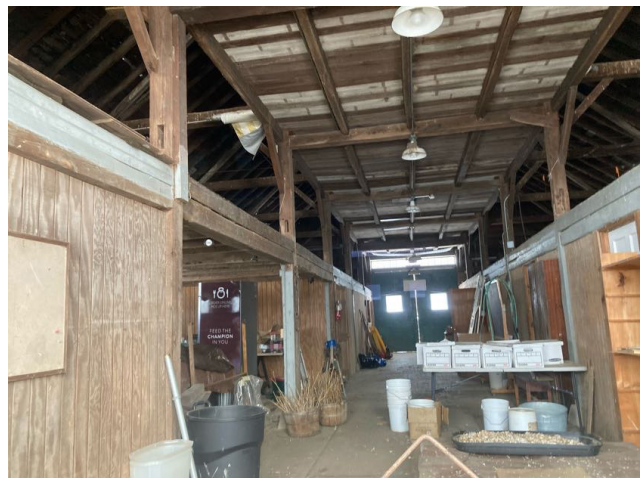
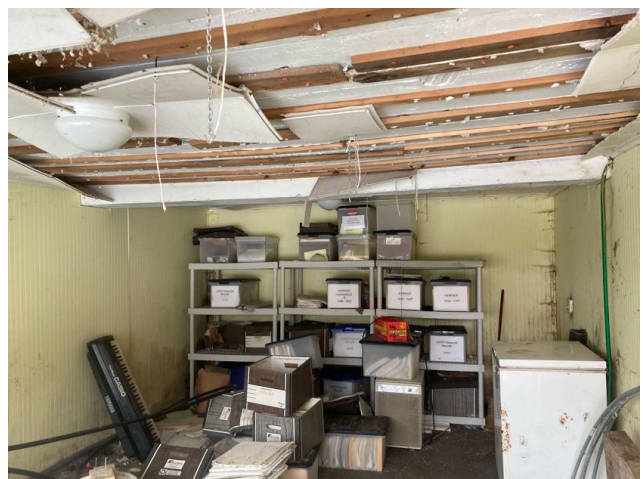
The community barn #2, is in good shape. Currently it is being used for offices, restrooms and general storage of some of the small farm institute materials. The interior floor is wood turned on the end grain. The interior of the community barn is in fairly good condition. There is mold visible. The exterior wood siding paneling is deteriorated in multiple locations, mainly around the base perimeter. The barn does not have gutters or downspouts. The windows and sliding barn doors are in poor condition.

The follow work should occur to maximize the longevity of the community barn. The asphalt shingle roof, diamond style, should be replaced. Gutters and downspouts should be added to help alleviate the drainage issues and siding deterioration at the base of the barn. There may be some sheathing / plank replacement needed once the roof is demolished. The siding should be replaced in kind, where not repairable. The overall siding should be prepared and painted thoroughly. The windows are in poor condition and should be replaced. The sliding barn doors could use adjustment and maintenance.

The mold should be remediated.

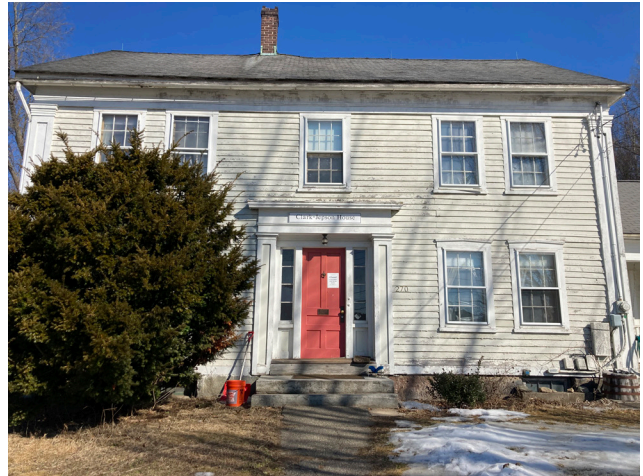
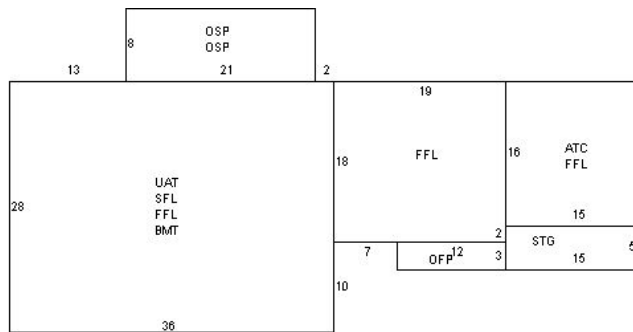
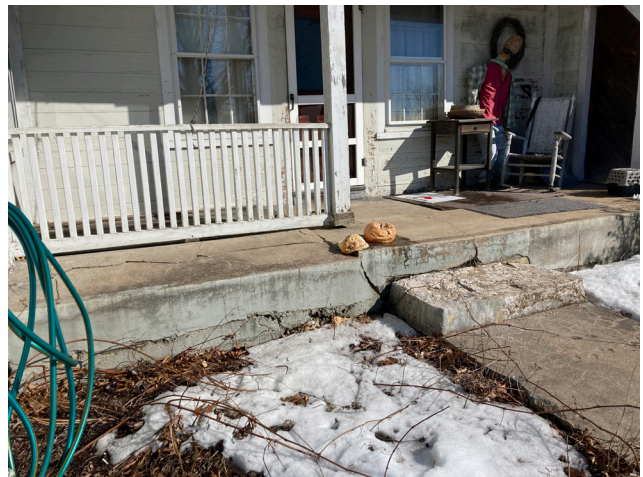
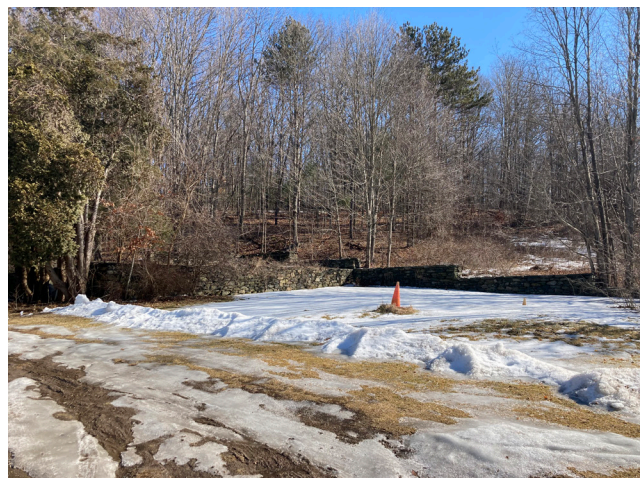
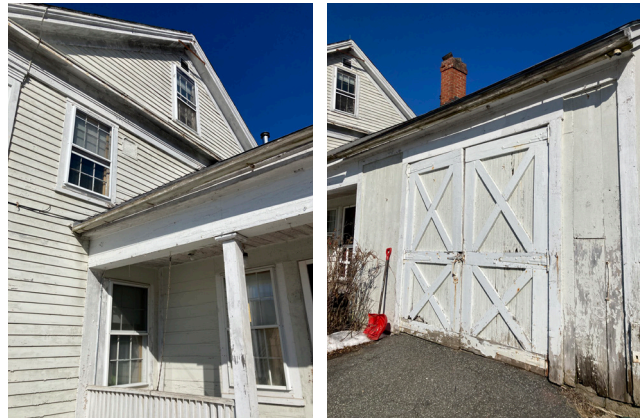
The Jepson Farmstead is an office that is across Jackson Street from the community barn #1. Weston & Sampson was not able to view the interior of the house. The asphalt shingle roof is in need of replacement and past its useful service life. The siding is deteriorating in multiple places. The windows are in poor shape.

The asphalt shingle roof should be replaced. When it is getting replaced, there will be some sheathing / plank replacement. The siding should be repaired as needed. And then prepared and painted appropriately. The windows should be replaced.

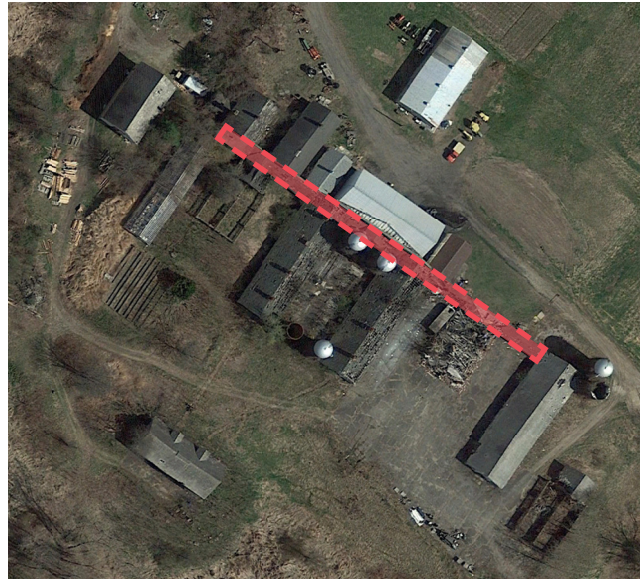
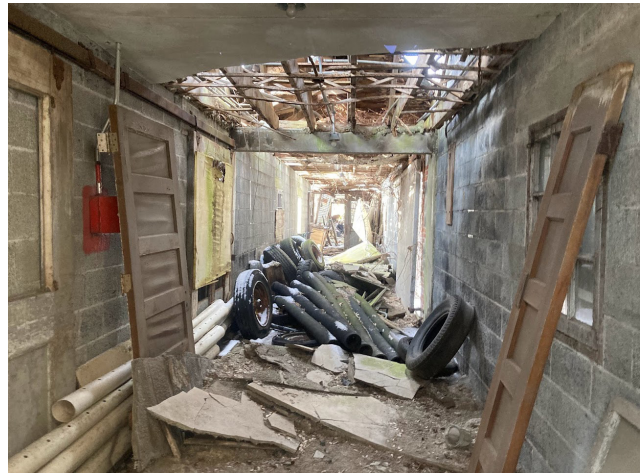
Item	Description	Condition
Foundation	Concrete slab	Poor
Building Construction	CMU block, wood framing	Poor
Roof Construction	Wood joist & Asphalt shingles; gable	Poor
Doors	Various personnel & sliding barn doors	Poor
Windows	Various fixed, single-hung windows	Poor
Utilities	N / A	-

Based on the conditions of the connector, it is recommended that this structure should be demolished.
