DEPARTMENT OF PUBLIC UTILITIES

PIPELINE ENGINEERING AND SAFETY DIVISION

INCIDENT REPORT

627 Pleasant Street, Winthrop, Massachusetts

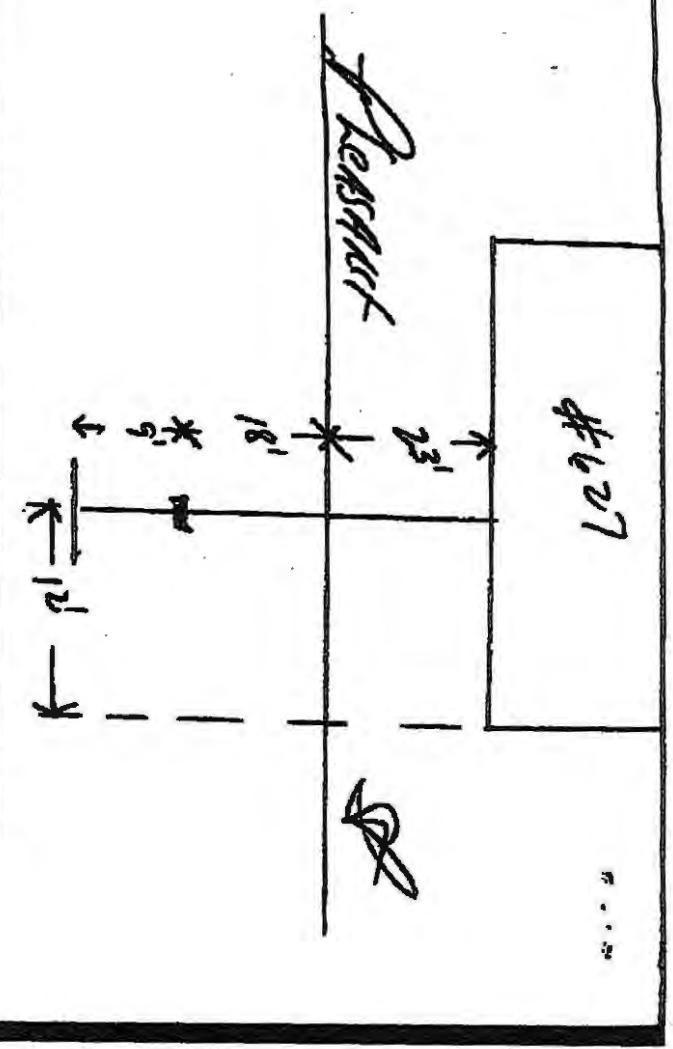
Response: The service to #627 Pleasant St was 1 inch plastic, installed on 04/24/1986. The pressure test listed on the attached service card indicates a psig test for 15 minutes. The operating pressure and MAOP is the same as the main as answered in IR PL-12. There is no leak history on the service between January 1, 2002 and February 22, 2012. The service card for this address is attached as Exhibit PL 1-13.

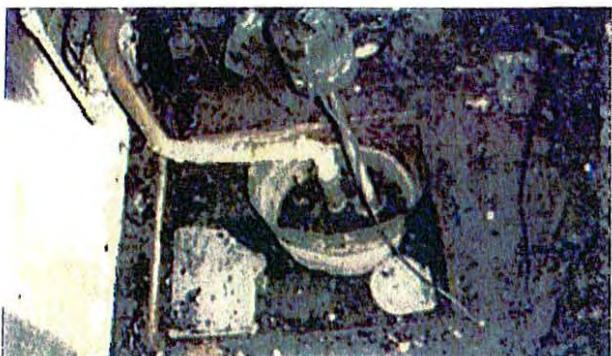
The fire scene examination and follow-up investigations revealed no avenue for gas vapors to enter the dwelling. No utility supply leaks or orifices were discovered.

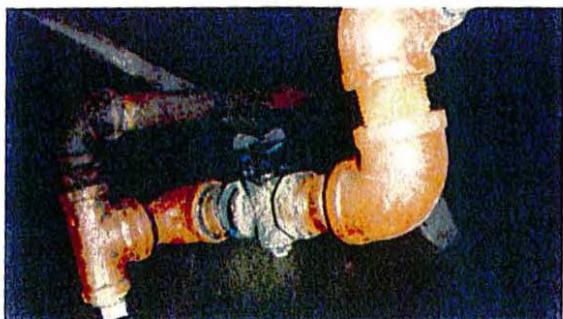
The examination centered around the sump pump area to determine if a leak in the drain pipe occurred and allowed the migration of gas vapors into the dwelling. The area around the sump pipe was excavated and tested with no conclusions. Further examination was requested by the home owners insurance investigators to scope the drain pipe.

On April 9, 2012, the examination continued with the DPU and insurance investigators. Additional excavation was performed and a scope of the pipe was performed with negative results. A minor leak was documented outside the dwelling foundation. The scope procedure was videotaped and we have a copy on file if needed.

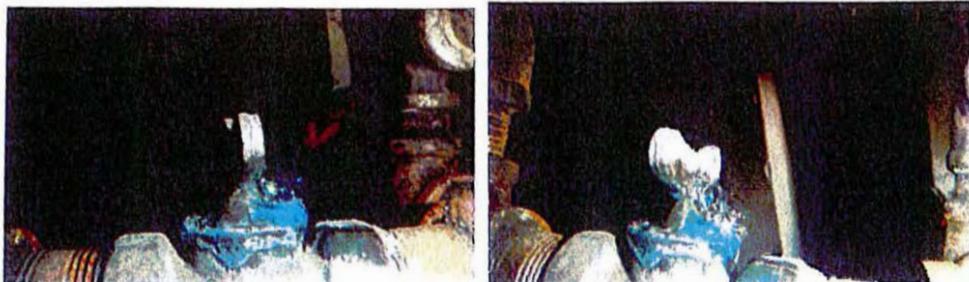
It is our continued opinion that the cause of the fire was from an internal source within the dwelling and not from the migration of gas vapors from outside the building. As previously reported, a gas valve located in the basement on the dwelling's side of the gas meter was found to leak as indicated by the bubbles from test soaping and was the most

probable cause for the gas vapor fire in the basement and other areas of the dwelling.
