PRESERVATION GUIDELINES FOR MUNICIPALLY OWNED HISTORIC BURIAL GROUNDS AND CEMETERIES

THIRD EDITION

**These Guidelines are a publication of the
Massachusetts Department of Conservation
and Recreation (DCR), Executive Office of
Energy and Environmental Affairs (EOEEA)**

Prepared by Walker-Kluesing Design Group
for the DCR Historic Cemeteries Preservation
Initiative.

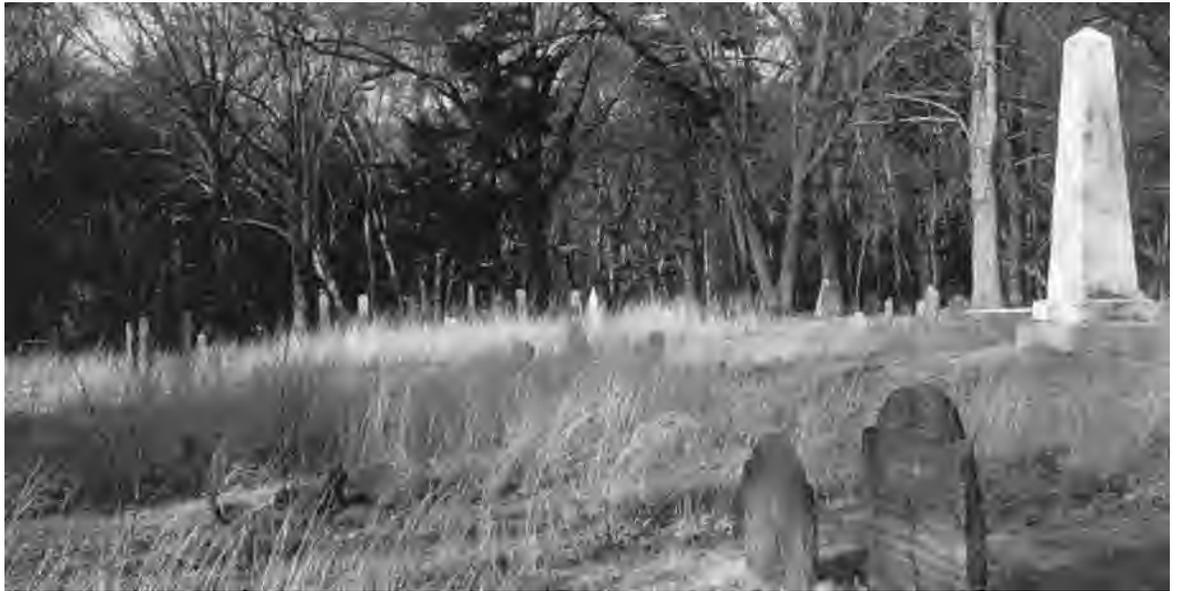
First Settlers Monument

A white marble obelisk honoring the First Settlers of Newton and marking the presumed site of the first Meeting House, which stood there from 1660 to 1697, has been placed at the high point of the site. While the structure appears in good condition, the marble is eroding from acid rain.

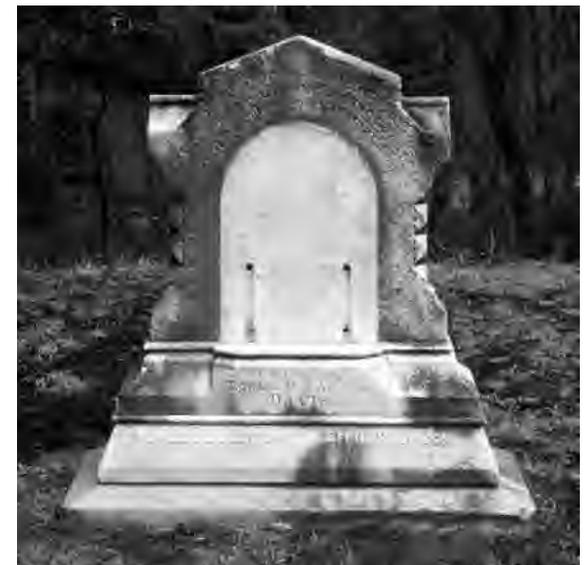
Marker vandalized by theft

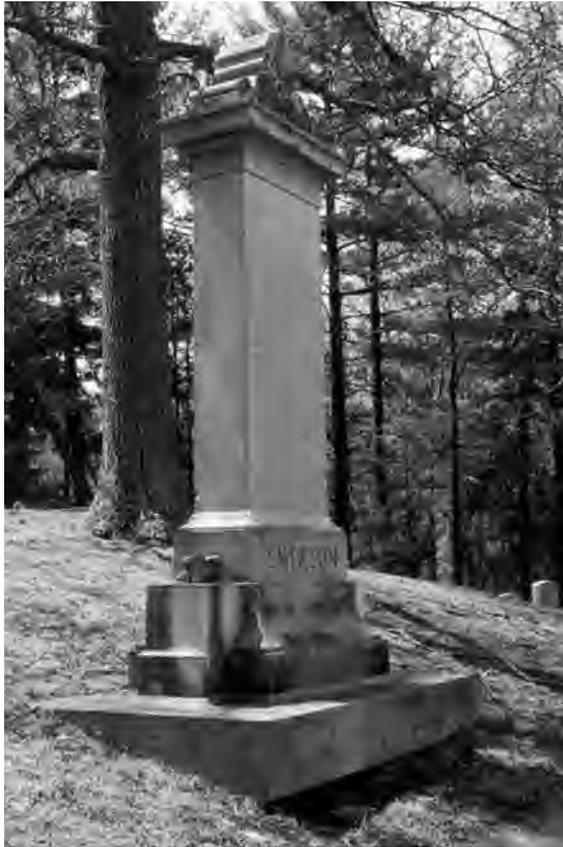
Exposed foundation of Emerson monument

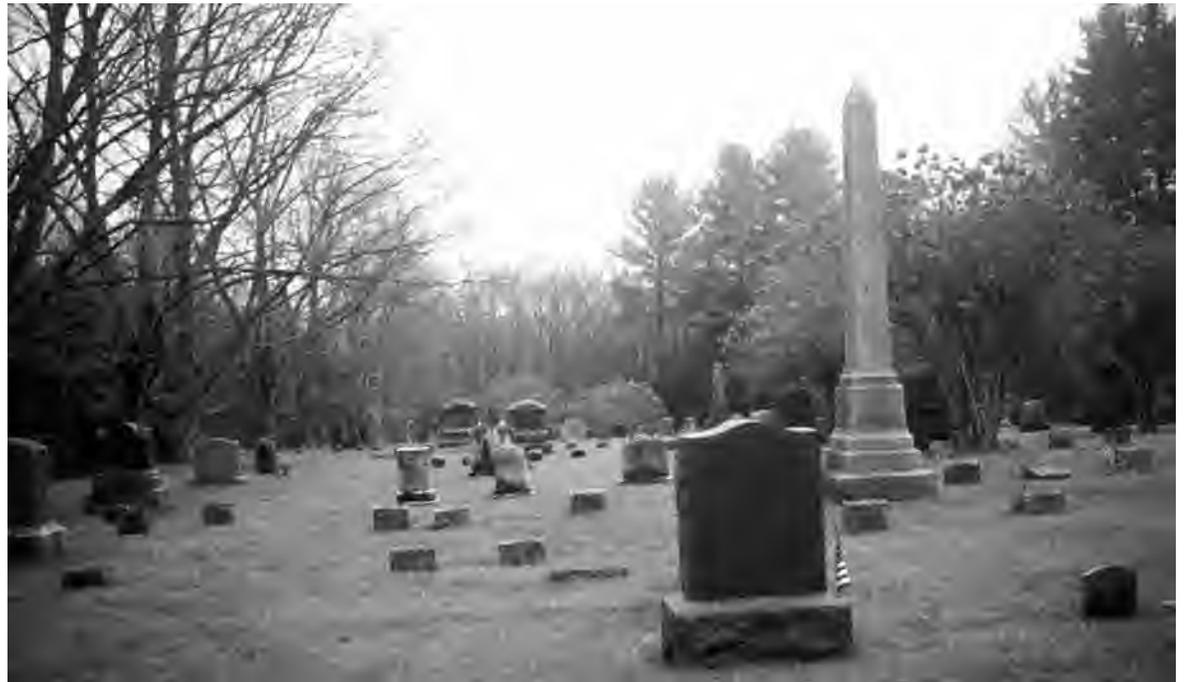
It appears that these trees have had some pruning in the past 5 years because of some old pruning wounds. However, large amounts of deadwood have accumulated since. A number of trees have codominant and multiple main stems like those in Center Cemetery. Ringville Cemetery does not have the same shade problems that Center Cemetery has.

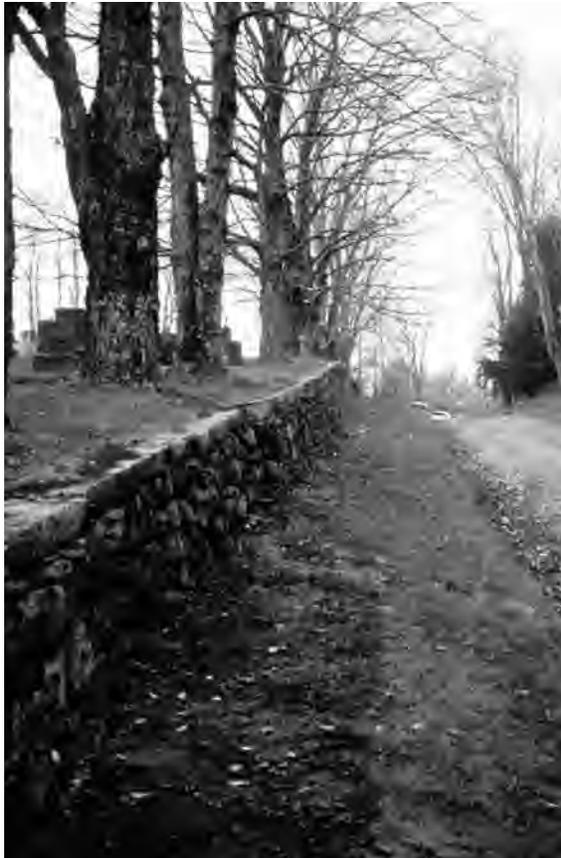
Ringville Cemetery,

Stone wall along Witt Hill Road

The dry laid rubble stone retaining wall along Witt Hill Road at Ringville Cemetery was built about 1900 with stone hauled by oxen and wagons from West Chesterfield Gorge, 8 to 9 miles away. It appears to have been built in two stages with a slightly different character for each. The west end appears to be relatively level with a vertical face while the sloping east end has about a 6" batter on the face. Overall, the wall appears to be in stable condition with some slight shifting of the granite cap stones that are about 4" thick, 16 to 20" wide and very long, with one about 21' long.

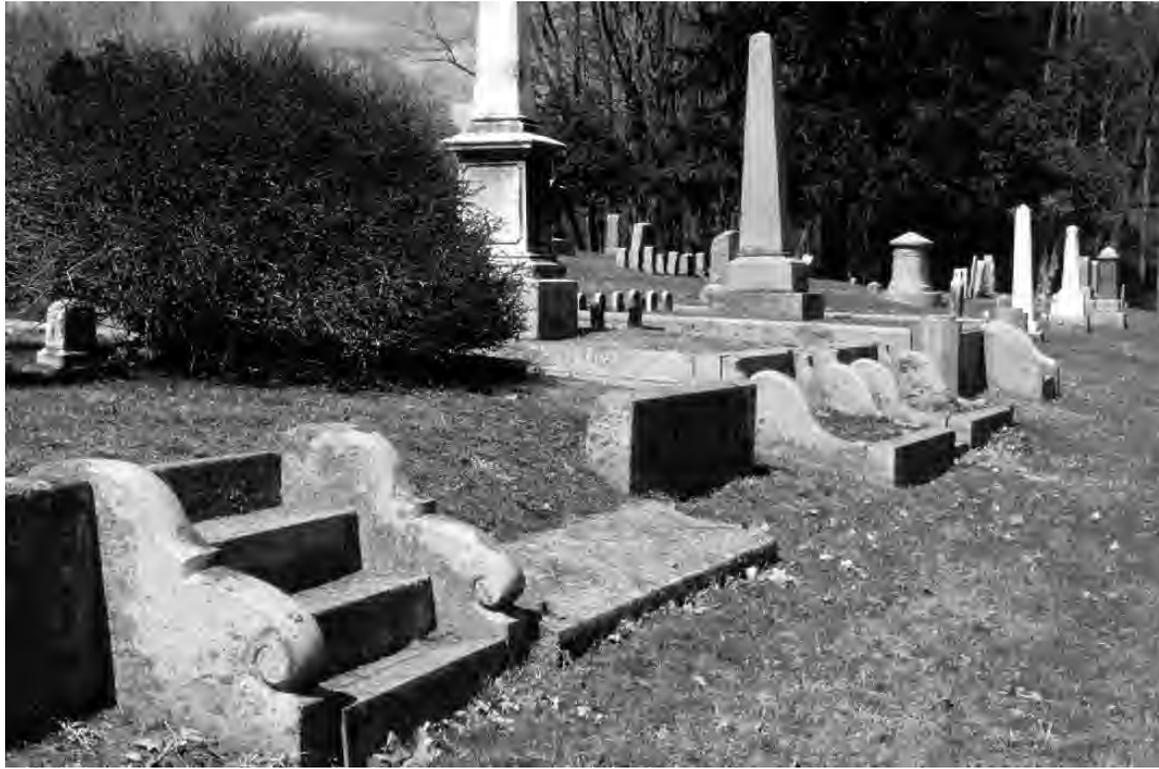
Family plot edging, steps and planters
