Massachusetts College of Art and Design

ADA Compliance Plan 2011

ADA Compliance Plan
Consultant Services
Contract #10-08

The Institute for Human Centered Design

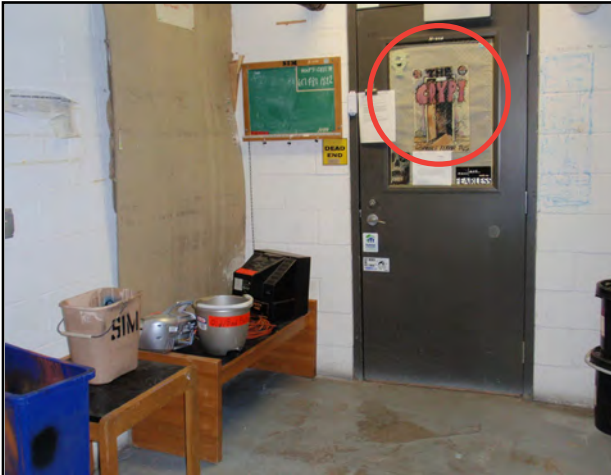
FIG. 1 NORTH BASEMENT - 'The Crypt' wrong location and non-compliant for char-

RECOMMENDATION TO IMPROVE ADA COMPLIANCE
Develop a campus-wide wayfinding program that includes ADA compliant signage installed at correct locations and heights.

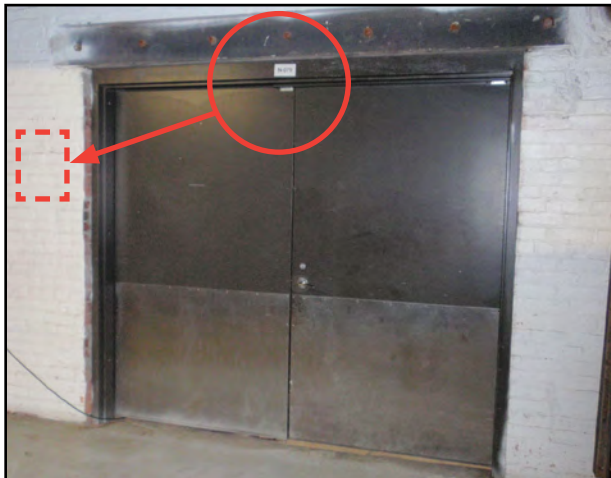
FIG.4 NORTH BASEMENT - Storage signage wrong location and non-compliant for character proportion and size

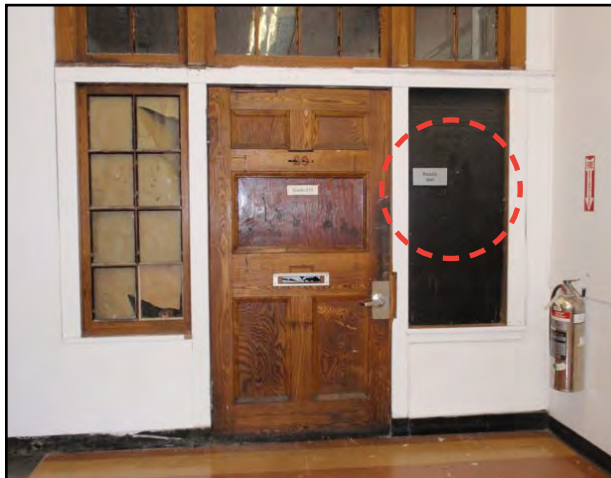
FIG.5 SOUTH - 2nd Floor wrong location and non-compliant for character proportion and size

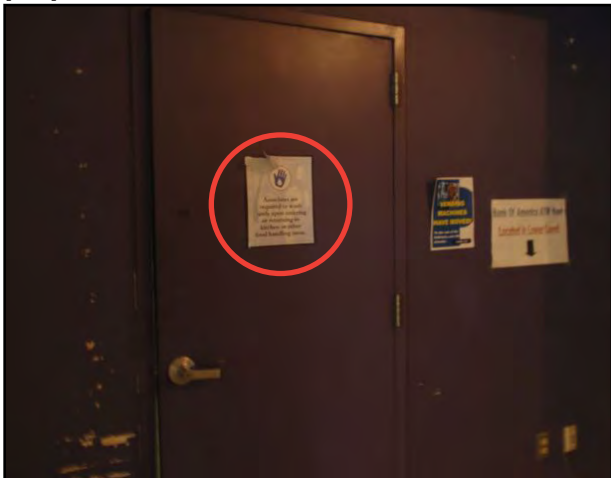
FIG.6 KENNEDY - 1st Floor - 'temporary signage' in use more than 7 days cannot be considered temporary signage

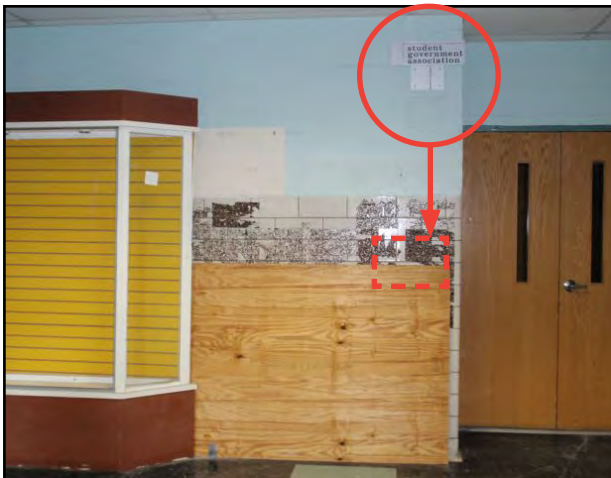
FIG.8 KENNEDY - 2nd Floor signage too high and non-compliant for character pro-

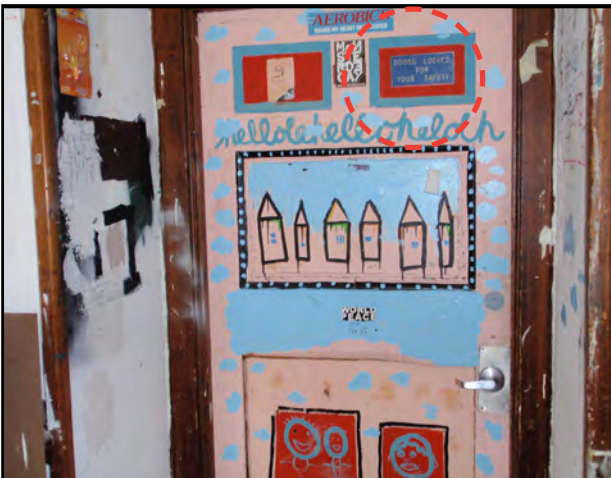
FIG.9 NORTH - 2nd Floor "doors locked for your safety" signage too high and non-compliant for character proportion and size

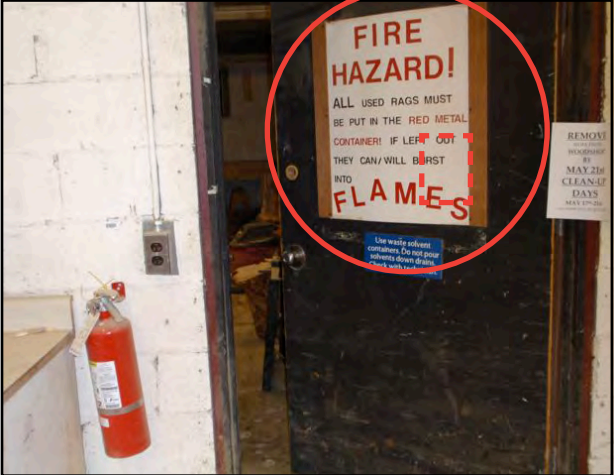
FIG.3 EAST - Basement Woodshop-signage ADA non-compliant

Directional and Informational signs that are required by the International Building Code (IBC 2009-1007.10 Directional Signage) throughout the campus are either missing or do not conform to mounting locations and height requirements.

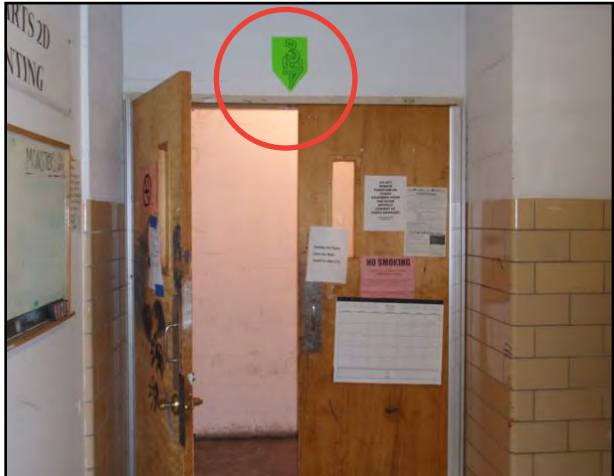
FIG.4 KENNEDY - 3rd Floor signage too high

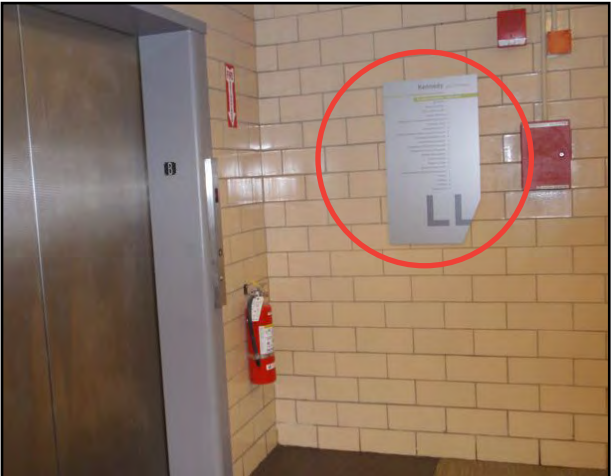
FIG.6 KENNEDY - Basement Elevator Lobby Directory confusing & non-compliant for text height and contrast

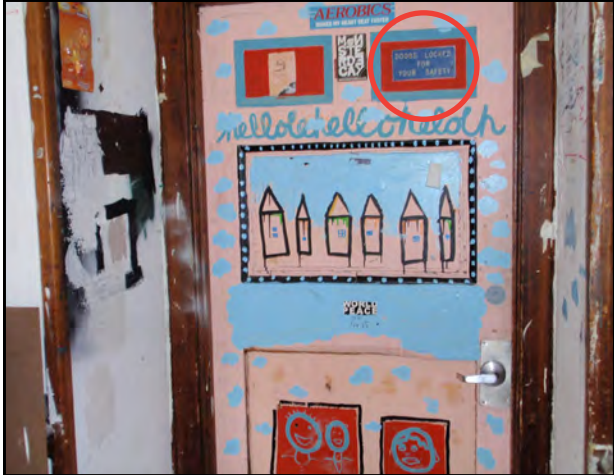
FIG. NORTH - 2nd Floor "doors locked for your safety" signage too high and non-compliant for character proportion and size

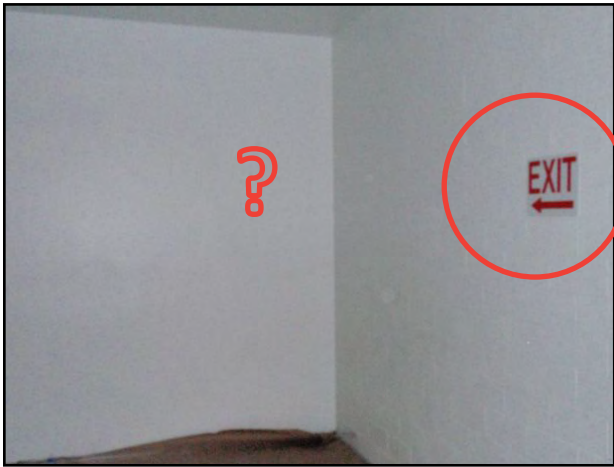
FIG. SOUTH - 2nd Floor exit arrow direction points to blank wall there is no exit

Coordinate exit arrows with egress direction. Missing or inaccurate signage can cause confusion and delay in an emergency situation.

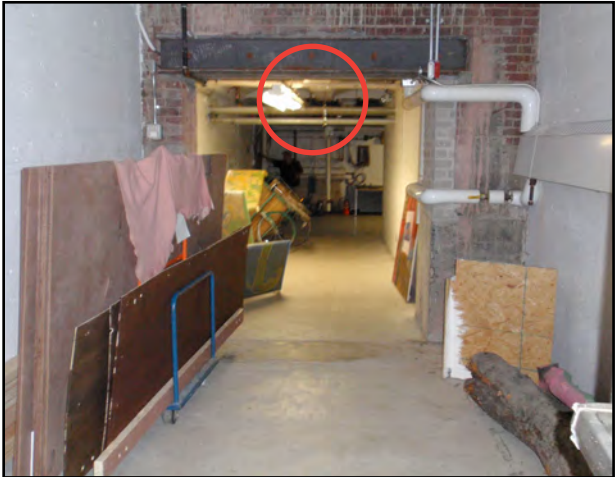
FIG. NORTH - Basement Exit sign cannot be seen as it is obstructed by plumbing

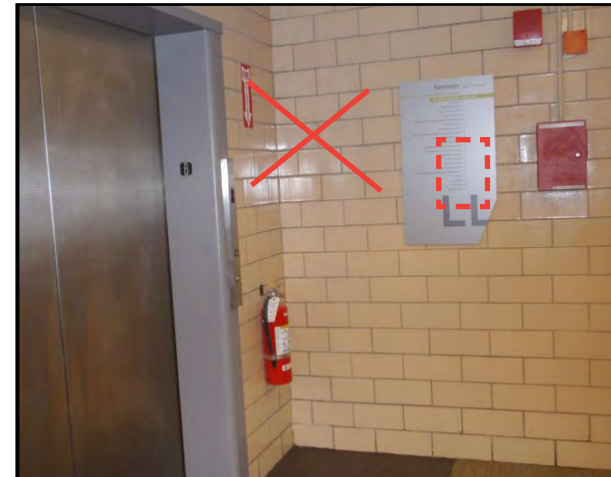
FIG. KENNEDY - Basement elevator lobby new directory confusing, non-compliant for text height, contrast & content not coord.

Directory information and signage should be coordinated and consistent between website, marketing materials, program/event signage, egress plans, wayfinding, directional signage and designation signage. ADA accessible toilet rooms should be noted on the directory.

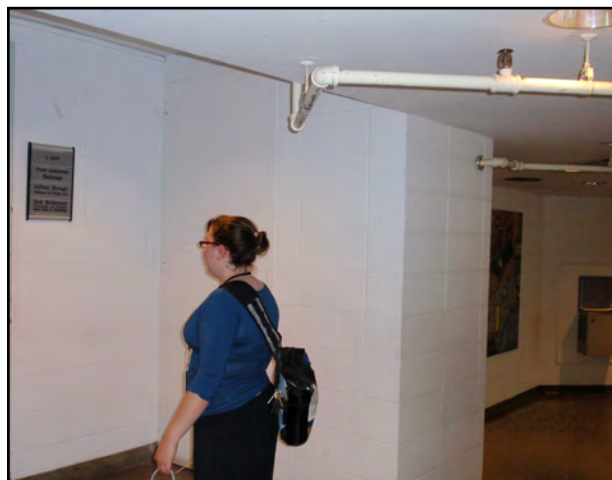
FIG. TOWER- 10th Floor Elevator Lobby Directory located too high

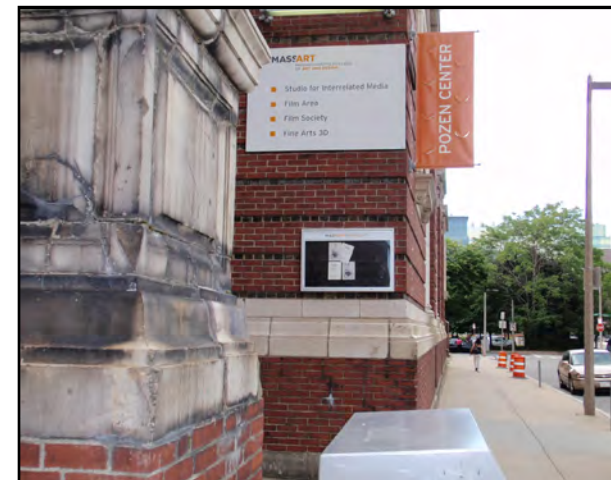
FIG. EXTERIOR - North Building directory content not coordinated with campus map and interior space usage.

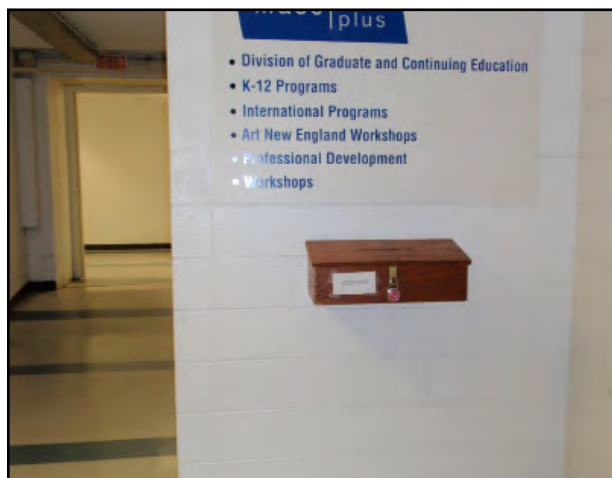
FIG. TOWER- 2nd Floor Program information that is not on any other directory

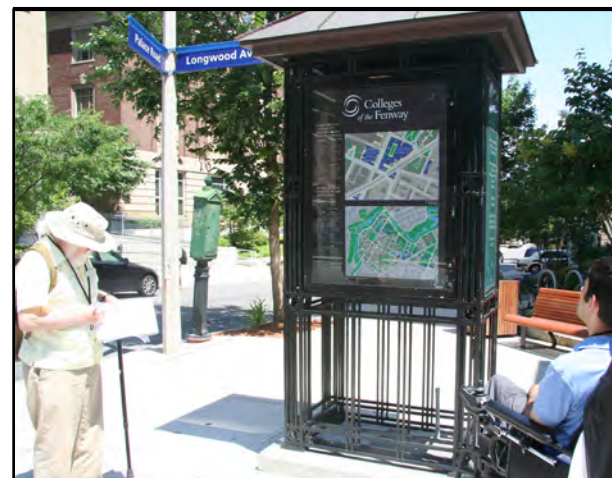
FIG. EXTERIOR- Longwood/Huntington directory difficult to read small characters are too high for a person who is seated.

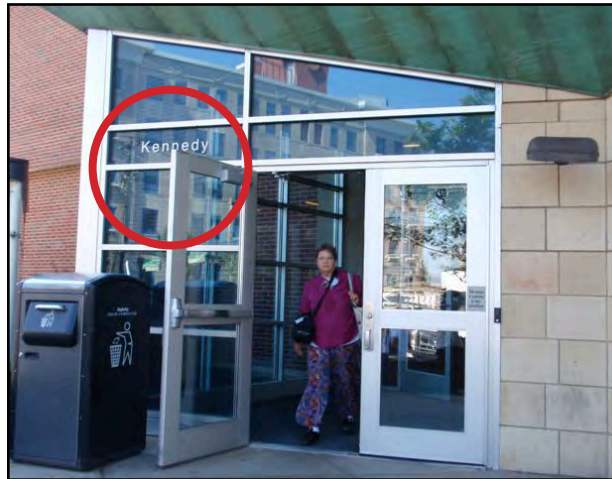
FIG. 1 KENNEDY-Front Entrance

ADA accessible entrances are not marked with the International Symbol of Accessibility, Fig. 1,2,4

Building numbers, names and titles are missing or are inconsistent throughout the campus. Fig. 1,3,5,6,8,9

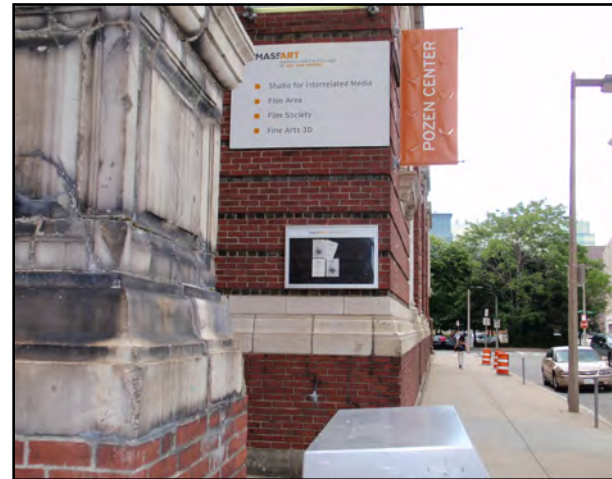
FIG. 2 NORTH-Entrance from sidewalk

At the inaccessible or locked entrances there are no directions to the locations of the nearest ADA accessible entrance. Fig. 2,7

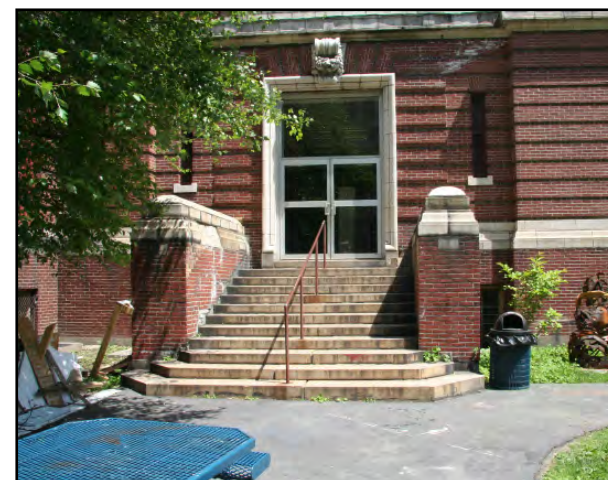
FIG. 9 COURTYARD-Entrance

RECOMMENDATION TO IMPROVE ADA COMPLIANCE
All entrances to MassArt are not ADA compliant, the entrances that are ADA compliant are required to have the international symbol of accessibility and the non-compliant entrances must have directions to the accessible entrances.

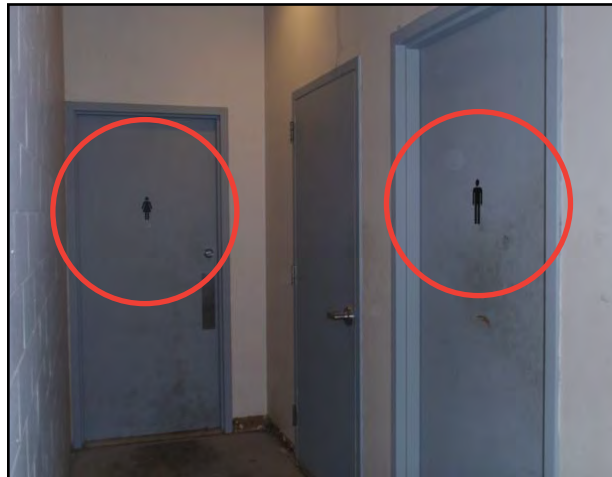
FIG. EAST - 1st Floor non-compliant toilet

If the toilet room is not ADA accessible provide signage that directs to the nearest accessible toilet room.

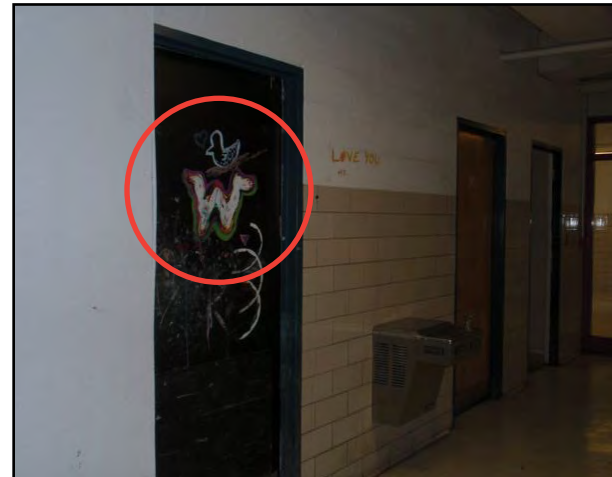
FIG. KENNEDY - 4th Floor non-compliant

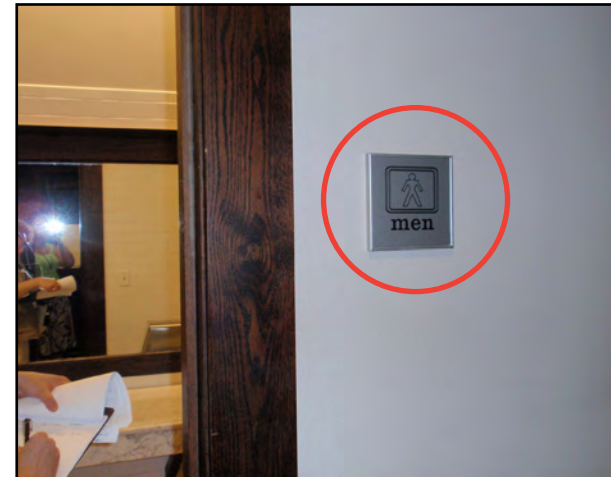
FIG. NORTH- 1st Floor non-compliant toilet

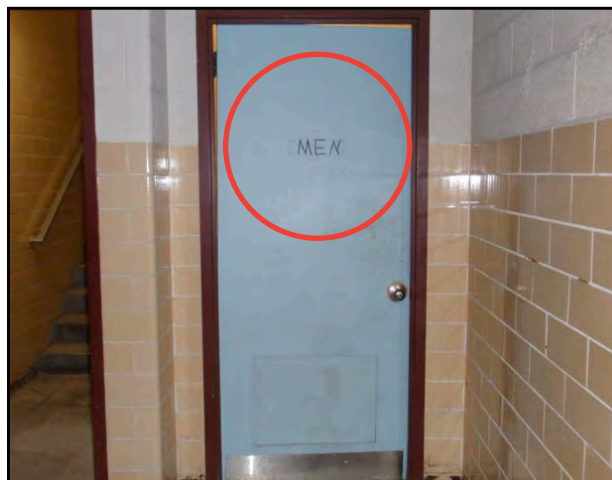
FIG. EAST - Basement handwritten non-compliant toilet room signage

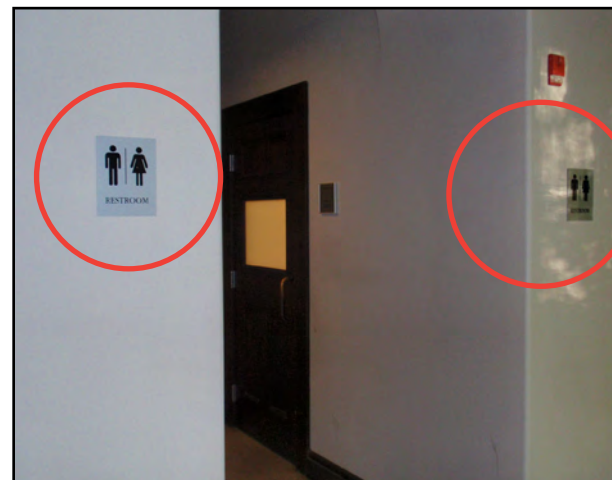
FIG. NORTH - 1st Floor non-compliant toilet

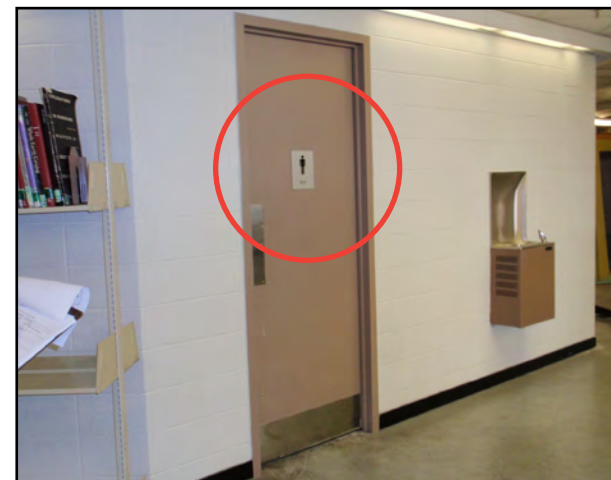
FIG.TOWER - 13th Floor non-compliant toi-

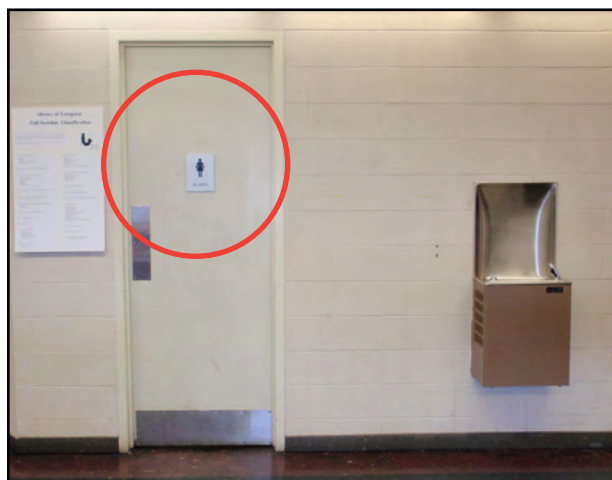
FIG.TOWER - 12th Floor non-compliant toi-

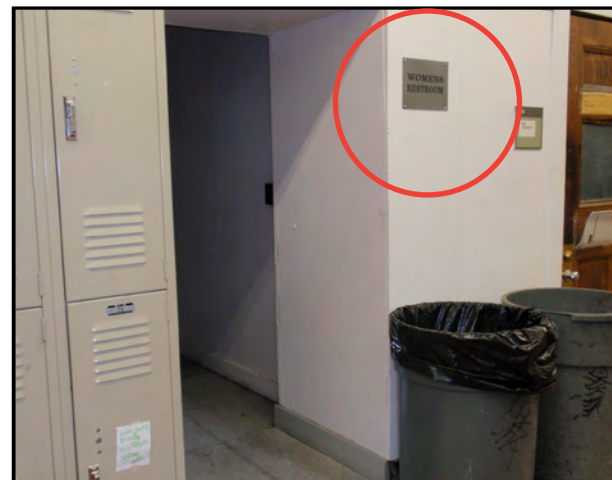
FIG.SOUTH 2nd Floor non-compliant toilet

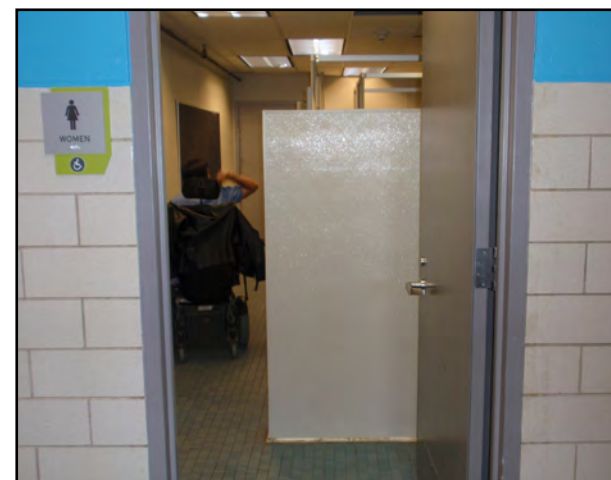
FIG KENNEDY - Basement non-compliant

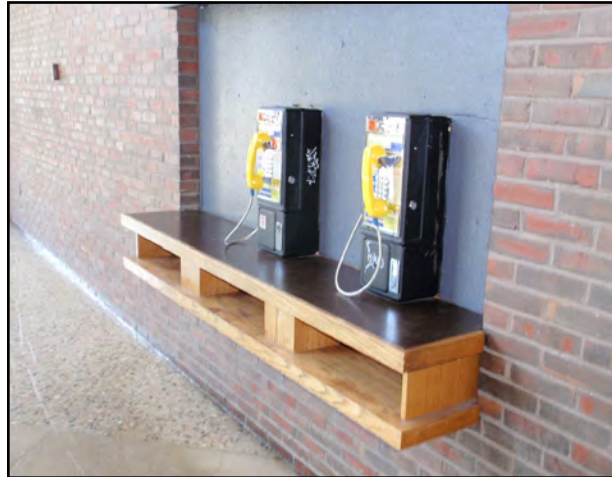
FIG. TOWER --1ST Floor

TTY identification signage missing or out of sight.

RECOMMENDATION TO IMPROVE ADA COMPLIANCE
Install signage using the International TTY symbol to identify TTY telephones

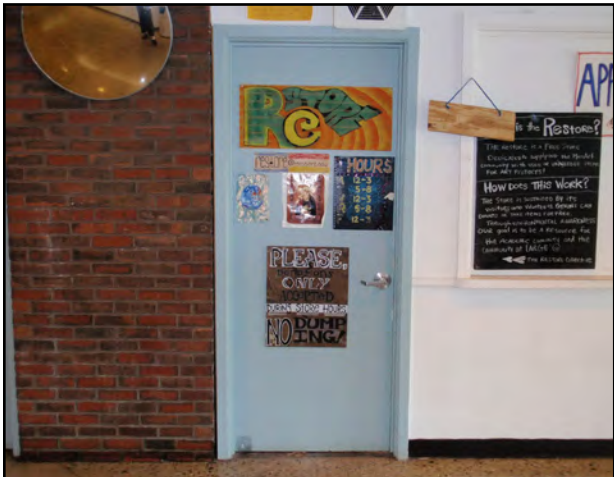
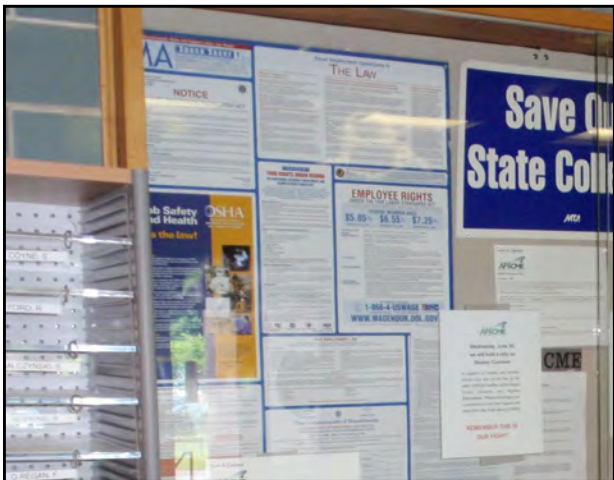
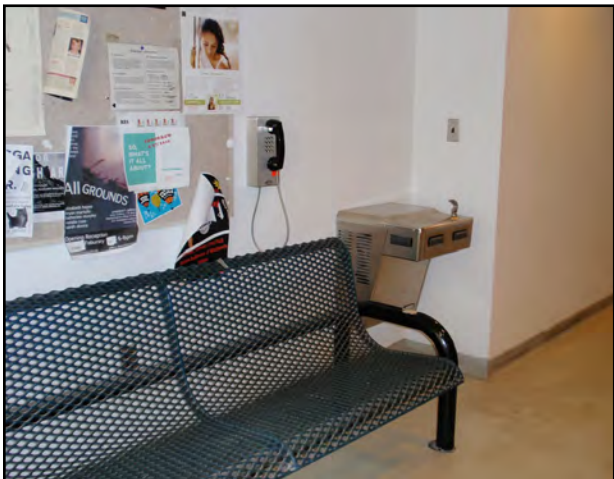
Noticeboards are an important means of communication. Notices, noticeboards and bulletin boards should not be located at a height that makes it difficult or impossible for anyone to read the information. Further, they should not be located behind furniture which makes it more difficult to read the information. Rearrange information so that large-type (over 48 points) announcements and posters are at the top and typed material is at the bottom. Establish criteria for bulletin boards as part of the wayfinding/signage up-grading program.

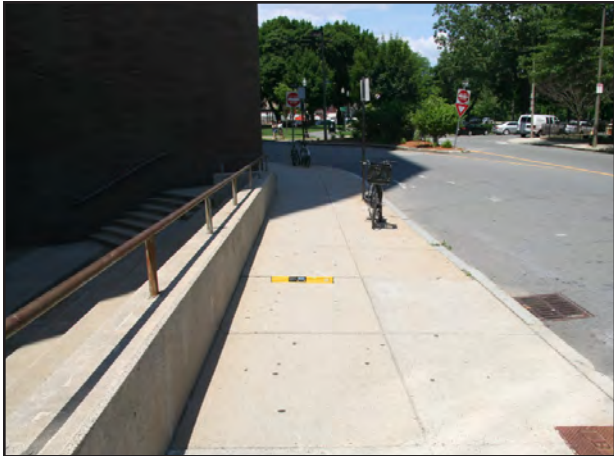
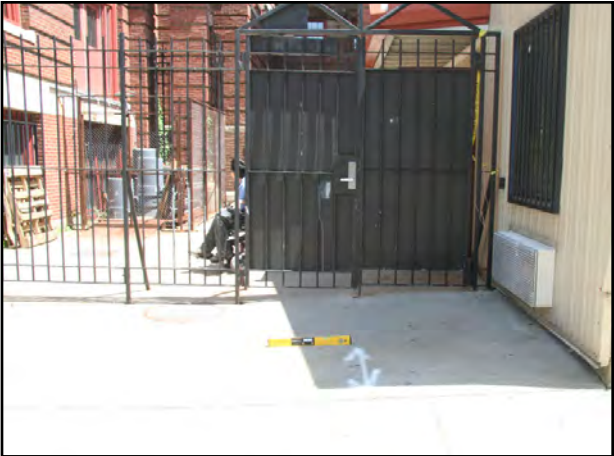
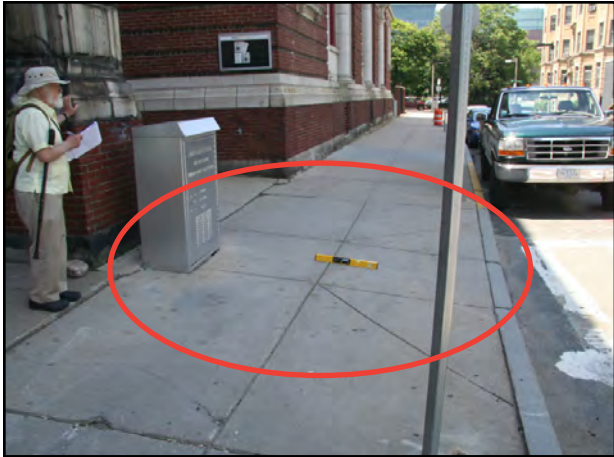
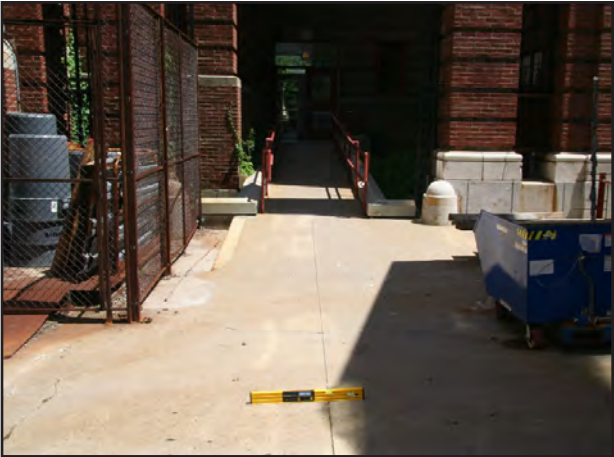
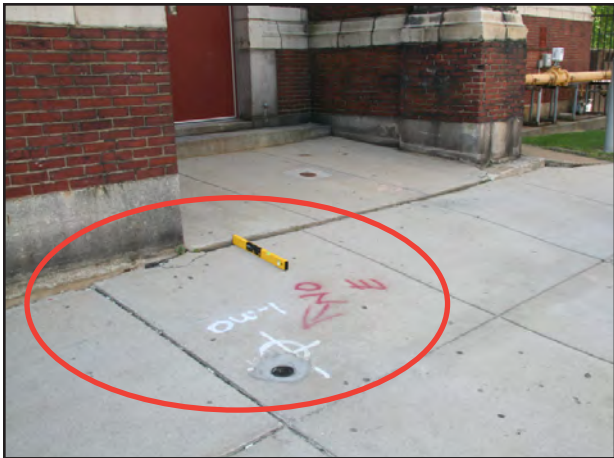
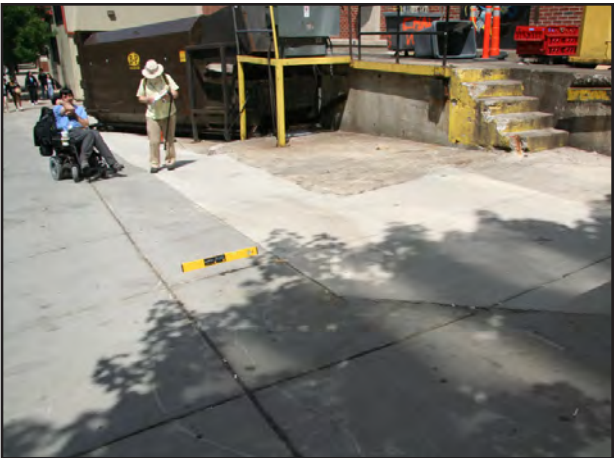
Excess Cross Slope (Typ)
 The photos depict areas in which sidewalk or walkway cross slope exceeds the 2% maximum. Depending on the location, the cross slope may range from 3% to over 7%.
[See Appendix - A-2010 ADA Standards 403 Accessible Routes]

RECOMMENDATION TO IMPROVE ADA COMPLIANCE
CAPITAL IMPROVEMENT: For surfaces controlled by MassArt, the surfaces should be removed and replaced with surfaces that have cross slopes less than 2%. Design for 1.5% to allow for construction tolerance.

OPERATIONAL: For surfaces controlled by other entities such as the City of Boston, MassArt should work with and document efforts with the City to have the surfaces removed and replaced with surfaces that have cross slopes less than 2%. Design for 1.5% to allow for construction tolerance.

ISSUE B
CAPITAL IMPROV.
 Replace walkway surfaces with cross slope that does not exceed 2%.

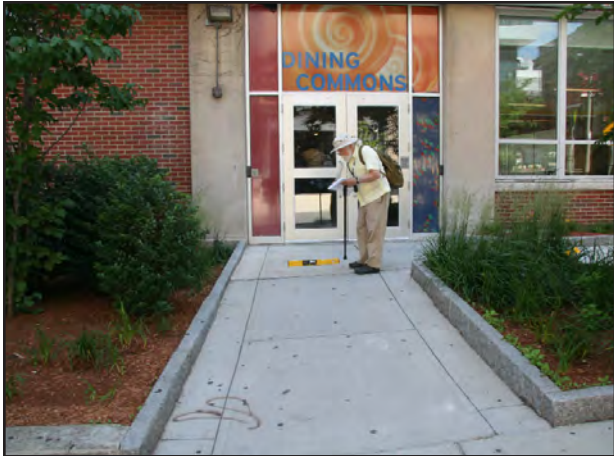
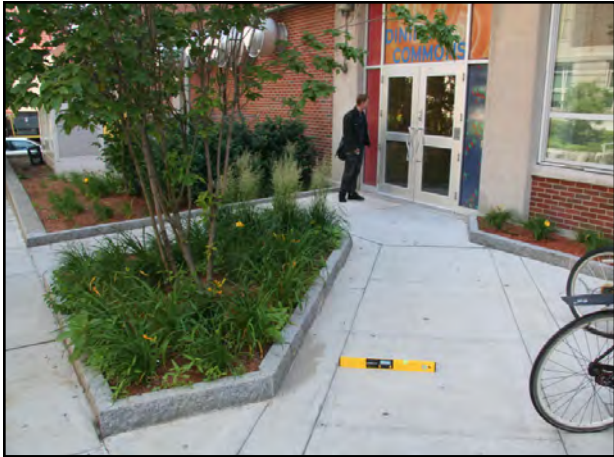
LOCATION | X07a

Excess Running and Cross Slopes at Building E Kennedy entrance on Palace Rd

CAPITAL IMPROVEMENT: These surfaces were installed recently by a MassArt contractor and they should be removed and replaced with surfaces that have cross slopes less than 2%. Design for 1.5% to allow for construction tolerance. Ensure that a 5' deep level landing is provided at the doors.

CAPITAL IMPROVEMENT: Remove door landing and walkway shown in Photo X07a, then install a new 5' deep level landing at the entrance doors and a new ramp that meets cross slope and handrail requirements.

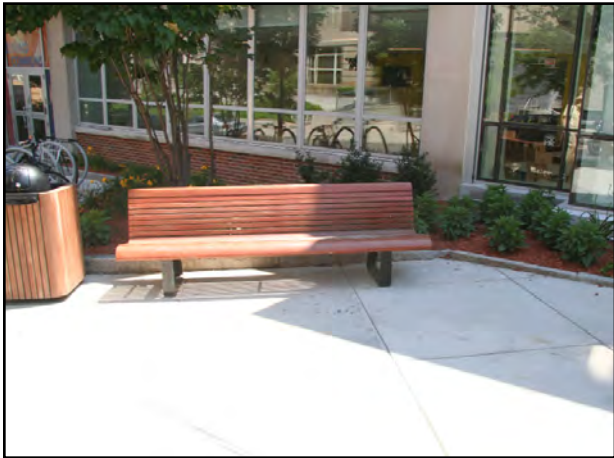
LOCATION | X08

Bench at Building E on Palace Rd

OPERATIONAL: Relocate the trash can.

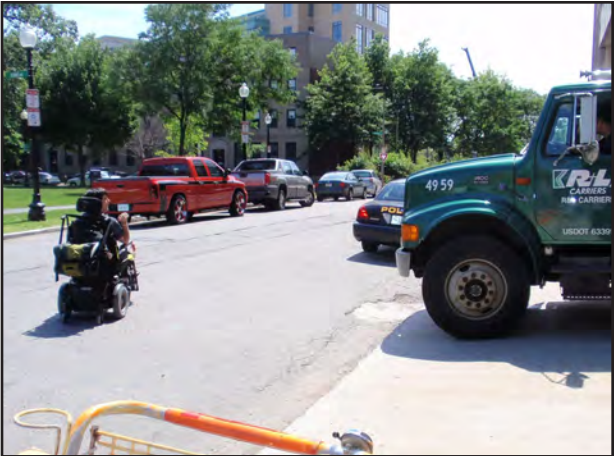
LOCATION | X09

Parking and Deliveries create accessible route obstruction

Vehicles using the sidewalk for delivery parking [photo X09].

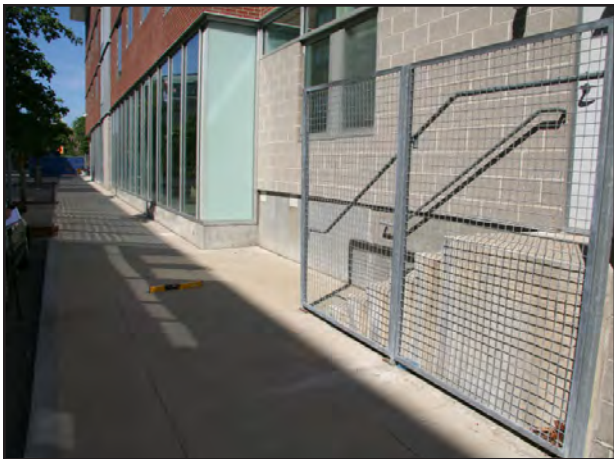
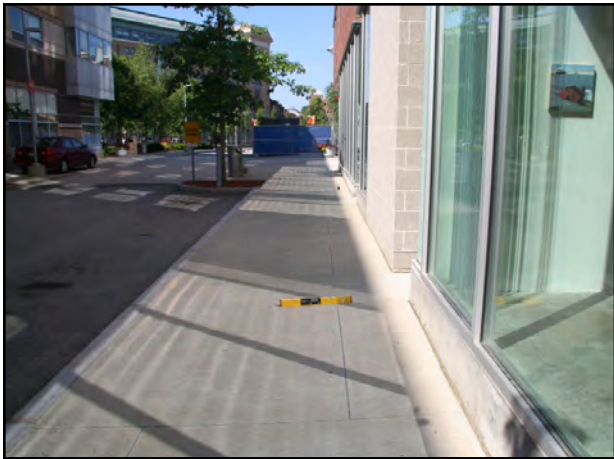
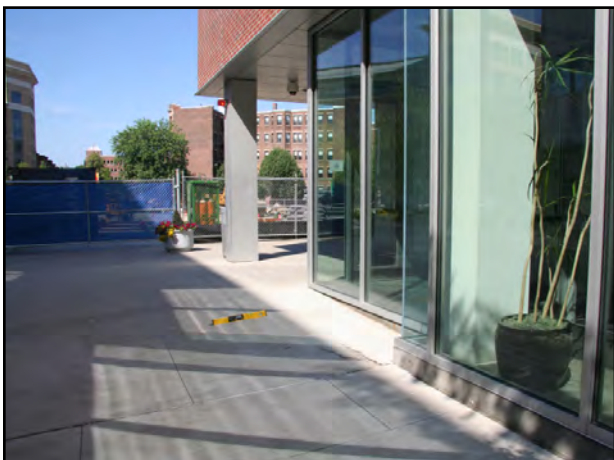
LOCATION | X09a

Excess Cross Slope at Artist Residence sidewalk - New Construction

[See Appendix - A-2010 ADA Standards 403 Walking Surfaces]

RECOMMENDATION TO IMPROVE ADA COMPLIANCE
CAPITAL IMPROVEMENT: These surfaces were installed recently by a MassArt contractor and the surfaces should be removed and replaced with surfaces that have cross slopes less than 2%. Design for 1.5% to allow for construction tolerance. Ensure that a 5' deep level landing is provided at the doors and stairs.

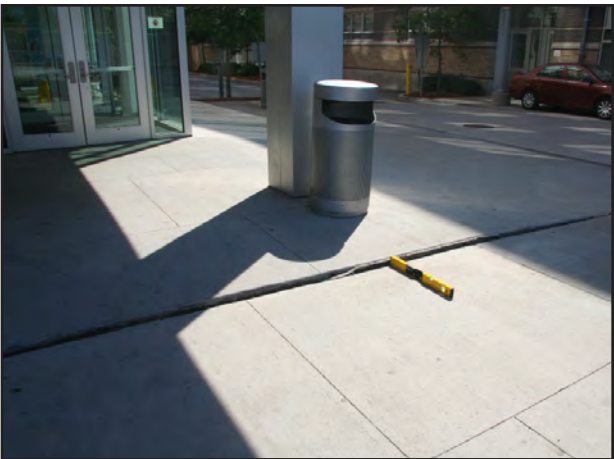
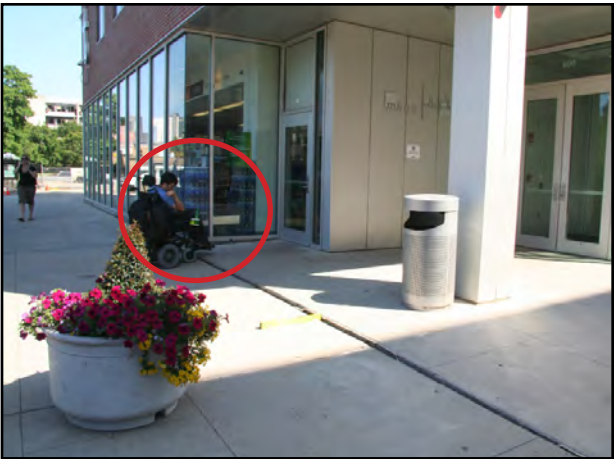
LOCATION | X10a

Tripping Hazard at Artist Residence & Store Entrances - New Construction

RECOMMENDATION TO IMPROVE ADA COMPLIANCE
CAPITAL IMPROVEMENT: Remove 2.5" vertical displacement.

CAPITAL IMPROVEMENT: Provide a 5' deep level landing at store entrance.

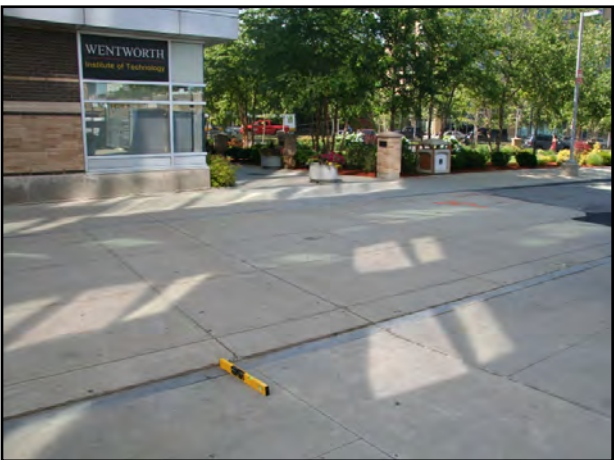
LOCATION | X11

Walkway from Artist Residences to Tower Building - New Construction

RECOMMENDATION TO IMPROVE ADA COMPLIANCE
MAINTENANCE: Repair surfaces.

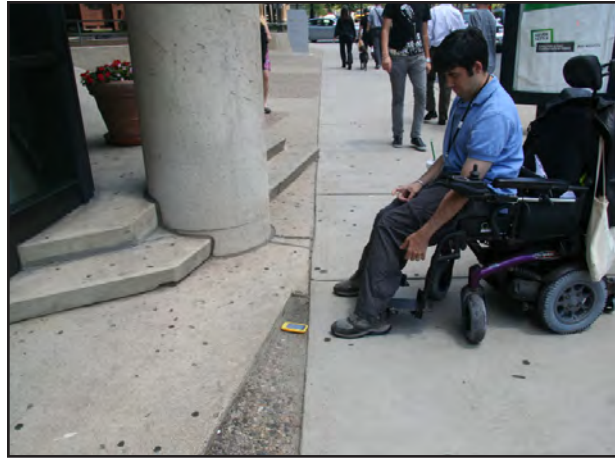
LOCATION | X12

Tower Building

[See Appendix - A-2010 ADA Standards 403 Walking Surfaces]

RECOMMENDATION TO IMPROVE ADA COMPLIANCE
CAPITAL IMPROVEMENT: Repair surfaces to eliminate vertical displacements.

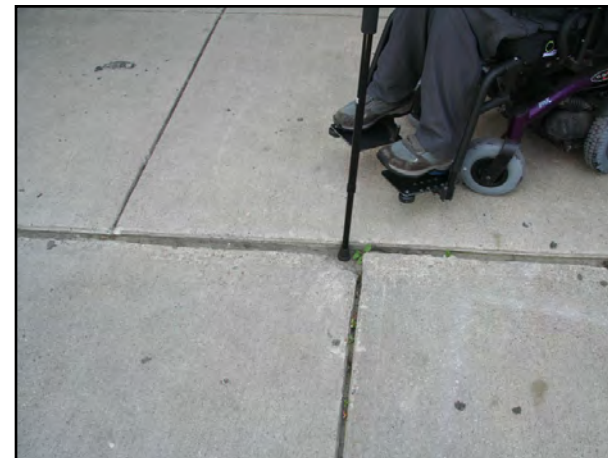
LOCATION | X16

Pozen Entrances/Exits @ Evans & Tetlow

[See Appendix - A-2010 ADA Standards 403 Walking Surfaces]

RECOMMENDATION TO IMPROVE ADA COMPLIANCE
CAPITAL IMPROVEMENT: Repair surfaces to eliminate vertical displacements.

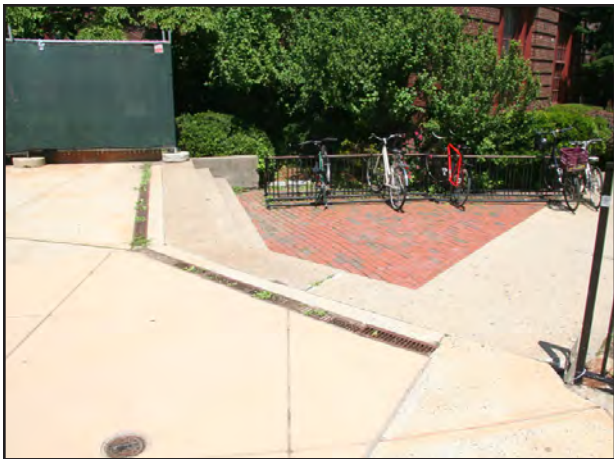
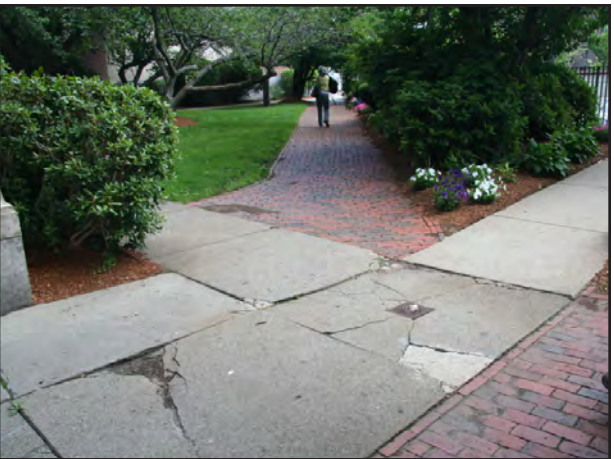
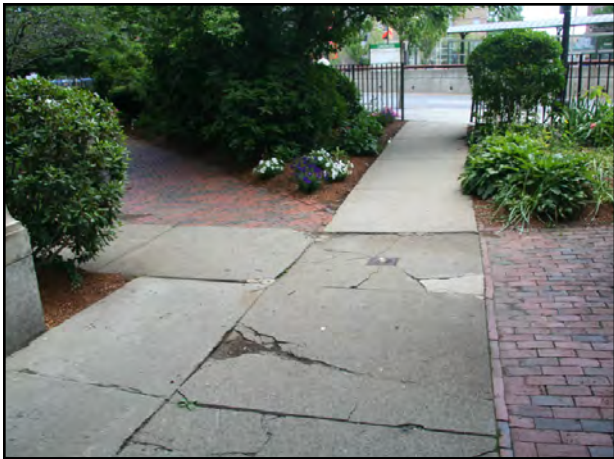
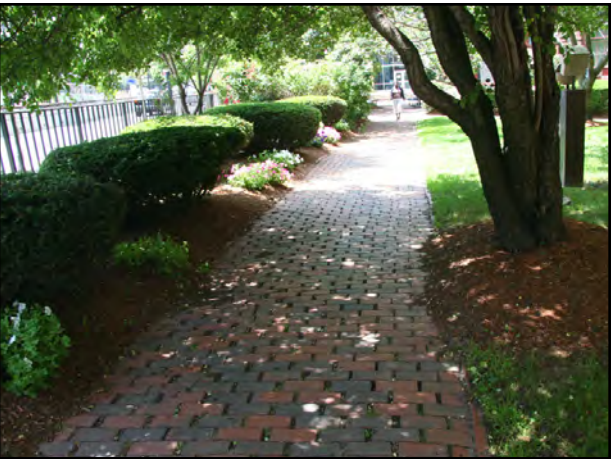
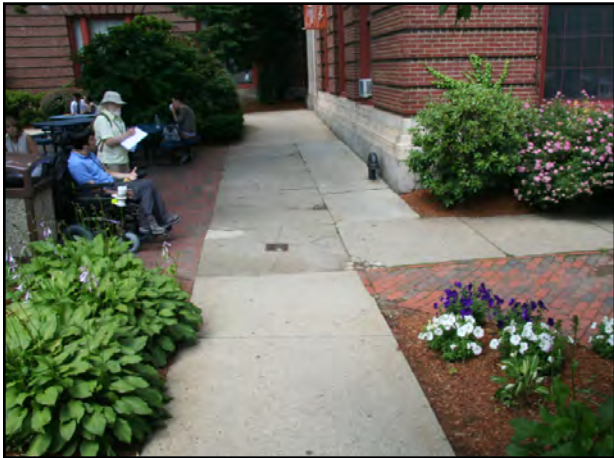
LOCATION | X18

South Building
 The photos on this page depict a sampling of areas where people were observed tripping on surfaces that have vertical displacements greater than 1/2".
[See Appendix - A-2010 ADA Standards 403 Walking Surfaces]

RECOMMENDATION TO IMPROVE ADA COMPLIANCE
CAPITAL IMPROVEMENT: Repair or replace surfaces to eliminate vertical displacements.

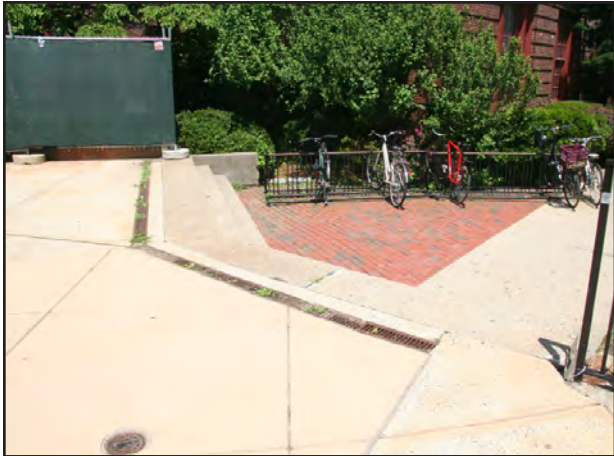
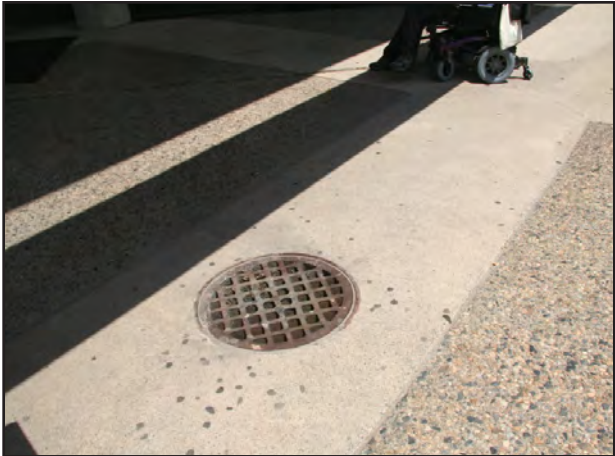
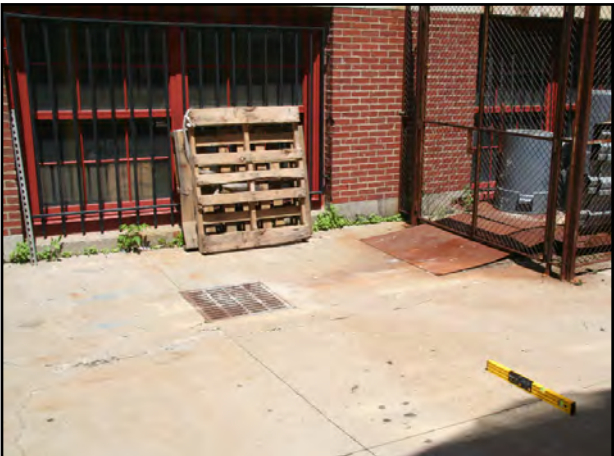
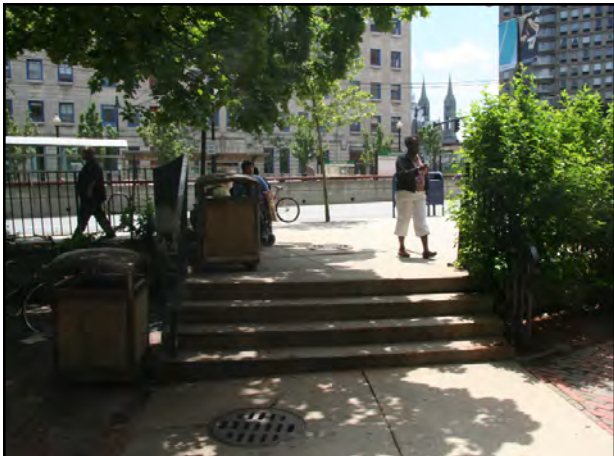
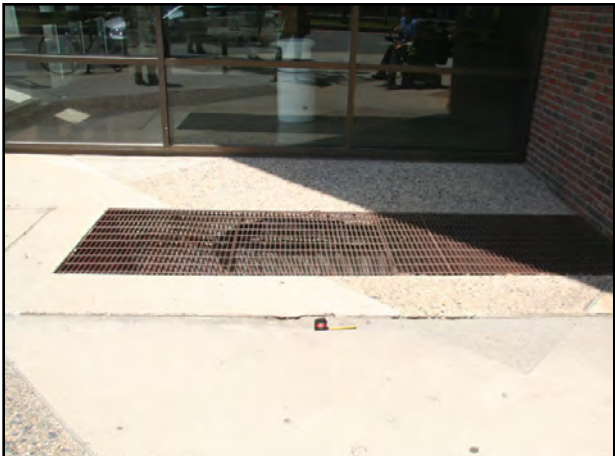
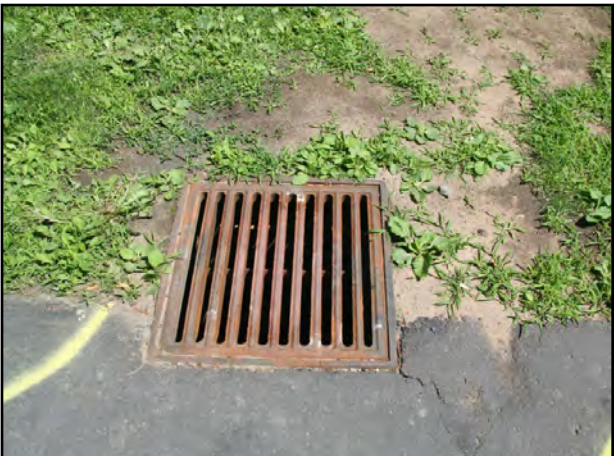
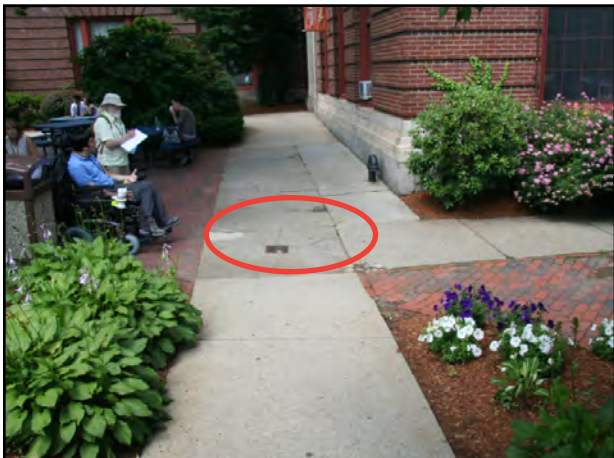
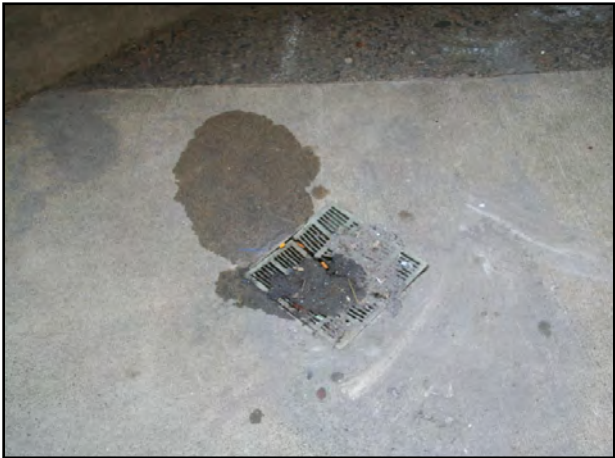
Grates
 The photos on this page depict a sampling of grates that have openings larger than 1/2" and may also have vertical displacements greater than 1/2" around their edges. The grate in photo X26 is of a collapsed grate and is a hazard for users of the ramp at Tower.
[See Appendix - A-2010 ADA Standards 403 Walking Surfaces]

RECOMMENDATION TO IMPROVE ADA COMPLIANCE
SMALL MAINTENANCE: Replace grates with openings of 1/2" or less and repair surfaces to eliminate vertical displacements.

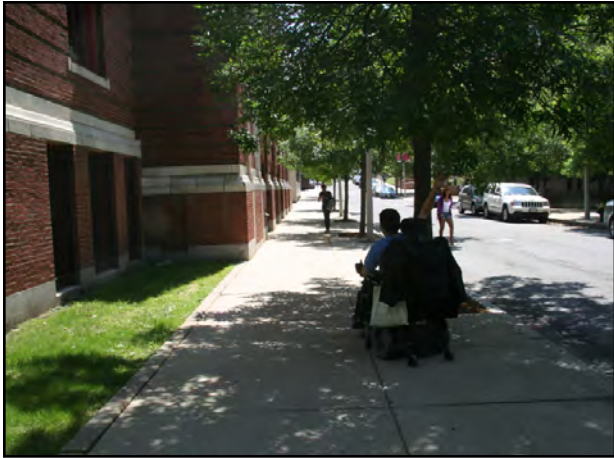
LOCATION | X28

Palace Road Trees - Protruding Objects
 The tree limbs hang substantially below 80" when dry; they are even lower when wet and are a hazard.

RECOMMENDATION TO IMPROVE ADA COMPLIANCE
OPERATIONAL: Trim or otherwise Head up trees above 96" to ensure limbs do not hang below 80" when wet.

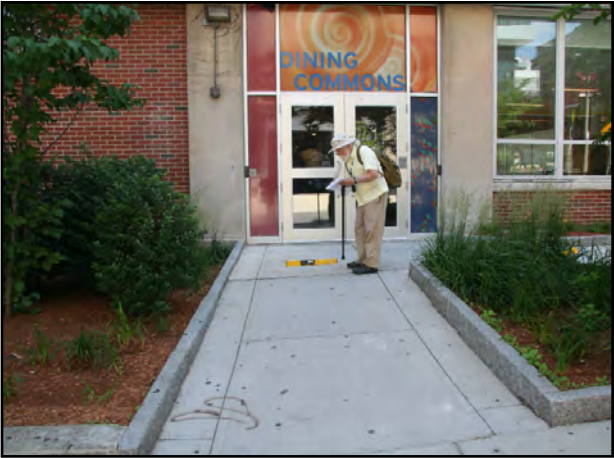
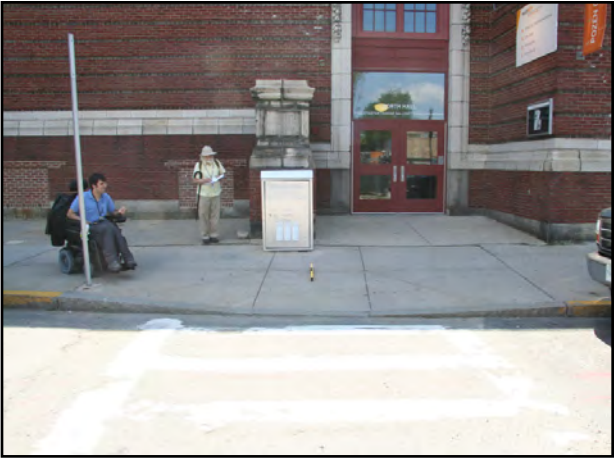
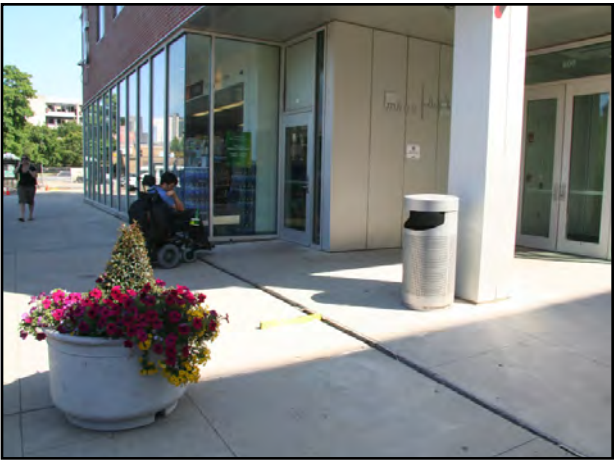
LOCATION | X29

Level Landings at Entry Doors
 The landings at each of these doorways are not level and substantially exceed the 2% maximum cross slope allowed.
[see General Issues-2010 ADA Standards 404 Doors]

RECOMMENDATION TO IMPROVE ADA COMPLIANCE
CAPITAL IMPROVEMENT: Provide a 5' deep level landing for the width of the entrance as well as wherever swipe card / locks are. Ensure that swipe card reader
