Massachusetts College of Art and Design

ADA Compliance Plan 2011

ADA Compliance Plan
Consultant Services
Contract #10-08

The Institute for Human Centered Design

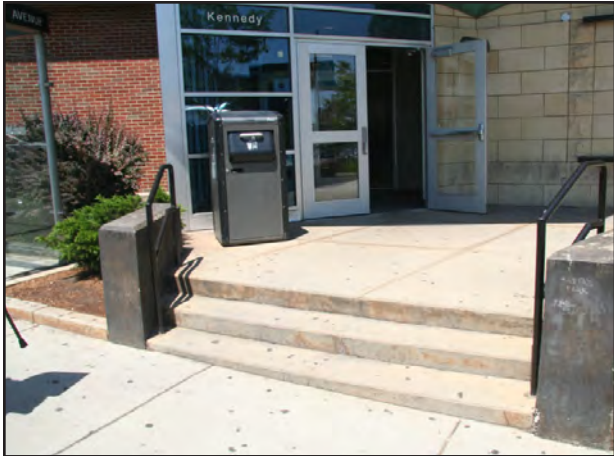
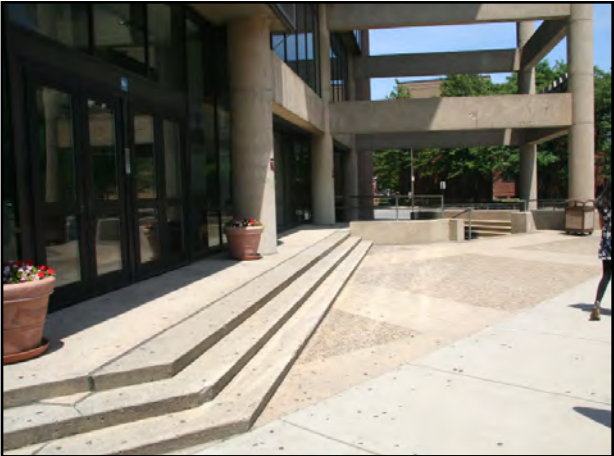
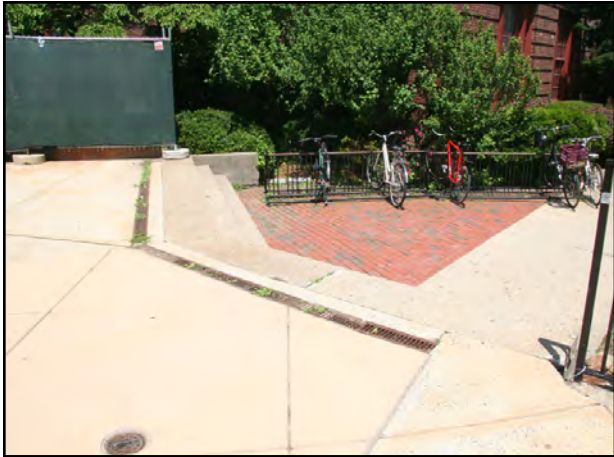
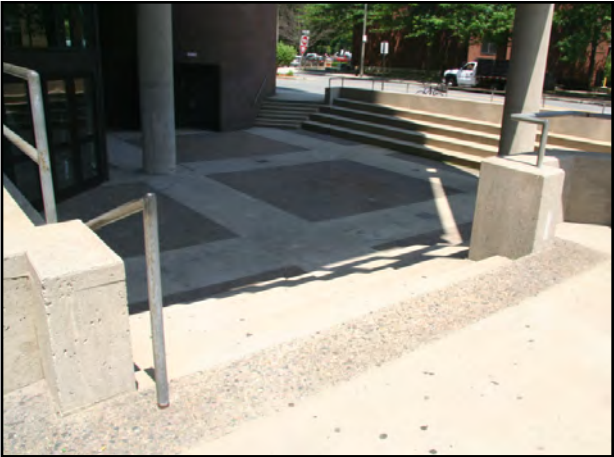
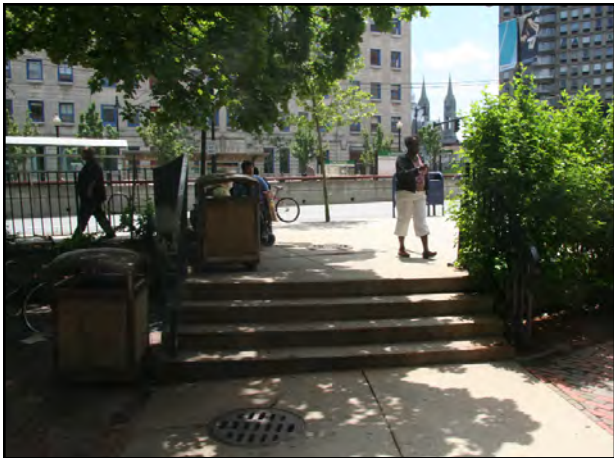
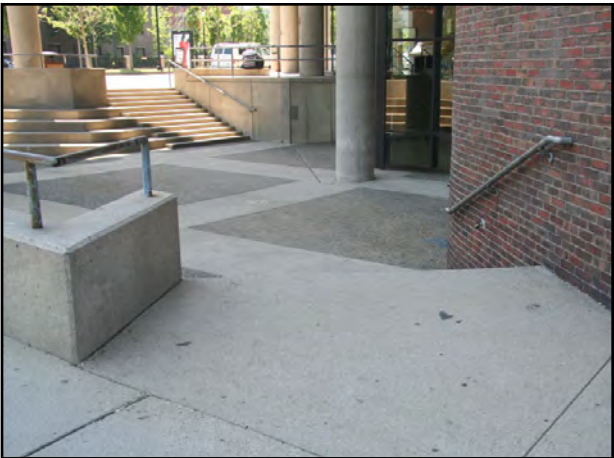
LOCATION | X32

Stairs-Handrail
 Stairs are missing one or more handrails.
 Handrail does not have extensions.
*[See Appendix - A-2010 ADA Standards
 504 Stairways, MAAB 27]*

**RECOMMENDATION TO IMPROVE SAFETY
 & USER EXPERIENCE**
 SMALL MAINTENANCE: Provide continuous
 handrails on both sides.
 SMALL MAINTENANCE: Provide handrail exten-
 sions, wrap as needed to avoid extension becom-
 ing a protruding object.

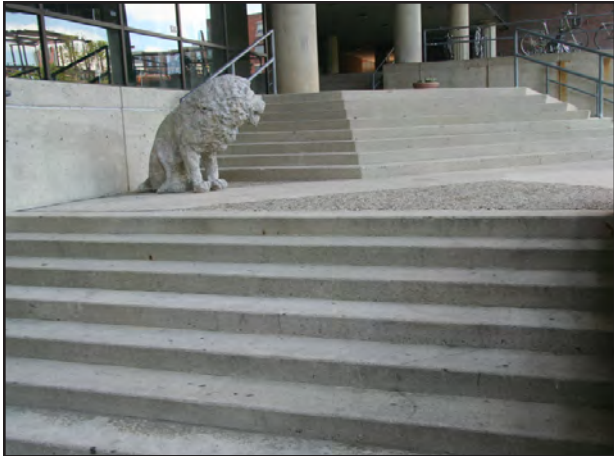
LOCATION | X37

Stairs-Handrail
 Stairs are missing one or more handrails.
 Handrail does not have extensions.
*[See Appendix - A-2010 ADA Standards
 504 Stairways, MAAB 27)*

**RECOMMENDATION TO IMPROVE SAFETY
 & USER EXPERIENCE**
SMALL MAINTENANCE: Provide continuous
 handrails on both sides.

SMALL MAINTENANCE: Provide handrail exten-
 sions.

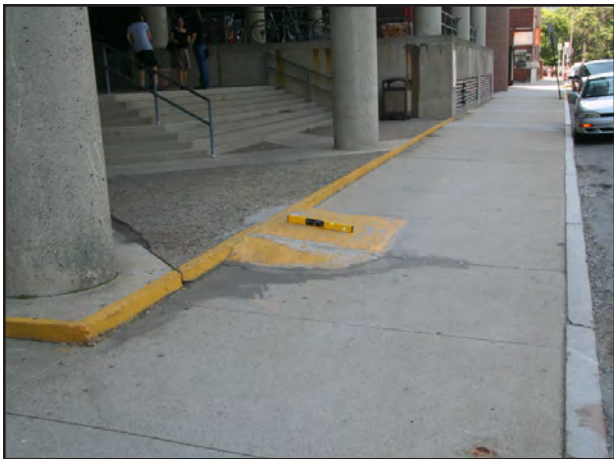
LOCATION | X41a

Ramp on Evans Way Sidewalk at Tower Bldg
 The built up ramp slope exceeds 11%.
[See Appendix - A-2010 ADA Standards 405 Ramps]

RECOMMENDATION TO IMPROVE ADA COMPLIANCE
 Implement a design similar to what is drawn for a new entrance to the Tower Building.

Work with the City of Boston to remove 4-5 sidewalk panels, then raise grade of sidewalk to provide accessible route.

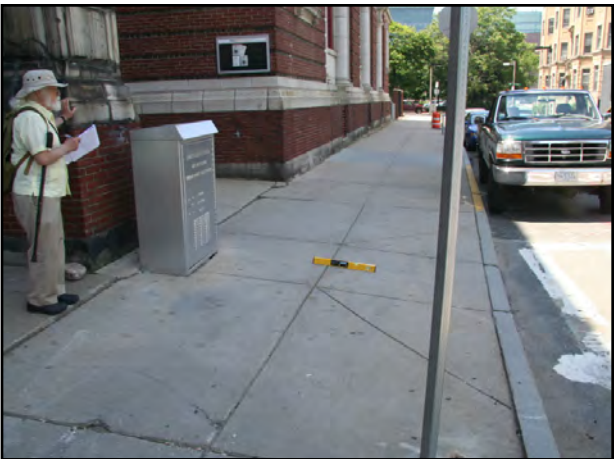
LOCATION | X43a

Curb Ramp
 Curb ramp does not have level landing at top because of City of Boston utility cabinet.
[See Appendix - A-2010 ADA Standards 405 Ramps]

RECOMMENDATION TO IMPROVE ADA COMPLIANCE
 Work with City of Boston to either relocate curb ramp to align with Pozen entrance or relocate utility cabinet. If curb ramp is relocated, attention will be needed to achieve ramp compliance as well as at least a 5' deep level landing at the Pozen entrance.

ISSUE K CAPITAL IMPROV.
 Install curb ramps that meet MAAB & 2010 ADA Standards.

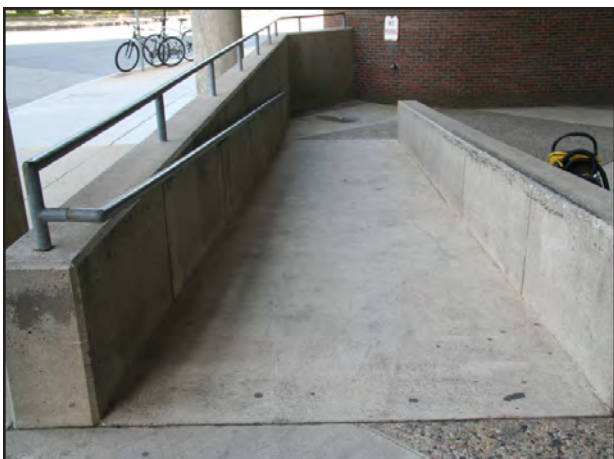
LOCATION | X42

Tower Ramp
 Ramp does not have handrails with extensions and lacks lower railing.
[See Appendix - A-2010 ADA Standards 405 Ramps, MAAB 24.5]

RECOMMENDATION TO IMPROVE ADA COMPLIANCE
 Provide handrails with extensions on either side.

Provide lower handrails.

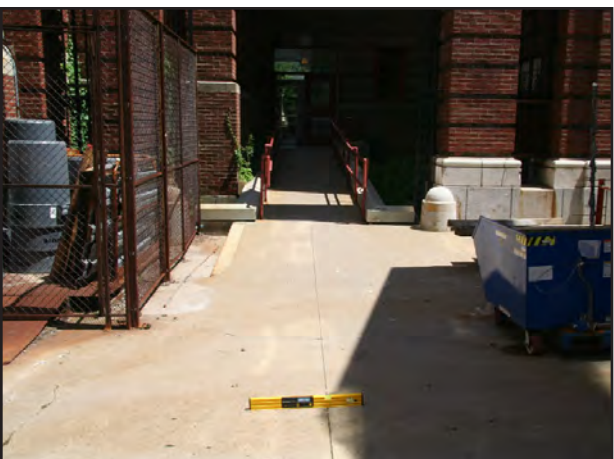
LOCATION | X44

Ramp next to Glass Building
 The ramp slope does not end where the handrails end. In fact, the slope continues almost to where the level is in the photo.
[See Appendix - A-2010 ADA Standards 405 Ramps, MAAB 24.5]

RECOMMENDATION TO IMPROVE ADA COMPLIANCE
 Implement a new entry sequence in this location that serves all three buildings as well as the courtyard.
 Where the slope exceeds 5% running slope, provide handrails in accordance with ADAAG & MAAB requirements.

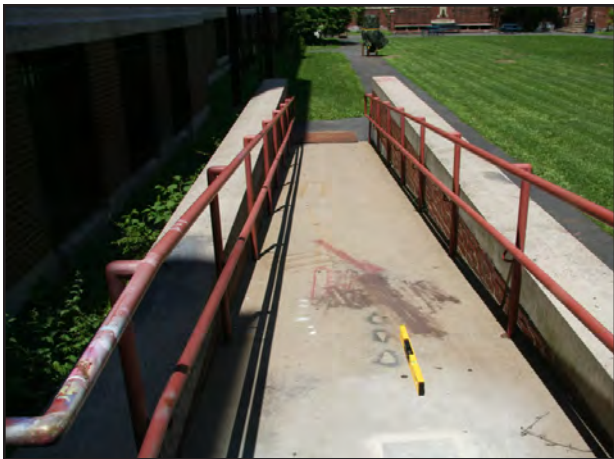
LOCATION | X45a

Ramp to Courtyard

RECOMMENDATION TO IMPROVE ADA COMPLIANCE OPERATIONAL: Immediately discontinue courtyard usage for school and public events until the bottom of the courtyard ramp is fixed and meets MAAB & 2010 ADA Standards.

CAPITAL IMPROVEMENT: Reconstruct the courtyard path to provide an accessible route to the ramp and a 5' deep level landing.

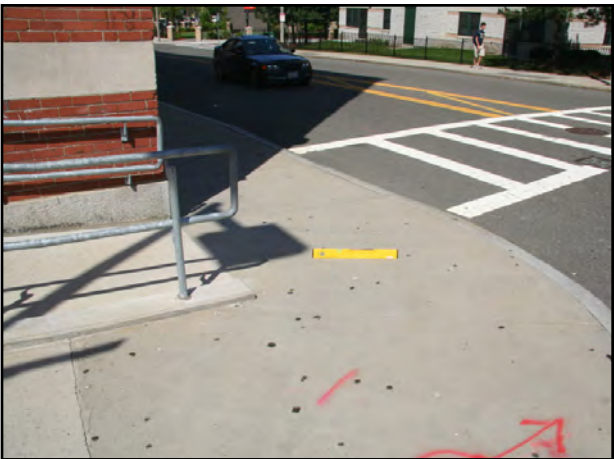
LOCATION | X47

Building Ramp & Curb Ramp at St. Alphonsus
 Neither the building ramp nor curb ramp have level landings. The slope is 4.4%.
[See Appendix - A-2010 ADA Standards 405 Ramps, MAAB 24]

RECOMMENDATION TO IMPROVE ADA COMPLIANCE
 Work with City of Boston to regrade area 2% or less in all directions and install a parallel curb ramp.

ISSUE K CAPITAL IMPROV.
 Install curb ramps that meet MAAB & 2010 ADA Standards.
 Install ramps that have railings with extensions that meet MAAB & 2010 ADA Standards.

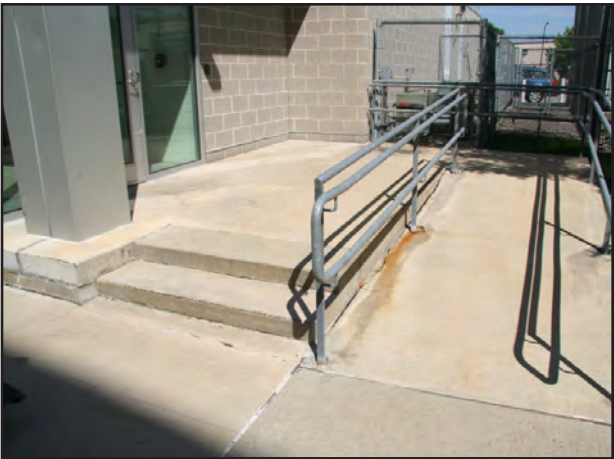
LOCATION | X48

Artist Residence SW Entry/Exit Ramp at Vancouver Drive
 The building ramp does not have a level landing at bottom. The sidewalk slope is 2.9% and thus the landing has a 2.9% cross slope.
 The toe of the ramp has a 1" threshold.
[See Appendix - A-2010 ADA Standards 403 Walking Surfaces, 405 Ramps, MAAB 24]

RECOMMENDATION TO IMPROVE ADA COMPLIANCE CAPITAL IMPROVEMENT: Work with City of Boston and Wentworth to regrade area to get a 2% or less landing in all directions and eliminate 1" threshold.

INTERIM RECOMMENDATION
 Immediately discontinue courtyard usage for school and public events until the bottom of the courtyard ramp is fixed.

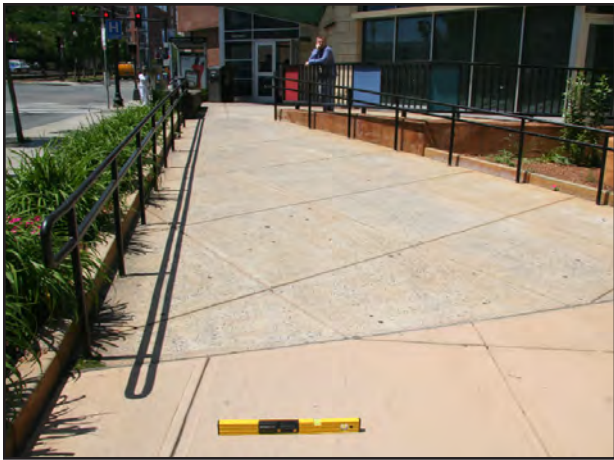
LOCATION | X46

Building E Ramp

RECOMMENDATION TO IMPROVE ADA COMPLIANCE CAPITAL IMPROVEMENT: Where the running slope exceeds 5% running slope, provide handrails with extensions either side.

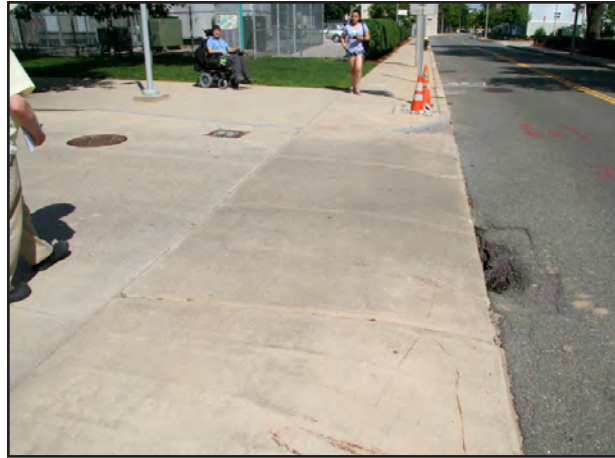
LOCATION | X49a

Route to MassArt Parking Lot

RECOMMENDATION TO IMPROVE ADA COMPLIANCE
CAPITAL IMPROVEMENT: Reconstruct the driveway apron to provide an accessible sidewalk across the apron, ensure less than 2% slope in all directions.

CAPITAL IMPROVEMENT: Construct an accessible route to reach campus map and directory.

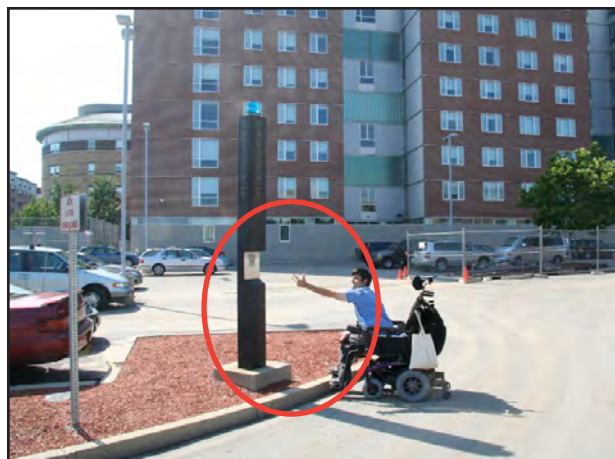
LOCATION | X50

MassArt Parking Lot

RECOMMENDATION TO IMPROVE ADA COMPLIANCE
CAPITAL IMPROVEMENT: Stripe and sign accessible parking spaces; ensure that these connect to an accessible route, ie sidewalk.
CAPITAL IMPROVEMENT: Relocate call box or remove curbing.

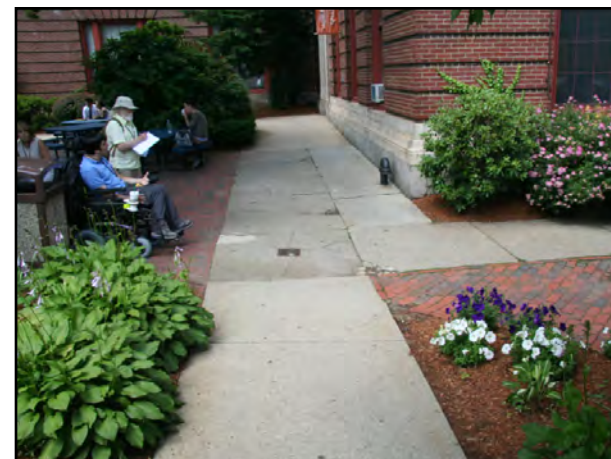
LOCATION | X53

Picnic Tables (Typical)

RECOMMENDATION TO IMPROVE ADA COMPLIANCE
OPERATIONAL: At each location ensure that at least 1 or 5%, whichever is greater, of the picnic tables are accessible by providing a 19" extension that gives at least a 27" high and 30" wide clear space.

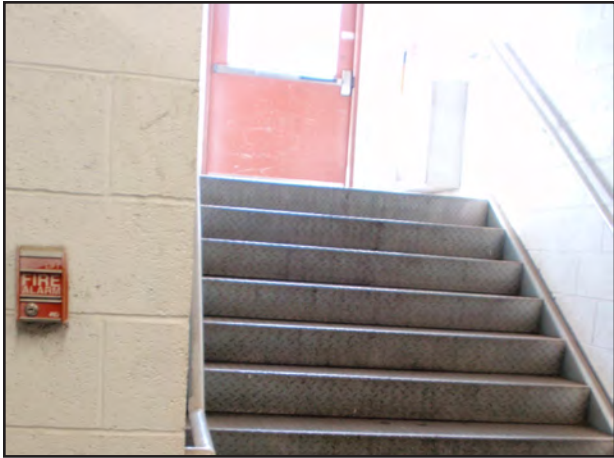
LOCATION | B07

Stairs - Contrast

ISSUE E
SMALL MAINT. PROJECT
Apply required modifications to stairs to comply with 2010 ADA advisory.
\$200/stair run

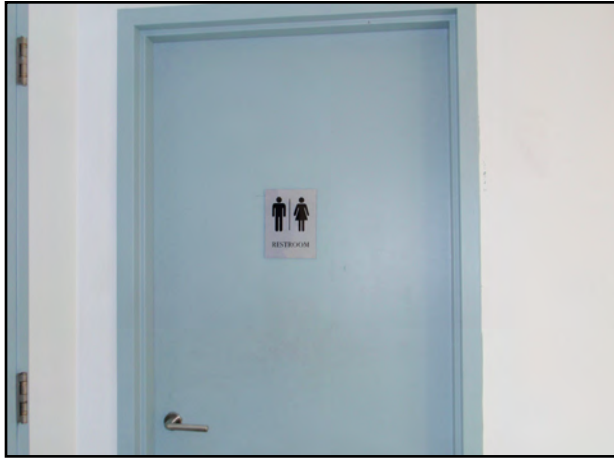
LOCATION | 303

Signs - ADA Facilities and Amenities

Implement an overall inspection of fire safety signs making sure they are ADA and NFPA compliant, are lit if required and are in the correct locations according to building code.

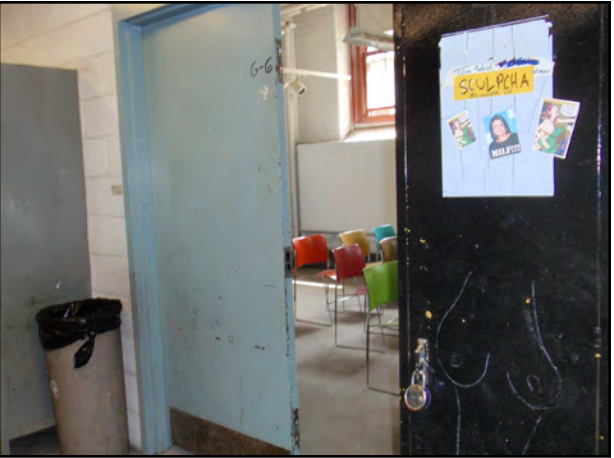
LOCATION | B08

Signs - Designation Signs

Consider providing permanent egress maps at stairs and elevator lobbies on all floors. This will help occupants to navigate their way out of the building in case of emergency.

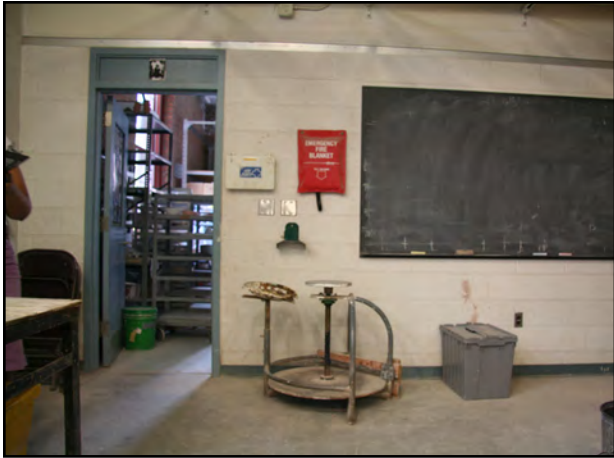
LOCATION | 110

Doors throughout Collins have similar issues.

RECOMMENDATION TO IMPROVE ADA COMPLIANCE OPERATIONAL: Remove all obstructions from around entrances and doorways.

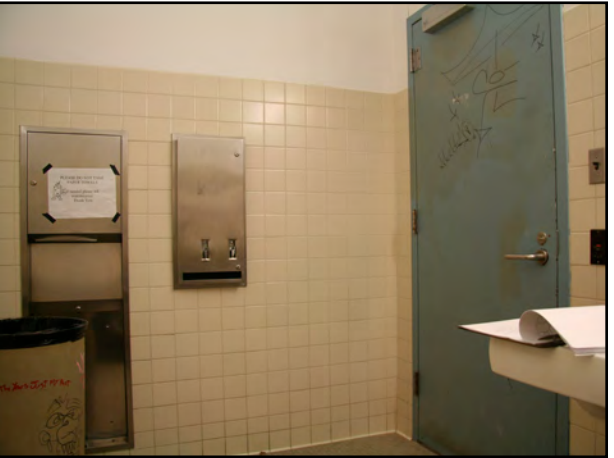
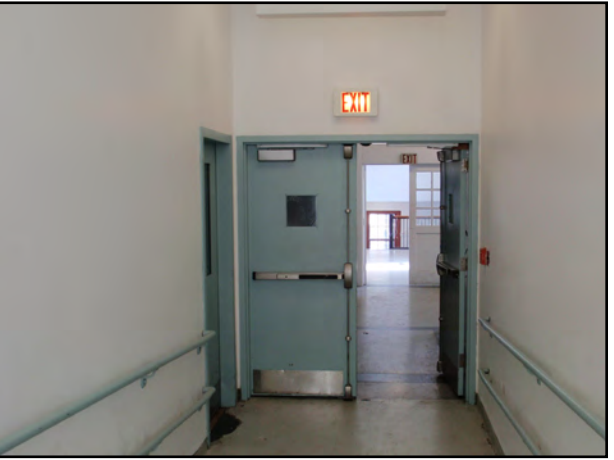
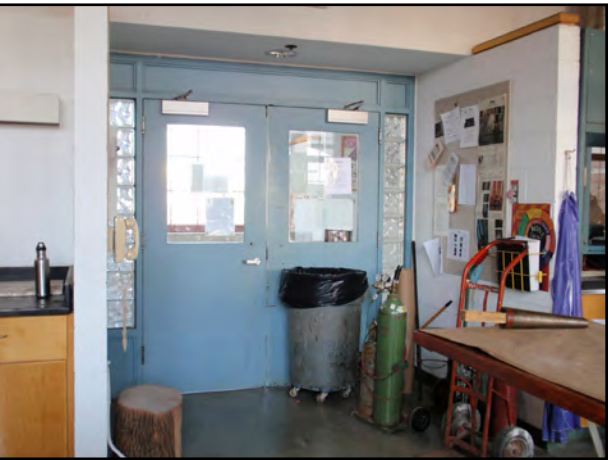
Door - Adjustment

Doors have door opening forces that are greater than 5lbs, this is too heavy for easy opening and means that the door closes too fast to be able to enter easily. This could cause delay in an emergency.

RECOMMENDATION TO IMPROVE ADA COMPLIANCE OPERATIONAL: Adjust and maintain all interior doors so that they have opening forces that don't exceed 5lbs. Prioritize for doors on an accessible route, toilet room or classroom.

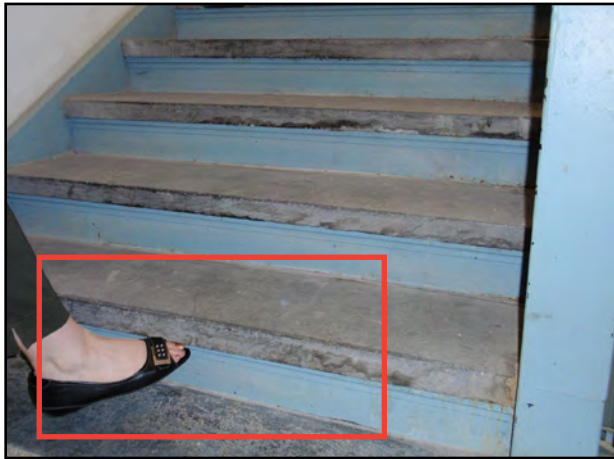
LOCATION | 308

The stairs on all floors in Collins have similar issues.

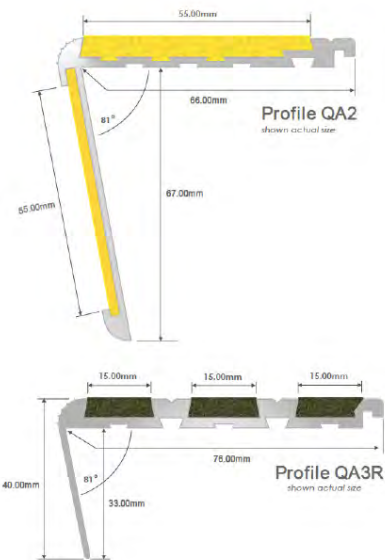
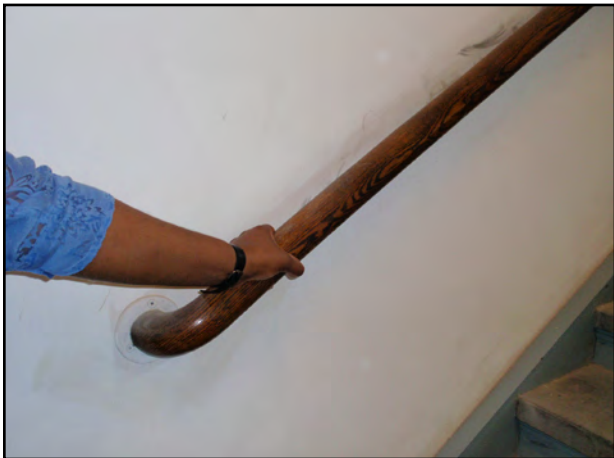
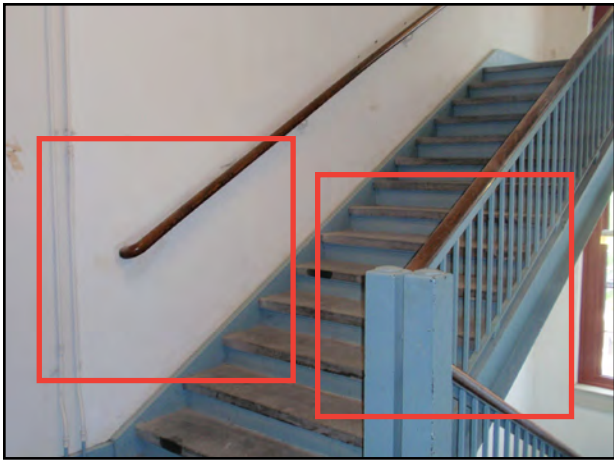
LOCATION | 308

The stairs used as an egress route if elevators are not available have nosing that are greater than 1" and are tripping hazards

MAINTENANCE: Install treads that will cover nosing overhang see diagram. For additional safety consider an edge strip with an integrated photo-luminescent strip that glows in the dark.

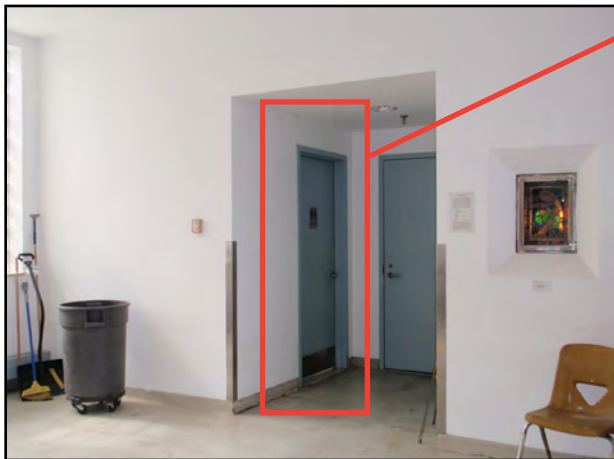
LOCATION | 200

The toilet rooms on all floors in Collins are stacked and have similar issues. As these single-user toilet rooms in Collins are the only toilet rooms in the building and are shared by North Building at least one on each floor should be made ADA compliant. The toilet room to be made ADA compliant should be the left hand side one as the width and length dimensions of the room are adequate.

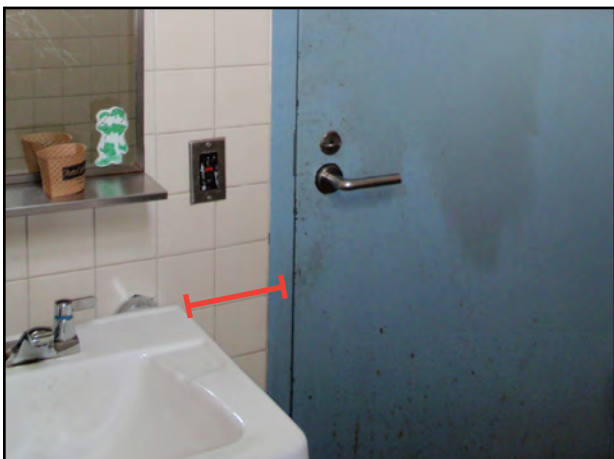
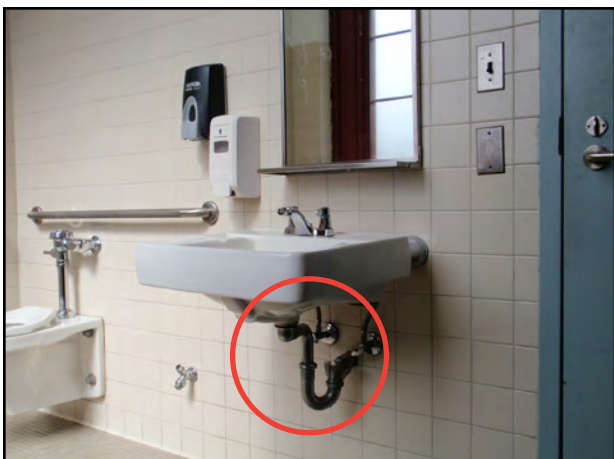
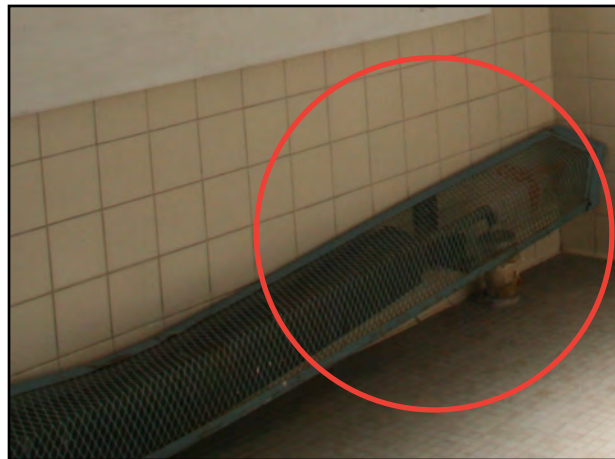
LOCATION | 200

Exposed pipes and surfaces

The lavatory (sink) pipes are not wrapped and could cause injury.

Radiator covers are missing or broken and infringe on maneuvering space.

CAPITAL IMPROVEMENT: Wrap lavatory (sink) pipes with insulating material and repair broken radiator covers.

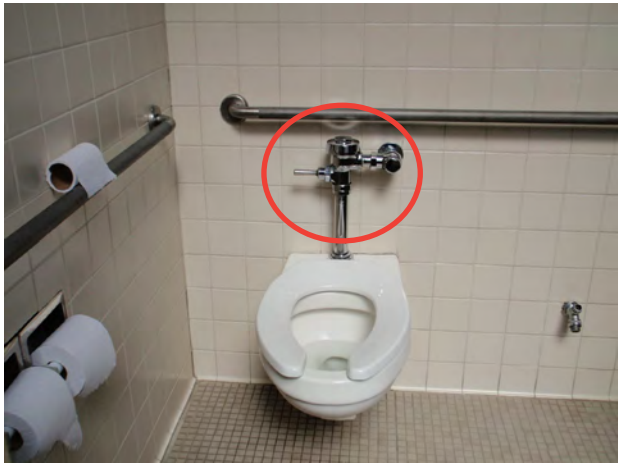
LOCATION | 203

Flush Control

RECOMMENDATION TO IMPROVE ADA COMPLIANCE
 CAPITAL IMPROVEMENT: If possible reinstall flush on the open side or install an automatic flush if plumbing allows.

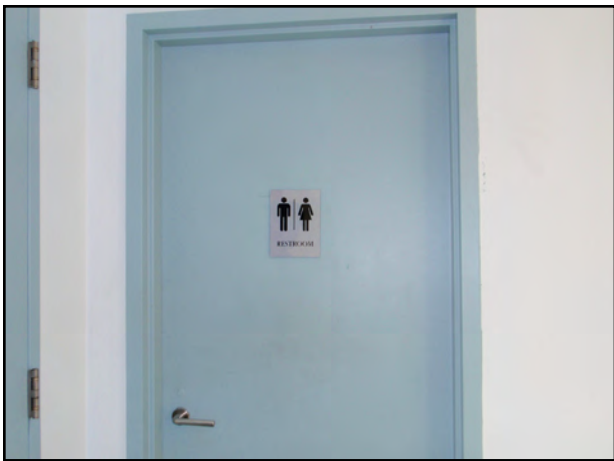
LOCATION | 203

ISSUE A1
CAPITAL IMPROV.
 As toilet room modifications throughout the building are extensive, consider requesting capital improvement funding. Otherwise each issue could be addressed as a small maintenance project over time.

INTERIM RECOMMENDATION
 Until modifications are complete provide 2010 ADA Standards compliant signage to direct users to nearest accessible toilet room.

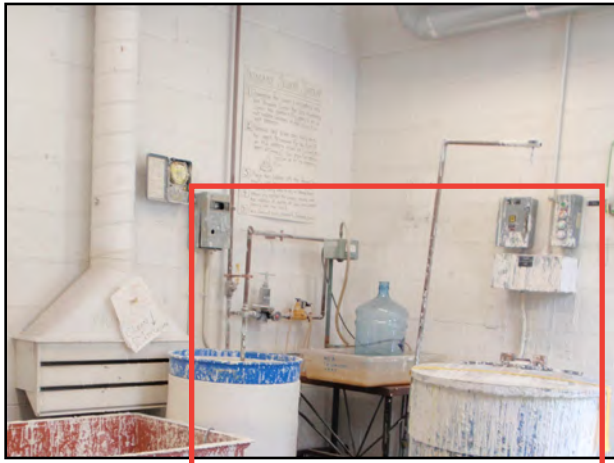
LOCATION | B

The sinks throughout Collins do not meet ADA standards of accessibility for height, clearance or knee space.

RECOMMENDATION TO IMPROVE ADA COMPLIANCE
 SMALL MAINTENANCE: Where required install 1 or 5% ADA compliant sinks that are no higher than 34" AFF, and have the required knee space, faucet reach and type and clear space around it.

RECOMMENDATION TO IMPROVE SAFETY & USER EXPERIENCE
Replace or modify student utility sinks to be accessible: Replace at least one sink with a sink that meets 2010 ADA Standards on each of the 2nd and 3rd floors, or at this type of sink provide enough space around the sink for a side approach, add an adjacent work counter at 34" AFF with room for knee space. Replace the faucet with a flexible hose attachment.

ISSUE G
SMALL MAINT. PROJECT
 Install new or modify sink.

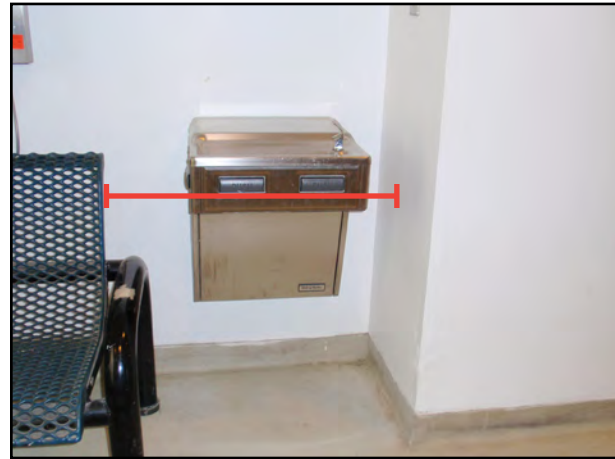
LOCATION | 300

The drinking fountains on all floors in Collins have similar issues.

RECOMMENDATION TO IMPROVE ADA COMPLIANCE CAPITAL IMPROVEMENT: To benefit people of all statures and abilities replace drinking fountain with a High-Low fountain,

SMALL MAINTENANCE: install a paper cup dispenser ensuring that level of paper cups is maintained and that the dispenser is not a protruding object and is mounted such that the cups are dispensed at a height of 48".

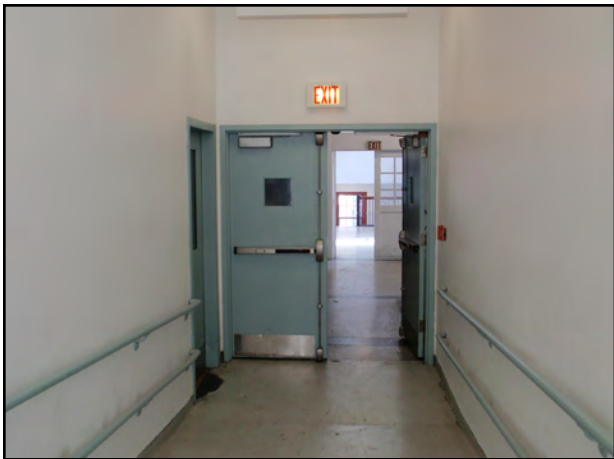
LOCATION | 200

The ramps on 1st, 2nd and 3rd floors in Collins have similar issues.

Provide ADA compliant signs at stairwells indicating floor level. Ensure that these signs are mounted at the correct height and location.

Provide ADA compliant exit signs. Ensure that these signs are mounted at the correct height and location.

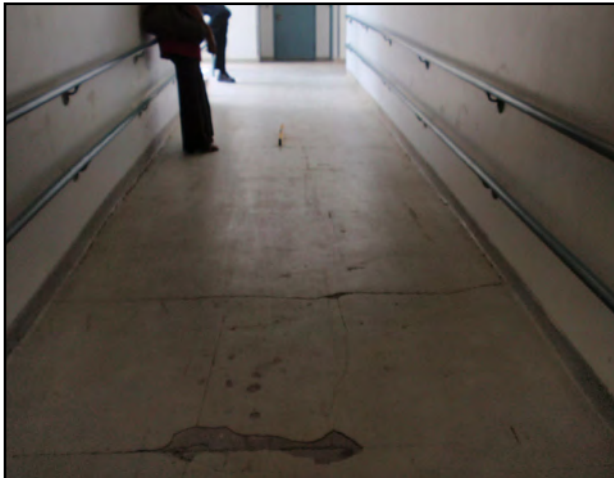
LOCATION | 206

Ramp slope up to the 3rd floor is 9%, and the cross slope is 4%. The rail has no extensions, the floor has cracks and loose material and is a tripping hazard. This ramp is part of to the main accessible route and so work to modify it should be made a priority.

SMALL MAINTENANCE:-Re-engineer ramp run and cross slope to correct slope and resurface. Repair the flooring so that it is stable, firm and slip resistant.

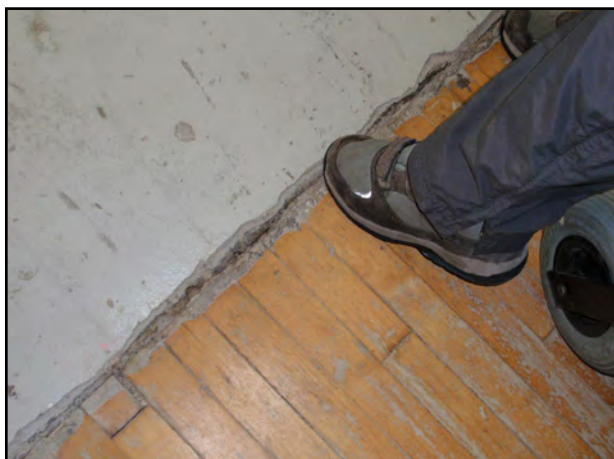
LOCATION | 206

Ramp transition is uneven and creates a tripping hazard. The flooring is uneven and is a tripping hazard that could cause injury.

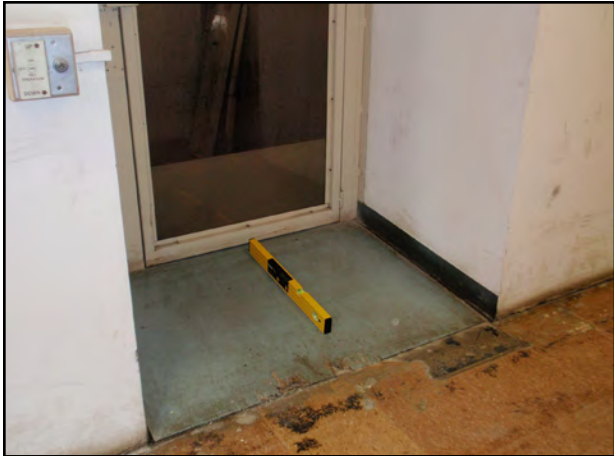
LOCATION | B10/208 Lift
The lift is out of working order and is key operated (See NOTE).

Threshold
 The threshold is 2 1/2" high, a tripping hazard and is difficult for a wheel to go over.

RECOMMENDATION TO IMPROVE ADA COMPLIANCE
 Provide ADA compliant signs indicating floor level. Use the International Symbol for Accessibility on a sign for this lift. Ensure that these signs are mounted at the correct height and location and that this lift appears on the Directory.

RECOMMENDATION TO IMPROVE ADA COMPLIANCE
 CAPITAL IMPROVEMENT: Re-engineer slope so that it is less than 2%. consider replacing lift.

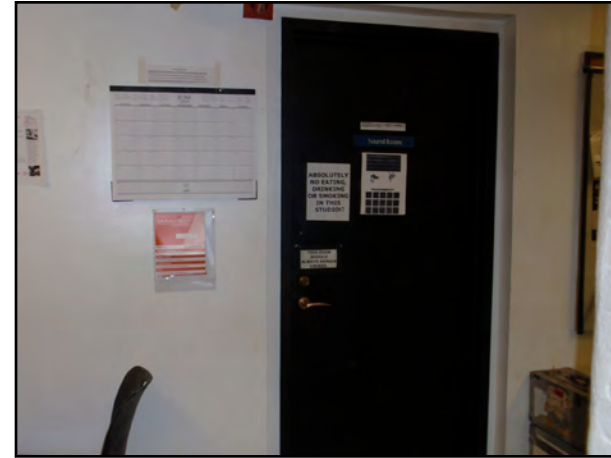
LOCATION | 10

Designation signs are missing or are not ADA compliant. There are no signs on the Storage Room doors between the toilet rooms. This could cause confusion in an emergency situation.

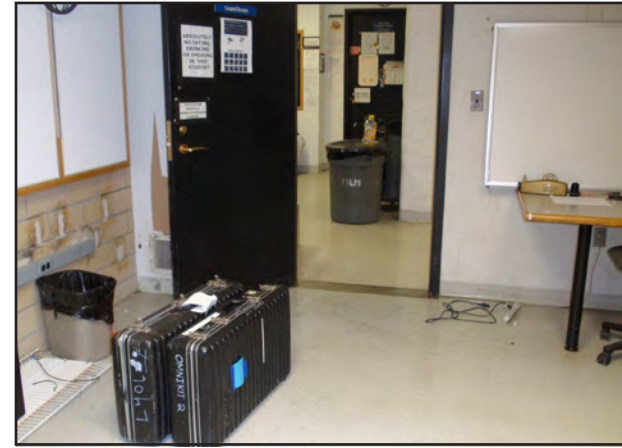
LOCATION | 108

Doors with closers have door opening forces that are greater than 5lbs, this is too heavy for easy opening and means that the door closes too fast to be able to enter easily. This could cause delay in an emergency.

RECOMMENDATION TO IMPROVE ADA COMPLIANCE OPERATIONAL: Remove all obstructions from around entrances and doorways.

If a door is to be kept open do not use heavy object on the floor that become tripping hazards and accessible route obstructions. Provide a doorstop mechanism that doesn't cause and obstruction such as examples below.

RECOMMENDATION TO IMPROVE ADA COMPLIANCE OPERATIONAL: Create a comprehensive maintenance program and schedule to check and adjust all interior doors so that they have an opening pressure that doesn't exceed 5 lbs. .

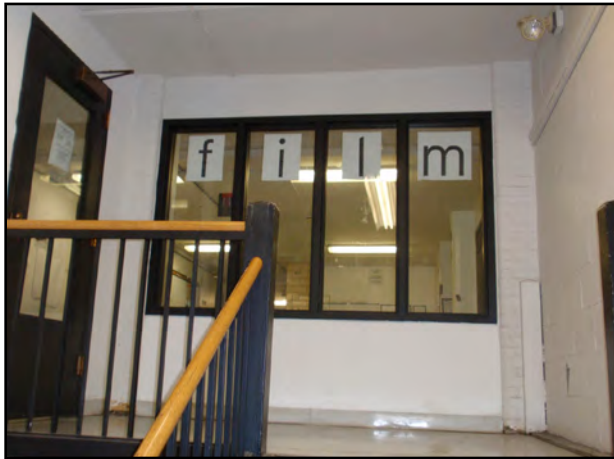
LOCATION | 101a

The stairs on all floors have similar issues.

Handrails are either missing or ADA non-compliant for size and shape.

RECOMMENDATION TO IMPROVE ADA COMPLIANCE
 Re-install handrail with extensions.

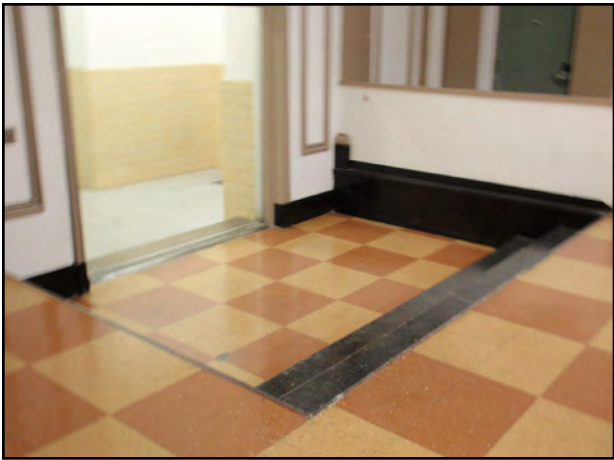
LOCATION | 112 Crackertorium

The stairs have nosings that are greater than 1" and are tripping hazards

MAINTENANCE: Install treads that will cover nosing overhang see diagram. For additional safety consider an edge strip with an integrated photoluminescent strip that glows in the dark.

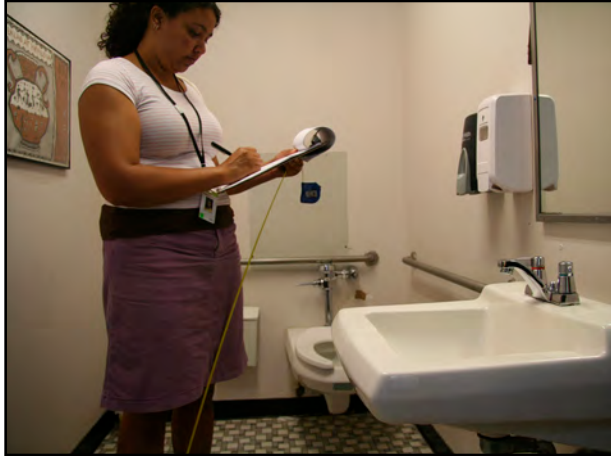
LOCATION | 113a

The Toilet Room on this floor is not compliant because it doesn't have the required maneuvering clearances. Substantial cost would be required to make it compliant.

In the interim at each non-compliant Toilet Room provide ADA compliant signage with directions to the nearest ADA compliant Toilet Room (which are in North building adjacent to Pozen). Ensure that these signs are mounted at the correct height and location.

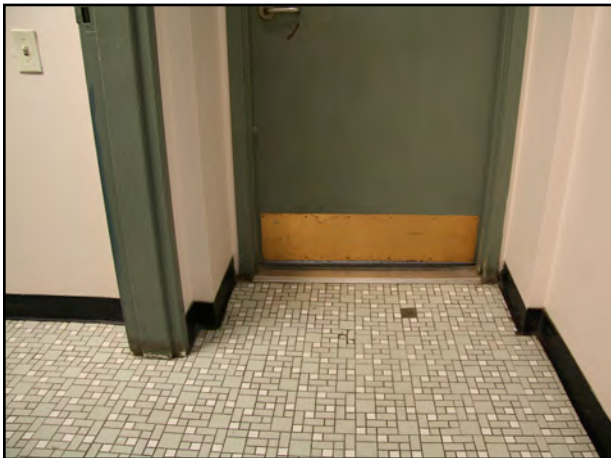
LOCATION | 113b

There are other toilet rooms at the South Crackerorium. These toilet rooms are also not ADA compliant for issues such as toilet placement, height, flush control location, sink plumbing not covered, flooring, grab bar location. But, most importantly, the entrance and maneuvering clearances are not correct and would require extensive renovations. This could be addressed as part of the Design Center Renovation.

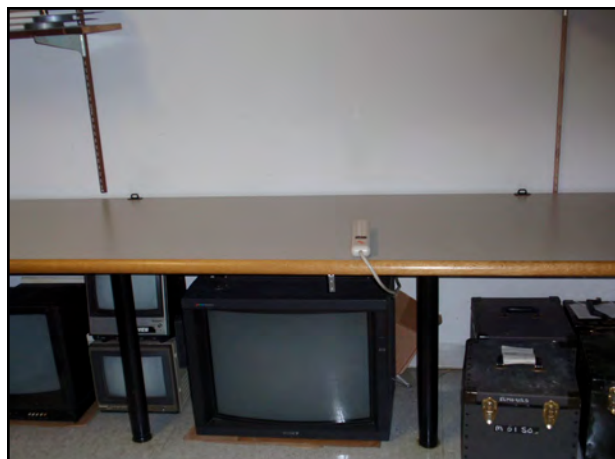
LOCATION | 104c

Controls are obstructed or are out of reach range.
[See Appendix A -2010 ADA Standards 308 Reach Ranges & 205 & 309 Operable Parts]

RECOMMENDATION TO IMPROVE ADA COMPLIANCE
Ensure that the controls are within reach ranges of 15" and 48" AFF.

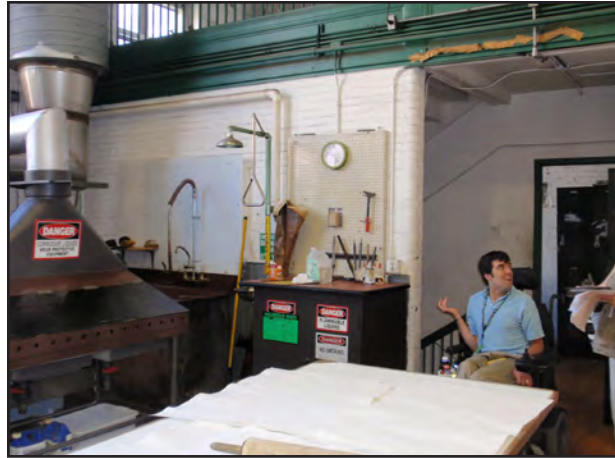
LOCATION | 201a

Aisles and paths are not defined creating egress safety and tripping hazards in the accessible route. Wires are run across floors.

RECOMMENDATION TO IMPROVE ADA COMPLIANCE OPERATIONAL: Remove obstructions and educate staff, students and faculty to maintain a 36" min. wide clear space through rooms, spaces and accessible routes at all times. Ensure controls can be reached by relocating controls to within reach ranges.

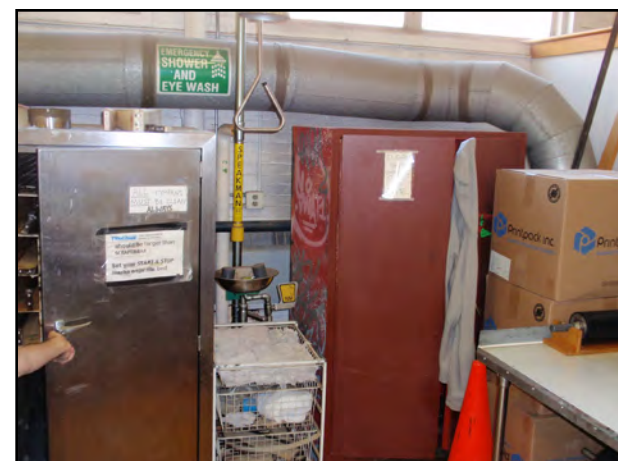
LOCATION | 207c

Counter is too high at 35 1/2".

RECOMMENDATION TO IMPROVE ADA COMPLIANCE OPERATIONAL: Counter could be lowered to 34" or furniture could be replaced with adjustable counters.

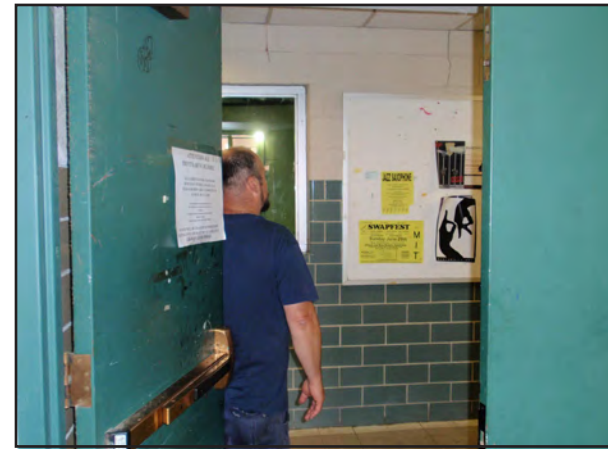
LOCATION | 200

Doors with closers have door opening forces that are greater than 5lbs, this is too heavy for easy opening and means that the door closes too fast to be able to enter easily. This could cause delay in an emergency.

RECOMMENDATION TO IMPROVE ADA COMPLIANCE OPERATIONAL: Remove all obstructions from around entrances and doorways.

RECOMMENDATION TO IMPROVE ADA COMPLIANCE OPERATIONAL: Create a comprehensive maintenance program and schedule to check and adjust all interior doors so that they have an opening pressure that doesn't exceed 5 lbs. .

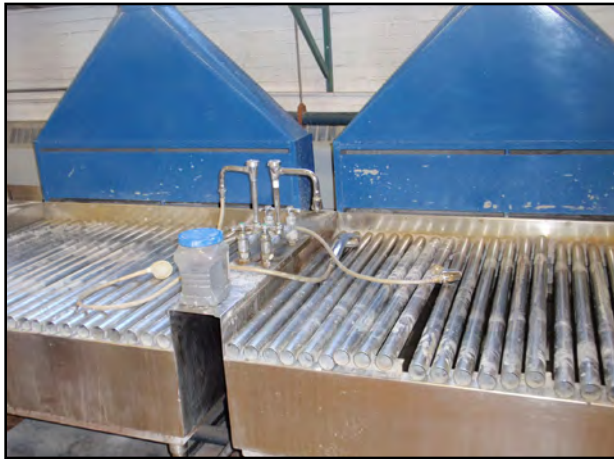
LOCATION | 204a

The sinks throughout Printmaking are not ADA compliant for height, clearance or knee space. There are utility sinks that are not janitorial but are required for cleaning equipment such as rollers, brushes, screens, ink, and containers for chemicals which makes their use a part of the educational experience. These sinks are not ADA compliant:

RECOMMENDATION TO IMPROVE ADA COMPLIANCE
 SMALL MAINTENANCE: Where required install 1 or 5% ADA compliant sinks that are no higher than 34" A.F.F., and have the required knee space, faucet reach, lever type faucet handles and clear space around it.

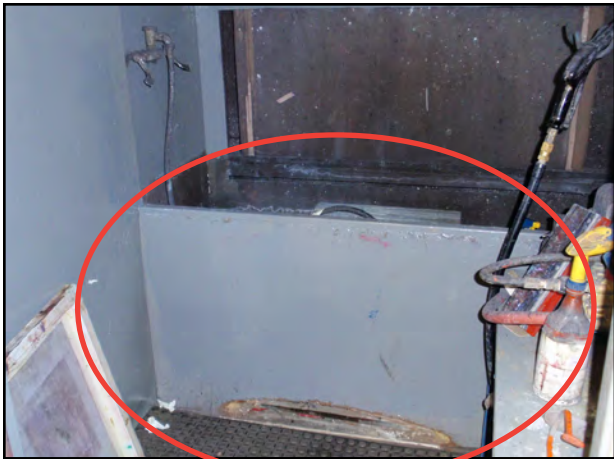
LOCATION | 210

Sinks - Knee space
 The underside of the sink doesn't allow for knee space the screenprinting wash station shows worn areas where there is no toe clearance even for students who stand. **LOCATION | 202a,b,c,d,e**
[See Appendix A -2010 ADA Standards Sinks]

RECOMMENDATION TO IMPROVE ADA COMPLIANCE
 SMALL MAINTENANCE: Where required modify 1 or 5% ADA compliant sinks. Provide enough space around the sink for a side approach and add an adjacent work counter with room for knee space. Replace the faucet with lever handles and consider adding a flexible hose to provide even greater usability.

ISSUE G
SMALL MAINT. PROJECT
 Modify sink to become more user friendly.
 \$150 / sink

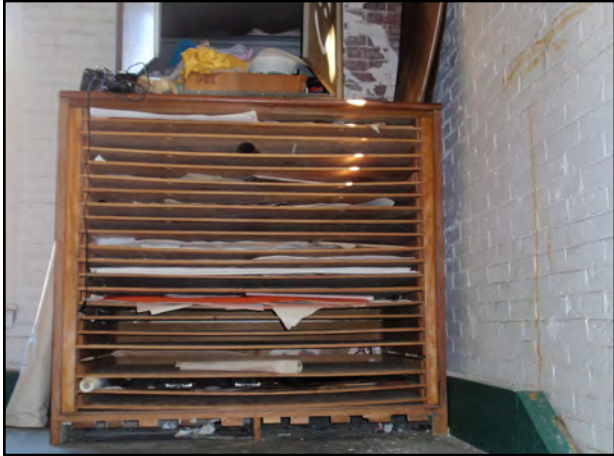
LOCATION | 202

Furniture
 Specialized equipment is not compliant for reach ranges for control operation, knee space and clearances. **LOCATION | 109**
[See Appendix A -2010 ADA Standards 308 Reach Ranges & 309 Operable Parts]

RECOMMENDATION TO IMPROVE ADA COMPLIANCE
 Many pieces of equipment in the Printshop are necessary and ADA compliant versions are not available. Students with a disability needing to use this equipment will require individualized academic adjustment dependent on type of disability.

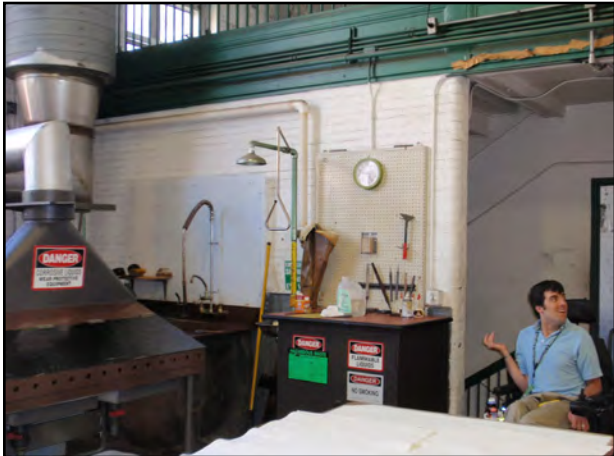
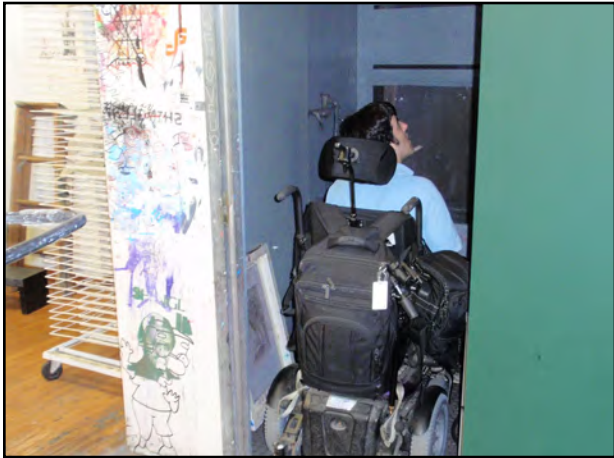
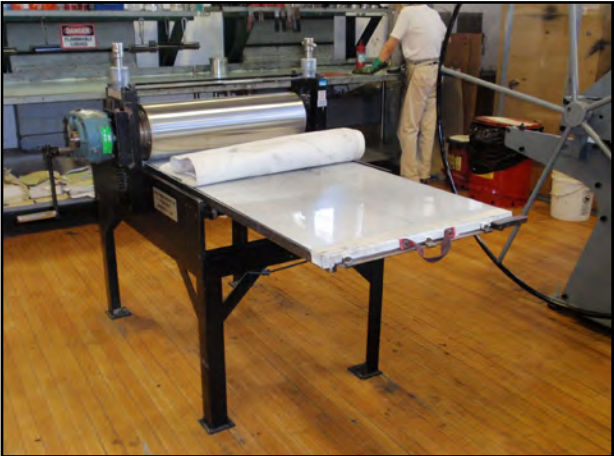
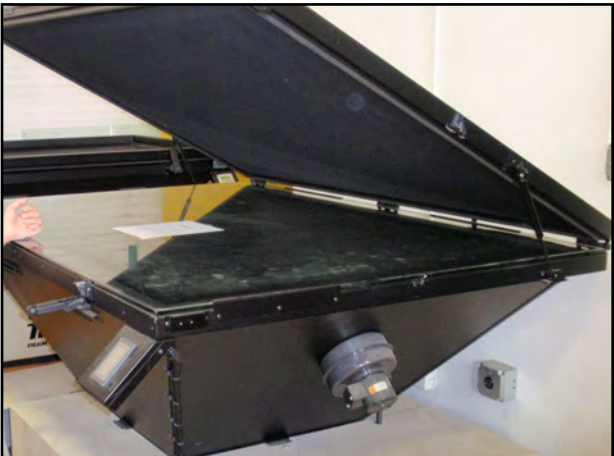
Emergency Shut-offs
 Emergency shut-offs and controls are blocked and cannot be reached due to obstructions, and/or are out of reach ranges. This is hazardous for all.
[See Appendix A -2010 ADA Standards 206 Accessible Routes 401, 402, 403.5.1 Clearances, 308 Reach Ranges, 309 Operable parts]

Emergency Equipment
 Emergency eye-wash stations (42" A.F.F.), showers (66" A.F.F.) and fire safety equipment are difficult to find or reach and/or access is obstructed.
[See Appendix A -2010 ADA Standards 308 Reach Ranges, 309 Operable parts]

RECOMMENDATION TO IMPROVE ADA COMPLIANCE OPERATIONAL: Remove obstructions and educate staff, students and faculty to maintain a 36" min. wide clear space through rooms, spaces and accessible routes to all equipment and controls.

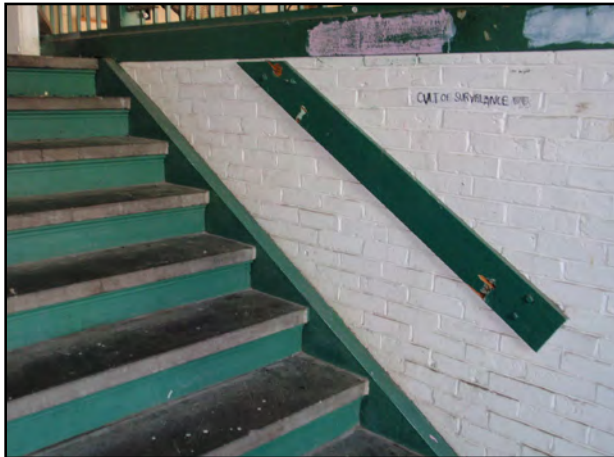
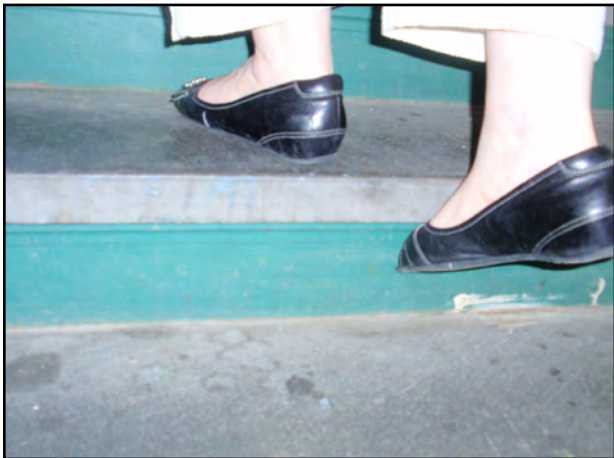
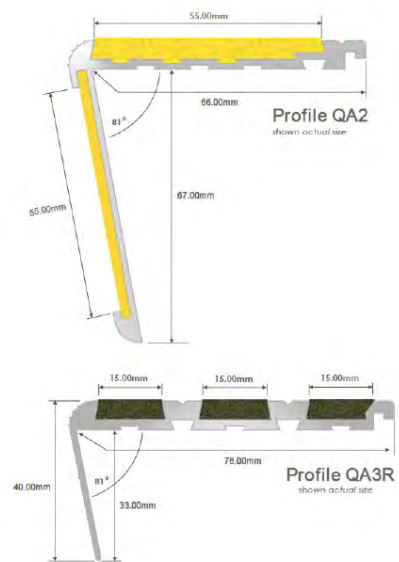
The stairs on all floors have similar issues.

Handrails are either missing or ADA non-compliant for size and shape.

The stairs have nosings that are greater than 1" and are tripping hazards

RECOMMENDATION TO IMPROVE ADA COMPLIANCE
CAPITAL IMPROVEMENT: Provide ADA compliant signs at stair wells indicating floor level. Ensure that these signs are mounted at the correct height and location.

RECOMMENDATION TO IMPROVE ADA COMPLIANCE
SMALL MAINTENANCE: Handrail gripping surfaces with a circular cross section shall have an outside diameter of 1¼ inches min and 2 inches max. Replace handrail.

RECOMMENDATION TO IMPROVE ADA COMPLIANCE
SMALL MAINTENANCE: Install treads that will cover nosing overhang see diagram. For additional safety consider an edge strip with an integrated photoluminescent strip that glows in the dark.

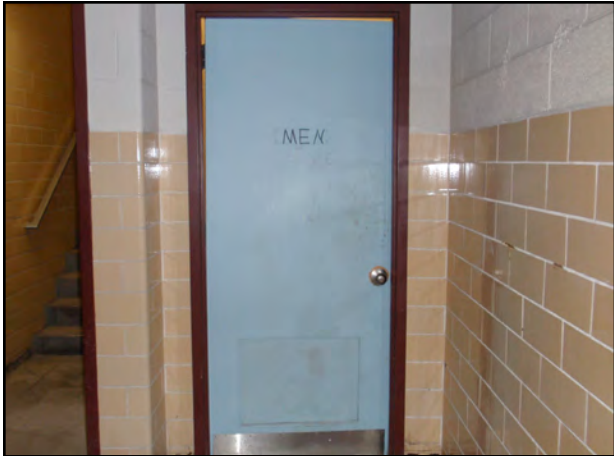
LOCATION | B03 & B04

Signs - ADA Facilities and Amenities
