Massachusetts College of Art and Design

ADA Compliance Plan 2011

ADA Compliance Plan
Consultant Services
Contract #10-08

The Institute for Human Centered Design

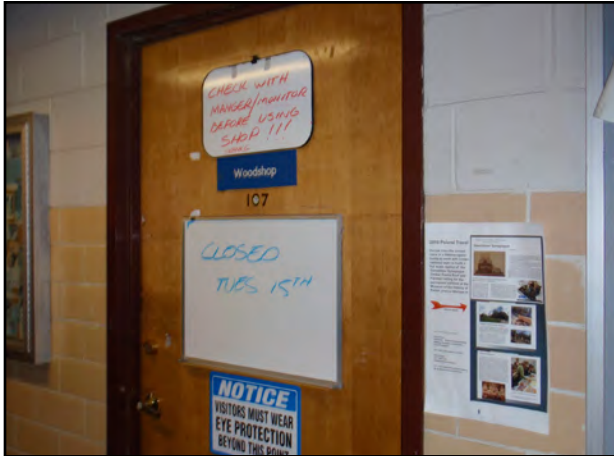
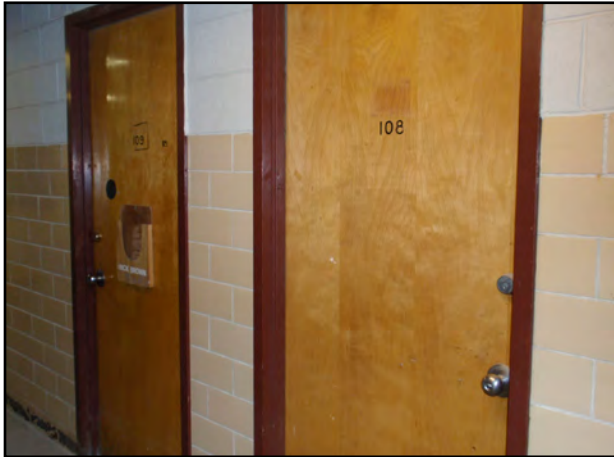
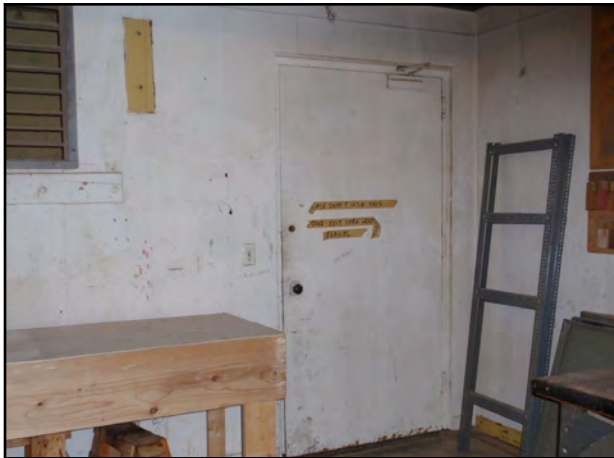
Signs - Designation Signs

ISSUE A2
CAPITAL IMPROV.
 Design and implement a campus-wide wayfinding program that includes 2010 ADA Standards compliant designation, directional and informational signs.
\$150-200/sign

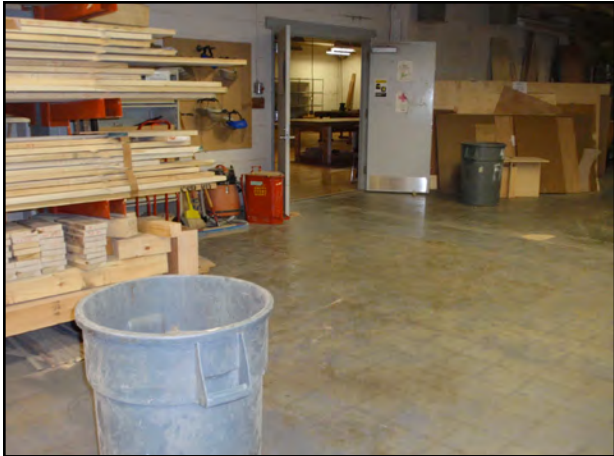
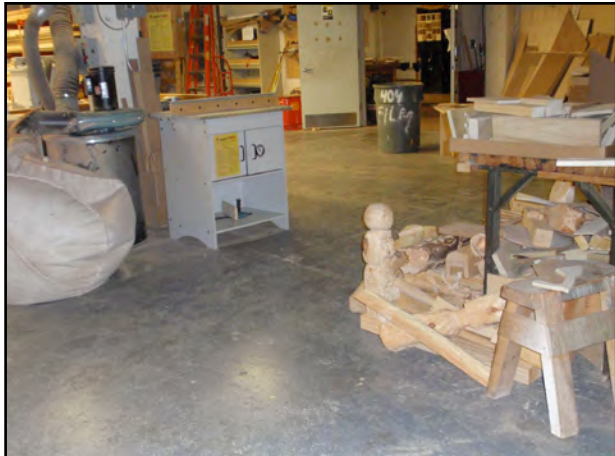
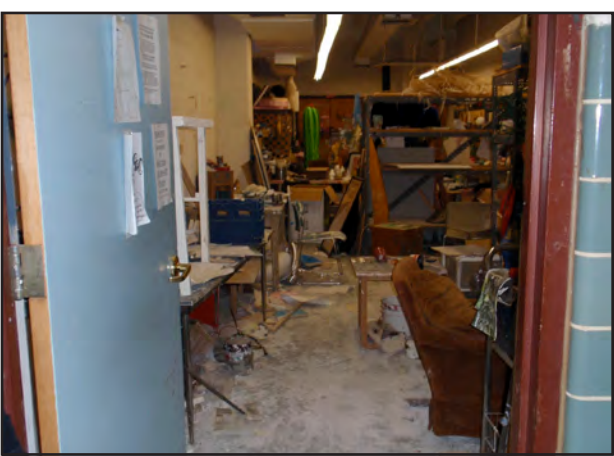
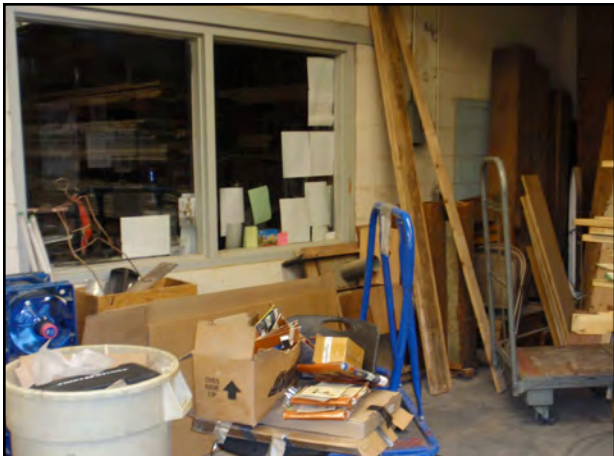
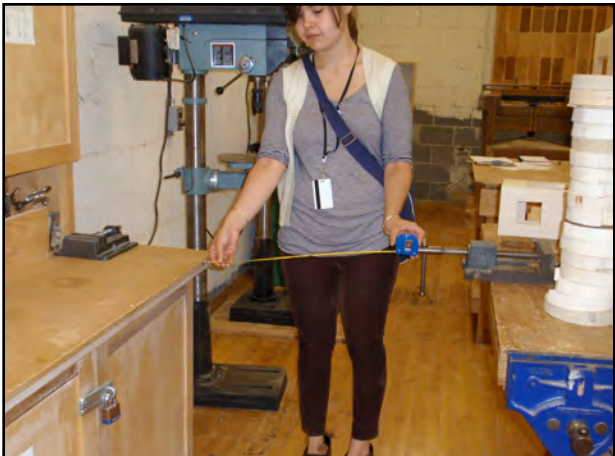
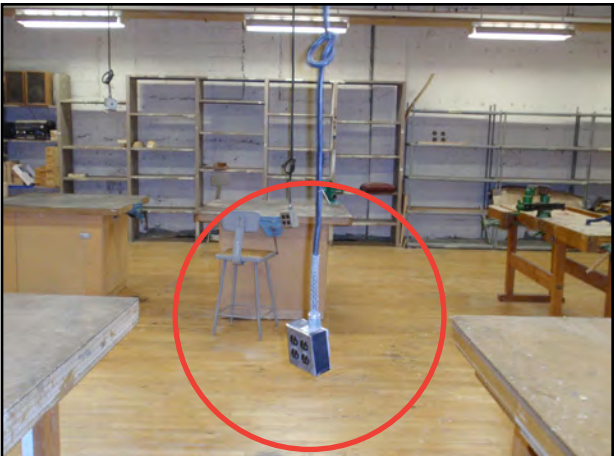
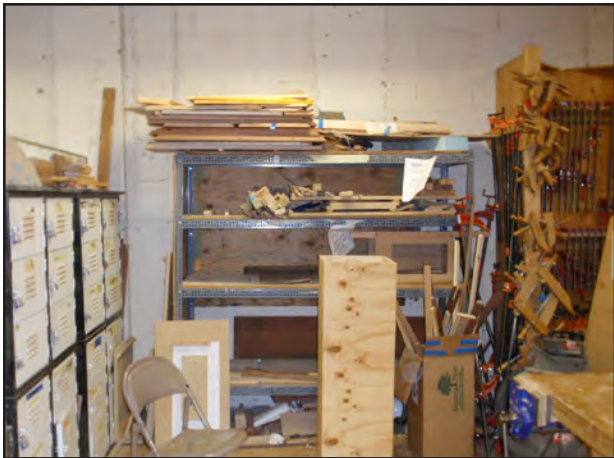
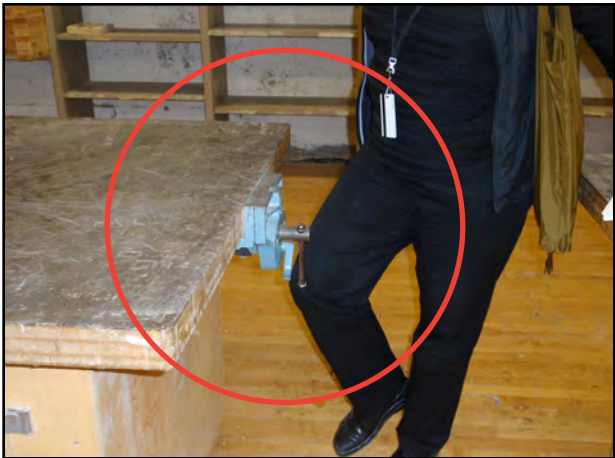
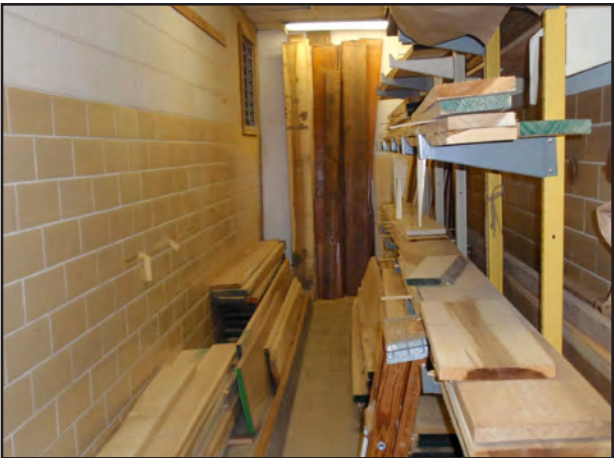
There is no compliant accessible route to Woodworking. A possible route could be made through the North Building basement via an ADA non-compliant entrance on Tetlow Street, using the elevator to the North basement over a non-compliant ramp to Woodworking. There is no signage that indicates that this is a possible route.

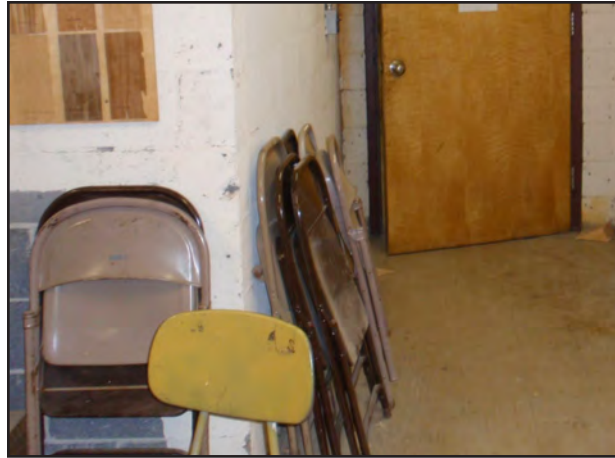
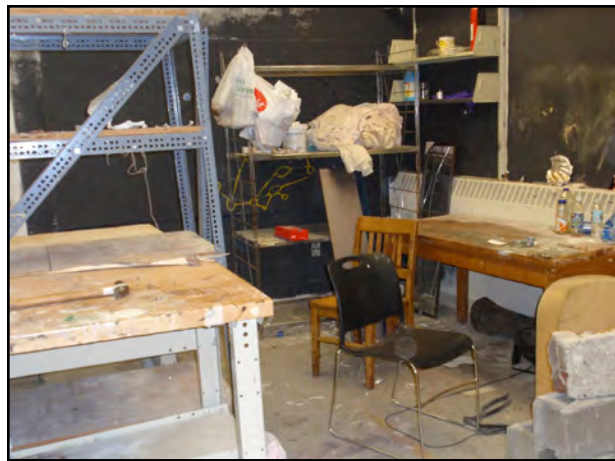
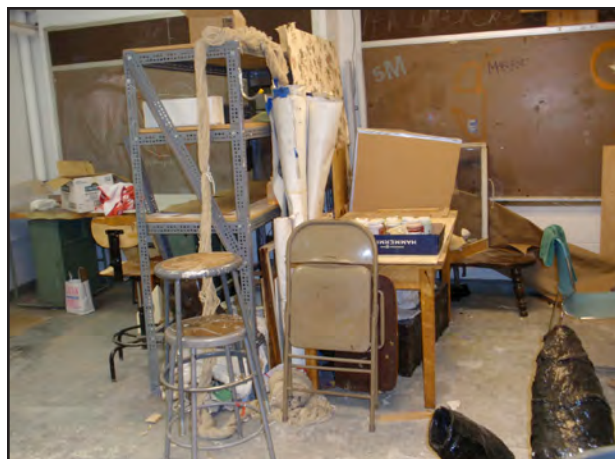
Aisles and paths are not defined creating egress safety and tripping hazards in the accessible route.

RECOMMENDATION TO IMPROVE ADA COMPLIANCE
OPERATIONAL: Remove obstructions and educate staff, students and faculty to maintain a 36" min. wide clear space through rooms, spaces and accessible routes at all times. Ensure that there are no protruding objects that are more

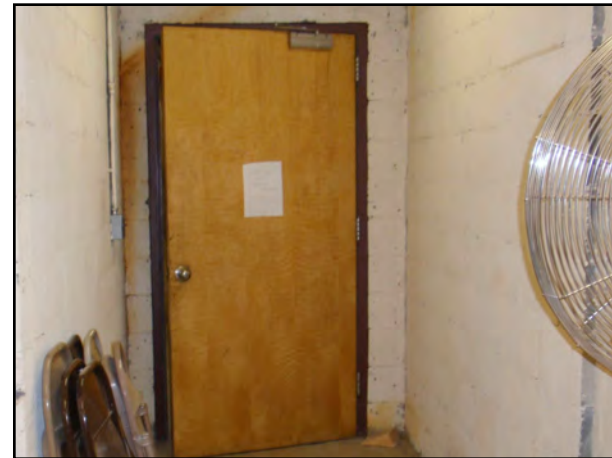
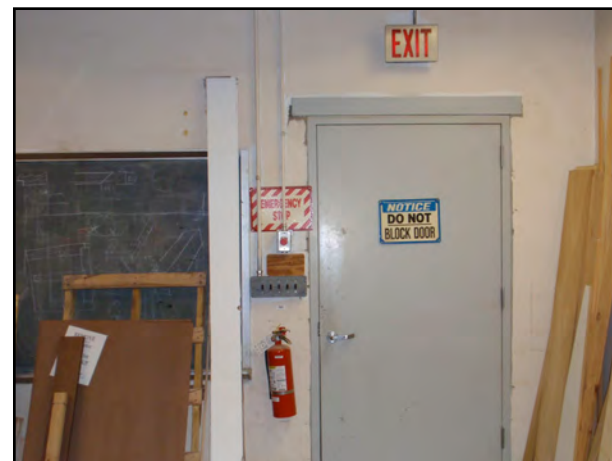
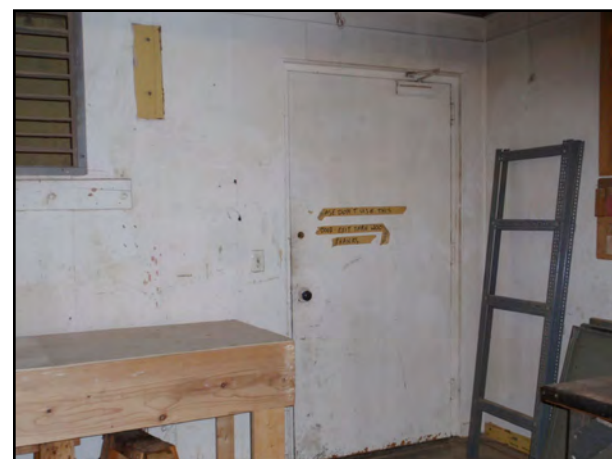
D-GYM BUILDING - Basement - | B - Accessible Route & | D-1 - Door Clearances

If a door is to be kept open do not use heavy object on the floor that become tripping hazards and accessible route obstructions. Provide a doorstep mechanism that doesn't cause an obstruction such as examples below.

Implement plan to maintain clear areas around doors and adjust door closing pressures to achieve correct opening forces.

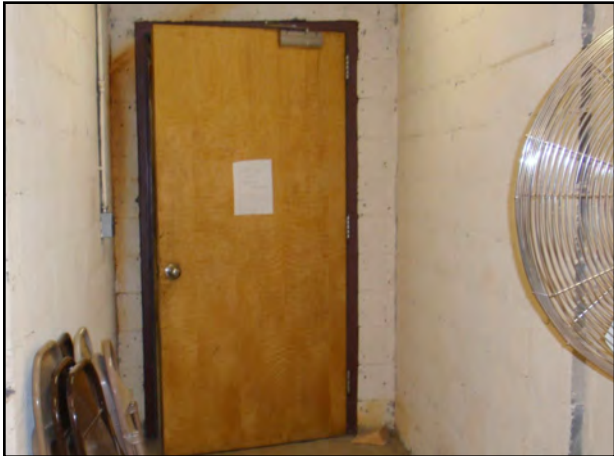
LOCATION | B06

Door - Closer Adjustment
Doors with closers have door opening forces that are greater than 5lbs, this is too heavy for easy opening and means that the door closes too fast to be able to enter easily. This could cause delay in an emergency.

RECOMMENDATION TO IMPROVE ADA COMPLIANCE OPERATIONAL: Create a comprehensive maintenance program and schedule to check and adjust all **interior** doors so that they have an opening pressure that doesn't exceed 5 lbs.

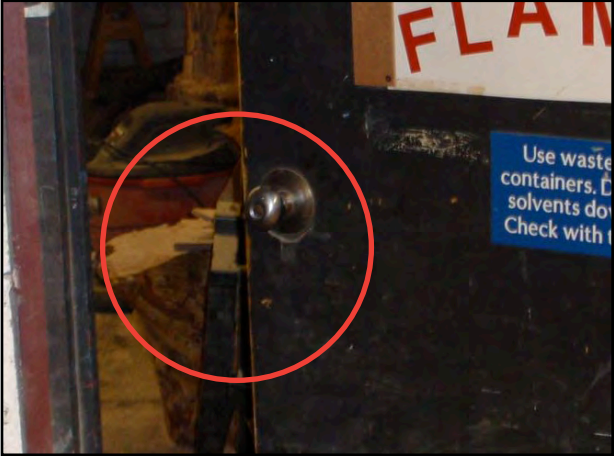
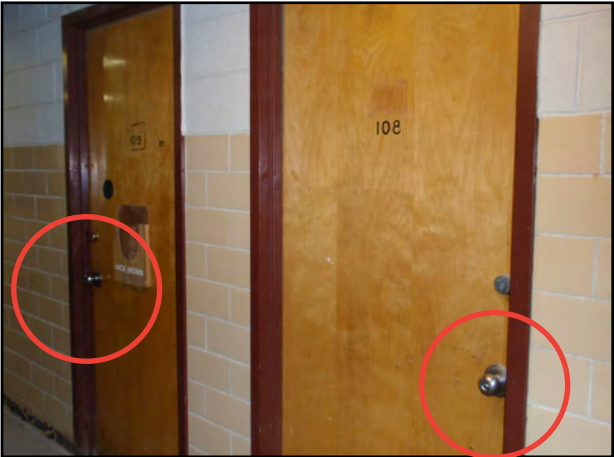
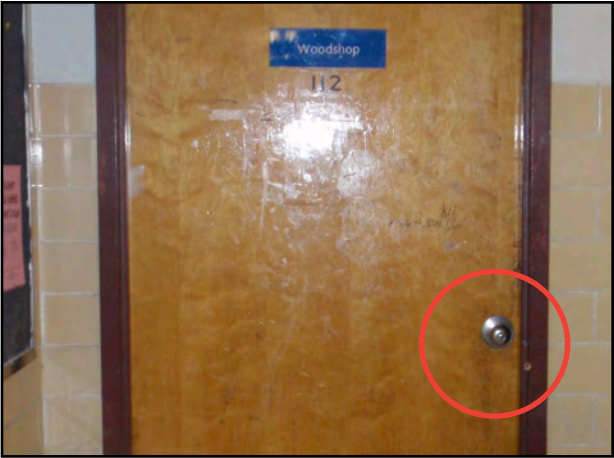
Door - Hardware
Doors have knob handles.

RECOMMENDATION TO IMPROVE ADA COMPLIANCE SMALL MAIN. PROJECT: Replace knob hardware with lever-type hardware that doesn't require tight pinching grasping or twisting of the wrist. Prioritize work to doors that are on an accessible route.

ISSUE D3 SMALL MAINT. PROJECT
Implement plan to replace knob hardware with lever-type hardware. **PRIORITIZE FOR DOORS ON ACCESSIBLE ROUTE.**

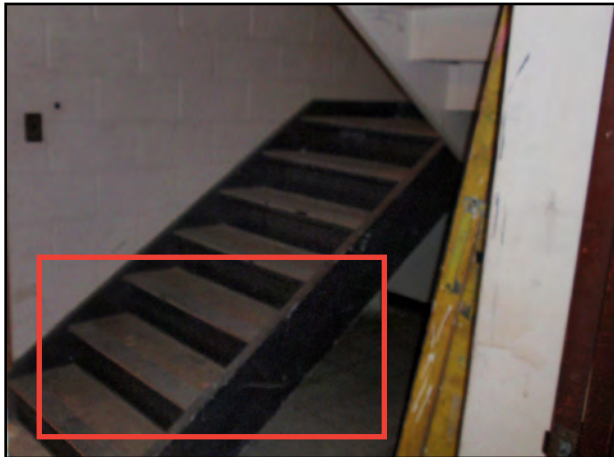
LOCATION | 102

The stairs on all floors in the Gym Building have similar issues. If they are on an egress route the following modifications must be made:

Handrails are missing.

SMALL MAINTENANCE: There is no contrast between the tread and riser. For safety consider installing an edge strip with an integrated photo-luminescent strip that glows in the dark. **fig. 1**

Re-install handrail with extensions.

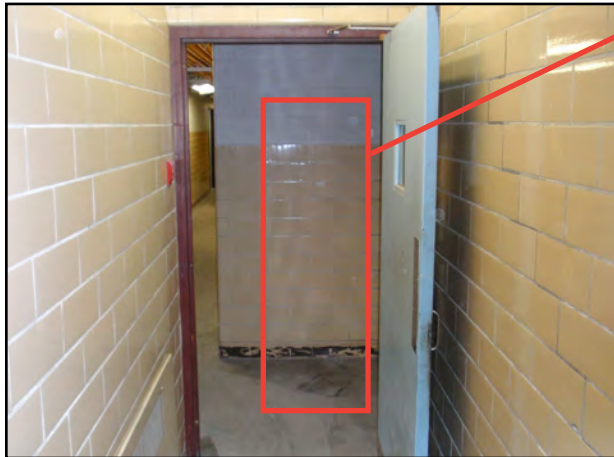
LOCATION | ?

None of the toilet rooms are fully accessible. Toilet rooms have inadequate dimensions to be made accessible. The ADA requirements for these toilet rooms can be rectified in the Design Center Project. At least one new unisex Toilet Room would be required per floor.

Until modifications are complete provide 2010 ADA Standards compliant signs to direct users to nearest accessible toilet room even if it is in another building.

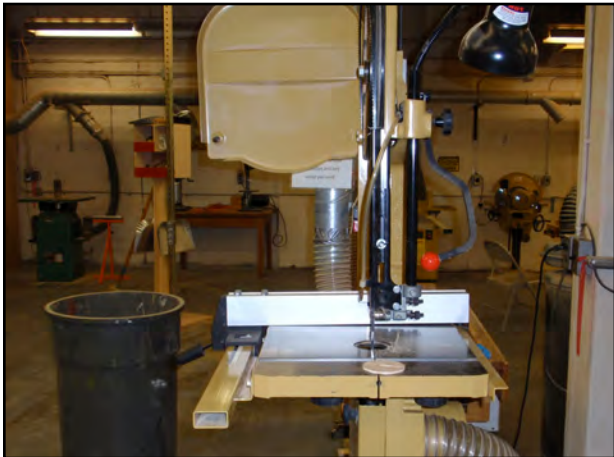
LOCATION | B06

Furniture

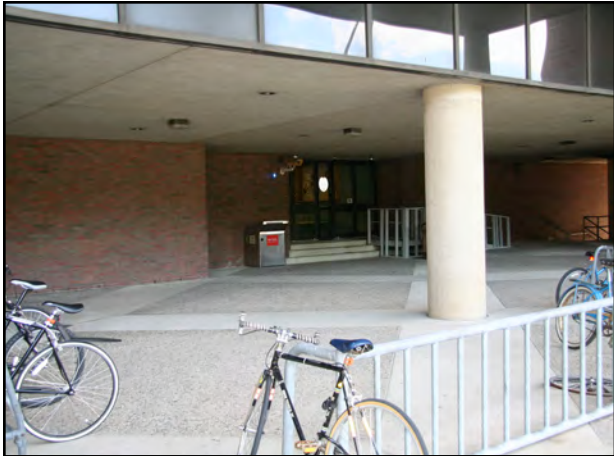
LOCATION | 100

Signs - ADA Facilities and Amenities

CAPITAL IMPROVEMENT Tactilely read ADA compliant exit signs are missing from doors at exit passageways, exit discharge, and exit stairways.

CAPITAL IMPROVEMENT: Consider providing directories for each floor. If directories are provided ensure that all ADA compliant amenities are noted on them.

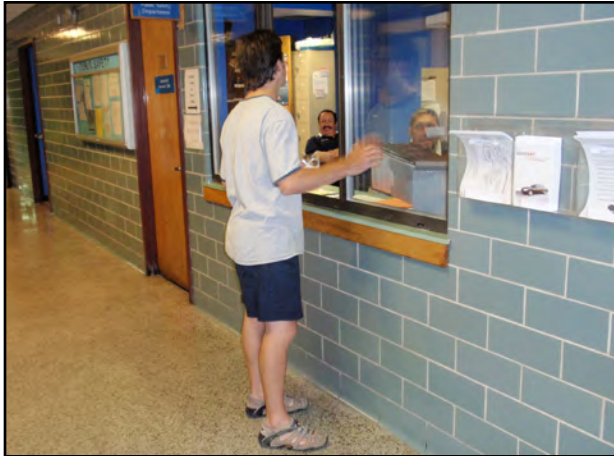
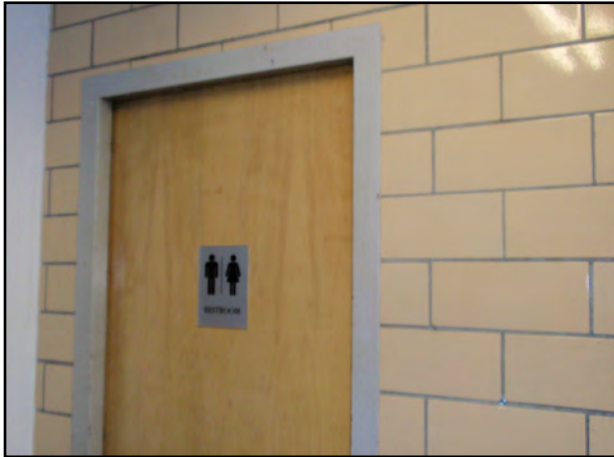
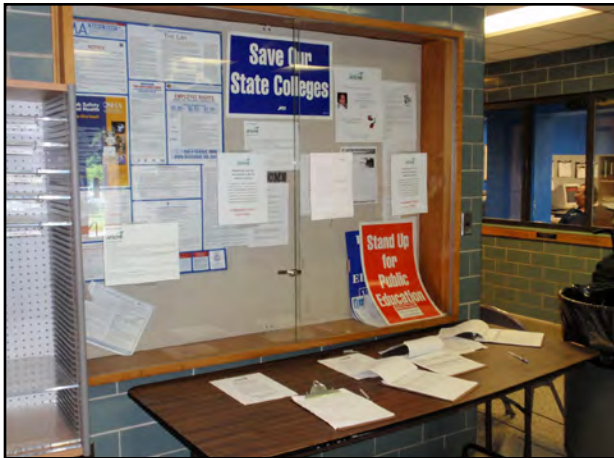
Designation signs are missing or are not ADA compliant. There are no signs on the Storage Room doors between the toilet roomsthis can cause confusion in an emergency situation.

Consider providing permanent egress maps at stairs and elevator lobbies on all floors. This will help occupants to navigate their way out of the building in case of emergency.

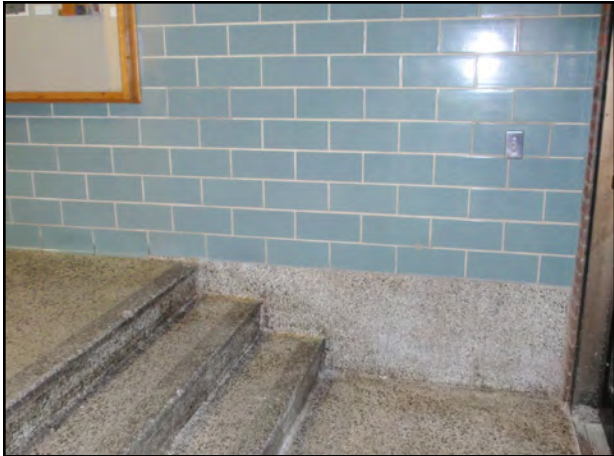
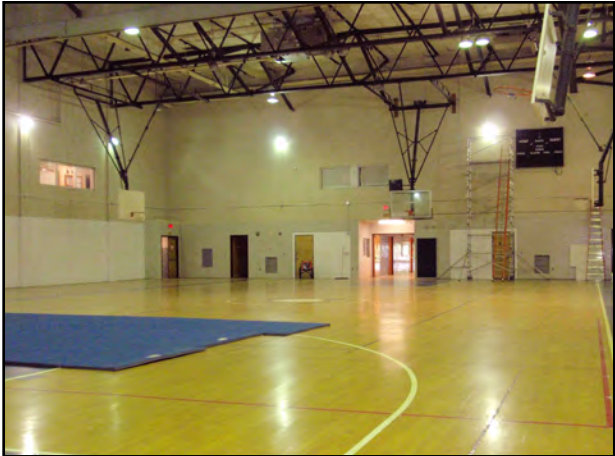
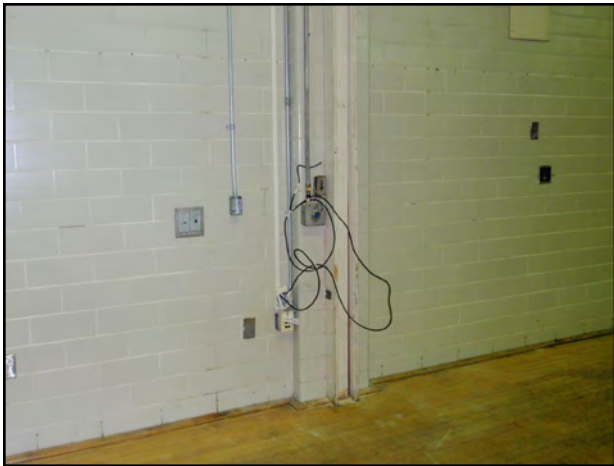
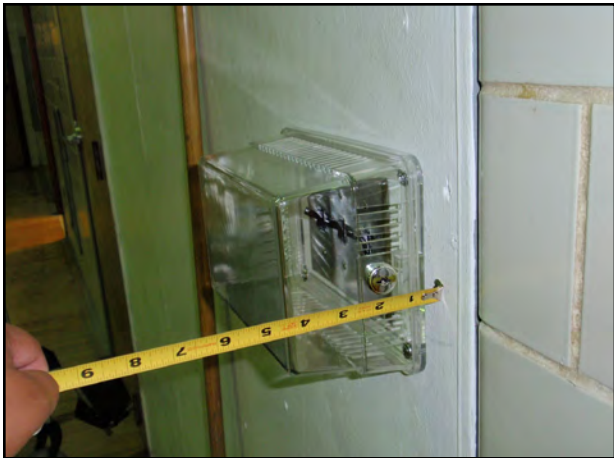
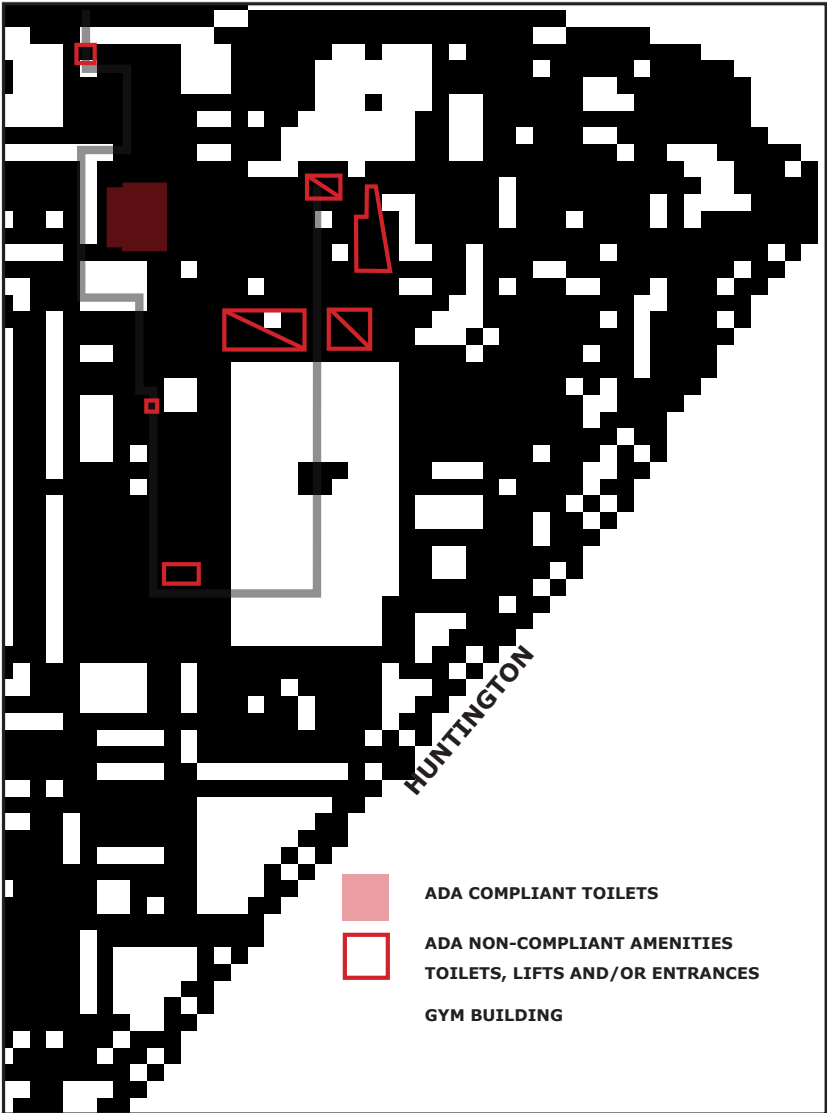
There is no compliant accessible route to the Gym.
 A potential route could be made through the North Building via an ADA non-compliant entrance on Tetlow Street, using the elevator to the North 1st Floor, passing Pozen and the Crackertorium up a non-compliant lift in East through the film department to the Gym. There is no signage that indicates that this is a possible route.

Aisles and paths are not defined creating egress safety and tripping hazards in the accessible route. .

RECOMMENDATION TO IMPROVE ADA COMPLIANCE OPERATIONAL: Remove obstructions and educate staff, students and faculty to maintain a 36" min. wide clear space through rooms, spaces and accessible routes at all times. Ensure that there are no protruding objects that are more than 4" from the walls, and between above 27" and 80" AFF

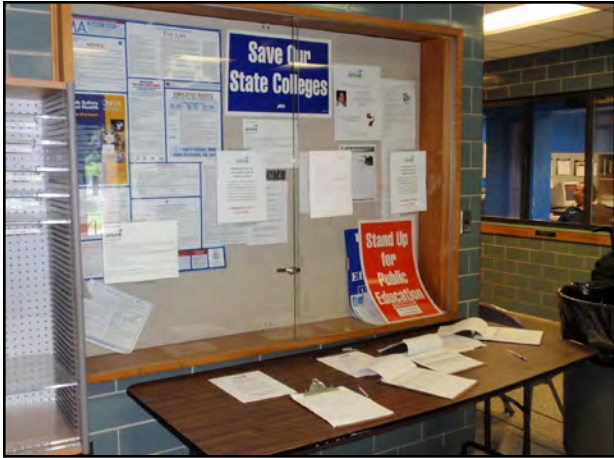
LOCATION | 102

Notices

RECOMMENDATION TO IMPROVE ADA COMPLIANCE
Rearrange notices so that the notices with smaller type size are lower and reserve space above 60" AFF for notices with larger type size. Relocate or remove table, consider providing hooks for clipboards.

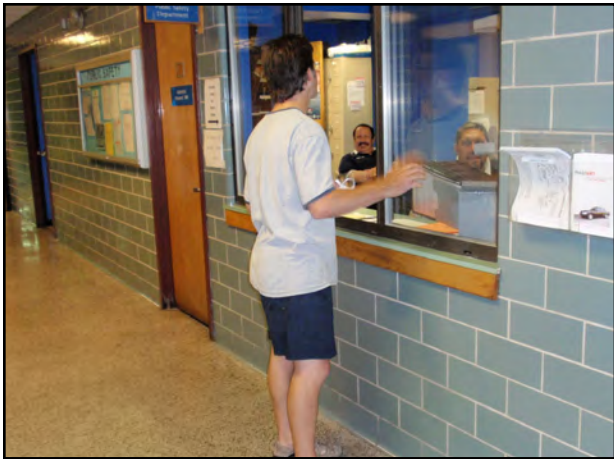
LOCATION | 103

The counter is higher than 34" and there is no knee clearance.

[See Appendix A -2010 ADA Standards 902.4 Countertop height]

RECOMMENDATION TO IMPROVE ADA COMPLIANCE OPERATIONAL: Either lower the countertop or make sure that there is always staff available to open door to deal with students or visitors.

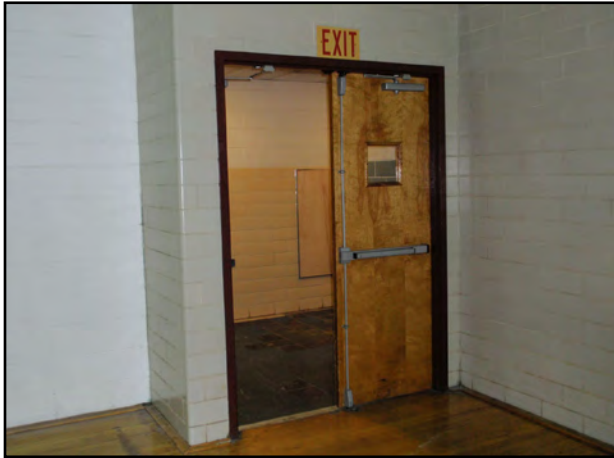
LOCATION | 106

Double-Leafed Doors

RECOMMENDATION TO IMPROVE ADA COMPLIANCE
Automatic door openers cannot be used to open both door leaves as this would disturb the events. Provide asymmetrical leaves with one operable leaf measuring no less than 36 inches.

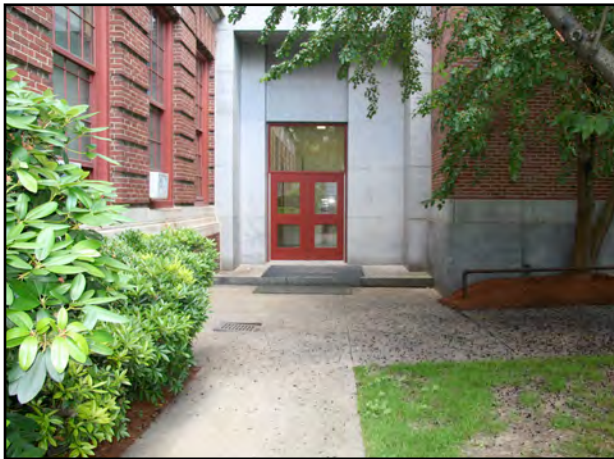
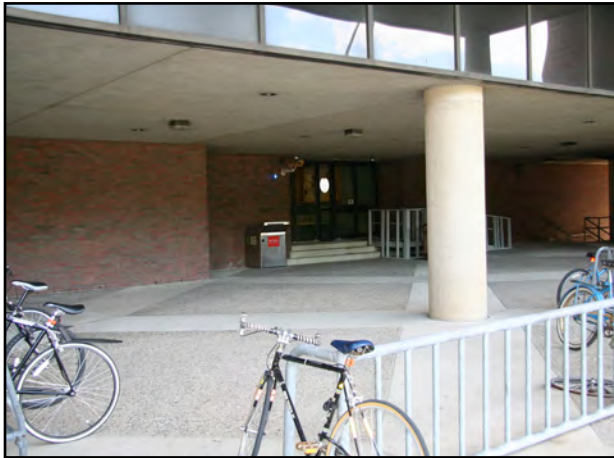
Exterior and interior doors with closers have door opening forces that are greater than 15lbs, this is too heavy for easy opening and means that the door closes too fast to be able to enter easily. This could cause delay in an emergency.

[See Appendix A -2010 ADA Standards 404.2.8 Door Closers]

RECOMMENDATION TO IMPROVE ADA COMPLIANCE OPERATIONAL: Create a comprehensive maintenance program and schedule to check and adjust all doors so that the exterior doors have opening forces that don't exceed 15lbs and interior doors that don't exceed 5 lbs. .

D1 Small Maintenance
Implement plan to maintain clear areas around doors and adjust door closing pressures to achieve correct opening forces.
\$25/hr

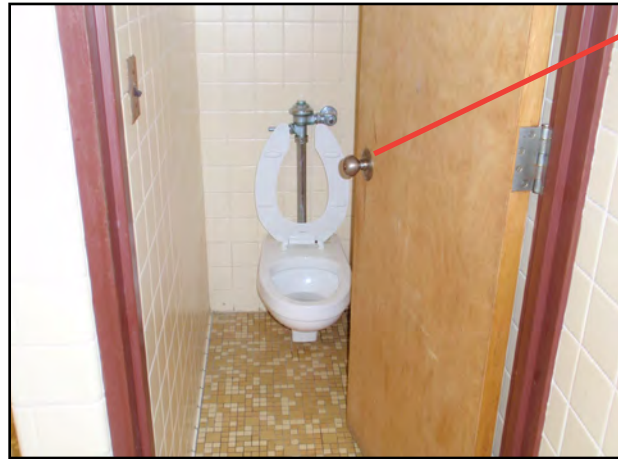
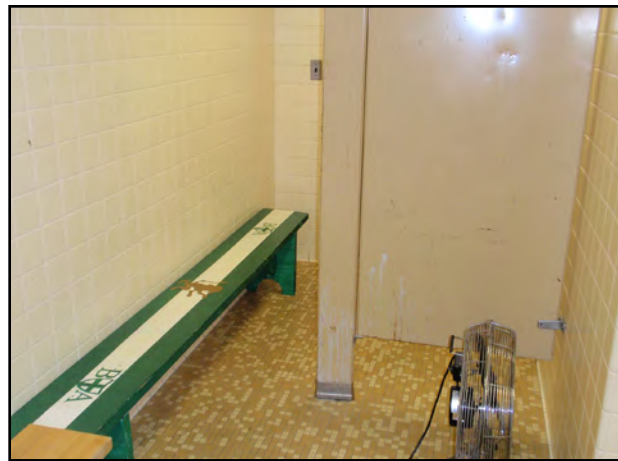
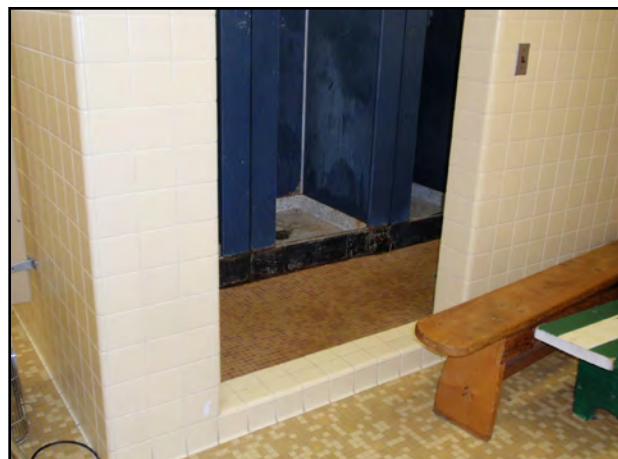
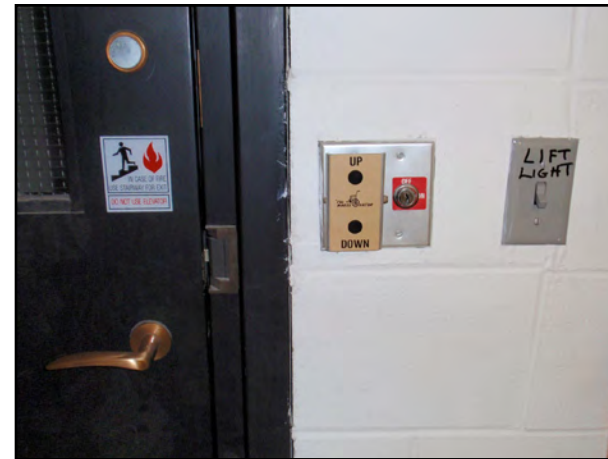
All of the toilet rooms and Locker Rooms on the 1st floor of Gym are not ADA compliant. The configuration and the widths and length dimensions of the rooms and stalls are not adequate. Major renovations to these toilet rooms would be required to bring them into compliance.

If renovations to this Building are not made in the near future it will be necessary to make these toilet rooms and Locker Rooms ADA compliant.

F
Capital Improv.
toilet rooms and Locker Rooms require major reconfiguration and renovation if future Design Center Renovation project does not go forward.

IMMEDIATE TEMPORARY ACTION
Until modifications are complete provide 2010 ADA Standards compliant signs to direct users to nearest Accessible Toilet Room.

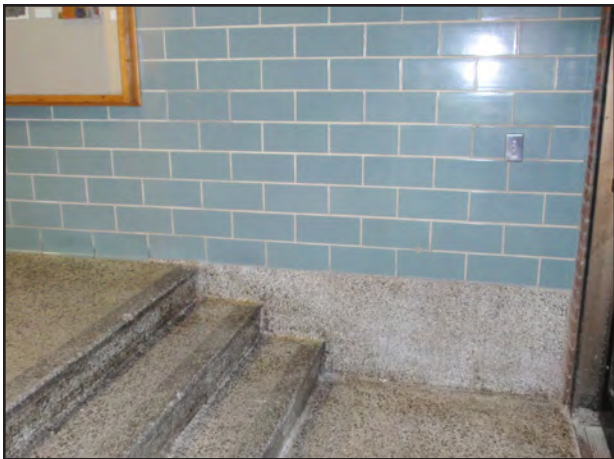
LOCATION | 101

Stairs-Contrast

Egress stairs have missing handrails and extensions.

RECOMMENDATION TO IMPROVE ADA COMPLIANCE
Provide non-slip luminous strips or paint at edge of tread and nosing.

RECOMMENDATION TO IMPROVE ADA COMPLIANCE
Provide handrails with top and bottom extensions.

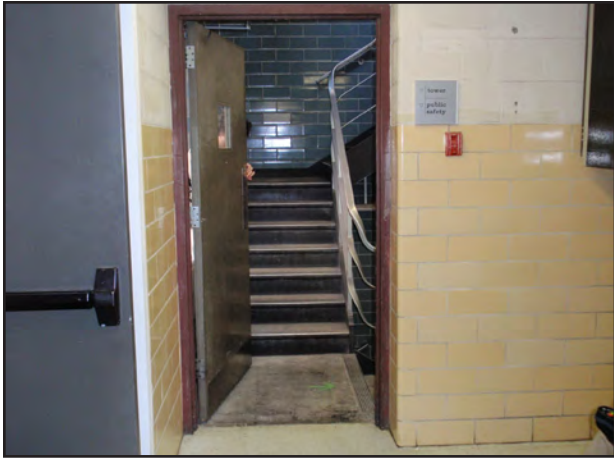
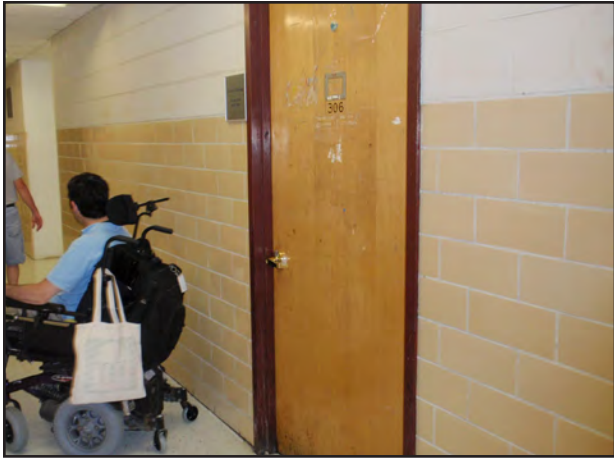
The following issues are similar on both the 3rd and 4th floor.

Throughout the third floor of the Gym Building designation signs are missing or are not ADA compliant. This can cause confusion in an emergency situation. eg **LOCATIONS | 305**

RECOMMENDATION TO IMPROVE ADA COMPLIANCE CAPITAL IMPROVEMENT: All permanent rooms must have ADA compatible room designation signs. Rooms that do not have room numbers lead to confusion especially in an emergency situation. As part of the campus-wide wayfinding program provide ADA compliant signs on the latch side of the door mounted at 48" min AFF to the baseline of the tactile characters on signs and 60 inches maximum AFF or ground surface, measured from the baseline of the highest tactile character. If there is no room on the latch side place signs on wall perpendicular to the latch or on the door as long as the person reading the sign tactilely will not be injured if the door is opened.

Consider providing permanent egress maps at stairs and elevator lobbies on all floors. This will help occupants to navigate their way out of the building in case of emergency..

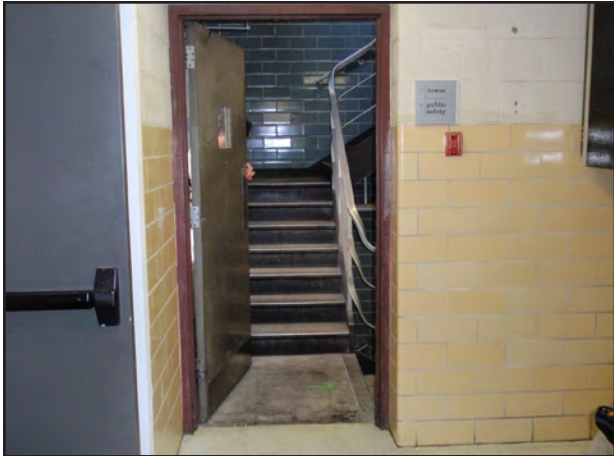
LOCATION | 304/404

Stairs - Landings

SMALL MAINTENANCE: Replace the glazing with glazing where the glass is 43" AFF or keep the door open during office hours on closures that would close the door in case of fire.

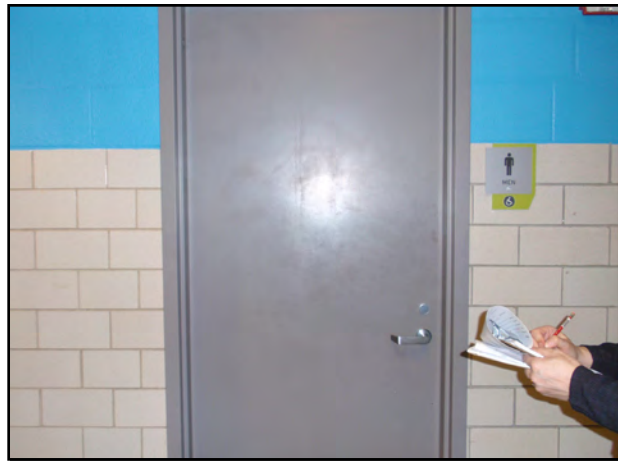
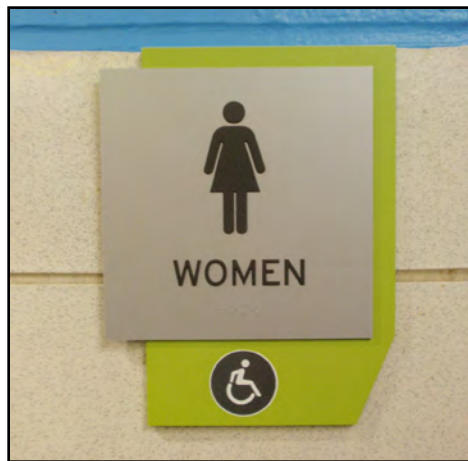
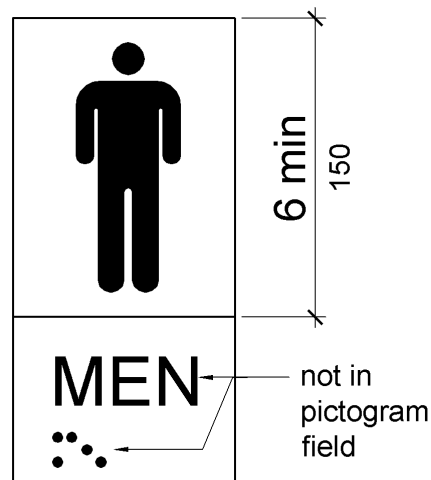
Signs - ADA Facilities and Safety

Both the men's and the women's toilet rooms are not ADA compliant so should not be identified as if they are.

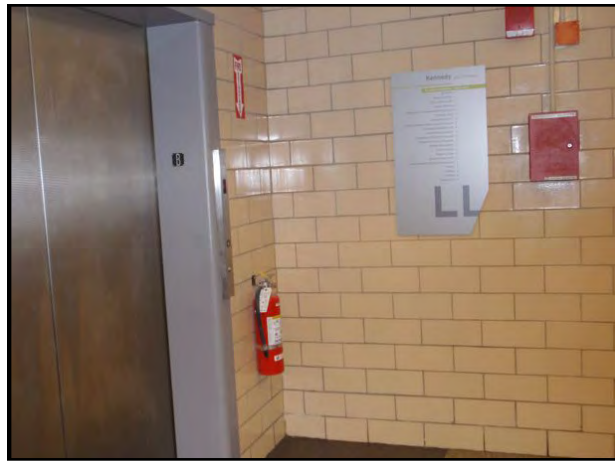
LOCATION | 002

Building Directory

The existing Directory calls out the basement as the 'Lower Level' however, on the campus map and on Directories all over the campus it is called the 'Basement'. Location information should be consistent and coordinated throughout the campus. There should be one updated centralized source providing this information. The floor levels in elevators, published materials and virtual information should also coordinate.

Make certain that the Directory information corresponds to the Basement program & usage. Be sure to add information regarding the accessible toilet after the toilet rooms have been modified to be accessible.

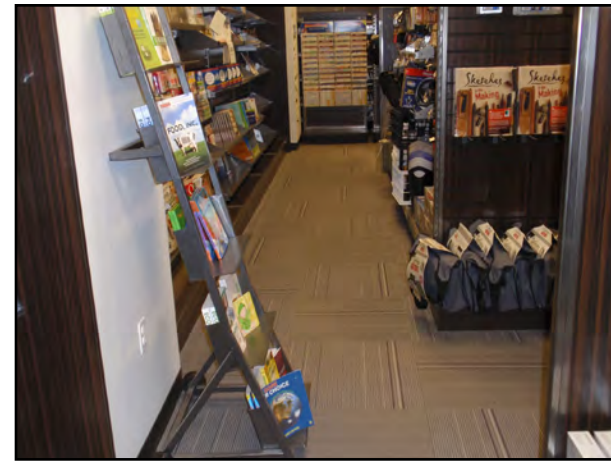
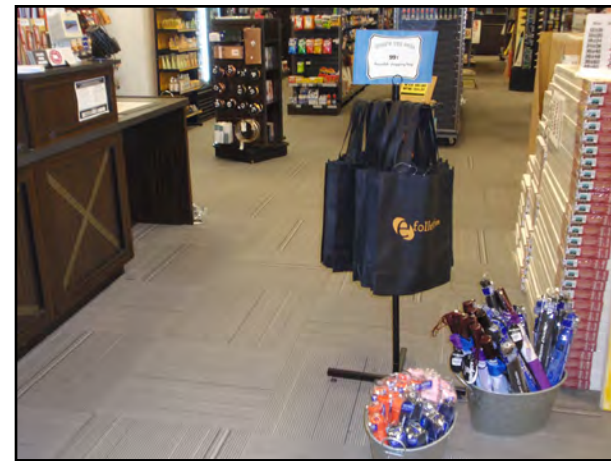
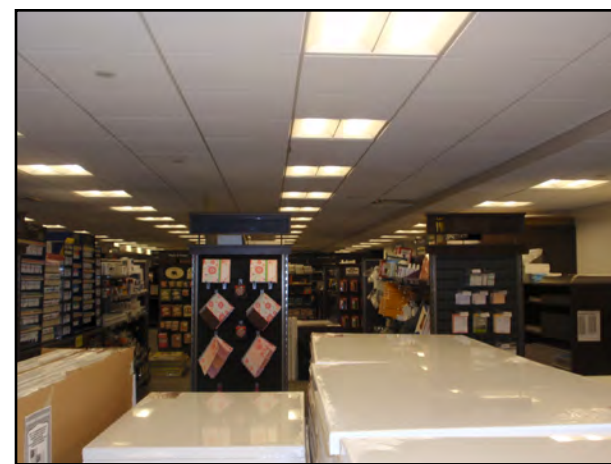
Aisle Obstruction

OPERATIONAL: Remove obstructions and educate staff, students and faculty to maintain a 36" min. wide clear path through rooms, spaces and accessible routes at all times.

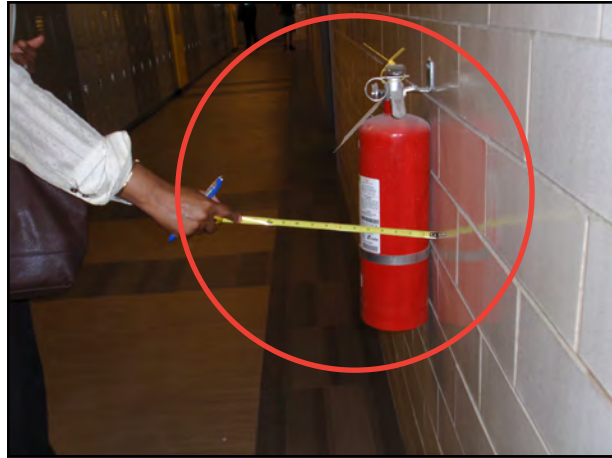
LOCATION | 012

Protruding Objects

SMALL MAINTENANCE: Protruding objects are not only a cause of injury to people who have no or low vision but to anyone walking down a corridor especially in an emergency or if they are passing in a corridor.

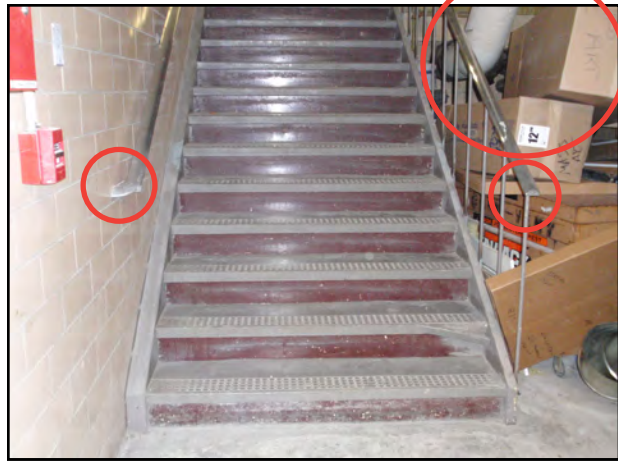
LOCATION | 017

Stairs - Rails and rail extensions

SMALL MAINTENANCE: Consider installing new rail with rail extensions top and bottom of stair. Handrail gripping surfaces should extend one foot beyond the stair flights and ramp runs in accordance with 505.10.

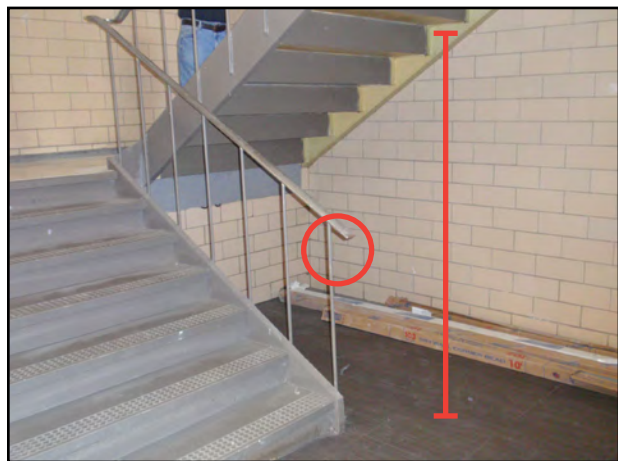
LOCATION | 01a

Stairs-Nosings

OPERATIONAL: Install curved wedges to the underside of the stair nosings to create a smooth transition. Consider using an integrated nosing and tread.

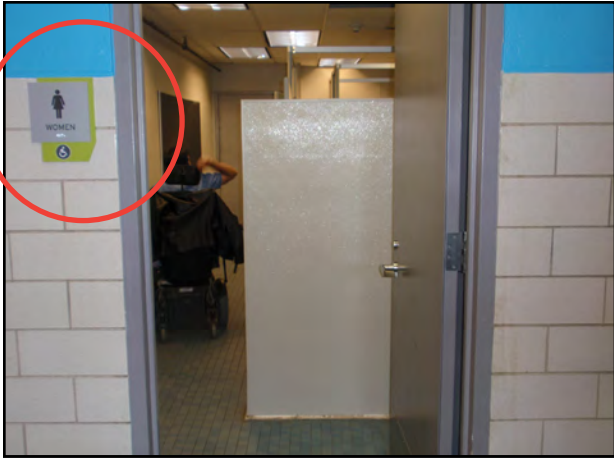
LOCATION | 013a

ADA Facilities and Amenities
 Both the men's and the women's toilet rooms are not ADA compliant so should not be identified with the International Symbol of Accessibility.

While these toilet rooms are not fully ADA compliant, provide ADA compliant signs with directions to the nearest ADA compliant toilet room on the first floor. Ensure that these signs are mounted at the correct height and location.

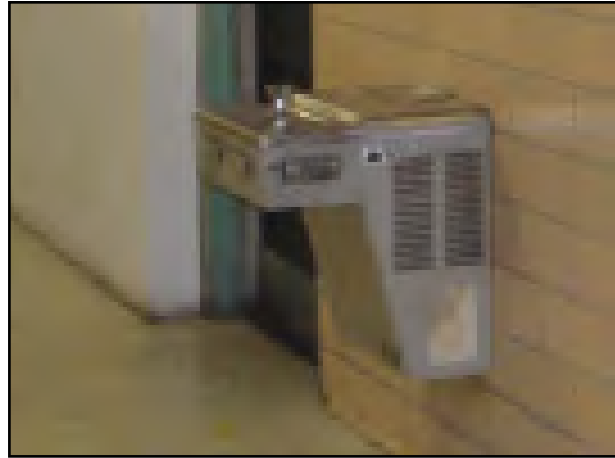
LOCATION | 013/14 (This is the same as 3rd Floor Drinking Fountain)

Drinking Fountain - Protruding Object

RECOMMENDATION TO IMPROVE ADA COMPLIANCE
See C protruding Objects.

RECOMMENDATION TO IMPROVE ADA COMPLIANCE
Provide cups with dispenser and trash that doesn't protrude from the wall more than 4" and within reach range.

Replace with a high-low drinking fountain that complies with 2010 ADA standards 211, 307, 602 601, 602.

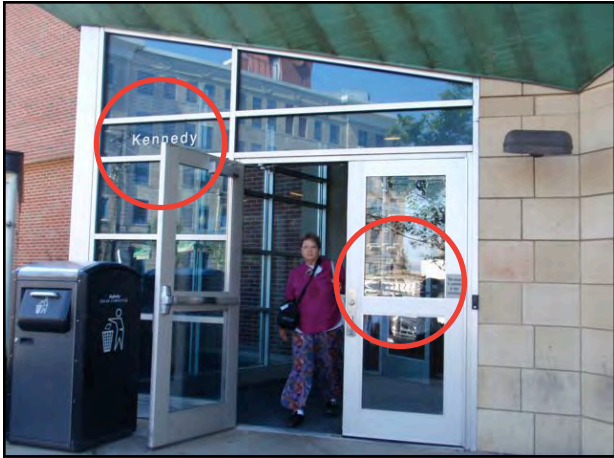
LOCATION | 101

Signs - ADA Facilities and Safety
 Accessible entrances at Huntington and Longwood are not marked with the International Symbol of Accessibility.
[See Appendix A - 2010 ADA Standards 216.6 Entrances, 703 Signs-, 703.2, 703.3, 703.4]

RECOMMENDATION TO IMPROVE ADA COMPLIANCE
 Provide an ADA compliant sign that identifies Huntington and Longwood entrances as accessible entrances. Ensure that location and mounting height meet ADA Standards for accessibility.

Where a directional sign is required, it should be located to minimize backtracking. In some cases, this could mean locating a sign at the beginning of a route, not just at the inaccessible entrances to a building.

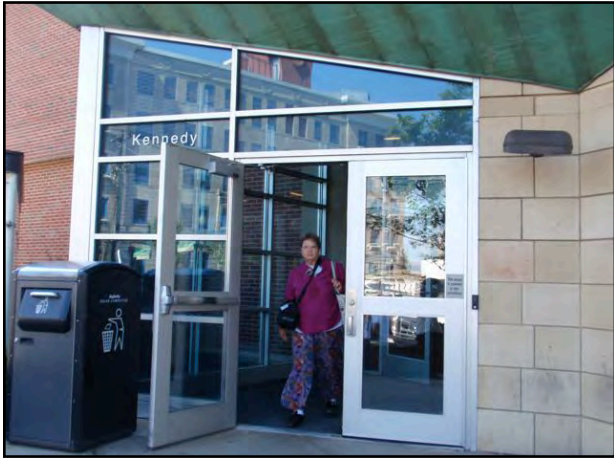
LOCATION | 101

Door - Closer Adjustment
The Palace Road, Longwood Ave and the Huntington Ave accessible entrance doors all have an opening force of 20lbs which is too heavy for easy opening.

RECOMMENDATION TO IMPROVE ADA COMPLIANCE OPERATIONAL: Adjust all exterior doors so that they have an opening pressure that doesn't exceed 15 lbs.

RECOMMENDATION TO IMPROVE SAFETY & USER EXPERIENCE
Assisted and/or door openers could be installed to help visitors enter and exit the building especially during peak traffic periods such as during the breakfast and lunchtime rushes.

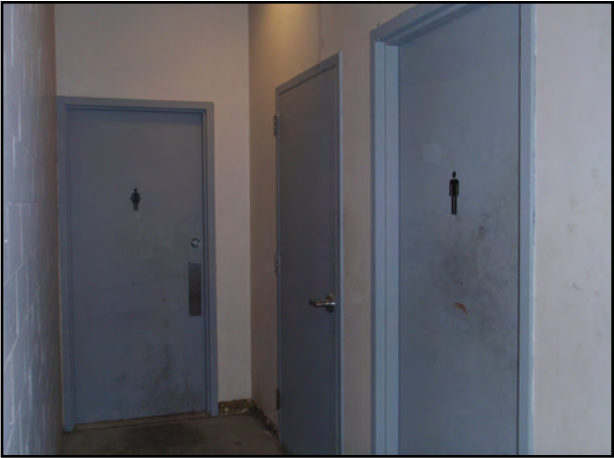
LOCATION | 116,117

Door Closers
The Toilet Room door opening force is 20lbs.

The double fire egress doors on the 1st Floor has a door opening force 20lbs, too heavy for easy opening. This could cause delay in an emergency.
[See Appendix A - 2010 ADA Standards 404.2.8 Door Closers]

RECOMMENDATION TO IMPROVE ADA COMPLIANCE OPERATIONAL: Adjust all interior door closers so that they have an opening pressure that doesn't exceed 5lbs.

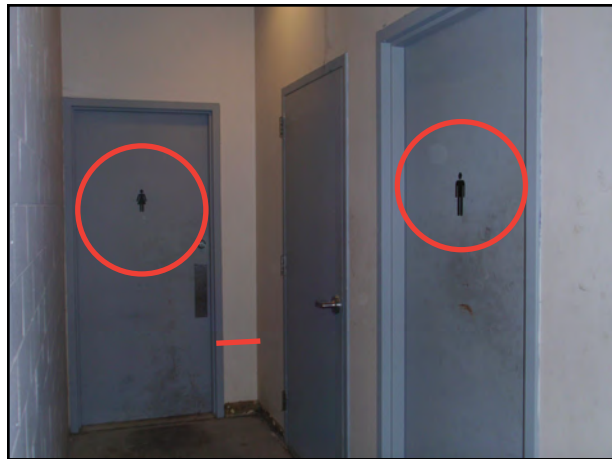
LOCATION | 116 & 117

Accessible Toilet Room

The storage room between the toilet rooms has no sign this could cause confusion in an emergency.

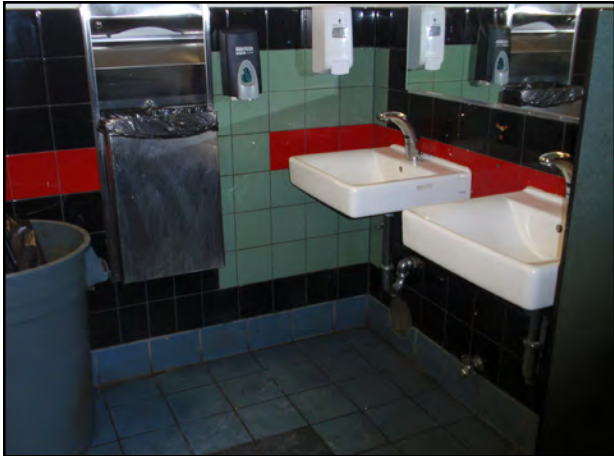
LOCATION | 117e

Mirrors

OPERATIONAL: Either lower mirror so that the bottom of the reflective surface is at 40” or provide a full length mirror elsewhere in the room.

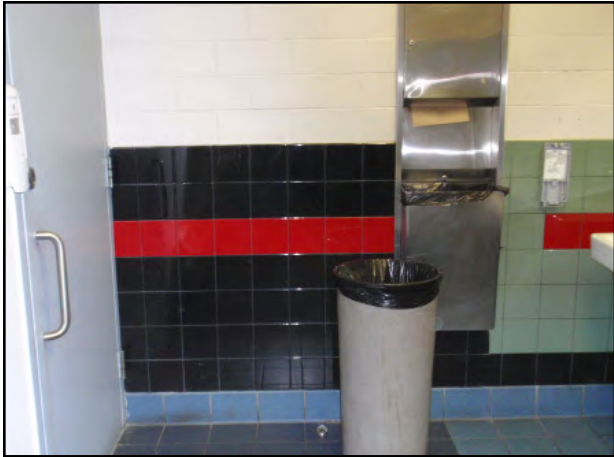
LOCATION | 117 & in 16

Dispenser Reach Range

RECOMMENDATION TO IMPROVE ADA COMPLIANCE

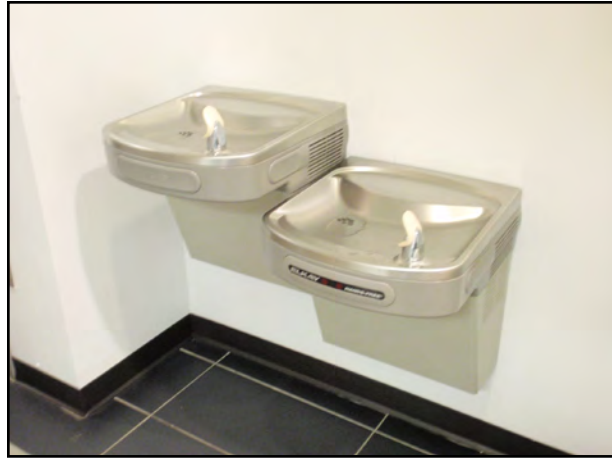
LOCATION | 100

Drinking Fountain
 These drinking fountains meet 2010 ADA Standards.
