Massachusetts College of Art and Design

ADA Compliance Plan 2011

ADA Compliance Plan
Consultant Services
Contract #10-08

The Institute for Human Centered Design

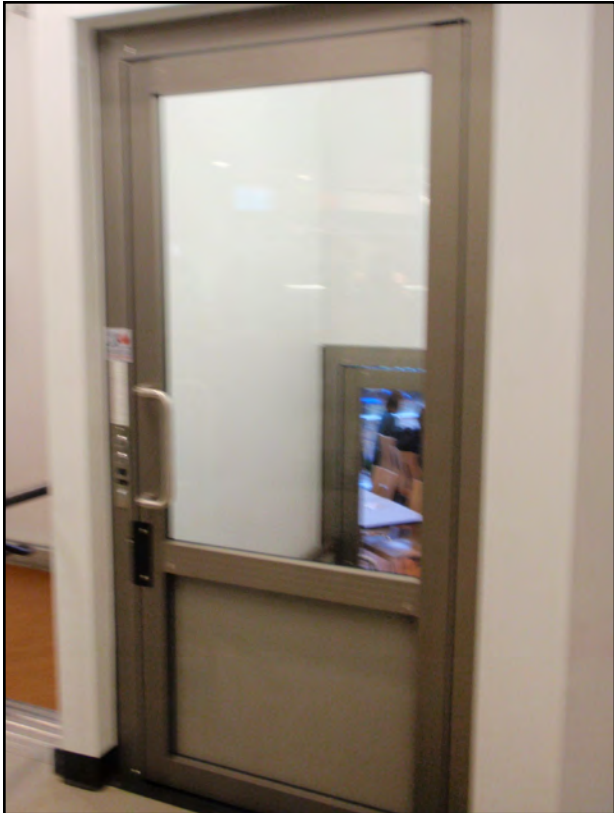
LOCATION | 118

Lift
Lift requires key for operation. Security staff need to be called in order to provide key.
[see General Issues 2010 ADA Standards Lifts & Elevators 407]

RECOMMENDATION TO IMPROVE ADA COMPLIANCE
Due to new legislation see note, the lift is required to be keyless.

INTERIM RECOMMENDATION
Until modifications are complete provide 2010 ADA Standards compliant signs to direct users to nearest compliant lift or ramp.

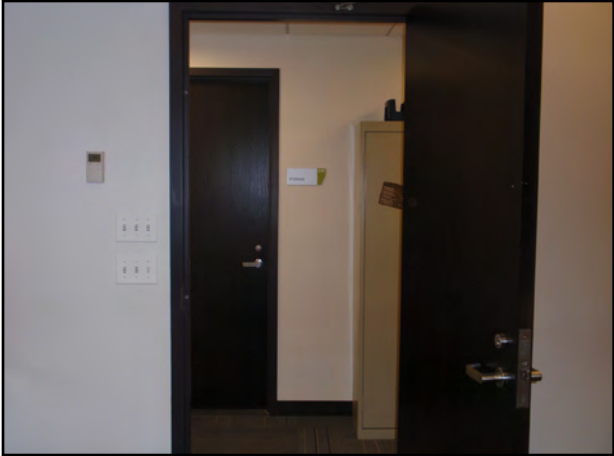
LOCATION | Office

Signs - ADA Facilities and Amenities

RECOMMENDATION TO IMPROVE ADA COMPLIANCE
 As this toilet room is not fully ADA compliant, in the interim provide ADA compliant signs with directions to the nearest ADA compliant toilet room. Ensure that these signs are mounted at the correct height and location.

Once these toilet rooms have been modified to become ADA compliant, provide ADA compliant signage on the latch pull side of the door mounted at 48" min. AFF to the baseline of the tactile characters on signs and 60" max. AFF measured from the baseline of the highest tactile character.

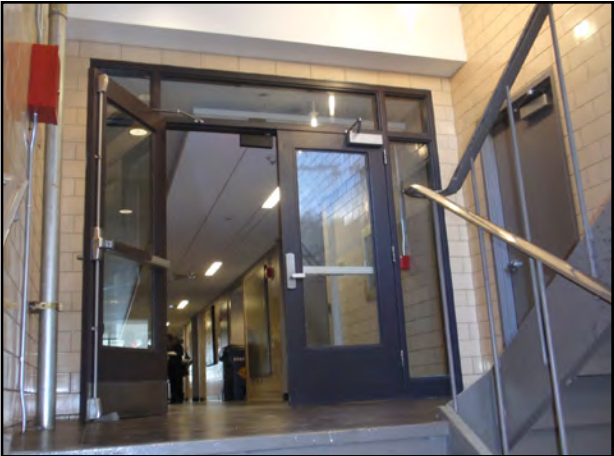
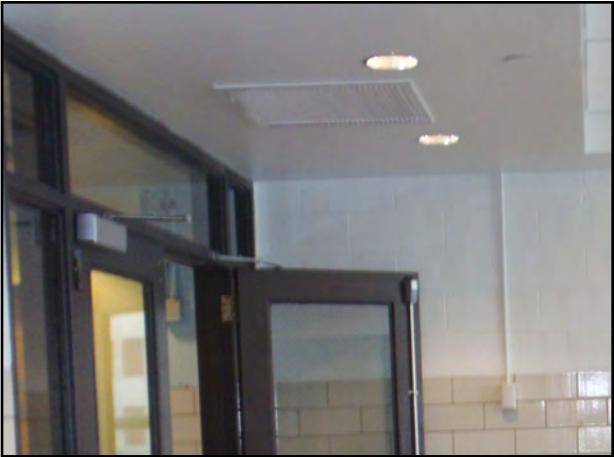
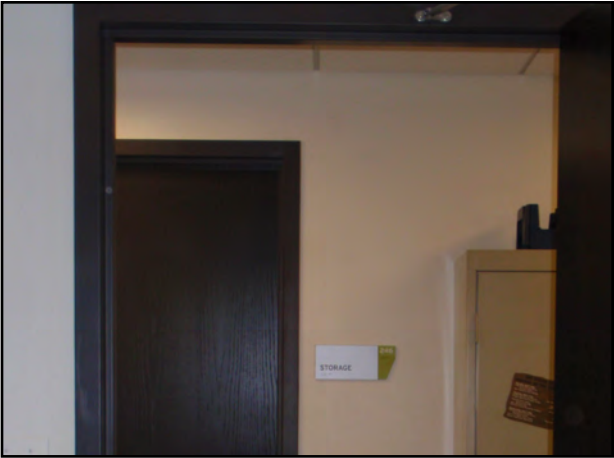
Signage - Designation Signs
 New signage had not all been installed at time of survey.

INTERIM RECOMMENDATION
 Until modifications are complete provide 2010 ADA Standards compliant signage to direct users to nearest accessible toilet room.

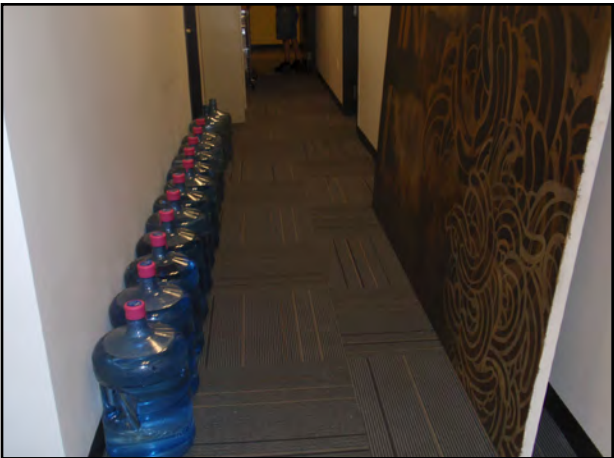
LOCATION | Student Life Offices

Door Obstruction

Cardboard boxes and other materials obstruct access in and out of the door. This reduces maneuvering clearances, can cause injury as a tripping hazard and can become very dangerous in an emergency situation.

ISSUE B
Access routes
OPERATIONAL
 Create program to maintain a clear width of 36" min. throughout the accessible routes and paths.
\$25 Staff labor

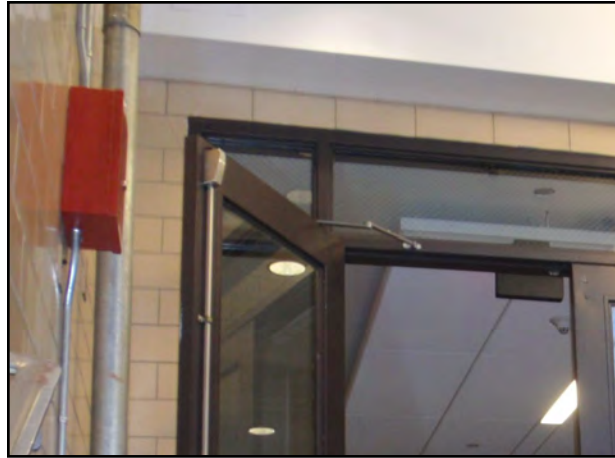
LOCATION | Stairwell Two-Palace Rd/Longwood

Protruding Objects

Fire box protrudes more than 4 “ into the accessible route and it is 54” high from the bottom of the box to the floor. It may cause injury as a person using a cane would not be able to detect it.

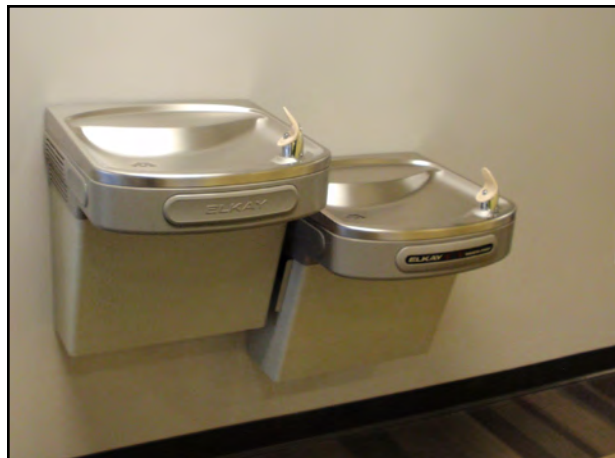
LOCATION | Corridor

Drinking Fountains protrude more than 4” into the accessible route and the underside of the leading edge is more than 27” AFF. It may cause injury as it protrudes into the corridor, and a person using a cane would not be able to detect it. Recessing these drinking fountains or providing an alcove similar to the condition on the first floor see page 22 could be a solution.

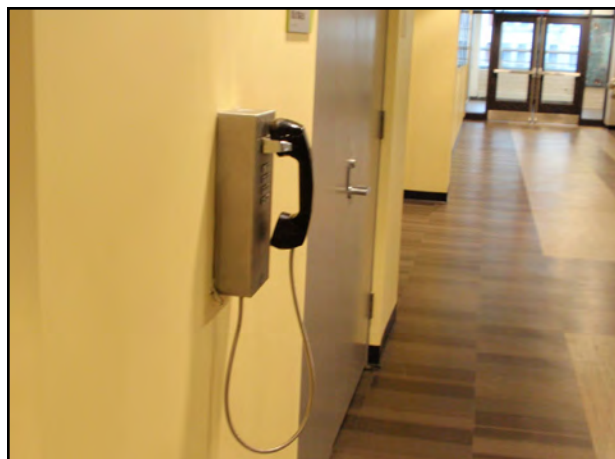
LOCATION | Corridor

Emergency Telephone protrudes more than 4” into the accessible route and the underside of the leading edge is more than 27” AFF. It may cause injury as it protrudes into the corridor, and a person using a cane would not be able to detect it.

Recess emergency telephones into the wall or form an alcove around them using wing walls.

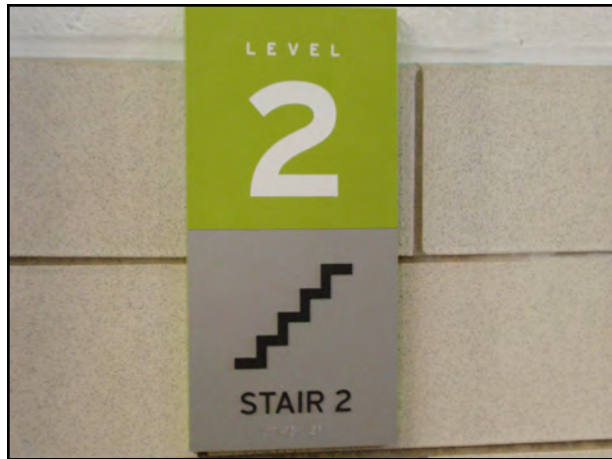
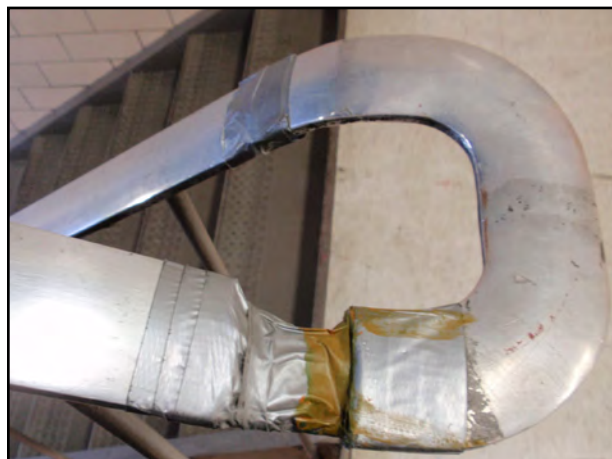
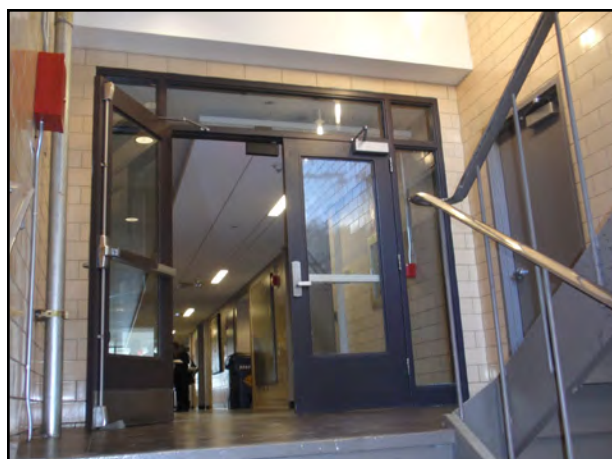
Stairs - Signs

RECOMMENDATION TO IMPROVE ADA COMPLIANCE
 Redesign and install ADA compliant signage.

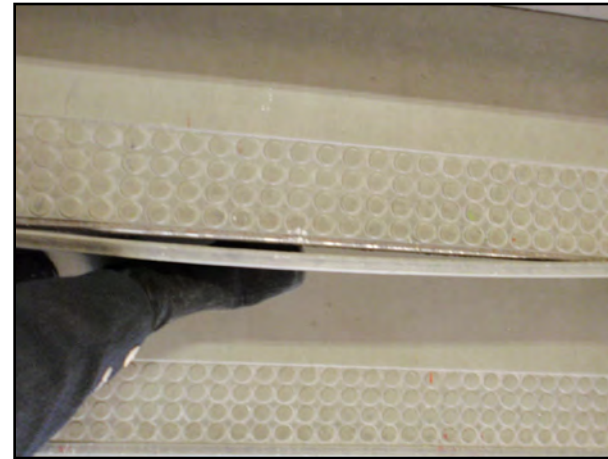
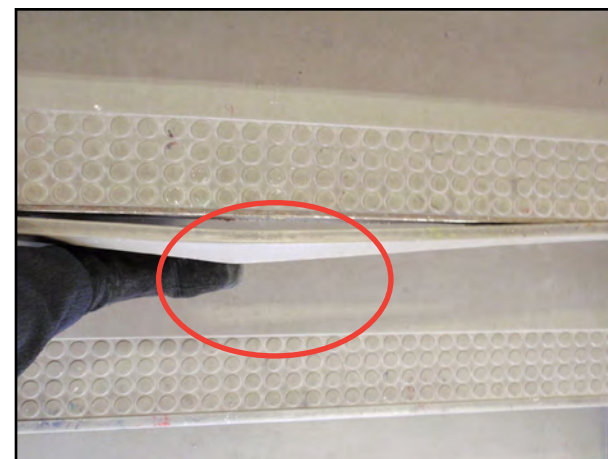
The stairs on all floors in Kennedy Building have similar issues.

All stairs have nosings that are greater than 1" this can be a tripping hazard and could cause injury.

ISSUE E
CAPITAL IMPROV.
 Repair stair and tread
 \$1,000/run

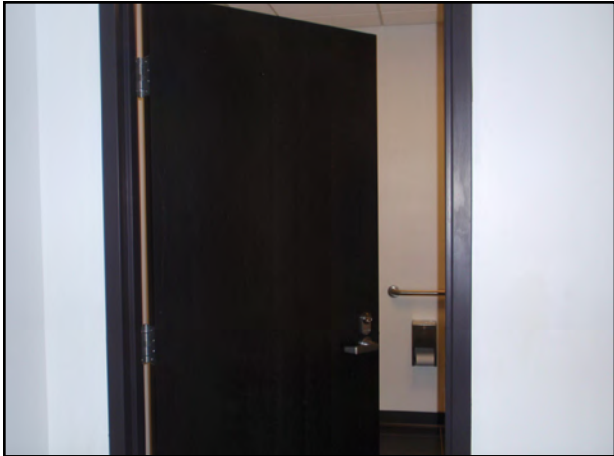
LOCATION | Student Counselling Offices Toilet Room

Multi-stall toilet rooms on this floor were not complete at the time of the survey.

RECOMMENDATION TO IMPROVE ADA COMPLIANCE SMALL MAINTENANCE: Since this toilet room is not fully ADA compliant, until modifications are complete provide ADA compliant signs with directions to the nearest ADA compliant toilet room on the first floor. Ensure that these signs are mounted at the correct height and location.

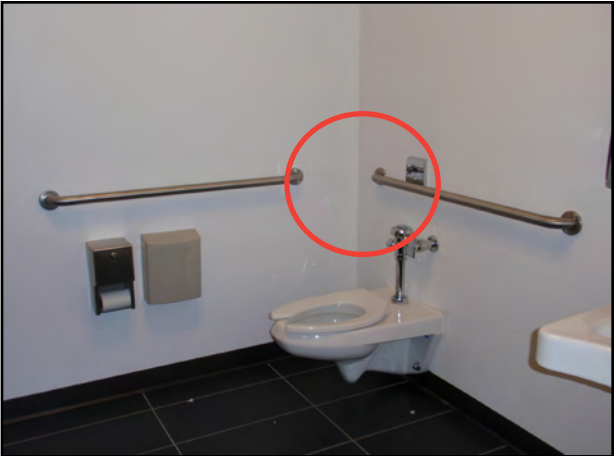
LOCATION | Student Counselling Offices Toilet Room

Grab Bars

RECOMMENDATION TO IMPROVE ADA COMPLIANCE SMALL MAINTENANCE: Reinstall grab bars so that the side grab bar is max. 12" from the back wall and the rear grab bar is 6" from the side wall. Reinstall flush and sensor 2 1/2" away from grab bar, but no higher than 48" AFF.

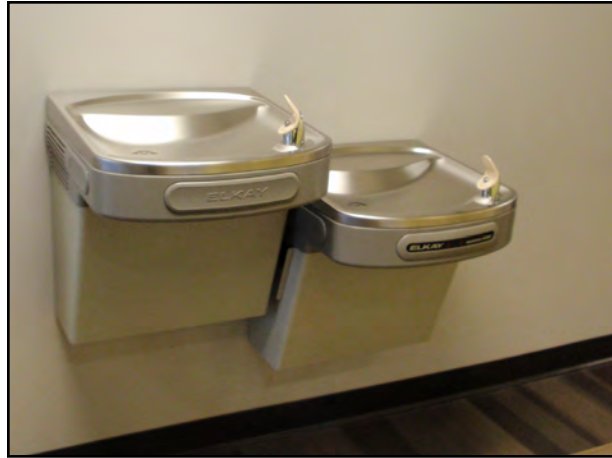
LOCATION | Corridor

Drinking Fountain

The drinking fountain is accessible but protrudes into the accessible route, see ISSUE C Protruding Objects.

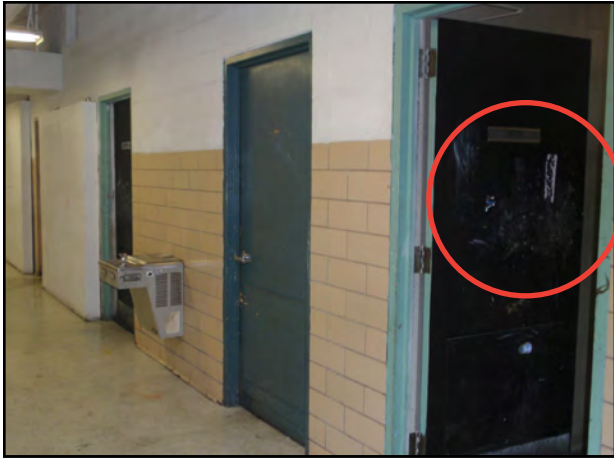
LOCATION | 311

Signs - ADA Facilities and Safety
 Both the men's and the women's toilet rooms have non-ADA compliant handwritten designation signs on the doors. **LOCATION | 311**
[See Appendix A - 2010 ADA Standards 703 Signs-703.2, 703.3, 703.4]

RECOMMENDATION TO IMPROVE ADA COMPLIANCE
CAPITAL IMPROVEMENT: Provide ADA compliant Toilet room signs **and** until these toilet rooms are modified to be accessible, provide ADA compliant toilet room signs that give directions to the nearest ADA compliant toilet rooms. The International Symbol of Accessibility must be used.
[See Appendix A - 2010 ADA Standards 703 Signs-703.2, 703.3, 703.4, 703.6.1 Pictogram field]

Ensure that room designation signs are mounted at the correct height and location. Signs are required to be installed on the latch pull side of the door mounted at 48" min AFF to the baseline of the tactile characters on signs and 60" maximum AFF .measured from the baseline of the highest tactile character.
[See Appendix A - 2010 ADA Standards 703 Signs-703.4.1]

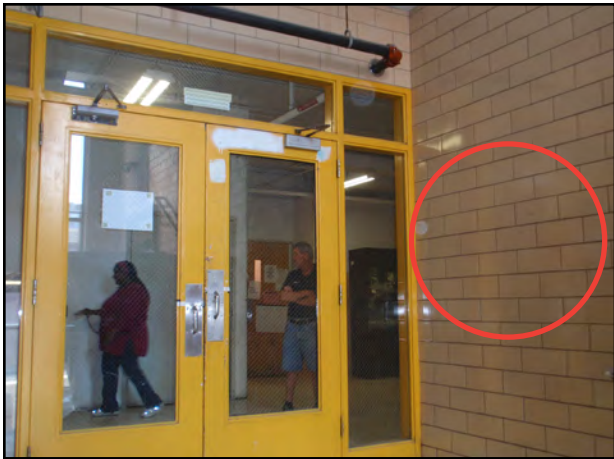
LOCATION | 314

Signs - Exit Doors & Passageways
 Throughout the floor braille and tactile ADA compliant exit signs are missing from doors at exit passageways, exit discharge points, and exit stairways.
[See Appendix A - 2010 ADA Standards 216.4.1 Exit Doors, 703.1 703.2, 703.3.5 Signs]

RECOMMENDATION TO IMPROVE ADA COMPLIANCE
CAPITAL IMPROVEMENT: As part of a campus-wide wayfinding program install ADA compliant exit signs at doors at exit passageways, exit discharge points, and exit stairways.
See section 1003.2.13.6 of the International Building Code (2000 edition) or section 1007.7 of the International Building Code (2003 edition)

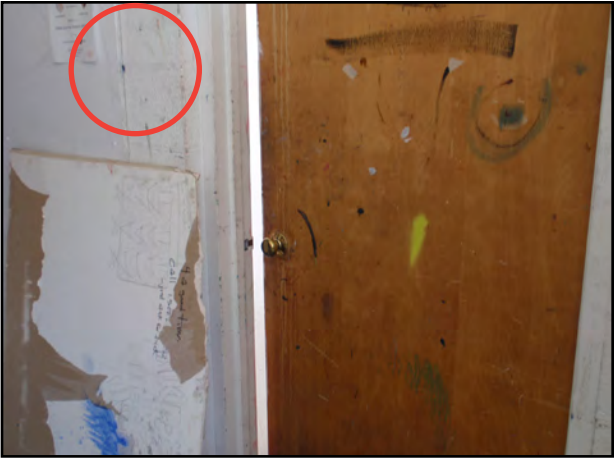
LOCATION | 317

Signs - Designation
 Most room, space designation signs are missing. All signs are not ADA compliant for mounting location, height requirement, and tactile reading requirements. Nor do the characters meet size, font, and proportion requirements. Nor are the raised character requirements met. **LOCATION | 316,315, 317**
[See Appendix A - 2010 ADA Standards 703 Signs-703.2, 703.3, 703.4], MAAB 411.1.1]

RECOMMENDATION TO IMPROVE ADA COMPLIANCE
CAPITAL IMPROVEMENT: As part of a campus-wide wayfinding program ensure that all permanent rooms and spaces have signs that meet ADA requirements.

CAPITAL IMPROVEMENT: Provide ADA compliant signs mounted on the latch pull side of the door. Mount to avoid the door swing at 48" min AFF to the baseline of the tactile characters and 60" max AFF, measured from the baseline of the highest tactile character. If there is no room on the latch pull side place signs on the nearest adjacent wall as long as the person reading the sign tactilely will not be injured if the door is opened.
[See Appendix A - 2010 ADA Standards 703 Signs-703.4.2 Locations]

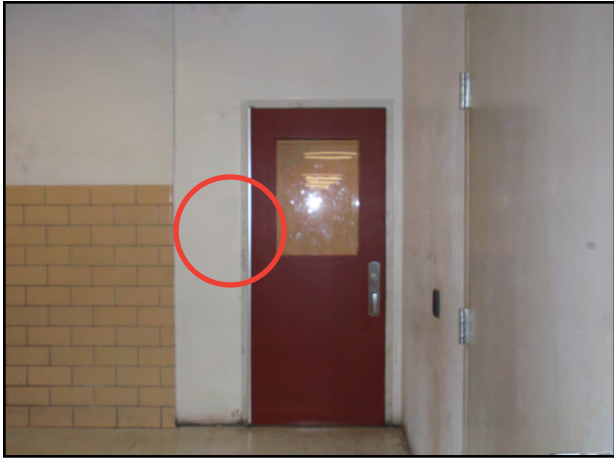
LOCATION | 315

Sign -Directional
 Directional signs are missing and/or are not ADA compliant. It is difficult to know how to get from one building to another. **LOCATION | 315**
[See Appendix A - 2010 ADA Standards 703 Signs-703.5]

RECOMMENDATION TO IMPROVE ADA COMPLIANCE
CAPITAL IMPROVEMENT: As part of a campus-wide wayfinding program provide directional signage wherever it helps with navigation.
[See Appendix A - 2010 ADA Standards 216.4.3, 703 Signs-703.5]

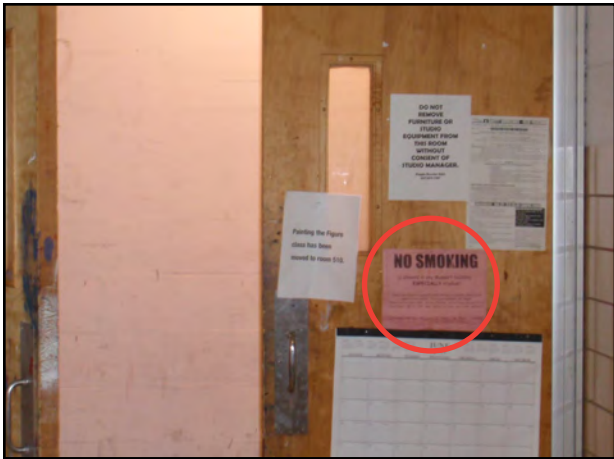
LOCATION | 316

Sign - Informational
 Informational signs like the no smoking sign are not ADA compliant for mounting location, height requirement, and the characters do not meet size, font, and proportion requirements. **LOCATION | 316**
[See Appendix A - 2010 ADA Standards 703 Signs-703.5]

RECOMMENDATION TO IMPROVE ADA COMPLIANCE
CAPITAL IMPROVEMENT: As part of a campus-wide wayfinding program eliminate all unnecessary signs and notices and replace necessary informational signs with ADA compliant signs that are within visual range of someone who is seated. The materials with 36 point text should be higher than text with less than 36 point lettering.

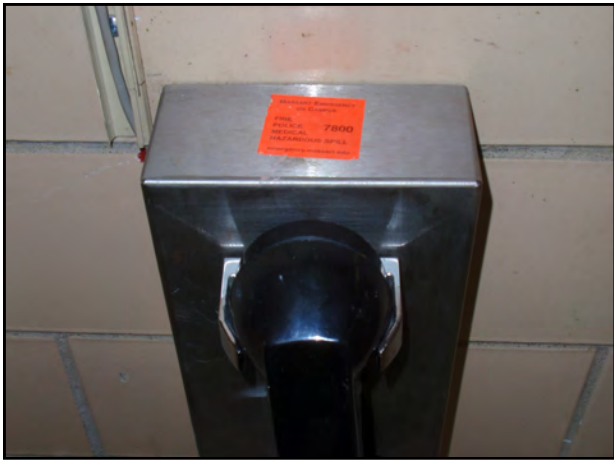
LOCATION | 305

Sign - Informational Signs
 Emergency information is posted on top of the telephone out of view to a wheelchair user or a person of short stature. **LOCATION | 305**
[See Appendix A - 2010 ADA Standards 703 Signs-703.5]

RECOMMENDATION TO IMPROVE ADA COMPLIANCE
CAPITAL IMPROVEMENT: As part of a campus-wide wayfinding program post informational signs mounted at correct height, ensuring that the character height, proportions and contrast are ADA compliant.

Provide an ADA compliant sign at this public telephone with directions to the nearest TTY telephone.
[See Appendix A - 2010 ADA Standards 216.3 Signs-]

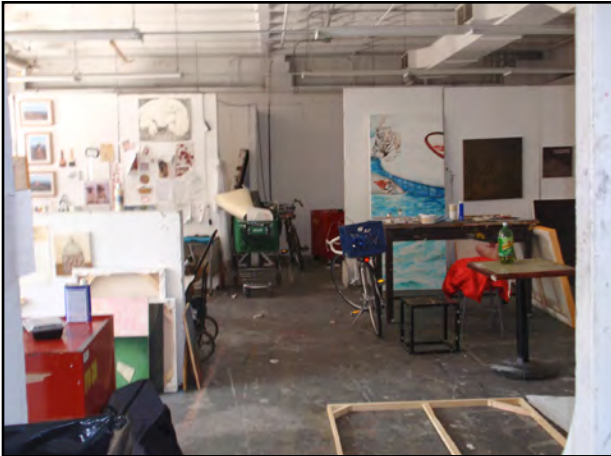
LOCATION | 306

Aisle Obstruction
 Accessible path of travel in, out and through Studios and rooms is compromised by furniture and storage. These obstructions create egress, safety, and tripping hazards for everyone.
[See Appendix A - 2010 ADA Standards 206 Accessible Routes 401, 402, 403.5.1 Clearances

RECOMMENDATION TO IMPROVE ADA COMPLIANCE
 Relocate furniture and storage out of the accessible path.

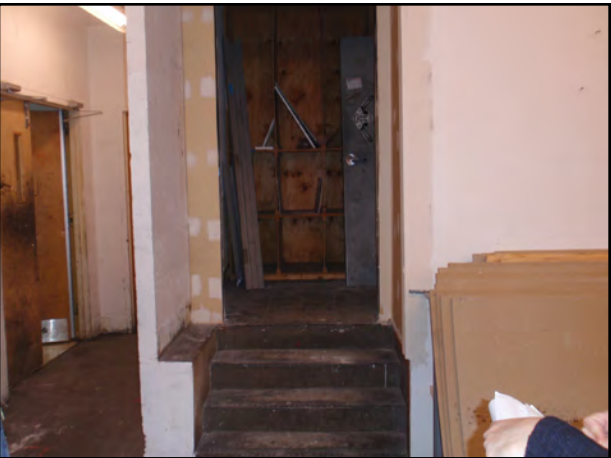
LOCATION | 317

Inaccessible Spaces within Rooms
 Storage spaces in some studios require stairs to access them and so are inaccessible to wheelchair users.
[See Appendix A - 2010 ADA Standards 206 Accessible Routes 401, 402, 403.5.1 Clearances

RECOMMENDATION TO IMPROVE ADA COMPLIANCE
 Provide equivalent studio storage space that does not require stairs to access it.

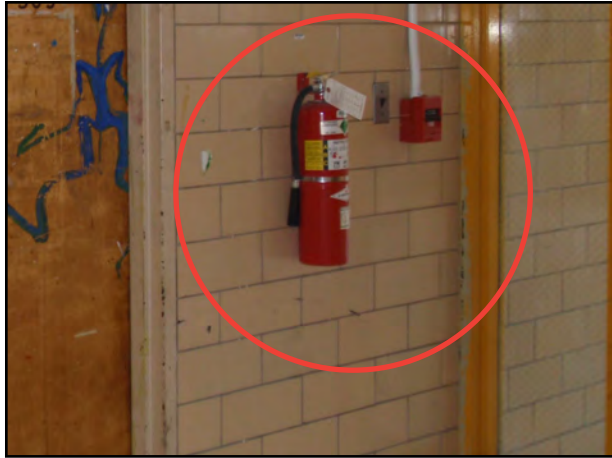
LOCATION | 304

Fire Extinguisher

Fire extinguisher protrudes 5" from the wall and is more than 27" AFF this could cause injury, a person using a cane would not be able to detect it.

RECOMMENDATION TO IMPROVE ADA COMPLIANCE
Recess fire extinguisher into the wall or encase in a fire cabinet that extends lower than 27" so that it could be cane detectable.

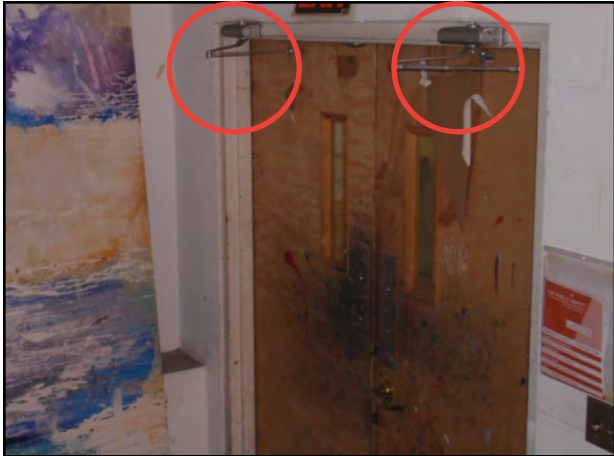
LOCATION | 321

Door Closers
 Many doors with door closers have opening forces greater than 5lbs this makes the doors difficult to open, especially for someone in a wheelchair. This could cause delay in an emergency.
[See Appendix A - 2010 ADA Standards 404.2.8 Door Closers]

RECOMMENDATION TO IMPROVE ADA COMPLIANCE
 Adjust all interior doors so that they have an opening pressure that doesn't exceed 5lbs.

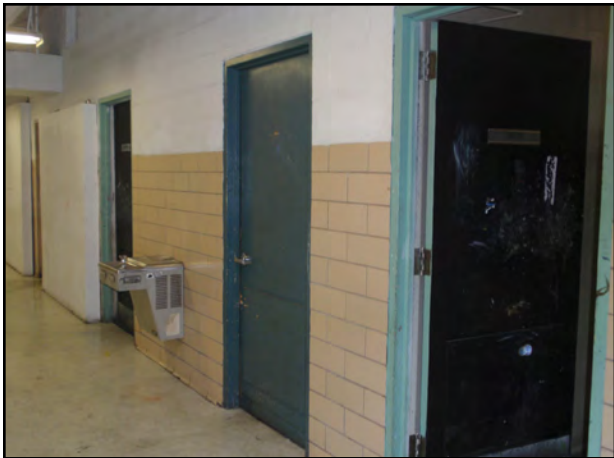
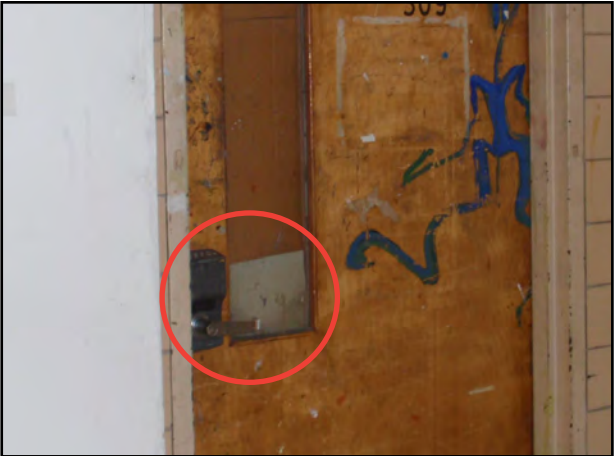
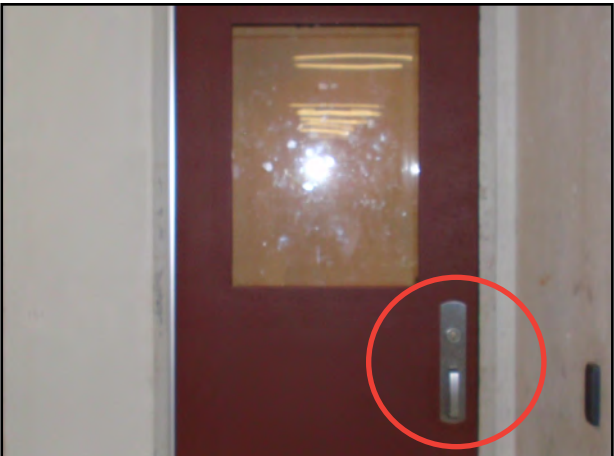
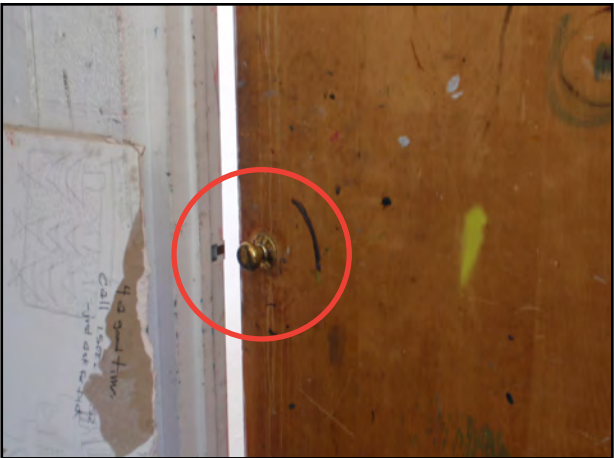
Door Hardware
 Door hardware cannot be operated with a closed fist. **LOCATION | 304,315,30**
[See Appendix A - 2010 ADA Standards Operable]

RECOMMENDATION TO IMPROVE ADA COMPLIANCE
 Reinstall hardware that can be operated using a closed fist. Door hardware that can be operated with a closed fist or a loose grip accommodates the greatest range of users. Hardware that requires simultaneous hand and finger movements require greater dexterity and coordination, and is not recommended.

ISSUE D3
SMALL MAINT. PROJECT
 Implement plan to replace knob hardware with lever-type hardware. **PRIORITIZE FOR DOORS ON ACCESSIBLE ROUTE.**
 \$400/set

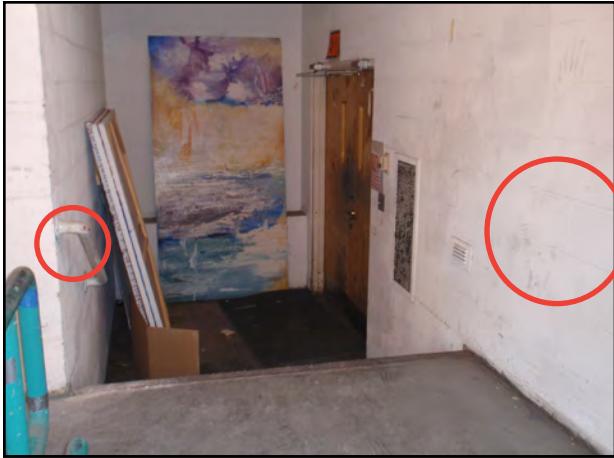
LOCATION | 321

Stairs-Hand Rails
These stairs are missing hand rails and rail extensions. The stair landing is also the landing for a ramp. A person using the ramp may fall because the stairs are not marked.

RECOMMENDATION TO IMPROVE ADA COMPLIANCE
SMALL MAINTENANCE PROJECT: Install new rails with extensions, install contrasting stair edging strip, maintain clutter-free zone at the bottom of the stair and provide more lighting.

ISSUE E
SMALL MAINT. PROJECT
Install new rails, treads and nosings
\$600/run

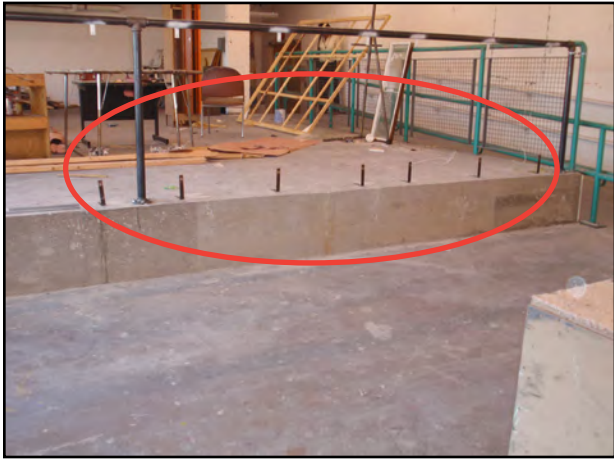
LOCATION | 320

Hand Rails
The bottom rail is missing from the raised part of the studio and pieces of rails are sticking up and could cause injury .

RECOMMENDATION TO IMPROVE ADA COMPLIANCE
SMALL MAINTENANCE PROJECT: Remove old pieces of rails and install new rails.

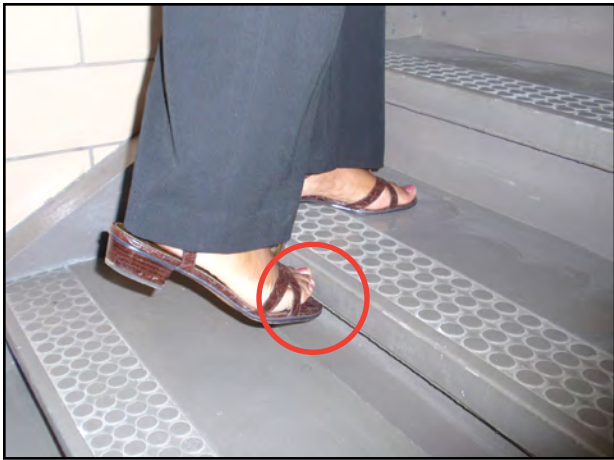
LOCATION | Same as Basement

Stairs-Nosings
The nosings are greater than 1/2" and can become a tripping hazard.

RECOMMENDATION TO IMPROVE ADA COMPLIANCE
SMALL MAINTENANCE PROJECT: Provide nosing infill strip to reduce the overhang.

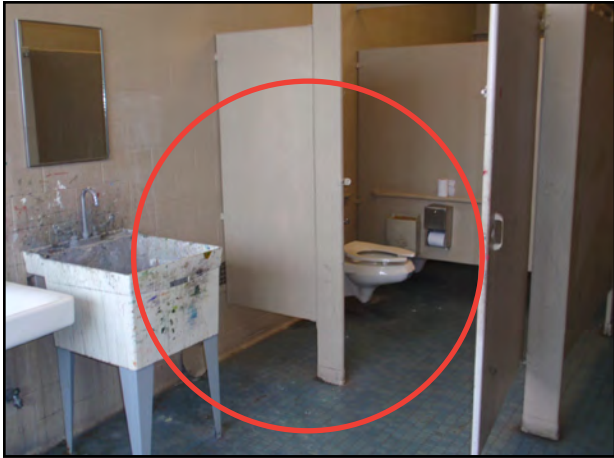
LOCATION | 311

ADA Facilities and Amenities
 Both the Men's and the Women's toilet rooms are not ADA compliant so should not be marked as being ADA compliant.

RECOMMENDATION TO IMPROVE ADA COMPLIANCE
 Modify toilet rooms to become ADA compliant.

While these toilet rooms is not fully ADA compliant, provide ADA compliant signs with directions to the nearest ADA compliant toilet room on the First Floor. Ensure that these signs are mounted at the correct height and location.
[See Appendix A - 2010 ADA Standards 703 Signs-703.2, 703.3, 703.4]

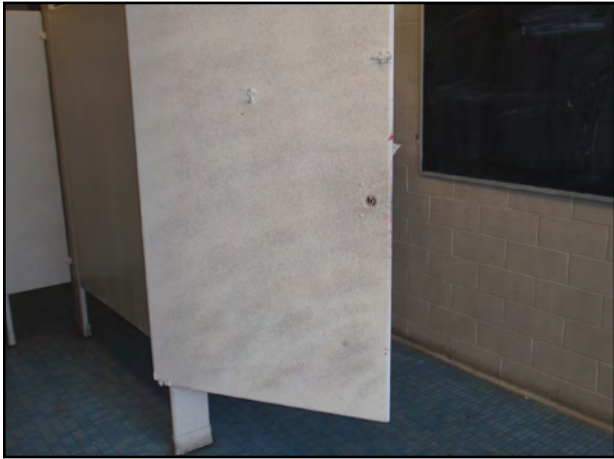
LOCATION | 311

ADA Signs
 The sign is not ADA compliant for size, contrast, the icon of International Accessibility has been substituted for a non-ADA compliant icon.
[See Appendix A - 2010 ADA Standards 703 Signs-703.2, 703.3, 703.4]

RECOMMENDATION TO IMPROVE ADA COMPLIANCE
 When these toilet rooms have been modified to become ADA compliant, provide ADA compliant signs on the latch pull side of the door. Mount at 48" min. AFF to the baseline of the tactile characters, and 60" max. AFF, measured from the baseline of the highest tactile character. Use the icon of International Accessibility to designate that it is a ADA compliant toilet room.

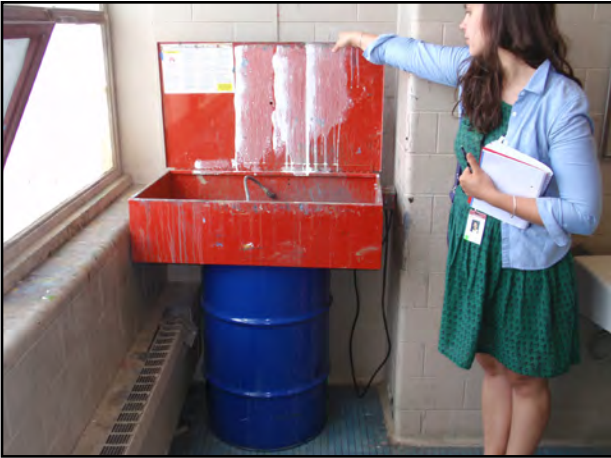
LOCATION | 310

Sinks: Typical to Art Schools there are many utility sinks required for cleaning equipment such as brushes, paint and chemical containers. These utility sinks pose a particular accessibility problem as they need to be deeper than the usual sink therefore there is no knee space under the sink. To ensure a student in a wheelchair can work at this type of sink a 'reasonable accommodation' could be to use a standard utility sink that is no higher than 34", provide enough space around the sink for a side approach and add an adjacent work counter with room for knee space.

ISSUE F
Capital Improv.
Utility sink installation & sink \$1,500

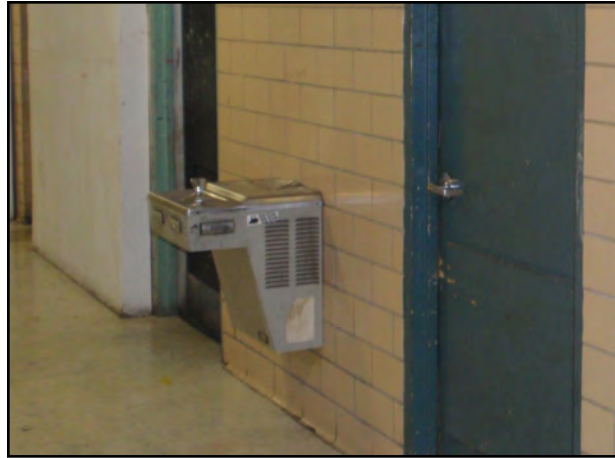
LOCATION | 309

Drinking Fountain

Replace with a high-low drinking fountain that complies with *2010 ADA standards 211, 307, 602 601, 602.*

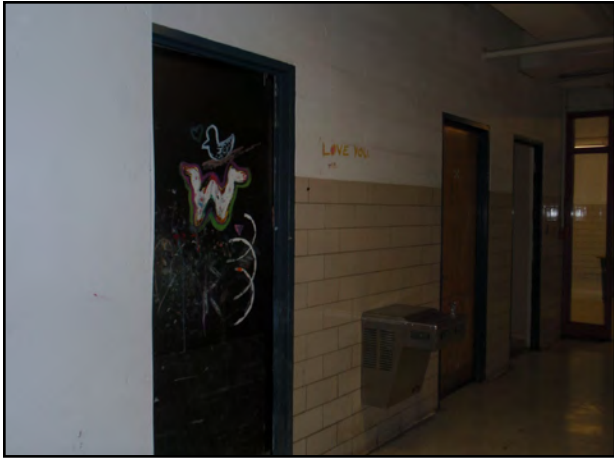
LOCATION | 410

Signs - ADA Facilities and Safety

RECOMMENDATION TO IMPROVE ADA COMPLIANCE
CAPITAL IMPROVEMENT: Provide ADA compliant Toilet room signs **and** until these toilet rooms are modified to be accessible, provide ADA compliant toilet room signs that give directions to the nearest ADA compliant toilet rooms. The International Symbol of Accessibility must be used.
[See Appendix A - 2010 ADA Standards 703 Signs-703.2, 703.3, 703.4, 703.6.1 Pictogram field]

Ensure that room designation signs are mounted at the correct height and location. Signs are required to be installed on the latch pull side of the door mounted at 48" min AFF to the baseline of the tactile characters and 60" max. AFF .measured from the baseline of the highest tactile character.
[See Appendix A - 2010 ADA Standards 703 Signs-703.4.1]

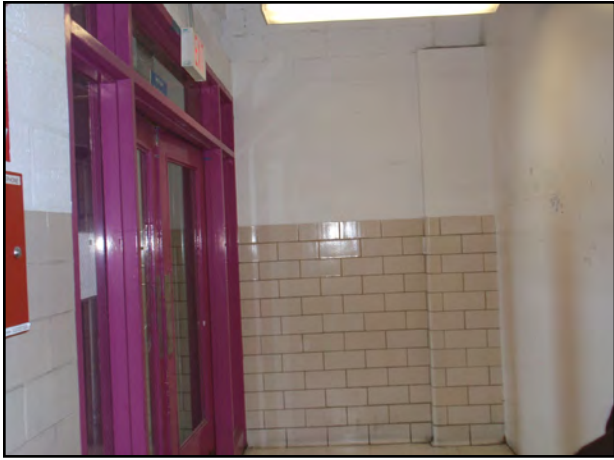
LOCATION | 414

Throughout the floor tactilely read ADA compliant exit signs are missing from doors at exit passageways, exit discharge points, and exit stairways.
[See Appendix A - 2010 ADA Standards 216.4.1 Exit Doors, 703.1 703.2, 703.3.5 Signs]

RECOMMENDATION TO IMPROVE ADA COMPLIANCE
CAPITAL IMPROVEMENT: As part of a campus-wide wayfinding program install ADA compliant exit signs at doors at exit passageways, exit discharge points, and exit stairways.
See section 1003.2.13.6 of the International Building Code (2000 edition) or section 1007.7 of the International Building Code (2003 edition)

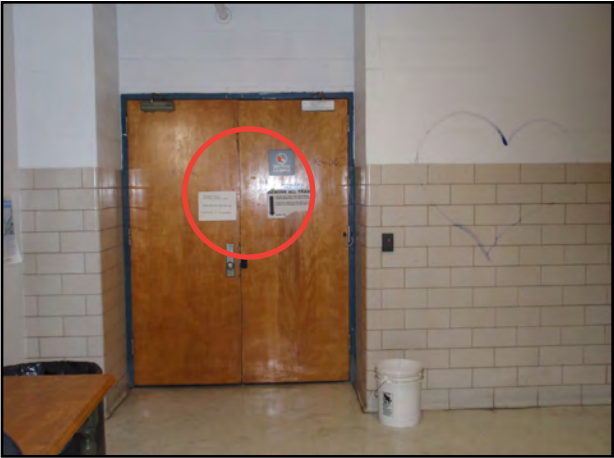
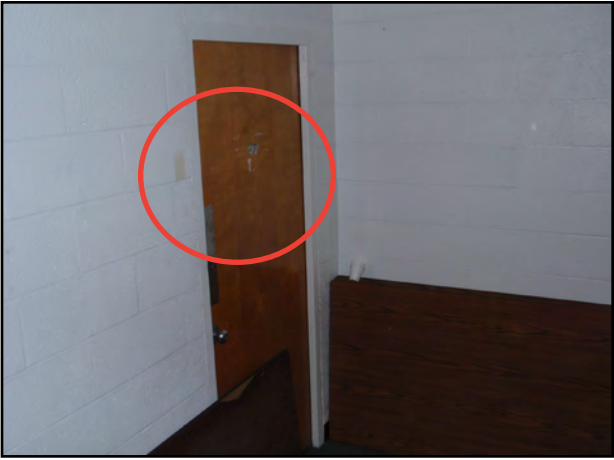
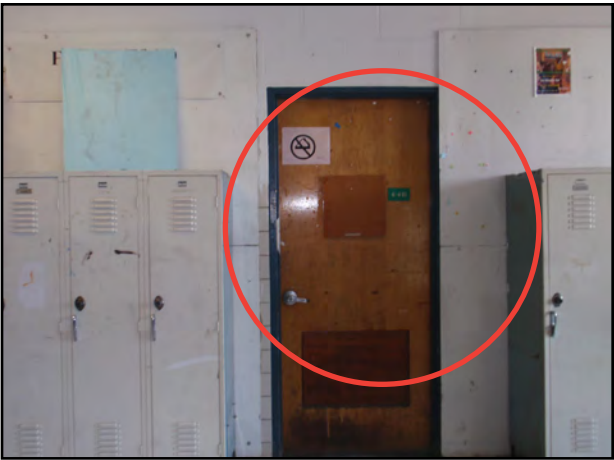
Most room, space designation signs are missing. All signs are not ADA compliant for mounting location, height requirement, and tactile reading requirements. Nor do the characters meet size, font, and proportion requirements. Nor are the raised character requirements met.
[See Appendix A - 2010 ADA Standards 703 Signs-703.2, 703.3, 703.4], MAAB 411.1.1]

RECOMMENDATION TO IMPROVE ADA COMPLIANCE
 As part of a campus-wide wayfinding program ensure that all permanent rooms and spaces have signs that meet ADA requirements.

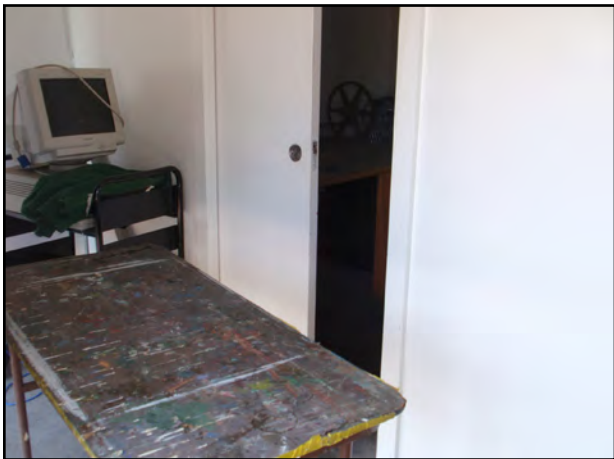
LOCATION | Typical

Door-Clearance
 Furniture blocks door from opening.

RECOMMENDATION TO IMPROVE ADA COMPLIANCE OPERATIONAL Remove furniture from blocking doorway. Ensure that staff, faculty and students are aware of the necessity to keep clear space at doors.

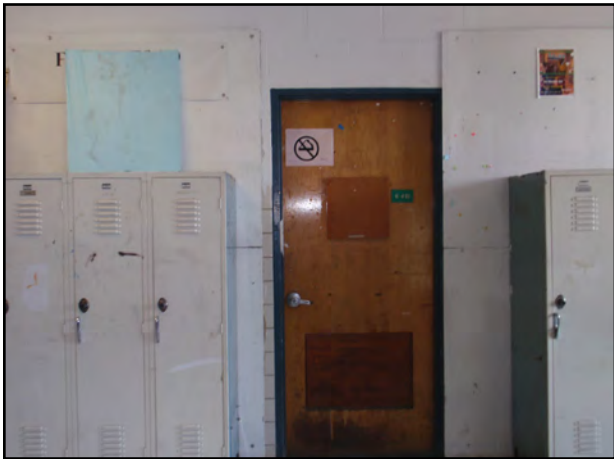
LOCATION | 403

Door-Clearance
 Lockers obstruct required clear space at latch pull side of door.

RECOMMENDATION TO IMPROVE ADA COMPLIANCE OPERATIONAL Remove lockers near doors to retain 18: clear space at latch pull side.

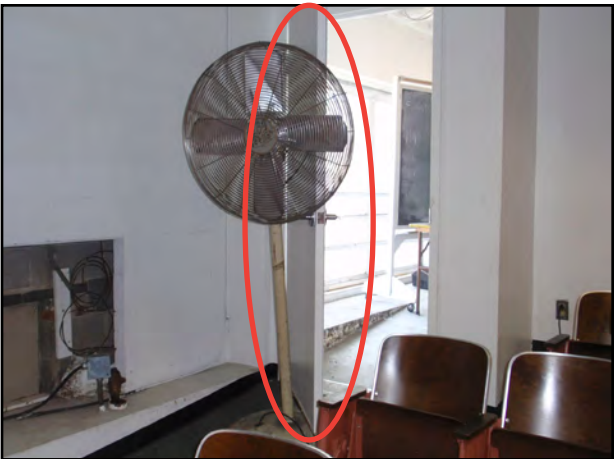
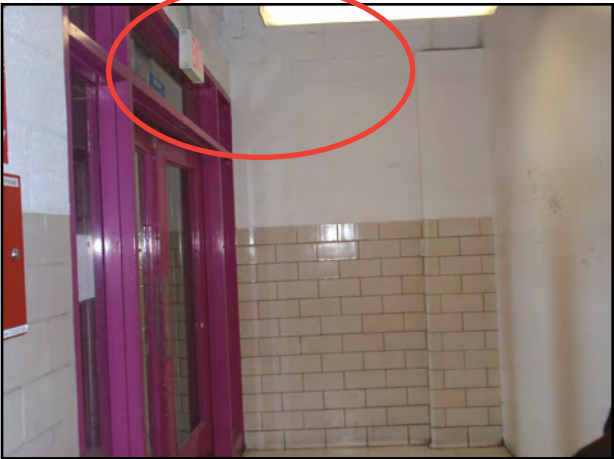
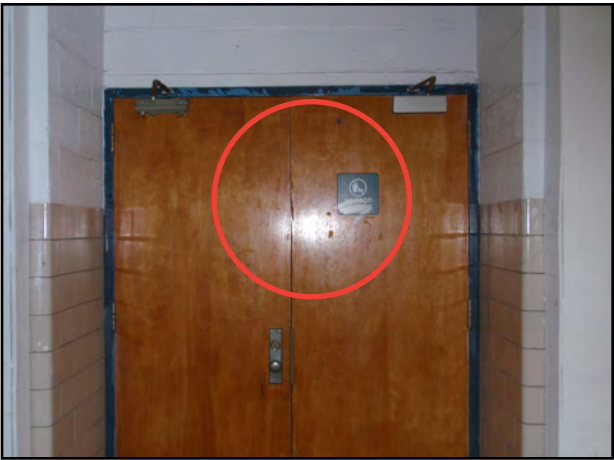
Door Closers
 The door opening force is 20 lbs which makes it difficult to open, especially for a person in a wheelchair and could also cause delay in an emergency.

The double fire egress doors have a door opening force of 25 lbs which is too heavy for easy opening. Additionally it makes the doors difficult to get through because the closing time is too fast. This could cause problems in an emergency.

RECOMMENDATION TO IMPROVE ADA COMPLIANCE OPERATIONAL: Create a comprehensive maintenance program and schedule to check and adjust all interior doors so that they have an opening pressure that doesn't exceed 5 lbs.

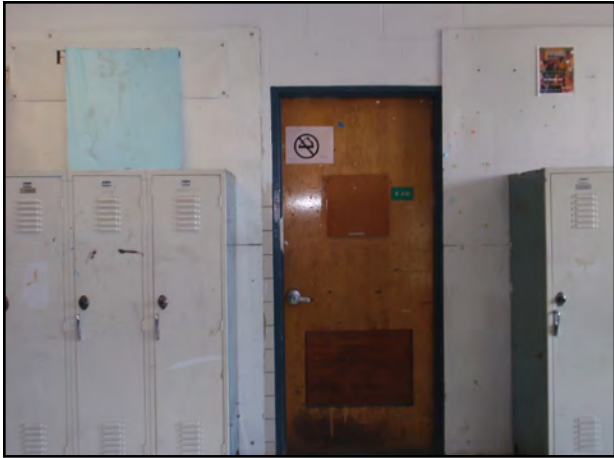
LOCATION | 402

Lockers

RECOMMENDATION TO IMPROVE ADA COMPLIANCE
Make sure that there is at least 5% but no less than one locker is ADA compliant the preference would be for two.

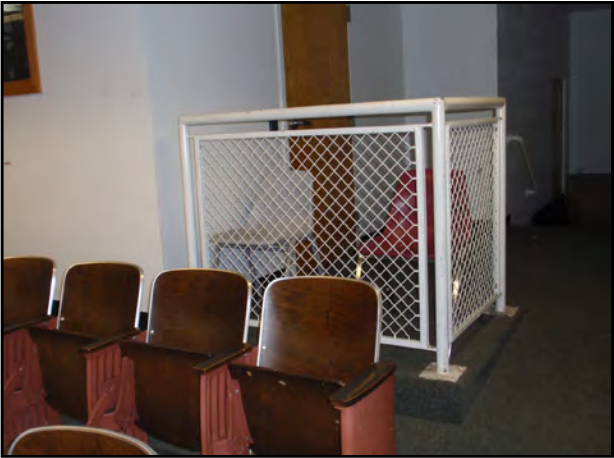
LOCATION | 406

Furniture

RECOMMENDATION TO IMPROVE ADA COMPLIANCE
Remove cage and reallocate Accessible clear spaces to accommodate two wheelchair users and their companion within the main seating area but with access to the aisle. Consistent with the overall intent of the ADA, individuals who use wheelchairs must be provided equal access so that their experience is substantially equivalent to that of other members of the audience. Thus, while individuals who use wheelchairs need not be provided with the best seats in the house, neither may they be relegated to the worst.

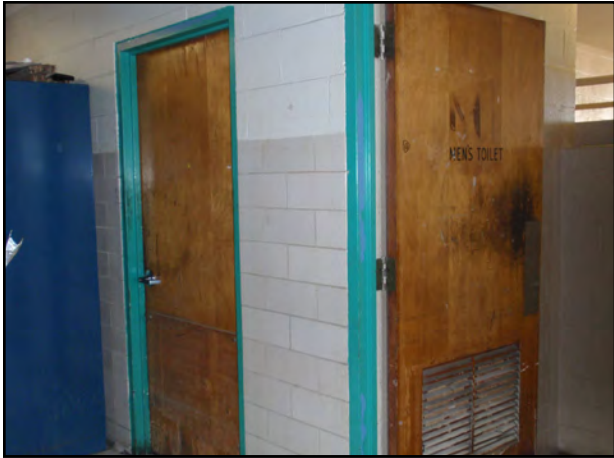
LOCATION | 610

Signs - ADA Facilities and Safety

Ensure that all ADA compliant toilet rooms are noted on the Directories.

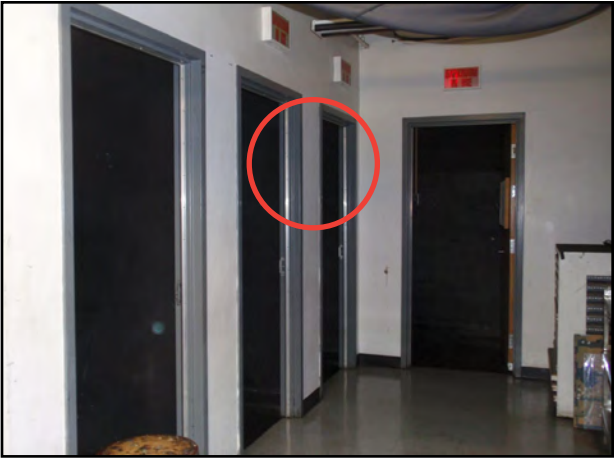
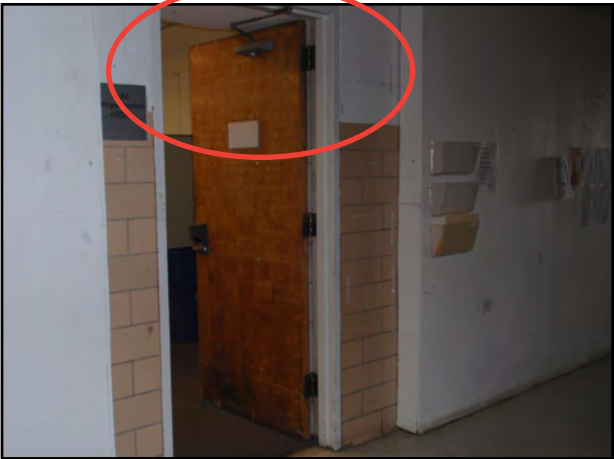
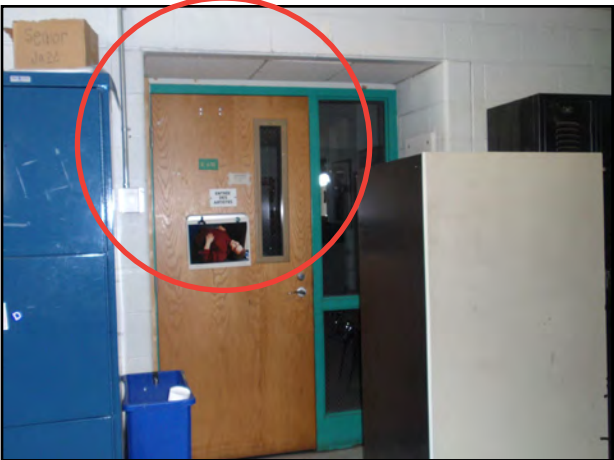
Most room, space designation signs are missing. All signs are not ADA compliant for mounting location, height requirement, and tactile reading requirements. Nor do the characters meet size, font, and proportion requirements. Nor are the raised character requirements met.

ISSUE A2
Capital Improv.
 Campus-wide Wayfinding Prog. Design and implementation
 \$150/Sign

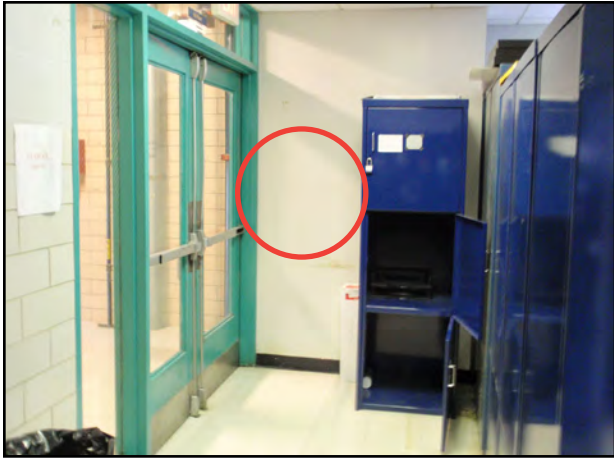
LOCATION | 607

Sign - Directional
 Directional signs are missing and/or are not ADA compliant.
[See Appendix A - 2010 ADA Standards 703 Signs-703.5]

RECOMMENDATION TO IMPROVE ADA COMPLIANCE
 CAPITAL IMPROVEMENT: As part of a campus-wide wayfinding program provide directional signage wherever it helps with navigation.
[See Appendix A - 2010 ADA Standards 216.4.3, 703 Signs-703.5]

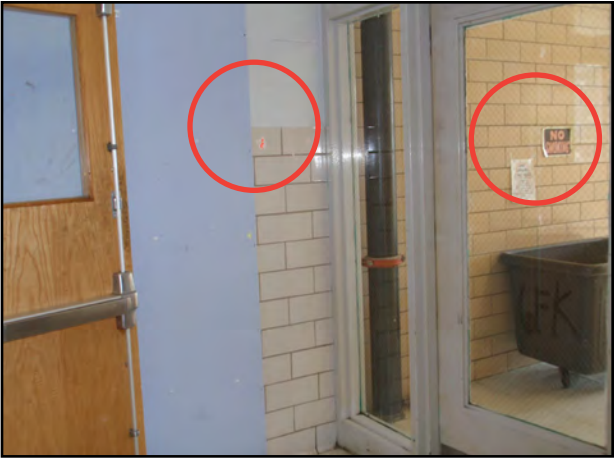
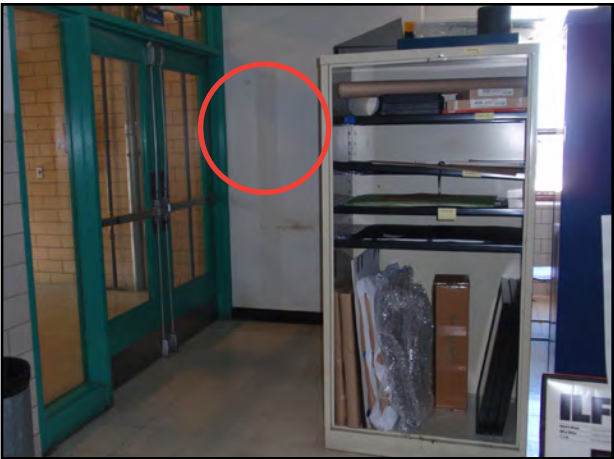
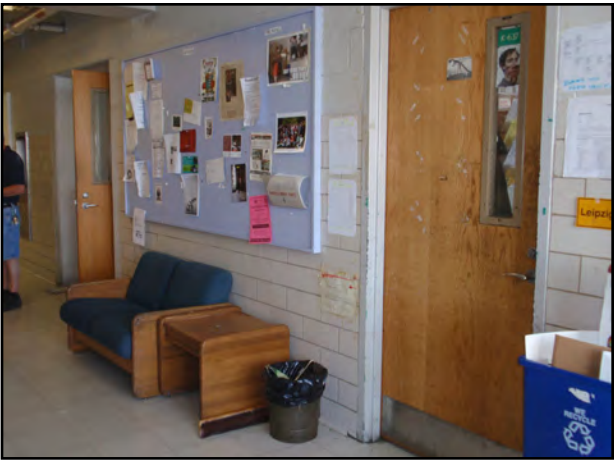
RECOMMENDATION TO IMPROVE SAFETY & USER EXPERIENCE
 On directories and signs ensure that the contrast between background and the characters is great enough for easy reading especially in the low light levels. Also make sure that the characters are clear and large enough for people with low vision to be able to easily read them.

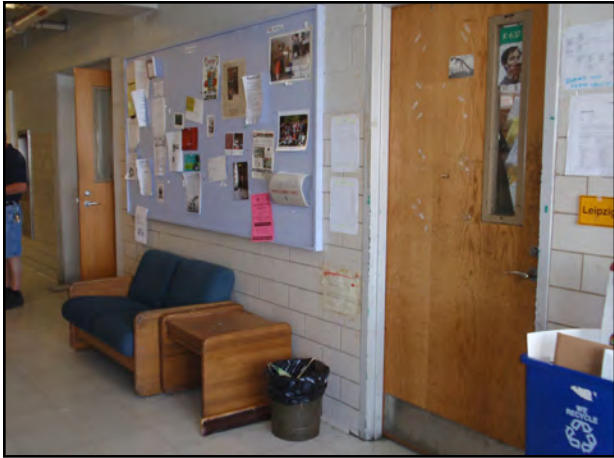
LOCATION | 603

Aisle Obstruction

Corridors are obstructed by furniture, seating and trash receptacles that can become egress safety hazards and tripping hazards in the accessible route.

OPERATIONAL: Educate staff, students and faculty to rearrange furniture to maintain a 36" min. clear width in through corridors, rooms, spaces and accessible routes at all times. The clear space required may be greater depending on occupancy and space usage.
