Massachusetts College of Art and Design

ADA Compliance Plan 2011

ADA Compliance Plan
Consultant Services
Contract #10-08

The Institute for Human Centered Design

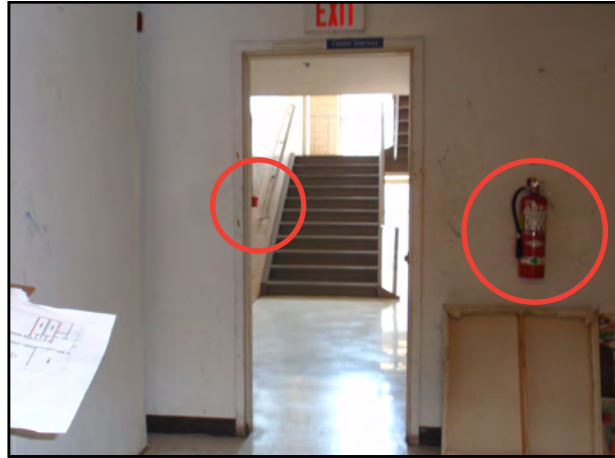
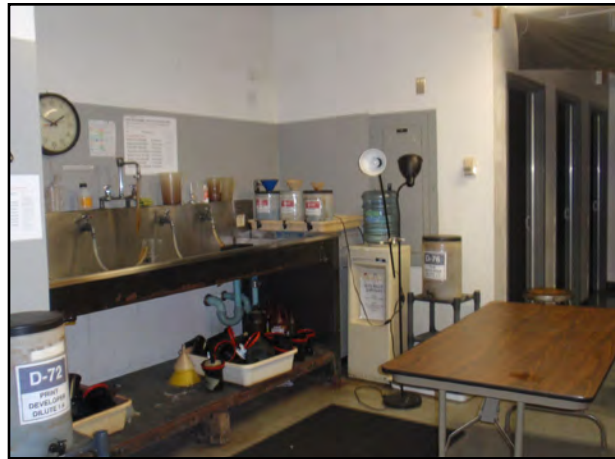
Protruding Objects

Fire extinguisher protrudes 5" from the wall and could cause injury because a person using a cane would not be able to detect it as it is more than 27" high off the floor.

Fire box protrudes more than 4 " into the accessible route and it is 54" high from the bottom of the box to the floor. Similar to the fire extinguisher above, it may cause injury as a person using a cane would not be able to detect it.

RECOMMENDATION TO IMPROVE ADA COMPLIANCE
 Recess fire extinguisher into the wall or encase in a fire cabinet that extend lower to the floor than 27" so that it could be cane detectable.

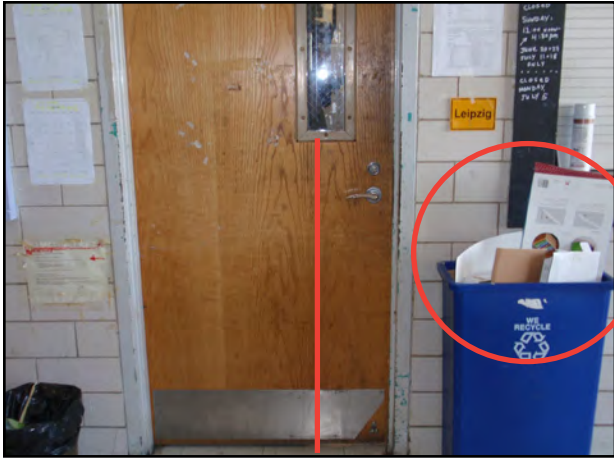
LOCATION | TYPICAL

Door-Clearance
 Recycling Receptacle is obstructing the 18" clear space on the latch side of the door making the door very difficult to open.

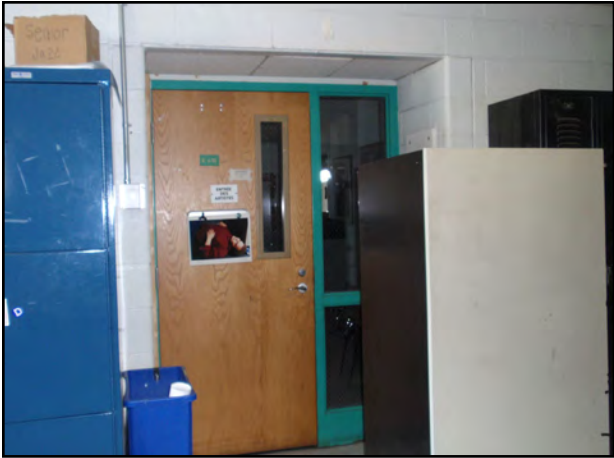
LOCATION | TYPICAL

Door Clearance
 Lockers and storage items block access to the door.

The double fire egress doors have a door opening force of 25 lbs. which is too heavy for easy opening and could cause delay in an emergency.

The double fire egress doors on the 1st Floor has a door opening force 20 lbs., too heavy for easy opening. This could cause delay in an emergency.

RECOMMENDATION TO IMPROVE ADA COMPLIANCE
 Adjust all interior doors so that they have an opening pressure that doesn't exceed 5lbs.

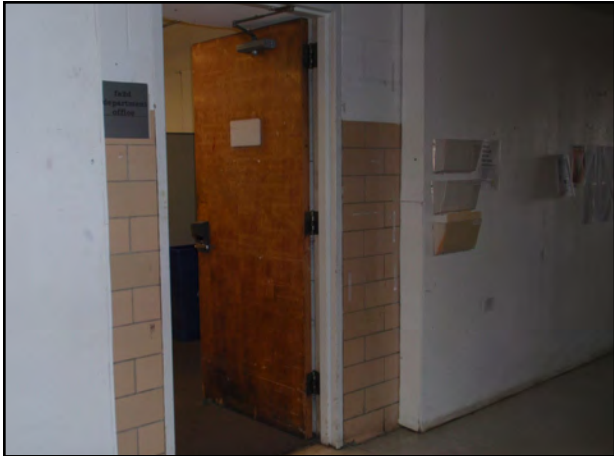
LOCATION | TYPICAL

Door Closer adjustment
 Many doors with door closers have opening forces greater than 5lbs. this makes the doors difficult to open, especially for someone in a wheelchair. Additionally this could cause delay in an emergency.
[See Appendix A - 2010 ADA Standards 404.2.8 Door Closers]

RECOMMENDATION TO IMPROVE ADA COMPLIANCE OPERATIONAL: Adjust all interior doors so that they have an opening pressure that doesn't exceed 5lbs. Create an ongoing schedule of maintenance to ensure that this pressure does not exceed the maximum required by ADA 2010 Standards.

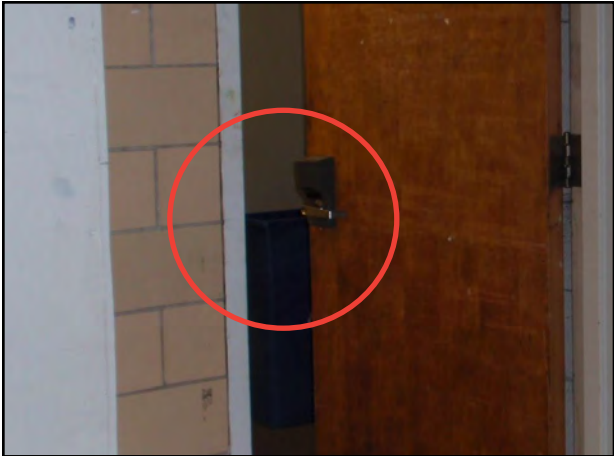
LOCATION | TYPICAL

Door Hardware
 Card swipe not easy to use.
RECOMMENDATION TO IMPROVE ADA COMPLIANCE SMALL MAINTENANCE PROJECT: Switch all card swipe or digital pad security locks with proximity card reader.

ISSUE D3 SMALL MAINT. PROJECT
 Door hardware replacement \$400/set

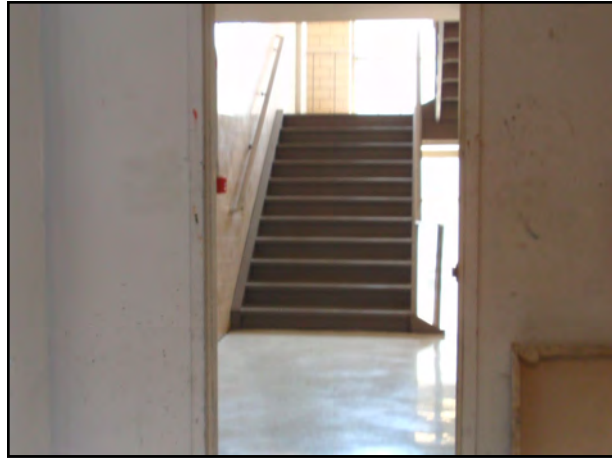
LOCATION | 607

Stairs-Rails and rail extensions

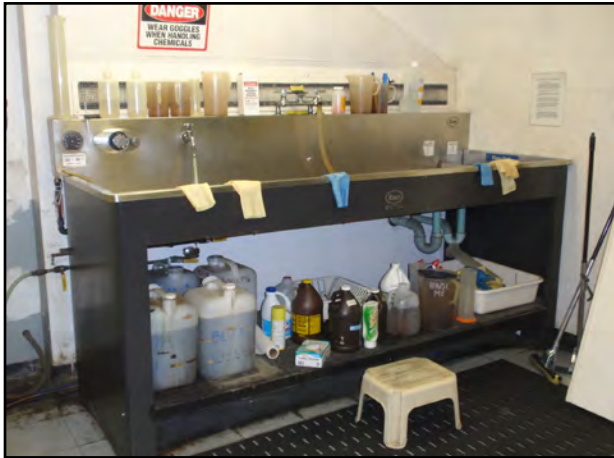
LOCATION | 606

Classroom Sinks - Replace or modify sinks to be accessible

RECOMMENDATION TO IMPROVE ADA COMPLIANCE
SMALL MAINTENANCE: Replace at least one sink in each room that has sinks with a sink that meets 2010 ADA Standards on each of the second and third floors, or at this type of sink provide enough space around the sink for a side approach, add an adjacent work counter with room for knee space, add a flexible hose attachment.

ISSUE G
SMALL MAINT. PROJECT
Install new accessible sink or modify existing sink in each room that has a sink.
\$1,000 / new ADA sink or \$150 / modify sink

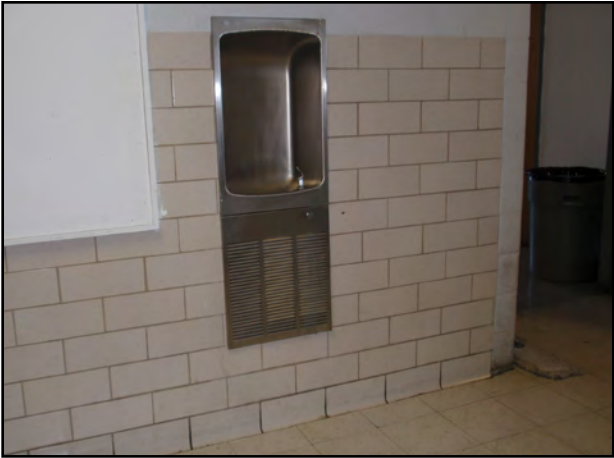
LOCATION | 608

Drinking Fountain

RECOMMENDATION TO IMPROVE ADA COMPLIANCE
Provide cups with dispenser and trash that doesn't protrude from the wall more than 4" and within reach range.

or
Replace with a high-low drinking fountain that meets 2010 ADA standards.

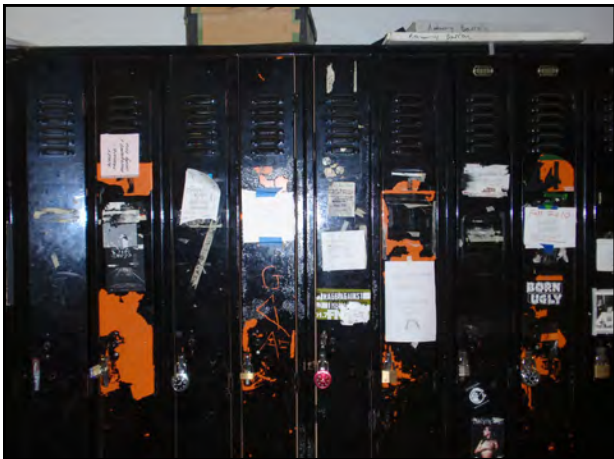
LOCATION | 604

Lockers

RECOMMENDATION TO IMPROVE ADA COMPLIANCE
Make sure that there is at least 5% but no less than one locker in each locker bank meets ADA Standards the preference would be for two

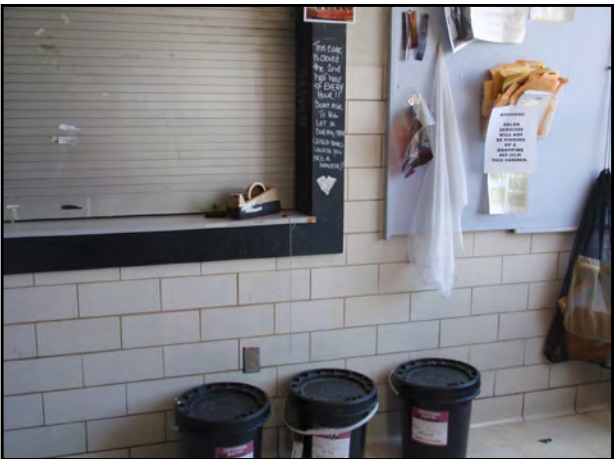
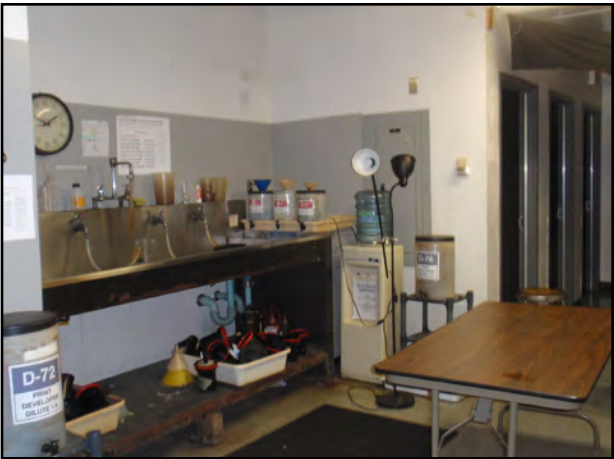
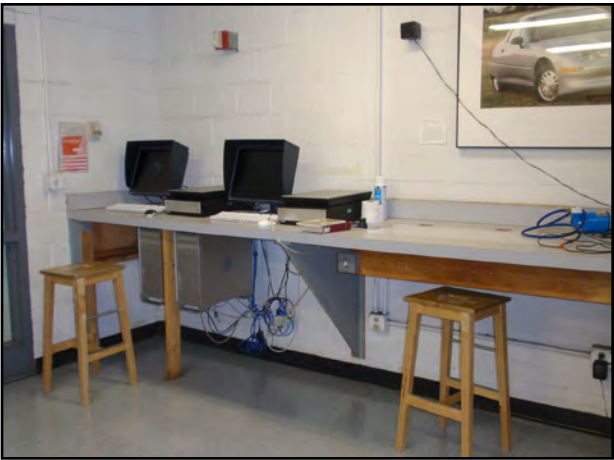
Furniture

RECOMMENDATION TO IMPROVE ADA COMPLIANCE
Make sure that there is at least one table or 36" of counter space that has a top surface of 34" AFF and a min. knee clearance of 27" to the underside of the table so that the table can be used by a sitting person.

RECOMMENDATION TO IMPROVE SAFETY & USER EXPERIENCE
To ensure that trash and recycle bins are used by everyone they should be placed in easy reach with the top of the lid being at 34" above floor level.

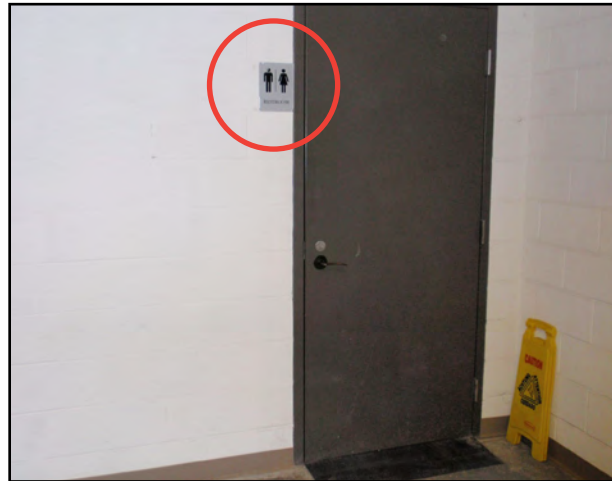
LOCATION| 004

Signage - ADA Facilities and Amenities

When this toilet room becomes ADA accessible install an International Sign of Accessibility and remove directions to other accessible toilet rooms.

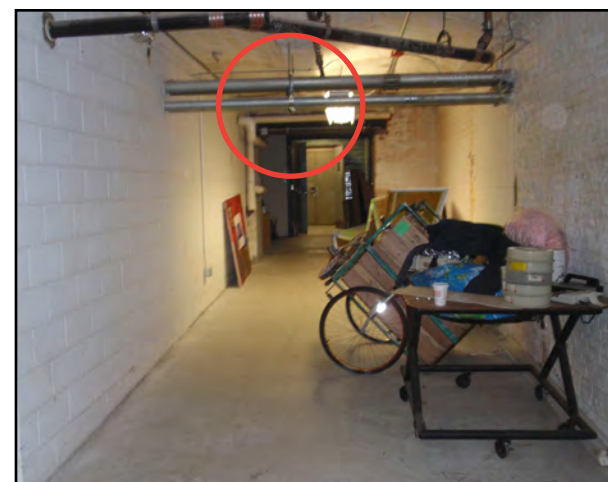
LOCATION| 010

SMALL MAINTENANCE: The emergency exit signage is missing or hidden from view by plumbing or other ceiling obstructions.

Consider installing emergency signage in accordance with state and federal building codes.

Consider providing emergency egress plans at ends of corridors, stairs and elevators.

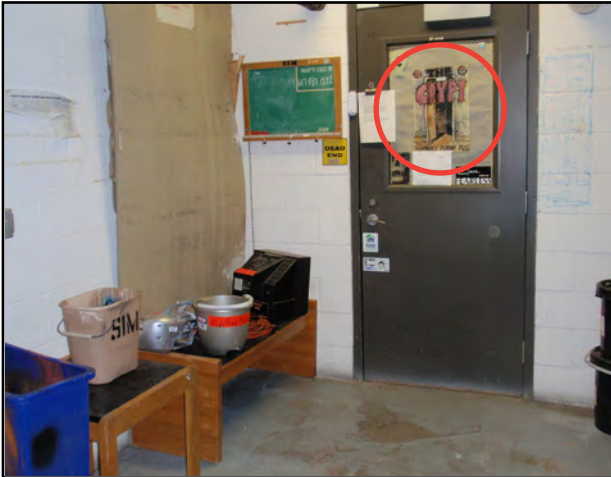
LOCATION| 005

Room Designation

RECOMMENDATION TO IMPROVE ADA COMPLIANCE SMALL MAINTENANCE/CAPITAL IMPROVEMENT: Develop a comprehensive campus-wide wayfinding program that ensures signs are installed to meet ADA standards for height and location.

RECOMMENDATION TO IMPROVE SAFETY & USER EXPERIENCE SMALL MAINTENANCE Ensure that room location signage is distinct from ADA facilities, wayfinding and fire and safety signage.

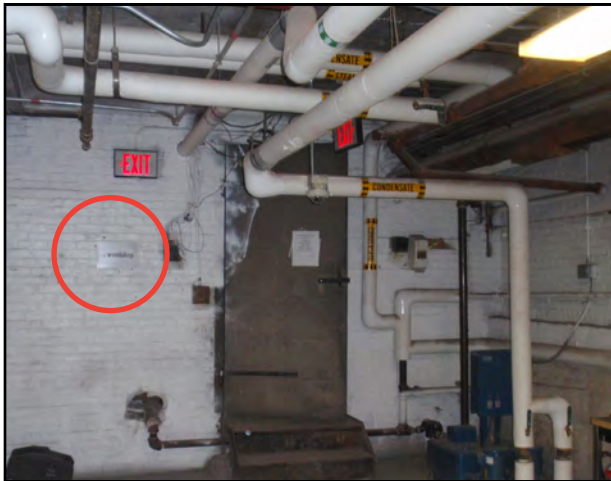
LOCATION| 009

Directional Signage

Directional signage is missing or hidden from view by plumbing or other ceiling obstructions. [See Appendix A 2010 ADA Standards Signs-216,216.3, 703.5]

RECOMMENDATION TO IMPROVE ADA COMPLIANCE CAPITAL IMPROVEMENT: Develop - 2010 ADA Standards compliant directional signs as part of the comprehensive campus-wide wayfinding program.

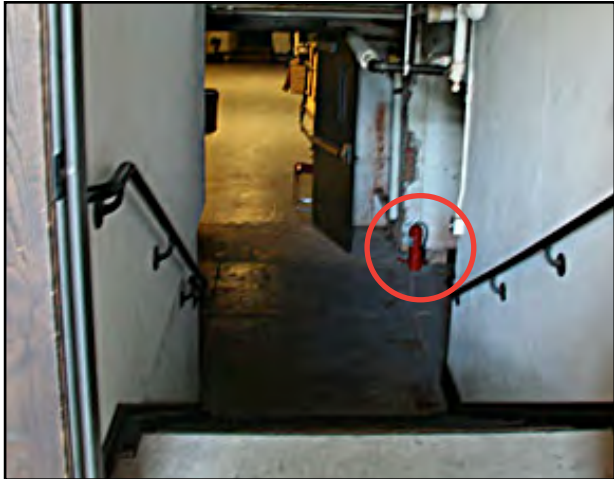
LOCATION | 001

Obstructions in Accessible Route or-Path

RECOMMENDATION TO IMPROVE ADA COMPLIANCE
OPERATIONAL: Relocate the furniture and other objects away from the main circulation path and doors.

The fire extinguisher in **LOCATION 001** should be mounted and identified with a sign according to NFPA Code.

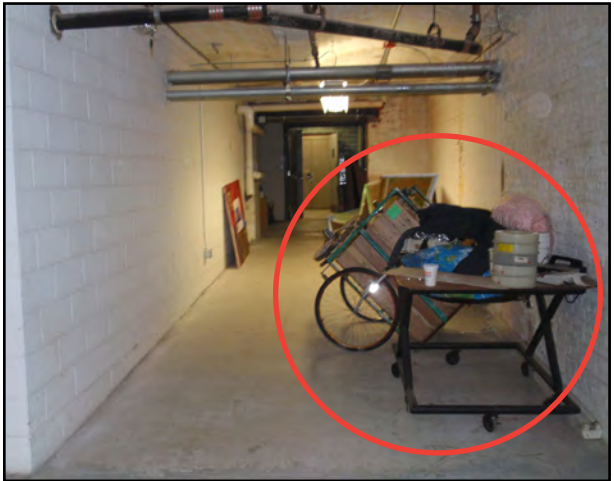
LOCATION | 010

RECOMMENDATION TO IMPROVE SAFETY & USER EXPERIENCE
 Minimum clearances are dependant on Federal and State Building and Fire codes depending on whether the route is on the main egress route. In this case in **LOCATION 010** the minimum width would be 6'-0". The required width will be determined by the code that provides the greater access.

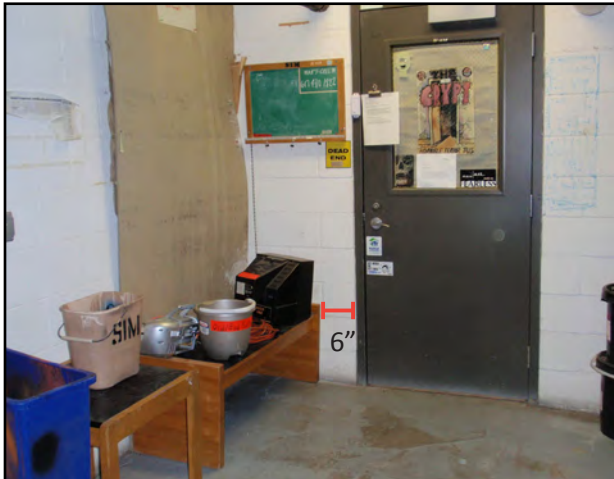
LOCATION | 005

Door Clearances

RECOMMENDATION TO IMPROVE ADA COMPLIANCE
OPERATIONAL/SMALL MAINTENANCE: Rearrange furniture to provide required clear space at latch pull side of the doors.

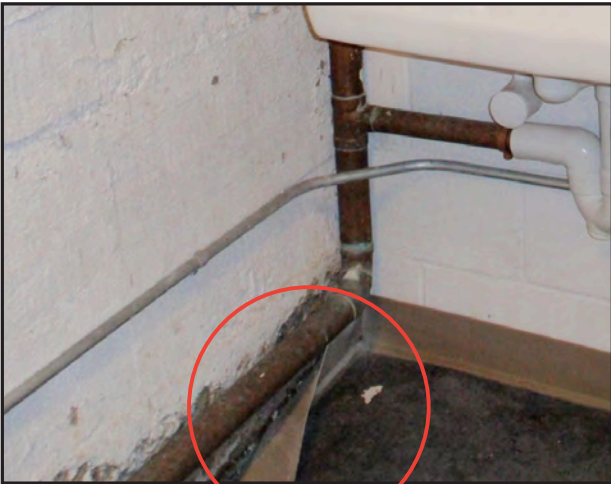
LOCATION| 004c

Tripping hazard

Replace or glue loose rubber base back into place where it is coming away from the wall. It is a tripping hazard and obstruction to clear path.

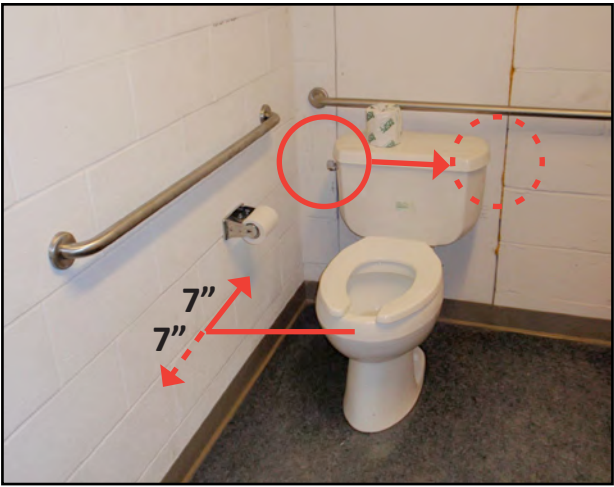
LOCATION| 004a

Toilet paper dispenser-

RECOMMENDATION TO IMPROVE ADA COMPLIANCE
 SMALL MAINTENANCE: Reinstall toilet paper dispenser 7"-9" in from the front of the toilet and 15" min. AFF.

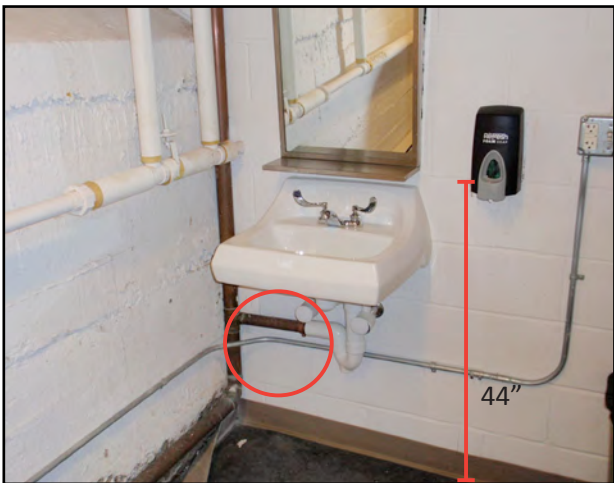
LOCATION| 004b

Mirrors

Bottom of tilted mirror reflective surface starts at 44" AFF.
[See Appendix A 2010 ADA Standards 603.3 Mirrors]

RECOMMENDATION TO IMPROVE ADA COMPLIANCE
 SMALL MAINTENANCE: Reinstall mirror at correct height of 40" AFF. Ensure that shelf doesn't interfere with operation of faucets. Consider using a mirror without a shelf or provide full length mirror.

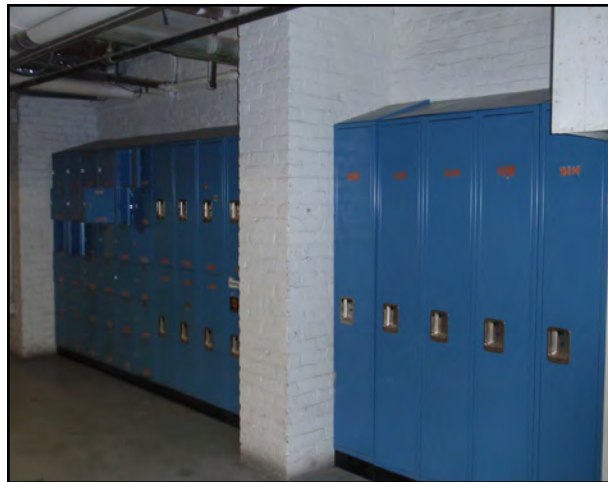
LOCATION| 006

Storage - Lockers

At each locker area replace or modify 5% or no fewer than one locker at each of the locker areas to meet ADA accessibility standards for reach range and operable parts. Modifications include lowering shelves to within reach ranges ie. the lowest surface at 15 AFF and the highest shelf or coat hook no more than 48 inches AFF. and providing locks that don't require tight grasping, pinching or twisting of the wrist. If modifications cannot be made replace locker with an ADA compliant version. CAPITAL IMPROVEMENT: Purchase adjustable furniture to add flexibility and functionality to rooms.

For easy orientation and wayfinding lockers should have a conspicuous numbering or alpha-betized lettering identification system.

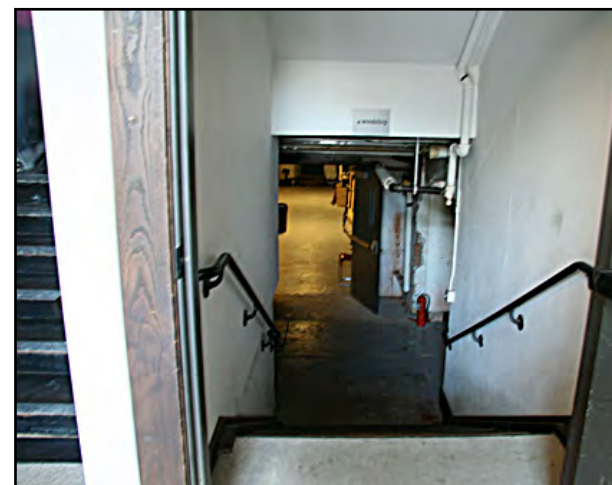
LOCATION| 001

Ramp

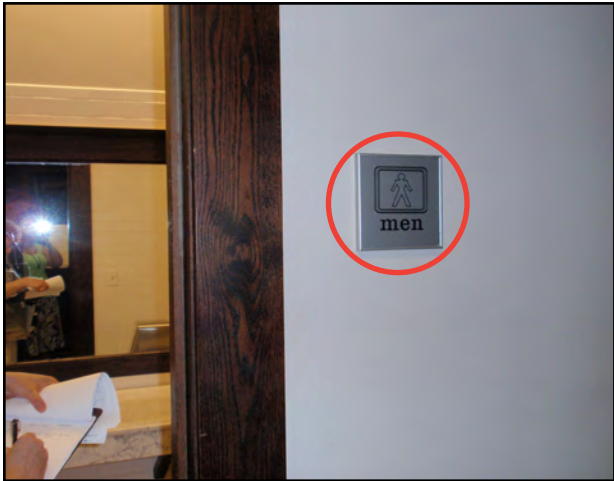
LOCATION| 108

Room Designation Signs

ADA compliant toilet room signs are missing at both the women's and men's toilet rooms.

RECOMMENDATION TO IMPROVE ADA COMPLIANCE
 CAPITAL IMPROVEMENT: Design a comprehensive campus-wide wayfinding program that identifies each ADA accessible facility with signage that is ADA compliant and has the ADA International Symbol of Accessibility.

Coordinate information with directories and on-line information.

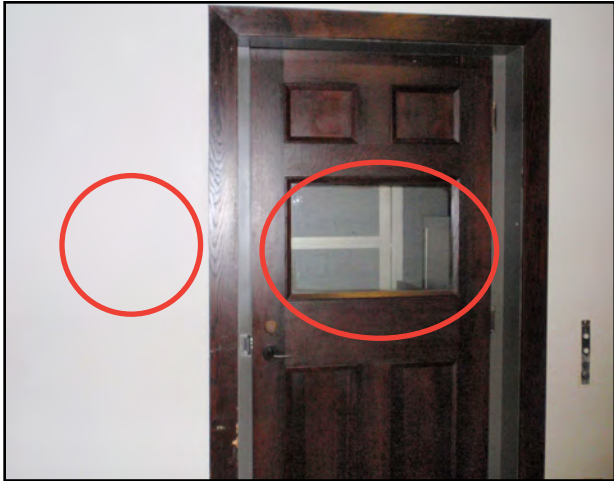
LOCATION| 111

Room Designation Signs

RECOMMENDATION TO IMPROVE ADA COMPLIANCE
 SMALL MAINTENANCE/CAPITAL IMPROVEMENT: Install an ADA compliant sign with the International Sign of Accessibility.

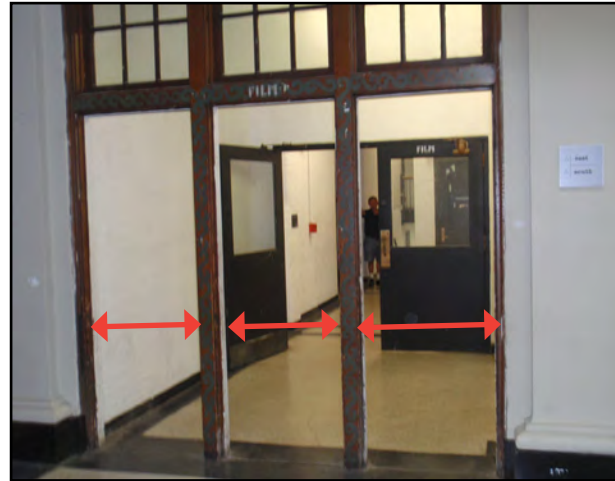
LOCATION| 109

Entry width

Connecting openings are each 29" clear width, making it impossible for a wheelchair user to pass through to the East Building from the North Crackeratorium.

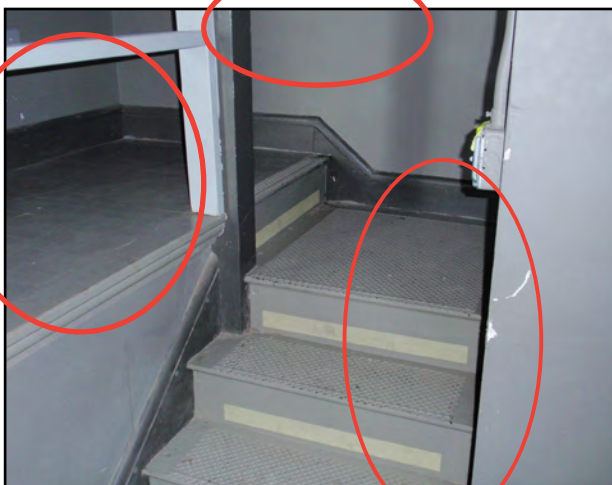
LOCATION| 118

Stair Safety

Since lighting levels are low this can be hazardous. Additionally, there is great contrast in lighting conditions on entering the building from the outside. This means that it will take the eyes time to adjust to be able to perceive the stairs.

SMALL MAINTENANCE: Where stairs are used as the sole egress route replace the handrail so that there are extensions at the top and the bottom of the stair. Consider also installing a rail at the back wall for people to lean on at the landing.

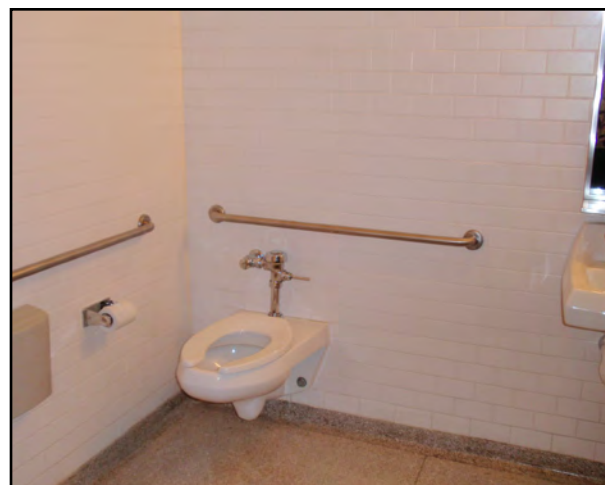
LOCATION| 116

ADA Accessible toilet room-Signs

SMALL MAINTENANCE/CAPITAL IMPROVEMENT: Replace current signage with ADA compliant signage.

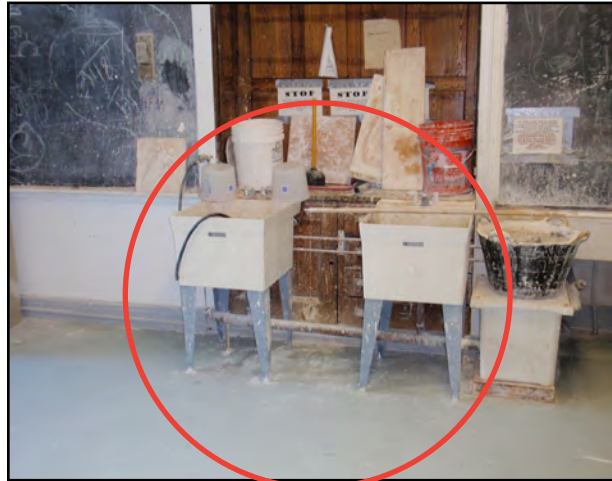
FIG 114

Classroom sinks

SMALL MAINTENANCE: Replace at least one sink with a sink that meets 2010 ADA Standards on each of the second and third floors, or at this type of sink provide enough space around the sink for a side approach, add an adjacent work counter with room for knee space and replace the faucet with a flexible hose attachment.

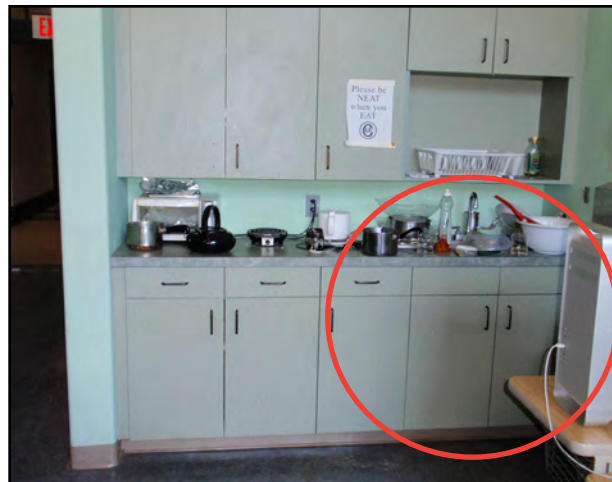
LOCATION| 115

Sink & counter height

SMALL MAINTENANCE: Modify kitchenette. Replace part of counter with a sink that meets ADA standards for depth and that is mounted so that the rim is at 34" AFF. Create space below sink for knee space. Clear floor space 30" x 48" for frontal or parallel approach to all features. Spray hose type faucet recommended. It is important that lighting levels are bright enough for people with low vision to be able to work and not cast shadows on their work area. Light colored matte surfaces help to increase light while decreasing glare.

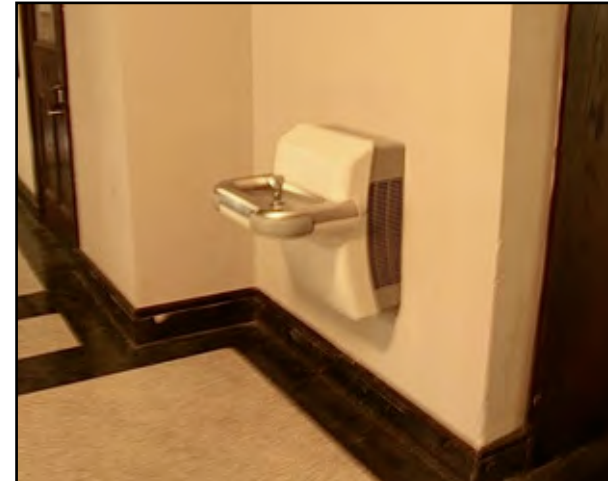
LOCATION| 112

Protruding object

The drinking fountain protrudes into the accessible route, undetectable by cane and it could cause injury. Also the single height of the fountain doesn't allow for people of different statures and bending abilities.

RECOMMENDATION TO IMPROVE ADA COMPLIANCE

SMALL MAINTENANCE: For people that have difficulty bending replace the existing drinking fountains on the accessible route with a High-Low type, or add an additional drinking fountain with a spout between 38" and 43" AFF or add a cup dispenser making sure that the dispenser doesn't stick out more than 4" from the wall and is mounted such that the cups are dispensed at a height of 48" AFF.

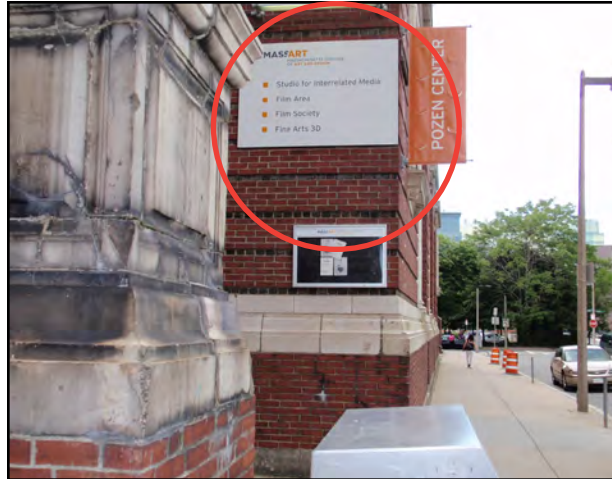
LOCATION | 101

Directories

RECOMMENDATION TO IMPROVE SAFETY & USER EXPERIENCE

Ensure that ADA facility information is on the directory and it is positioned to avoid backtracking.

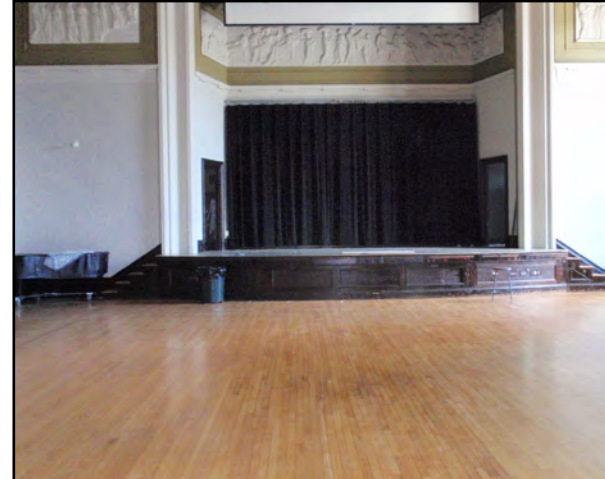
LOCATION | 103

Assistive listening device signage

As the Pozen Center and the Godine Gallery are open to the public they are required to be ADA compliant, currently signage announcing the availability of the Assistive Listening Devices is missing.

RECOMMENDATION TO IMPROVE ADA COMPLIANCE

Ensure that all programs, promotional materials and website announcements coordinate instructions on how to obtain Assistive Listening Devices.

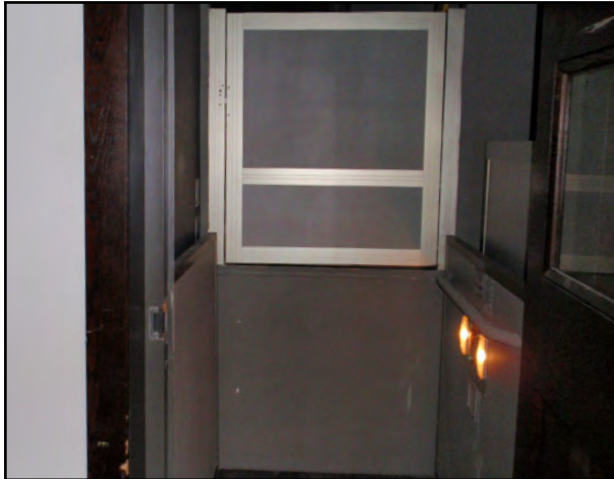
LOCATION| 111

Lift
 The lift requires key for operation. Health and Safety staff are required to be called in order to provide key.
[See Appendix A 2010 ADA Standards Lifts & Elevators 407]
 This lift is often not working and cannot be easily found since it is behind a door and there is no signs identifying its location.

RECOMMENDATION TO IMPROVE ADA COMPLIANCE
 SEE NOTE : Remove key switch. In the interim provide a key on request to students who are wheelchair users.

SMALL MAINTENANCE: Ensure a regular program of inspection and maintenance is set up.

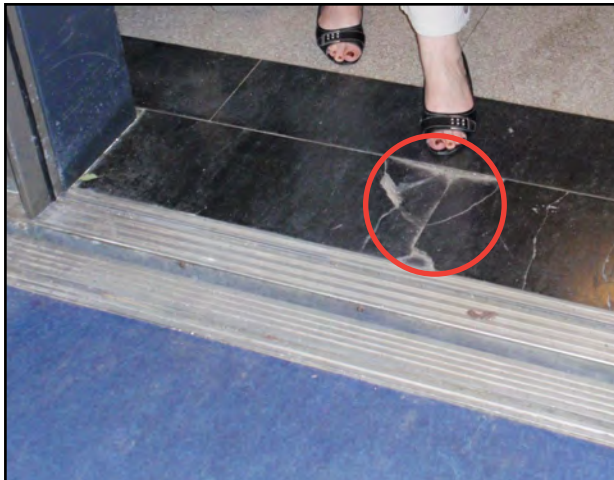
LOCATION| 105

Tripping hazard
 The threshold of east elevator is cracked creating a tripping hazard.
[See Appendix A 2010 ADA Standards 401 Ramps]

RECOMMENDATION TO IMPROVE ADA COMPLIANCE
 Repair threshold. Flooring must be stable, firm and slip resistant.

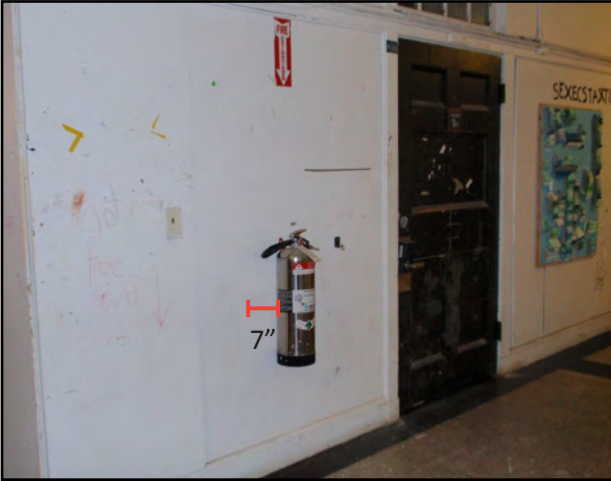
LOCATION | 208

Informational signs

RECOMMENDATION TO IMPROVE SAFETY & USER EXPERIENCE
 Install blade signage above 80" AFF to direct to fire extinguisher and enable visibility along corridor.

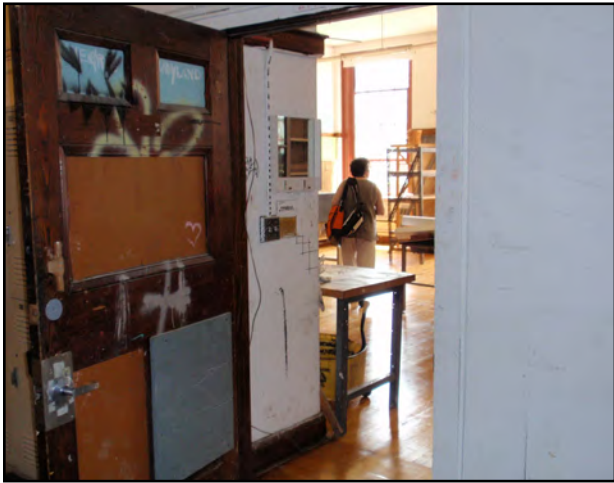
LOCATION | 204

Directional & designation signs

Signs do not meet ADA standards for height, location or design.

RECOMMENDATION TO IMPROVE ADA COMPLIANCE
 SMALL MAINTENANCE/CAPITAL IMPROVEMENT :
 As part of a campus-wide wayfinding program provide designation signage for every permanent space.

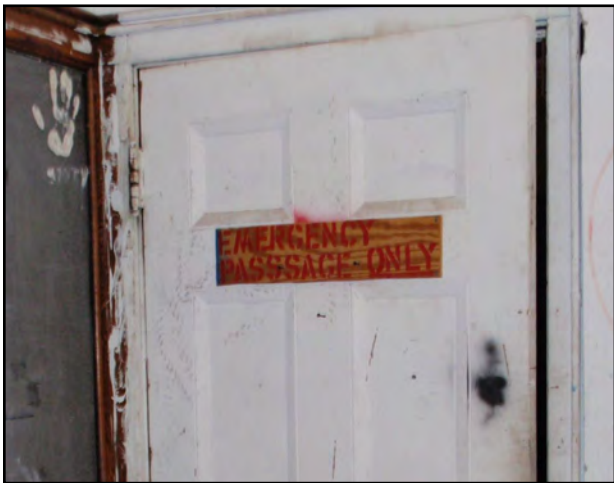
LOCATION | 204

Exit signs

Signs do not meet ADA standards for height, location or design.

RECOMMENDATION TO IMPROVE ADA COMPLIANCE
 SMALL MAINTENANCE/CAPITAL IMPROVEMENT :
 Provide ADA compatible signage.

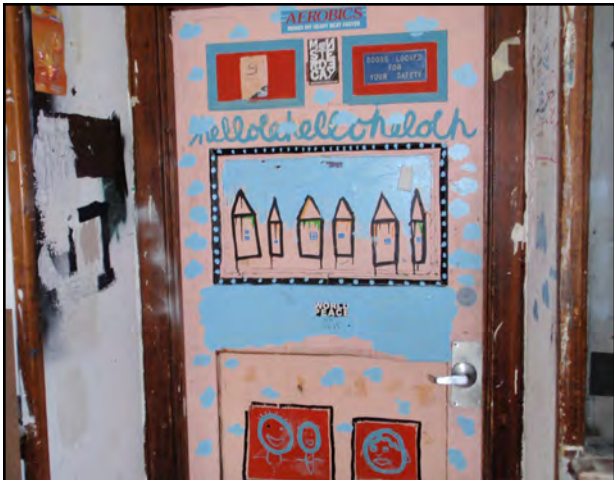
LOCATION|

Door hardware
 Similar issues as above, with the exception that this door has a lever handle.

RECOMMENDATION TO IMPROVE ADA COMPLIANCE
 SMALL MAINTENANCE: Post ADA compatible signage redirecting to nearest accessible exit [See Appendix A - 4.1 & 5.1-2].

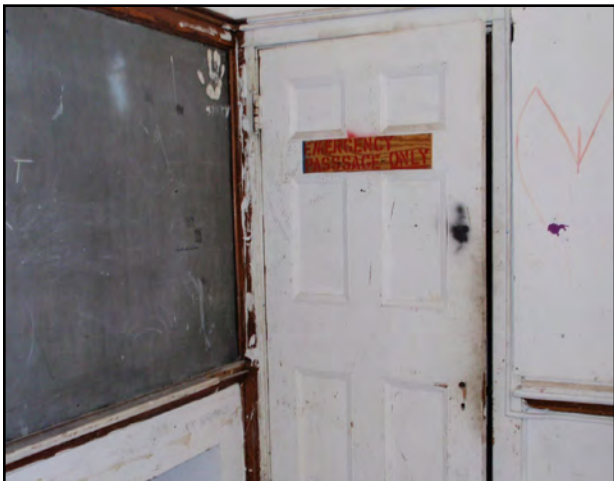
LOCATION|

Door hardware
 Similar issues as above. This sign reads “Emergency passage only”. If this door is used as an emergency exit door it is required to have signage that meets ADA standards. Additionally panic hardware should be installed. The current condition would create confusion in an emergency.

RECOMMENDATION TO IMPROVE ADA COMPLIANCE
 SMALL MAINTENANCE: Install ADA compatible signage redirecting to nearest accessible exit.

Replace door knob with hardware that does not require pinching, tight grasping or twisting of the wrist.

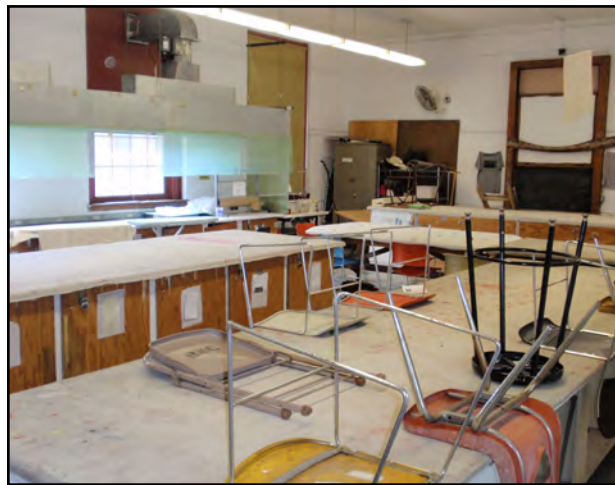
LOCATION| 311

Room designation Signage- N381 - Fibers junior/senior study

Many of the classrooms and studios do not have room or exit signage.

RECOMMENDATION TO IMPROVE ADA COMPLIANCE
As part of a comprehensive wayfinding program provide room signage and lit exit signs at fire exit doors.

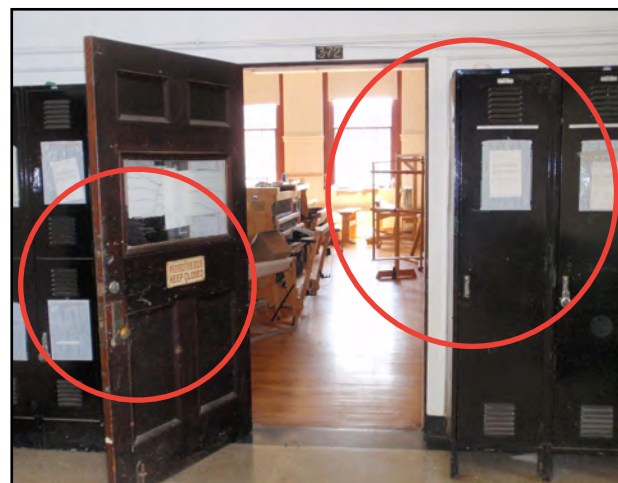
LOCATION| 304

Notices

RECOMMENDATION TO IMPROVE ADA COMPLIANCE
Limit the number of notices that can be attached to doors.

Mount at height 48" AFF to the bottom of the sign.

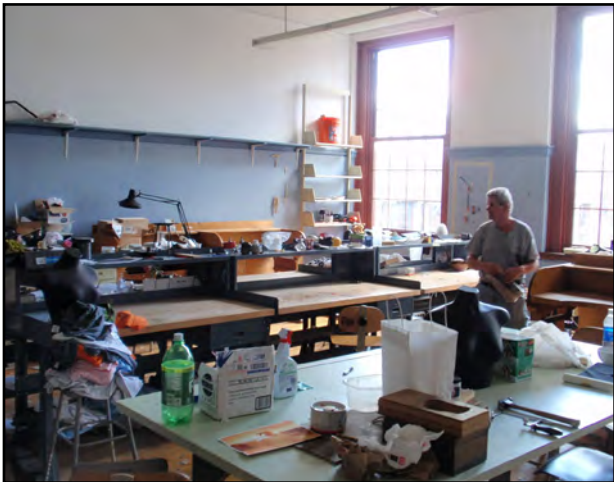
LOCATION| 306

Obstruction in Accessible Route

RECOMMENDATION TO IMPROVE ADA COMPLIANCE
Relocate furniture and

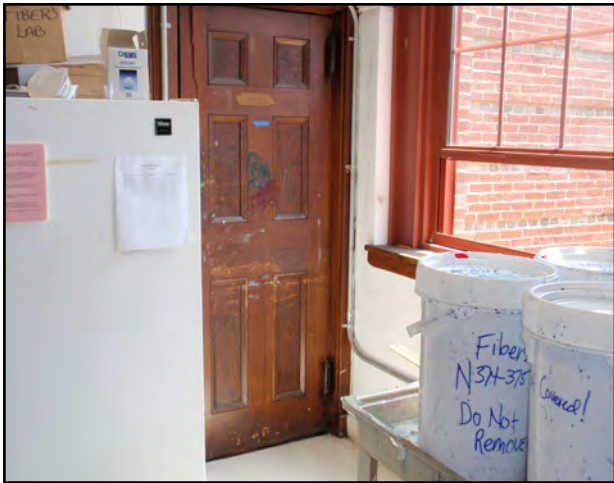
LOCATION| 305

Obstruction in Accessible Route

Furniture placement obstructs accessible path.

RECOMMENDATION TO IMPROVE ADA COMPLIANCE
Rearrange equipment and supplies to maintain 36" aisle throughout the space and educate other users to do so.

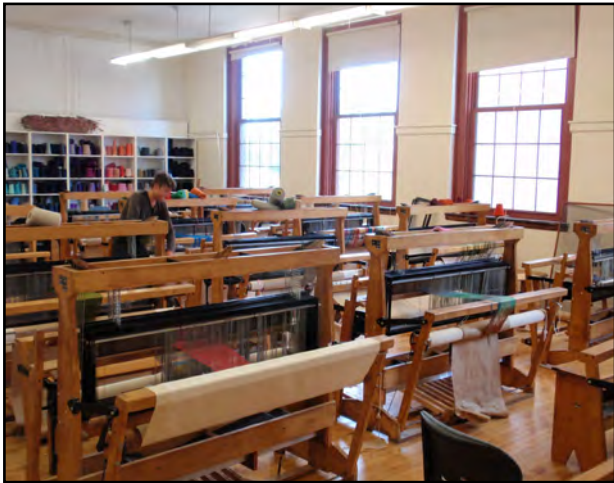
LOCATION| 303

Furniture Placement

Furniture placement obstructs accessible path.

RECOMMENDATION TO IMPROVE ADA COMPLIANCE
Make sure that looms have adequate area around them for a person in a wheelchair to load and unload them. Also maintain at minimum a 36" minimum path around the perimeter of the classroom and allow 60" path at wool storage (36" for wheelchair, 24" for person to pass) this may require reducing number of looms.

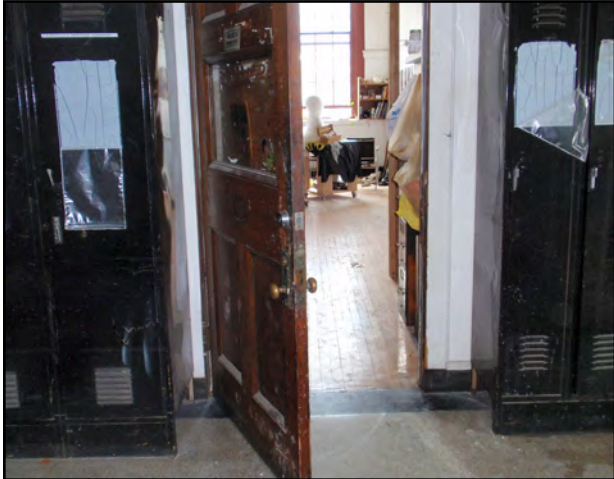
LOCATION| 310

Door Obstruction

RECOMMENDATION TO IMPROVE ADA COMPLIANCE

The locker nearest the latch side of the door should be removed to create a clear space of 18" allowing access to the room.

Replace the knob handle with a lever handle.

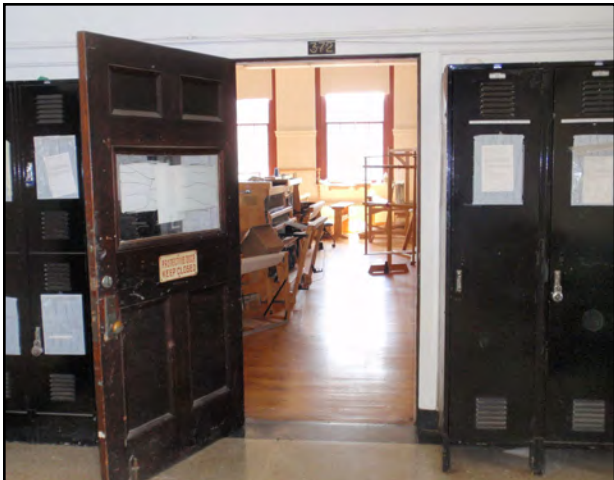
LOCATION| 305

Door Obstruction

N372 Similar issues as above, with the exception that this door has a lever handle.

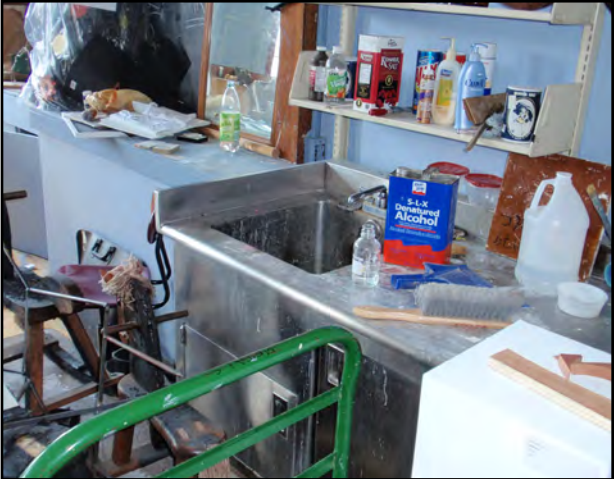
LOCATION| 305

Sink N376 studio.

RECOMMENDATION TO IMPROVE ADA COMPLIANCE

Provide at least one sink or 5% of all sinks that has a reachable faucet controls and has knee space below.

Relocate furniture / storage to maintain access to sink and store chemicals in reach range.

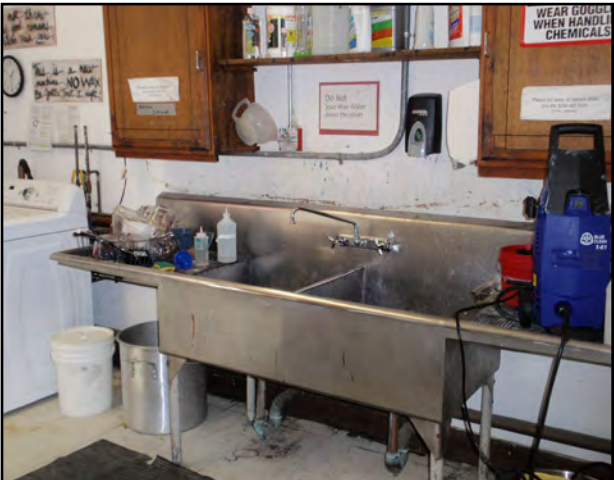
LOCATION| 305

Sink N374

RECOMMENDATION TO IMPROVE ADA COMPLIANCE

Store chemicals on shelving within reach range and where you don't have to reach over the sink or on a mobile cart dedicated to this function.

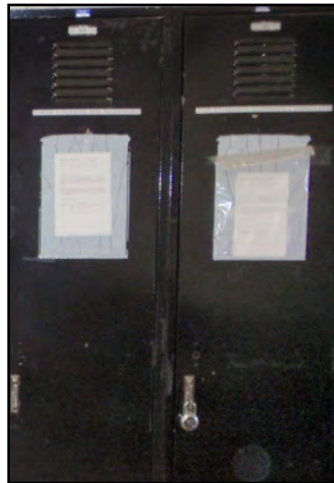
LOCATION| 305

Lockers

Lockers are not ADA compliant.
[See Appendix A - 2010 ADA Standards- 225 Storage,].

RECOMMENDATION TO IMPROVE ADA COMPLIANCE
Replace 1 or 5% of the lockers provided with ADA compliant versions. See locker note for basement p14.

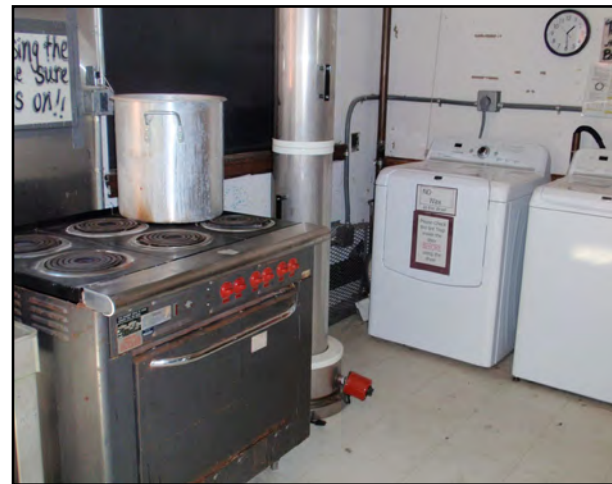
LOCATION| 305

Reach range

RECOMMENDATION TO IMPROVE ADA COMPLIANCE
To accommodate seated users or people who cannot reach existing equipment replace range with cooktop only and kneespace below. Locate cooktop next to sink with potfiller for easy pot filling without lifting. Install inclined mirror above pot so that contents of pot can be viewed from seated position without having to reach. Provide at least one front loading washing ma-

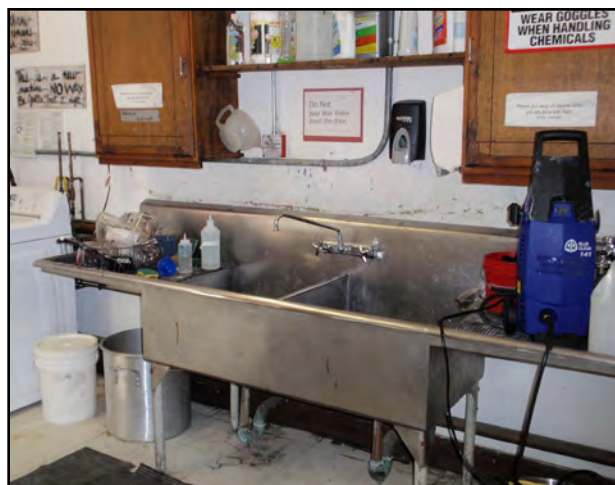
LOCATION| 304

Storage out of reach range

RECOMMENDATION TO IMPROVE ADA COMPLIANCE
Store chemicals on shelving where you don't have to reach over the sink or provide a mobile cart dedicated to storing chemicals.

Provide at least one ADA accessible sink.

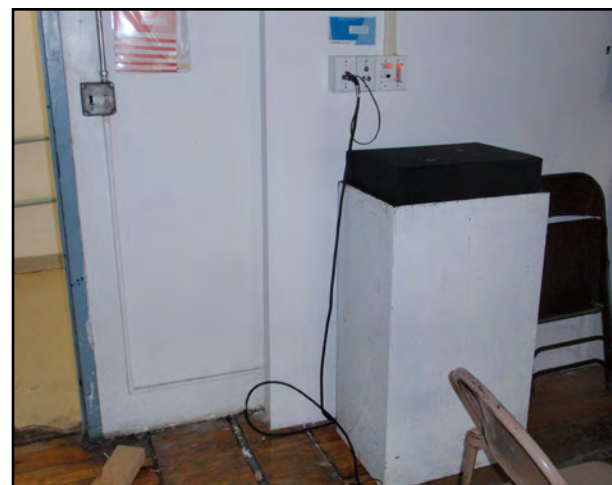
LOCATION| 310

Appliance Controls

Similar issues as above. The top controls are out of reach range at 52" AFF

RECOMMENDATION TO IMPROVE ADA COMPLIANCE
Move equipment so that a user does not have to reach over the equipment or lower the controls.

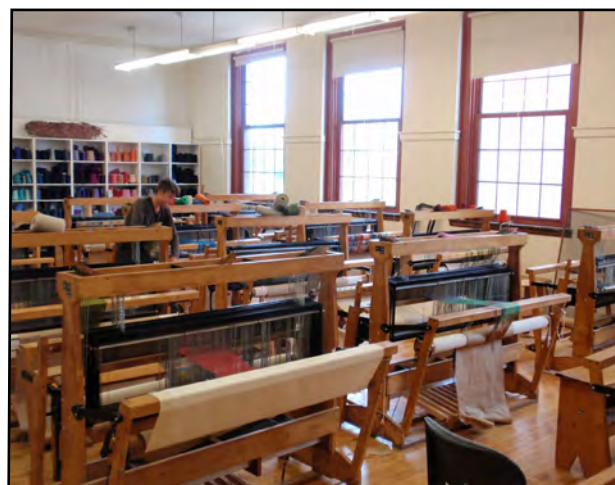
LOCATION| 303

Storage out of reach range

RECOMMENDATION TO IMPROVE ADA COMPLIANCE
Move all materials that students will require to lower shelves use upper storage for display or for items infrequently used.

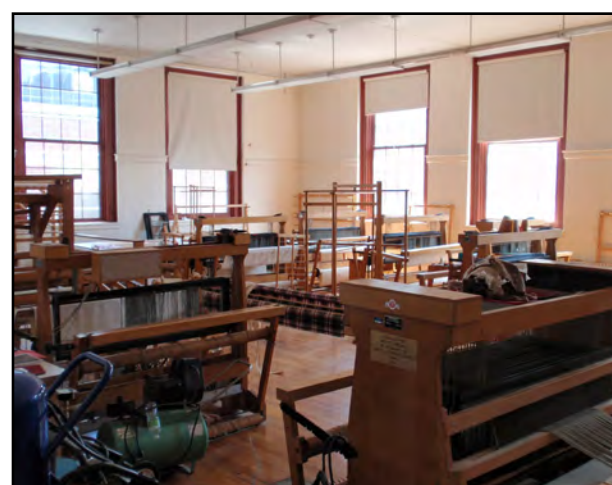
LOCATION| 304

Reach range

Similar issues as above. Equipment may not able to be used by wheelchair user.

RECOMMENDATION TO IMPROVE ADA COMPLIANCE
Make sure at least one or 5% of any piece of equipment can be used by wheelchair users.

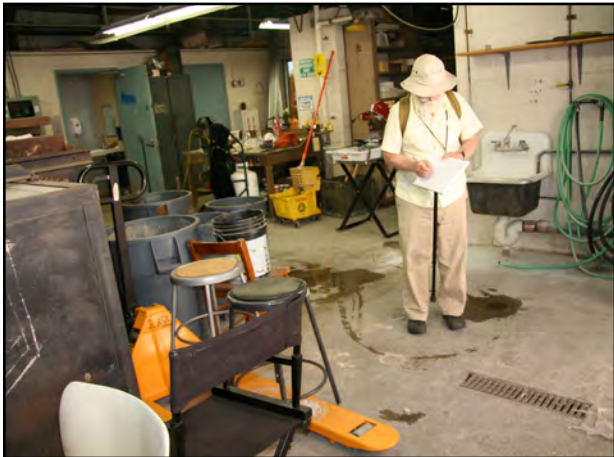
LOCATION | 103 f

Accessible Routes - Aisle Obstruction

Accessible routes, aisles and pathways through rooms are obstructed by damaged flooring tiles, loose wires, furniture, equipment and other objects that compromise egress safety and create tripping hazards.

USER EXPERIENCE: Ensure that access to safety equipment is not blocked.

ISSUE B
OPERATIONAL
Implement plan to maintain 36” min. clear areas through accessible routes and paths.

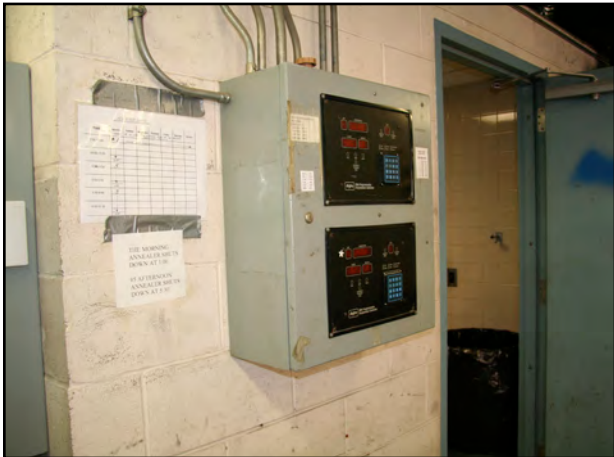
LOCATION | 103 e

The following issues occur many times throughout the floor.

SMALL MAINTENANCE: Remove, relocate or inset into wall, objects protruding more than 4" into accessible routes that are not cane detectable where the leading edge of the object is higher than 27" AFF and or may not give the minimum headroom of 80" AFF from accessible routes. In certain instances, installing a railing or locating a piece of furniture directly under the protruding object may mitigate the hazard. For additional information See Appendix A 307.

Prioritize the most hazardous objects. If this is not possible extend the sides to the ground or at least lower than 27" AFF so that the object can be detected by cane.

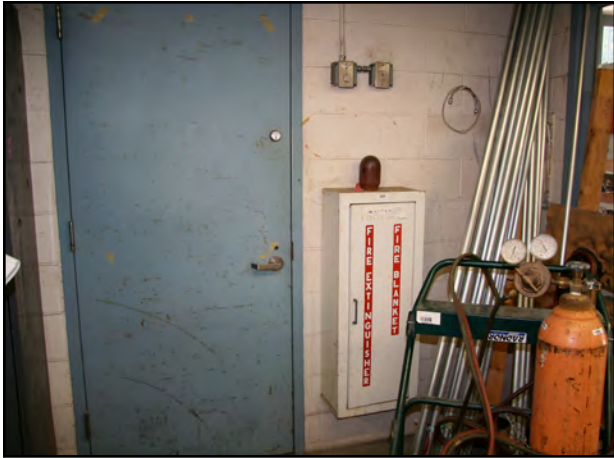
LOCATION | 103 c

Door - Clearances

Thresholds on an accessible route are more than 3/4" high. [See Appendix A -2010 ADA Standards 404.2.5 Thresholds]

RECOMMENDATION TO IMPROVE ADA COMPLIANCE OPERATIONAL: Remove and replace threshold with 1/2" max. high threshold.
