Massachusetts College of Art and Design

ADA Compliance Plan 2011

ADA Compliance Plan
Consultant Services
Contract #10-08

The Institute for Human Centered Design

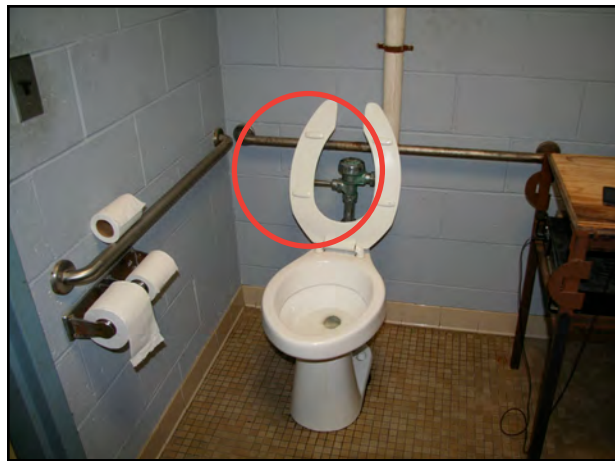
LOCATION | 102 b

The single-user toilet is not fully ADA compliant toilets. Provide at least one single-user toilet room.

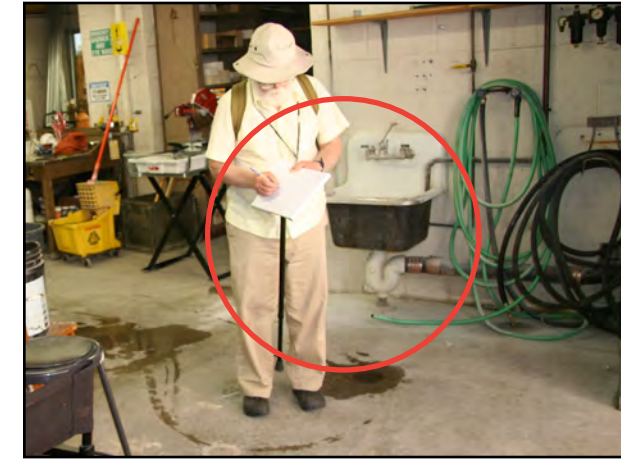
LOCATION | 103 f

There are utility sinks on the second floors that are not janitorial but are required for cleaning equipment such as brushes, and related materials which makes their use a part of the educational experience. These sinks do not meet 1991 or 2010 ADA standards for height, clearance or knee space.

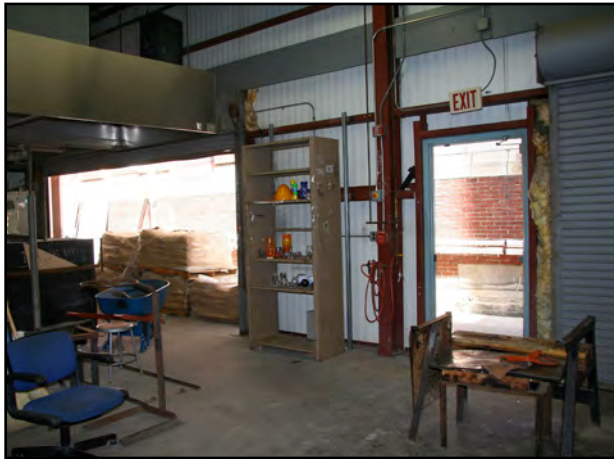
LOCATION | 103h

Furniture - Dimensions and Reach ranges

SMALL MAINTENANCE: As furniture and equipment is upgraded and replaced, make sure that 5% of all items but not less than one item in each room should allow an individual with disabilities to use it. Make sure that work surfaces and sinks are at 34" AFF, with knee spaces at least 27" AFF, 30" wide and 19" deep, and make sure that controls are located within accessible reach ranges. To support programs for all, provide adjustable furniture such as a few low tables or carts with locking casters that would supplement the countertop areas and provide additional space for equipment for multiple programs.

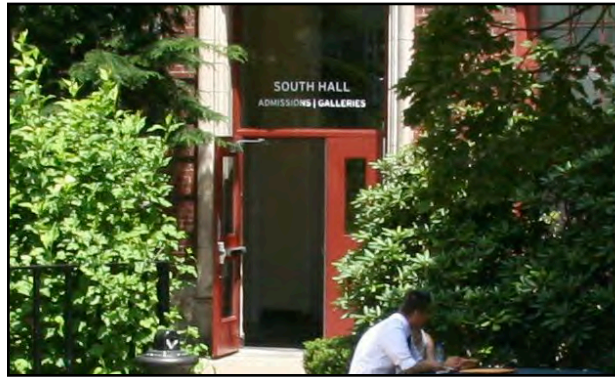
LOCATION | 101

Signs - ADA Facilities and Amenities

Ensure that these signs are mounted at the correct height and location and use the International Symbol of Accessibility. Signs indicating ADA compliant entrances should be placed to avoid backtracking.

Ensure that all ADA compliant amenities are noted on Directories at each floor level.

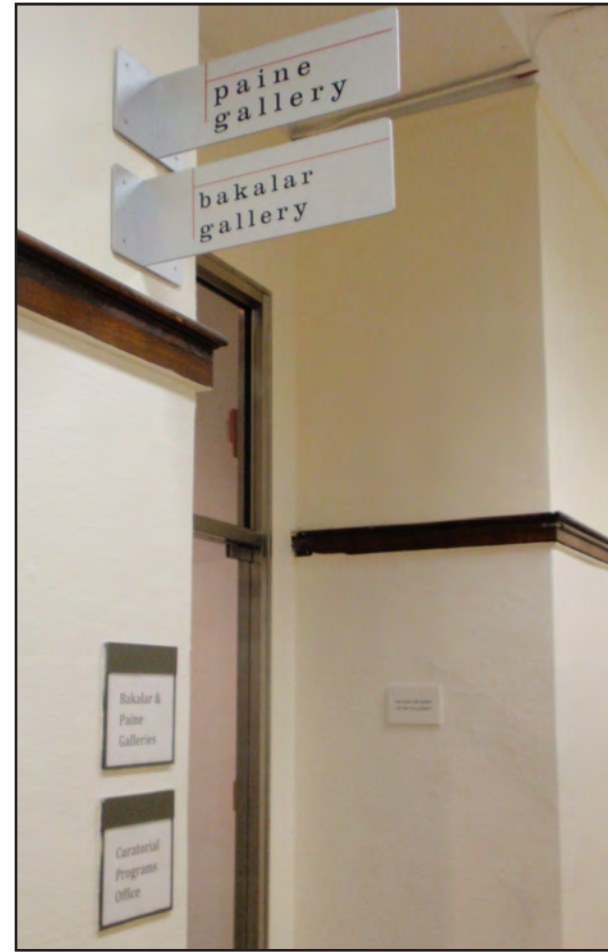
LOCATION | 112

CAPITAL IMPROVEMENT: Tactile read ADA compliant exit signs are missing from doors at exit passageways, exit discharge, and exit stairways throughout the building.

Until modifications are complete provide 2010 ADA Standards compliant signage to direct users to nearest accessible Toilet Room and other accessible amenities.

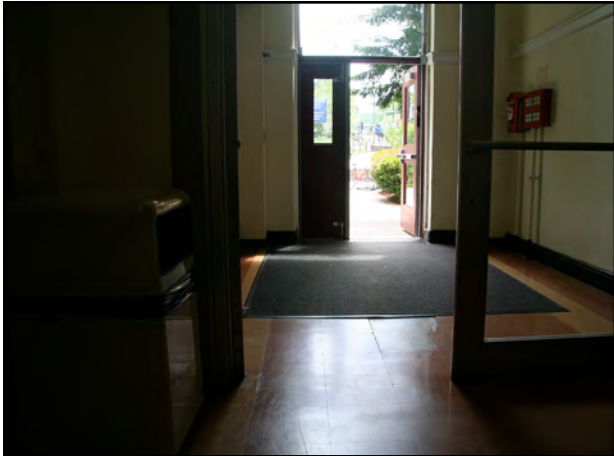
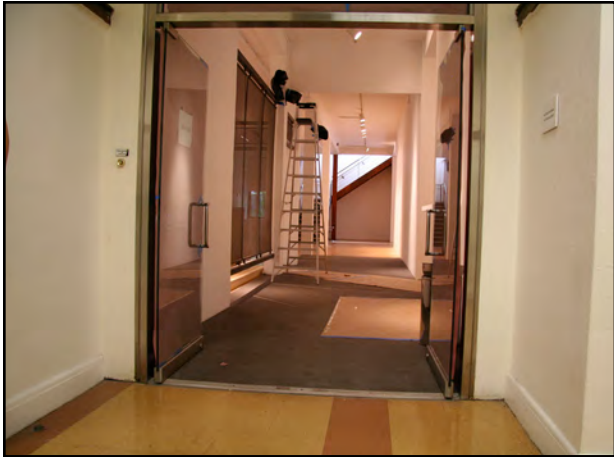
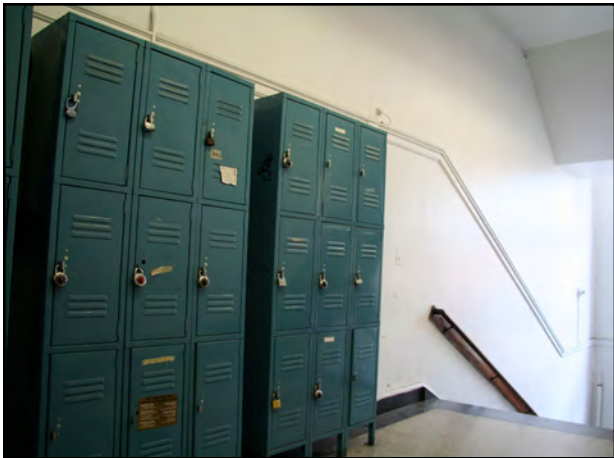
LOCATION | 102

Signs - Directories

Coordinate with program and usage across physical, print, and digital environments in order to avoid confusion.

Add information regarding the location of accessible toilet rooms when the accessible toilet rooms are installed.

ISSUE A3
CAPITAL IMPROV.
 Design and implement a campus-wide wayfinding program that includes Directories.

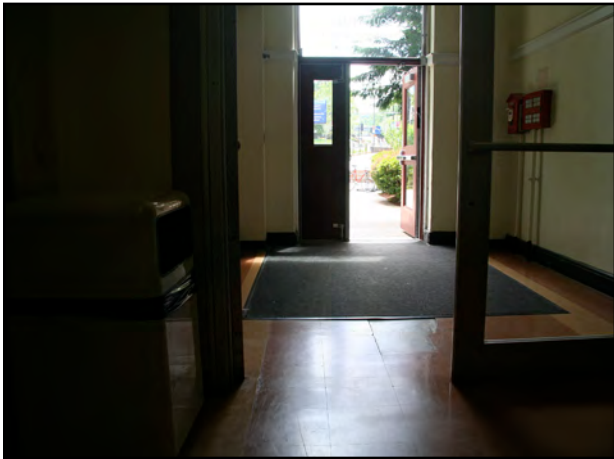
LOCATION | 102

South Building has an accessible entry off the street adjacent to Huntington Ave. This entrance is level with the Admissions Offices, the Arnheim and the Bakalar Galleries, however, there are no elevators so galleries and programs on other floors cannot be accessed without going out of the South Building to use the Kennedy Building elevators and through secured doors that provide access back into the 2nd and 3rd floors separately. There are no signs indicating accessible routes and no instructions on how to follow them in the building, on the website or in print materials.

The South Crackertorium where events and exhibitions are held is on the first floor between the South and East Buildings and is accessible. However, a person using a mobility device cannot get to the connecting East Building since there are stairs and a two foot change in level at the East Building side of the Crackertorium. The Collins building is also not accessible since there are stairs and a three foot change in level. The Courtyard also is not on an accessible route.

Accessible routes, aisles and pathways through rooms are obstructed by damaged flooring tiles, loose mats, **LOCATION | 102**, furniture, equipment and other objects that compromise egress safety and create tripping hazards.

ISSUE B
OPERATIONAL
 Implement plan to maintain 36" min. clear areas through accessible routes and paths.

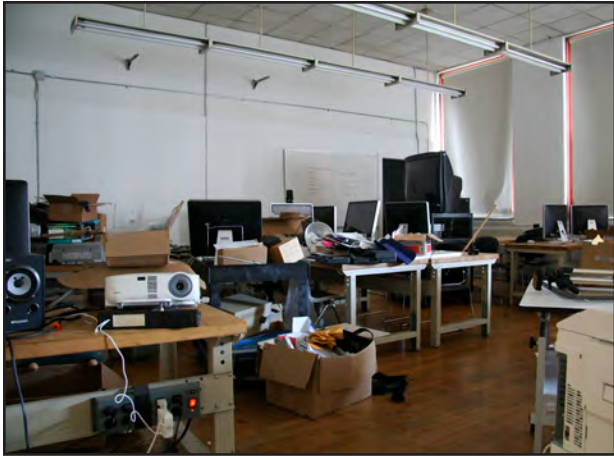
LOCATION | 304

Accessible Aisle Obstruction
 Accessible routes, aisles and pathways through rooms are obstructed by damaged flooring tiles, mats, furniture, equipment and other objects that are egress safety and tripping hazards.
[See Appendix A -2010 ADA Standards 206 Accessible Routes 401, 402, 403.5.1 Clearances]

RECOMMENDATION TO IMPROVE ADA COMPLIANCE OPERATIONAL: Remove obstructions and rearrange furniture and equipment and educate staff, students and faculty to maintain a 36" min. wide clear space through accessible routes rooms, spaces, and paths at all times.

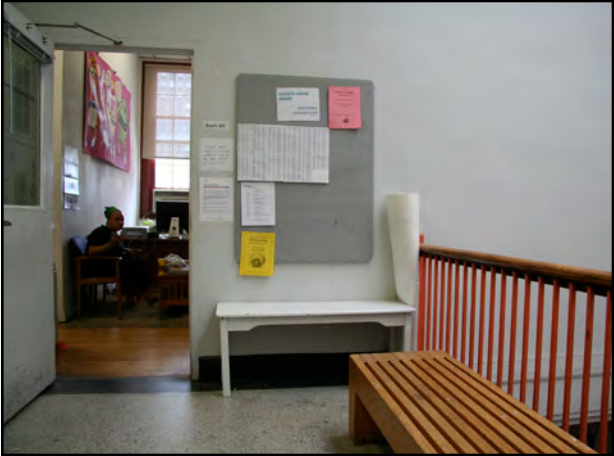
LOCATION | 308

Landing clearances
 The clearance at the landing to stairs is obstructed with no passing space. This is dangerous to anyone using the stair.
[See Appendix A -2010 ADA Standards 603 Stair]

RECOMMENDATION TO IMPROVE ADA COMPLIANCE OPERATIONAL: Remove obstructions or rearrange furniture and equipment so as to not block the landing. Educate staff, students and faculty to maintain a 42" min.wide clear space at landings and egress stairs.

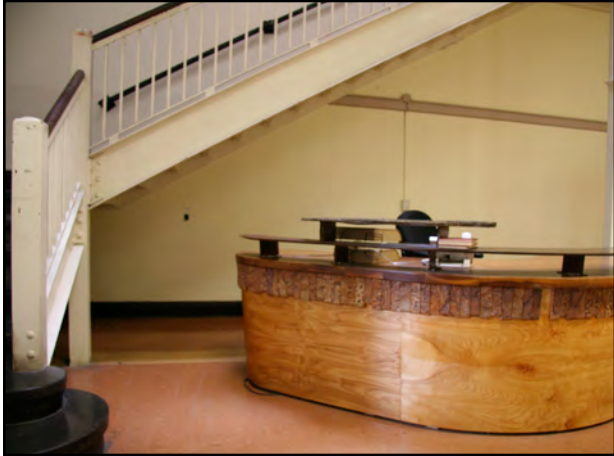
LOCATION | 105

Protruding Object - Stair Headroom
 The space under the stair in part is lower than 80" AFF and could cause a head injury. **LOCATION | 105 & 103**

[See Appendix A -2010 ADA Standards 204, 307 Protruding Objects]

RECOMMENDATION TO IMPROVE ADA COMPLIANCE
 SMALL MAINTENANCE: Infill or design barrier to prevent injury or access under the stairs.

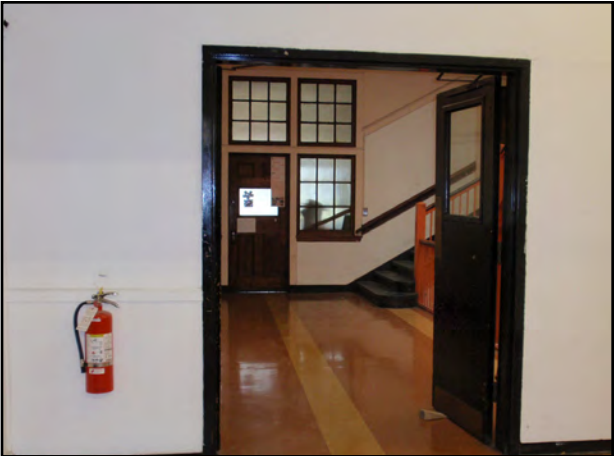
LOCATION | 205

Protruding Object - Mailboxes
 When the table is removed out of the accessible route the mailboxes will become a protruding hazard as they protrude into the accessible route more than 4" and as they are higher than 27" AFF they are not cane detectable.

RECOMMENDATION TO IMPROVE ADA COMPLIANCE
 SMALL MAINTENANCE: Either reinstall the mailboxes so that they are within reach ranges of 48" AFF to the top slot and 15" AFF to the bottom or extend the sides to the ground (or at least lower than 27" AFF to be cane detectable) or relocate in an alcove away from the accessible route.

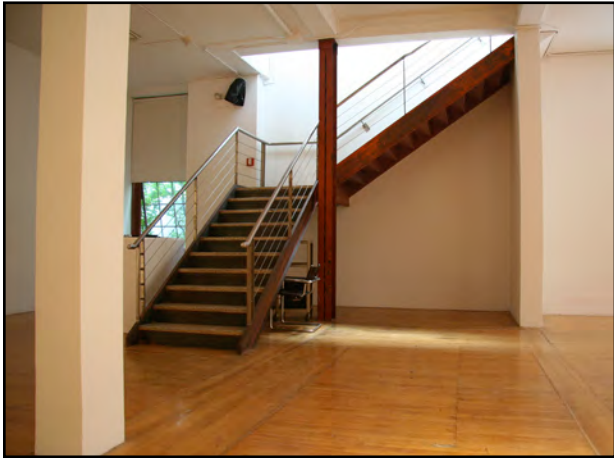
LOCATION | 113

Protruding Objects
 Shelving or other objects such as dispensers, fire extinguishers or bump outs protrude into the accessible route and circulation paths more than 4" and since they are higher than 27" AFF they are not cane detectable.

[See Appendix A -2010 ADA Standards 204, 307 Protruding Objects]

RECOMMENDATION TO IMPROVE ADA COMPLIANCE
 SMALL MAINTENANCE: Remove, relocate or inset into wall, objects protruding more than 4" into accessible routes that are not cane detectable where the leading edge of the object is higher than 27" AFF and or may not give the minimum headroom of 80" AFF from accessible routes. In certain instances, installing a railing or locating a piece of furniture directly under the protruding object may mitigate the hazard. For additional information See Appendix A 307.

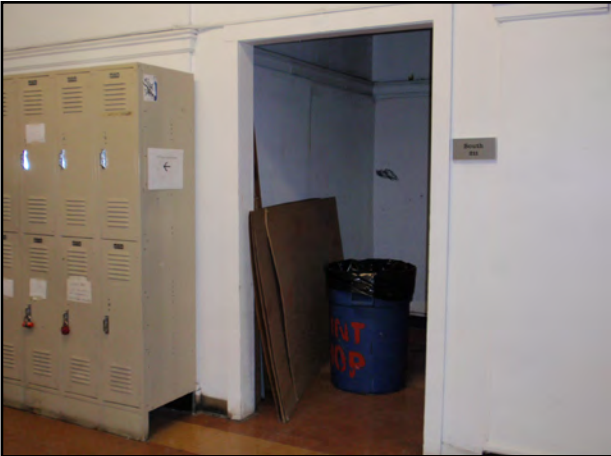
LOCATION | 204

Door - Maneuvering clearances
 Doors on accessible routes do not have the required latch or hinge side clearances.
[See Appendix A -2010 ADA Standards 404.2.4 Door Maneuvering Clearances]

RECOMMENDATION TO IMPROVE ADA COMPLIANCE
 SMALL MAINTENANCE or OPERATIONAL: Remove walls to provide clearances or if in a classroom relocate class to classroom with ADA compliant maneuvering spaces or install automatic door openers.

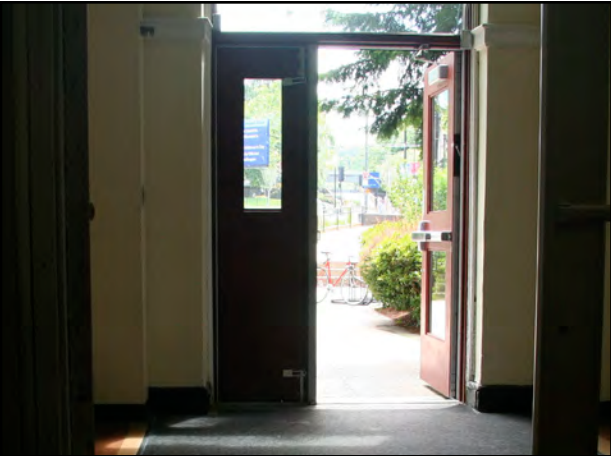
LOCATION | 101

Door - Opening force adjustment
 Exterior doors with closers have door opening forces that are greater than 15 lbs., interior doors with closers have door opening forces that are greater than 5lbs., this is too heavy for easy opening and means that the doors close too fast to be able to enter easily. This could also cause delay or injury in an emergency.
[See Appendix A -2010 ADA Standards 404.2.8 Door Closers]

RECOMMENDATION TO IMPROVE ADA COMPLIANCE
 OPERATIONAL: Develop and implement a comprehensive maintenance program and schedule to check and adjust doors so that the necessary door opening force for interior doors is max. 5lbs. and max. 15lbs. for exterior doors.

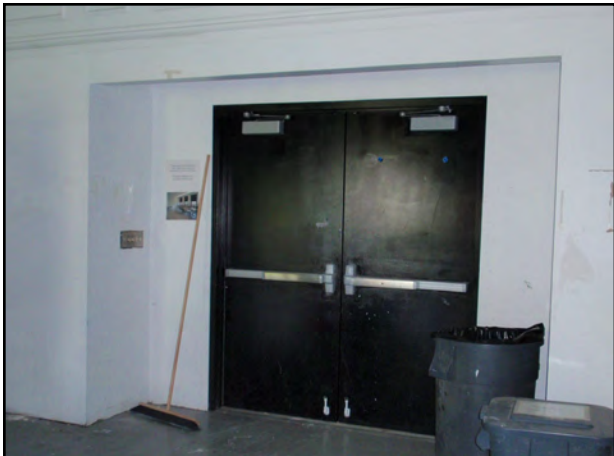
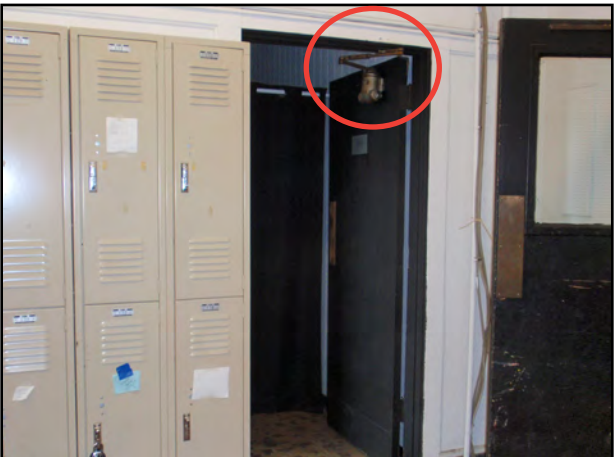
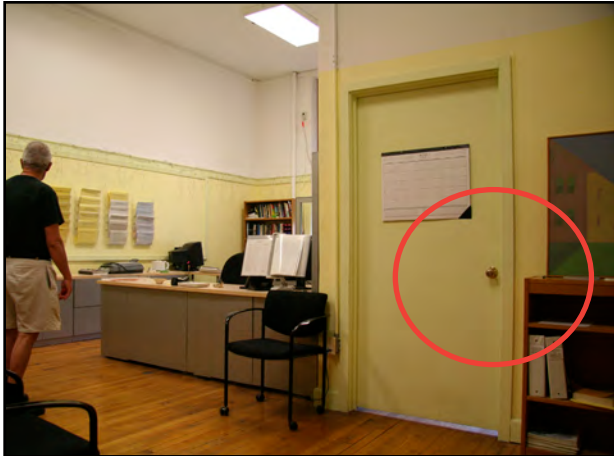
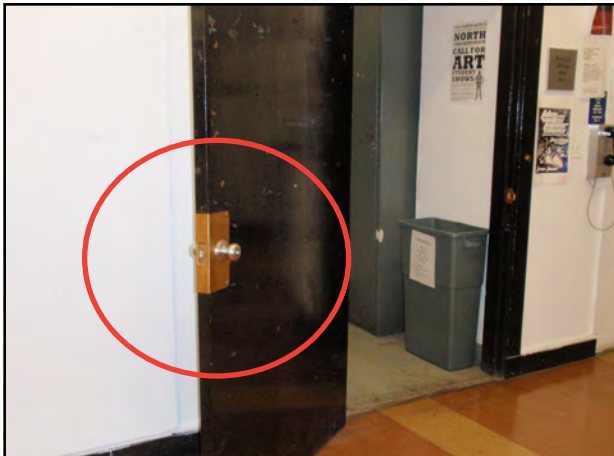
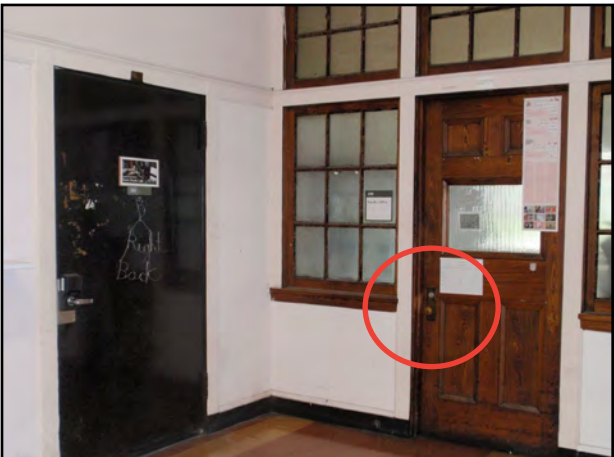
Door - Hardware

RECOMMENDATION TO IMPROVE ADA COMPLIANCE
SMALL MAINTENANCE: Replace knob hardware with meets ADA standards that doesn't require tight pinching grasping or twisting of the wrist.

ISSUE D3
SMALL MAINT. PROJECT
Implement plan to replace knob hardware with lever-type hardware. PRIORITY FOR DOORS ON ACCESSIBLE ROUTE.
\$400/set

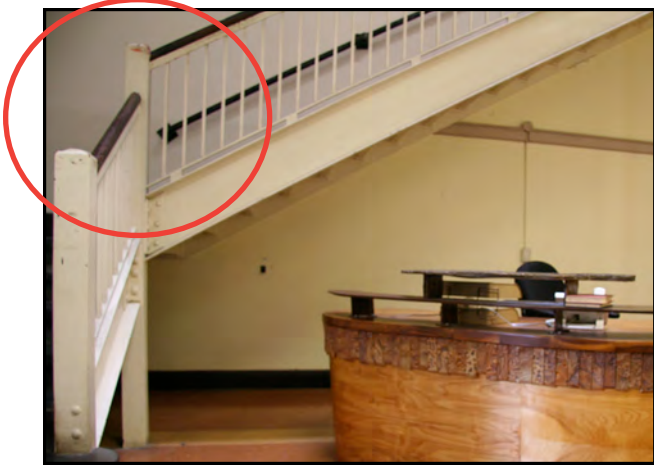
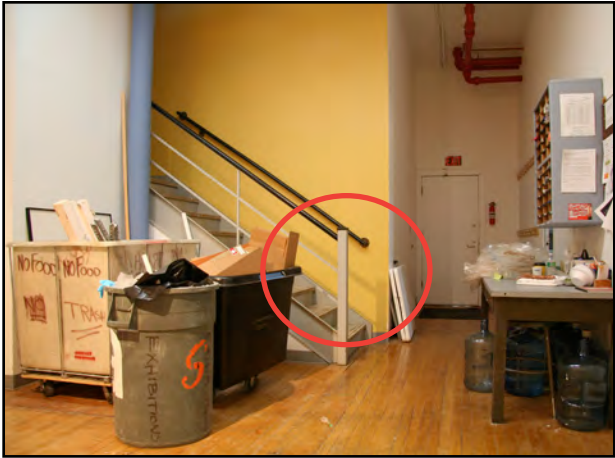
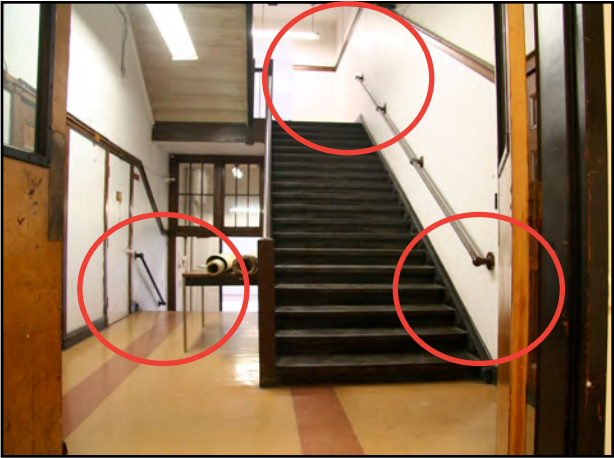
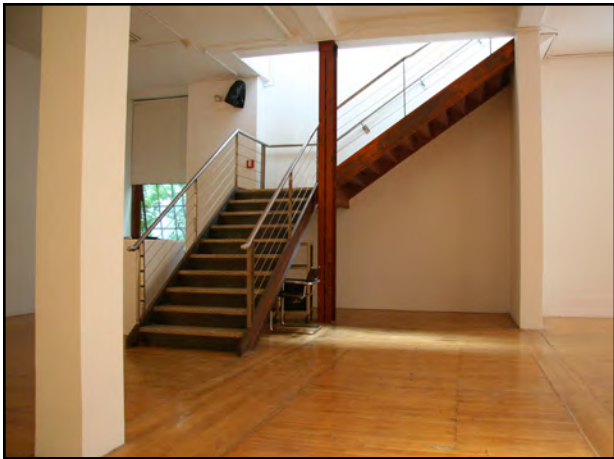
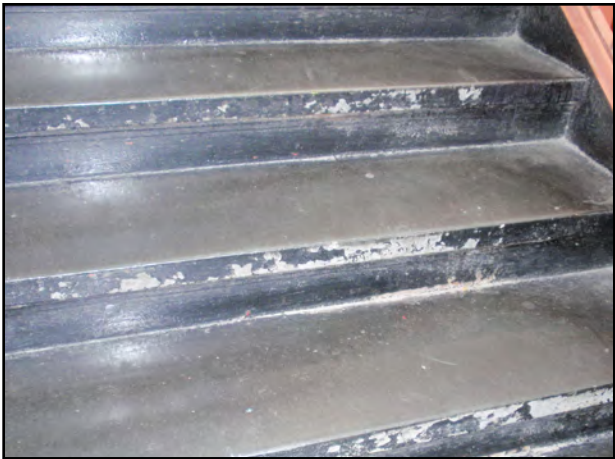
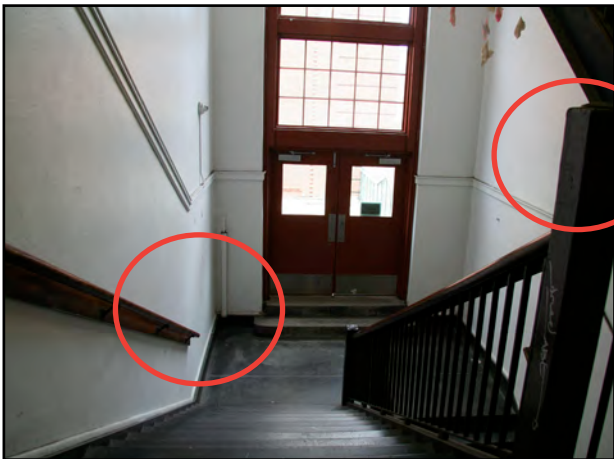
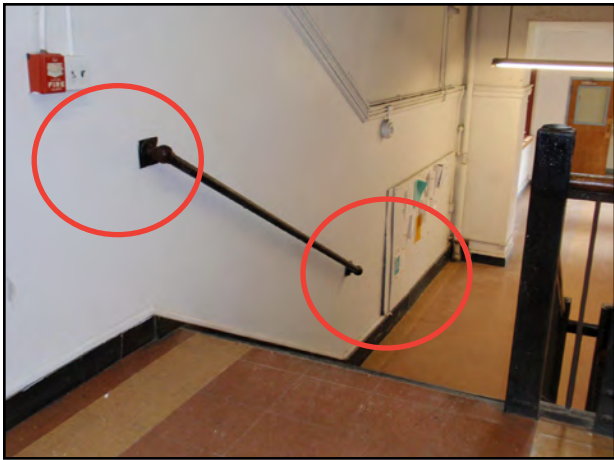
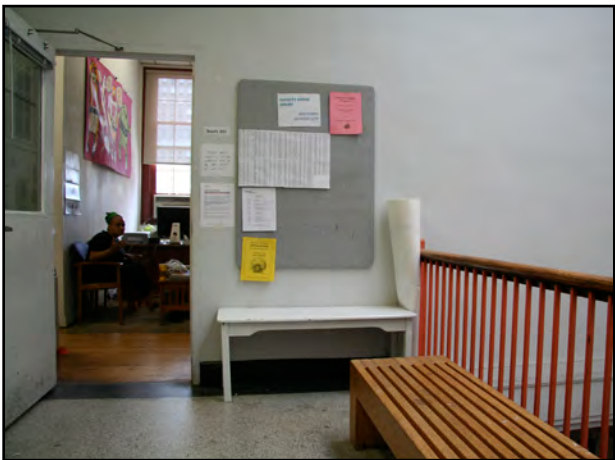
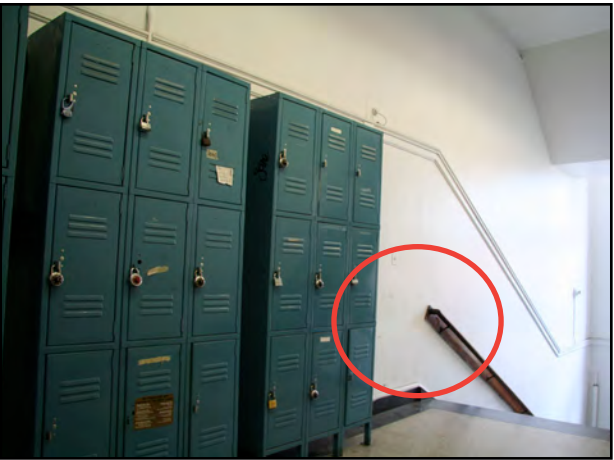
E_Stairs

The stairs on all floors in South Building have similar issues.

All stairs have nosings that are greater than 1" this can be a tripping hazard and could cause injury.
[See Appendix A -2010 ADA Standards 504.5 Nosings]

SMALL MAINT. PROJECT
 Apply required modifications to stairs to comply with 2010 ADA requirements.

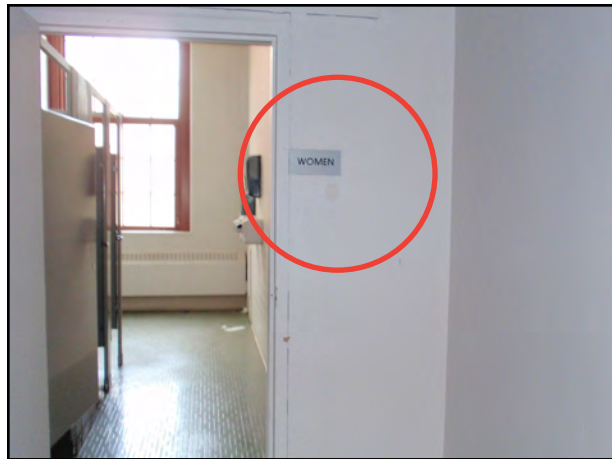
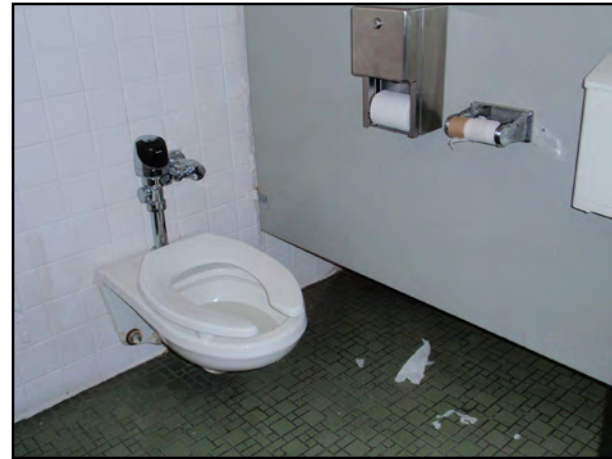
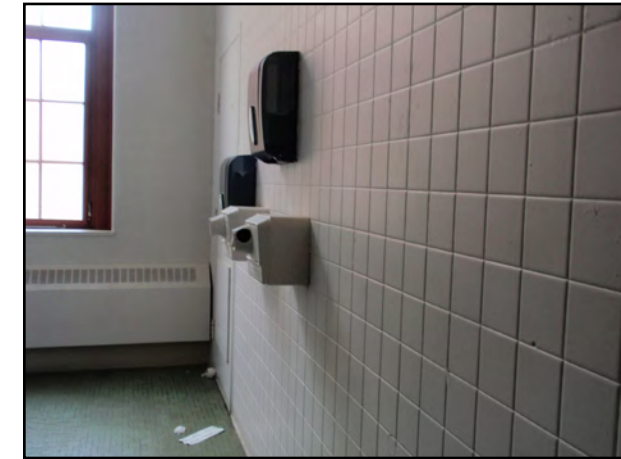
F_Toilet Rooms

There are no fully ADA accessible toilet rooms in South Building.

The current staff toilet room on the first floor is not on an accessible route. There are toilet rooms at the Crackertorium that could be used but require major renovations to provide the required clearances and dimensions. Likewise the toilet rooms on the second floor do not have the required door clearances, walls would be required to be moved as well as modifications to faucets, lavatories, plumbing pipes, dispensers, toilet flush controls, grab bars, mirrors, urinals, compartment hardware, door widths, door opening forces and flooring to bring meet ADA compliance. The sum of these modifications would be greater than the cost of creating a new single-user toilet room on each floor. Additionally in both men's and women's toilet rooms if two of the existing toilet stalls were combined to produce one accessible one the overall toilet count for the building would be decreased.

**ISSUE F
CAPITAL IMPROV.**
As there are no elevators and toilet rooms throughout the building would require extensive modifications, consider providing at least one single-user accessible toilet room for each floor.

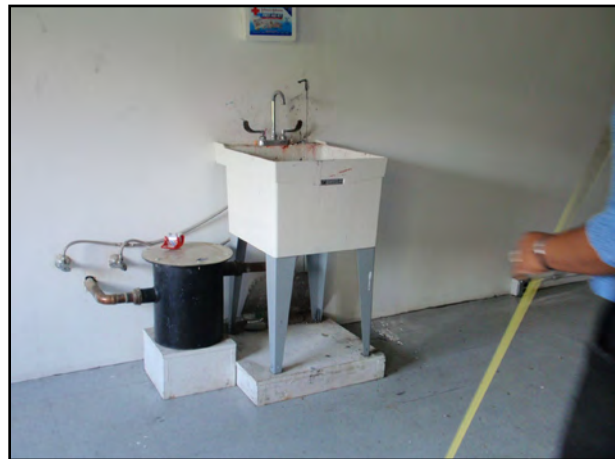
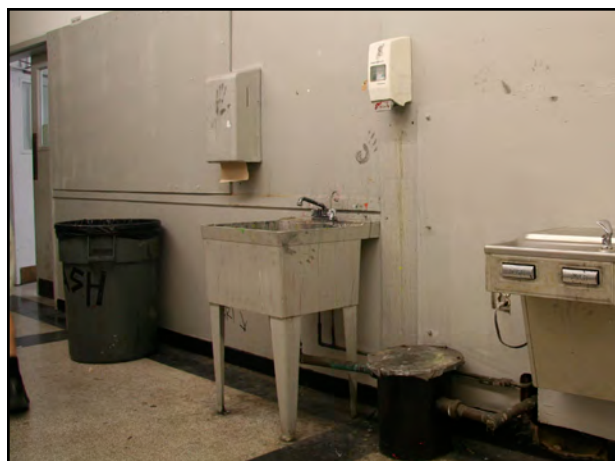
G_Sinks

There are utility sinks on the second and third floors that are not janitorial but are required for cleaning equipment such as brushes, and related materials which makes their use a part of the educational experience. These sinks do not meet 1991 or 2010 ADA standards for height, clearance or knee space.

SMALL MAINTENANCE: Replace at least one sink with a sink that meets 2010 ADA Standards in each of the rooms that have these sinks, or at this type of sink provide enough space around the sink for a side approach, add an adjacent work counter with room for knee space, add a flexible hose attachment for additional flexibility.

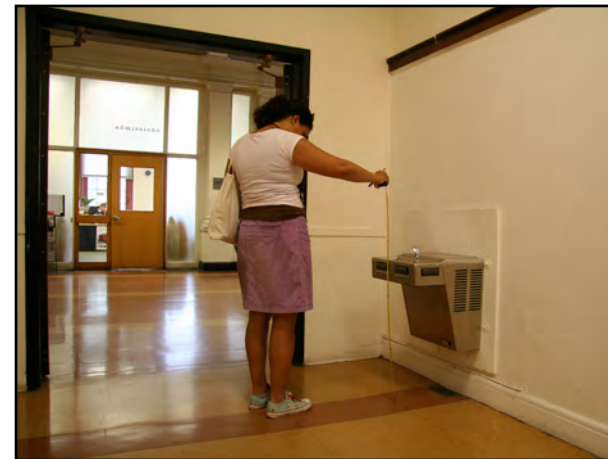
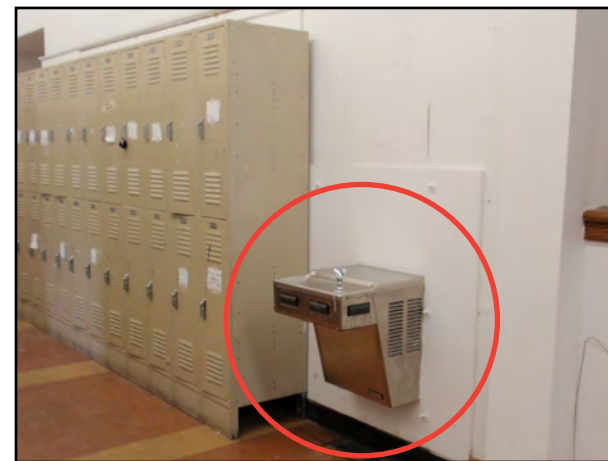
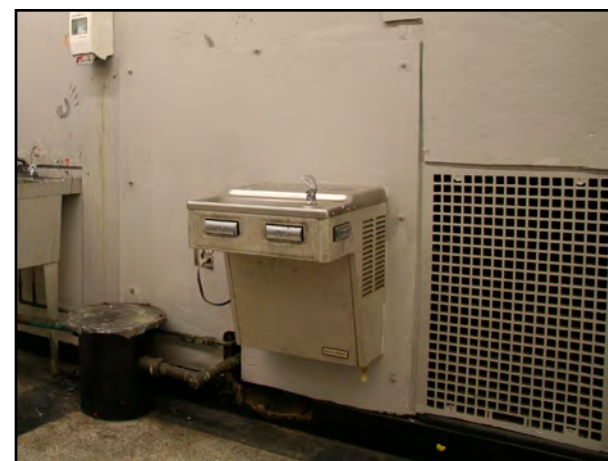
H_Drinking Fountains

The drinking fountains on all floors in South-Building have similar issues.

The drinking fountain protrudes into the accessible route, is undetectable by cane and could cause injury.

SMALL MAINTENANCE: Provide ADA compliant signs with directions to the nearest ADA compliant drinking fountain (which are in Kennedy Building). Ensure that these signs are ADA compliant and are mounted at the correct height and location.

CAPITAL IMPROVEMENT: Replace drinking fountain with a High-Low fountain or install a second fountain with a spout at a height that will allow for a person that has difficulty bending,

SMALL MAINTENANCE: Provide wing walls outside the required clearance space either side of the drinking fountain to ensure that it is cane detectable.

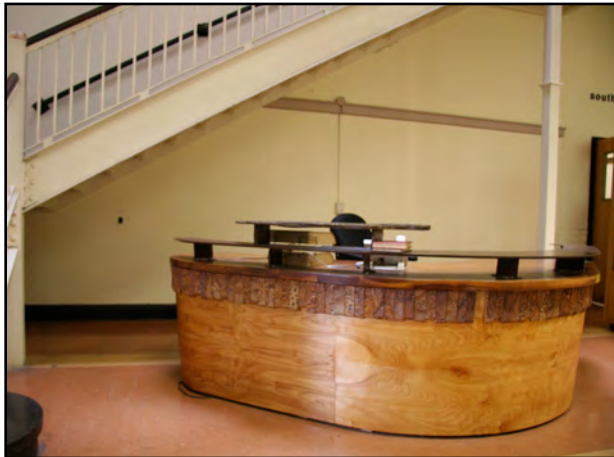
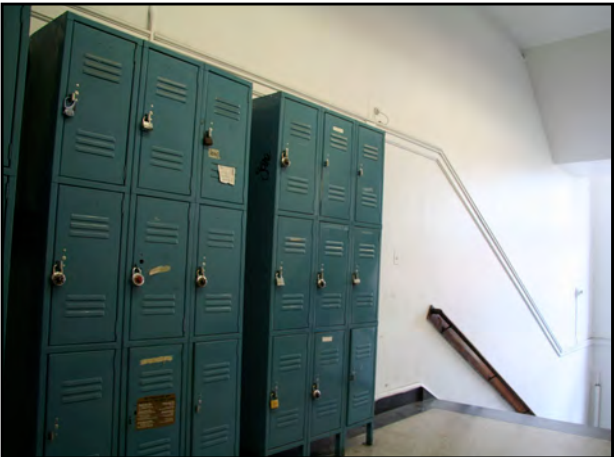
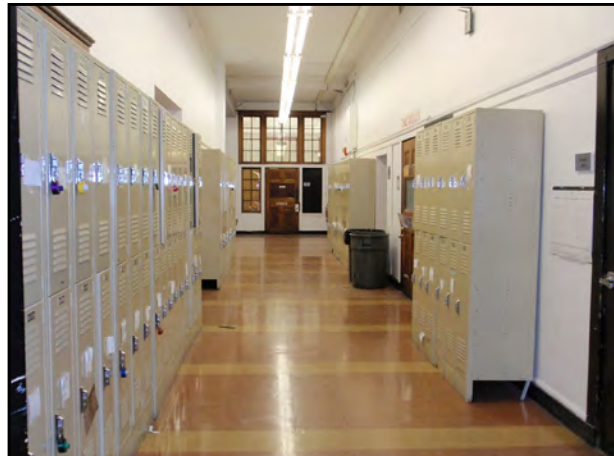
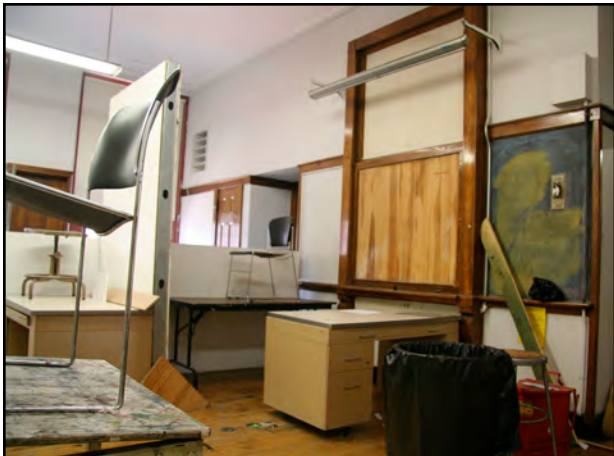
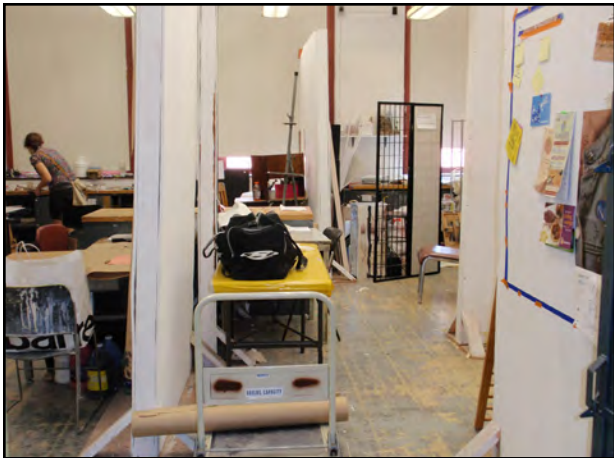
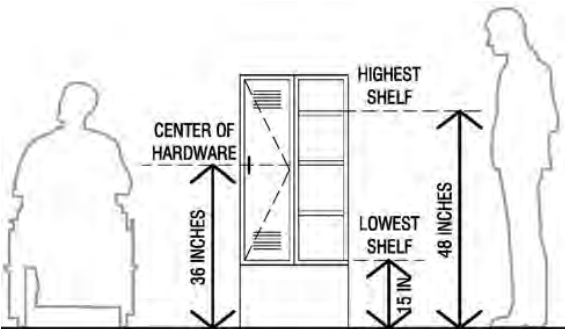
J_ Furniture & Lockers

Furniture - Dimensions and Reach ranges

SMALL MAINTENANCE: As furniture and equipment is upgraded and replaced, make sure that 5% of all items but not less than one item in each room should allow an individual with disabilities to use it. Make sure that work surfaces and sinks are at 34" AFF, with knee spaces at least 27" AFF, 30" wide and 19" deep, and make sure that controls are located within accessible reach range of between 15" AFF and 48" AFF. To support programs for all, provide adjustable furniture such as a few low tables or carts with locking casters that would supplement the countertop areas and provide additional space for equipment for multiple programs.

At each locker area replace or modify 5% or no fewer than one locker at each of the locker areas on each of the floors two and three to meet ADA accessibility standards for reach range and operable parts. Modifications include lowering shelves to within reach ranges ie. the lowest surface at 15 AFF and the highest shelf or coat hook no more than 48 inches AFF. and providing locks that don't require tight grasping, pinching or twisting of the wrist. If modifications cannot be made replace locker with an ADA compliant version. **CAPITAL IMPROVEMENT:** Purchase adjustable furniture to add flexibility and functionality to rooms.

ISSUE J
OPERATIONAL
 Modify existing lockers and furniture
or
CAPITAL IMPROV.
 Provide new ADA compliant furniture, equipment & lockers.
 \$ dependent on requirements

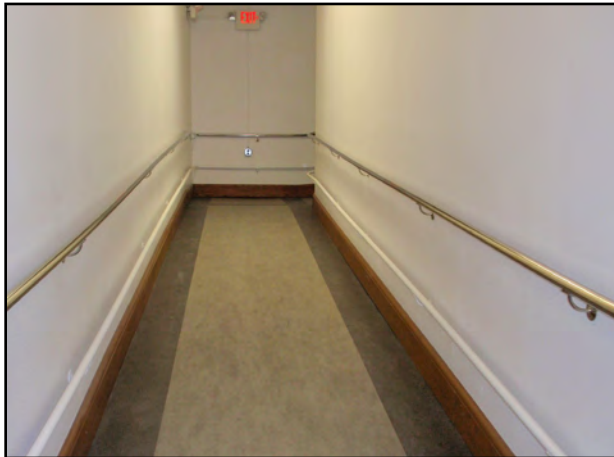
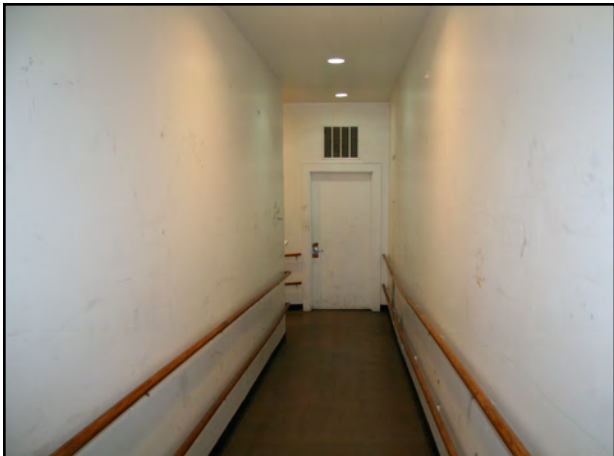
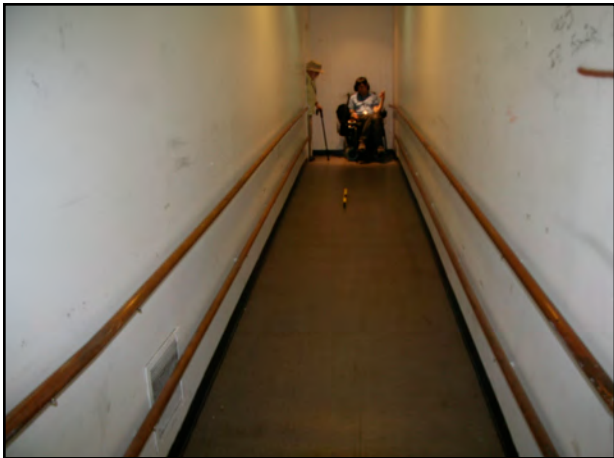
K_Ramps & Handrails

Ramps connecting to Kennedy on the second and third floors meet 2010 ADA accessibility standards for slope and handrail requirements.

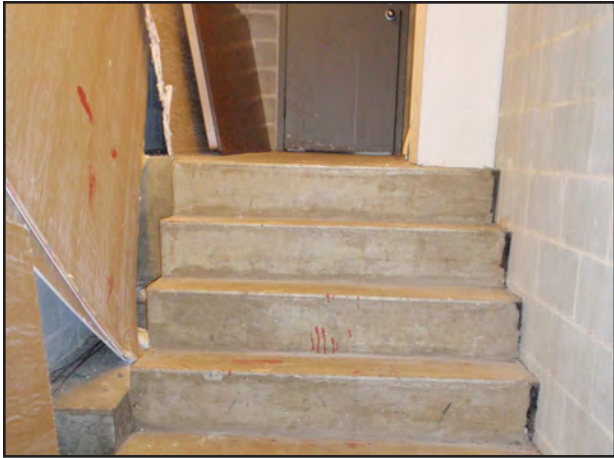
LOCATION | L01

Stairs - Contrast
 The egress route out of the back of the theater is dimly lit and the stairs have no contrast between tread and riser which makes them difficult to see in the dark. **LOCATION| L01**
[See Appendix A -2010 ADA Standards 603 Toilet Rooms]

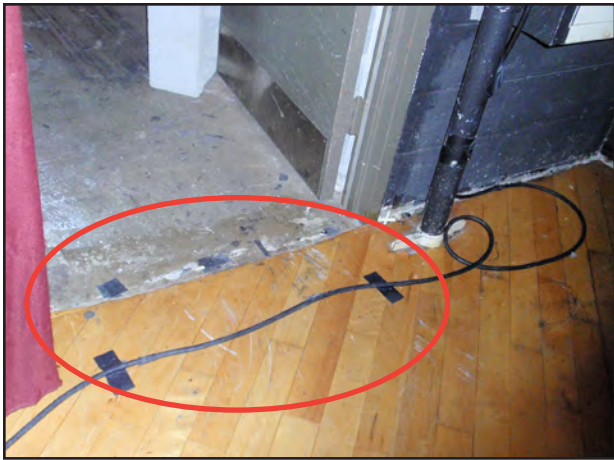
LOCATION | L06a

Floor-Tripping hazard
 Wires and cords crossover accessible routes and are only precariously attached to the floor creating a tripping hazard. **LOCATION| L06a**
[See Appendix A -2010 ADA Standards 206 Accessible Routes 401, 402, 403.5.1 Clearances]

RECOMMENDATION TO IMPROVE ADA COMPLIANCE
OPERATIONAL: Redirect wiring so that it follows along walls or furniture and does not cross the path of travel.

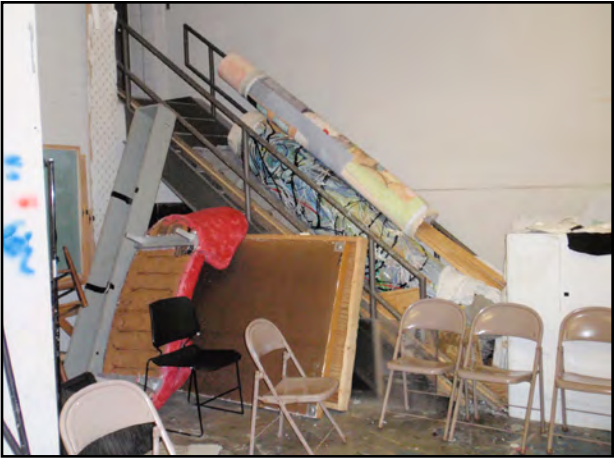
LOCATION | L06b

Accessible Aisle Obstruction
 Aisles and pathways through rooms are obstructed by furniture and other items like CMU blocks that are used to hold doors open. Aisles and paths are not defined creating egress safety and tripping hazards in the accessible route. **LOCATION | L06b, L06c & L06d**
[See Appendix A -2010 ADA Standards 206 Accessible Routes 401, 402, 403.5.1 Clearances]

RECOMMENDATION TO IMPROVE ADA COMPLIANCE
OPERATIONAL: Remove obstructions and educate staff, students and faculty to maintain a 36" min. wide clear space through rooms, spaces and accessible routes at all times.

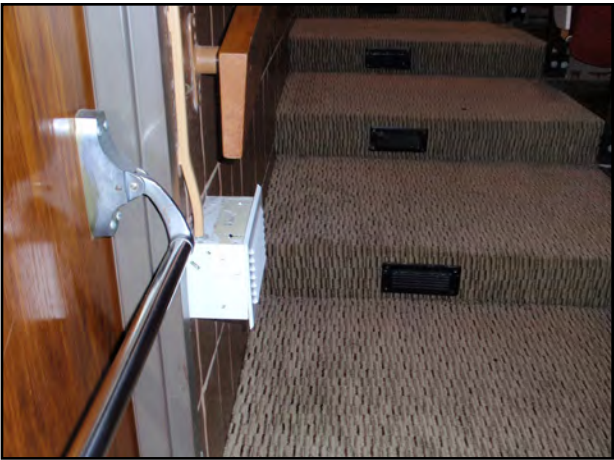
LOCATION | L07

RECOMMENDATION TO IMPROVE SAFETY & USER EXPERIENCE
 Consider boxing in the vent at **LOCATION| L07** Although the vent is below 27" AFF and is cane detectable it protrudes 5" into the accessible route. This is especially hazardous because of low light levels in the auditorium. Additionally, the vent has sharp edges that could make it hazardous for someone reaching for the adjacent handrail.

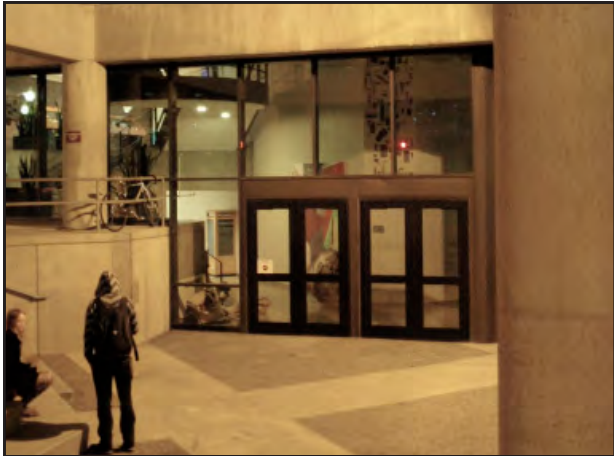
LOCATION | XL01

Door - Opening Forces
The Huntington Avenue 'Pit' entrance doors have an opening force of 20 lbs. which is too heavy for easy opening it. **LOCATION | XL01**

RECOMMENDATION TO IMPROVE ADA COMPLIANCE OPERATIONAL: Adjust all exterior doors so that they have an opening pressure that doesn't exceed 15 lbs.

RECOMMENDATION TO IMPROVE SAFETY & USER EXPERIENCE
Assisted and/or door openers could be installed to help visitors enter and exit the building especially during peak traffic periods such as the during performances. The automatic doors of the Evans Way entrance does not work and causes confusion for visitors.

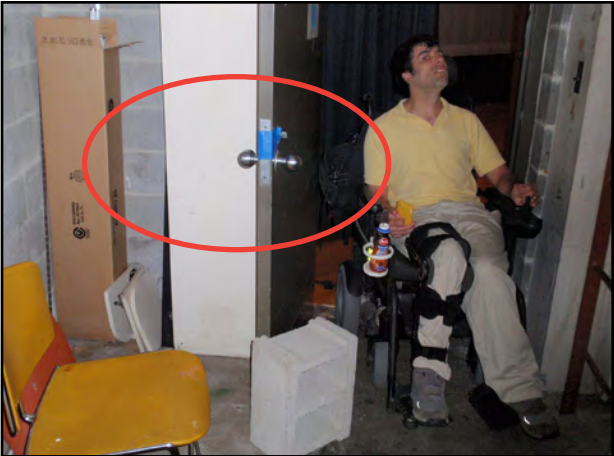
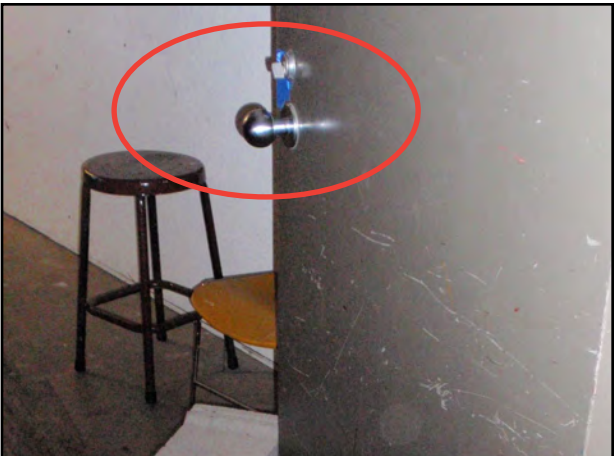
Door Hardware
The doorknobs require tight grasping, pinching or twisting of the wrist to operate. This could cause delay and impede exiting in an emergency.

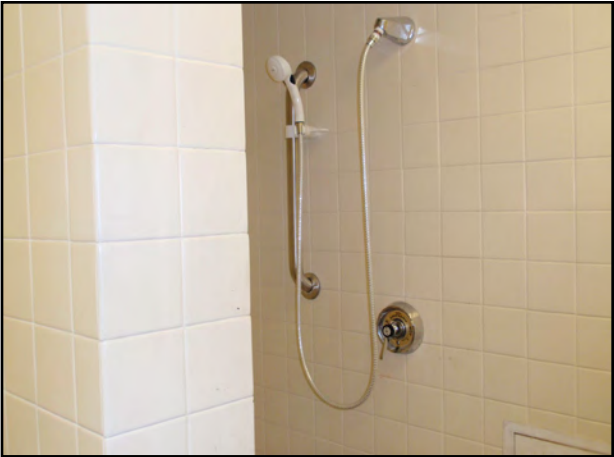
LOCATION | L05e

Accessible Stalls

CAPITAL IMPROVEMENT: Re-configure toilet and shower rooms to provide at least one accessible stall in each toilet/shower room.

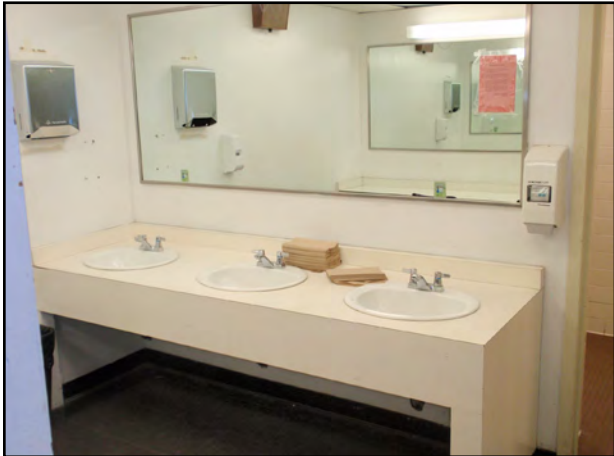
LOCATION | L05c

Maneuvering space at Lavatories
The maneuvering space around the lavatories (sinks) is not enough to allow a wheelchair user to turn.
[See Appendix A -2010 ADA Standards 302 Floor or Ground Surfaces]

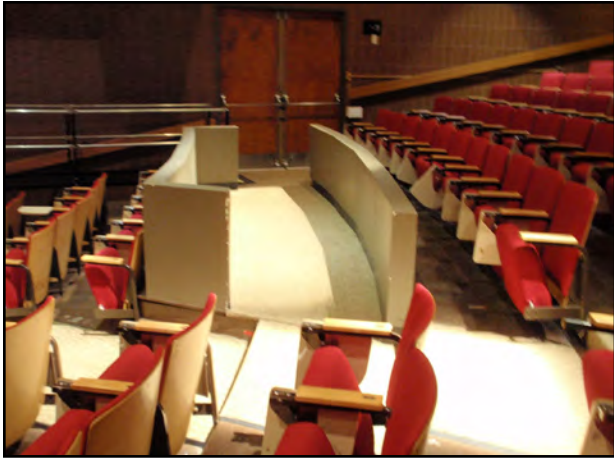
LOCATION | L02

Furniture - Accessible Viewing Space within Fixed Seating

RECOMMENDATION TO IMPROVE ADA COMPLIANCE CAPITAL IMPROVEMENT: Provide space for wheelchair users and their companions. Ensure that the space is large enough to allow for a 36" min. wide clear access aisle in front or behind the wheelchairs.

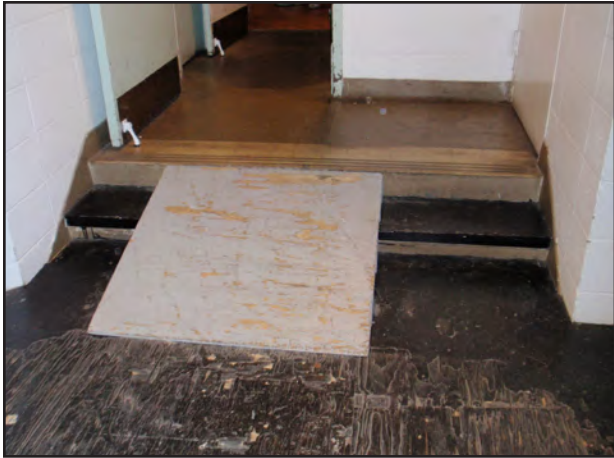
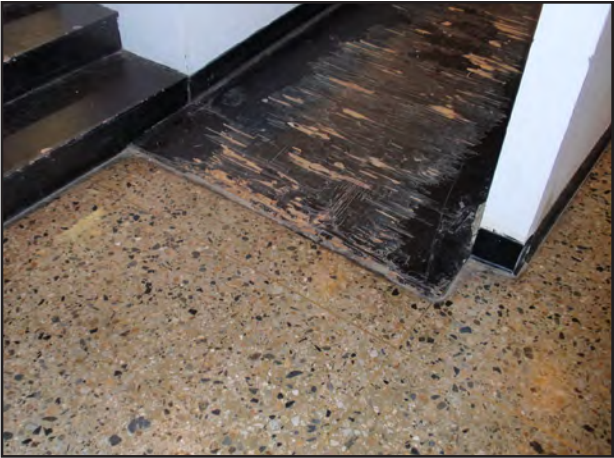
LOCATION | L04a

Ramps
 The ramp at **LOCATION| L04** does not meet ADA standards for accessibility for slope, flooring surface, handrails, width, landings or turning area.
[See Appendix A -2010 ADA Standards 405 Ramps]

RECOMMENDATION TO IMPROVE ADA COMPLIANCE
 CAPITOL IMPROVEMENT: Major renovations are required to bring this ramp into compliance.

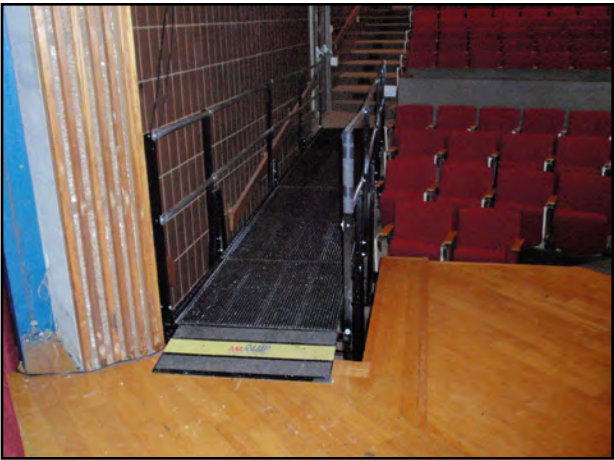
LOCATION | L03a

Ramps
 The ramps outside the Auditorium do not meet ADA Standards for the following criteria: the width is 31" it should be 36" min. clear, the handrails are not the required do not have extensions. The thresholds are tripping hazards as they are more than 1/2" high at the sides. These ramps have flooring surfaces that are not stable or firm and have an uneven surface.

RECOMMENDATION TO IMPROVE ADA COMPLIANCE
 Modify ramps to meet ADA standards.

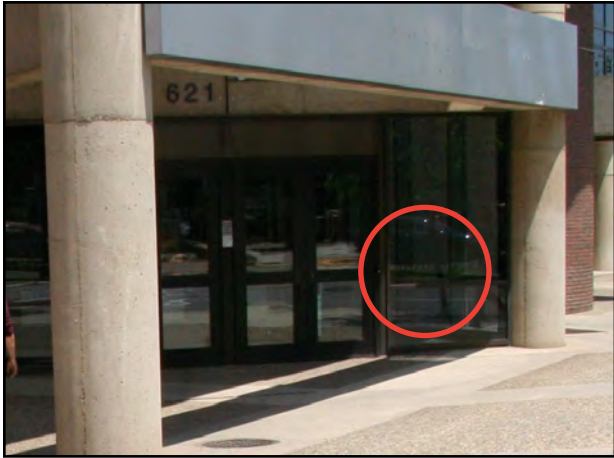
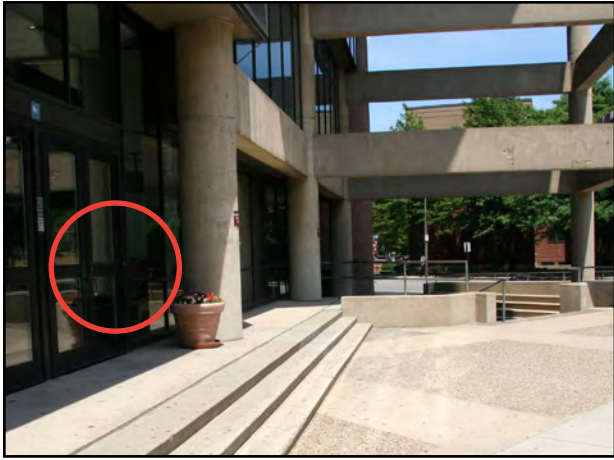
Signs - ADA Facilities and Safety
 Accessible entrances are not marked with the International Symbol of Accessibility.
General Issues-2010 ADA Standards 216.6 Entrances, 703 Signs-, 703.2, 703.3, 703.4]

Provide ADA compliant signs at non-accessible entrances that direct the user to the nearest accessible entrance. Ensure that location and mounting height comply with 2010 ADA standards. Where a directional sign is required, it should be located to minimize backtracking. In some cases, this could mean locating a sign at the beginning of a route, not just at the inaccessible entrances to a building.

RECOMMENDATION TO IMPROVE SAFETY & USER EXPERIENCE
 Provide building signs and addresses so that they can be easily read especially by emergency services.
