Massachusetts College of Art and Design

ADA Compliance Plan 2011

ADA Compliance Plan
Consultant Services
Contract #10-08

The Institute for Human Centered Design

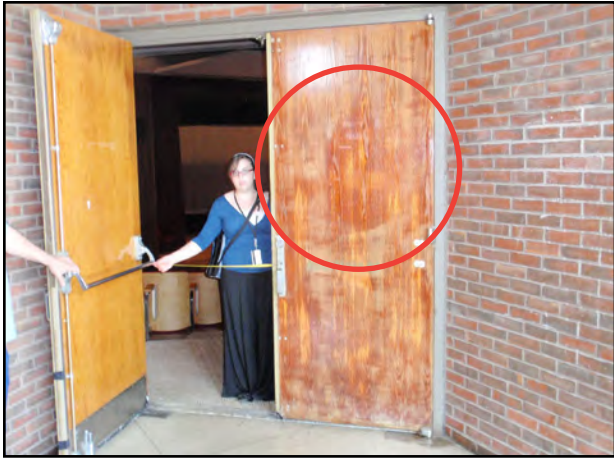
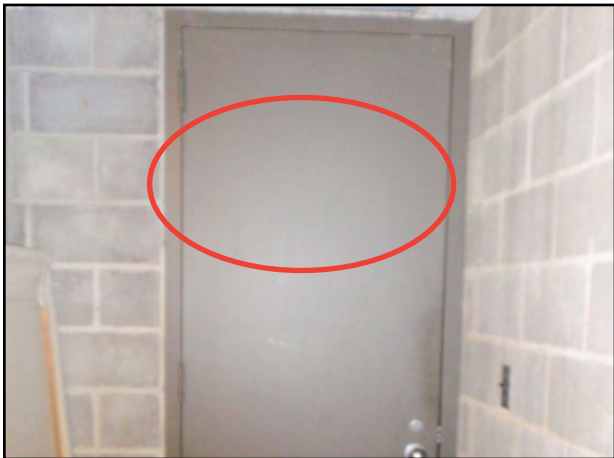
Signs - ADA Designation Signs
Designation signs throughout the floor are either missing or are not ADA compliant. This can cause confusion in an emergency situation.

RECOMMENDATION TO IMPROVE ADA COMPLIANCE CAPITAL IMPROVEMENT: As part of the Campus-wide wayfinding program provide ADA compliant signs on the latch pull side of the door mounted at 48" min AFF to the baseline of the tactile characters on signs and 60 inches maximum AFF or ground surface, measured from the baseline of the highest tactile character. If there is no room on the latch pull side place signs on wall perpendicular to the latch or on the door as long as the person reading the sign tactilely will not be injured if the door is opened.

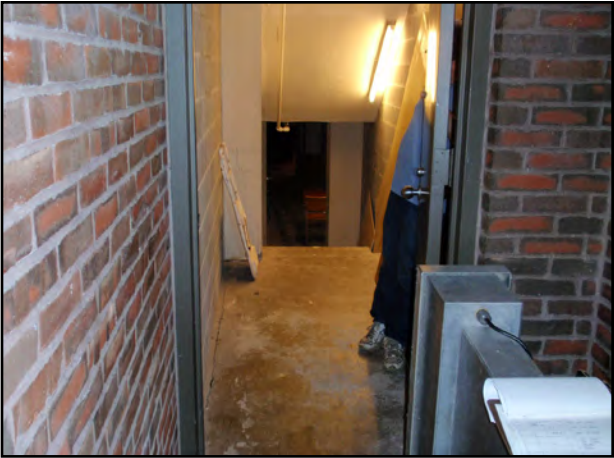
LOCATION | 103

RECOMMENDATION TO IMPROVE SAFETY & USER EXPERIENCE
 The clearance at this door is reduced by equipment, although this cannot be a wheelchair accessible route because there are stairs it is used as an egress door and should be 36" min. wide. **LOCATION | 101**

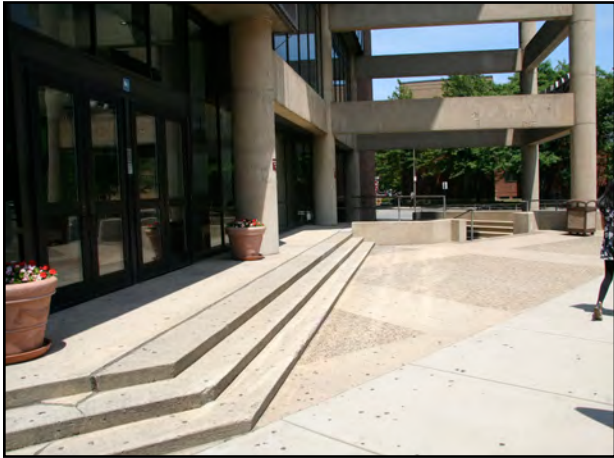
LOCATION | X102

Door - Opening forces
 The Huntington Avenue accessible entrance doors have an opening force of 20lbs. which is too heavy to be easily opened. **LOCATION | 101**

RECOMMENDATION TO IMPROVE ADA COMPLIANCE OPERATIONAL: Adjust all exterior doors so that they have an opening pressure that doesn't exceed 15lbs.

RECOMMENDATION TO IMPROVE SAFETY & USER EXPERIENCE
 Automatic door openers could be installed to help visitors enter and exit the building especially during peak traffic periods such as the during performances.

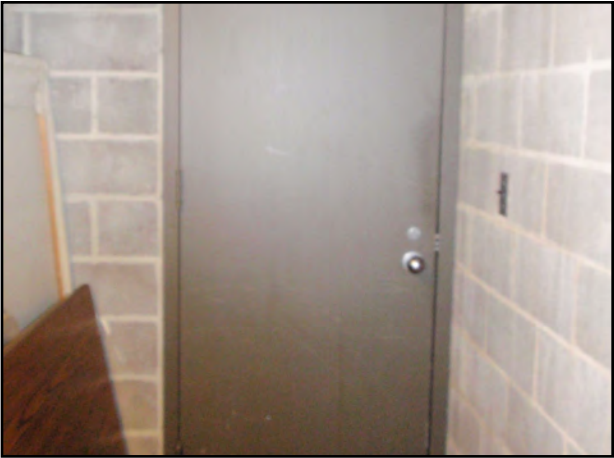
LOCATION | 101

Door Knobs
 Doors have door knob type hardware. A person who has limited dexterity would not be able to exit in an emergency.

RECOMMENDATION TO IMPROVE ADA COMPLIANCE OPERATIONAL: Replace all door knobs with lever type hardware.

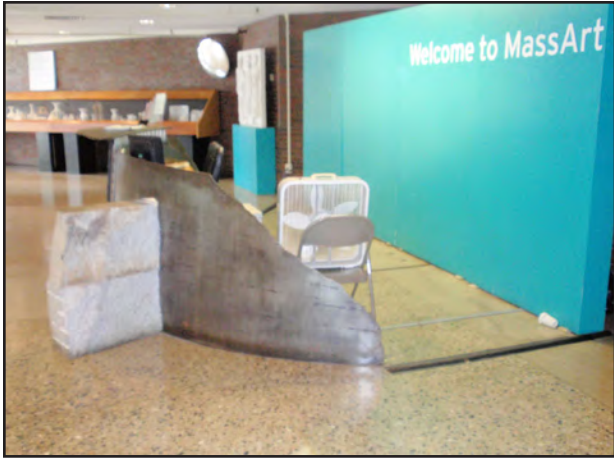
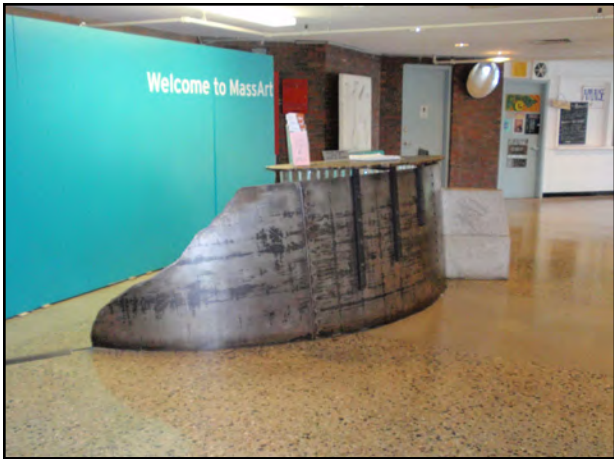
Signs - Directories

Directories are missing.

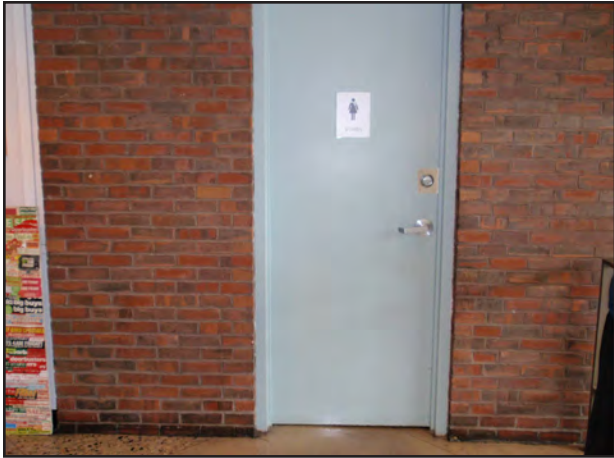
LOCATION | U03a

Toilet count

These toilet rooms serve the Auditorium. If the Auditorium is classified as A-1 Use group the number of fixtures required would be 9 WCs for Women, 2 WCs and 3 urinals for men and 3 lavatories (sinks) for each gender. [CMR 248]. This would require that at least one accessible toilet room for each gender and an alternative ADA stall. The current fixture count is much less than this. Alternatively if the alterations necessary to bring these multi-stall toilet rooms into compliance are infeasible, the addition of an accessible single-user toilet rooms in the same vicinity will be acceptable. Even better would be to install at least one accessible single-user toilet room on the first floor adjacent to the Auditorium.

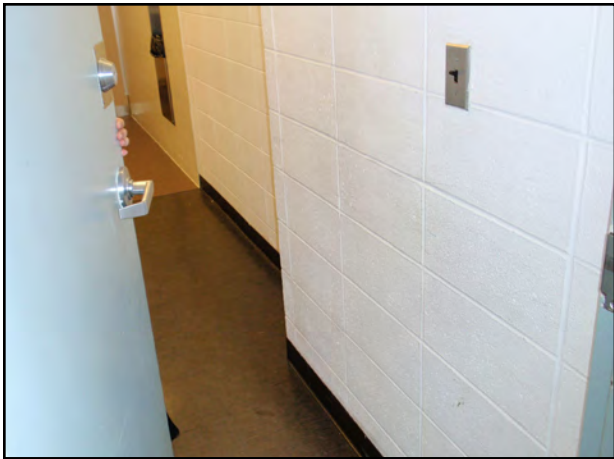
LOCATION | U03b

ADA Signs

CAPITAL IMPROVEMENT: he designation sign at both the men's and the women's toilet rooms are not ADA compliant for tactile letters, braille and location.
[See Appendix A -2010 ADA Standards 703 Signs-703.2, 703.3, 703.4]

RECOMMENDATION TO IMPROVE ADA COMPLIANCE
 CAPITAL IMPROVEMENT: As part of a Campus-wide wayfinding program install ADA compliant signs at correct location and height. Provide ADA sign with directions to nearest accessible toilet rooms. When necessary provide ADA compliant signs at the toilet rooms.

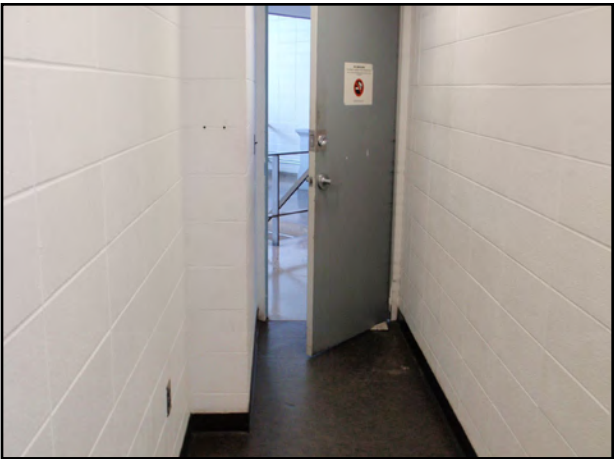
LOCATION | U03e

Door Clearance

Both the men's and women's toilet room doors are 32" min. wide and the door passage narrows to 37" there is not enough clearance room at this door for a wheelchair user.
[See Appendix A -2010 ADA Standards 603 Doors]

RECOMMENDATION TO IMPROVE ADA COMPLIANCE
 SMALL MAINTENANCE: Relocate doorway so that it is inset into the Toilet Room at the wider part of corridor. Ensure that there are the required clearances at latch pull side of the door or provide automatic door openers.

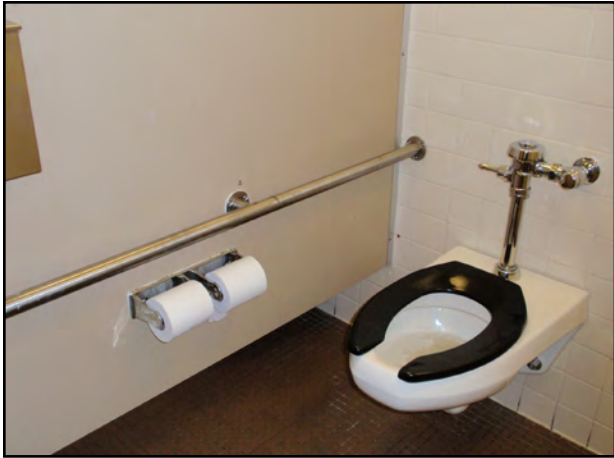
LOCATION | U03a

Water Closet

RECOMMENDATION TO IMPROVE ADA COMPLIANCE
SMALL MAINTENANCE: Reinstall water closet so
that the seat is max 17" AFF

SMALL MAINTENANCE: Reverse location of flush
so that it is on the open side of the toilet or
install automatic flush.

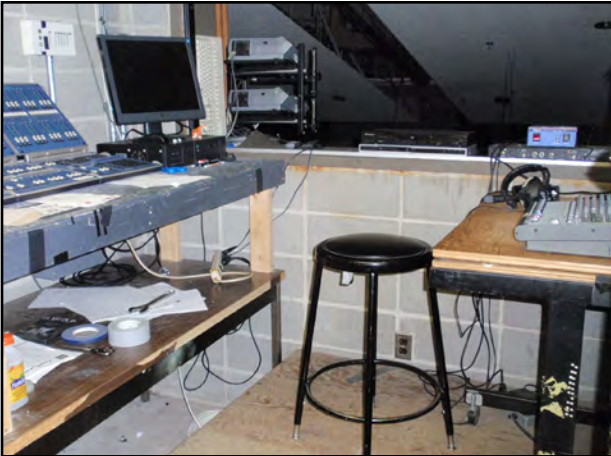
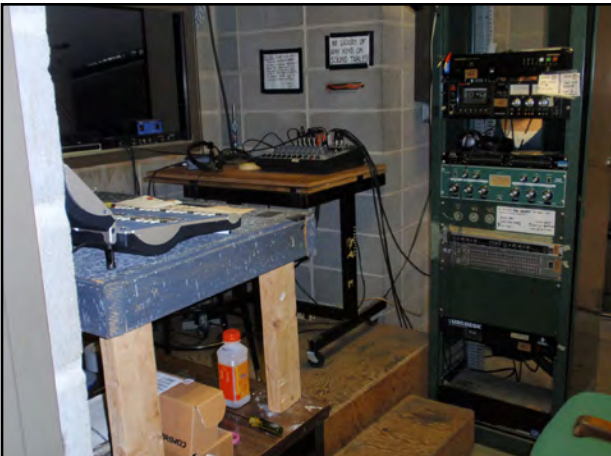
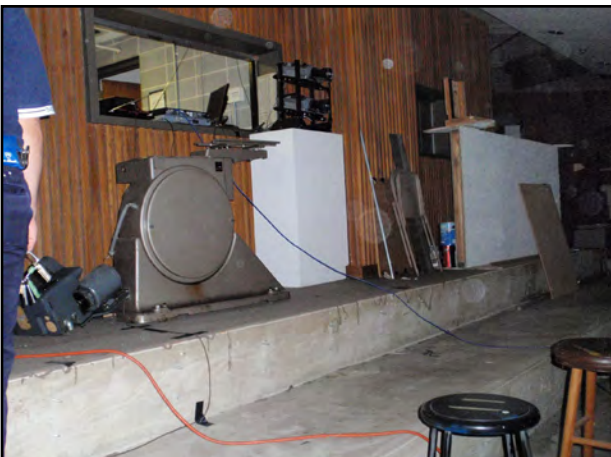
Aisle Obstruction - Furniture
 Arrangement of furniture clutters the classrooms and spaces and prevents easy access.

RECOMMENDATION TO IMPROVE ADA COMPLIANCE
 OPERATIONAL: Remove obstructions and educate staff, students and faculty to maintain a 36" min. wide clear circulation space through rooms, spaces and accessible routes at all times.

Safety & Usability Recommendation
 CAPITAL IMPROVEMENT: As part of a campus-wide wayfinding program wherever possible specify floor finishes and patterns to intuitively provide cues for keeping 36" min. wide clear spaces for routes and paths in rooms and through spaces.

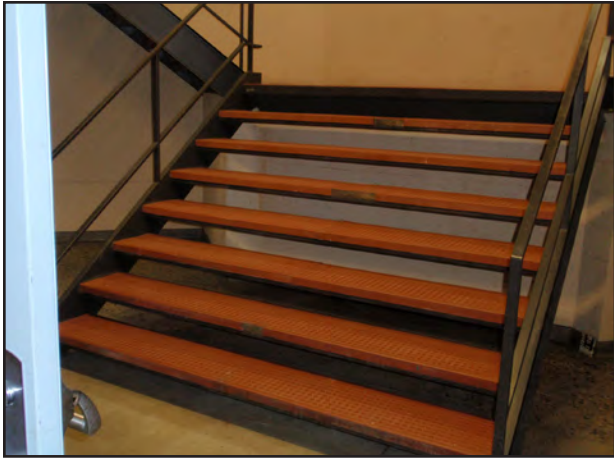
LOCATION | 205a

Stairs-open risers

These stairs are not on the main accessible route but the open risers are a tripping and falling hazard.

RECOMMENDATION TO IMPROVE ADA COMPLIANCE
SMALL MAINTENANCE: Close risers.

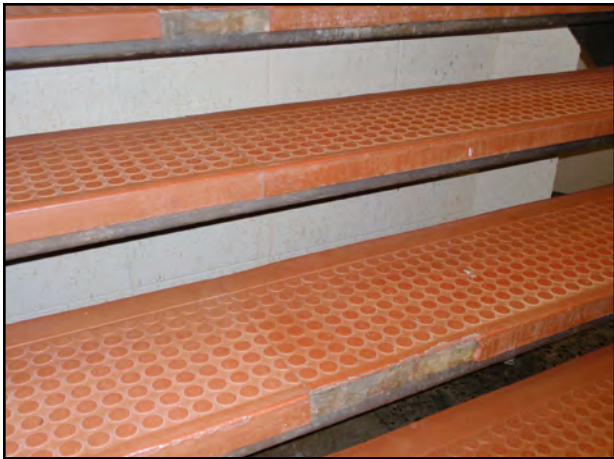
LOCATION | 202b

Nosings are greater than 1/2" and present a tripping hazard. **LOCATION | 202b**

RECOMMENDATION TO IMPROVE SAFETY & USER EXPERIENCE
SMALL MAINTENANCE: Ensure that nosings are not greater than 1/2"

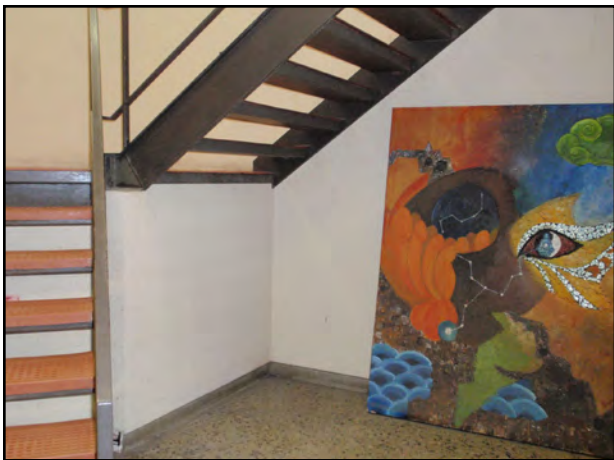
LOCATION | 205c

Stairs - Protruding Object

Area under stair is open and could cause a head injury. **LOCATION | 205c**

RECOMMENDATION TO IMPROVE ADA COMPLIANCE
SMALL MAINTENANCE: Prevent access to under-stair by installing a guard rail or enclose underside of stair with walls. This could become useful enclosed storage space.

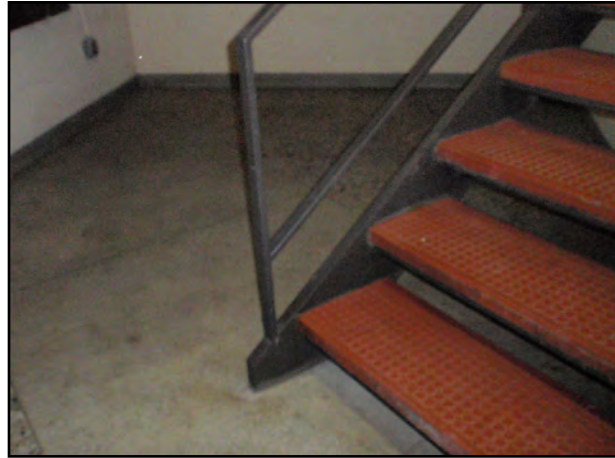
LOCATION | 205d

Stairs-Handrail

RECOMMENDATION TO IMPROVE ADA COMPLIANCE
SMALL MAINTENANCE: Provide handrail extensions.

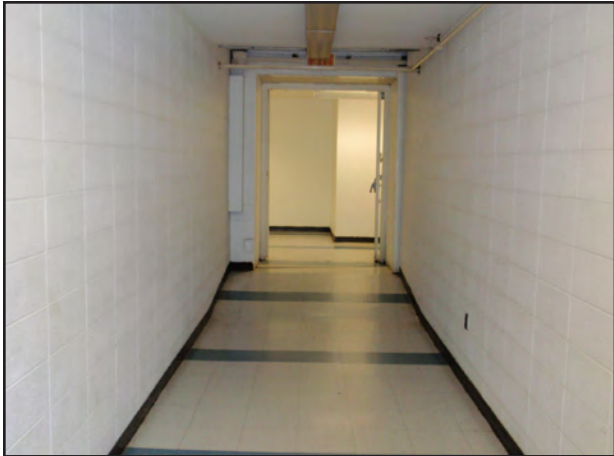
LOCATION | 203

Ramp
Ramp does not meet ADA standards for accessibility for slope.
*[See Appendix A -2010 ADA Standards
405 Ramps]*

RECOMMENDATION TO IMPROVE ADA COMPLIANCE
SMALL MAINTENANCE: Regrade ramp so that it is less than a 5% running slope and 2% cross slope. If the slope has to be 8.33% running slope, provide and/or If this ramp has a rise greater than 6" handrails with extensions must be provided on either side.

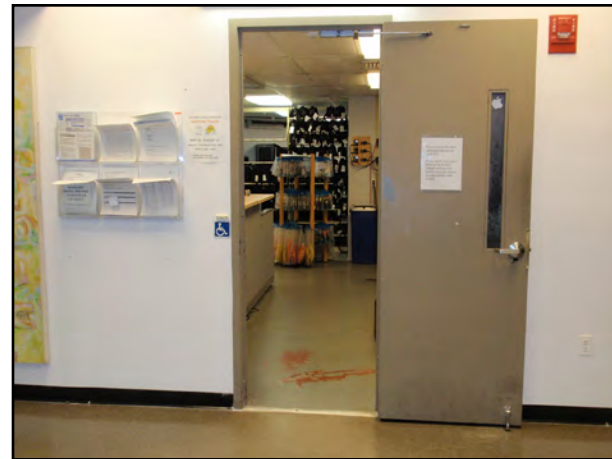
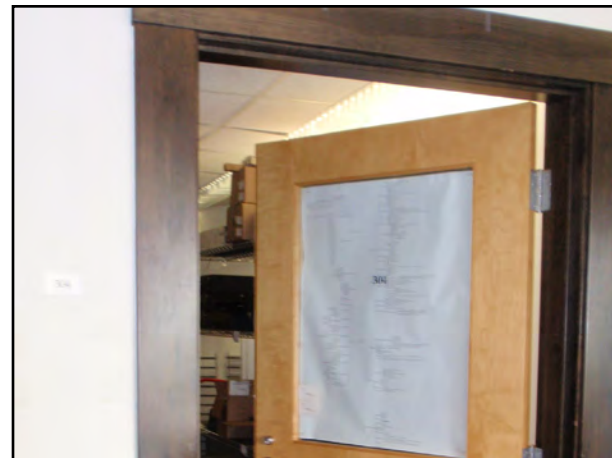
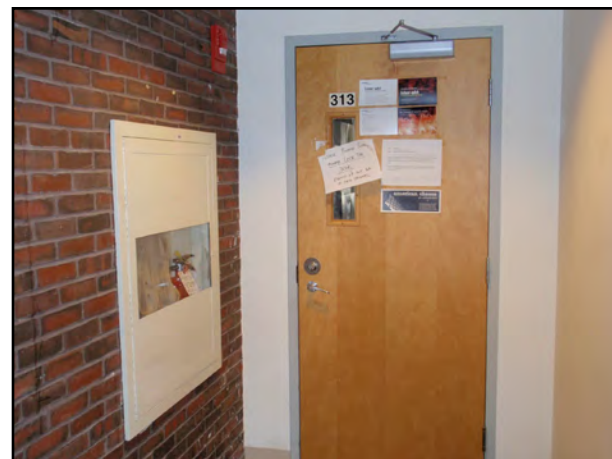
Signs - Designation & Directional Signs

CAPITAL IMPROVEMENT: Many tactilely read ADA compliant exit signs are missing from doors at exit passageways, exit discharge, and exit stairways.

INTERIM RECOMMENDATION
Until modifications are complete provide 2010 ADA Standards compliant signage to direct users to nearest accessible toilet room and other accessible amenities.

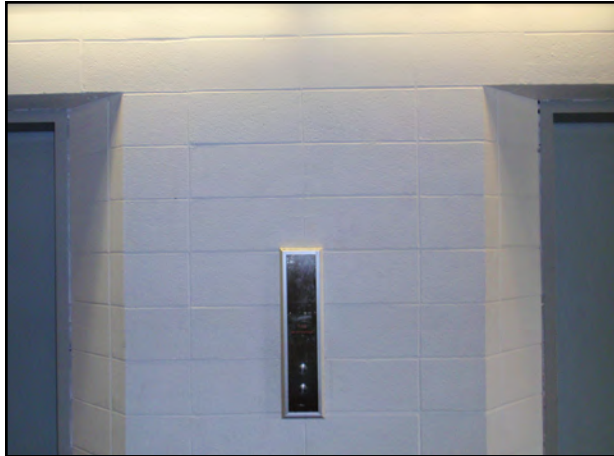
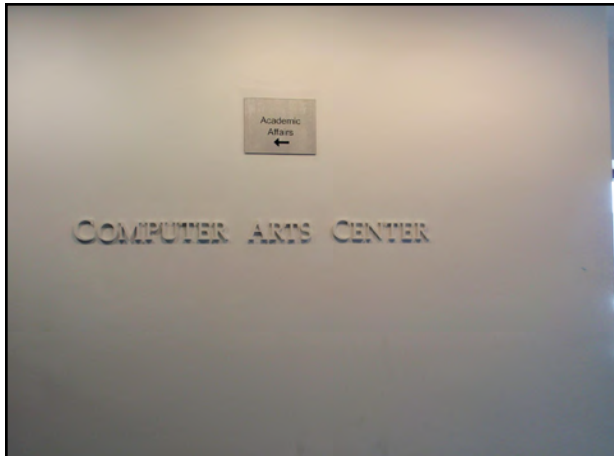
Signs - Directories

RECOMMENDATION TO IMPROVE SAFETY & USER EXPERIENCE
CAPITAL IMPROVEMENT: As part of a campus-wide wayfinding program consider putting a Directory at all elevator and stair lobbies. This will provide information about locations of services and accessible amenities on each floor and will allow people who have mobility difficulties to be able to see where they need to go without having to backtrack.

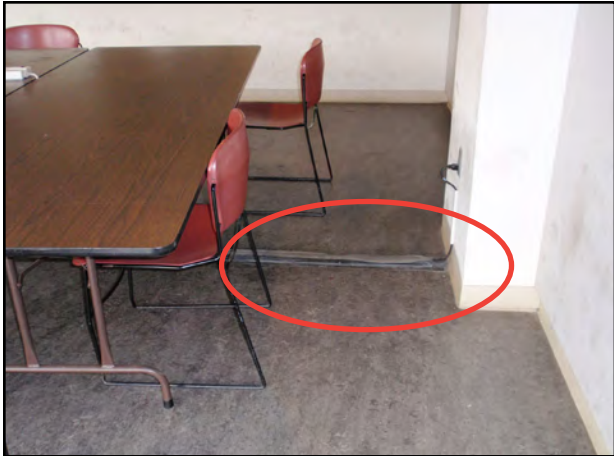
LOCATION | Typical

Aisle Obstruction - Wire management

Wires cross the floors creating an egress safety and tripping hazard in the accessible route.
 [See Appendix A -2010 ADA Standards
 206 Accessible Routes 401, 402, 403.5.1 Clearances]

RECOMMENDATION TO IMPROVE ADA COMPLIANCE
 OPERATIONAL: Manage wiring so that floors remain clear and educate staff, students and faculty to maintain a 36" min. wide clear circulation space through rooms, spaces and accessible routes at all times.

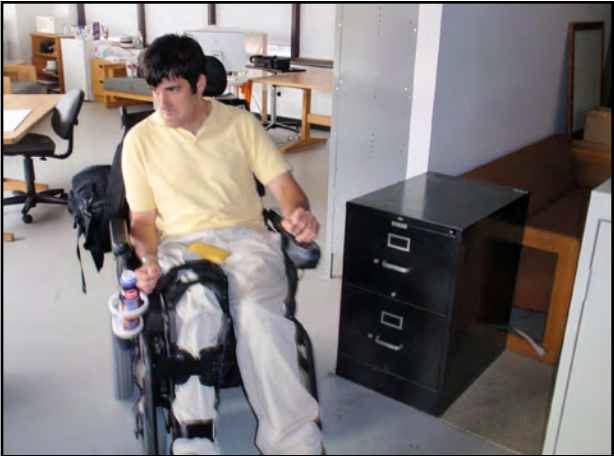
LOCATION | 304

Aisle Obstruction - Furniture

RECOMMENDATION TO IMPROVE ADA COMPLIANCE
 OPERATIONAL: Remove obstructions and educate staff, students and faculty to maintain a 36" min. wide clear circulation space through rooms, spaces and accessible routes at all times.

CAPITAL IMPROVEMENT: As part of a campus-wide wayfinding program wherever possible specify floor finishes and patterns to intuitively provide cues for keeping 36" min. wide clear spaces for routes and paths in rooms and through spaces.

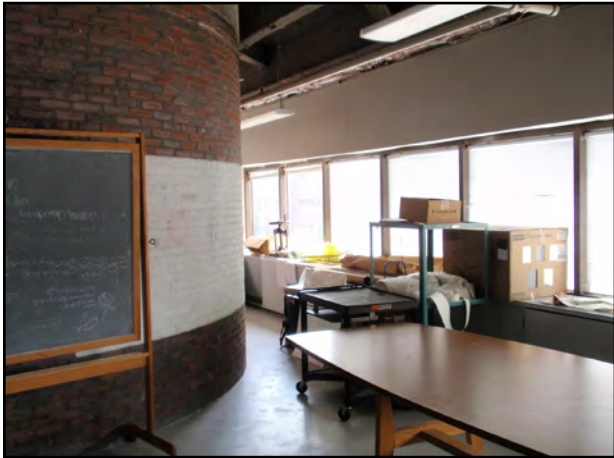
LOCATION | 304

Aisle Obstruction - Furniture
Arrangement of furniture clutters the classrooms and spaces and prevents easy access.
[See Appendix A -2010 ADA Standards 206 Accessible Routes 401, 402, 403.5.1 Clearances]

RECOMMENDATION TO IMPROVE ADA COMPLIANCE OPERATIONAL: Remove obstructions and educate staff, students and faculty to maintain a 36" min. wide clear circulation space through rooms, spaces and accessible routes at all times.

RECOMMENDATION TO IMPROVE SAFETY & USER EXPERIENCE CAPITAL IMPROVEMENT: As part of a Campus-wide wayfinding program wherever possible specify floor finishes and patterns to intuitively provide cues for keeping 36" min. wide clear spaces for routes and paths in rooms and through spaces.

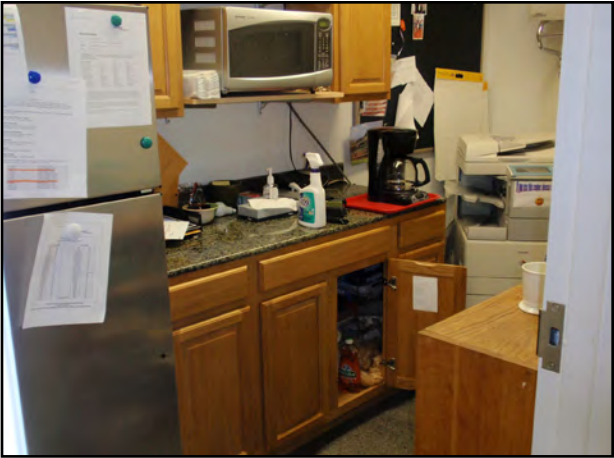
LOCATION | Typical

Aisle Obstruction
There is no maneuvering clearance in the kitchenette, a person using a wheelchair would not be able to use this kitchenette.
[See Appendix A -2010 ADA Standards 206 Accessible Routes 401, 402, 403.5.1 Clearances]

RECOMMENDATION TO IMPROVE ADA COMPLIANCE OPERATIONAL: Remove cabinet opposite the sink to allow for a wheelchair to turn around.

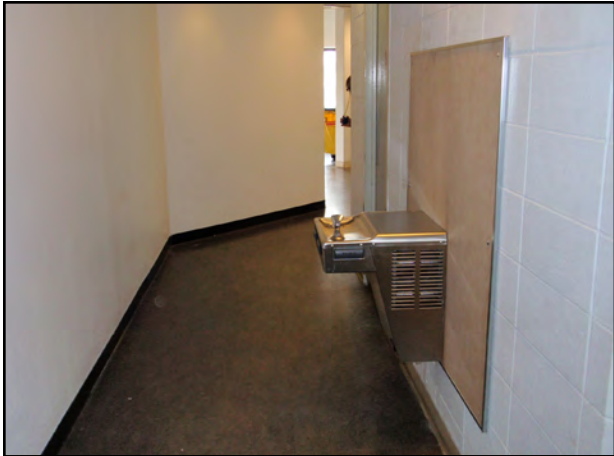
LOCATION | 315

Protruding Objects

OPERATIONAL: Protruding objects are not only a cause of injury to people who have no or low vision but to anyone walking down a corridor especially in an emergency or if they are passing in a corridor. Furthermore there is a risk that the fire hydrant will get knocked and become damaged.

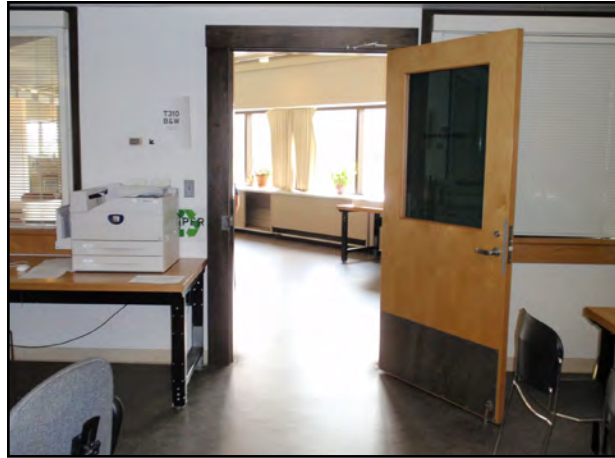
LOCATION | 303

Door Clearance - Maneuvering clearance

[See Appendix A -2010 ADA Standards 404.2.8 Door Clearances]

RECOMMENDATION TO IMPROVE ADA COMPLIANCE OPERATIONAL: Create a comprehensive maintenance program and educate staff, faculty and students to maintain 18" latch side maneuvering clearances at doors.

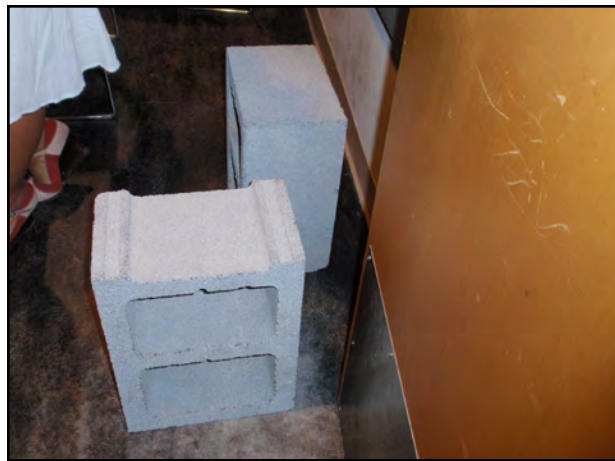
LOCATION | Typical

Door Clearance - Obstruction

CMU blocks are used to keep doors open but also create a tripping hazard and make the entranceway less than 32" min. clear.

[See Appendix A -2010 ADA Standards 404.2.8 Door Clearances]

RECOMMENDATION TO IMPROVE ADA COMPLIANCE OPERATIONAL: Provide small door stop wedges and create a comprehensive maintenance program to educate staff, faculty and students to maintain 32" mn. clearances at and around doors.

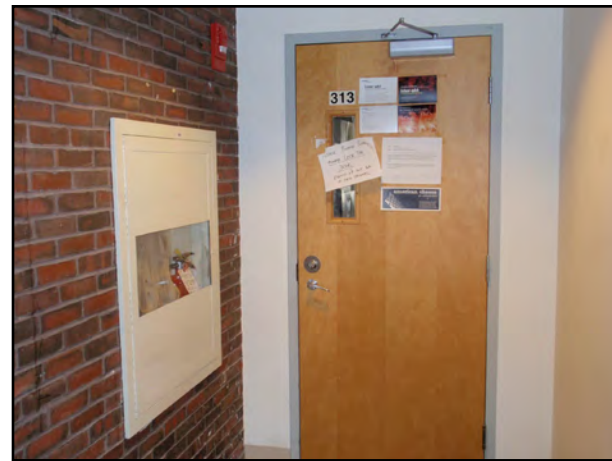
LOCATION | 304

Door Hardware - Closer and knob

This door is used as an exit door and has many issues: the door hardware is a knob so someone who cannot use a tight grasp will not be able to open the door or escape in case of emergency, there is a glazed area that is at 51 1/2" AFF to the bottom of the glazing so that someone sitting will not be able to see into the room, there is not enough maneuvering space at the latch side of the door, the door closer is set to an opening force greater than 5lb, the designation sign is not ADA compliant and there is no exit signage.

RECOMMENDATION TO IMPROVE ADA COMPLIANCE SMALL MAINTENANCE: If this door is to be used as an exit door (currently it is the only entry and exit to this space) all of the above are required to be corrected.

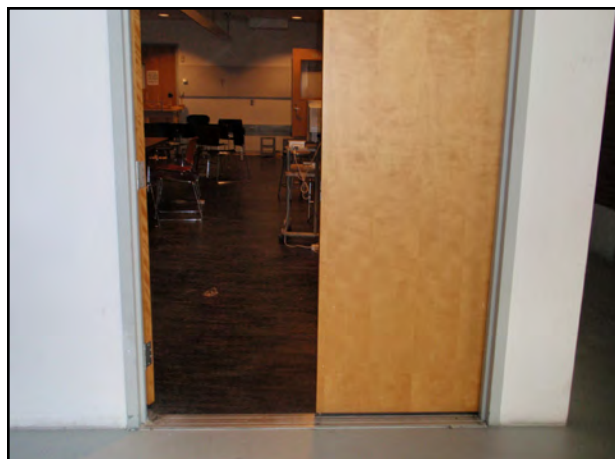
LOCATION | 303

Door Clearance - Double doors

RECOMMENDATION TO IMPROVE ADA COMPLIANCE OPERATIONAL: Keep doors open at all times or provide automatic opening doors or reinstall asymmetrical leaves with one operable leaf measuring no less than 36" min. so that there is a clear width of 32" min. when the door is opened at 90 degrees.

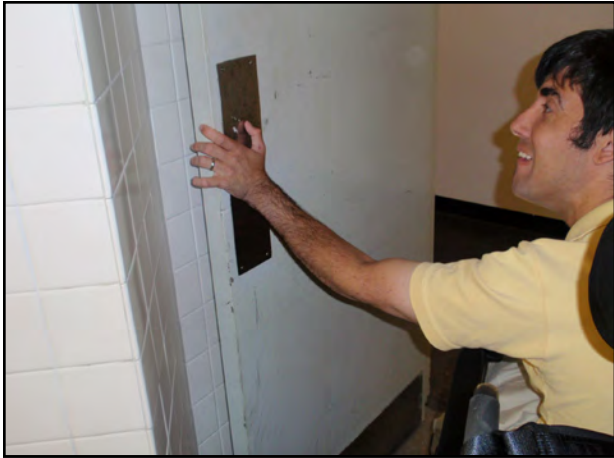
LOCATION | 313a

ADA Facilities and Amenities

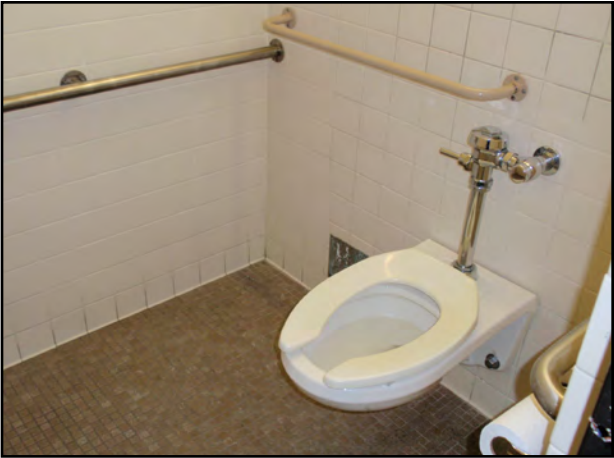
LOCATION | 313d

Water Closet Installation - Distance

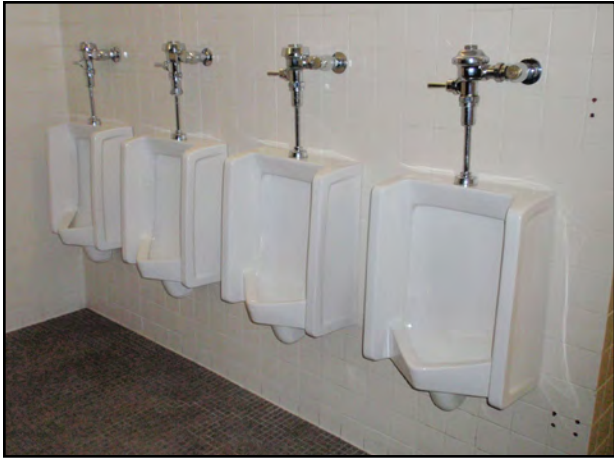
LOCATION | 313g

Urinal - Height

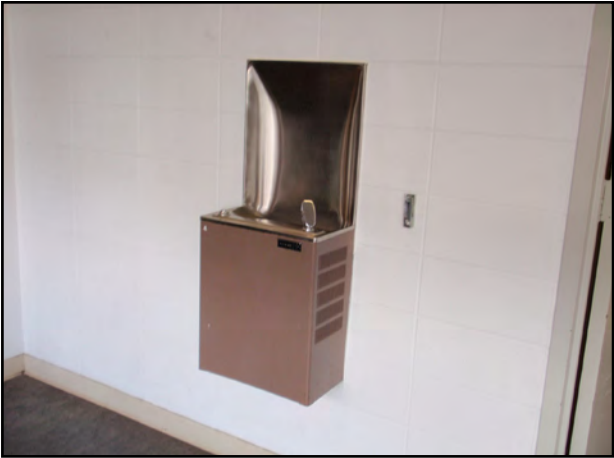
LOCATION | Typical

Drinking Fountains
 Do not have two spouts at heights that allow a person in a wheelchair and a person who has trouble bending to be able to use.
[See Appendix A -2010 ADA Standards 307, 602 Drinking Fountains]

RECOMMENDATION TO IMPROVE ADA COMPLIANCE
 Provide cups with dispenser and trash that doesn't protrude from the wall more than 4" and within reach range.

or
 Replace with a High-Low drinking fountain that complies with 2010 ADA standards 211, 307, 602 601, 602.

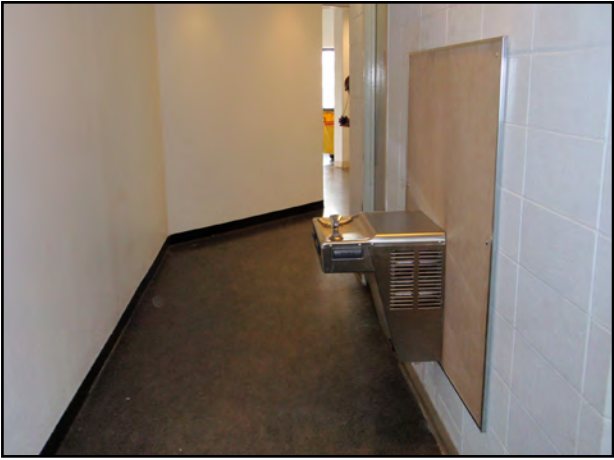
LOCATION | 315

Drinking Fountain - Protruding Object
 Drinking fountain protrudes 27" into accessible route, it could cause injury even though it is in the cane detectable range for height.
[See Appendix A -2010 ADA Standards 307, 602 Drinking Fountains]

RECOMMENDATION TO IMPROVE ADA COMPLIANCE
 Replace drinking fountain with High-Low model and relocate to a site that is easily accessible and is recessed into an alcove so that it isn't protruding into the accessible route more than 4".

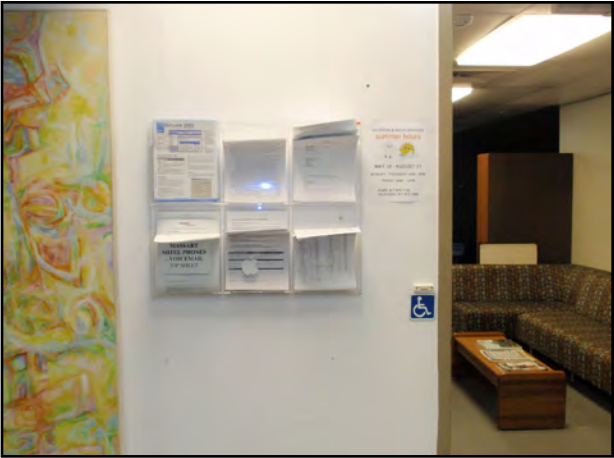
LOCATION | 311

Brochure Holder
 The height that the brochure holder is mounted at is not ADA compliant for height, and reach range
[See Appendix A -2010 ADA Standards Reach Range 308]

RECOMMENDATION TO IMPROVE ADA COMPLIANCE
 SMALL MAINTENANCE: Reinstall the brochure holder so that the highest brochure is max. 48" AFF.

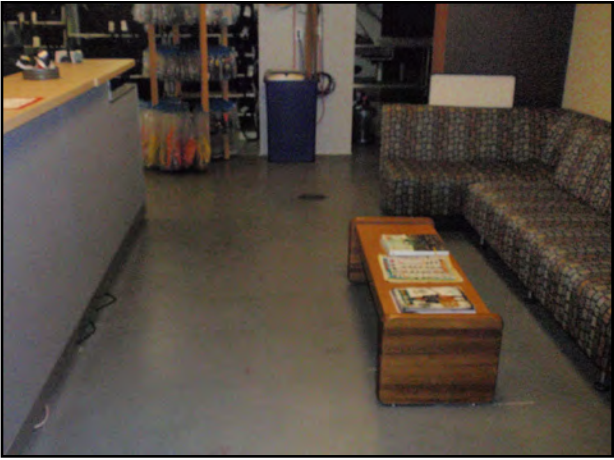
LOCATION | 311

Fixed Furniture
 Counter height is 43 3/4" AFF
[See Appendix A -2010 ADA Standards Service Counters 904.4.1]

RECOMMENDATION TO IMPROVE SAFETY & USER EXPERIENCE
 This room has an accessible sign however the door is only 29" wide, the International Symbol of Accessibility is an internationally recognized sign and its misuse can lead to confusion and could be a life safety risk.

RECOMMENDATION TO IMPROVE ADA COMPLIANCE
 SMALL MAINTENANCE: Make sure that at least a 36" min. portion of the counter is lowered to 36" AFF for a parallel approach.

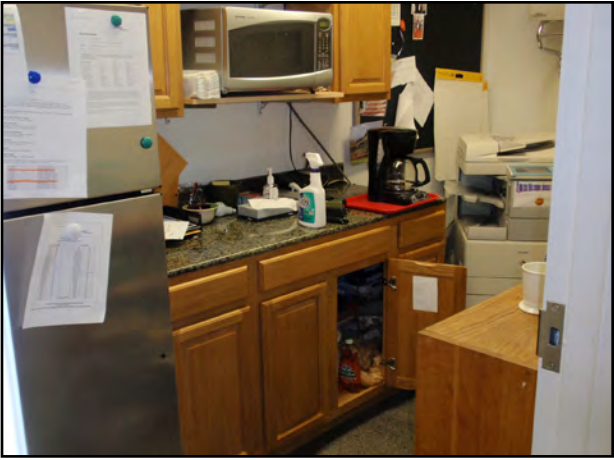
LOCATION | 311

Appliances
 Microwave is out of reach range.
[See Appendix A -2010 ADA Standards Kitchens & Kitchenettes 804]

RECOMMENDATION TO IMPROVE ADA COMPLIANCE
 SMALL MAINTENANCE: Provide a counter top microwave that could be used at the modified accessible counter. Provide knee clearance for someone who is sitting to be able to work at the counter.

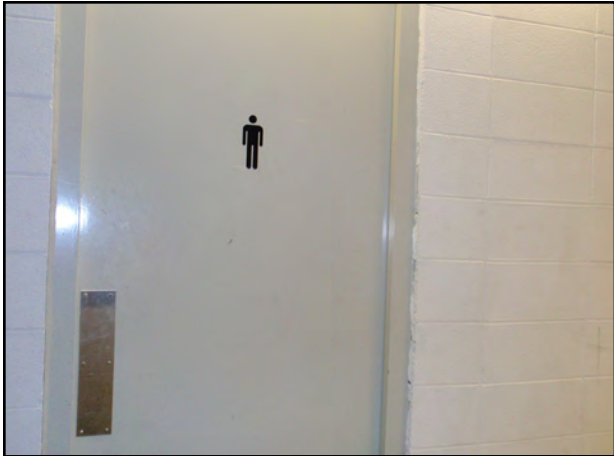
LOCATION | 414

Signs - ADA Facilities and Amenities

CAPITAL IMPROVEMENT: Ensure that all ADA compliant toilet rooms are noted on the Directories on each floor level.

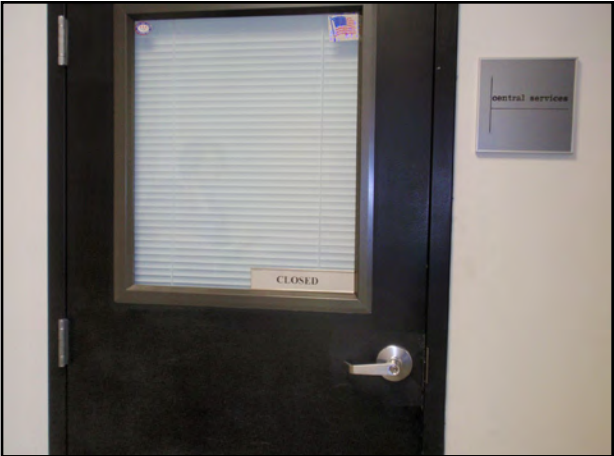
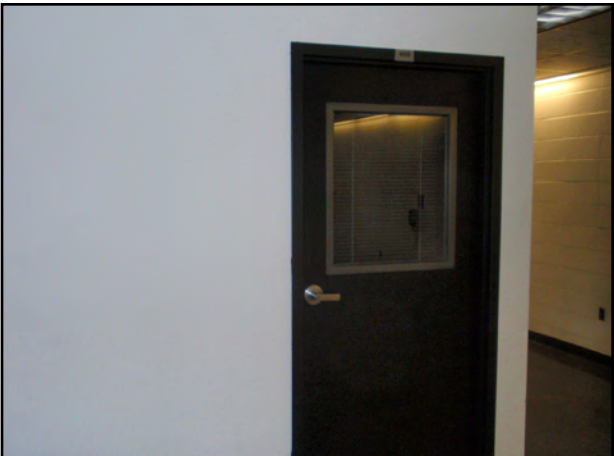
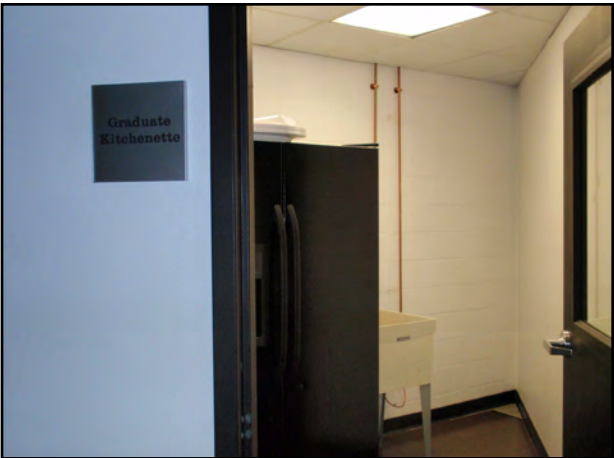
Signs - Designation & Directional Signs

CAPITAL IMPROVEMENT: Many tactilely read ADA compliant exit signs are missing from doors at exit passageways, exit discharge, and exit stairways.

INTERIM RECOMMENDATION
Until modifications are complete provide 2010 ADA Standards compliant signage to direct users to nearest accessible toilet room and other accessible amenities.

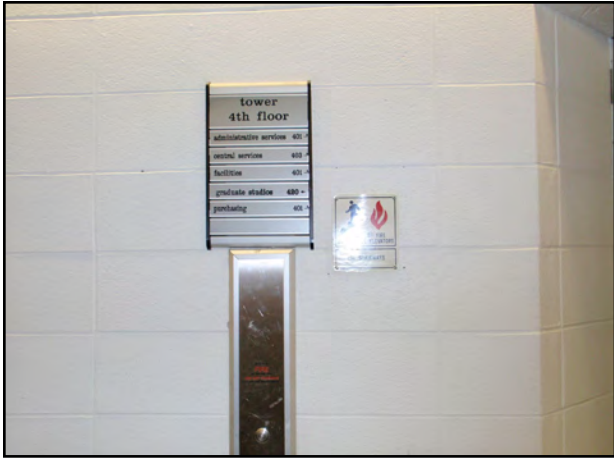
LOCATION | 401

Signs - Directories

RECOMMENDATION TO IMPROVE SAFETY & USER EXPERIENCE
CAPITAL IMPROVEMENT: As part of a campus-wide wayfinding program consider putting a Directory at all elevator and stair lobbies. This will provide information about locations of services on each floor and will allow people who have mobility difficulties to be able to see where they need to go without having to backtrack.

Make certain that the Directory information corresponds to the program & physical space usage. There should be one updated centralized source providing this information. The floor levels in elevators, published materials and virtual information should also coordinate. Be sure to add information regarding the accessible toilet after the toilet rooms have been modified to be compliant. Location information should be consistent and coordinated throughout the campus.

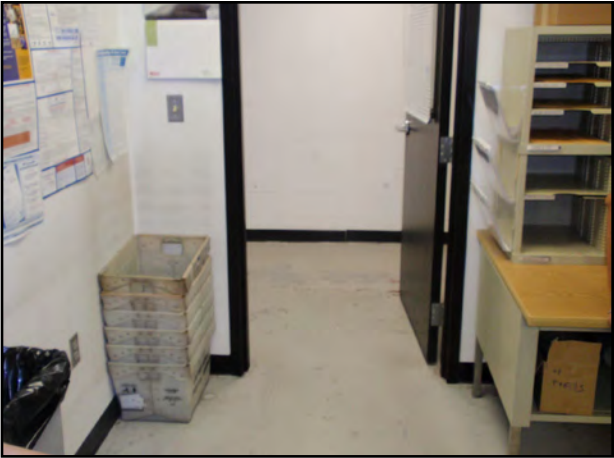
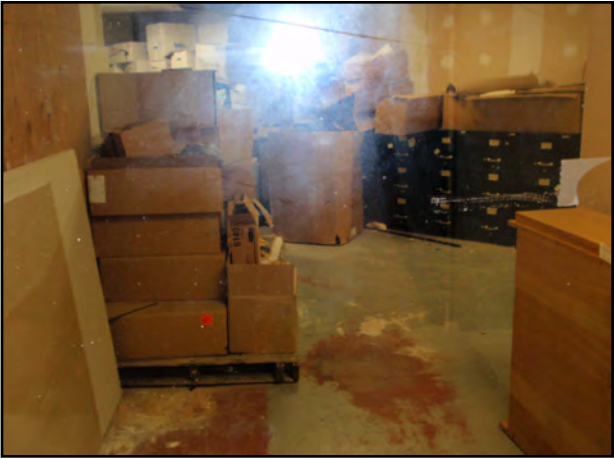
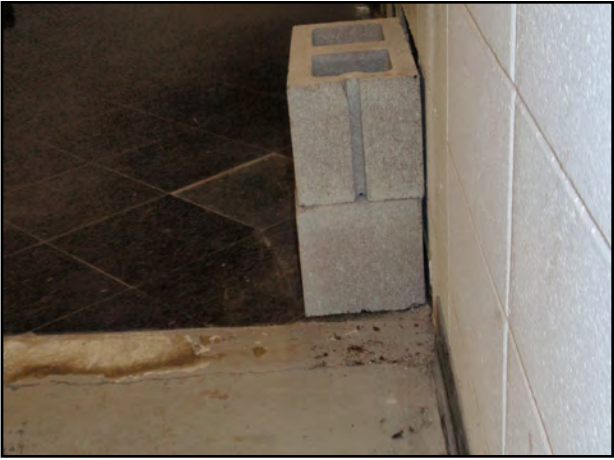
Aisle Obstruction - Furniture

RECOMMENDATION TO IMPROVE ADA COMPLIANCE
OPERATIONAL: Remove obstructions and educate staff, students and faculty to maintain a 36" min. wide clear circulation space through rooms, spaces and accessible routes at all times.

RECOMMENDATION TO IMPROVE SAFETY & USER EXPERIENCE
CAPITAL IMPROVEMENT: As part of a campus-wide wayfinding program wherever possible specify floor finishes and patterns to intuitively provide cues for keeping 36" min. wide clear spaces for routes and paths in rooms and through spaces.

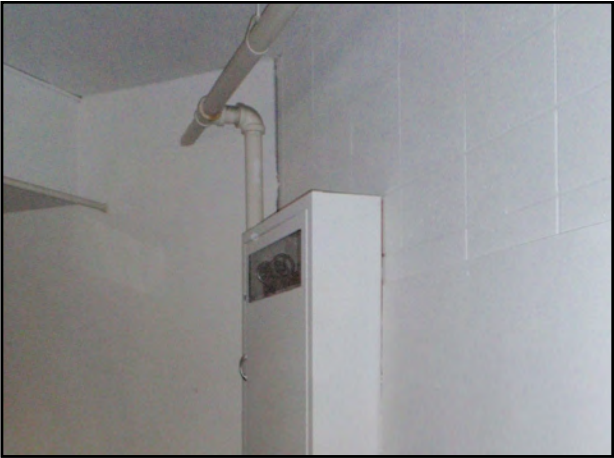
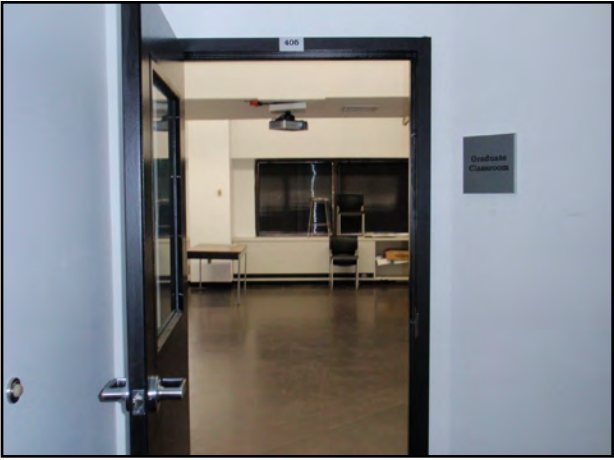
Protruding Objects
 Objects that protrude more than 4” from the wall and are more than 27” high off the floor creating an injury risk. Additionally a person using a cane would not be able to detect these objects.

RECOMMENDATION TO IMPROVE ADA COMPLIANCE
SMALL MAINTENANCE PROJECT: If feasible enclose objects with side panels that extend to the floor so that they can be detected by a person with a cane.

RECOMMENDATION TO IMPROVE SAFETY & USER EXPERIENCE
OPERATIONAL: Protruding objects are not only a cause of injury to people who have no or low vision but to anyone walking down a corridor especially in an emergency. Furthermore there is a risk that the object will get knocked and become damaged.

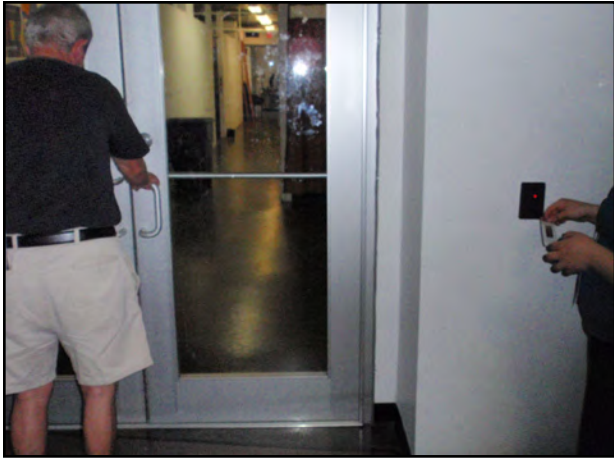
LOCATION | 405

Door - Maneuvering Spaces

OPERATIONAL: Furniture and other obstacles obstruct the clearances at doors.
[See Appendix A -2010 ADA Standards 404.2.8 Door Closers]

RECOMMENDATION TO IMPROVE ADA COMPLIANCE
OPERATIONAL: Ensure that areas in front of and beyond doors have required clearances and are not being obstructed.

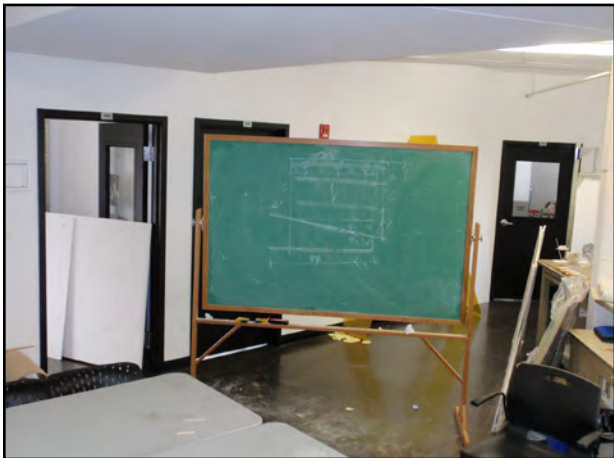
LOCATION | 403

Door Closers

Door opening forces are greater than 5lbs which makes doors difficult to open, especially for a person in a wheelchair.
[See Appendix A -2010 ADA Standards 404.2.8 Door Closers]

RECOMMENDATION TO IMPROVE ADA COMPLIANCE
OPERATIONAL: Create a comprehensive maintenance program and schedule to check and adjust all interior doors so that they have an opening pressure that doesn't exceed 5 lbs.

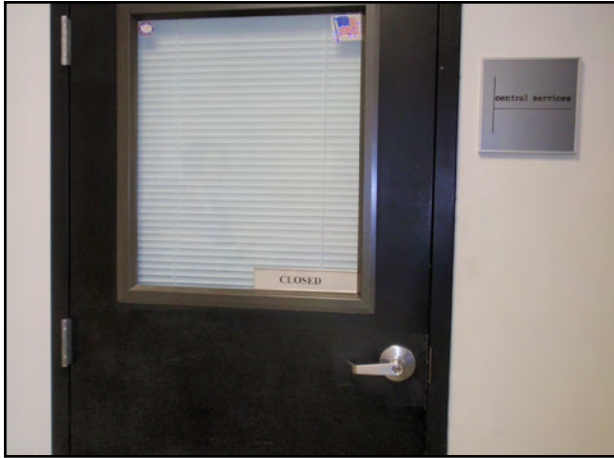
LOCATION | 406 Furniture and other obstacles

Door Windows

RECOMMENDATION TO IMPROVE ADA COMPLIANCE
OPERATIONAL: Either replace door so that the bottom of the glazed area is max. 43" AFF **or** keep glazed area covered as with this door.

ISSUE D3
SMALL MAINT. PROJECT
 Cover glazed areas with blinds.
 \$100/door

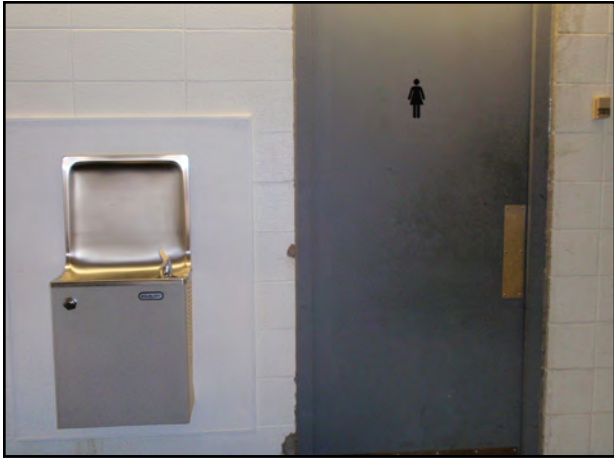
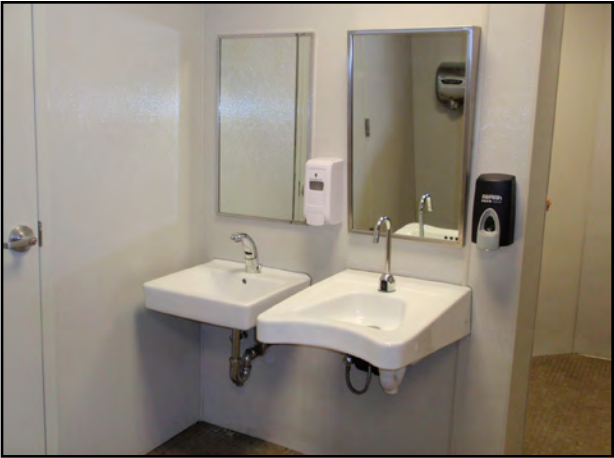
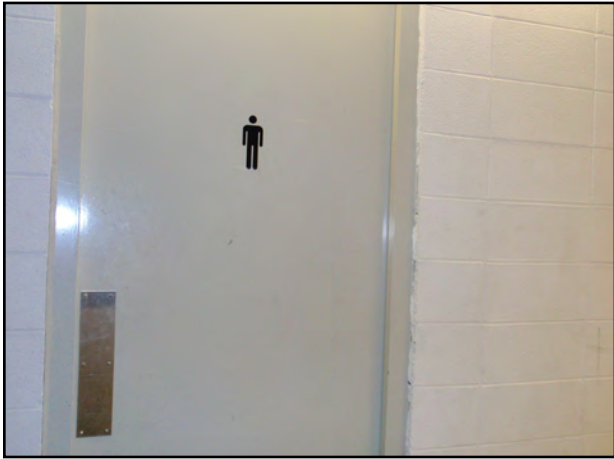
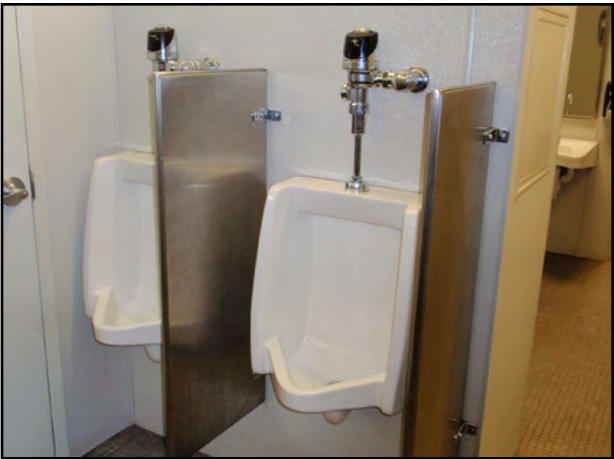
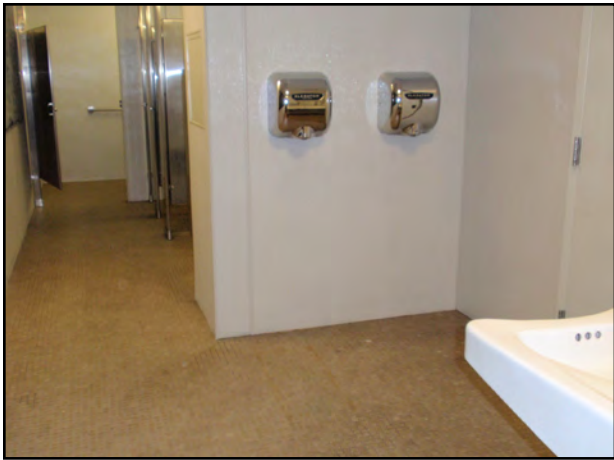
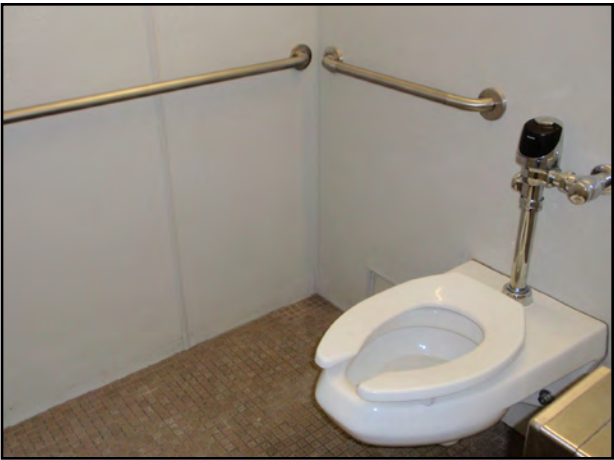
ISSUE F
CAPITAL IMPROV.
 To make this toilet room accessible- would require extensive modifications. Consider creating at least one new alternative accessible single-user toilet room on this floor.

INTERIM RECOMMENDATION
 Until modifications are complete provide 2010 ADA Standards compliant signs to direct users to nearest accessible toilet room even if it is in another building.

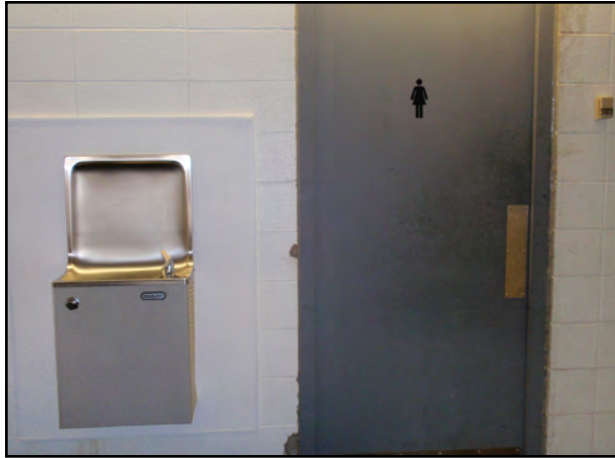
LOCATION | 411

Drinking Fountain - Protruding Object

RECOMMENDATION TO IMPROVE ADA COMPLIANCE
 Provide cups with dispenser and trash receptacle that doesn't protrude from the wall more than 4" and is within reach range and build wing walls to form an alcove with a clear with of 36" min.

Replace with a High-Low drinking fountain that complies with 2010 ADA standards 211, 307, 602 601, 602. To ensure that the drinking fountain does not protrude more than 4" into the accessible route or circulation provide an alcove.
