Massachusetts College of Art and Design

ADA Compliance Plan 2011

ADA Compliance Plan
Consultant Services
Contract #10-08

The Institute for Human Centered Design

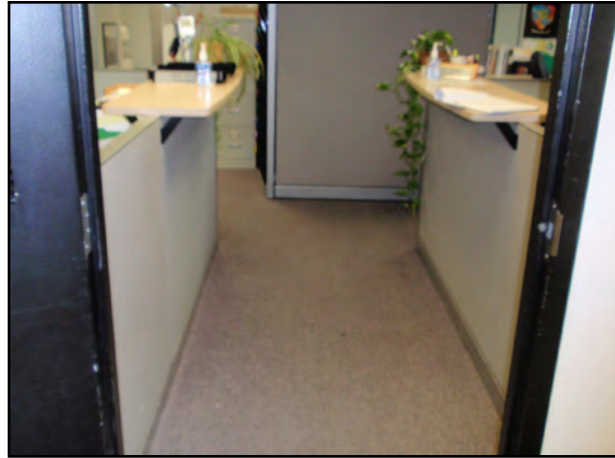
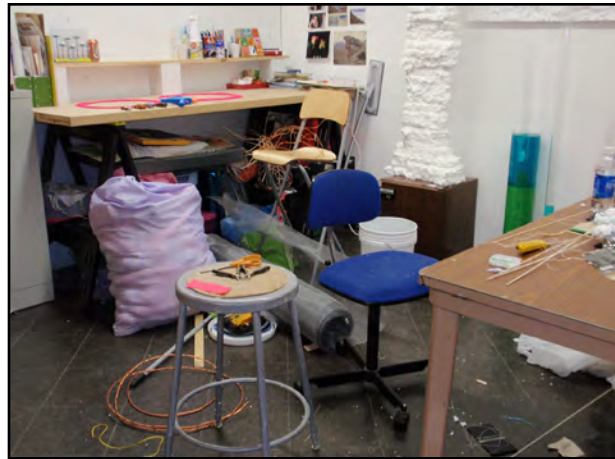
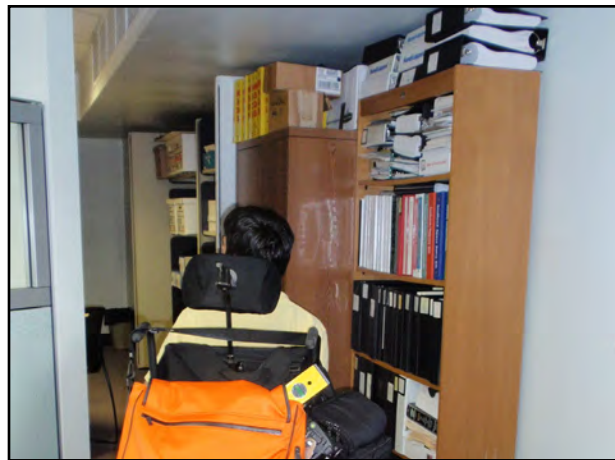
Furniture - Counter

RECOMMENDATION TO IMPROVE ADA COMPLIANCE
SMALL MAINTENANCE: Make sure that at least a 36" min. portion of the counter is lowered to 36" AFF for a parallel approach.

RECOMMENDATION TO IMPROVE ADA COMPLIANCE
 Make sure that there is at least 5% but no less than one storage area that is ADA compliant. The preference would be for two.

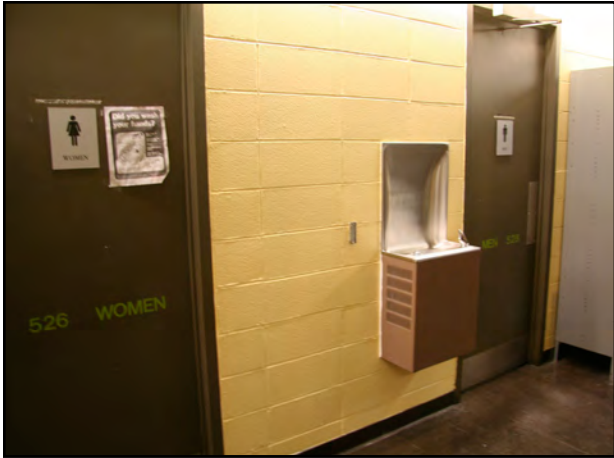
LOCATION | 508

Signs - ADA Facilities and Amenities

CAPITAL IMPROVEMENT: Ensure that all ADA accessible toilet rooms are noted on the Directories on each floor level.

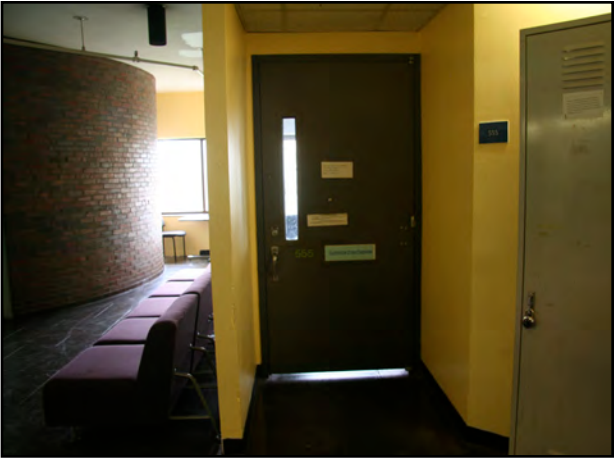
LOCATION | 514

Signs - Designation & Directional Signs

CAPITAL IMPROVEMENT: as part of the campus -wide wayfinding ensure that all floor have signs that indicate floor level. These signs should always be located adjacent to stairs and in elevator lobbies.

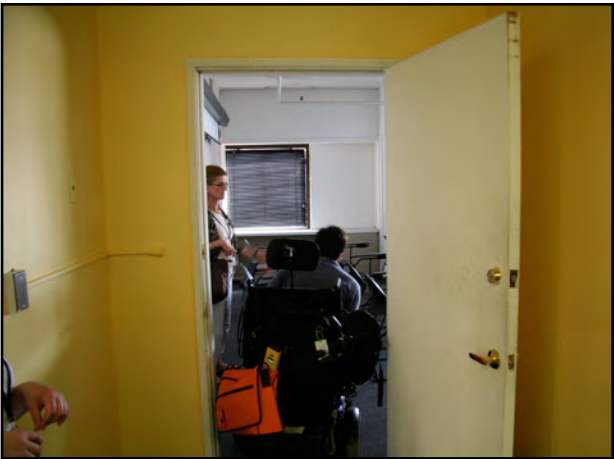
LOCATION | 502

Signs - Exit Doors & Passageways

CAPITAL IMPROVEMENT: Many tactilely read ADA compliant exit signs are missing from doors at exit passageways, exit discharge, and exit stairways.

Implement an overall inspection of fire safety signs making sure they are ADA, NFPA and 527 CMR compliant and are lit if required and are in the correct locations according to code.

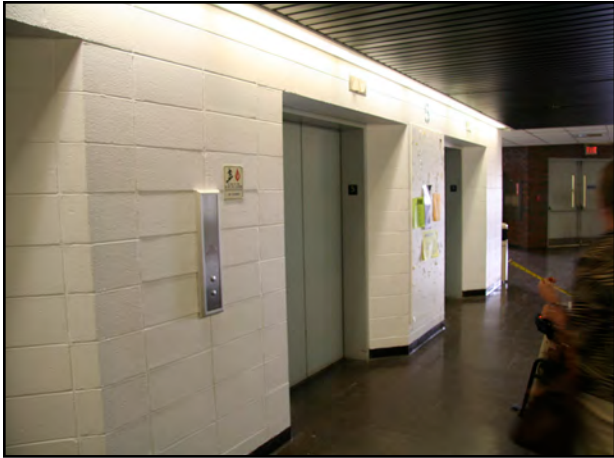
LOCATION | 501

Signs - Directories

RECOMMENDATION TO IMPROVE SAFETY & USER EXPERIENCE
CAPITAL IMPROVEMENT: As part of a campus-wide wayfinding program consider putting a Directory at all elevator and stair lobbies. This will provide information about locations of services on each floor and will allow people who have mobility difficulties to be able to see where they need to go and to prevent backtracking.

Make certain that the Directory information corresponds to the program & physical space usage. There should be one updated centralized source providing this information. The floor levels in elevators, published materials and virtual information should also coordinate. Be sure to add information regarding the accessible toilet after the toilet rooms have been modified to be accessible. Location information should be consistent and coordinated throughout the campus.

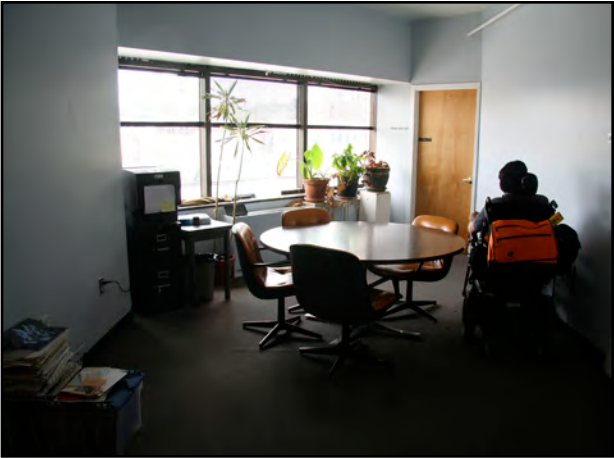
LOCATION | Typical

Aisle Obstruction - Furniture

RECOMMENDATION TO IMPROVE ADA COMPLIANCE
OPERATIONAL: Remove obstructions and educate staff, students and faculty to maintain a 36" min. wide clear space through rooms, spaces and accessible routes at all times.

RECOMMENDATION TO IMPROVE SAFETY & USER EXPERIENCE
CAPITAL IMPROVEMENT: As part of a campus-wide wayfinding program wherever possible specify floor finishes and patterns to intuitively provide cues for keeping 36" min. wide clear spaces for routes and paths in rooms and through spaces.

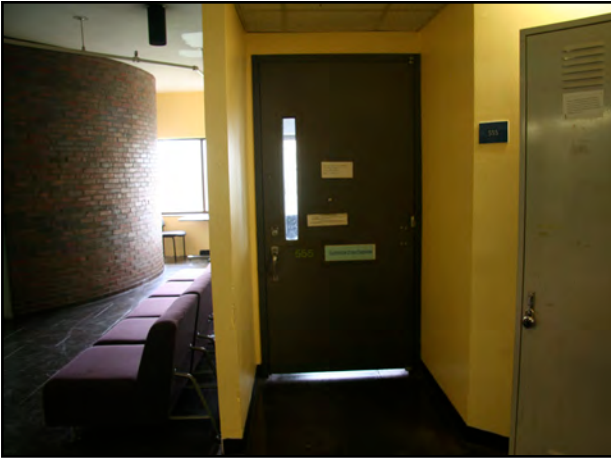
LOCATION | 514 (T555 no latch pull side clearance)

RECOMMENDATION TO IMPROVE ADA COMPLIANCE OPERATIONAL: Remove all obstructions from around entrances and doorways. If the required clearances at the latch pull side of the door do not exist due to constricted walls relocate class to classroom with ADA accessible door clearances. Alternatively ensure that the door is held open during office hours or anytime the room is in use.

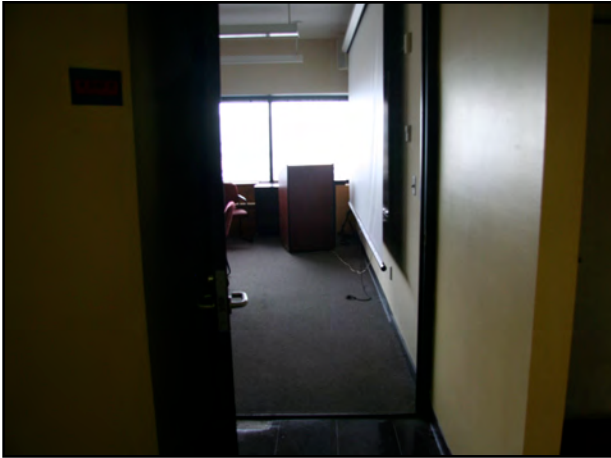
LOCATION | 516 (T555 no latch pull side clearance)

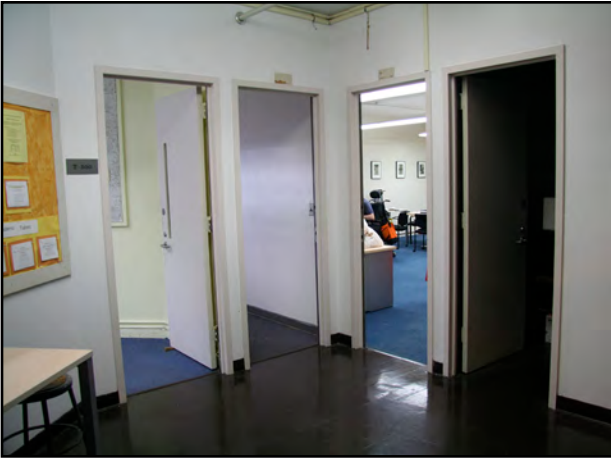
LOCATION | (T538 6" latch pull side clearance for corner door Learning Center)

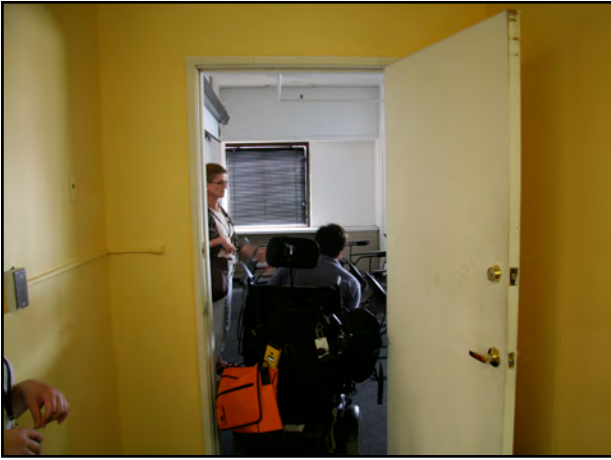
LOCATION | 502 (T551 17" latch pull side clearance)

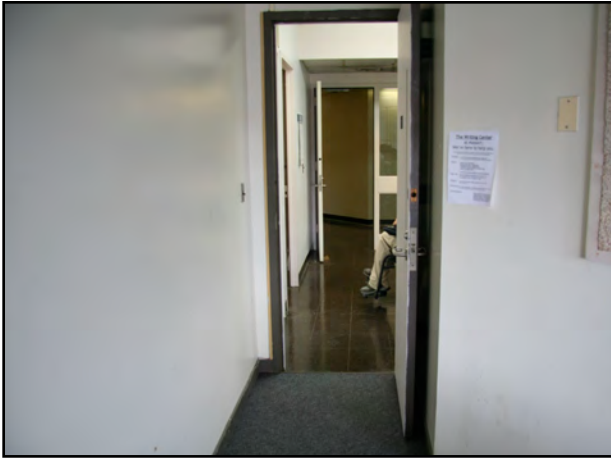
LOCATION | 503 (T552 no latch pull side clearance)

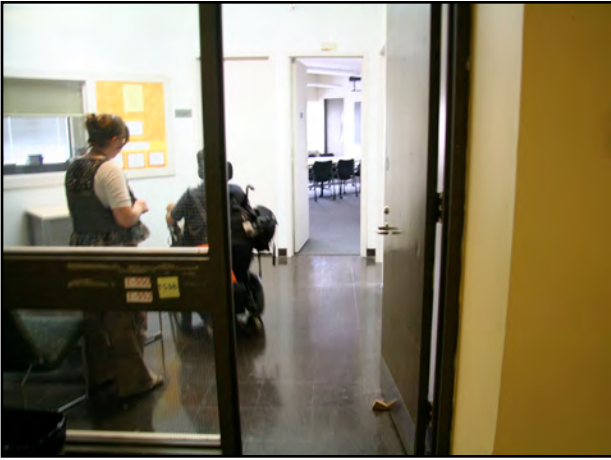
LOCATION | (T552,538,550 Door entry clear width 29")

RECOMMENDATION TO IMPROVE ADA COMPLIANCE SMALL MAINTENANCE or OPERATIONAL: Widen door frame to receive new 36" min. wide door **or** if in a classroom relocate class to classroom with doors that meet ADA standards for accessibility. It is especially important that the doors at the Learning Center are accessible.

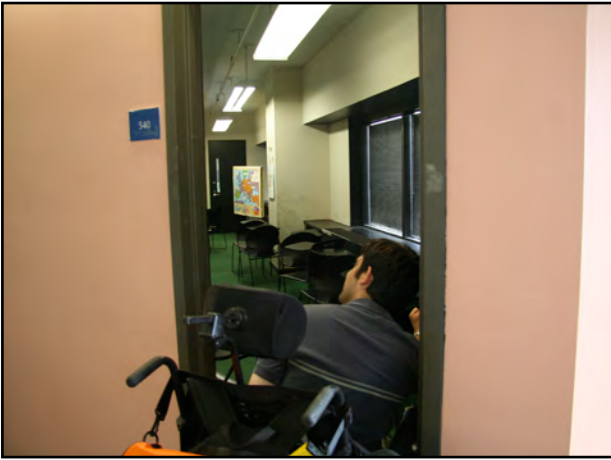
LOCATION | 503a (T540 Door entry clear width 29")

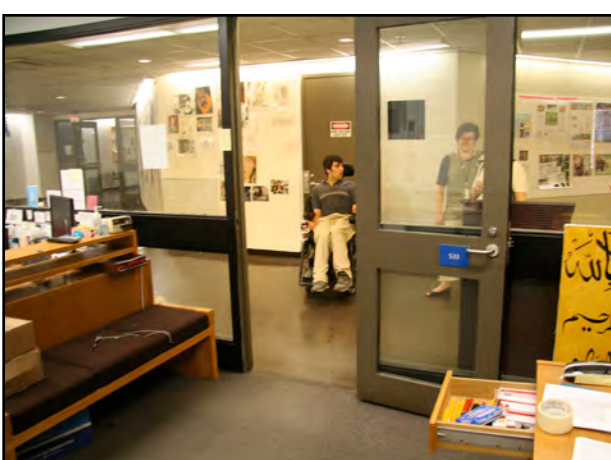
LOCATION | 506 - (533 Clearance obstruction)

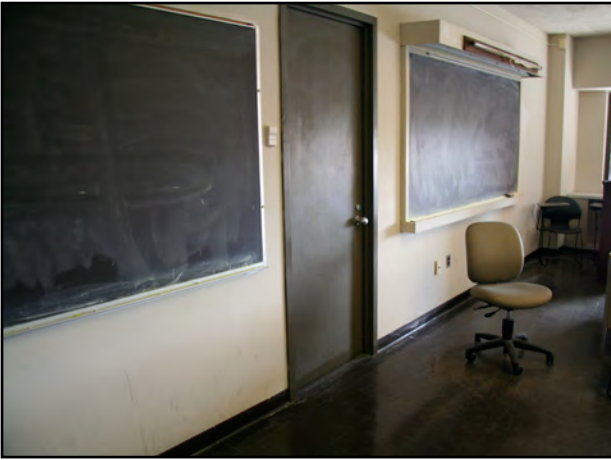
LOCATION | 506a (T535 Door knobs)

ISSUE D1 OPERATIONAL/ SMALL MAINT.
 Implement plan to maintain clear areas around doors.
 Widen doors and doorways if necessary.
 \$25/hr labor to clear
 various solutions
SMALL MAINT.
 \$2,000-\$5,000 to widen & replace door
or
OPERATIONAL
 Use alternative rooms and spaces.

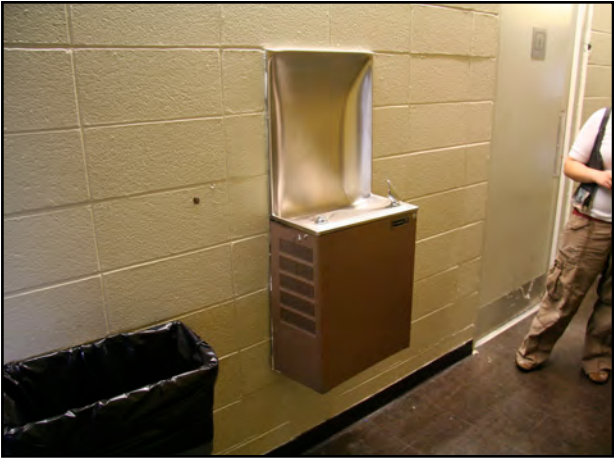
LOCATION | 508

Drinking Fountain - Not accessible

Replace with a High-Low drinking fountain that complies with ADA 2010 Standards.

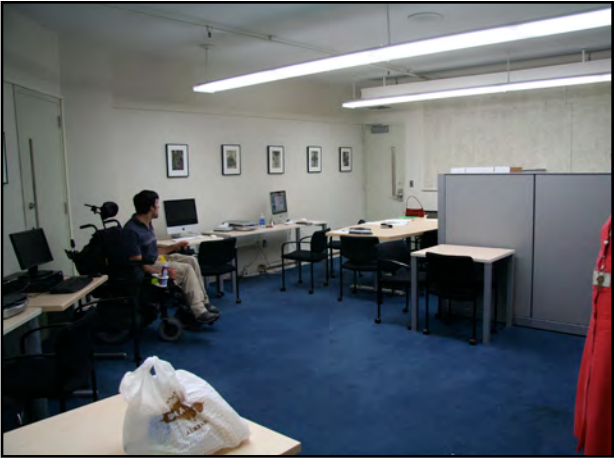
LOCATION | Typical

Furniture - Dimensions and Reach ranges

SMALL MAINTENANCE: As furniture and equipment is upgraded and replaced, make sure that 5% of all items but not less than one of each type of item in each room should allow an individual with disabilities to use it. Make sure that work surfaces, desks, and sinks are at 34" AFF, with knee spaces at least 27" AFF, 30" wide and 19" deep, and make sure that controls are located within accessible reach ranges. To support programs for all, provide adjustable furniture such as a few low tables or carts with locking casters that would supplement the countertop areas and provide additional space for equipment for multiple programs.

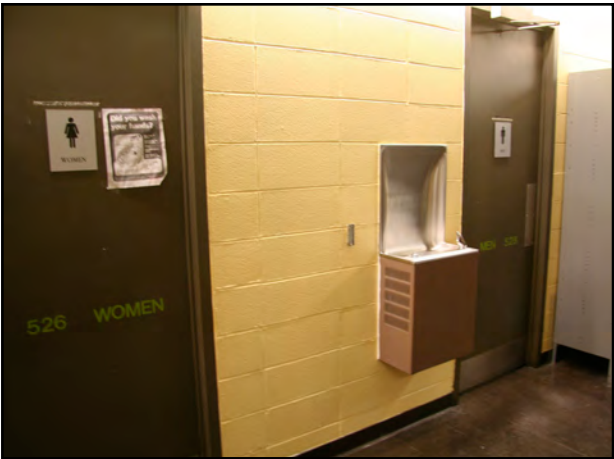
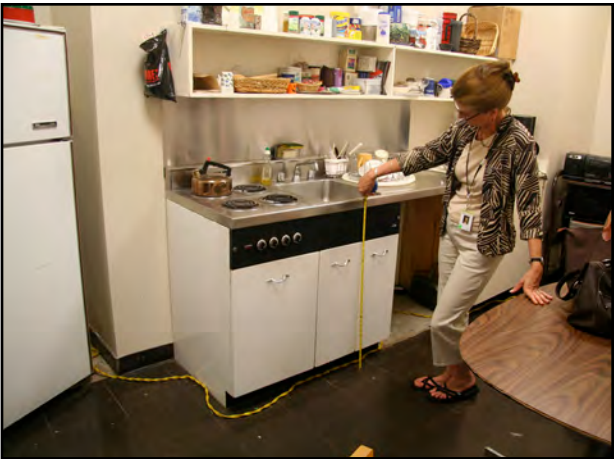
Furniture

SMALL MAINTENANCE: Lower a portion of the counter so that the top surface is at 34" AFF. and a minimum knee clearance of 27" to the underside of the counter. This may mean that the sink will have to be replaced with a sink that meets ADA dimensional standards.

**ISSUE J
 CAPITAL IMPROV.**
 Modify sink and counter
 \$2000/replace kitchenette

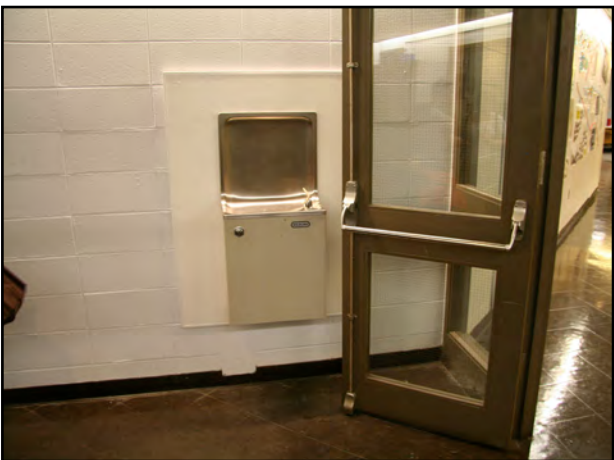
LOCATION | 513a

Drinking Fountain - Clearance

Replace drinking fountain complies with 2010 ADA standards 211, 307, 602 601, 602.

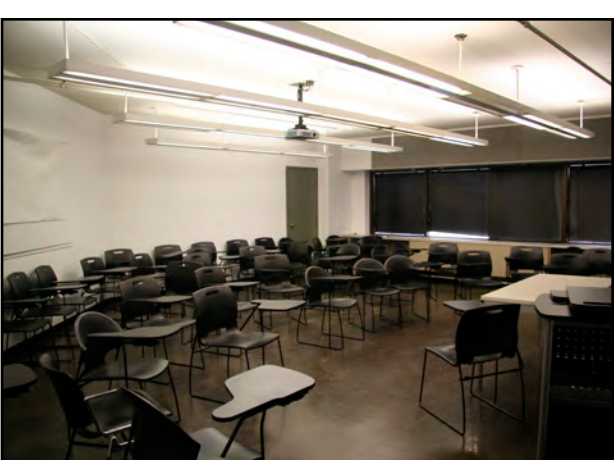
LOCATION | Typical

Furniture

CAPITAL IMPROV.: Provide at least one table that has a top surface of 34" AFF and a minimum knee clearance of 27" to the underside of the table.

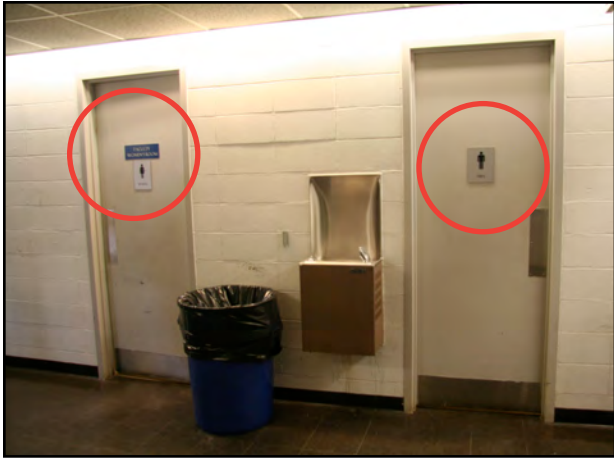
LOCATION | 613

Signs - ADA Facilities and Amenities

CAPITAL IMPROVEMENT: Ensure that all ADA accessible toilet rooms are noted on the Directories on each floor level.

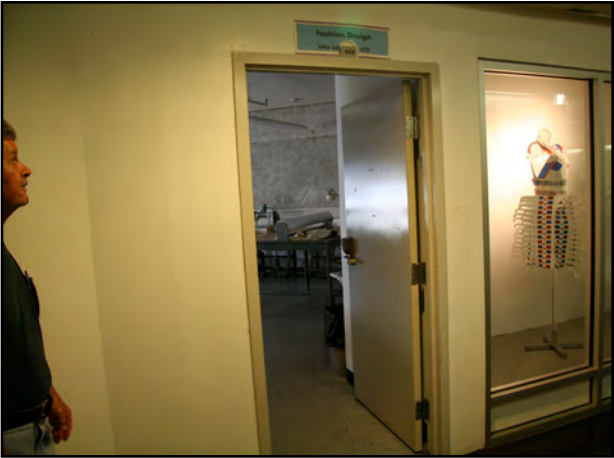
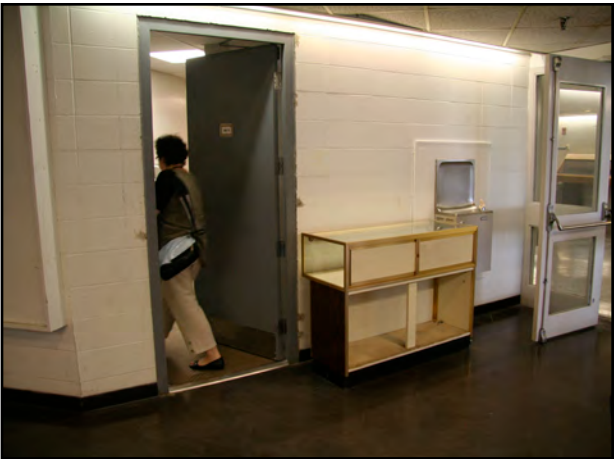
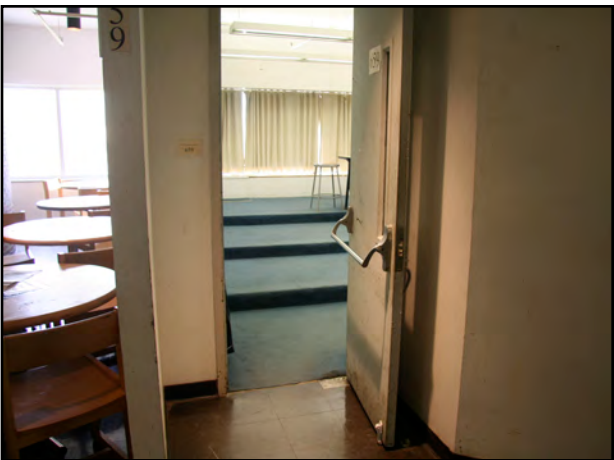
Signs - Designation & Directional Signs

CAPITAL IMPROVEMENT: Many tactilely read ADA compliant exit signs are missing from doors at exit passageways, exit discharge, and exit stairways.

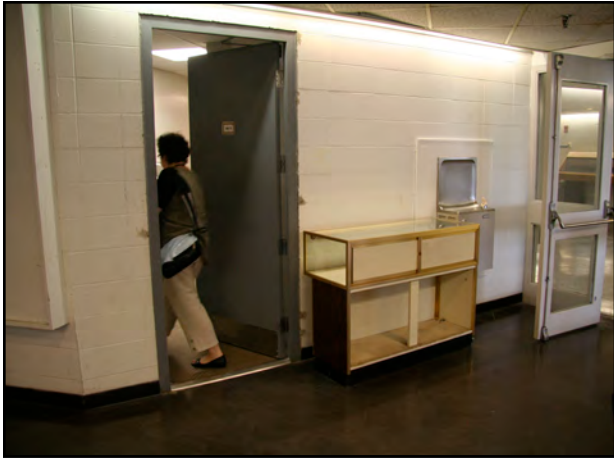
LOCATION | 613

ADA facilities and amenities

RECOMMENDATION TO IMPROVE ADA COMPLIANCE CAPITAL IMPROV.: Modify toilet rooms to become ADA compliant or create a new alternative accessible single-user toilet room for this floor. Modify toilet rooms to become ADA compliant. While these toilet rooms are not accessible install signs with directions to the nearest accessible toilet room. Ensure that these signs are mounted at ADA compliant height and location.

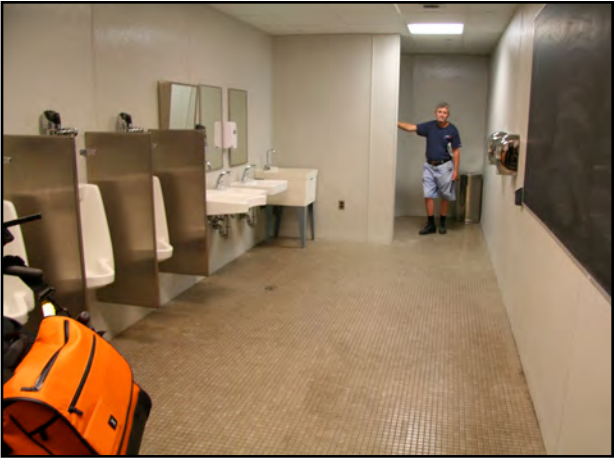
LOCATION | 613c

Water Closet - Distance from wall

The lavatory (sink) pipes are not wrapped and could cause injury.

To make this toilet room accessible-would require extensive modifications, consider creating at least one new alternative accessible single-user toilet room on this floor.

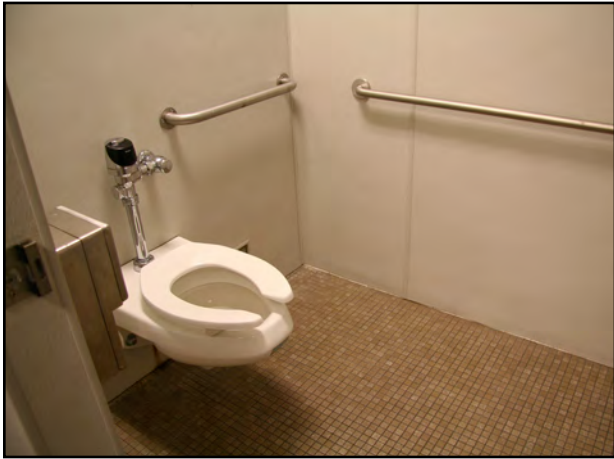
LOCATION | 613a

Men's & Women's Toilet Rooms

RECOMMENDATION TO IMPROVE ADA COMPLIANCE When these toilet rooms have been modified to become ADA compliant, provide ADA compliant signs on the latch pull side of the door. Mount at 48" min AFF to the baseline of the tactile characters, and 60 inches maximum AFF, measured from the baseline of the highest tactile character. Use the International Symbol of Accessibility to designate that it is an ADA compliant toilet room.

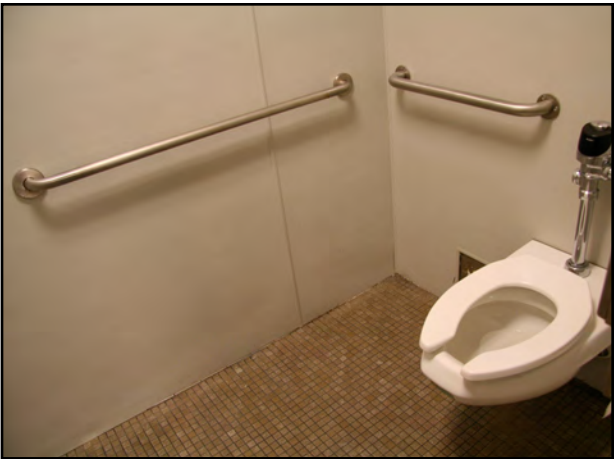
LOCATION | 613d

Grab bars - Incorrect

The flooring is uneven and is a tripping hazard that could cause injury.

SMALL MAINTENANCE: Repair tile flooring so that it is stable, firm and slip resistant.

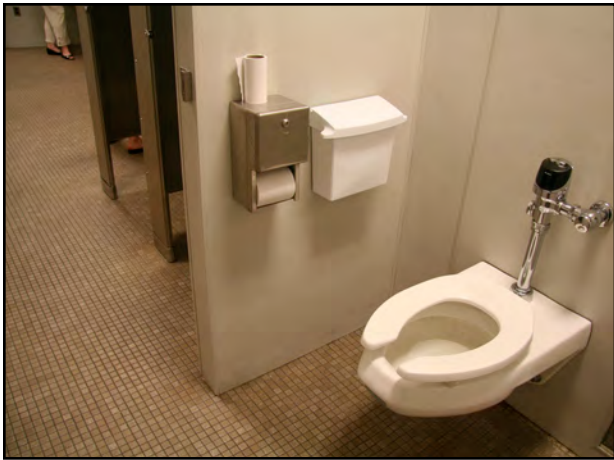
LOCATION | 613b

Door - Door opening force

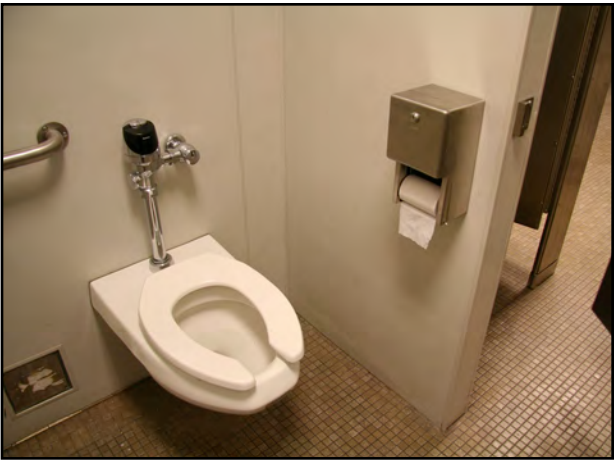
LOCATION | 613e

Accessible stall - Not enough clearance

Until modifications are complete provide 2010 ADA Standards compliant signs to direct users to nearest accessible toilet room even if it is in another building.

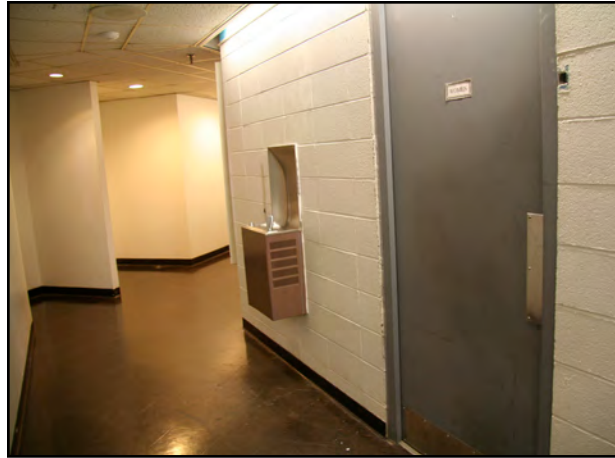
LOCATION | 615

Drinking Fountain - not accessible

Replace with a High-Low drinking fountain that complies with ADA 2010 Standards.

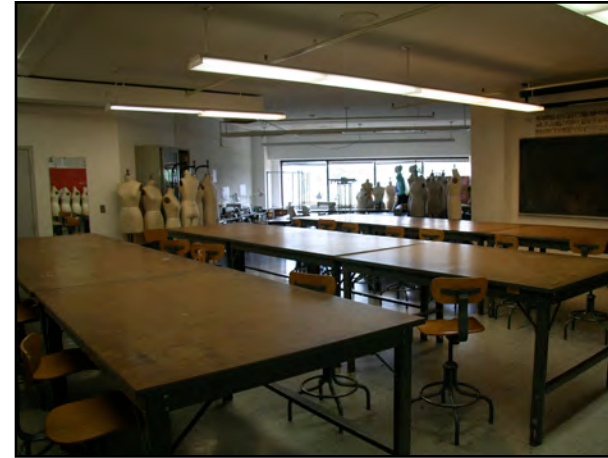
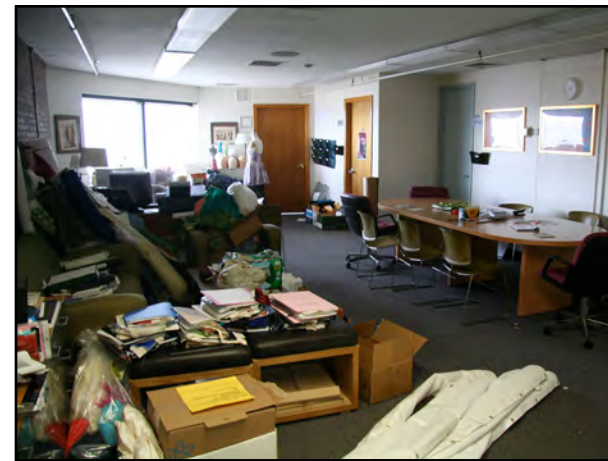
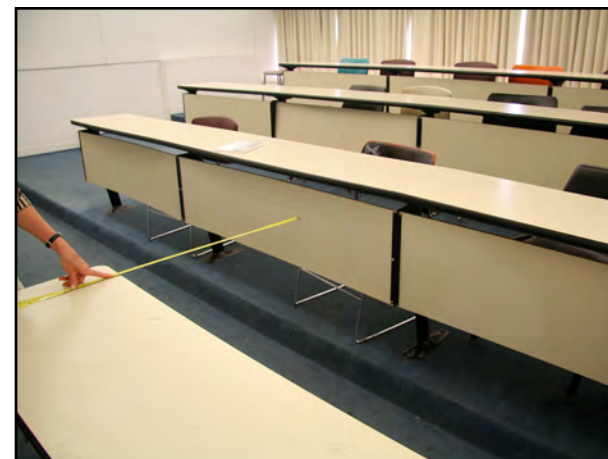
J-Lockers & Furniture

SMALL MAINTENANCE: As furniture and equipment is upgraded and replaced, make sure that 5% of all items but not less than one of each type of item in each room should allow an individual with disabilities to use it. Make sure that work surfaces, desks, and sinks are at 34" AFF, with knee spaces at least 27" AFF, 30" wide and 19" deep, and make sure that controls are located within accessible reach ranges. To support programs for all, provide adjustable furniture such as a few low tables or carts with locking casters that would supplement the countertop areas and provide additional space for equipment for multiple programs.

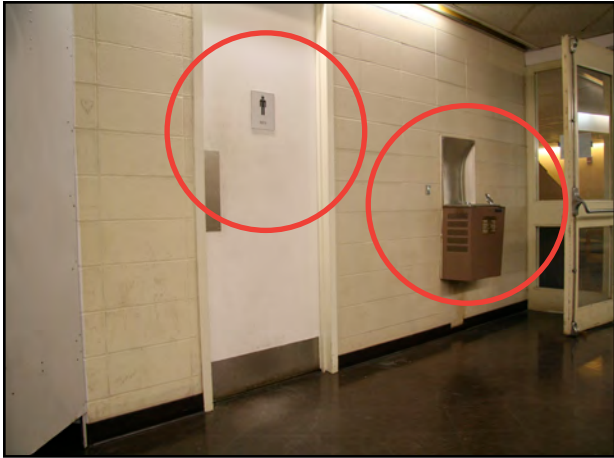
LOCATION | 713

Signs - ADA Facilities and Amenities

RECOMMENDATION TO IMPROVE ADA COMPLIANCE
SMALL MAINTENANCE: While toilet rooms and drinking fountains do not meet ADA standards for accessibility provide ADA compliant room designation signs and directions to the nearest ADA accessible amenities. Install these signs at the correct height and location and use the International Symbol of Accessibility.

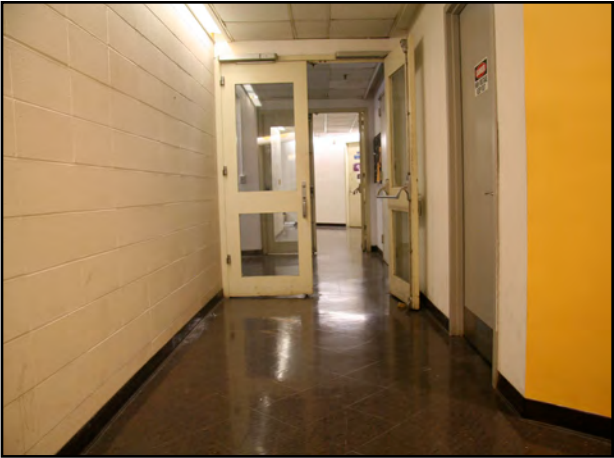
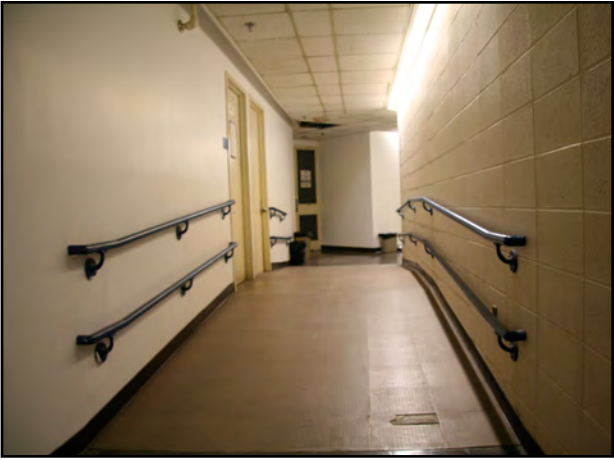
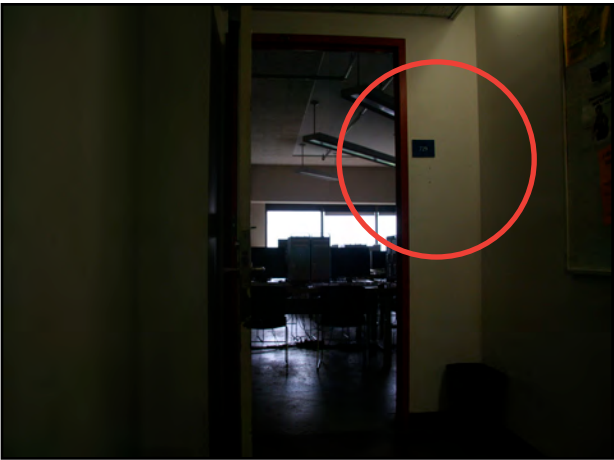
Signs - Designation & Directional Signs

RECOMMENDATION TO IMPROVE ADA COMPLIANCE
CAPITAL IMPROVEMENT: As part of the campus-wide wayfinding program provide signs for all permanent rooms that meet ADA Standards for accessibility. Place signage on the latch pull side of the door mounted at 48” min AFF to the baseline of the tactile characters on signs and 60” maximum AFF measured from the baseline of the highest tactile character. If there is no room on the latch side place signs on an adjacent wall so that a person reading the sign tactilely will not be injured if the door is opened.

INTERIM RECOMMENDATION
 Until modifications are complete provide 2010 ADA Standards compliant signage to direct users to nearest accessible toilet room and other accessible amenities.

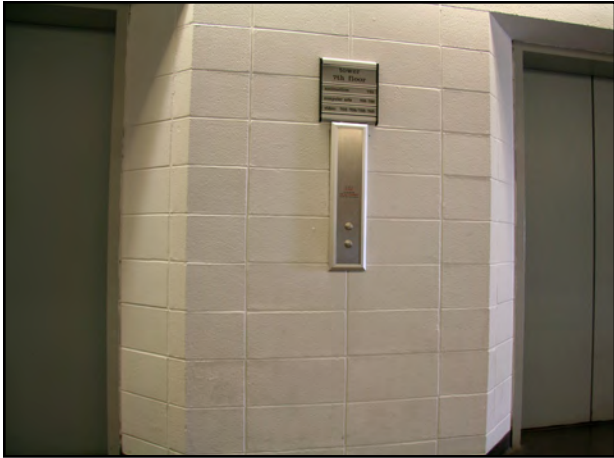
LOCATION | 701

Building Directory

Make certain that the Directory information corresponds to the floor's program & usage. Be sure to add information regarding the accessible toilet after the toilet rooms have been modified to meet ADA Standards for accessibility. **LOCATION | 701**

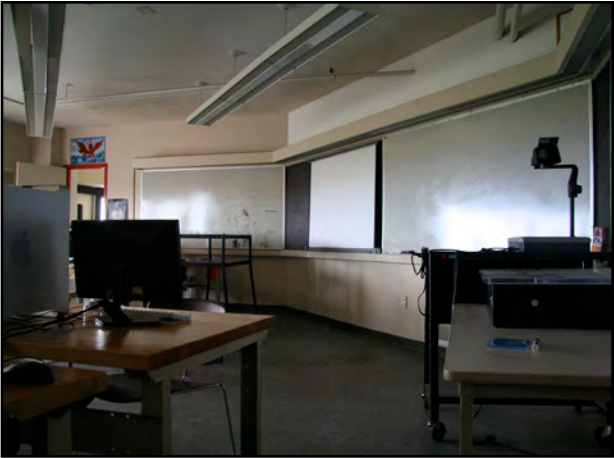
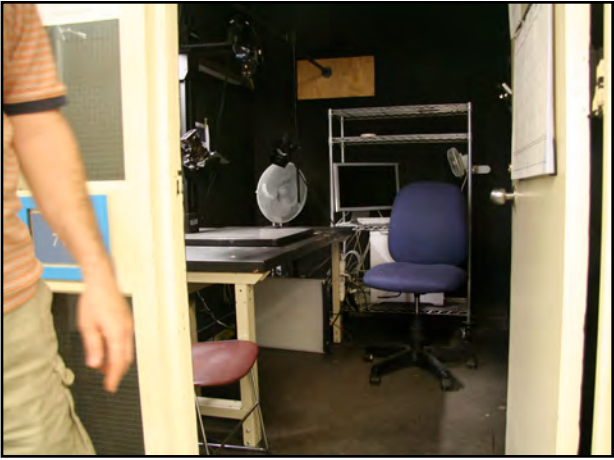
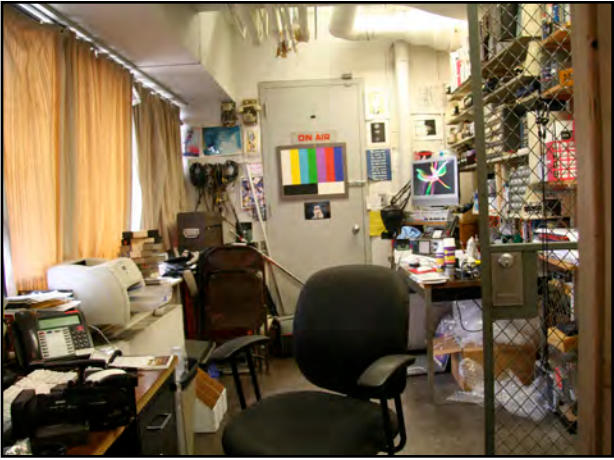
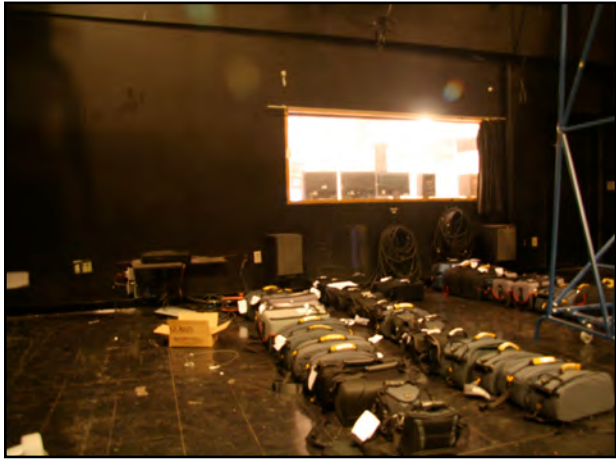
Aisle Obstruction

Aisles and pathways through rooms are not defined creating egress safety and tripping hazards in the accessible route.

RECOMMENDATION TO IMPROVE ADA COMPLIANCE OPERATIONAL: Remove obstructions and educate staff, students and faculty to maintain a 36" min. wide clear space through rooms, spaces and accessible routes at all times.

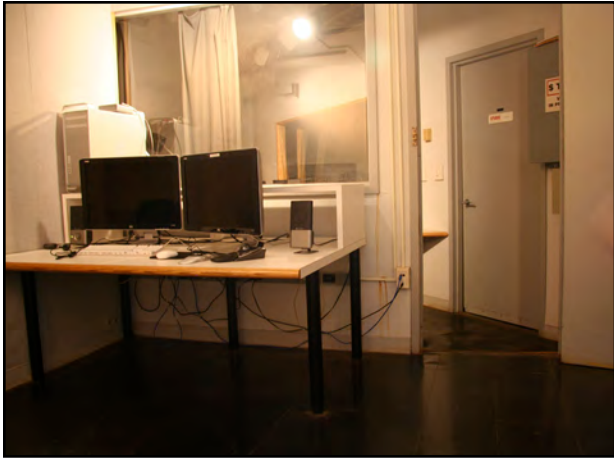
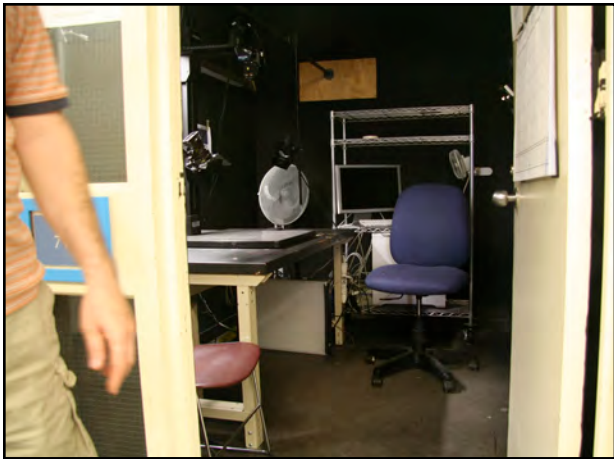
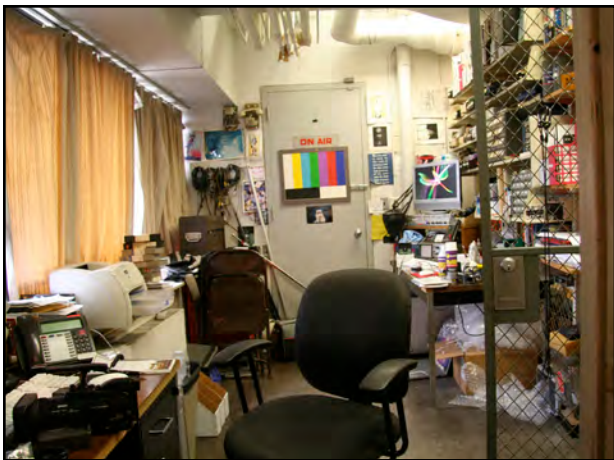
Aisle Obstruction

Accessible routes, aisles and pathways through rooms are obstructed by furniture, equipment and other objects that compromise egress safety and create tripping hazards.

RECOMMENDATION TO IMPROVE ADA COMPLIANCE OPERATIONAL: Remove obstructions, rearrange furniture and equipment, ensure floor mats are secured and do not slip or turn up at the edges. Educate staff, students and faculty to maintain a 36" wide min. clear space through accessible routes rooms, spaces, and paths at all times.

RECOMMENDATION TO IMPROVE SAFETY & USER EXPERIENCE CAPITAL IMPROVEMENT: As part of a campus-wide wayfinding program wherever possible specify floor finishes and patterns to intuitively provide cues for keeping 36" min. wide clear spaces for routes and paths in rooms and through spaces.

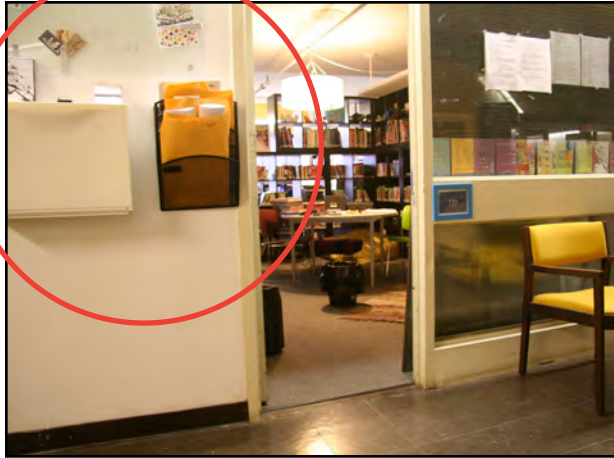
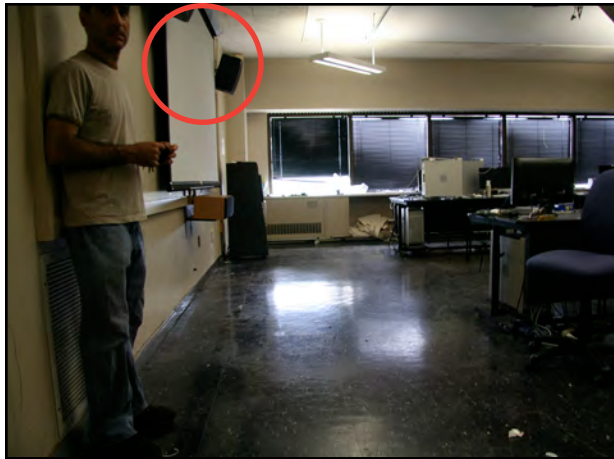
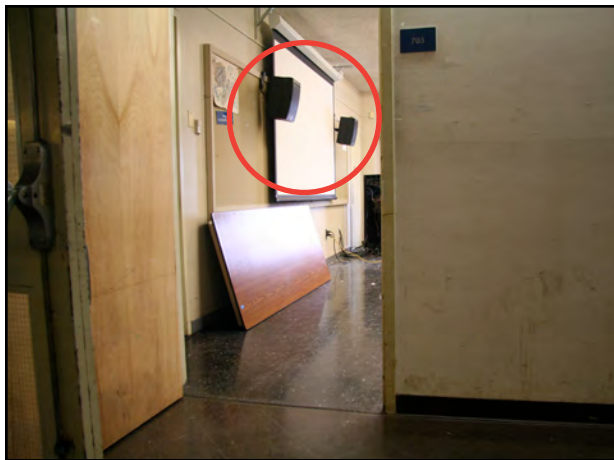
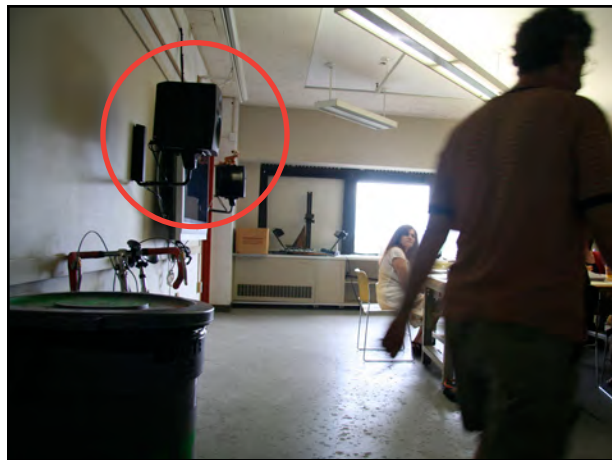
Protruding Objects

Letter rack protrudes 6 1/2" from the wall into the accessible route and the bottom of the rack is 31" AFF. This may cause injury, because a person using a cane would not be able to detect it.

RECOMMENDATION TO IMPROVE SAFETY & USER EXPERIENCE OPERATIONAL: Protruding objects can cause injury to anyone walking down a corridor especially in an emergency. Furthermore there is a risk that the protruding object will get knocked and become damaged.

RECOMMENDATION TO IMPROVE ADA COMPLIANCE OPERATIONAL: Use a rack that has sides that extend to the floor or lower the rack so that the bottom is less than 27" AFF so that it can be detected by a person with a cane.

ISSUE C SMALL MAINT. PROJECT
 Implement plan to remove, relocate or recess protruding objects. Prioritize for most hazardous.

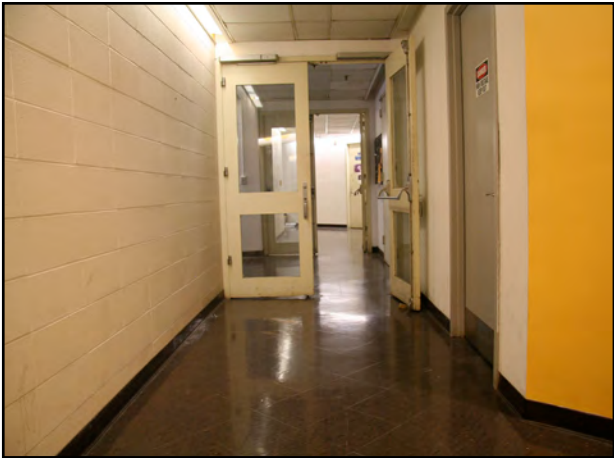
LOCATION | Typical

Door - Double Door Clearances

SMALL MAINTENANCE or OPERATIONAL: Widen door frame to receive new 36" min. wide door **or** if in a classroom relocate class to classroom with doors that meet ADA Standards for accessibility

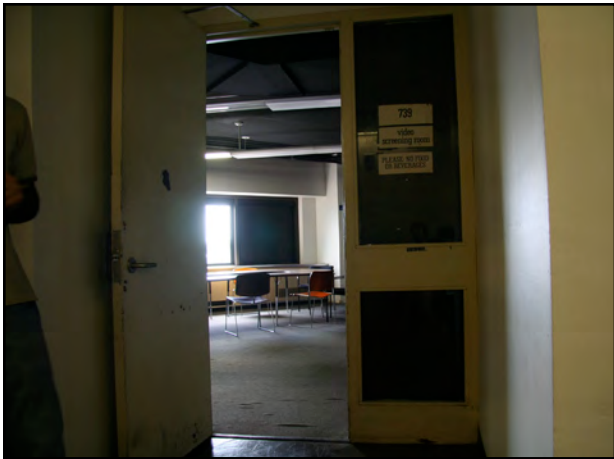
LOCATION | 705

Door - Maneuvering clearances

OPERATIONAL: Remove all obstructions from around entrances and doorways. If the required clearances at the latch and hinge sides of the door do not exist due to constricted walls relocate class to classroom with doors that meet ADA Standards for accessibility door clearances. Alternatively ensure that the door is held open

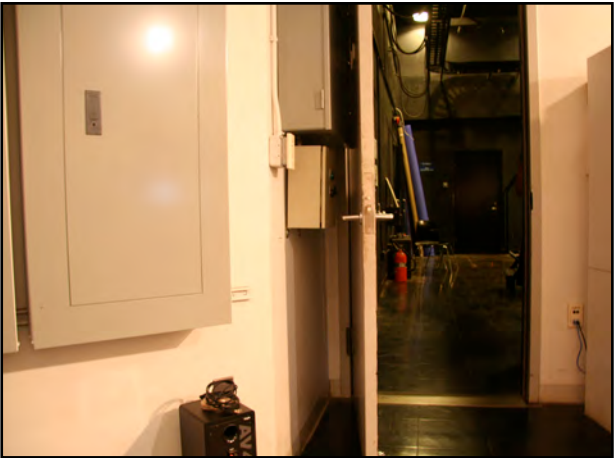
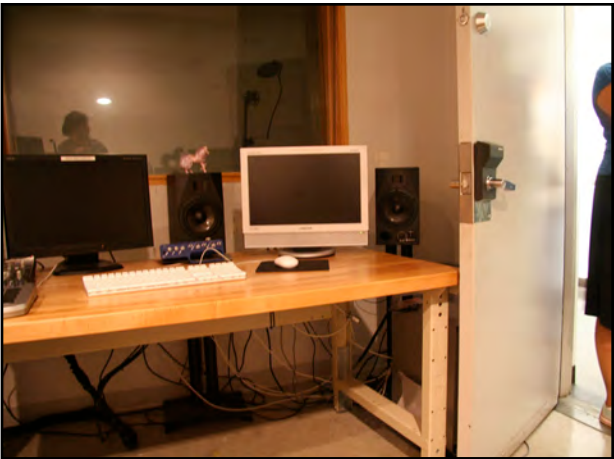
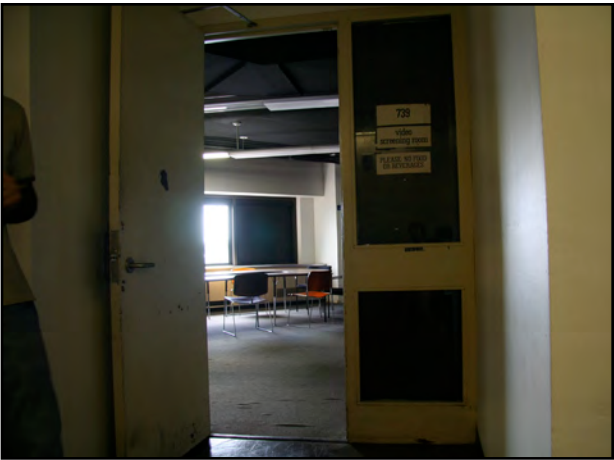
Door - Maneuvering clearances

various solutions door width \$2,000-\$5,000 to SMALL MAIN.: widen & replace door .

OPERATIONAL: Switch classrooms

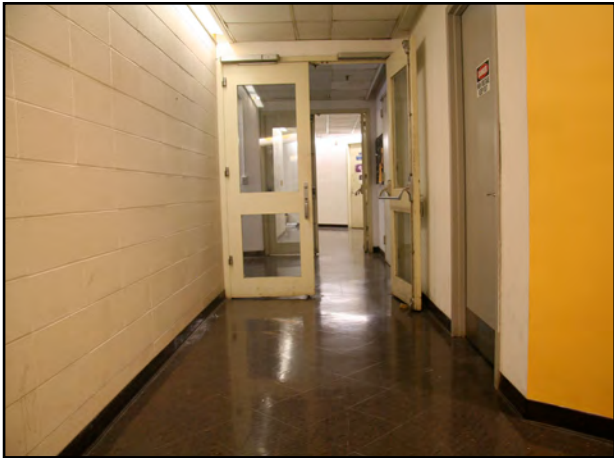
LOCATION | Typical

Door opening forces

The double fire egress doors have door opening forces exceeding of 5 lbs. which is too heavy for easy opening. Additionally it makes the doors difficult to get through because they close too fast. This could cause problems in an emergency.

OPERATIONAL: Ensure that areas beyond fire doors have clear egress routes.

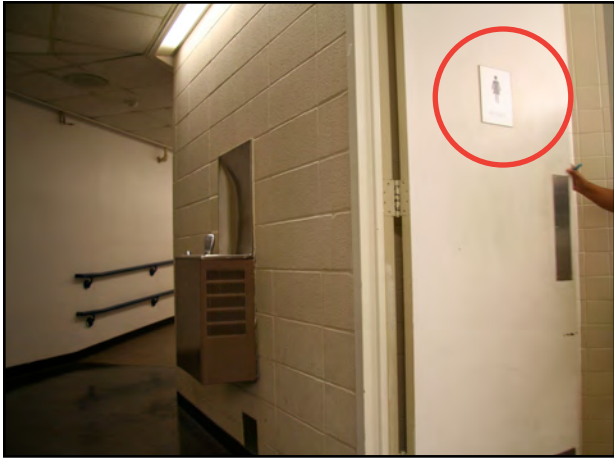
LOCATION | 702a

ADA Facilities and Amenities
 Both the men's and the women's toilet rooms do not meet ADA standards for accessibility.

RECOMMENDATION TO IMPROVE ADA COMPLIANCE
 Modify toilet rooms to meet ADA Standards for accessibility **or** create a new alternative accessible single-user toilet room for this floor. While these toilet rooms are not accessible install signs with directions to the nearest accessible toilet room. Ensure that these signs are mounted to meet ADA Standards for accessibility for height and location.

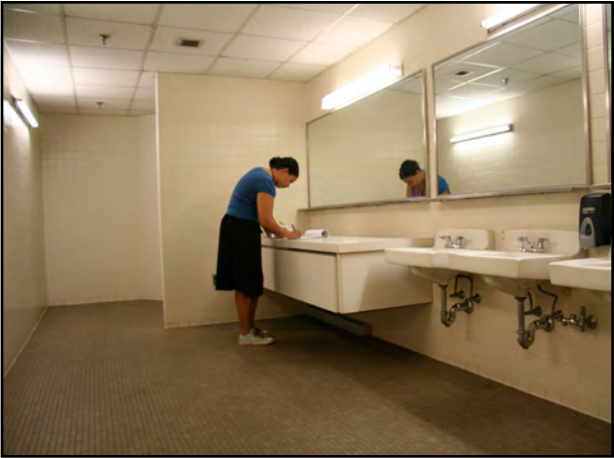
LOCATION | 702d

Door - Door clearance
 The door width clearance is 28 1/2" wide and the width of the maneuvering space inside the door is 40". The compartment door is bent and doesn't close properly. The compartment door width clearance is 29" and the clearance at the latch pull side of the door is only 11".

ISSUE F CAPITAL IMPROV.
 To make this toilet room accessible-would require extensive modifications. Consider creating at least one new alternative accessible single-user toilet room on this floor.

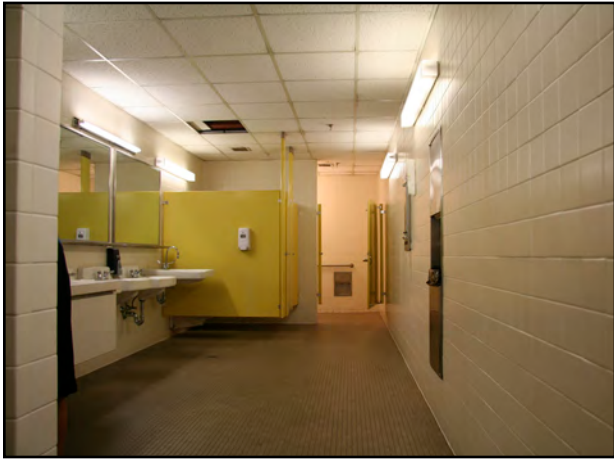
LOCATION | 702b

Men's & Women's Toilet Rooms
 Both the men's and the women's toilet rooms do not meet ADA standards for accessibility in the following areas:

RECOMMENDATION TO IMPROVE ADA COMPLIANCE
 When these toilet rooms have been modified to become ADA accessible, provide ADA compliant signs on the latch pull side of the door. Mount at 48" min AFF to the baseline of the tactile characters, and 60 inches maximum AFF, measured from the baseline of the highest tactile character. Use the International Symbol of Accessibility to designate that it is a ADA accessible toilet room.

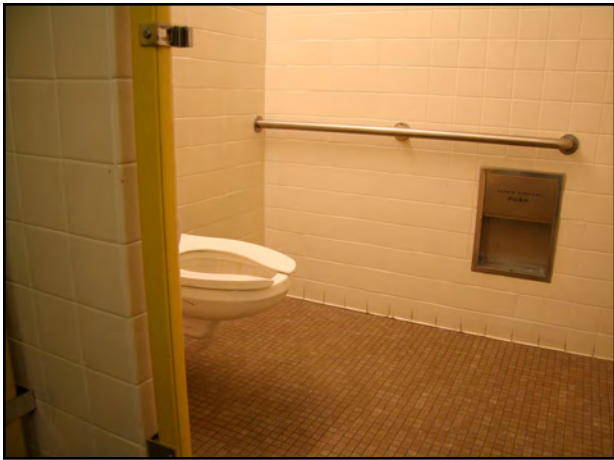
LOCATION | 702c

Door - Door opening force
 The door has an opening force of over 10 lbs. This makes it difficult to open and it closes too fast to be able to pass through easily.

OPERATIONAL: Adjust door closer to max. 5lb opening pressure.

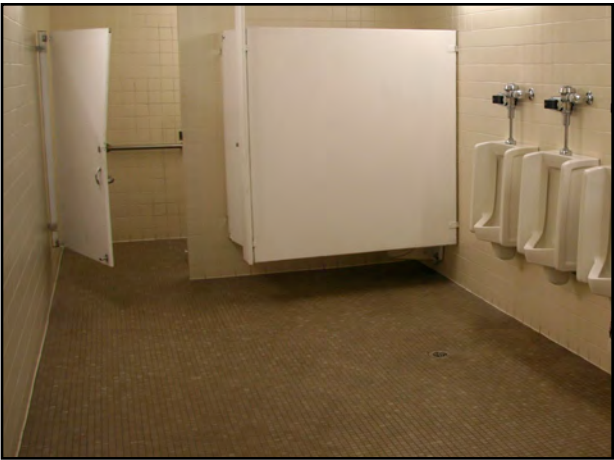
LOCATION | 702f

Sink - Pipes not covered
 The lavatory (sink) pipes are not wrapped and could cause injury.

INTERIM RECOMMENDATION
 Until modifications are complete provide 2010 ADA Standards compliant signs to direct users to nearest accessible toilet room even if it is in another building.

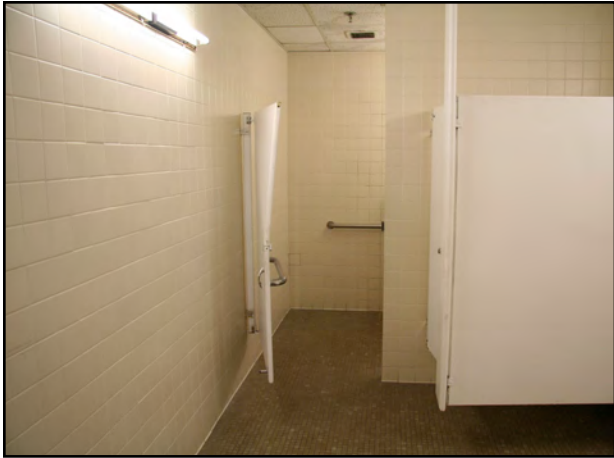
LOCATION | 702g

Grab bars - Incorrect installation and dimensions

The flooring is uneven and is a tripping hazard.

SMALL MAINTENANCE-Repair tile flooring so that it is stable, firm and slip resistant.

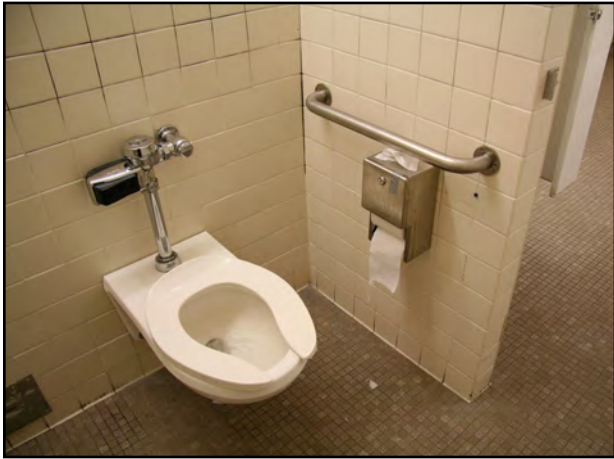
LOCATION | 702h

Accessible Compartment - Not enough clearance

Until modifications are complete provide 2010 ADA Standards compliant signs to direct users to nearest accessible toilet room even if it is in another building.
