Massachusetts College of Art and Design

ADA Compliance Plan 2011

ADA Compliance Plan
Consultant Services
Contract #10-08

The Institute for Human Centered Design

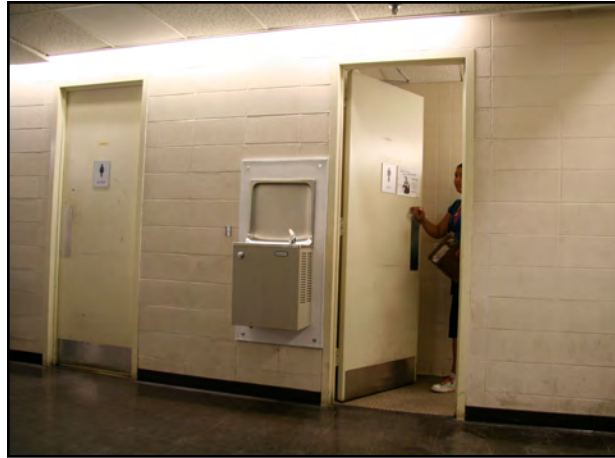
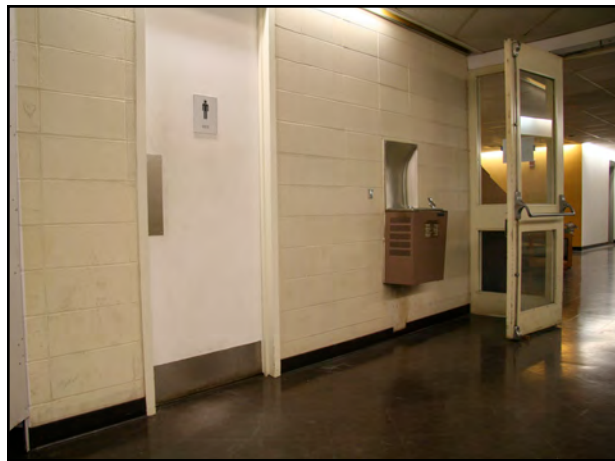
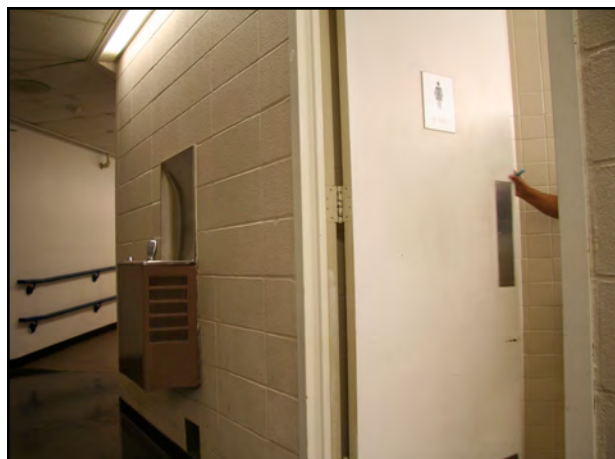
Drinking Fountain

SMALL MAINTENANCE: Replace with a High-Low drinking fountain that complies with 2010 ADA standards 211, 307, 602 601, 602.

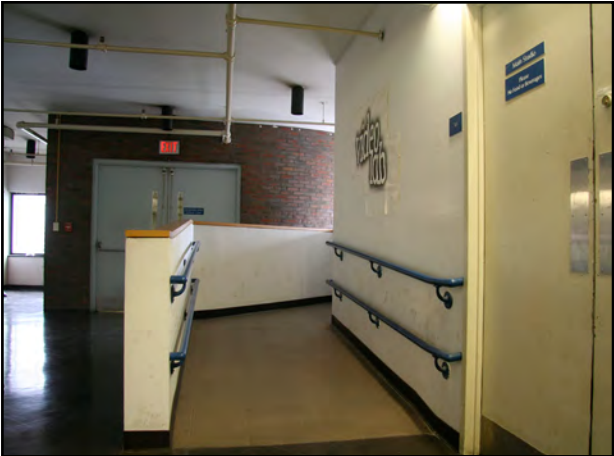
LOCATION | 714

Ramp - Landing/turning Space

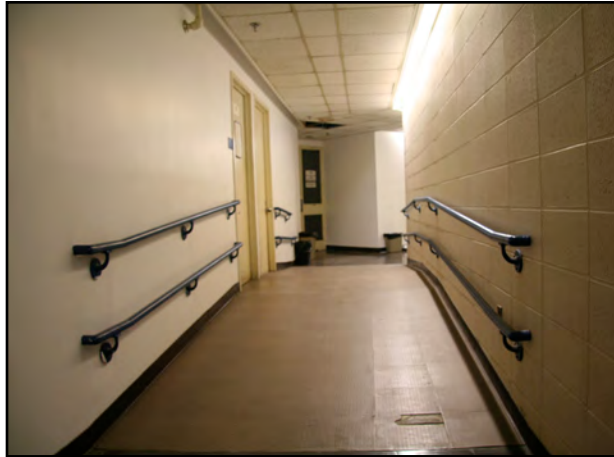
LOCATION | 705

The tiled ramp surface is damaged and not smooth. **LOCATION | 705**
[See Appendix A -2010 ADA Standards 405.4 and 302 Ramps]

SMALL MAINTENANCE: Repair flooring so that that the surface is smooth, firm and slip resistant.

ISSUE K
SMALL MAINT. PROJECT
Renovate ramp to provide landings and correct slope. Add stairs where possible for people who do not use wheelchairs but who have heart disease or limited stamina

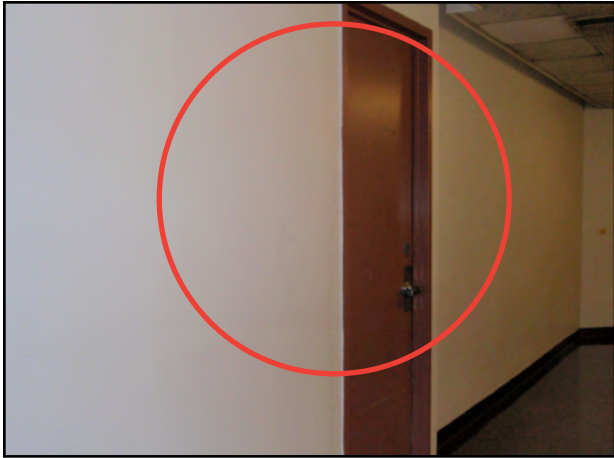
LOCATION | 813

Signs - ADA Facilities and Amenities

CAPITAL IMPROVEMENT: Many tactilely read ADA compliant exit signs are missing from doors at exit passageways, exit discharge, and exit stairways.

RECOMMENDATION TO IMPROVE ADA COMPLIANCE
SMALL MAINTENANCE: While toilet rooms and drinking fountain are not ADA accessible provide ADA compliant room designation signs and directions to the nearest ADA accessible amenities. Ensure that these signs are mounted at the correct height and location and use the International Symbol of Accessibility.

CAPITAL IMPROVEMENT: Ensure that all ADA accessible toilet rooms are noted on the Directories on each floor level.

Implement an overall inspection of fire safety signs making sure they are ADA, NFPA and 527 CMR compliant and are lit if required and are in the correct locations according to code.

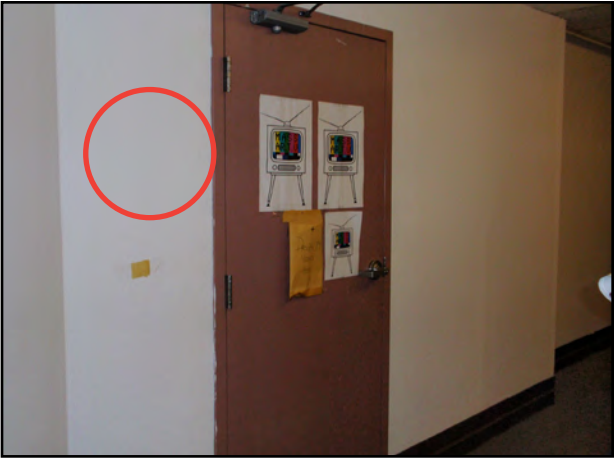
LOCATION | Typical

Signs - Designation & Directional Signs

RECOMMENDATION TO IMPROVE ADA COMPLIANCE
CAPITAL IMPROVEMENT: As part of the campus-wide wayfinding program provide signs for all permanent rooms that meet ADA Standards for accessibility. Place signage on the latch pull side of the door mounted at 48" min AFF to the baseline of the tactile characters on signs and 60" maximum AFF measured from the baseline of the highest tactile character. If there is no room on the latch side place signs on an adjacent wall so that a person reading the sign tactilely will not be injured if the door is opened.

As part of the campus-wide wayfinding program consider providing permanent egress maps at least at stairs and elevator lobbies on all floors. This will inform all occupants even those not familiar with the building of the egress route.

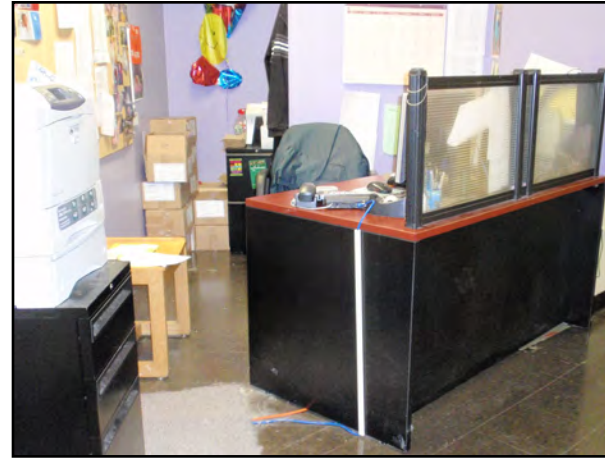
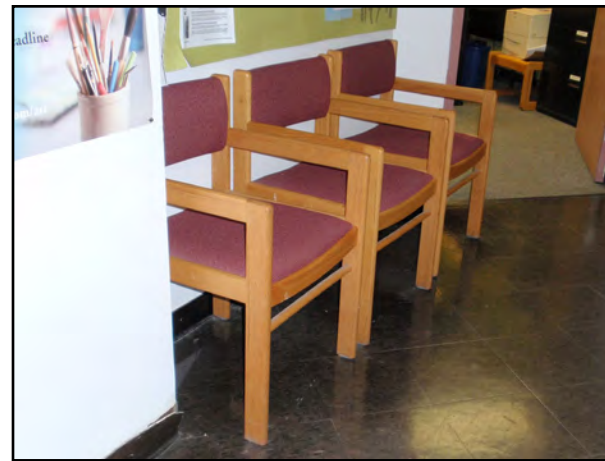
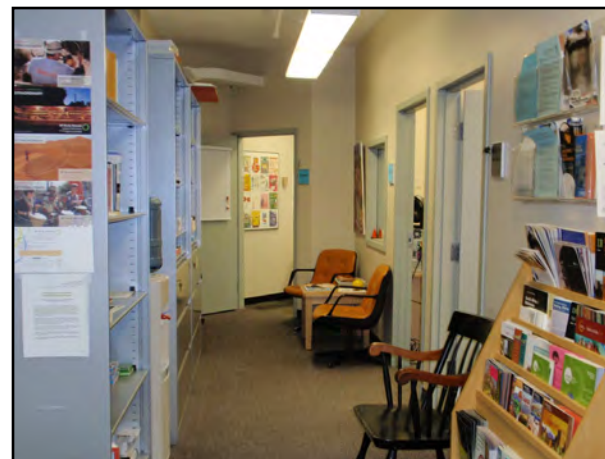
Accessible routes, aisles and pathways through rooms are obstructed by furniture, equipment and other objects that compromise egress safety and create tripping hazards.

RECOMMENDATION TO IMPROVE ADA COMPLIANCE OPERATIONAL: Remove obstructions and educate staff, students and faculty to maintain a 36" min. wide clear space through rooms, spaces and accessible routes at all times.

RECOMMENDATION TO IMPROVE ADA COMPLIANCE OPERATIONAL: Remove obstructions, rearrange furniture and equipment, ensure floor mats are secured and do not slip or turn up at the edges. Educate staff, students and faculty to maintain a 36" min. wide clear space through accessible routes rooms, spaces, and paths at all times.

RECOMMENDATION TO IMPROVE SAFETY & USER EXPERIENCE CAPITAL IMPROVEMENT: As part of a campus-wide wayfinding program wherever possible specify floor finishes and patterns to intuitively provide cues for keeping 36" min. wide clear spaces for routes and paths in rooms and through spaces.

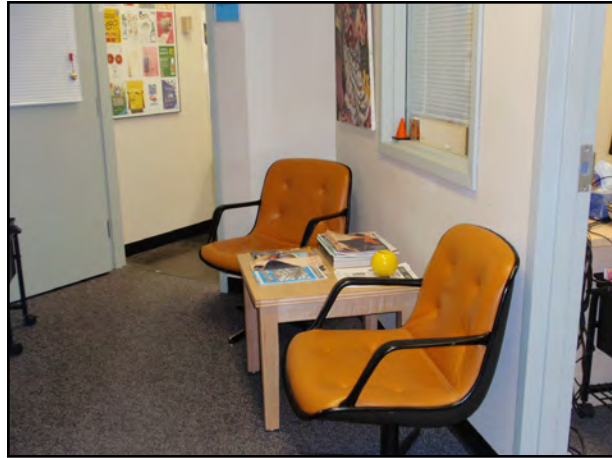
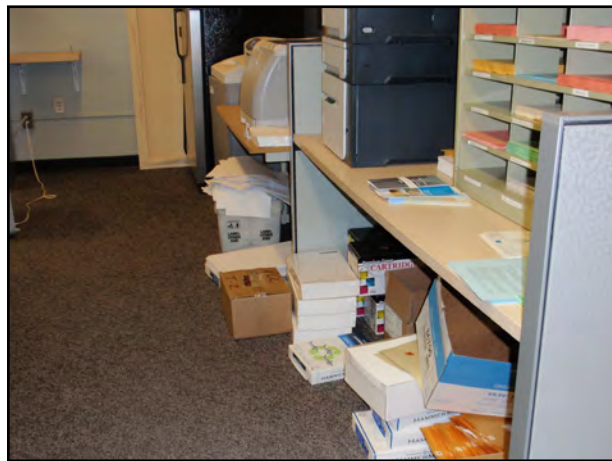
Aisle Obstruction

Accessible routes, aisles and pathways through rooms are obstructed by furniture, equipment, paper storage and other objects that compromise egress safety and create tripping hazards.

CAPITAL IMPROVEMENT: As part of a campus-wide wayfinding program wherever possible specify floor finishes and patterns to intuitively provide cues for keeping 36" min. wide clear spaces for routes and paths in rooms and through spaces.

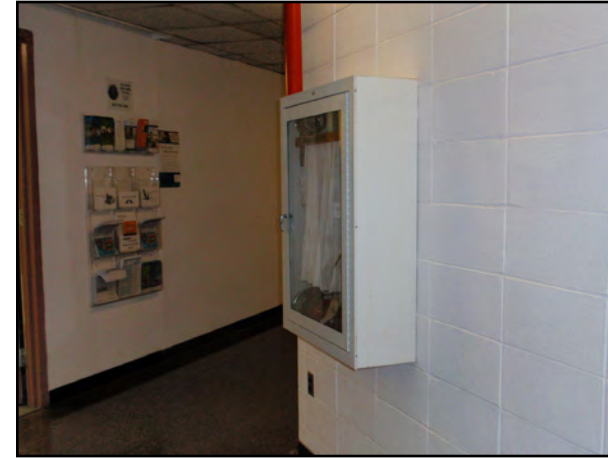
LOCATION | 805

Cabinet protrudes 6 1/2" from the wall into the accessible route and the bottom of the cabinet is 31" AFF. This may cause injury. A person using a cane would not be able to detect it.

OPERATIONAL: Protruding objects are not only a cause of injury to people who have no or low vision but to anyone walking down a corridor especially in an emergency or if people are passing in a corridor. Furthermore there is a risk that the protruding object will get knocked and become damaged.

Implement plan to remove, relocate or recess protruding objects. Prioritize for most hazardous.

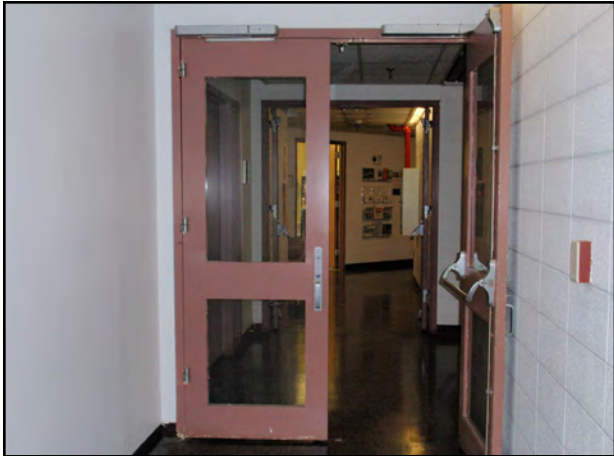
LOCATION | Typical

Door - Double Door Clearances

RECOMMENDATION TO IMPROVE ADA COMPLIANCE
 Provide asymmetrical leaves with one active leaf measuring no less than 32 inches clear when open at 90 degrees.

or
 Provide automatic door openers.

In the interim prop doors open during normal work hours. Ensure door props don't obstruct the clear path or become a tripping hazard.

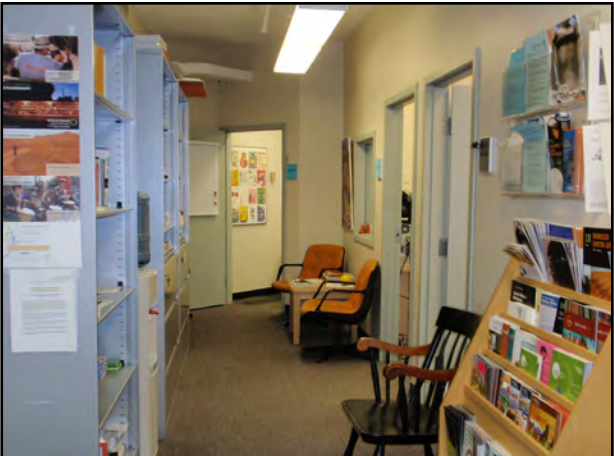
LOCATION | Typical

Door - Maneuvering clearances

RECOMMENDATION TO IMPROVE ADA COMPLIANCE
SMALL MAINTENANCE: The counter adjacent to the latch side of the door should be removed to create a clear space of 18" to allow an accessible approach to the door.

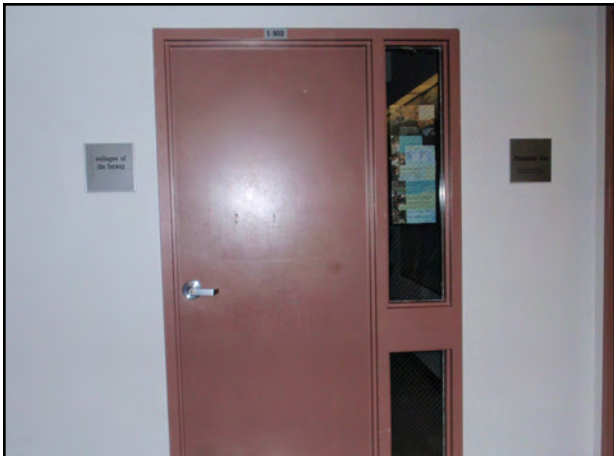
LOCATION | 812

Door - Single Door Clearances

RECOMMENDATION TO IMPROVE ADA COMPLIANCE
SMALL MAINTENANCE: The counter adjacent to the latch side of the door should be removed to create a clear space of 18" to allow an accessible approach to the door.

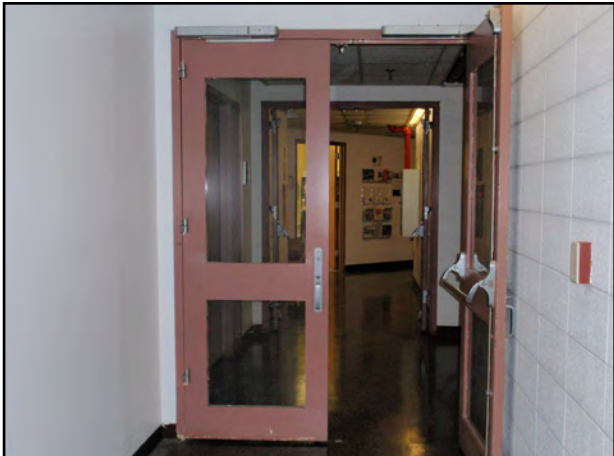
LOCATION | Typical

Door - Double Door

The double fire egress doors have a door opening force of 25 lbs which is too heavy for easy opening. Additionally it makes the doors difficult to get through because they close too fast. This could cause problems in an emergency.

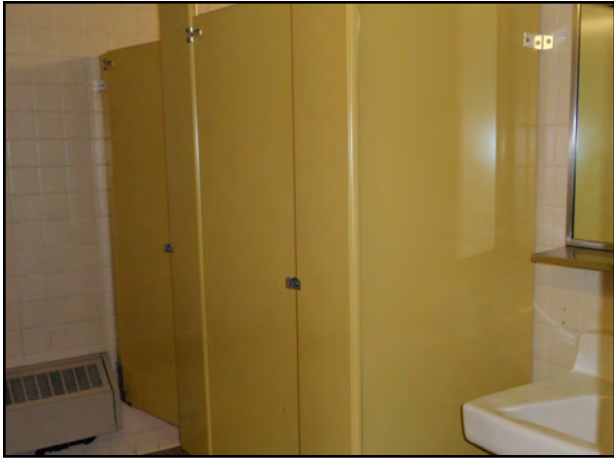
LOCATION | 802a

ADA Facilities and Amenities

RECOMMENDATION TO IMPROVE ADA COMPLIANCE
 Modify toilet rooms to become meet ADA Standards for accessibility.

While these toilet rooms is not fully ADA accessible, provide ADA compliant signs with directions to the nearest ADA accessible toilet room on the first floor. Ensure that these signs are mounted at the correct height and location.

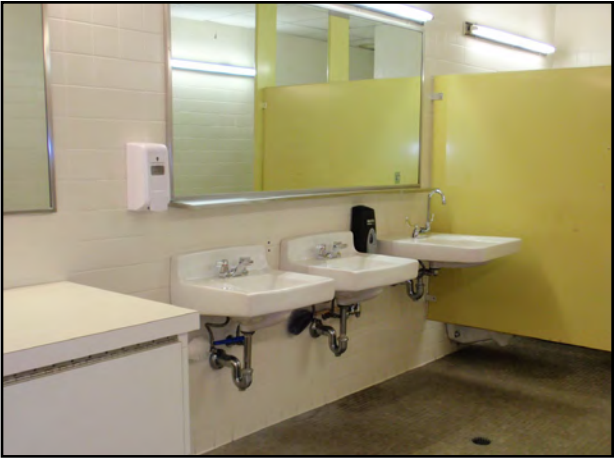
LOCATION | 802d

Mirror

RECOMMENDATION TO IMPROVE ADA COMPLIANCE
OPERATIONAL Re-install grab bars to meet ADA Standards for accessibility for location and height.

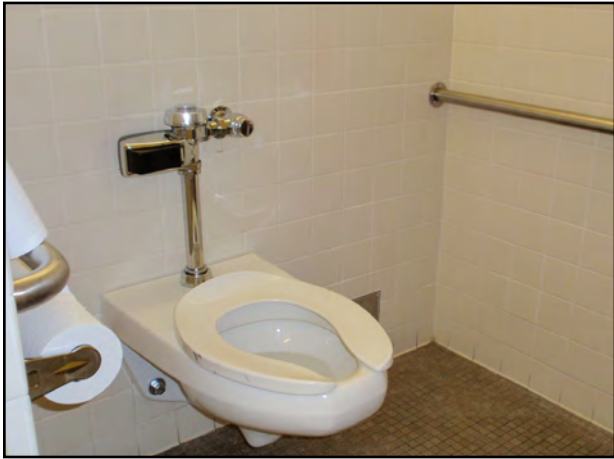
LOCATION | 802b

Typical for toilet rooms

RECOMMENDATION TO IMPROVE ADA COMPLIANCE
 If these toilet rooms are modified to become ADA accessible, provide ADA compliant signs on the latch side of the door. Mount at 48" min AFF to the baseline of the tactile characters, and 60 inches maximum AFF, measured from the baseline of the highest tactile character. Use the International Symbol of Accessibility to designate that it is a ADA accessible toilet room.

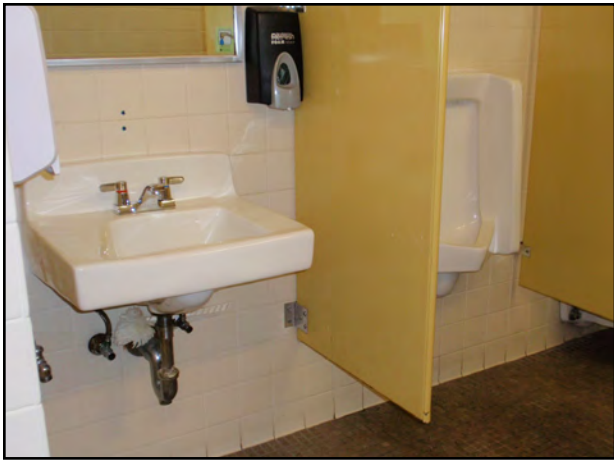
LOCATION | 802c

Door opening force

The lavatory(sink) pipes are not wrapped and could cause injury.

RECOMMENDATION TO IMPROVE ADA COMPLIANCE
OPERATIONAL Adjust door closer to max. 5lb opening force.

RECOMMENDATION TO IMPROVE ADA COMPLIANCE
OPERATIONAL Wrap lavatory (sink) pipes.

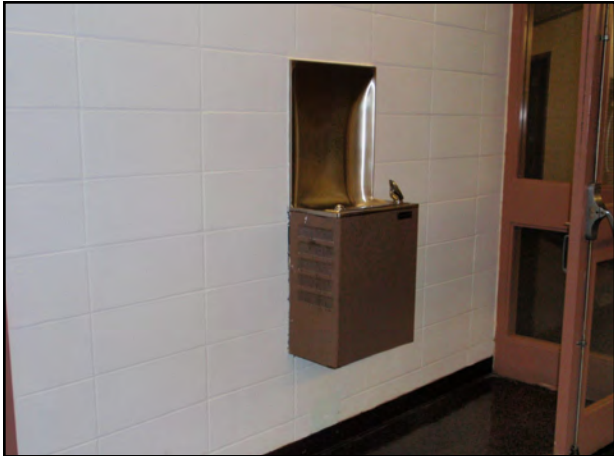
LOCATION | 814

Drinking Fountain - Does not have two spouts at heights that allow a person in a wheelchair and a person who has trouble bending to be able to use it.

SMALL MAINTENANCE: Replace with a High-Low drinking fountain that complies with 2010 ADA standards 211, 307, 602 601, 602.

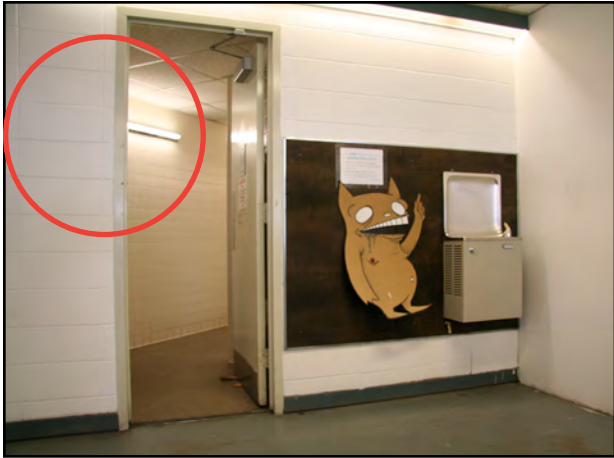
LOCATION | 908

Signs - ADA Facilities and Amenities

CAPITAL IMPROVEMENT: Many tactilely read ADA compliant exit signs are missing from doors at exit passageways, exit discharge, and exit stairways.

CAPITAL IMPROVEMENT: Ensure that all ADA accessible toilet rooms are noted on the Directories on each floor level.

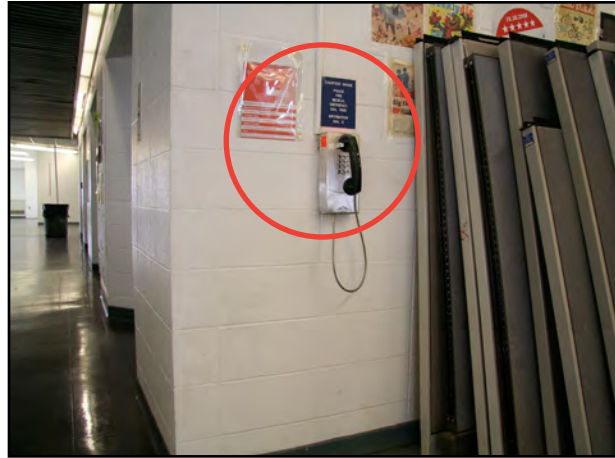
LOCATION | 914

Signs - Designation & Directional Signs

**INTERIM
 RECOMMENDATION**
 Until modifications are complete provide 2010 ADA Standards compliant signage to direct users to nearest accessible Toilet room and other accessible amenities.

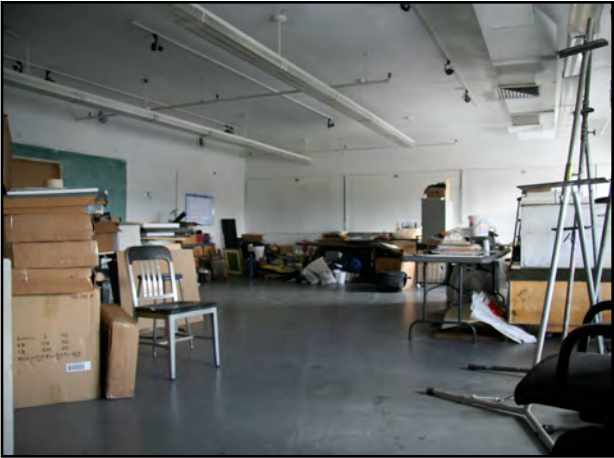
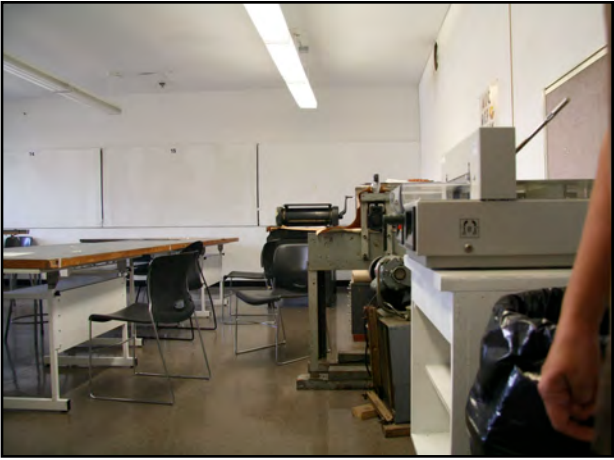
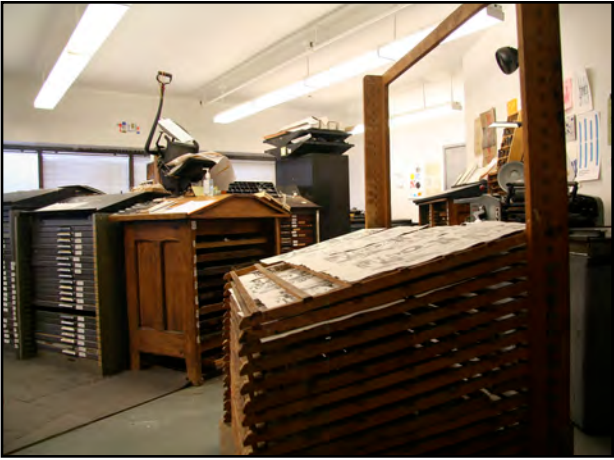
Aisle Obstruction

Aisles and pathways through rooms are not defined creating egress safety and tripping hazards in the accessible route.

OPERATIONAL: Remove obstructions and educate staff, students and faculty to maintain a 36" min. wide clear space through rooms, spaces and accessible routes at all times.

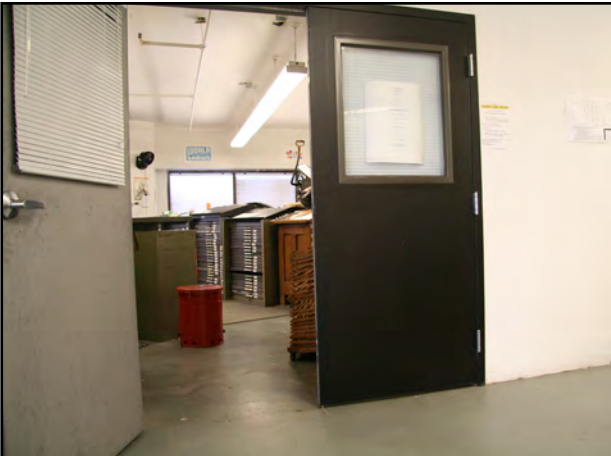
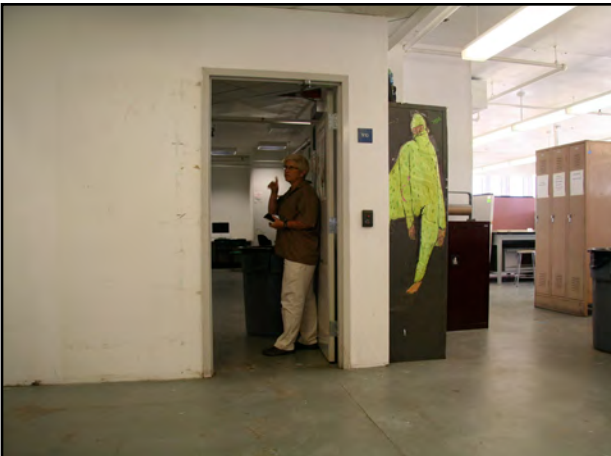
Door - Opening force

The double fire egress doors have a door opening force of 25 lbs which is too heavy for easy opening. Additionally it makes the doors difficult to get through because they close too fast. This could cause problems in an emergency.

RECOMMENDATION TO IMPROVE ADA COMPLIANCE OPERATIONAL: Create a comprehensive maintenance program and schedule to check and adjust all interior doors so that they have an opening pressure that doesn't exceed 5 lbs.

RECOMMENDATION TO IMPROVE SAFETY & USER EXPERIENCE
OPERATIONAL: Ensure that areas beyond fire doors have clear egress routes.

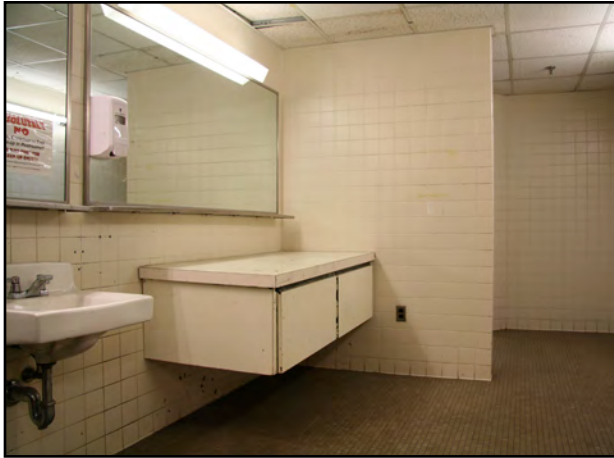
LOCATION | 902

Men's & women's toilet room

RECOMMENDATION TO IMPROVE ADA COMPLIANCE
 Modify toilet rooms to become to meet ADA Standards for accessibility.

While these toilet rooms are not fully ADA accessible, provide ADA compliant signs with directions to the nearest ADA accessible toilet room. Mount signs at the correct height and location to meet ADA standards.

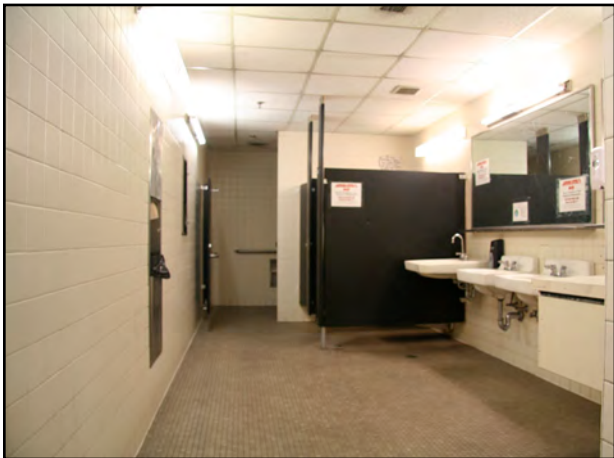
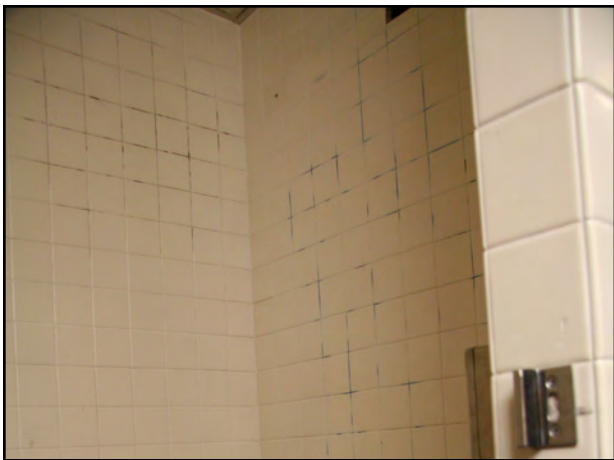
LOCATION | 902

The lavatory(sink) pipes are not wrapped and could cause injury.

SMALL MAINTENANCE Move 1 mirror so that the bottom of the reflective surface is 40" AFF or provide full length mirror in the lavatory (sink)

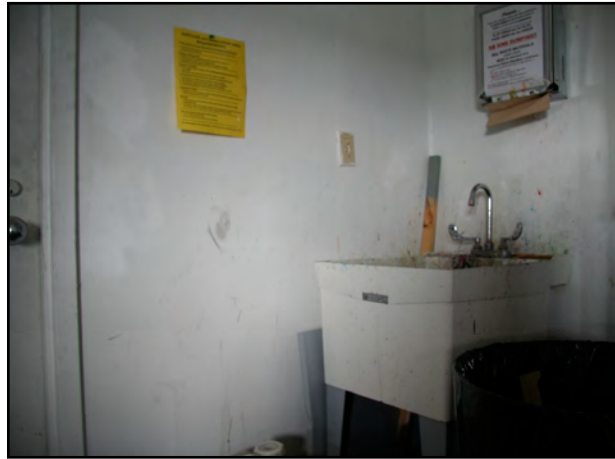
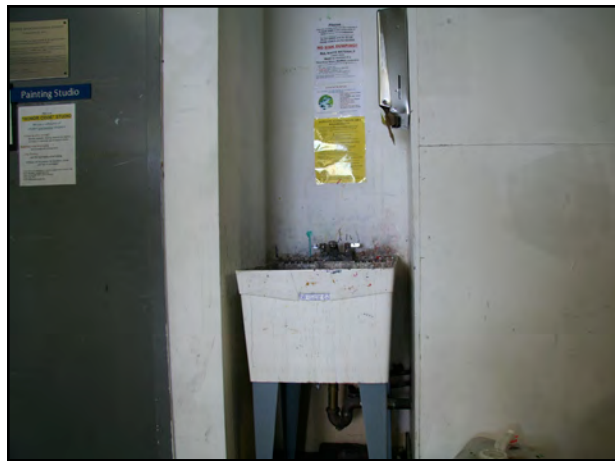
LOCATION | 906b

There are utility sinks on the this floor that are not janitorial but are required for cleaning equipment such as brushes, and related materials which makes their use a part of the educational experience. These sinks do not meet 1991 or 2010 ADA standards for height, clearance or knee space.

SMALL MAINTENANCE: Replace at least one sink with a sink that meets 2010 ADA Standards in each of the rooms that have these sinks, or at this type of sink provide enough space around the sink for a side approach, add an adjacent work counter with room for knee space, add a flexible hose attachment for additional flexibility.

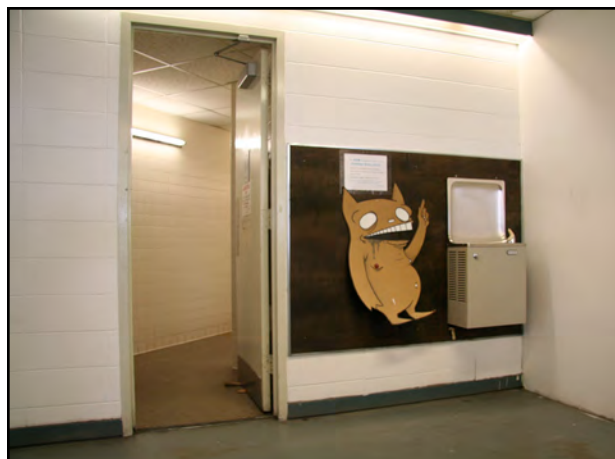
LOCATION | 908

Drinking Fountain

SMALL MAINTENANCE: To benefit people of all statures and abilities relocate and replace the existing drinking fountains on the accessible route with a High-Low type, or add a cup dispenser making sure that the dispenser doesn't stick out more than 4" from the wall and is mounted at a height no greater than 48" AFF to where the cups are dispensed from. Make sure that availability of cups are checked regularly. Provide at least one accessible drinking fountain per floor.

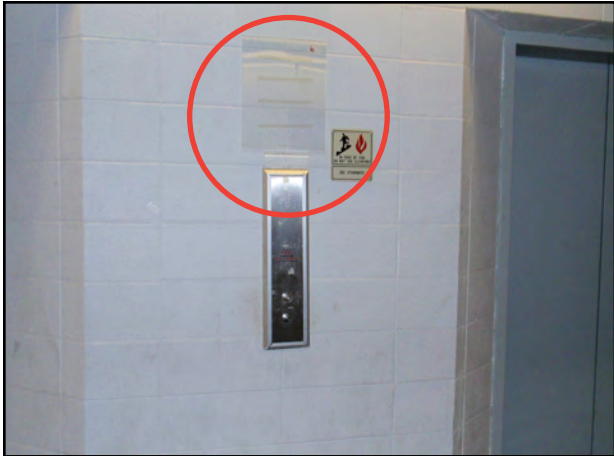
LOCATION | 1001

Building Directory
RECOMMENDATION TO IMPROVE SAFETY & USER EXPERIENCE

Make certain that the Directory information corresponds to the Floor's program & usage. Be sure to add information regarding the accessible toilet rooms after the toilet rooms have been modified to meet ADA Standards for accessibility.

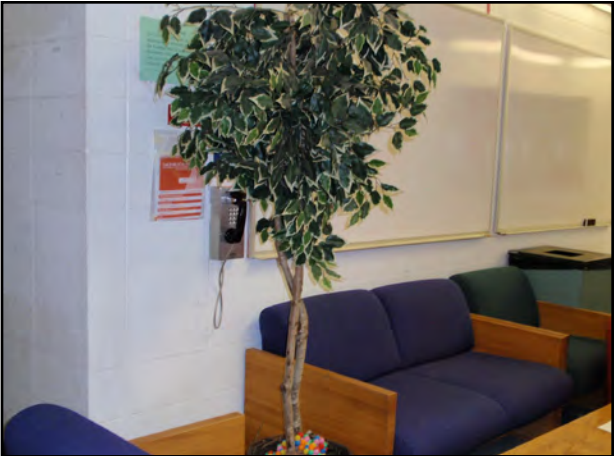
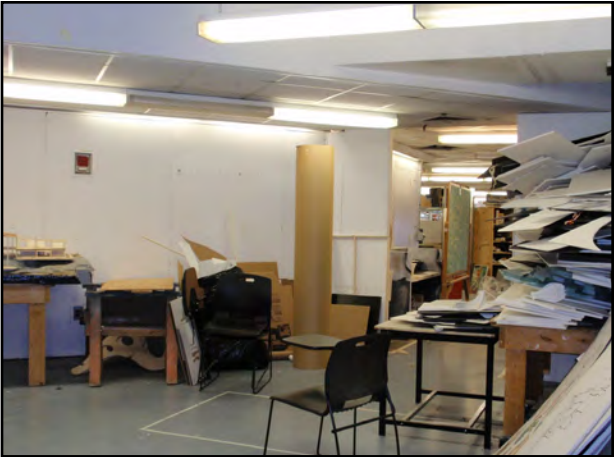
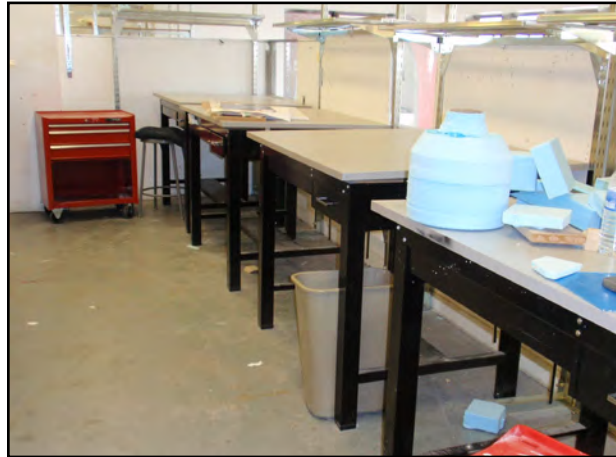
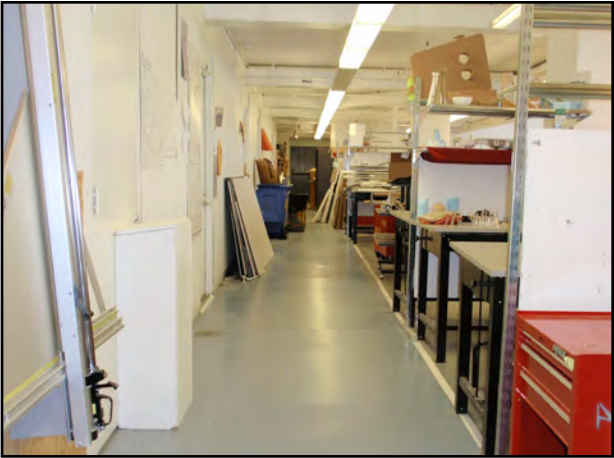
LOCATION | 1004

Aisle Obstruction

Aisles and pathways through rooms are not defined creating egress safety and tripping hazards in the accessible route.

RECOMMENDATION TO IMPROVE ADA COMPLIANCE
OPERATIONAL: Remove obstructions and educate staff, students and faculty to maintain a 36" min. wide clear space through rooms, spaces and accessible routes at all times.

RECOMMENDATION TO IMPROVE SAFETY & USER EXPERIENCE
CAPITAL IMPROVEMENT: As part of a campus-wide wayfinding program wherever possible specify floor finishes and patterns to intuitively provide cues for keeping 36" min. wide clear spaces for routes and paths in rooms and through spaces.

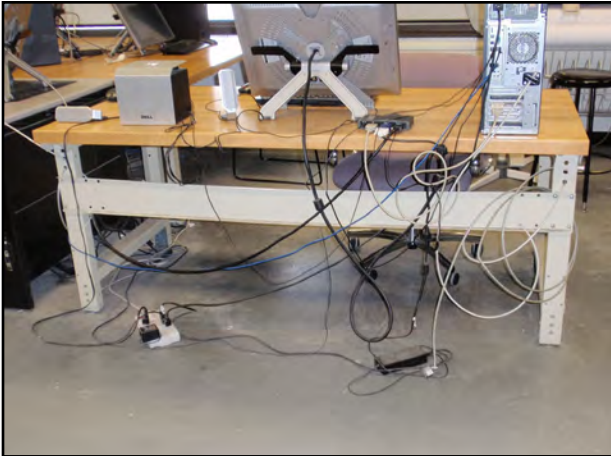
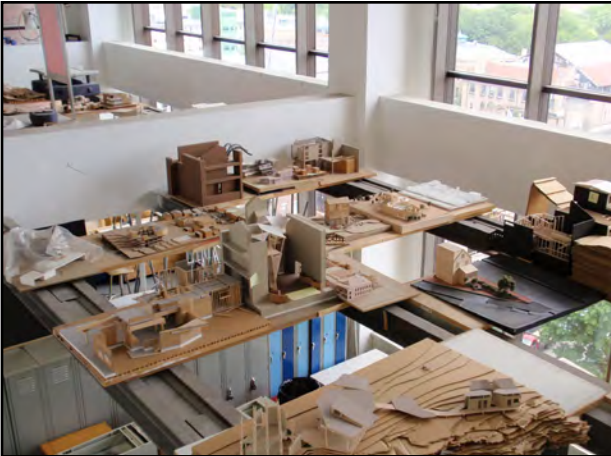
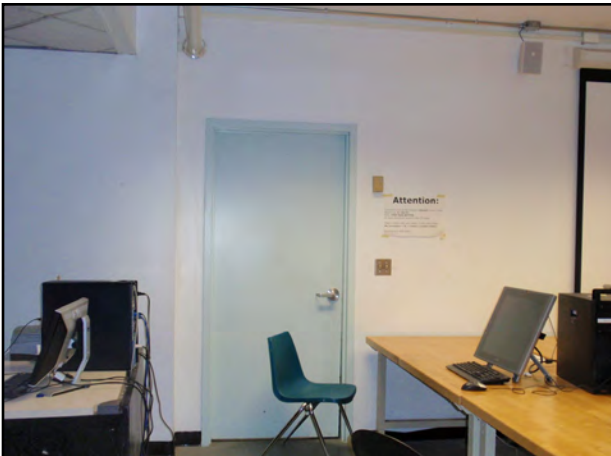
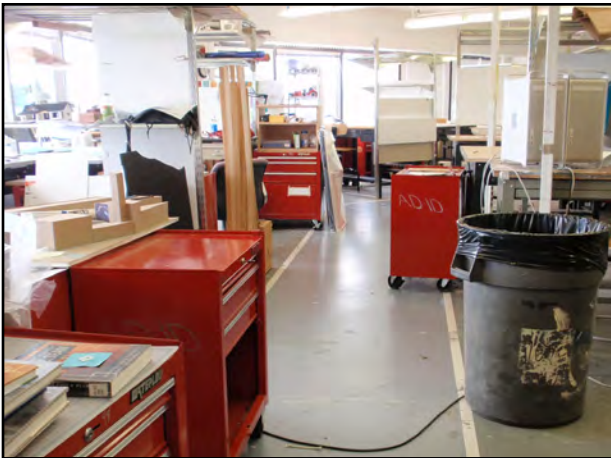
LOCATION | 1012

Aisle Obstruction

1. Aisles and pathways through rooms are not defined creating egress safety and tripping hazards in the accessible route.

RECOMMENDATION TO IMPROVE ADA COMPLIANCE OPERATIONAL: Remove obstructions and educate staff, students and faculty to maintain a 36" min. wide clear space through rooms, spaces and accessible routes at all times.

CAPITAL IMPROVEMENT: As part of a campus-wide wayfinding program wherever possible specify floor finishes and patterns to intuitively provide cues for keeping 36" min. wide clear spaces for routes and paths in rooms and through spaces.

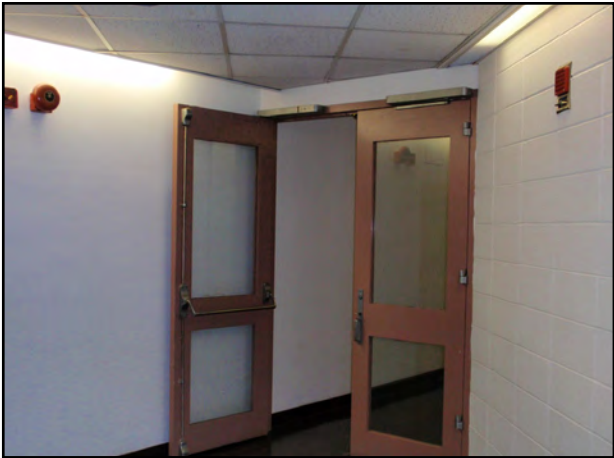
LOCATION | Typical

Door - Double Door Clearances

Provide automatic door openers.

In the interim prop doors open during normal work hours.

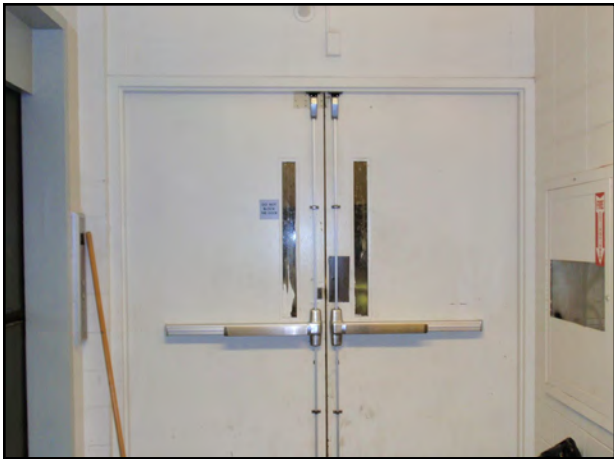
LOCATION | 1009

Door - Single Door Clearances

OPERATIONAL: Create a comprehensive maintenance program and schedule to check and adjust all interior doors so that they have an opening pressure that doesn't exceed 5 lbs.

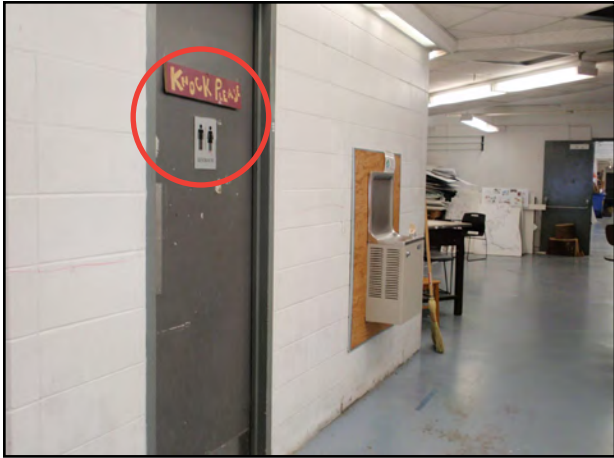
LOCATION | 1014

ADA Facilities and Amenities

Modify toilet rooms to meet ADA standards for accessibility or create a new alternative accessible single-user toilet room for this floor. While these toilet rooms are not accessible install signs with directions to the nearest accessible toilet room. Ensure that these signs are mounted at ADA compliant height and location.

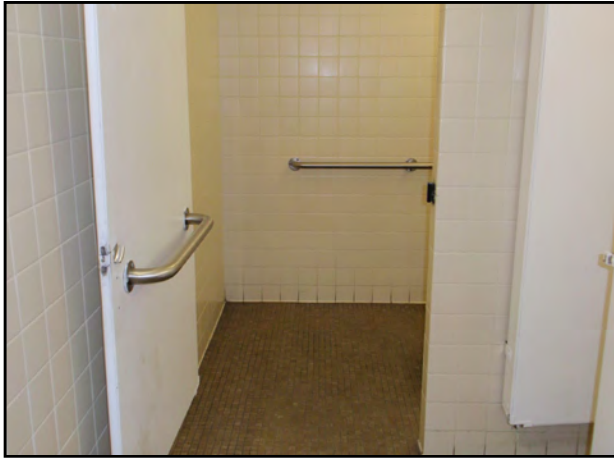
LOCATION | 1014/1003

Signs - Designation Signs

If these toilet rooms are modified to become ADA compliant, provide ADA compliant signs on the latch pull side of the door. Mount at 48" min AFF to the baseline of the tactile characters, and 60" max. AFF, measured from the baseline of the highest tactile character.

Use the symbol of International Accessibility to designate that it is a ADA compliant toilet room or provide signage with directions to a new alternative accessible single user restroom.

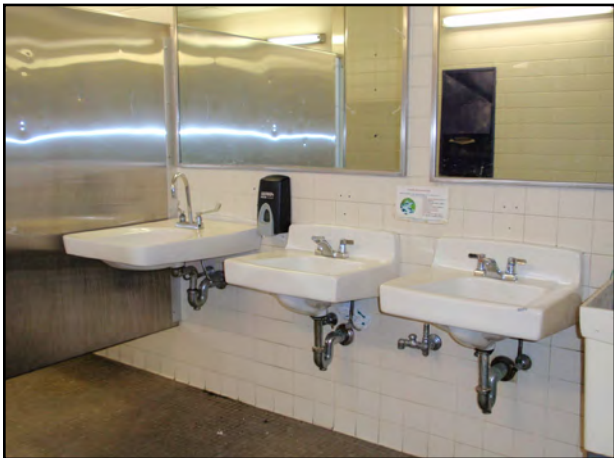
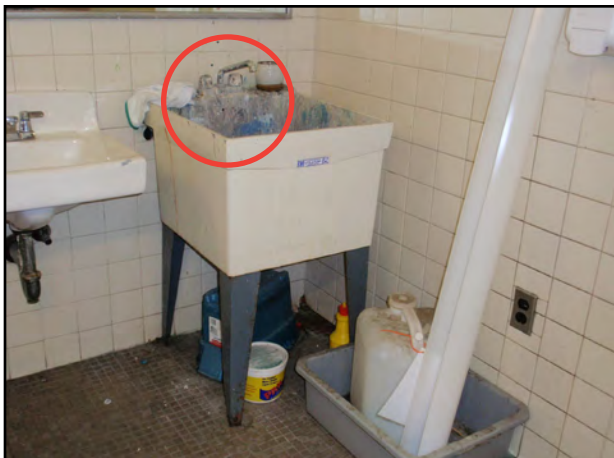
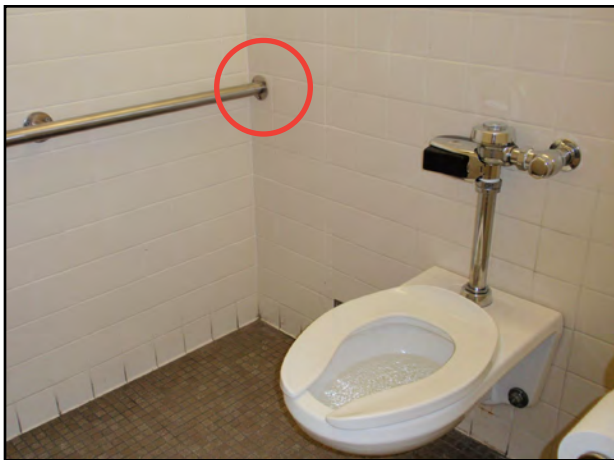
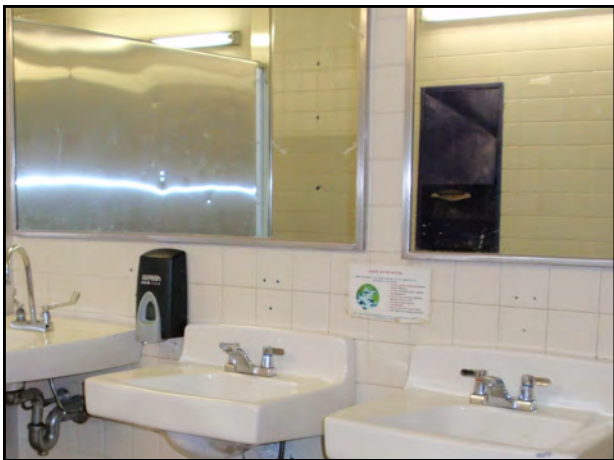
Both toilet rooms have the following non-accessible issues:

Door - Clearance

The lavatory (sink) pipes are not wrapped and could cause injury.

The rear grab bar is missing, the side grab bar is too small. They are installed incorrectly in relation to the water closet so they cannot be used as supports in transferring from a wheelchair.

OPERATIONAL: Adjust door closer to max. 5lbs. opening pressure.

Until modifications are complete provide 2010 ADA Standards compliant signs to direct users to nearest accessible toilet room even if it is in another building.

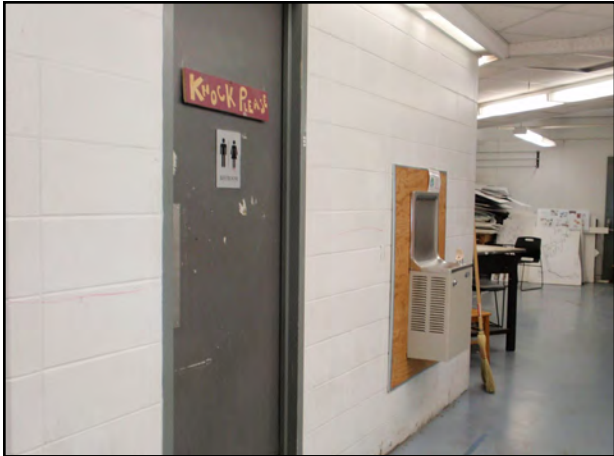
LOCATION | 1014

Drinking Fountain - Does not have two spouts at heights that allow a person in a wheelchair and a person who has trouble bending to be able to get water.

or
SMALL MAINTENANCE: Replace with a high-low drinking fountain that complies with 2010 ADA standards 211, 307, 602 601, 602.

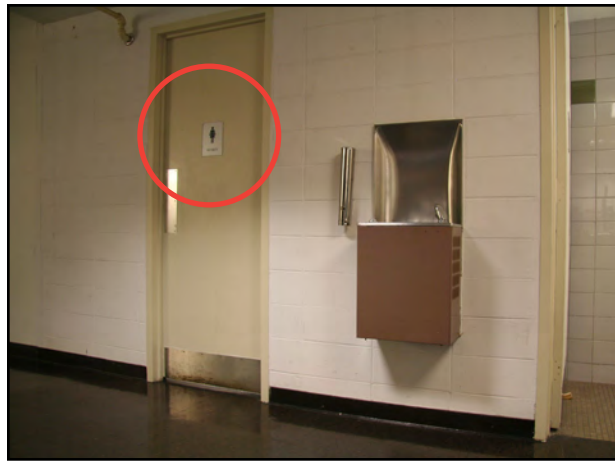
LOCATION | 1114

Signs - ADA Facilities and Amenities

RECOMMENDATION TO IMPROVE ADA COMPLIANCE
SMALL MAINTENANCE: While toilet rooms and drinking fountains are not accessible, provide ADA compliant room designation signs and directions to the nearest accessible amenities. Ensure that these signs are mounted at the correct height and location and use the International Symbol of Accessibility.

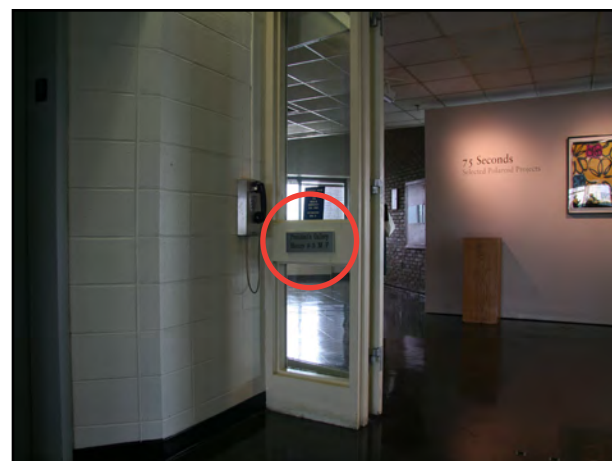
LOCATION | 1100

Signs - Designation & Directional Signs

RECOMMENDATION TO IMPROVE ADA COMPLIANCE
CAPITAL IMPROVEMENT: As part of the campus-wide wayfinding program provide signs for all permanent rooms that meet ADA Standards for accessibility. Place signage on the latch pull side of the door mounted at 48" min AFF to the baseline of the tactile characters on signs and 60" maximum AFF measured from the baseline of the highest tactile character. If there is no room on the latch side place signs on an adjacent wall so that a person reading the sign tactilely will not be injured if the door is opened.

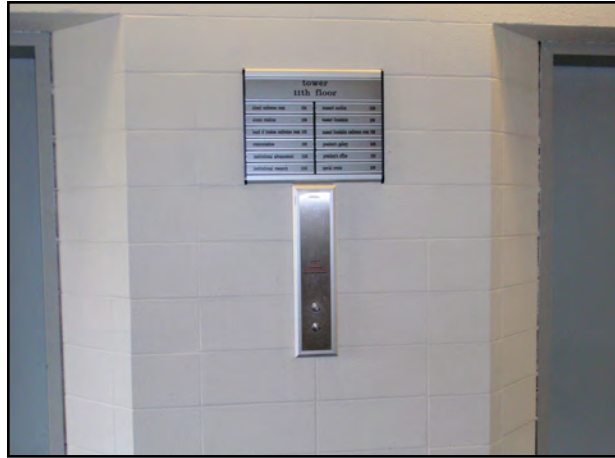
LOCATION | 1101

Building Directory

Make certain that the Directory information corresponds to the floor's program & usage. Be sure to add information regarding the accessible toilet rooms after the toilet rooms have been modified to be accessible.

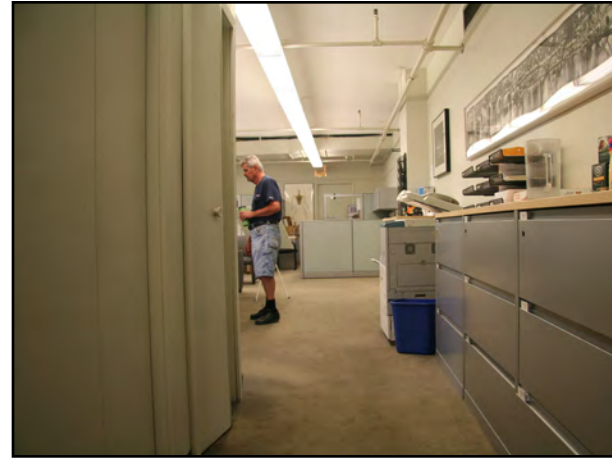
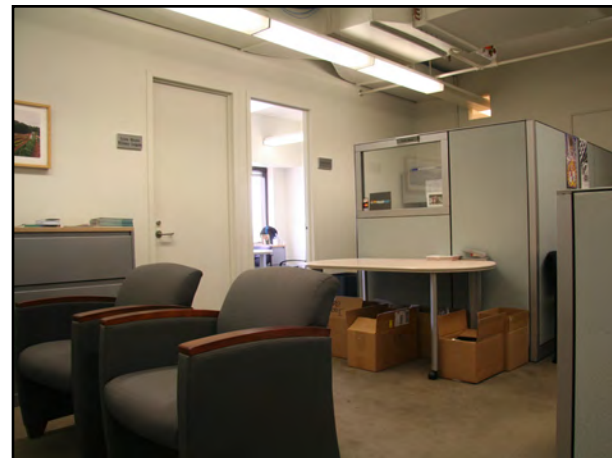
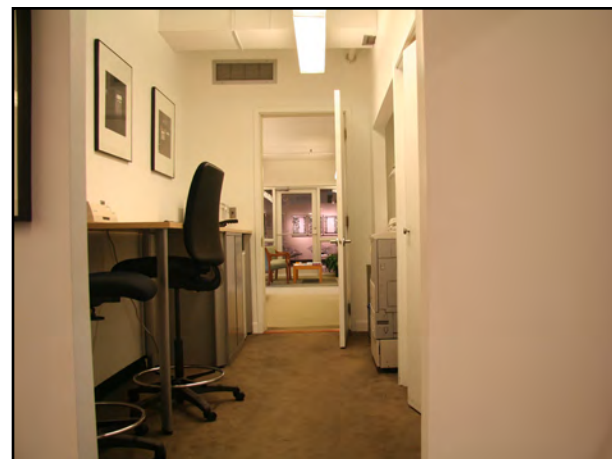
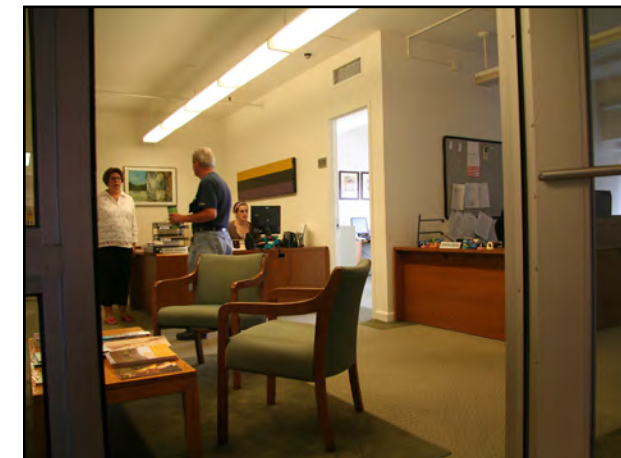
Aisle Obstruction

Aisles and pathways through rooms are not defined creating egress safety and tripping hazards in the accessible route.

ISSUE B
OPERATIONAL
Implement plan to maintain 36" min. clear areas through accessible routes and paths.

CAPITAL IMPROVEMENT: As part of a campus-wide wayfinding program wherever possible specify floor finishes and patterns to intuitively provide cues for keeping 36" min. wide clear spaces for routes and paths in rooms and through spaces. Some egress requirements may call for aisles and corridors to be wider than 36" min.

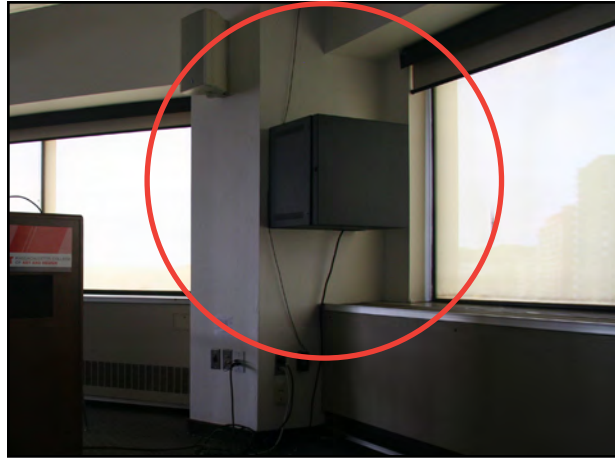
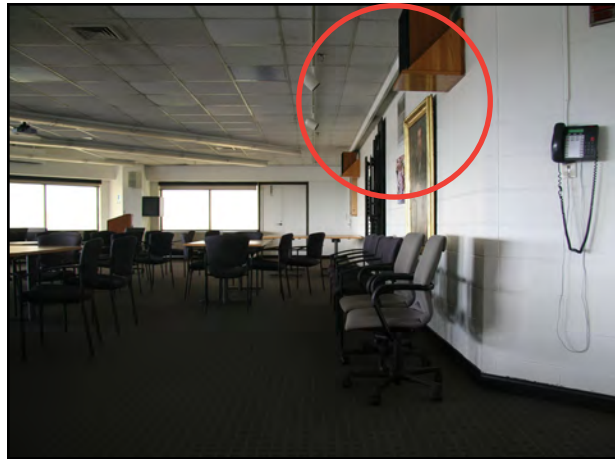
Protruding Objects- Speakers

Speakers protrude 10" from the wall into the accessible route and the bottom of the speaker is below 80" AFF. This may cause a head injury, and a person using a cane would not be able to detect the speaker.

Computer box protrudes 18 1/2" from the wall into the accessible route and the bottom of the box is below 45" AFF this may cause injury, it would not be detectable to a person using a cane.

Speakers protrude 10" from the wall into the accessible route and the bottom of the speaker is below 80" AFF this may cause injury, a person using a cane would not be able to detect them.

RECOMMENDATION TO IMPROVE ADA COMPLIANCE
SMALL MAINTENANCE: Raise the speakers so that the bottom of the speaker is more than 80" AFF. If this is not possible consider recessing it into the wall.

RECOMMENDATION TO IMPROVE ADA COMPLIANCE
SMALL MAINTENANCE: Enclose the computer box so that sides extend to the floor or lower the box so that the bottom is less than 27" AFF so that it can be detected by a person with a cane.

RECOMMENDATION TO IMPROVE ADA COMPLIANCE
OPERATIONAL: Turn speaker on its side and mount so that the bottom of the support is more than 80" AFF.
