Massachusetts College of Art and Design

ADA Compliance Plan 2011

ADA Compliance Plan
Consultant Services
Contract #10-08

The Institute for Human Centered Design

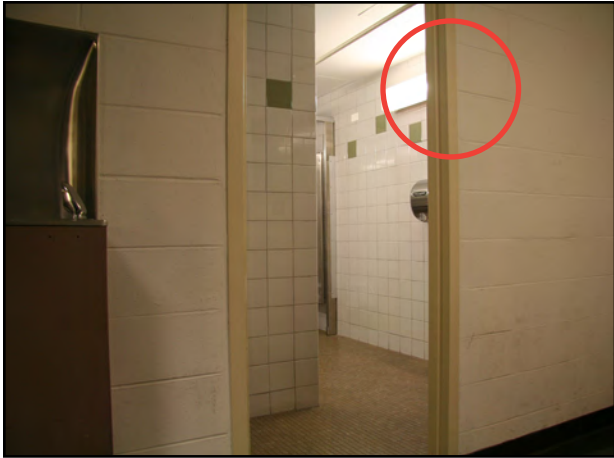
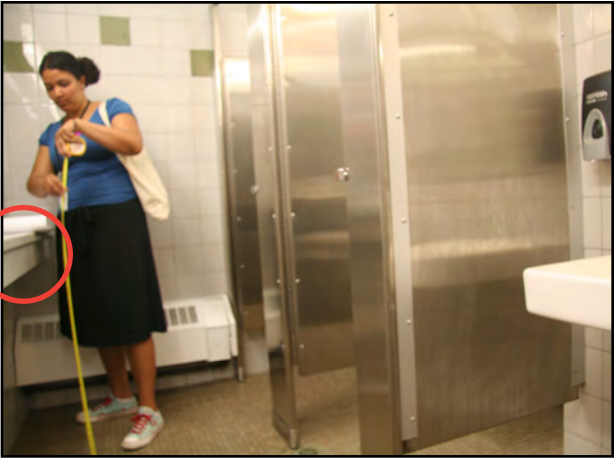
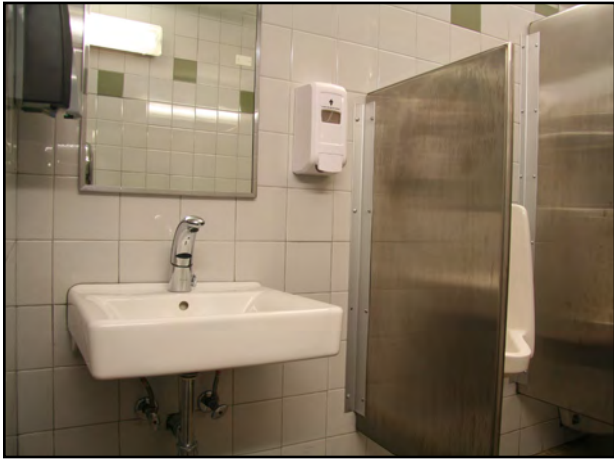
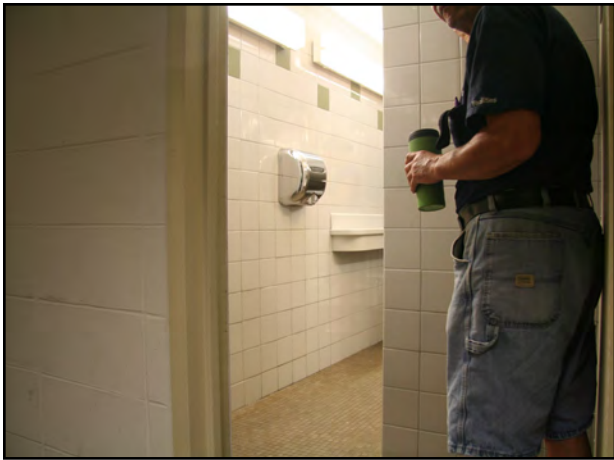
Men's & Women's Toilet Room
 See Issues for 7th Floor Toilet Rooms

Shelf protrudes 7 1/2" into accessible path and is 36" AFF.

RECOMMENDATION TO IMPROVE ADA COMPLIANCE
 Modify toilet rooms to meet ADA standards.

RECOMMENDATION TO IMPROVE ADA COMPLIANCE
 Remove shelf.

ISSUE F
CAPITAL IMPROV.
 To make this toilet room accessible-would require extensive modifications. Consider creating at least one new alternative accessible single-user toilet room on this floor.

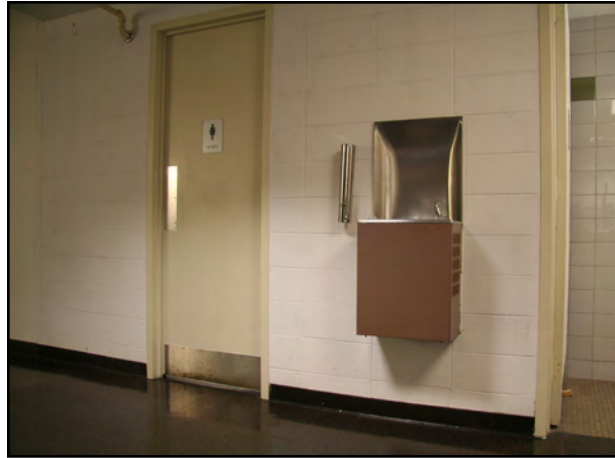
LOCATION | 1106

Drinking Fountain

RECOMMENDATION TO IMPROVE ADA COMPLIANCE OPERATIONAL: Ensure that cup dispenser is kept stocked

SMALL MAINTENANCE: Replace with a high-low drinking fountain that complies with 2010 ADA standards 211, 307, 602 601, 602.

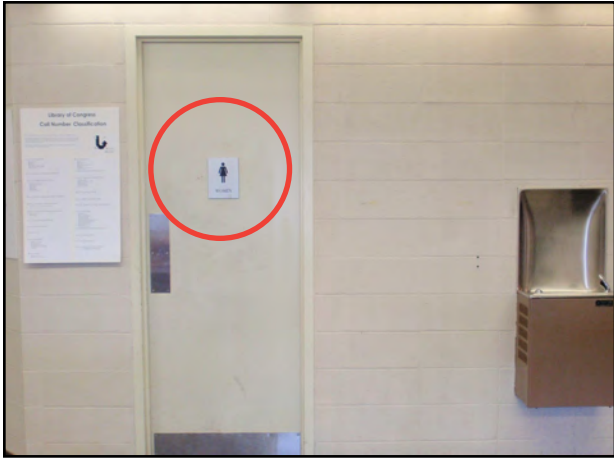
LOCATION | 1202

Signs - ADA Facilities and Amenities

CAPITAL IMPROVEMENT: Ensure that all ADA compliant toilet rooms are noted on the Directories on each floor level.

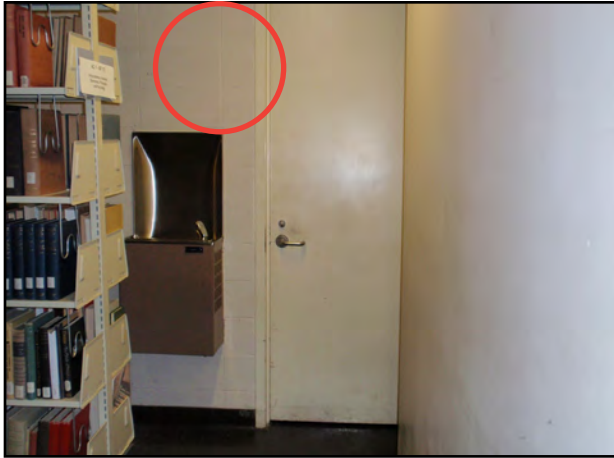
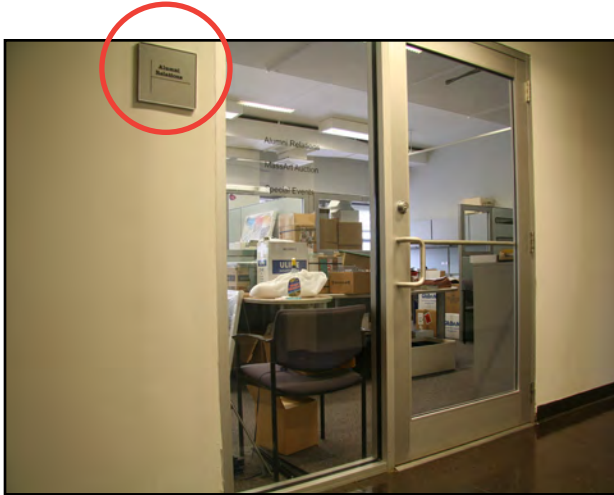
Signs - Designation & Directional Signs

INTERIM RECOMMENDATION
 Until modifications are complete provide 2010 ADA Standards compliant signage to direct users to nearest accessible Toilet Room and other accessible amenities.
\$150-200/sign

ISSUE A2
CAPITAL IMPROV.
 Design and implement a campus-wide wayfinding program that includes 2010 ADA Standards compliant designation, directional and informational signs.
\$150-200/sign

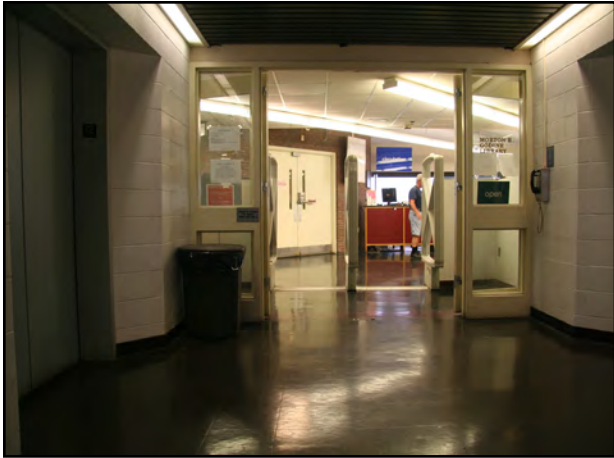
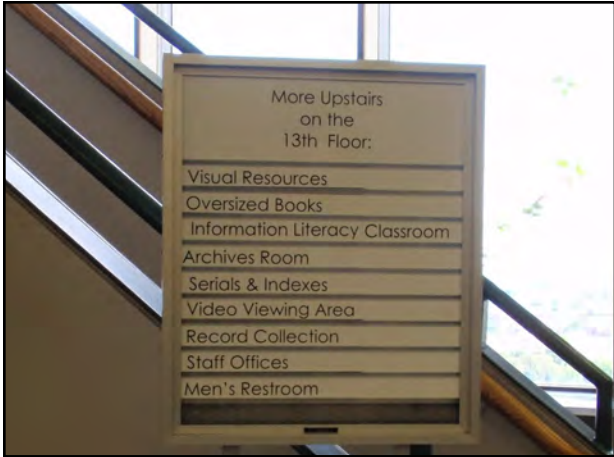
Building Directory
RECOMMENDATION TO IMPROVE SAFETY & USER EXPERIENCE
 As part of a campus-wide wayfinding program consider putting a Directory at elevator and stair lobbies. This will provide information about locations of services on each floor and will allow people who have mobility difficulties to be able to see where they need to go before having to make the effort of climbing stairs or backtracking.

Make certain that the Directory information corresponds to the floor's program & usage. Be sure to add information regarding the accessible toilet room after the toilet rooms have been modified to be accessible.

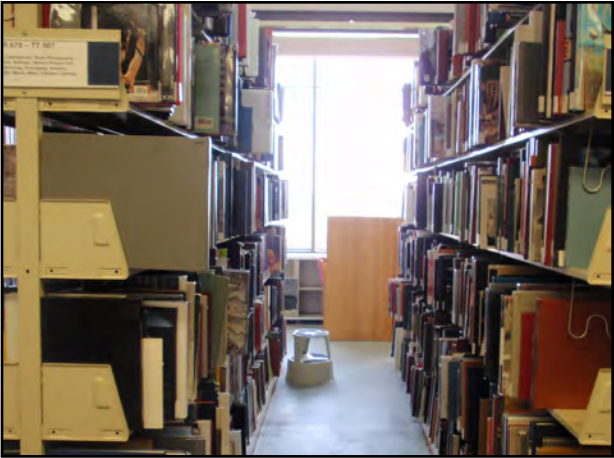
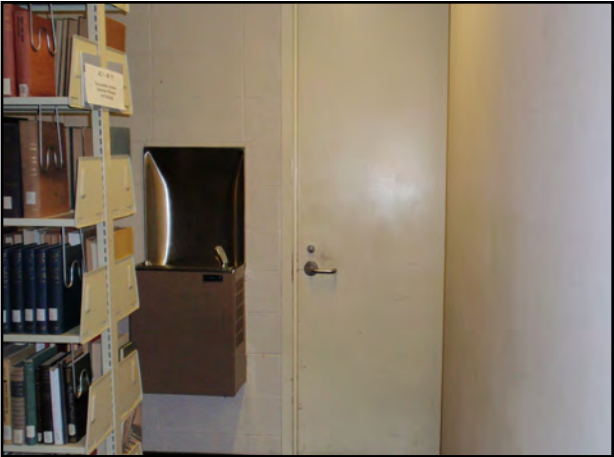
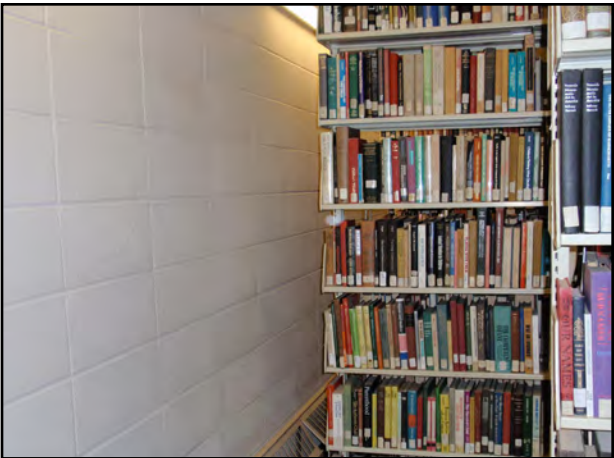
Aisle Obstruction
 Aisles and pathways through rooms are not defined creating egress safety and tripping hazards in the accessible route.
[See Appendix A -2010 ADA Standards 206 Accessible Routes 401, 402, 403.5.1 Clearances]

RECOMMENDATION TO IMPROVE ADA COMPLIANCE
OPERATIONAL: Remove obstructions and educate staff, students and faculty to maintain a 36" min. wide clear space through rooms, spaces and accessible routes at all times.

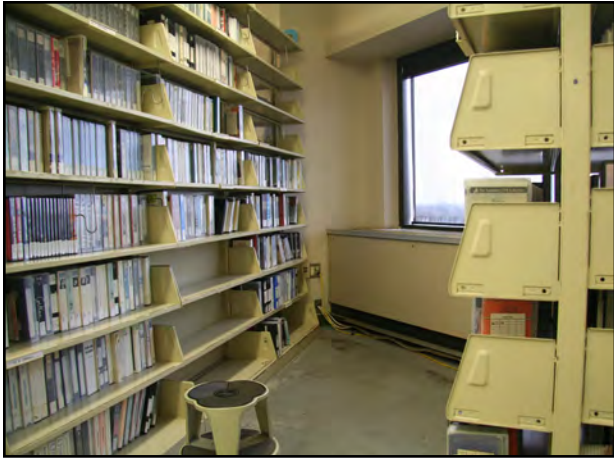
LOCATION | 1204

Aisle Obstruction

Aisles and pathways through rooms are not defined and kept free of obstructions. This creates egress safety and tripping hazards in the accessible route.

RECOMMENDATION TO IMPROVE ADA COMPLIANCE OPERATIONAL: Remove obstructions and educate staff, students and faculty to maintain a 36" min. wide clear space through rooms, spaces and accessible routes at all times.

RECOMMENDATION TO IMPROVE SAFETY & USER EXPERIENCE CAPITAL IMPROVEMENT: As part of a campus-wide wayfinding program wherever possible specify floor finishes and patterns to intuitively provide cues for keeping 36" min. wide clear spaces for routes and paths in rooms and through spaces.

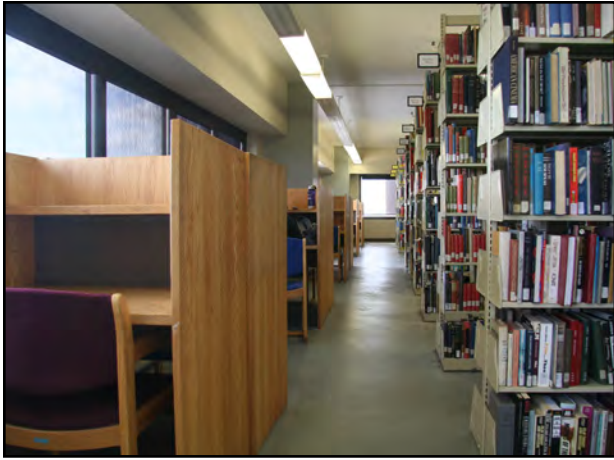
LOCATION | 1212

Accessible Route

RECOMMENDATION TO IMPROVE ADA COMPLIANCE OPERATIONAL: Re-arrange stacks so that there is at least 42" min. clear between the stacks and 48"min. at the ends of aisles.

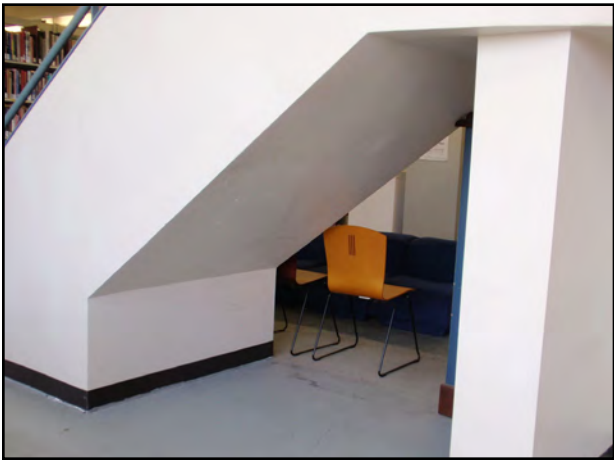
LOCATION | 1211b

Accessible Route-Elevator/Lift

RECOMMENDATION TO IMPROVE ADA COMPLIANCE CAPITAL IMPROVEMENT: Consolidate the library into a single floor or provide an elevator or lift inside the library to allow access between the floors.

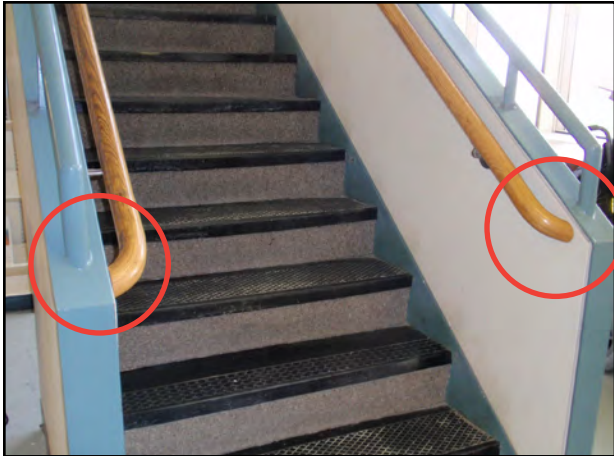
LOCATION | 1211

Stairs - Rails and Rail Extensions

Stairs handrails are missing rail extensions. Consider continuous rail at wall side of stairs.

SMALL MAINTENANCE: Install new rail with rail extensions. Handrail gripping surfaces shall extend beyond and in the same direction of stair flights.

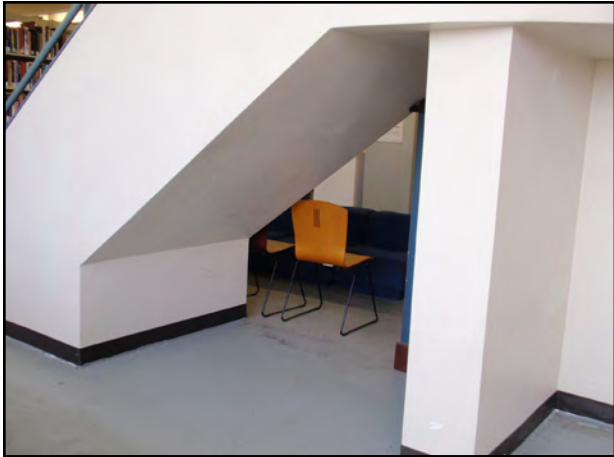
LOCATION | 1211

Stairs-Vertical Clearance (Headroom)

The space under the stair allows a person to walk into the stairs and cause a head injury.

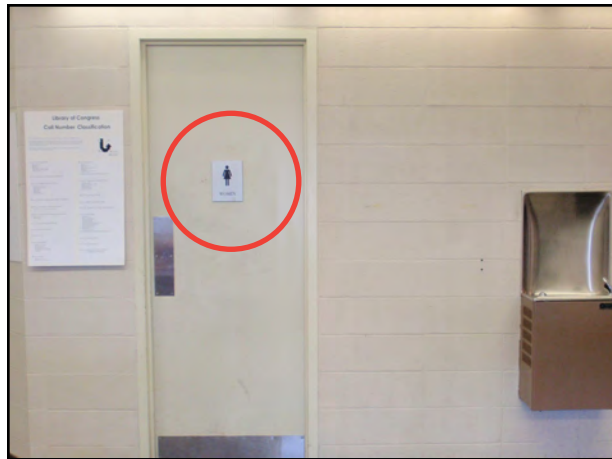
LOCATION | 1214a

ADA Facilities and Amenities

Modify toilet rooms to meet ADA standards for accessibility **or** create a new alternative accessible single-user toilet room for this floor. While these toilet rooms are not accessible install signs with directions to the nearest accessible toilet room. Ensure that these signs are mounted at ADA compliant height and location.

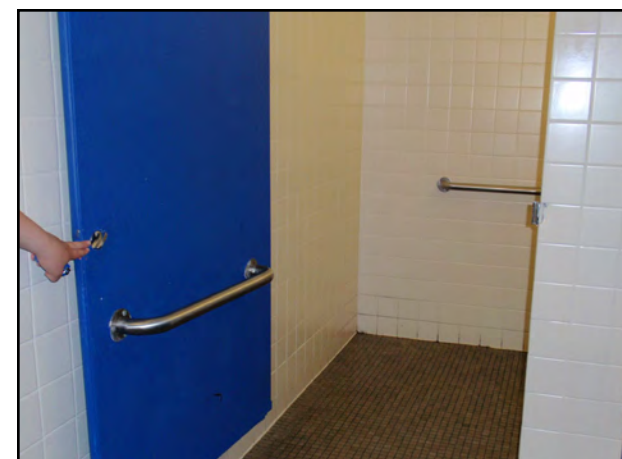
LOCATION | 1214c

Grab bars - Incorrect installation and dimensions

The rear grab bar is missing, the side grab bar is too small. There is an extra grab bar on the door of the compartment that reduces the door clear width. Additionally they are installed incorrectly in relation to the water closet so they cannot be used as supports in transferring from a wheelchair.

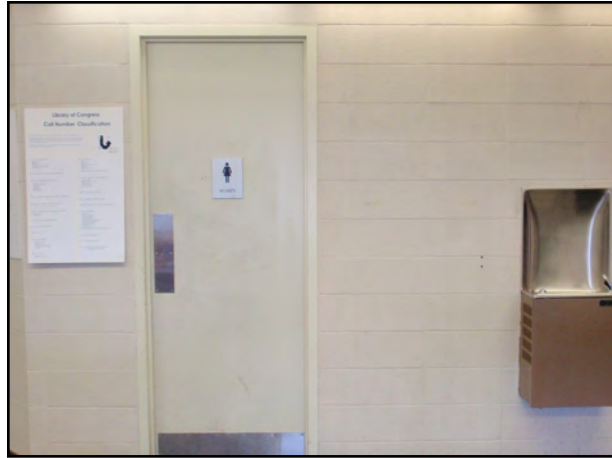
LOCATION | 1214

Drinking Fountain - Does not have two spouts at heights that allow a person in a wheelchair and a person who has trouble bending to be able to use it. **LOCATION | 1214**

RECOMMENDATION TO IMPROVE ADA COMPLIANCE OPERATIONAL: Provide cups with dispenser and trash that doesn't protrude from the wall more than 4" and within reach range.

SMALL MAINTENANCE: Replace with a high-low drinking fountain that complies with 2010 ADA standards 211, 307, 602 601, 602.

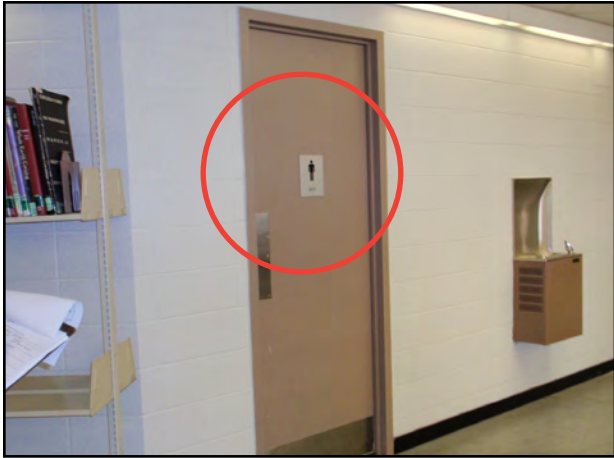
LOCATION | 1312

Signs - ADA Facilities and Amenities
 The toilet rooms and drinking fountains are not accessible but with modifications they could be.
 The toilet rooms sign is not accessible for location and height and there are no signs with directions to the nearest accessible amenities.
[See Appendix A -2010 ADA Standards 703 Signs-703.2, 703.3, 703.4,03.6.1 Pictogram field]

RECOMMENDATION TO IMPROVE ADA COMPLIANCE
SMALL MAINTENANCE: Whilst toilet rooms, phones and drinking fountains are not accessible provide ADA compliant room designation signs with directions to the nearest ADA accessible toilet room, drinking and phone. Ensure that these signs are mounted at the correct height and location and use the International Symbol of Accessibility.
[See Appendix A -2010 ADA Standards 703 Signs-703.2, 703.3, 703.4,03.6.1 Pictogram field]

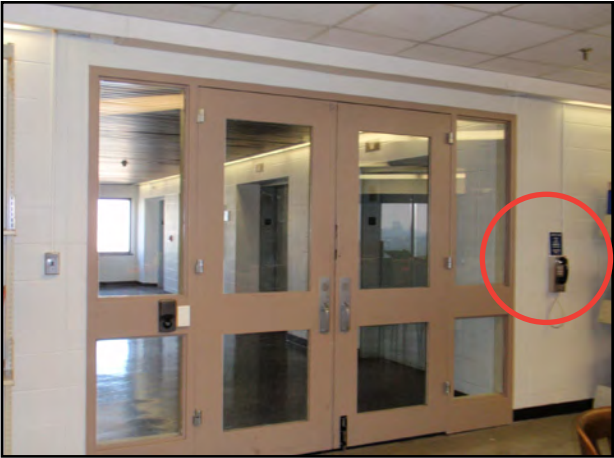
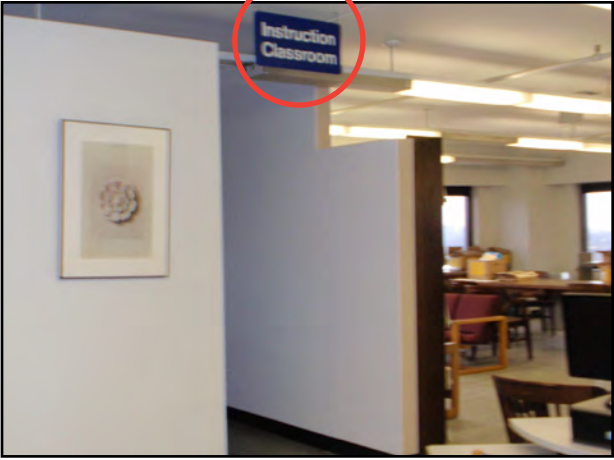
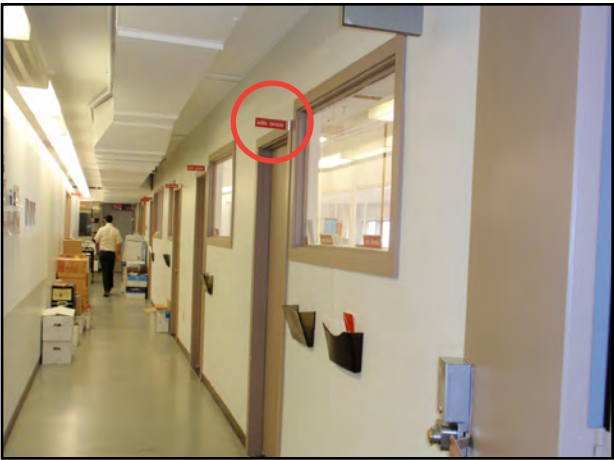
Signs - Designation & Directional Signs
 All permanent rooms & locations do not have room signs that meet ADA standards such as the braille and mounting requirements.
[See Appendix A -2010 ADA Standards 703 Signs-703.2, 703.3, 703.4]

RECOMMENDATION TO IMPROVE ADA COMPLIANCE
CAPITAL IMPROVEMENT: As part of the campus-wide wayfinding program provide signs for all permanent rooms that meet ADA Standards for accessibility. Place signage on the latch pull side of the door mounted at 48" min AFF to the baseline of the tactile characters on signs and 60" maximum AFF measured from the baseline of the highest tactile character. If there is no room on the latch side place signs on an adjacent wall so that a person reading the sign tactilely will not be injured if the door is opened.
[See Appendix A -2010 ADA Standards 703 Signs-703.2, 703.3, 703.4]

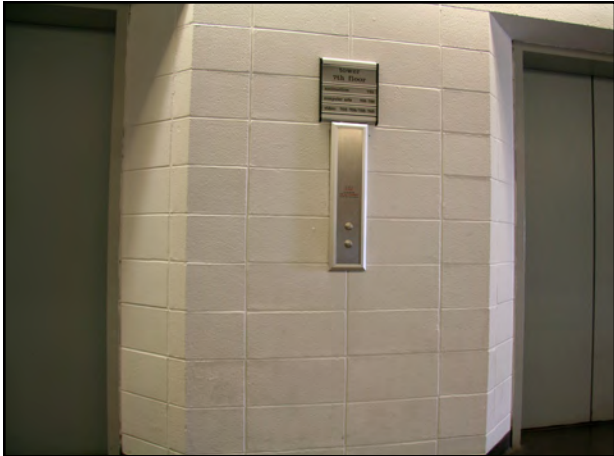
LOCATION | 1301

Building Directory

Make certain that the Directory information corresponds to the floor's program & usage. Be sure to add information regarding the accessible toilet after the toilet rooms have been modified to be accessible.

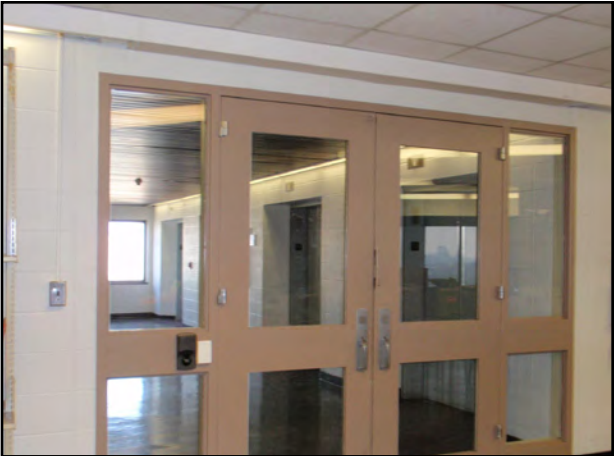
LOCATION | 1305

Aisle Obstruction

RECOMMENDATION TO IMPROVE ADA COMPLIANCE
OPERATIONAL: Ensure that there is a librarian or a member of staff always available to open the doors.
OPERATIONAL: Provide directions explaining how to enter the library.

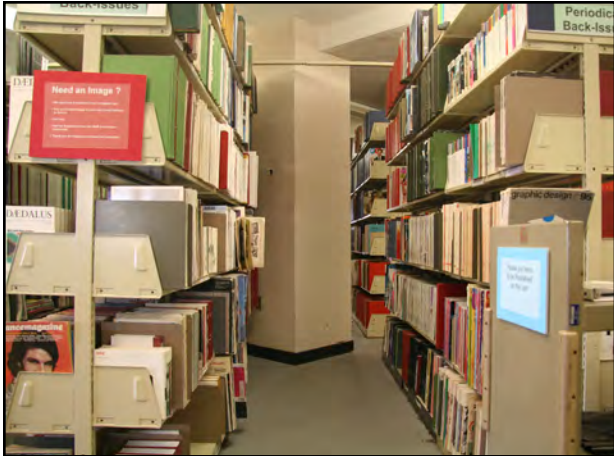
LOCATION | 1307

Aisle Obstruction

RECOMMENDATION TO IMPROVE ADA COMPLIANCE
OPERATIONAL: Rearrange stacks and furniture so that a 36" min. aisle and 42" turning space at the ends of aisles are maintained throughout the library.

Remove obstructions from 36" min. paths

Educate staff, students and faculty to maintain a 36" min. wide clear space through rooms, spaces and accessible routes at all times.

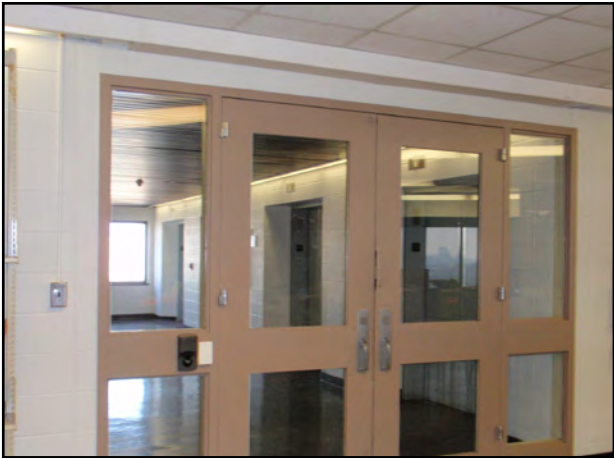
LOCATION | 1305

Door - Locked Entry Door

Post a sign notifying users that this entrance is not accessible.

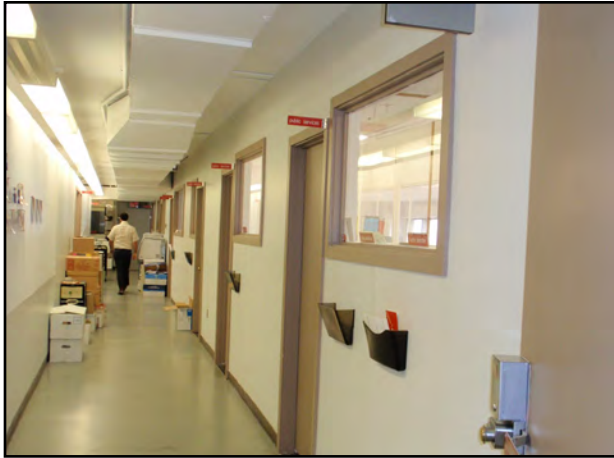
LOCATION | 1308

Door Closers

OPERATIONAL: Create a comprehensive maintenance program and schedule to check and adjust all interior doors so that they have an opening pressure that doesn't exceed 5 lbs.

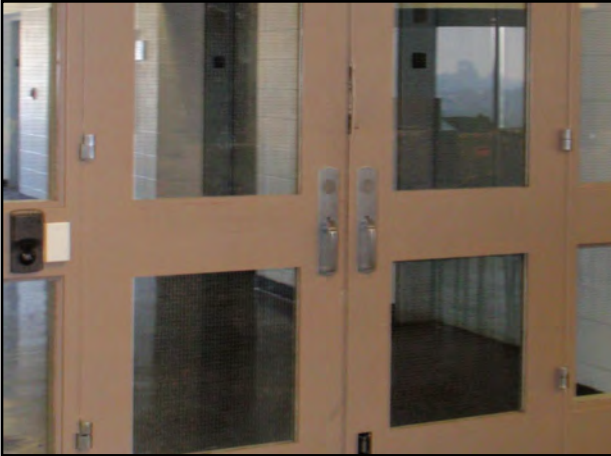
LOCATION | 1305

Door Hardware

The exit hardware requires tight grasping, pinching or twisting of the wrist this could cause delay and impede exiting in an emergency.

RECOMMENDATION TO IMPROVE ADA COMPLIANCE
SMALL MAINTENANCE: Reinstall hardware that does not require great coordination between a card swipe and opening of the door and that does not require tight grasping, pinching or twisting of the wrist.

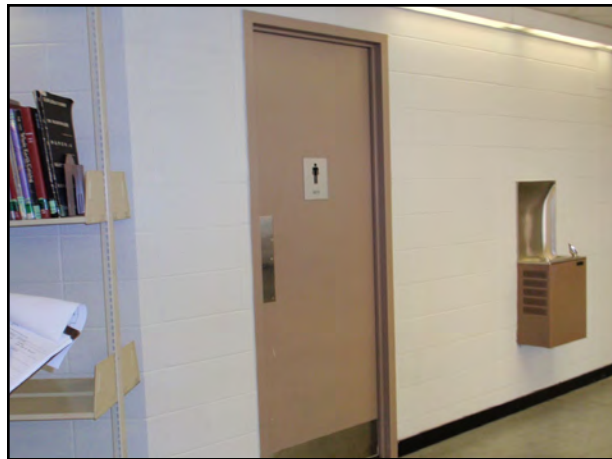
LOCATION | 1302a

ADA Facilities and Amenities

RECOMMENDATION TO IMPROVE ADA COMPLIANCE
Modify toilet room to become accessible single-user toilet room.

While this toilet room is not accessible, provide an ADA compliant sign with directions to the nearest accessible toilet room. Ensure that the sign is mounted at the correct height and location.

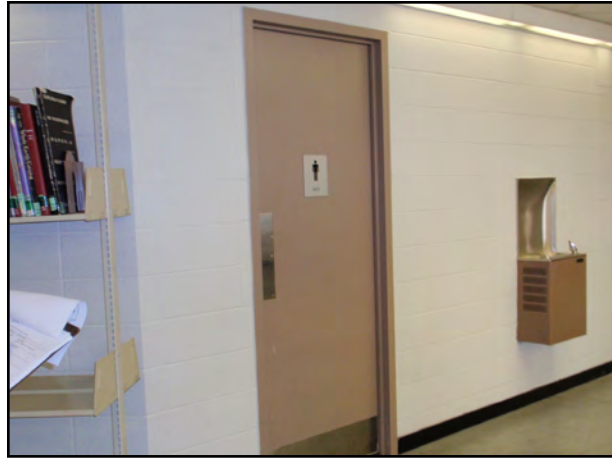
LOCATION | 1312

Drinking Fountain - Does not have two spouts at heights that allow a person in a wheelchair and a person who has trouble bending to be able to get water.

RECOMMENDATION TO IMPROVE ADA COMPLIANCE OPERATIONAL: Provide cups with dispenser and trash that doesn't protrude from the wall more than 4" and within reach range.

SMALL MAINTENANCE: Replace with a high-low drinking fountain that complies with 2010 ADA standards 211, 307, 602 601, 602.

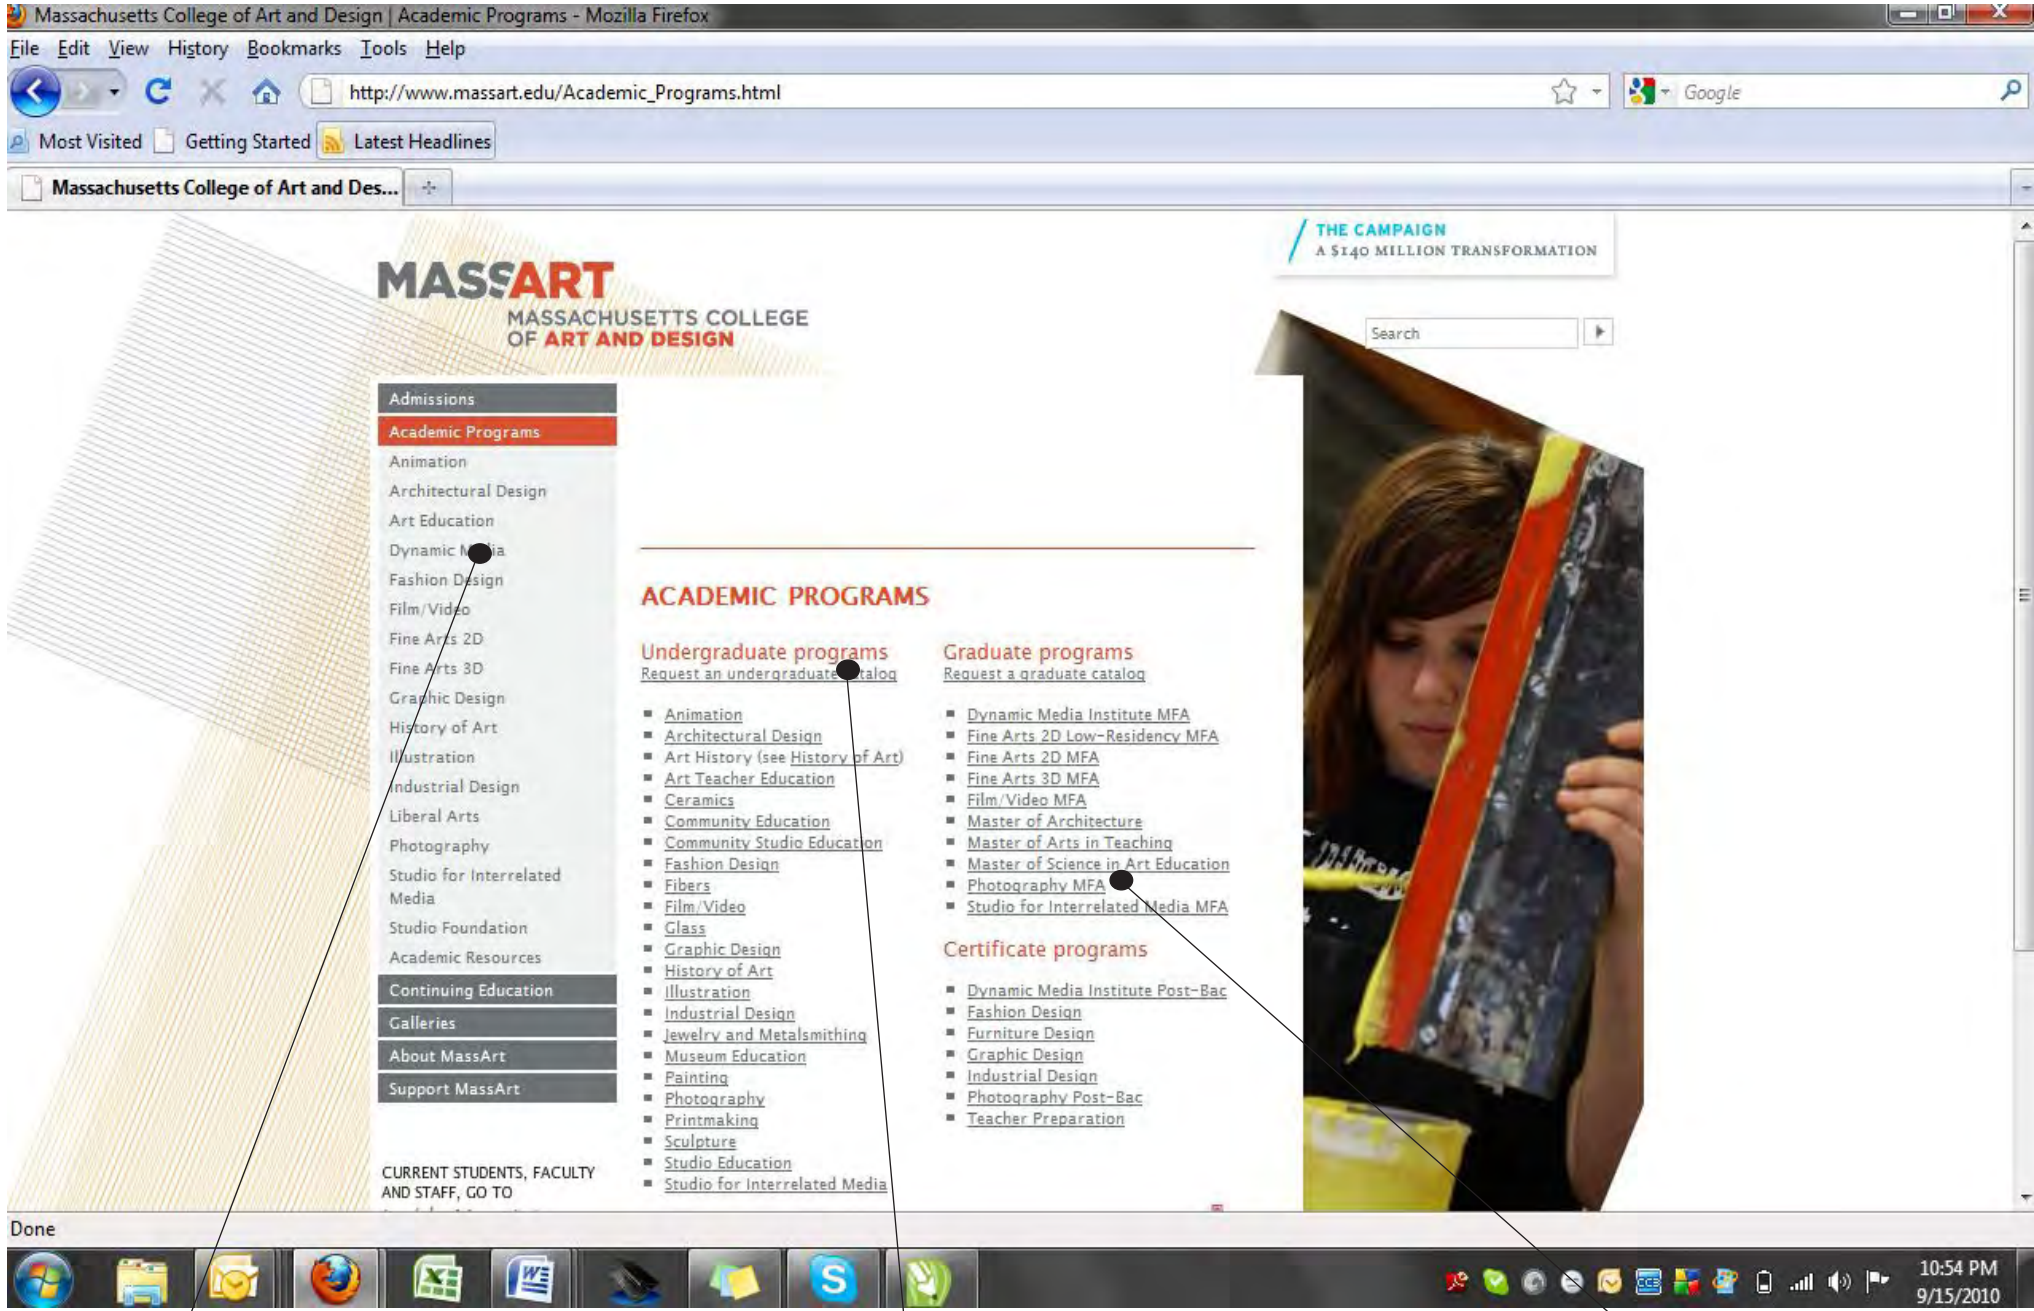
Using all caps is not recommended for sentences because it makes legibility more difficult. Ideally it is only used for a single, or couple word heading.

Increasing the font size slightly and or increasing the contrast would make this text more legible.

There is a nice use of line spacing which helps legibility.

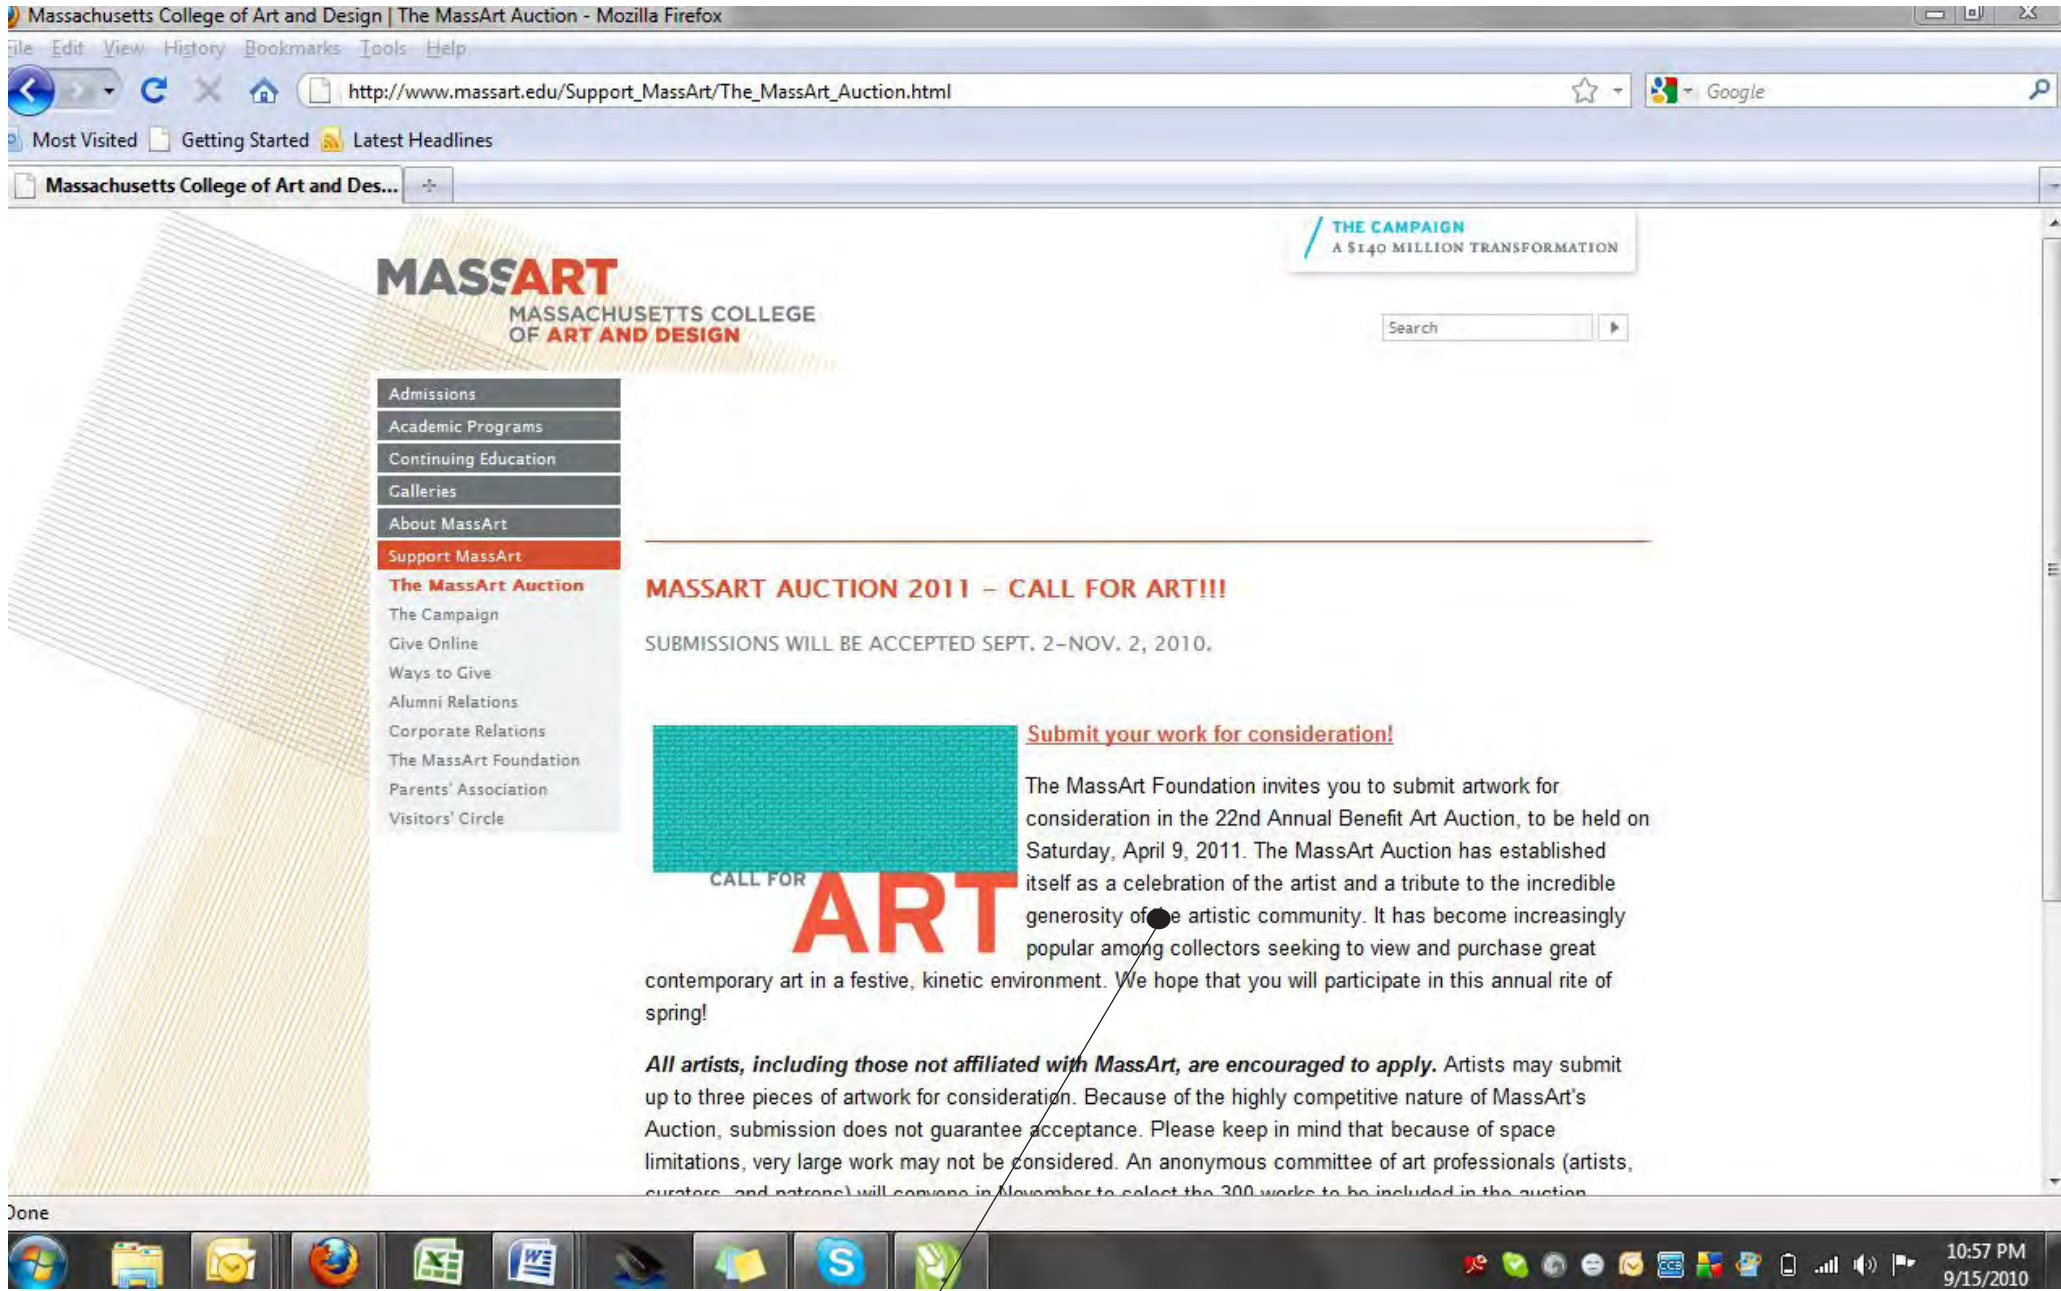
With the exception of font size and low contrast color, graphically this is an easy to navigate and understand. It creates a nice table of contents.

Nice use of color headings for sections.

Increasing the font size slightly and or increasing the contrast would make this text more legible. The underlines also make it more difficult to read however they remind the reader that they are links.

Although not as clear in this image, when on line this page illustrates how black on white is far more legible than the light gray on white.
