Massachusetts College of Art and  
Design

Tower Building Analysis

MASS State Project #MCA 1301-HS1

Issue | November 19, 2013

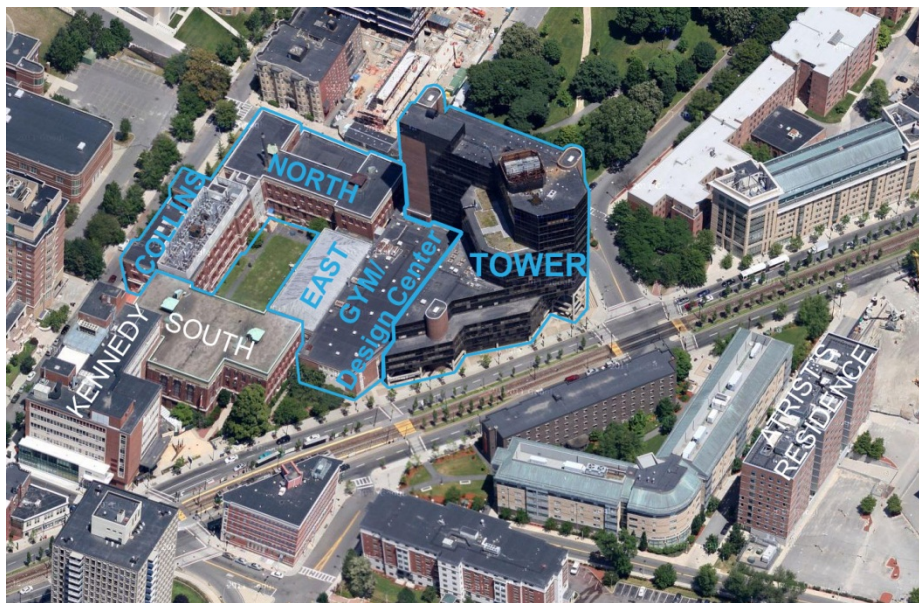
The most significant of these building systems is the main switchgear equipment, which currently poses a significant risk of failure. In the event of failure, a considerable amount of downtime (i.e. weeks) of the Tower not in operation would likely result. It is important to note that Collins, East, North and Gym buildings (future Center for Design + Media) on the MCAD campus are also fed from the Tower main electric room. These buildings would also be at risk in the event of failure.

Figure 1.3 MCAD Campus Buildings. The buildings identified in **BLUE** are fed from the Tower electric room.

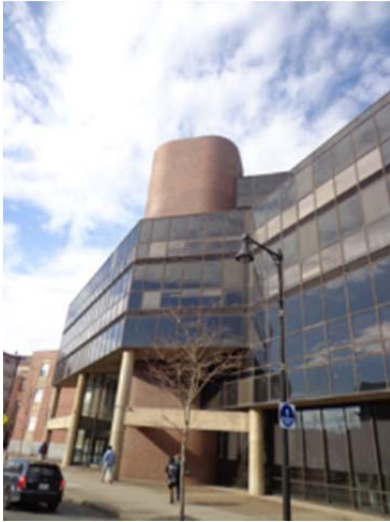
Figure 2.4.1 Concrete frame at street

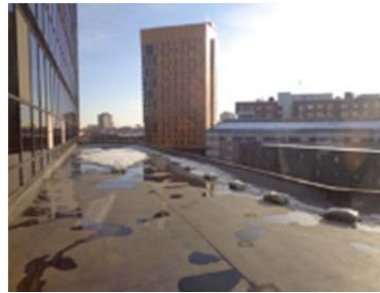
Figure 2.4.8 Water ponding and ice

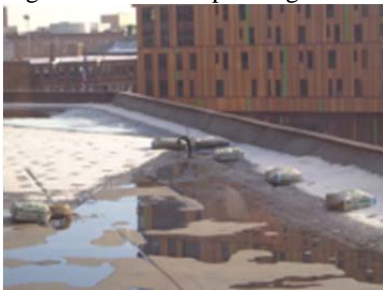
Figure 2.4.9 Sandbags on membrane

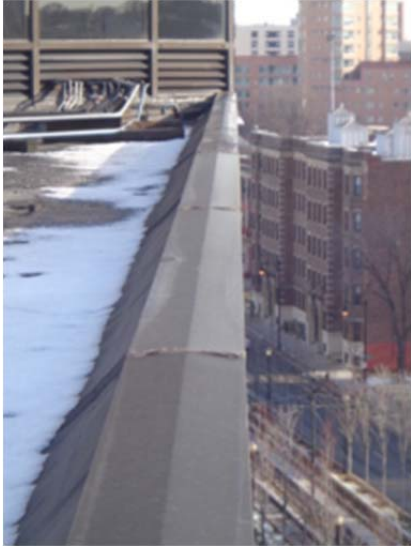
Figure 2.4.14 Coping laps

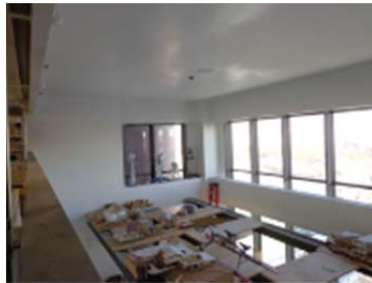
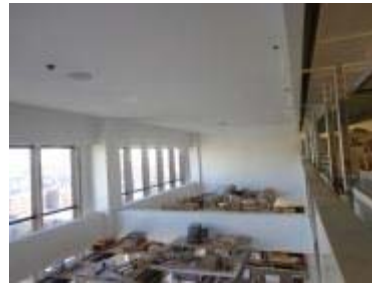
**Level 10**     **Industrial Design**  
The floorplate consists of open studio areas and classrooms. There is an open studio area that overlooks a two story high space to the level below, figures 4.18 and 4.19. This two story high space is not physically separated and therefore connects levels 10 & 11.

Figure 2.4.18 Two story high studio

Figure 2.4.19 Two story high studio

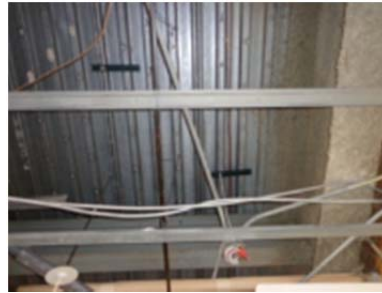
Figure 2.4.21 Inconsistent fireproofing

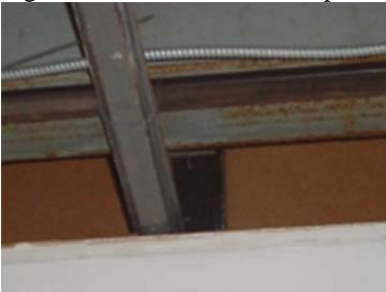
Figure 2.4.23 Inconsistent fireproofing

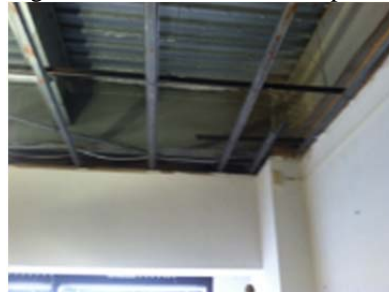
Figure 2.4.22 Inconsistent fireproofing

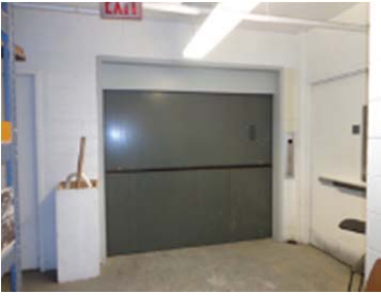
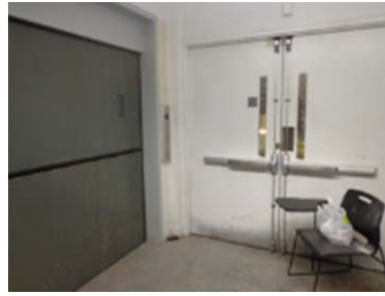
Figure 2.4.24 Freight Elevator

The freight elevator doors open directly into the exit access corridor, figures 2.4.24 and 2.4.25. This corridor provides the path of egress travel to the exits. Any event in the freight elevator/shaft may compromise access to the exit. This is not compliant based on the current code.

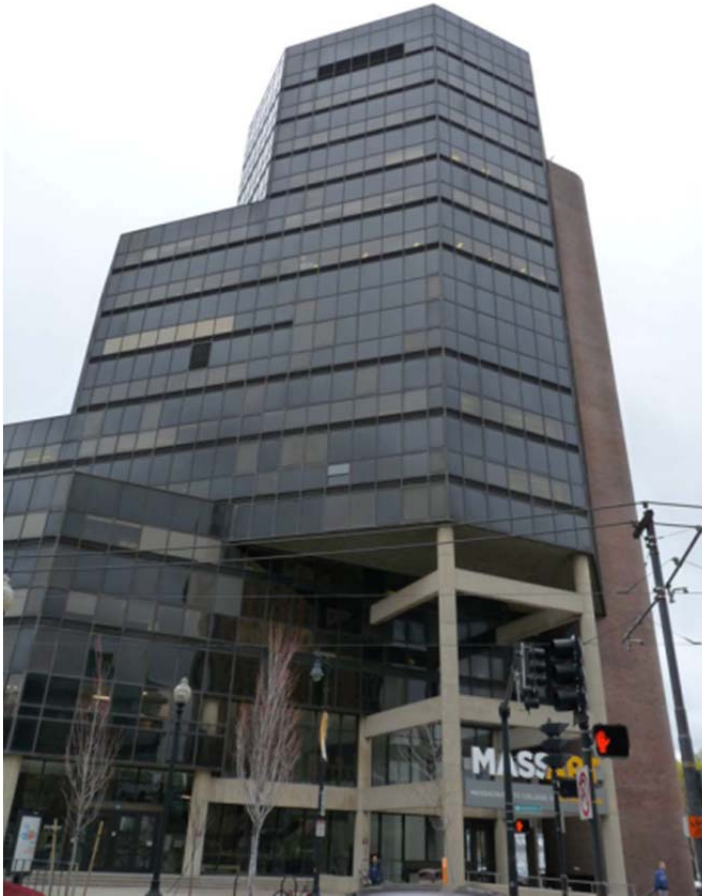
- At least one of the steel stiffeners on the penthouse curtain wall has become disengaged from the glazing frame. This does not appear to have been fixed when the repairs were performed.
- The repair work created a breach of the perimeter fire containment detail as the perimeter plate, which provided an air/smoke seal between floors was cut away to allow for installation of a new steel base plate.
- The exposed thread on the post-installed drill-in anchor bolts appeared to be excessive in exposed length and calls into question whether the full embedment depth was achieved.

The expansion bolt with the expanding spreader end removed was observed to be loosely positioned upside down where the anchor bolt should have been properly installed.

Figure 2.5.1 General Elevation of the Tower prior to the snap cap fastening

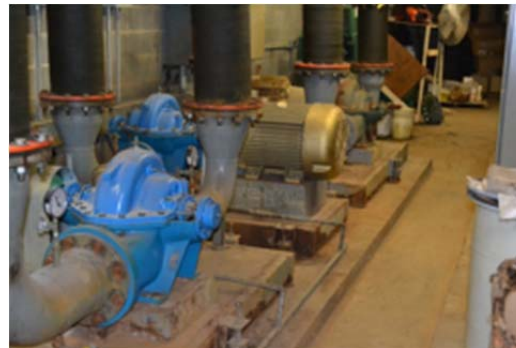
Figure 2.7.3 CHW pumps

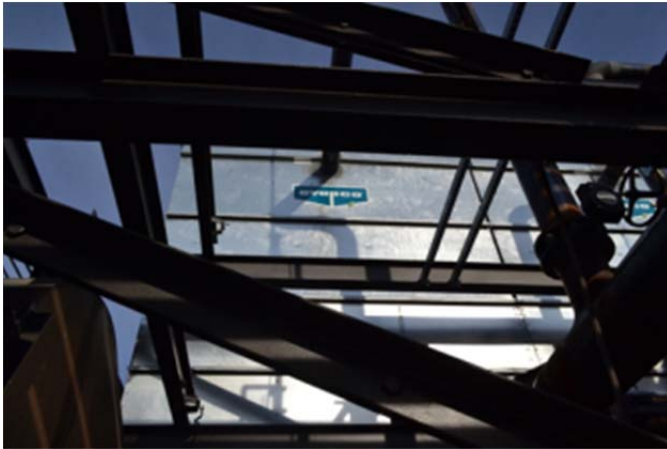
Figure 2.7.4 Cooling Tower

The cooling towers are less than 1 year old and under warranty. Cooling towers can expect a service life of 15 years.

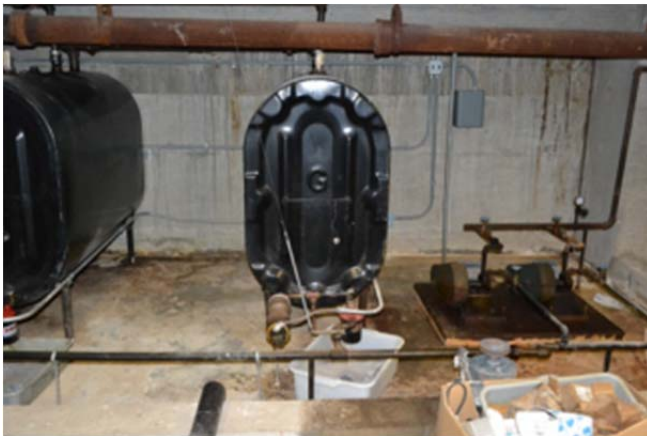
An emergency generator is located on the roof. Two 275 gallon diesel storage tanks are located in the basement, with spill containment, feeding a 60 gallon day tank located in the level 14 mechanical penthouse. Based on input from the building staff, the storage tanks and containment, shown below in figure 7.5, are 5 to 6 years old.

Figure 2.7.5 Diesel storage tanks

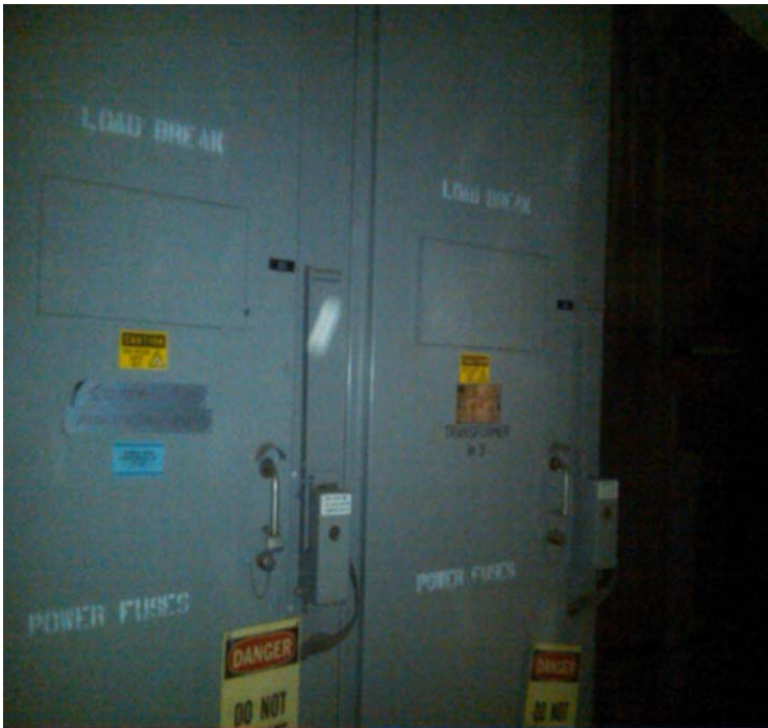
All equipment is located in the basement electrical room. The utility owned 15kV service entrance and distribution switchgear equipment are only a few years old and appear in good condition.

Figure 2.8.1: Existing utility owned 15kV switchgear

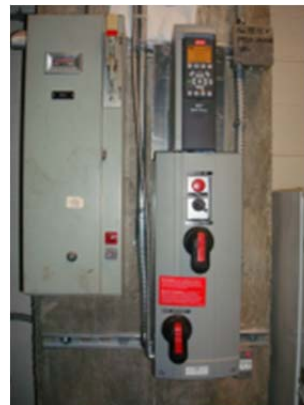
Figure 2.8.5: Some newer VFD's and motor controllers have been installed over the years.

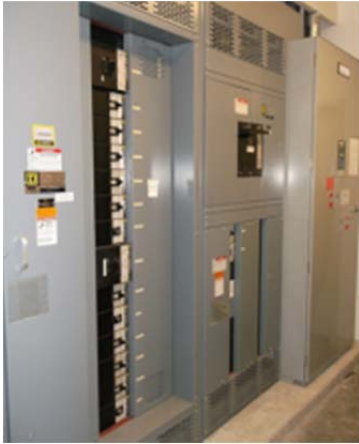
The emergency power panelboards serving the emergency lighting and miscellaneous emergency power loads for the tower are located in the same electrical closets as the normal power panelboards. A dedicated 2-hour fire rated space is required for all emergency system panelboards per latest code

Figure 2.8.6 Several pieces of emergency electrical distribution equipment were replaced around 1999 and are in good condition.

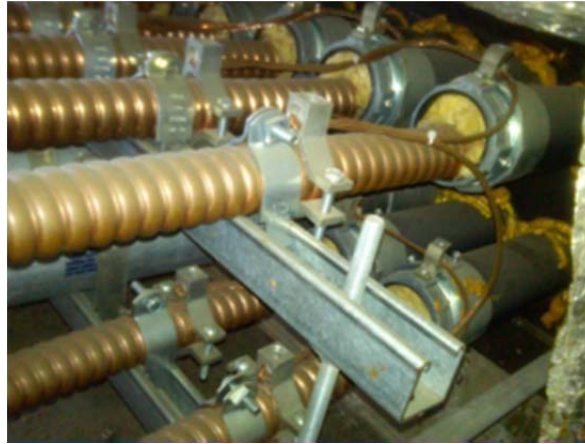
Figure 2.8.7 MI cable installed for emergency loads.

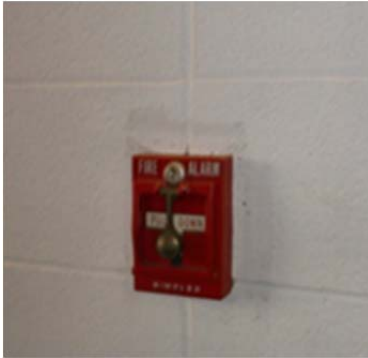
During the site observation tour, it appeared that all fire alarm system devices are original to the building and therefore, beyond their useful service life.

Figure 2.8.10 Existing fire alarm devices

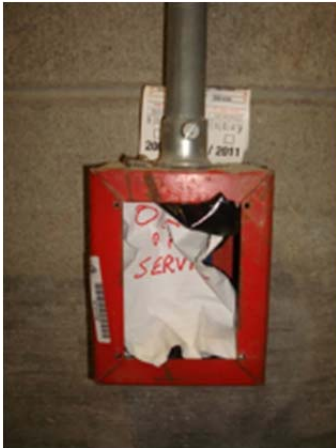
Figure 2.8.12 Existing fire alarm device appears to be abandoned.

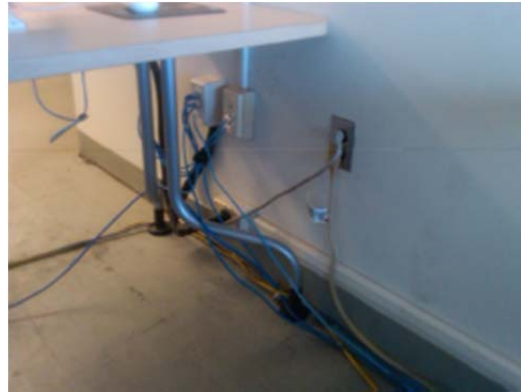
Figure 2.8.15 Surface mounted tel/data outlets and surface raceway have been installed over the years.

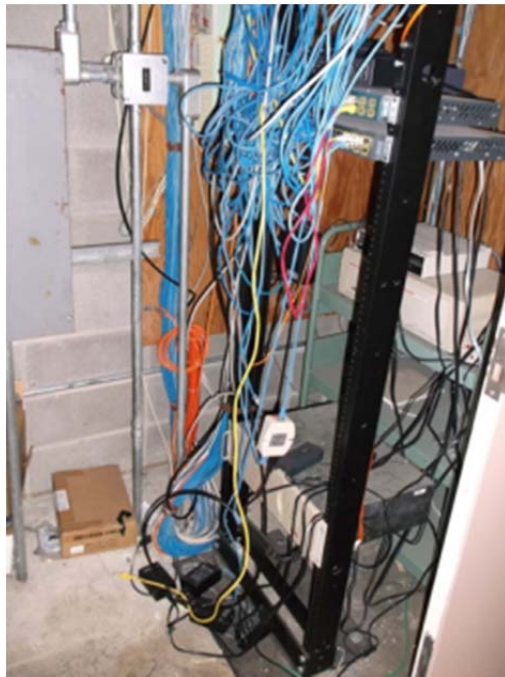
Figure 2.8.16 Typical telecomm closet with a mixture of newer and older patch panels and cabling

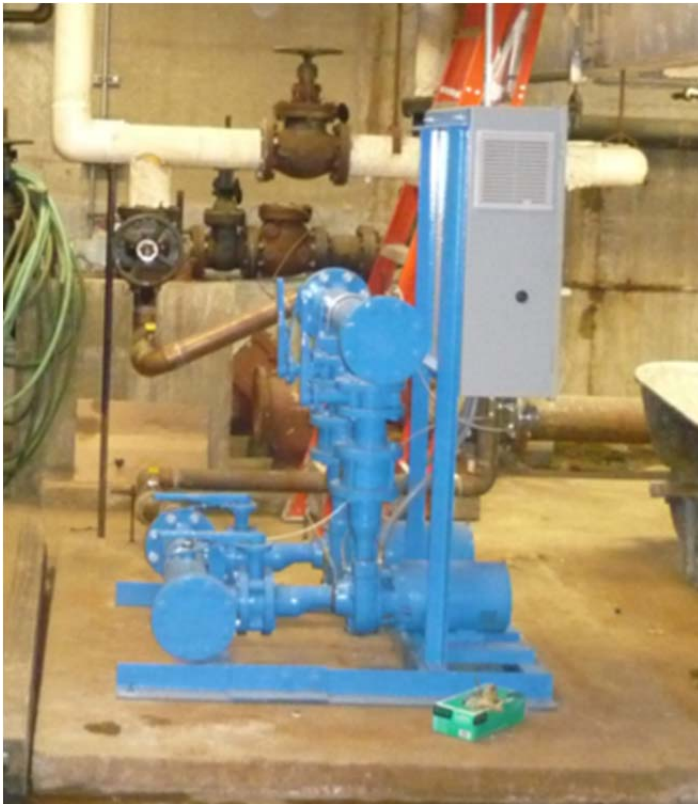
The domestic cold water runs through a duplex booster pump, Syncroflo Model 55C7.5 rated for 162 GPM, 45 PSI and 7.5 HP. The system includes a hydro accumulator located in the mechanical room on Level 14. This booster pumping system was installed about 1 year ago and appears to be in working order.

Figure 2.9.1. Duplex booster pump

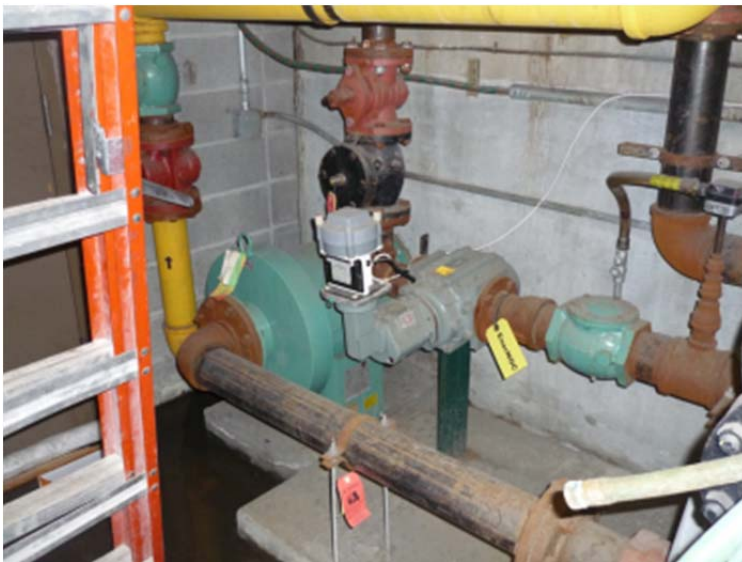
The building is supplied with a metered 4" gas service with a gas pressure booster located in the basement plumbing room. The gas supplies the domestic water heater located on level 2 and the mechanical chillers located in the basement. The gas system appears to be in working order.

Figure 2.9.4 Incoming gas main and booster.

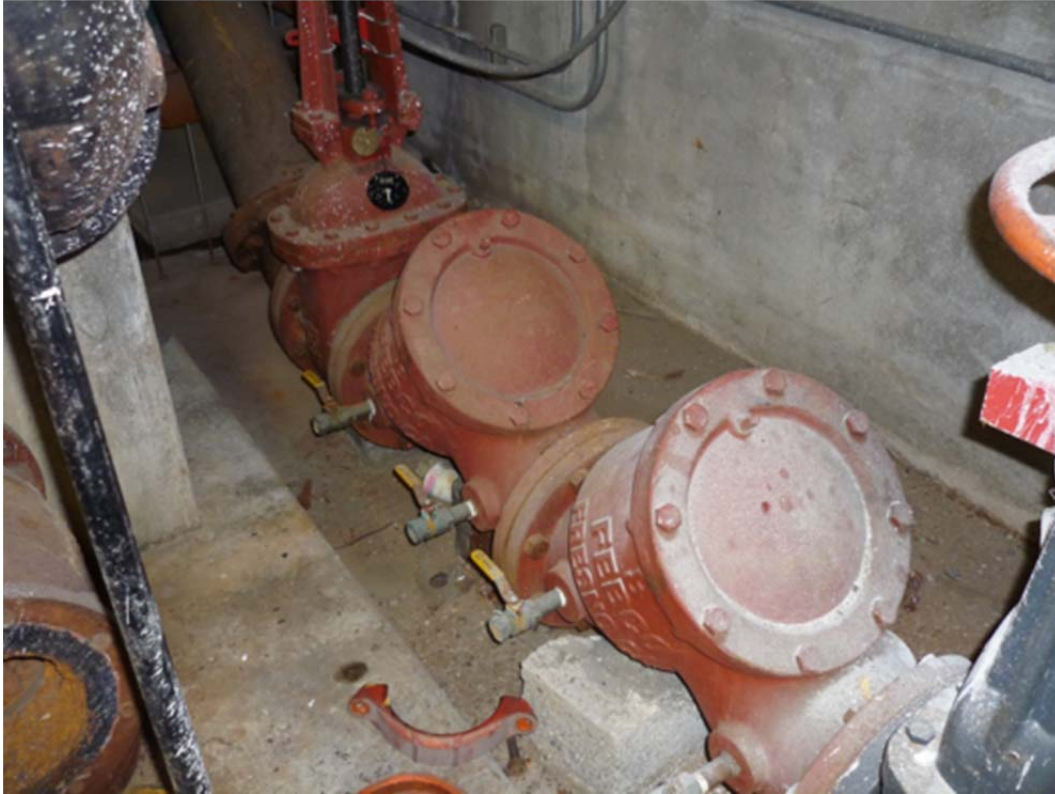
The MCAD Tower building is a fully sprinklered high-rise building. The fire protection system in the building is in working condition. The system is fed from an independent incoming 8" fire main, with double check valve backflow preventer, located in the fire pump room in the basement.

Figure 2.10.1 Incoming 8" fire main with double backflow preventer.

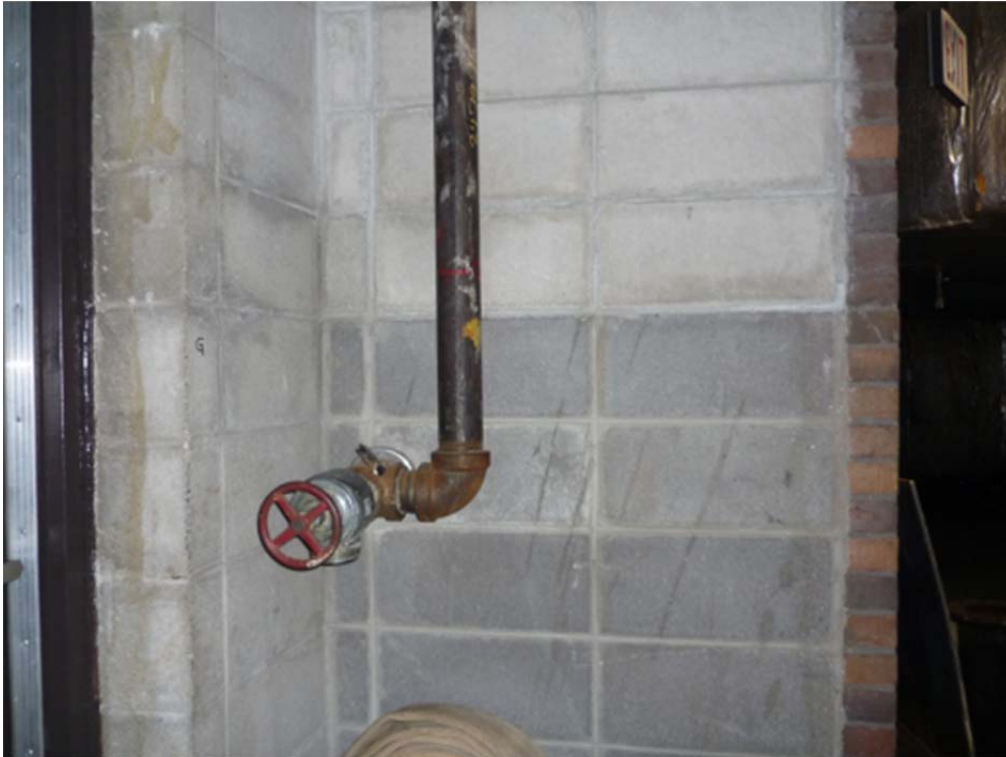
Each standpipe riser has a 2½" hose valve connection located at every floor level; however these connections are located within the occupied floor space and not within the stair enclosure, as required by NFPA 14.

In reviewing the existing drawings it seems the standpipe system was part of the original construction of the building. As built, the connections include a 1½" hose connection, with hose reel, at each floor landing. Today some of these hose stations have been removed, leaving only the 2½" hose valve connection, and in other areas both still remain.

Figure 2.10.4. Hose valve connection at Level 14

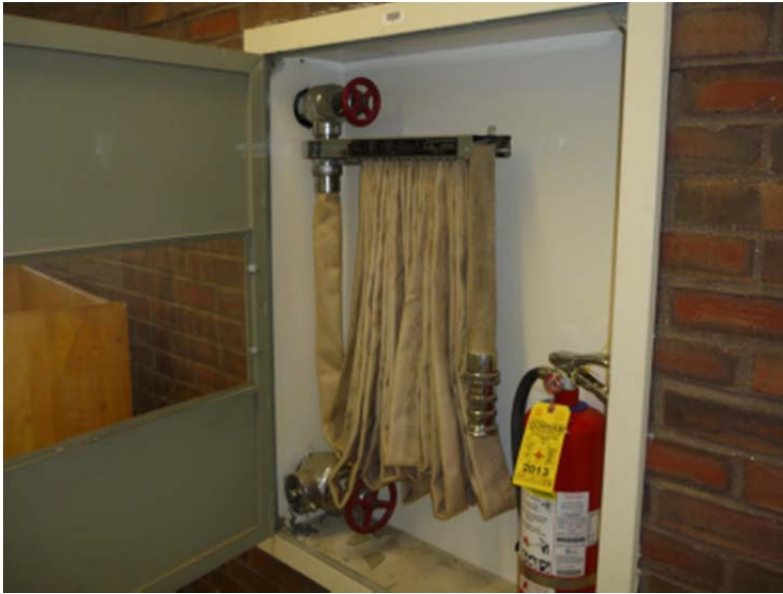
Figure 2.10.5. Hose valve cabinet with hose reel

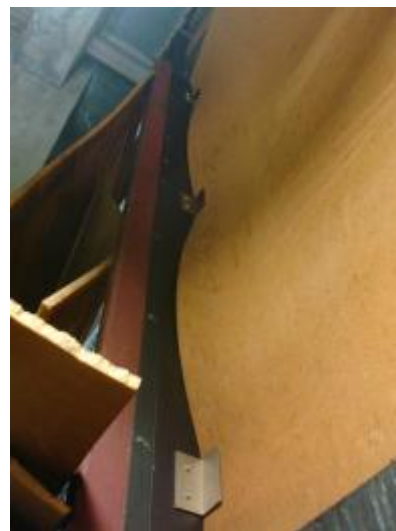
Figure 2.11.2

The spandrel panels are also likely insulated below current code requirements. As seen in the 13<sup>th</sup> floor mechanical room, the insulation is delaminating or completely off of the enclosure panels as the adhesive has failed, figure 2.11.1. Efforts to secure the insulation have been made, figure 2.11.2, but the insulation is still clearly detached from the exterior panel. Hence, the performance of the insulation has been compromised and is providing little to no protection from thermal transfer. Water infiltration damage was also evident in the insulation at several locations, refer to figure 2.11.1.

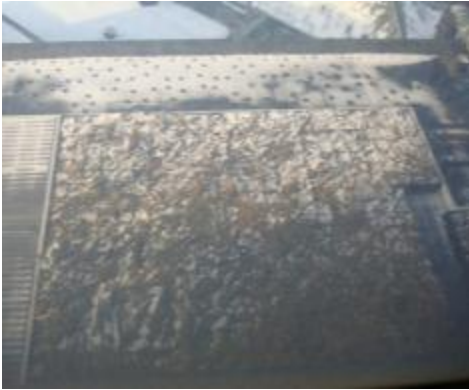
Figure 2.11.3

The roof of the Tower building appears to be a membrane roof assembly, black in color, figure 2.11.4. In our walk through, it was identified that only the Level 13 roof has been replaced within the last 2 years, which represents a small portion of the total roof area. The new roof is in very good condition but the remaining roof areas were noted to be in poor condition with adhesion, water ponding and leakage issues. There is a green roof installation on the Level 11 roof, figure 2.11.3.

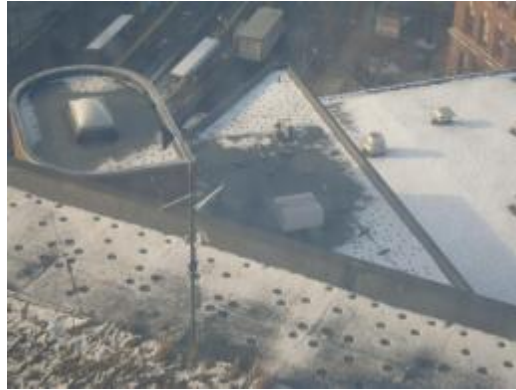
Figure 2.11.4

Black membrane roofs have become much less common as they absorb large amounts of solar radiation, typically reflecting only 23%, which contributes to heat gain into the building as well as heat island effects at the roof level. Alternately, white membrane systems have become increasingly common as they reflect a much higher amount of solar radiation, up to 69% and result in minimal rise of surface temperatures. In addition, green roofs are increasingly implemented as they not only have high thermal performance and mitigate heat island effects but also have stormwater reduction and attenuation as well as aesthetic and other environmental benefits.

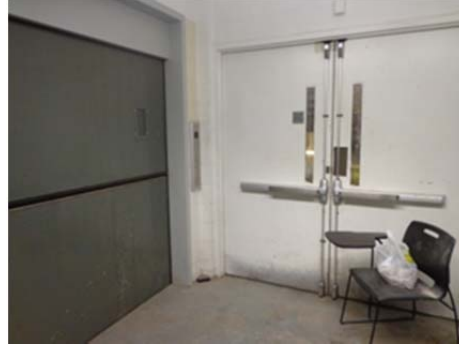
During our site visit we notice the freight elevator is adjacent to one of the egress stairs and this shaft is not pressurized.

Figure 3.3.4 Freight elevator and Stair 1.

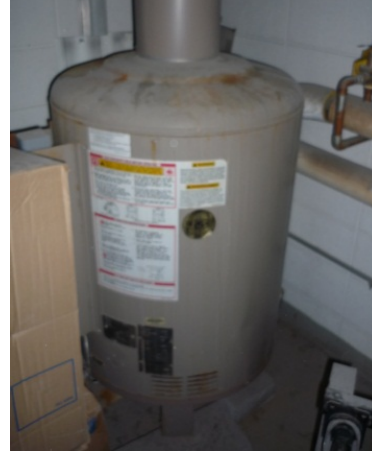
During our site visit we noticed that the water entering the gas water heater was 140°F and the leaving water was at 180°F. These are extremely high temperatures for a domestic water system. Typically domestic hot water is heated to 140°F and blended down to 120°F for circulation throughout the building.

Figure 3.3.8 Gas fired water heater with 180°F leaving water

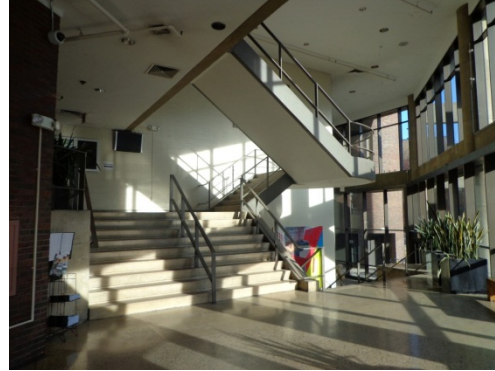
During our site visit, it was observed that the railings in the multi-story space that connect Level 2, the Upper Level, Ground Level and Level 1 do not meet the requirements for graspability, nor does it provide guards. The existing construction is painted, flat bar stock. In addition, the railings do not provide guardrail protection to the levels below.

Figure 3.3.10 Multi-story space

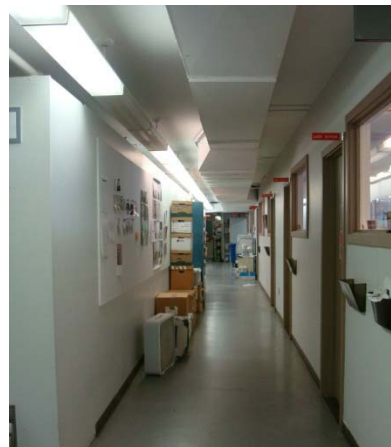
During our site visit, it was confirmed that the Tower has very limited lighting controls. Only the recently completed Public Safety office and adjacent Classroom on Level 2 were indicated to be equipped with occupancy sensors.

Figure 3.4.1 Interior hallway with small offices, right

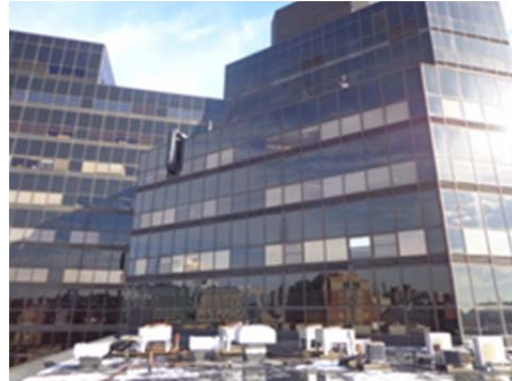
During our site visit, it was observed that the building envelope is in poor condition and likely has very poor thermal performance. An Arup report dated April 18, 2012 further identified and discussed deficiencies in the building envelope.

Figure 3.4.2 Tower curtainwall. Vision glazing is blocked up and/or blinds are drawn
