Request for Proposals for dcr. the Rehabilitation, Reuse & and Maintenance of:

WHITEHEAD

HOUSE

BUILDING CONDITIONS SURVEY WHITEHEAD HOUSE

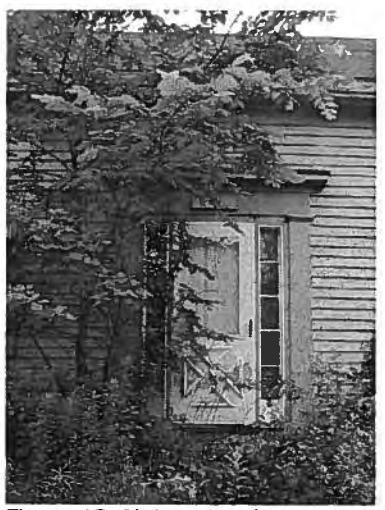
Figure 13. Main entry door, exterior

The exterior doors are in fair condition. The front door is a four panel wood door. The rear door is a six panel wood door. Both doors have modern aluminum storm/screens and are in fair condition. The doors need moderate repair, including weatherstripping, hardware rehabilitation, threshold replacement, some shaping to ease operation, and painting.

- Repair missing and damaged cornice return moulding. Dutchmen should be used whenever possible in lieu of complete replacement of original.
- Repair the damaged door surround and sill trim at the main entry door. Dutchmen replication pieces should be spliced into the original.
- Replace deteriorated clapboards.
- Replace deteriorated sections of corner boards with Dutchmen.

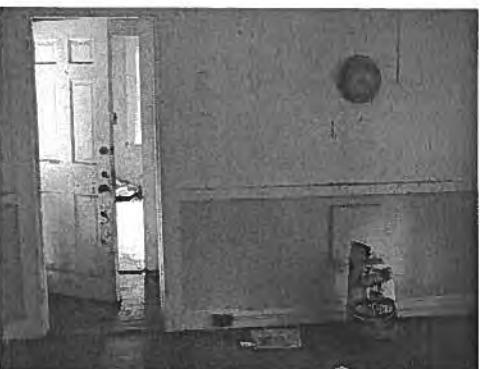
Figure 20. Stair.

The walls in the lower stair hall have been repaired with gypsum board instead of plaster. (Figure 20.)

- Replace closet shelving.
- Remove worn stair rugs, secure loose treads, prep for finish and paint.
- Retain historic layers of paint. Do not remove paint, except in areas where loose and flaking. Paint over existing painted woodwork as required.

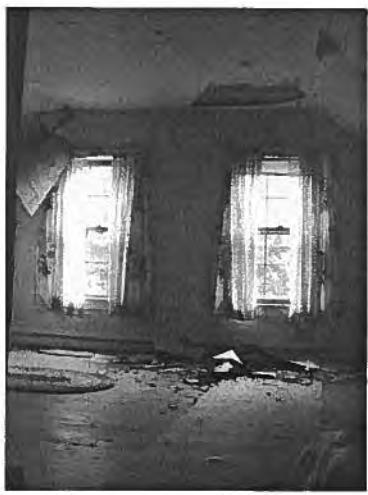
Figure 21. Second Floor Bedroom

The ceilings are primarily plaster on wood lath and are generally in good condition. There is some minor cracking of the plaster and the paint is flaking. In the second floor south bedroom, there is a plaster ceiling failure and the ceiling is buckling (Figure 21). The plaster in this room is in poor condition.

- Remove plaster debris in second floor bedroom.
- Test ceiling tiles for presence of asbestos.

- Remove loose flaking paint, repair minor cracks, replace missing plaster, secure loose plaster, skim coat as required and provide a smooth surface for finish painting.
- Remove living room ceiling tiles. Abate if necessary by a certified professional. Restore plaster ceiling.

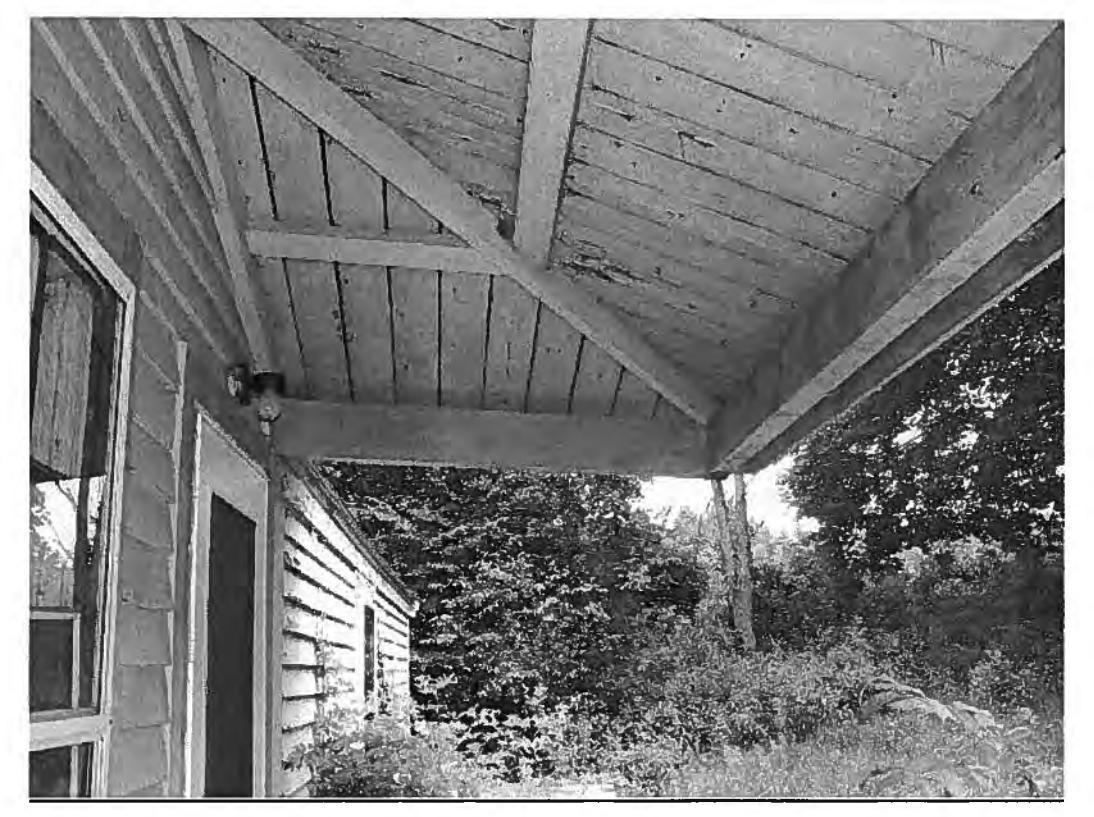
The entry roof is bordered at its eave line with substantial 4"x8" members that support sloping planking directly (see Fig. S4). The 4"x8" members are in turn supported by lathe-turned 6"x6" posts at the corners and middle. The western-most lathe-turned 6"x6" post is missing, apparently having rotted at its base and been removed. While the missing post should be replaced, the roof has maintained its form and levelness (see

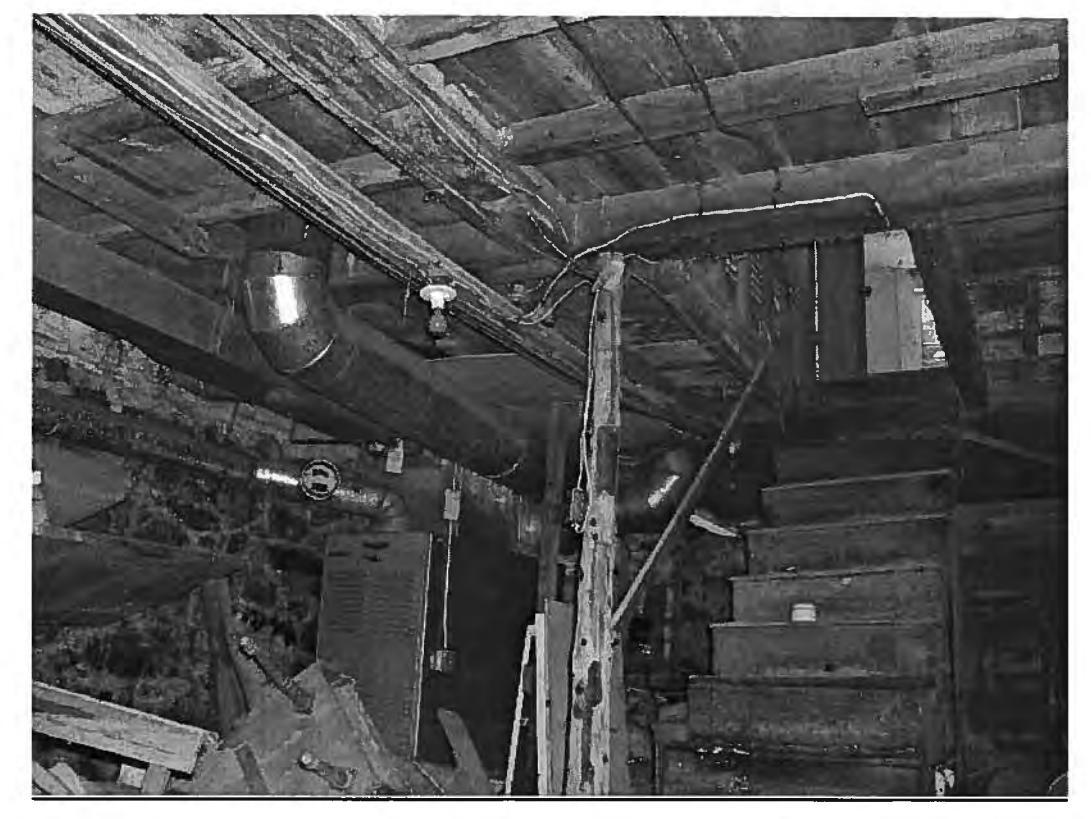
Figure S7

There was evidence of recent basement flooding on the debris material on the basement floor and damp conditions were present. The framing at the original section showed surficial signs of insect damage on many of the purlins and patches on the main beams (Fig. S7 & S9). The depth of this damage did not appear severe, but may require sistering with laminated veneer lumber (LVL) for any members that are found with deep damage. Severe insect damage was noticed at the 6"x6" wooden timbers supporting the brick hearth. The 6"x6" timbers will have to be replaced by steel lintel angles or the brick arch reconstructed due to the poor condition of the wood.

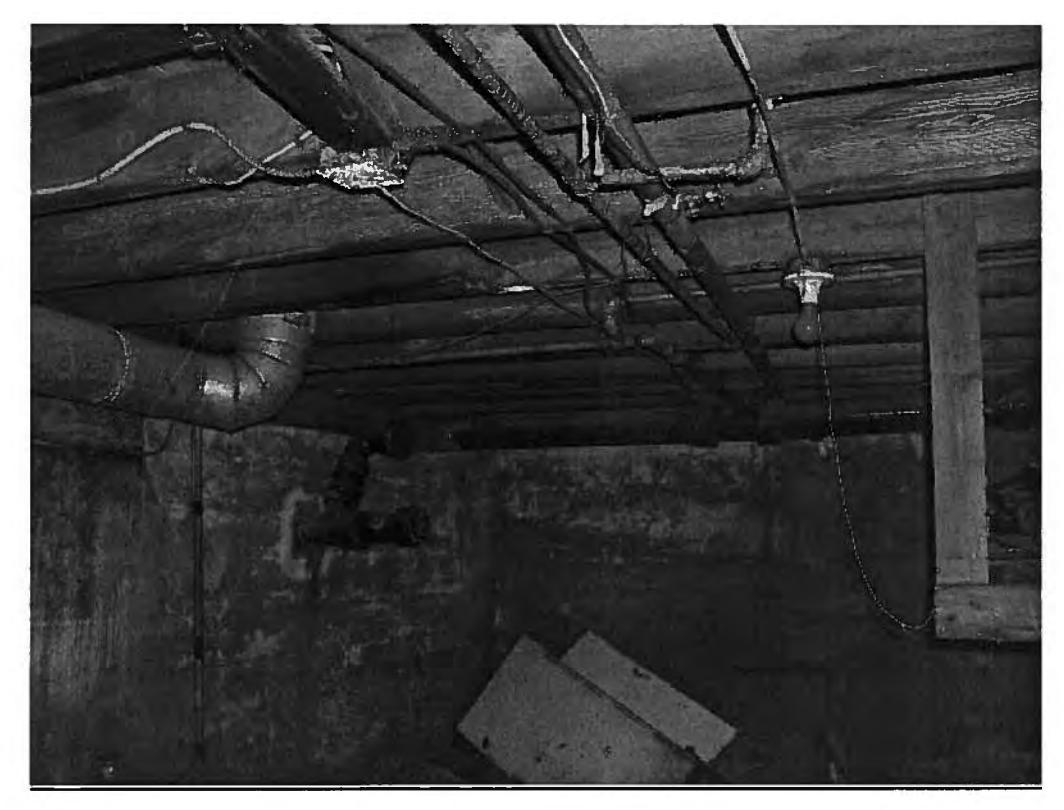
Figure S10

The entire width of the kitchen addition is spanned with full-cut 2"x10" dressed lumber of relatively clear hardwood at 16"o.c. The 2"x10"'s bear on sill plates atop concrete foundation walls (see Fig. S10).
