Comprehensive Wastewater Resilience Feasibility Study

Town of Scituate, Massachusetts

June 30, 2019

File No. 01.0173977.00

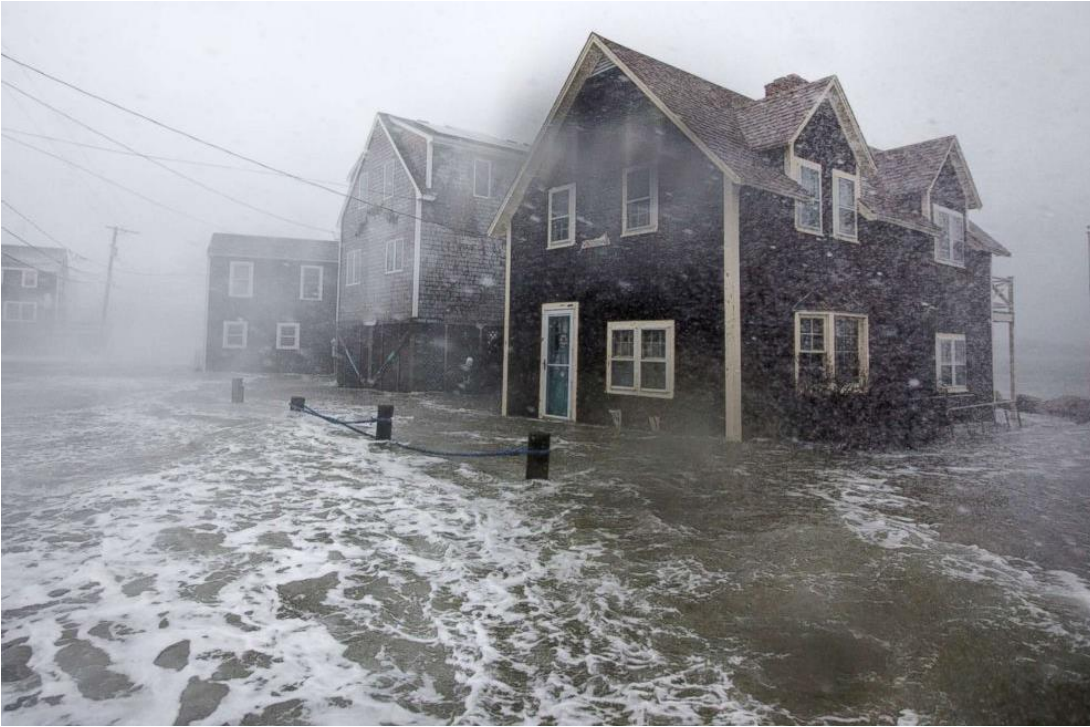
Figure 4-61: Image of inundated roadways in the vicinity of Cedar Point
