Report of
Facility Condition Assessment

Bay State Correctional Center
28 Clark Street
Norfolk, Massachusetts 02056

September 29, 2019

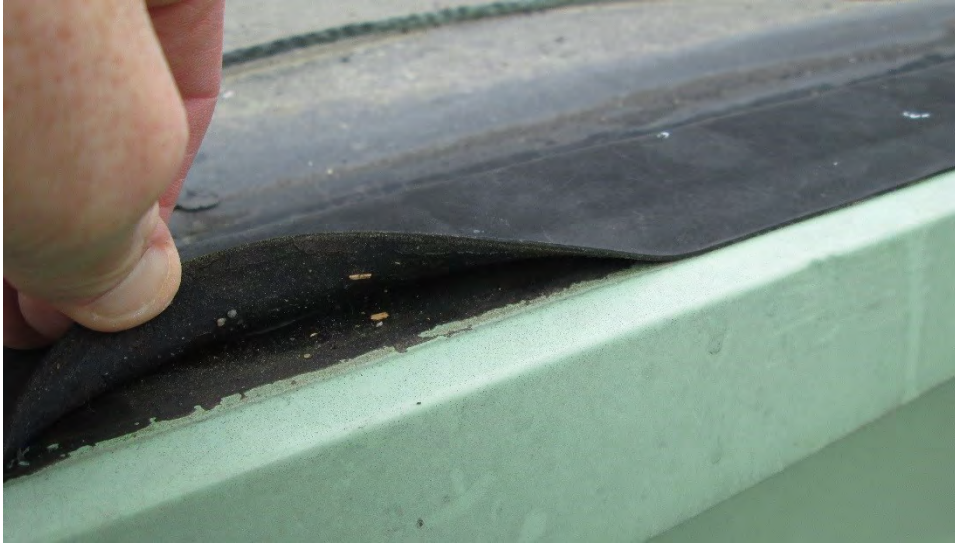
Photograph No. R-6
Poorly adhered flashing at
Visitor Building roof.

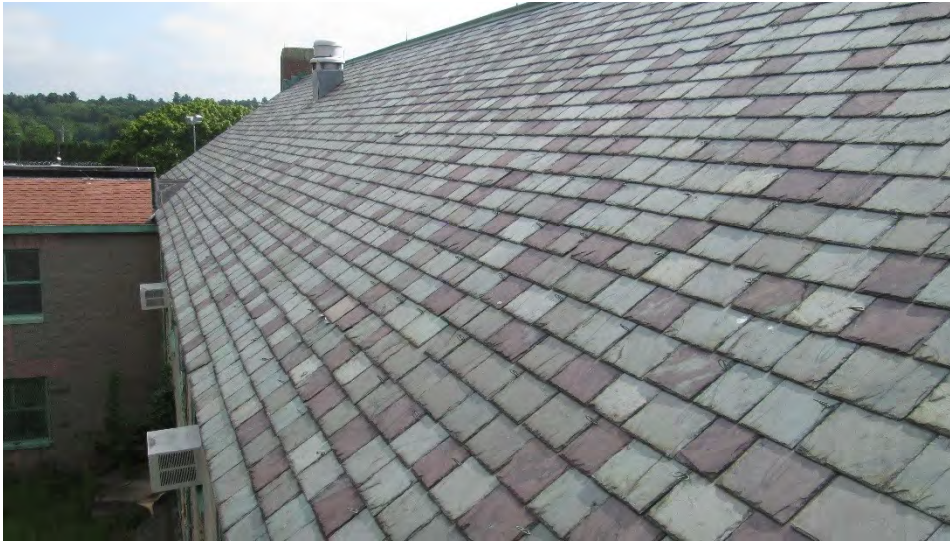
Photograph No. R-8
Shingle roof at Main
Housing.

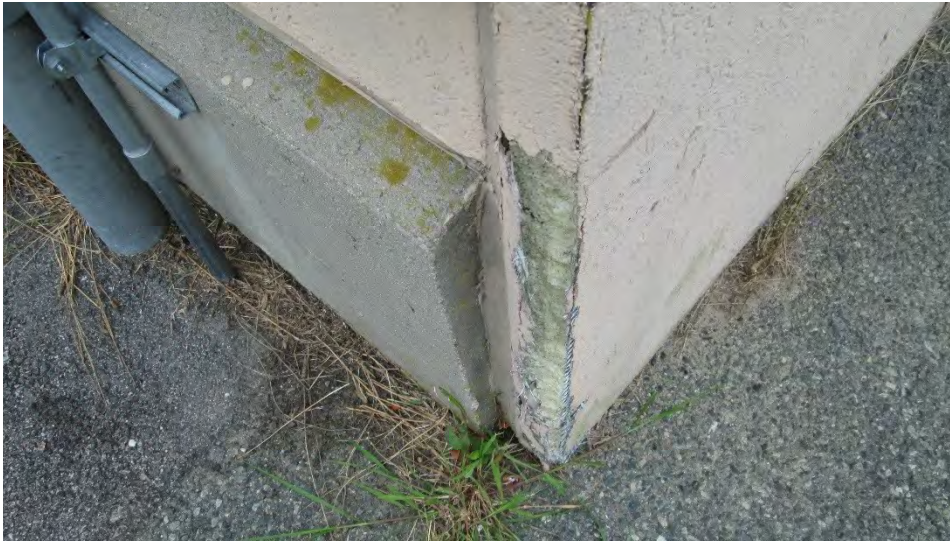
Photograph No. EX-1

Gate House building.

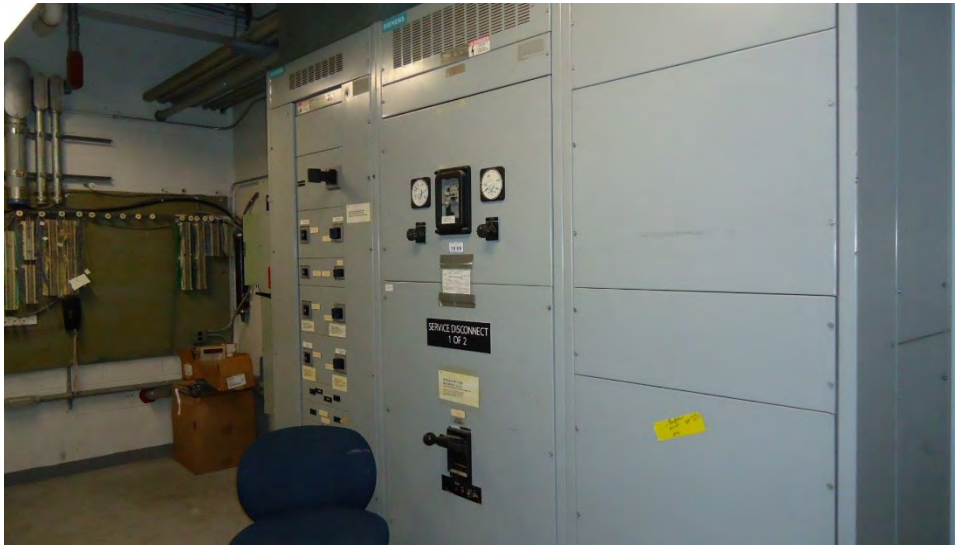
Photograph No. E-02

Gate House primary electrical service (subfeeds 1990's expansion effort)
