**Report of**  
**Facility Condition Assessment**  
South Middlesex Correctional Center  
135 Western Avenue  
Framingham, Massachusetts 01702

July 26, 2019

Reference: Report of Facility Condition Assessment  
South Middlesex Correctional Center  
135 Western Avenue  
Framingham, Massachusetts 01702  
Faithful+Gould Project No. 100066196

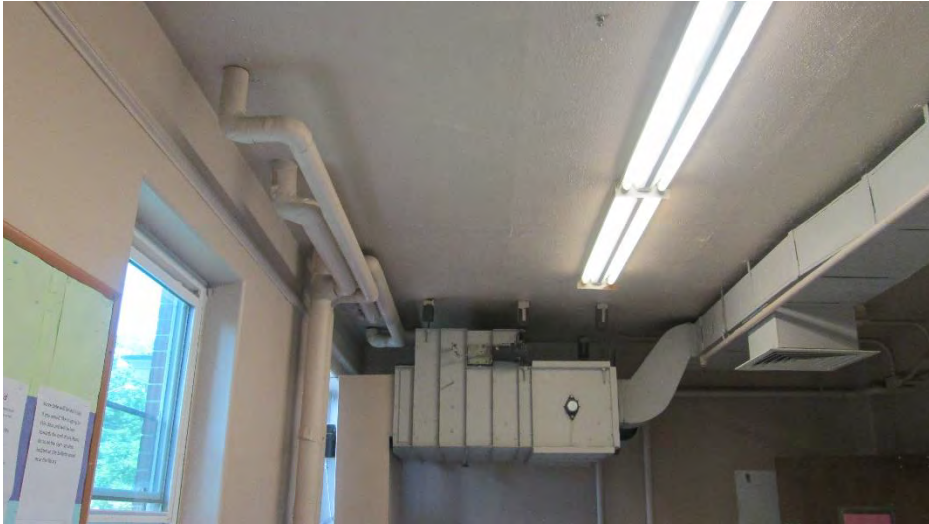
**Photograph No. M-06**

Common Area Air Handling Unit

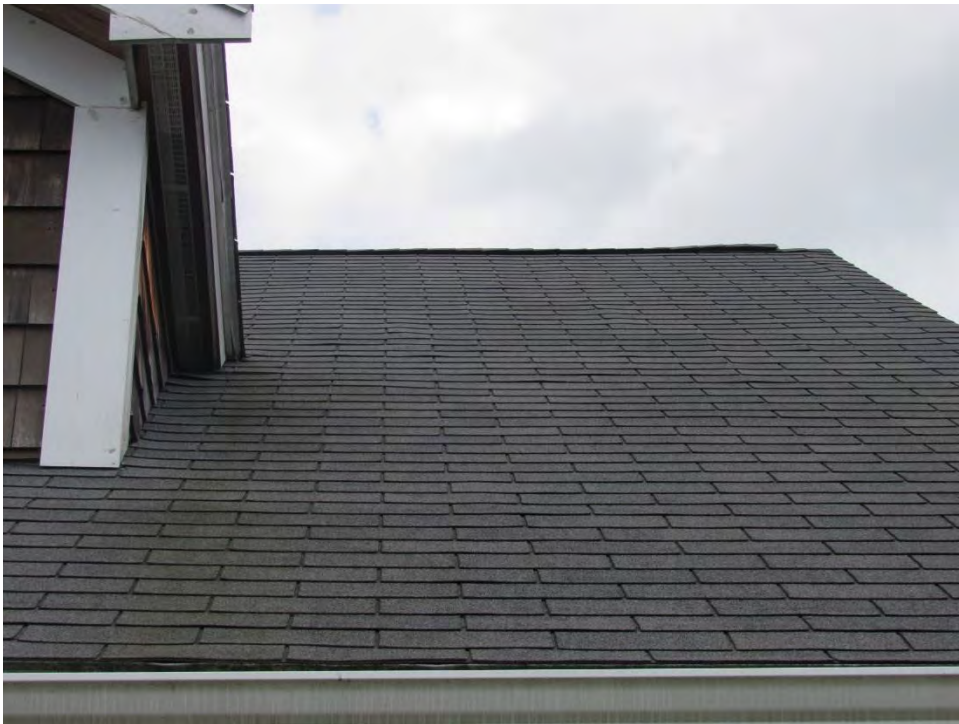
**Photograph No. R-7**  
Surface Scaling at Main  
Building Roof Tiles

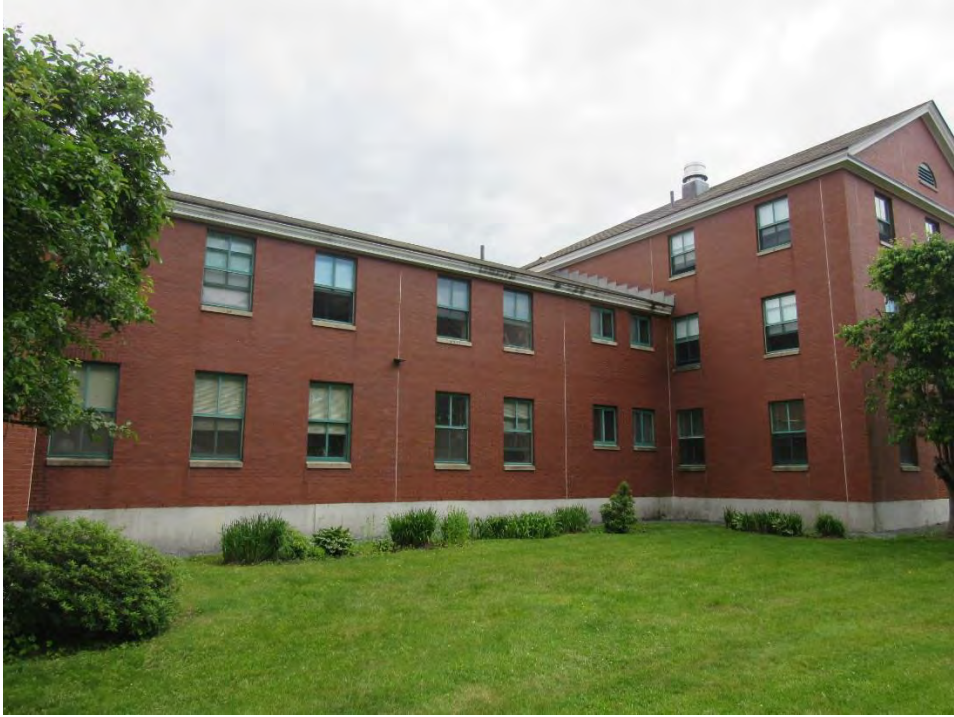
**Photograph No. EX-2**  
Failed Control Joint Sealant at Main Building Exterior Wall

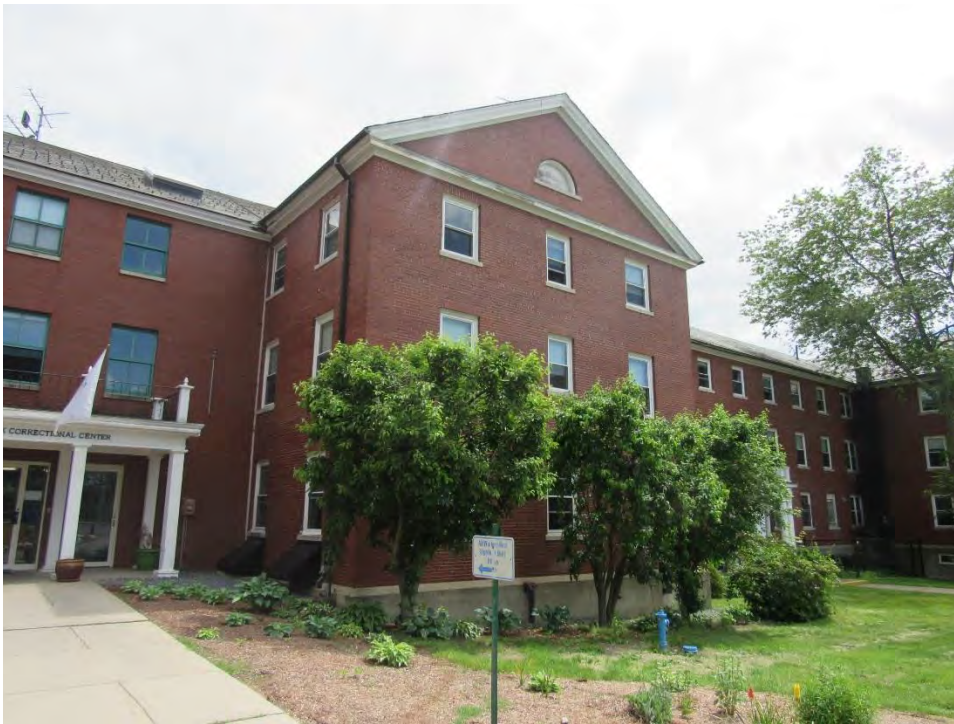
**Photograph No. EX-3**  
Front Elevation of Main Building

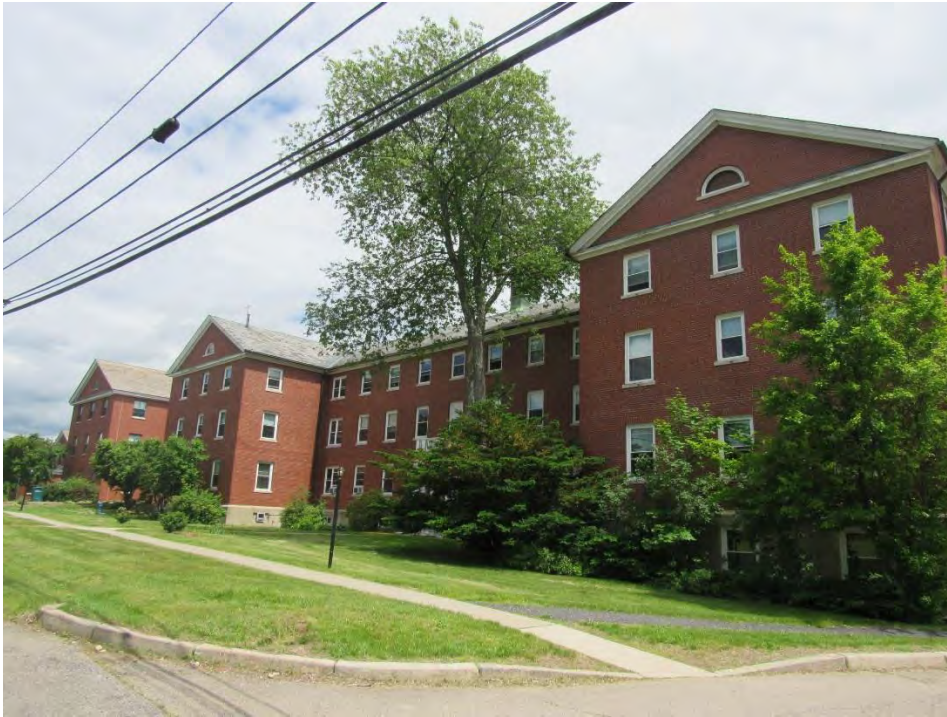
**Photograph No. EX-6**  
Rotted Window Frame at  
Front Elevation of Main  
Building

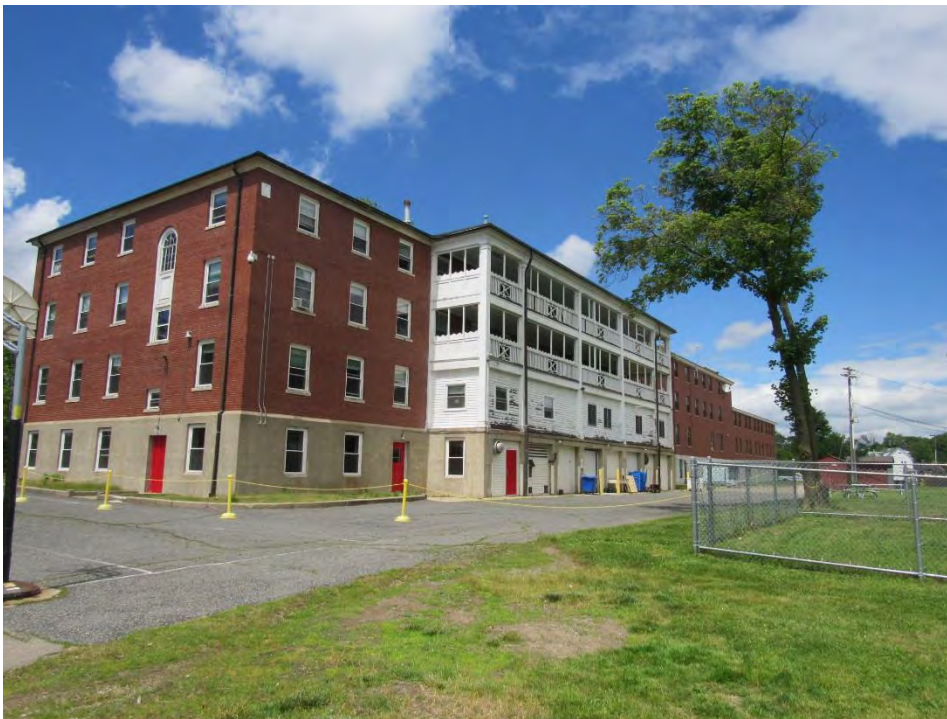
**Photograph No. EX-7**  
Front Elevation of Main Building

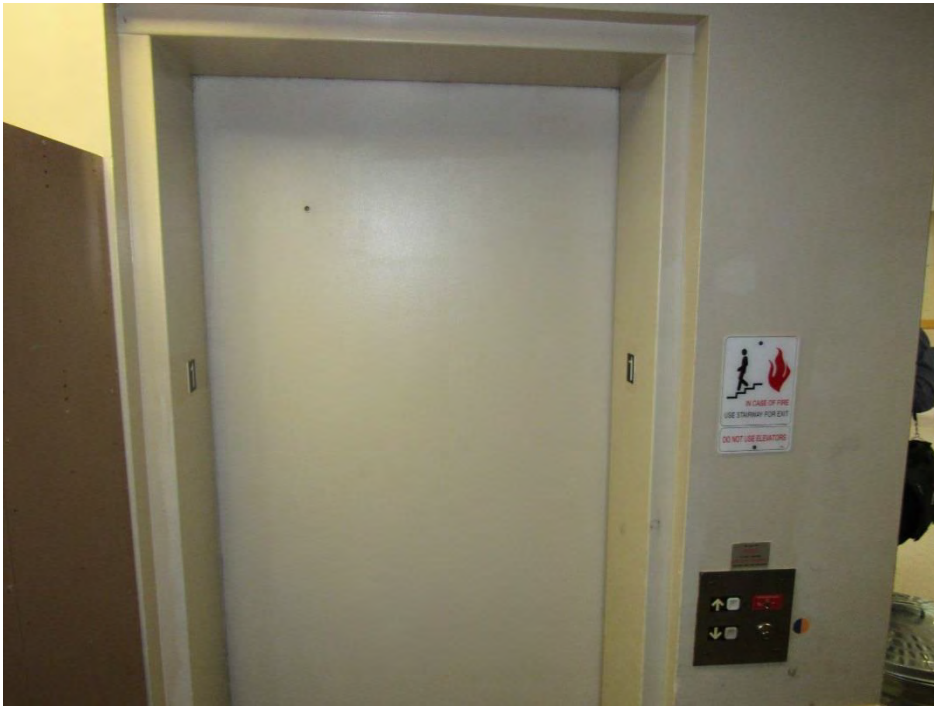
**Photograph No. C-1**  
Elevator Controller
