Springfield Prep Charter School

# Feasibility Study

2071 Roosevelt Ave, Springfield MA

# ACQUISITION PROPERTY CONDITION REPORT

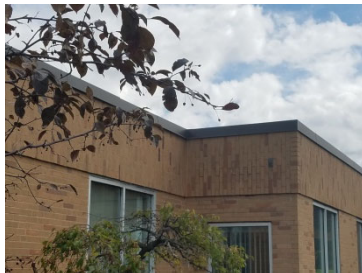
Brick veneer exterior with no parapet at roof.

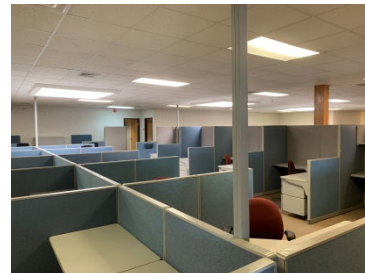
Typical interior cubicles within existing 24' column grid.

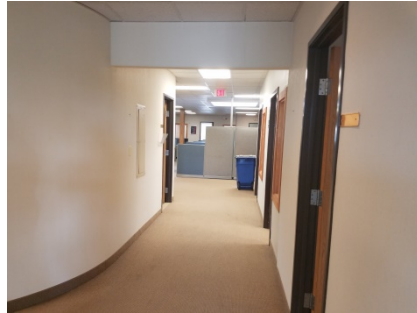
Typical carpet and hollow metal doorway

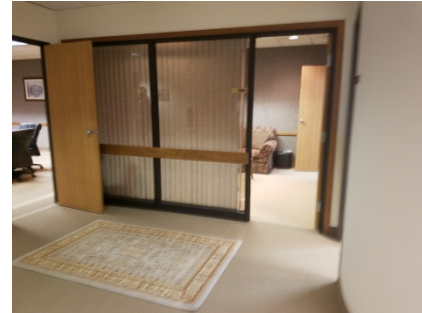
Typical interior glazed wall

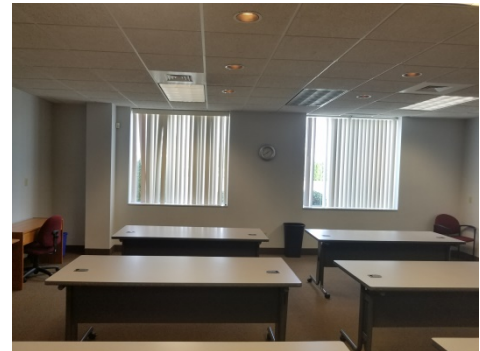
Acoustic tile ceiling and perimeter windows.

2x2 acoustic ceilings at 9' ceiling height. Fair Condition.

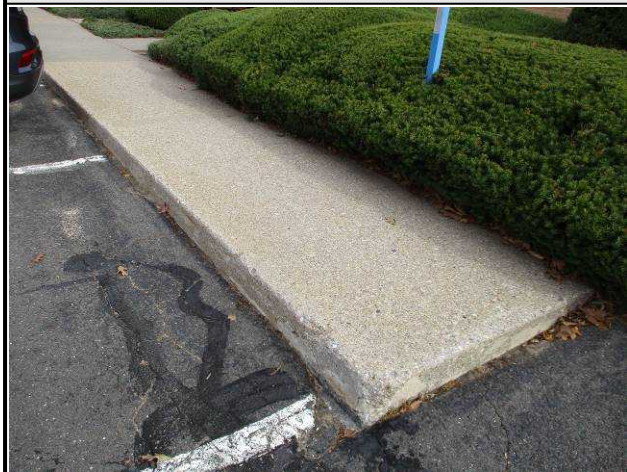
Typical concrete sidewalks.

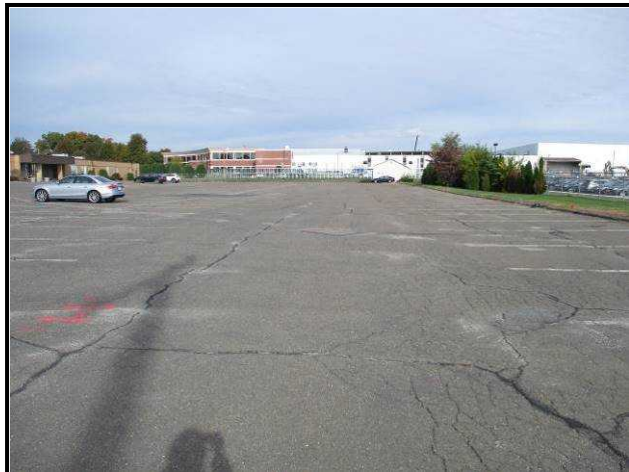
Asphalt-paved parking area at the rear of the Subject Building.

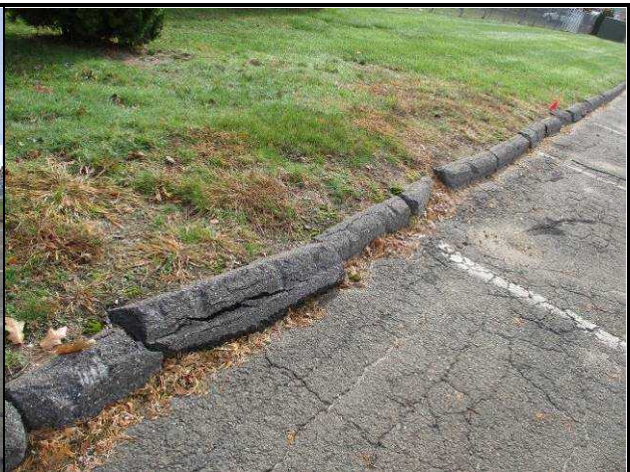
Extruded asphalt curbing at the rear parking lot.

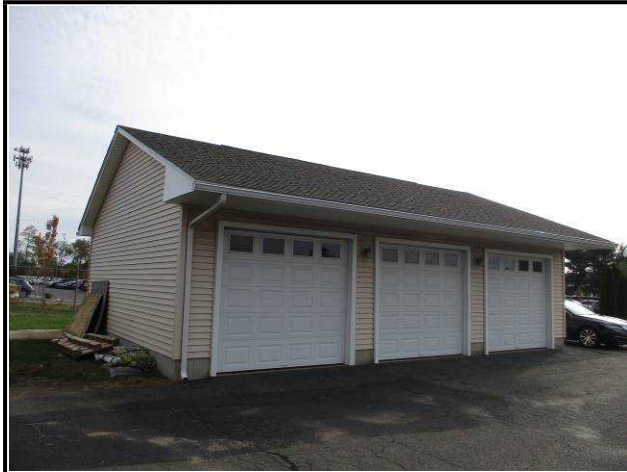
Maintenance garage building front and north side.

The Maintenance garage building located at the northeast corner of the Subject Property appears to be in good condition and will be maintained at the property as part of operational expenses during the analysis term.

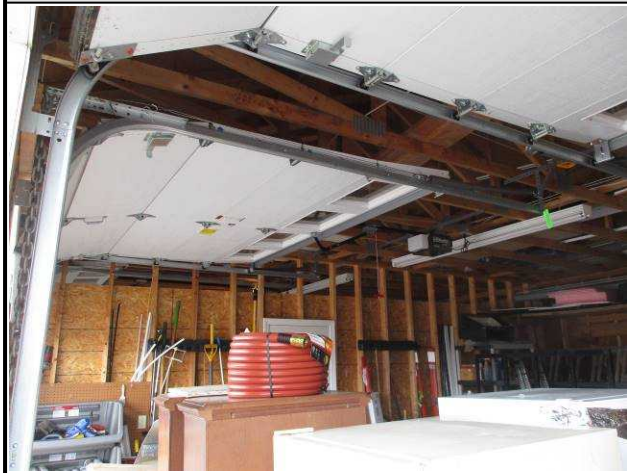
Maintenance garage building overhead doors.

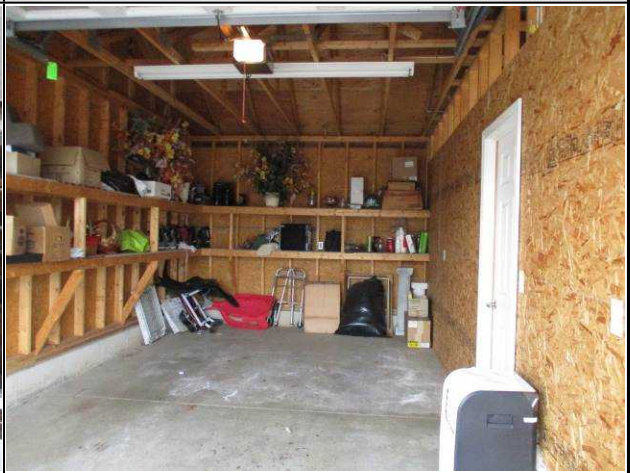
Maintenance garage building interiors.

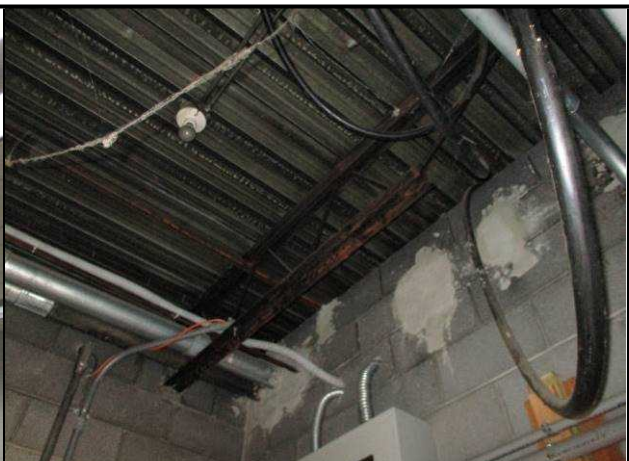
Corrugated metal roof decking and open-web steel joist.

Based on limited observations, the superstructures appear to be in good to fair overall condition and appear to be performing as designed. No obvious indications of irregularities, including significant floor and/or roof deflections, significant cracks, noticeably out of plumb building elevations, or other perceived structural defects, were reported or observed. However, the open-web steel roof joists observed in the electrical rooms were found to have rusted sections. Based on the observed conditions, Immediate Repairs are recommended for an assessment of all open-web steel roof joists to determine if this condition is isolated to these areas, or if it is prevalent throughout the Subject Building. Additionally, Immediate Repairs are recommended for all affected joists to be prepped, primed, and painted.

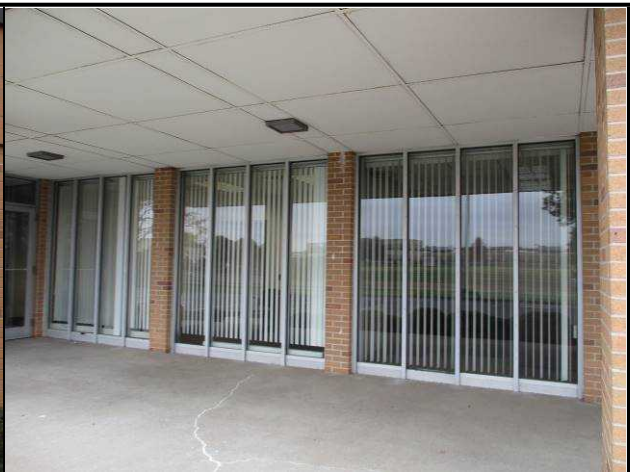
Typical storefront system at tenant entrances.

The observed storefront windows systems appeared to be weather tight and in good overall condition and will be maintained at the property as part of operational expenses during the analysis term.

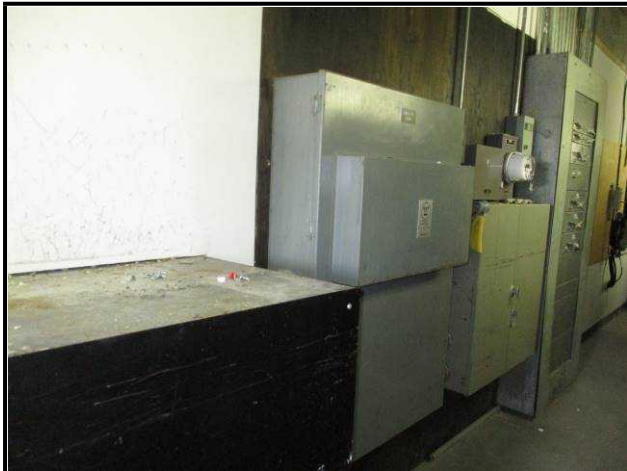
Main electrical service.

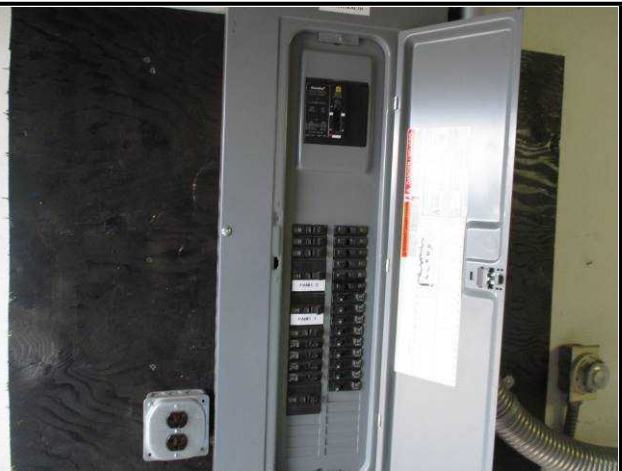
Typical electrical panel.

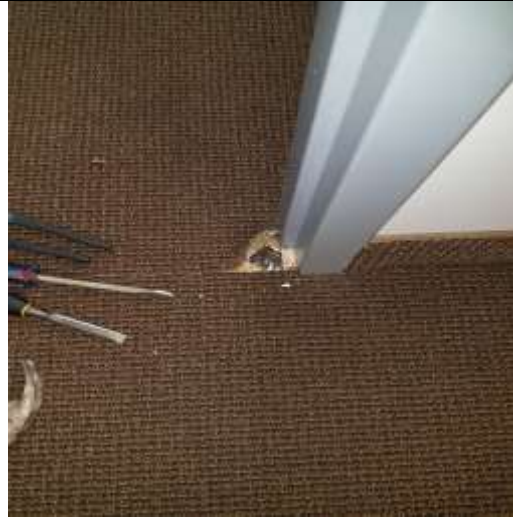
North office area floor tile beneath carpet

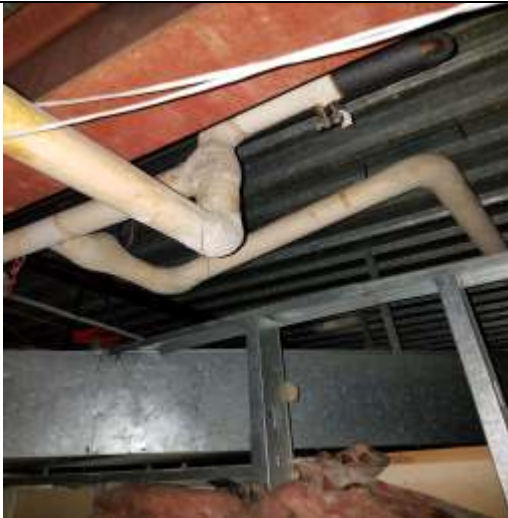
Asbestos pipe fittings in cafeteria plenum

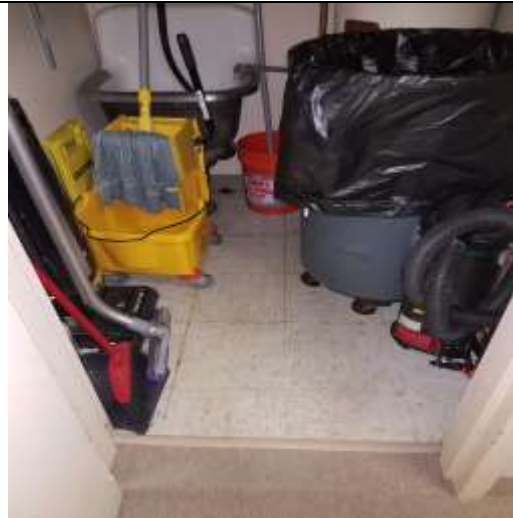
Janitor closet 2071, asbestos floor tile/mastic

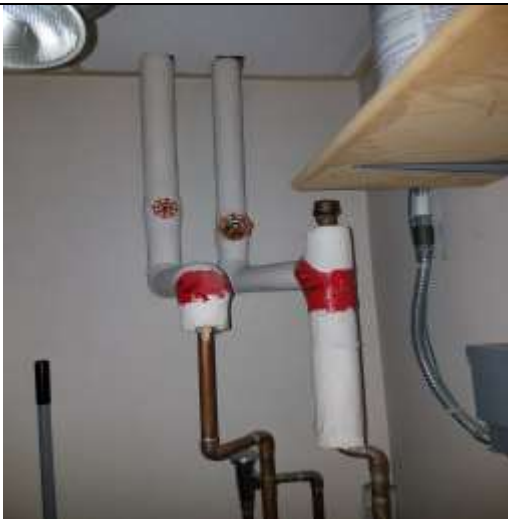
Janitor closet 2071, asbestos pipe fittings

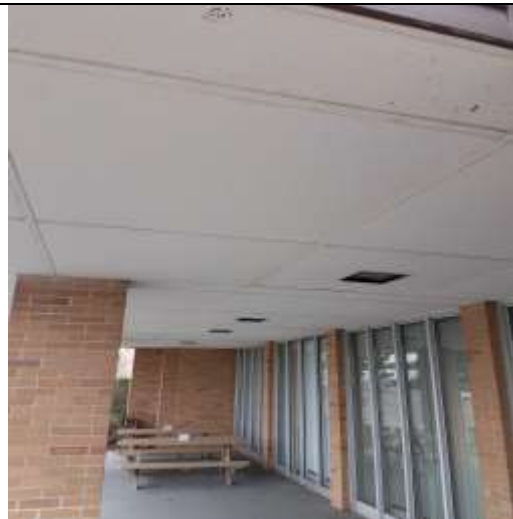
Asbestos ceiling panels at rear entrance

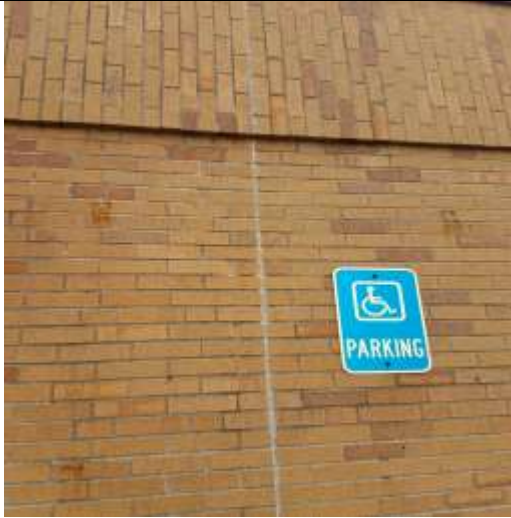
Wall expansion, not asbestos

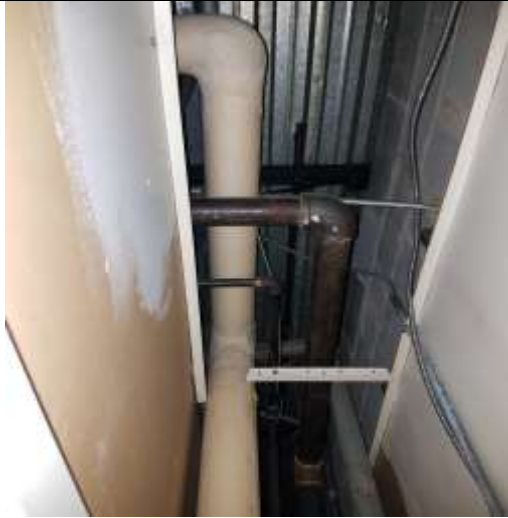
Kindred space, asbestos fitting

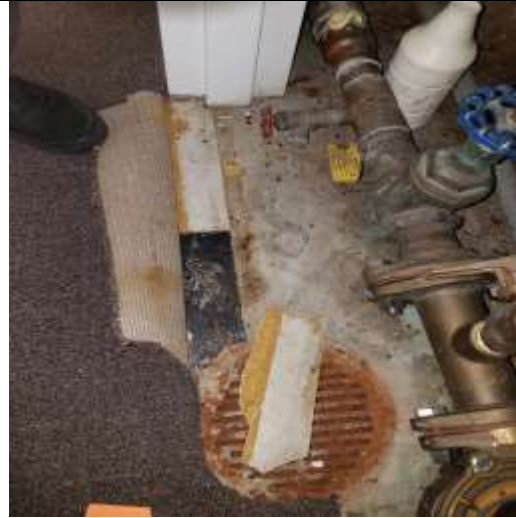
Kindred floor tile/mastic under carpet, asbestos

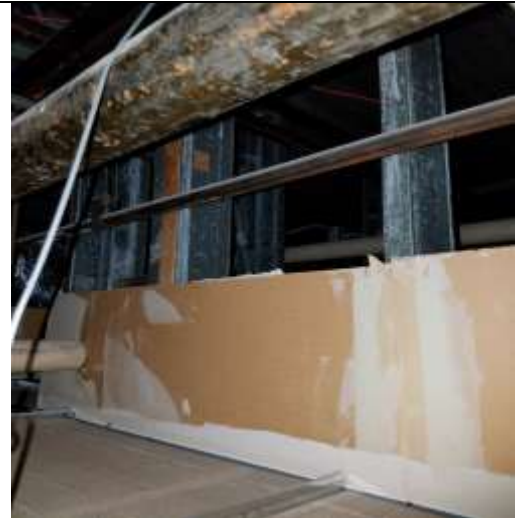
Old gypsum, tan JC and original wall stud
