**Crossing Assessment for the Sandy Neck Barrier Beach System Area  
of Critical Environmental Concern (ACEC)**

**Suggested Citation:** Duffey, S.M. and A.L. Pappal. 2019. Crossing Assessment for the Sandy Neck Barrier Beach System Area of Critical Environmental Concern (ACEC). Massachusetts Office of Coastal Zone Management, Boston, MA.

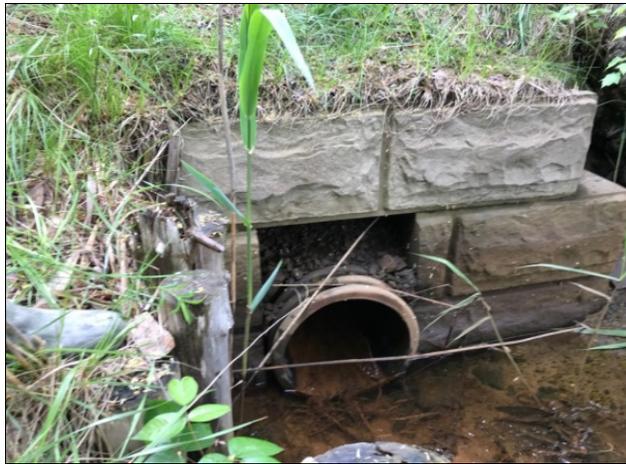
**Figure 14: The upstream culvert at site S5 shown at high tide.**

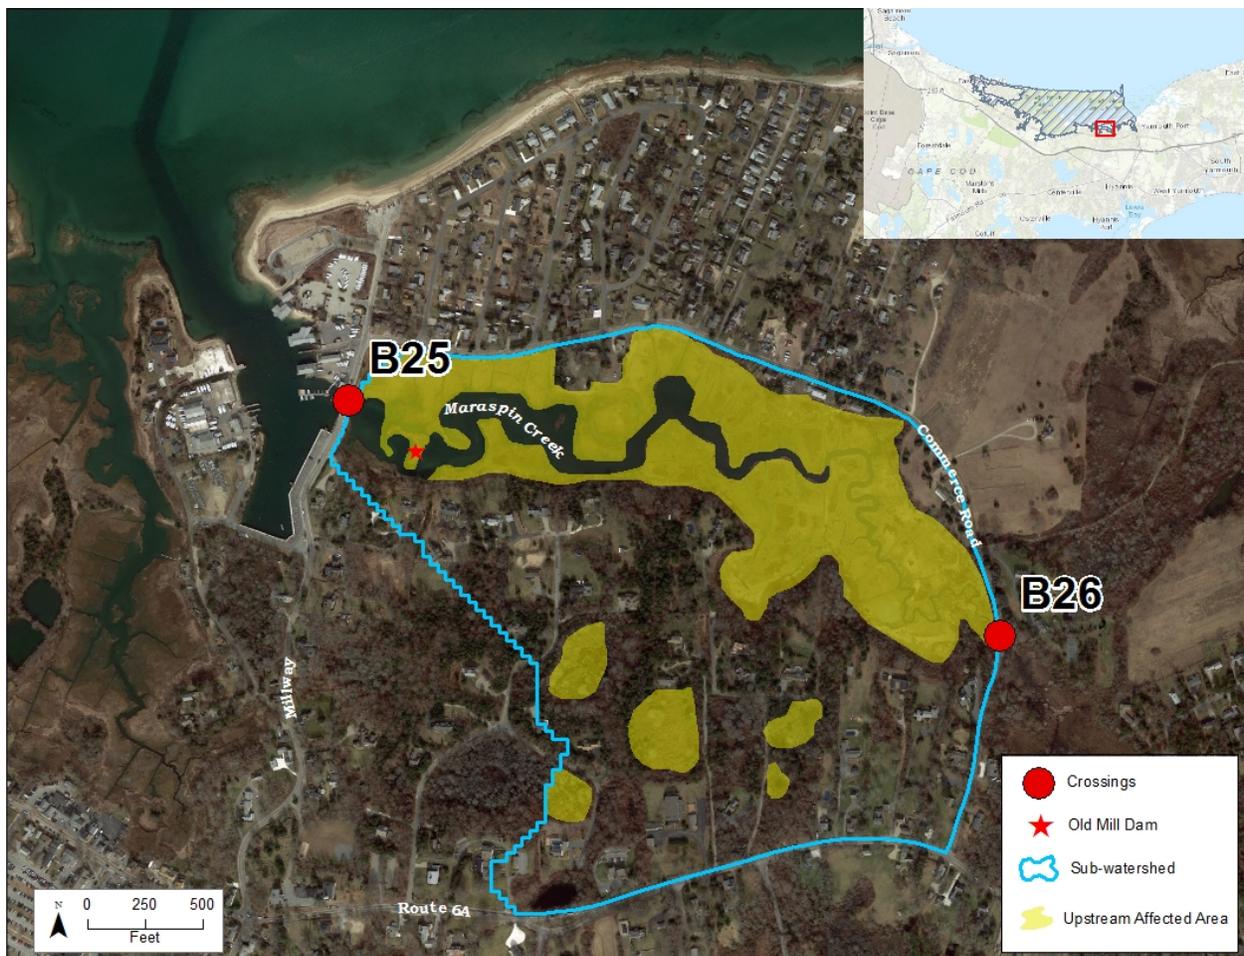
**Figure 44:** Site B25 is located at 41.7065°N 70.2984°W in Barnstable. Upstream Affected Area (as shown in the pea-green shaded area): Salt Marsh, 31.77 acres; Shallow Marsh, Meadow, or Fen, none; Shrub Swamp, 5.32 acres (based on the MassDEP Wetlands layer). Crossing B26 (pg. 41) is located upstream.

The concrete and stone bridge of Millway Road crosses Maraspin Creek at this site. The bridge appears to be in OK condition, and the upstream and downstream sides of the bridge are lined with large rocks for armoring. Overhead electrical wires are present at the site. This site is located downstream of crossing B26 (pg. 41). The upstream side of the crossing has a mix of ownership among private landowners, the Massachusetts Audubon Society (Mass Audubon), and the Barnstable Land Trust. The downstream side is owned by the Town of Barnstable and Millway

Marina, Inc. In the Cape Cod Atlas of Tidally Restricted Salt Marshes, a rise in elevation from the downstream to upstream side is noted. The remnants of an old mill dam on one of the many channels flowing through the upstream salt marsh were also observed (Justus et al. 2001). These characteristics were also observed in the current assessment, as well as rip rap on the upstream side of the crossing. The vegetation on the upstream side is very different from the downstream, as the upstream side is a salt marsh dominated by *Spartina* spp. while the downstream side is a public marina with no vegetation. Visual indicators of a restriction include marsh slumping, bank erosion, and ponded water on the upstream side of the crossing. There is no invasive common reed (*Phragmites australis*) at the bridge, but there are significant stands further upstream into Maraspin Creek. The perch created by the rip rap located in the creek may impede the movement of aquatic organisms at low tide. The elevation change, old mill dam, and rip rap should all be taken into account if this site is considered for restoration.

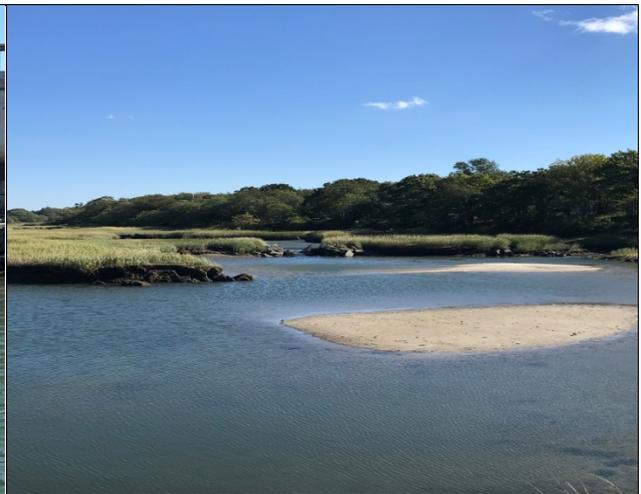
**Figure 46: The upstream area at site B25 is salt marsh habitat, where water must flow through multiple channels to move upstream, including through the site of an old mill dam.**

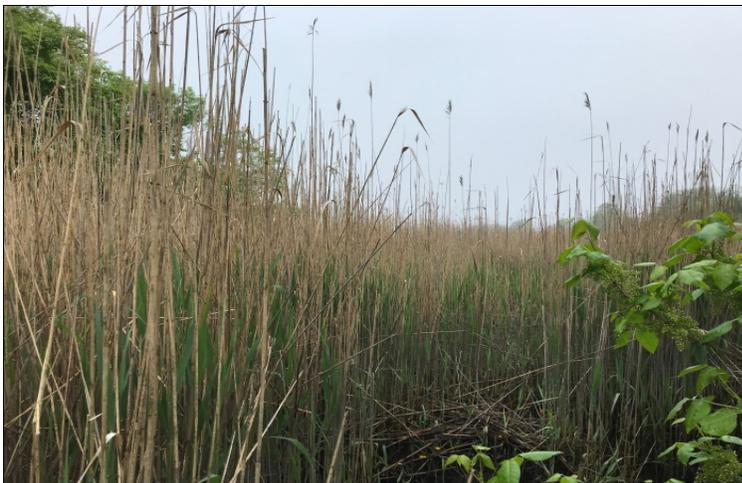
**Figure 50: A dense stand of the invasive common reed (*Phragmites australis*) dominates the immediate downstream area at site B26.**

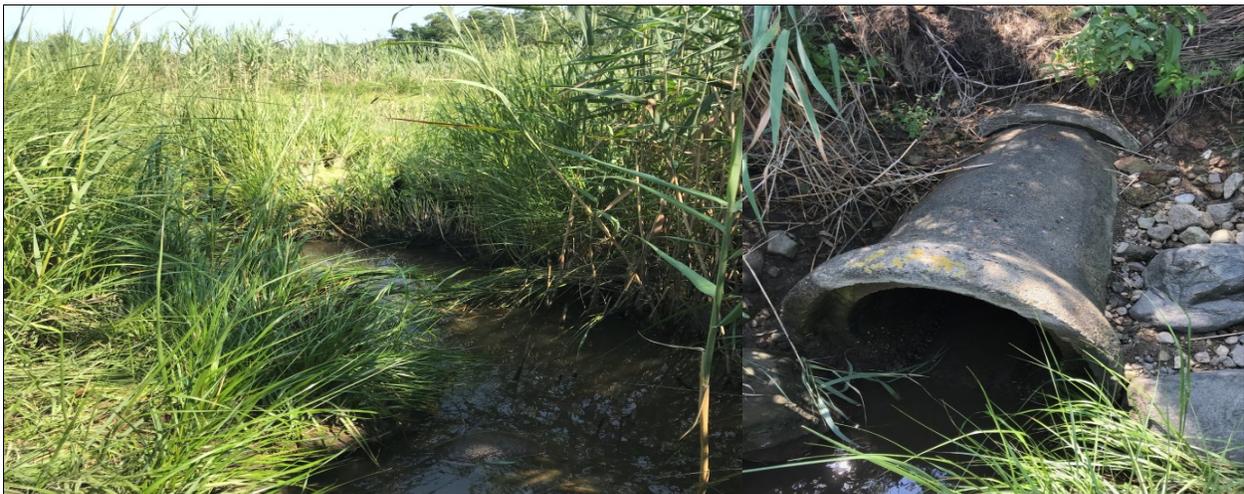
Figure 57: The invasive common reed (*Phragmites australis*) is abundant on the upstream side of site Y2 with minor abundance on the downstream side.

Figure 58: The upstream culvert extends out from a “sleeve” at the foot of the road fill at site Y2.

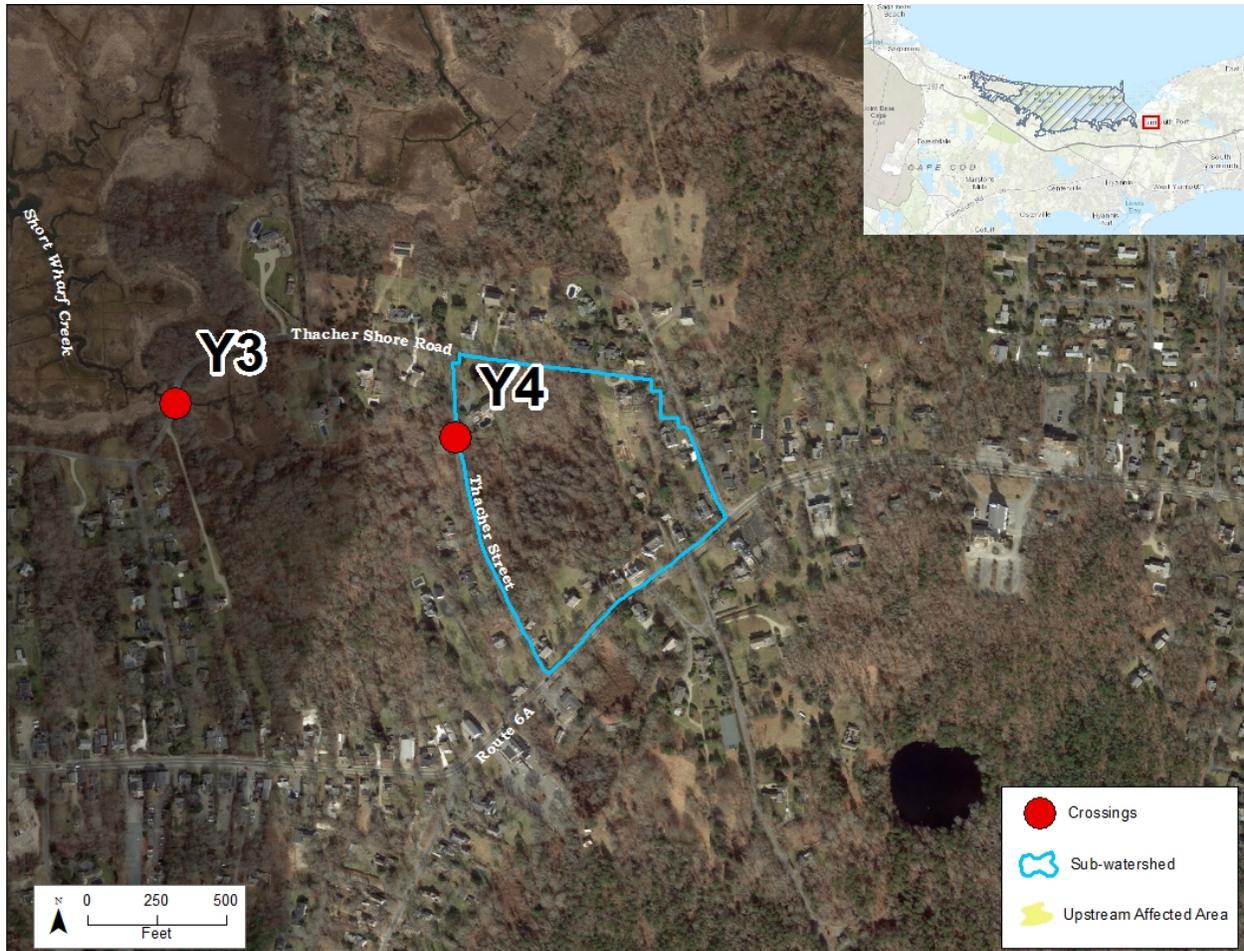
**Figure 68:** Site Y4 is located at 41.7069°N 70.246°W in Yarmouth. There is no Salt Marsh, Shallow Marsh, Meadow, or Fen, or Shrub Swamp in the upstream affected area. Crossing Y3 (pg. 53) is located downstream.

Thacher Street crosses Short Wharf Creek at this site. The type of crossing is unknown because it is covered by stone placed around both the upstream and downstream sides. It is possible that the structure is at least partially collapsed and failing, evidenced by the very minimal observed water flow through the structure. No visible utilities are present at the site. Crossing Y3 (pg. 53) is located downstream and could be contributing to the restriction at this site by impairing flow and drainage, and therefore should be considered with any restoration efforts at Y4. The area downstream is
