*Massachusetts Coastal Infrastructure  
Inventory and Assessment Project  
Massachusetts Department of Conservation and Recreation  
Office of Waterways*

## Upper Cape Cod

**Falmouth**

**July 6, 2009**

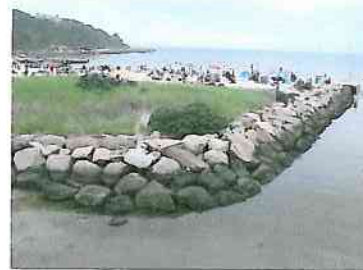
This structure is the south jetty at Old Silver Beach. There is minor displacement of the armor stones and minor slumping at the head. The structure is generally in good condition.

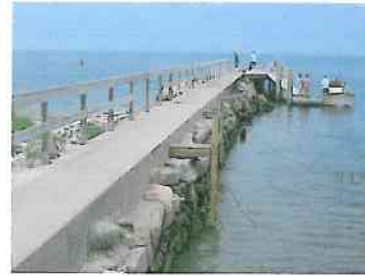
This structure is the south jetty at the entrance to West Falmouth Harbor. The structure consists of a wide concrete cap sitting atop armor stone. There is some weathering of the stone and cap present. The stones at the head are becoming unraveled.

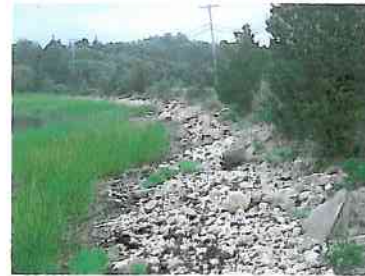
This structure is a revetment along Chapoquoit Road heading to Chapoquoit Beach. The structure consists of dumped stone rubble with some small armor stone interspersed. There is no defined side slope or crest. There is little interlocking between stones. Erosion of the bank is evident behind the stones.

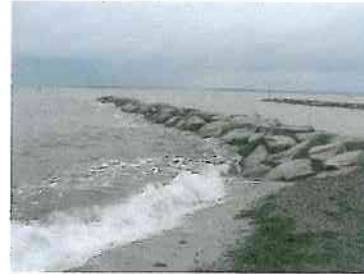
This structure is the east jetty at the entrance to Green Pond. The armor is slumped and unraveled at the head of the structure and slumping in the midsection of the trunk.

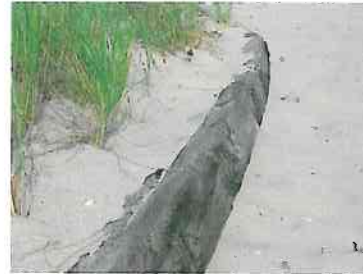
This structure is reported as a wooden bulkhead. One section is visible beneath dune. The bulkhead appears to have fallen over and now lies flat. Structure length reported is only the visible section. Further inspection wasn't possible.

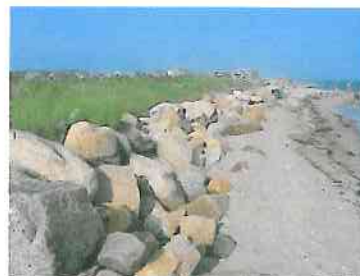
This structure is a stone revetment fronting a parking lot east of the entrance to Bourmes Pond. The armor stones are scattered in a row with no interlocking. There is no discernable crest or sideslope present.

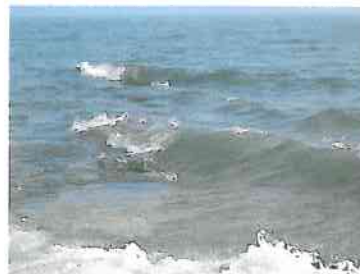
This structure is a single stone groin on the beach west of the entrance to Bourmes Pond. The groin was wholly submerged and inspection was not possible. Reported length is based on aerial photos.

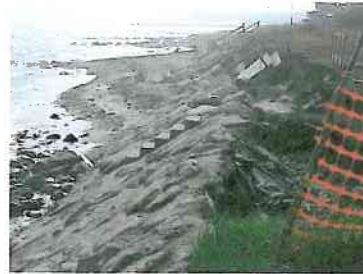
This structure is a grouted stone revetment at the end of Davis Neck Road. The grout is removed at the toe. There is major slumping at the crest with significant erosion of the fill behind the structure.

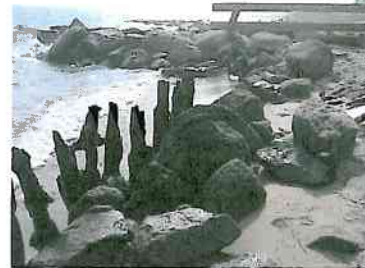
This structure is a small stone revetment and the remnants of a wooden bulkhead at the end of Davisville Road. There are simply some stones sitting in a row across the beach and the weathered remains of some timbers. There is no storm protection provided.

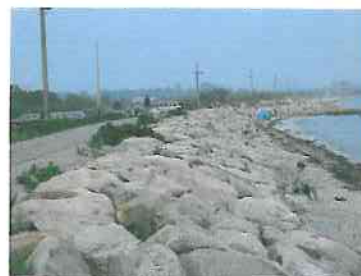
This structure is a stone revetment fronting a bike path immediately southwest of Trunk River. Some sections of the structure are slumping forward and are losing fill material from behind crest.

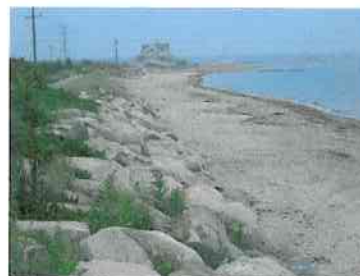
This structure is a stone revetment immediately northeast of Trunk River. Some areas of the crest have slumped forward. There is evidence of some fill behind the crest being eroded.

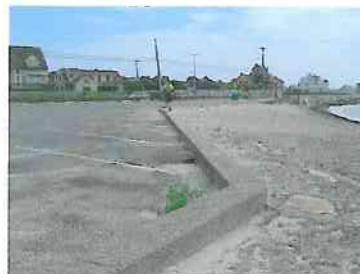
This structure is a sheet pile seawall with a concrete cap at the eastern end of the Surf Drive Beach parking lot. The sheetpile is mostly below the beach. There is cracking and spalling of the concrete cap evident. The toe at the eastern end of the wall is becoming exposed. There is no evidence of undermining at this point.

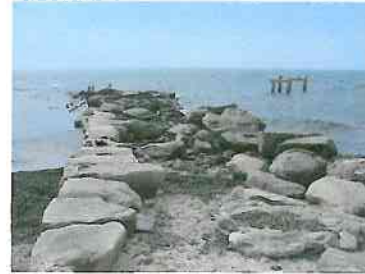
This structure is a stone groin at the west end of the Surf Drive Beach parking lot. This 'groin' is actually the western portion of the Old Stone Dock which used to be present at this location. There are no sideslopes to speak of, simply two rows of stones stacked aside one another.

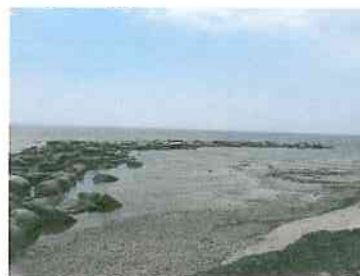
This structure is a stone breakwater at the Surf Drive Beach parking lot. This 'breakwater' is actually the eastern portion of the Old Stone Dock which used to be present at this location. The stones show no interlocking. The structures serves as a small wavebreak for swimming but provides no storm protection.

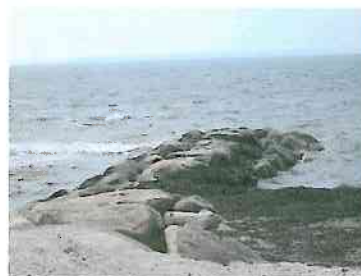
This structure is the west jetty at the Siders Pond outlet through Surf Drive Beach. Some stones are slumped at the head of the structure. The stones at the trunk near the outlet are also slumping.

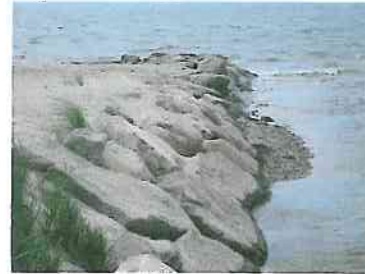
This structure is the east jetty at the Siders Pond outlet through Surf Drive Beach. Some stones are slumped at the head of the structure. The stones at the trunk near the outlet are also slumping.

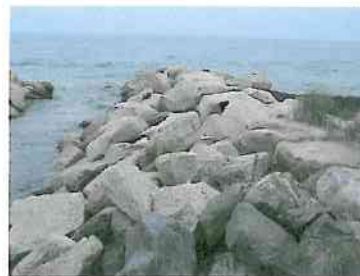
This structure is the west jetty at Salt Pond. The crest still shows a constant elevation. The armor on the side slopes is displaced and slumped. There is reduced interlocking between stones.

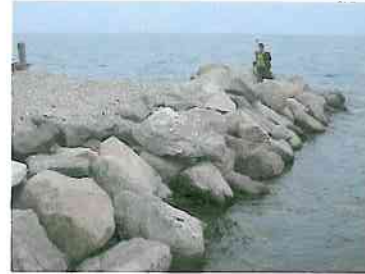
This structure is the jetty on the east side of the Salt Pond outlet. There is no discernable crest evident. The armor stones on the side slopes are displaced and slumped forwards.

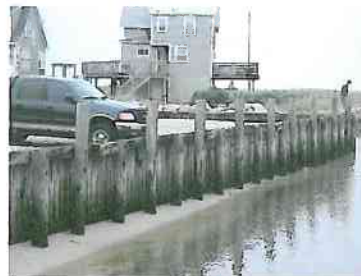
This structure is a timber bulkhead fronting West Avenue and a parking lot at the southeast corner of Wild Harbor. The timbers are weathered and the vertical piles are thinning at the base. This structure was not inspected below the water line.

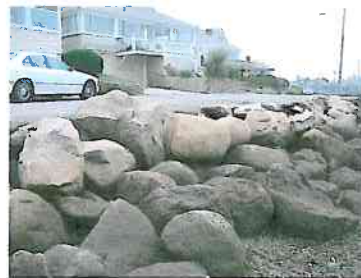
This structure is a stone revetment fronting West Avenue along the east side of Wild Harbor. The armor stone is slumped and becoming unraveled. There is a loss of interlocking between armor stones.

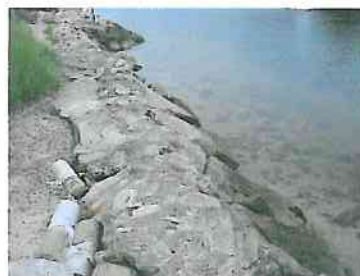
The structure is a stone revetment along the southern entrance to Wild Harbor leading to the south jetty. The stone and side slopes are in fair condition and the toe is intact. The crest and side slopes are level and straight.

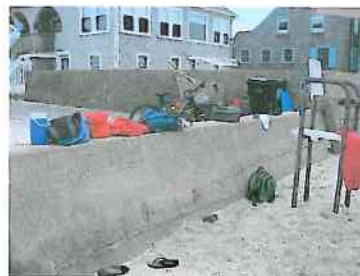
This structure is a small concrete seawall at the end of Silver Beach Avenue. The wall shows some weathering and surface cracks. It is generally in good condition.

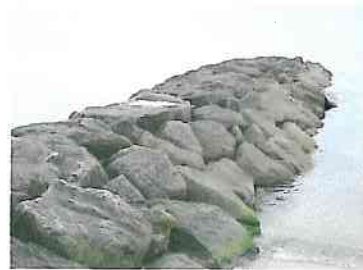
This structure is the 4 groins along Silver Beach. The side slopes and crests show good lines and are in fair condition. The armor stone is discolored and weathered.

Structure is sound but may exhibit minor deterioration, section loss, cracking, spalling, undermining, and/or scour. Structure adequate to withstand major coastal storm with little to moderate damage. Actions taken to reinforce structure to provide full protection from major coastal storm and for extending life of structure. Moderate wind or wave damage to landform exists. Landform may not be sufficient to fully protect shoreline during a major coastal storm. Actions taken to provide addition material for full protection and extended life.

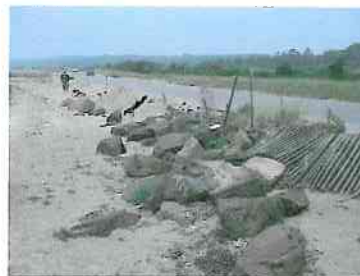
This structure is the remnants of riprap placed along the shoreline across from the west end of Salt Pond. The structure is fully unraveled and partially buried by the beach. There is no interlocking between stones.

Conditions of structure/landform may warrant emergency stabilization as failure may result in potential loss of property and/or life. Landform eroded, loss of integrity. Structure exhibits critical levels of deterioration, section loss, cracking, spalling, undermining, and/or scour. Structure provides little or no protection from a major coastal storm. Actions taken to totally reconstruct structure to regain full capacity. Landform stability is severely compromised, rate of erosion/material loss may be increasing, and landform does not provide adequate protection from a major coastal storm. Actions taken to recreate landform to adequate limits for full protection from a major coastal storm.

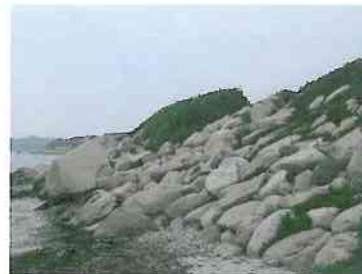
This structure is the western section of the revetment running around Nobska Point. The stone was dumped, not placed and there is little interlocking between stones. There is granite stone dumped at the end of the structure which lies over the old material.

*Condition***D***Rating***Poor***Level of Action***Major***Description*

Structure exhibits advanced levels of deterioration, section loss, cracking, spalling, undermining, and/or scour. Structure has strong risk of significant damage and possible failure during a major coastal storm. Structure should be monitored until repairs/reconstruction can be initiated. Actions taken to reconstruct structure to regain full capacity to resist a major coastal storm. Landform eroded, stability threatened. Landform not adequate to provide protection during major coastal storm. Actions taken to recreate landform to adequate limits for full protection from a major coastal storm.

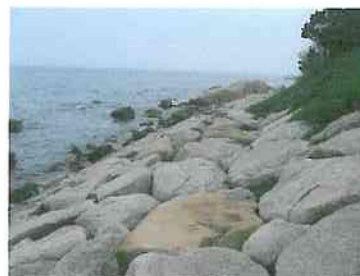
This structure is a stone revetment which runs a majority of the length around Nobska Point. The structure exhibits a 2-tiered crossed section, with a side slope up from the water line, a crest width of one armor stone and then a second sloped section running above the crest up the bank. The upper section is heavily vegetated.

*Condition***B***Rating***Good***Level of Action***Minor***Description*

Structure observed to exhibit very minor problems, superficial in nature. Minor erosion to landform is present. Structure / landform adequate to provide protection from a major coastal storm with no damage. Actions taken to prevent / limit future deterioration and extend life of structure.

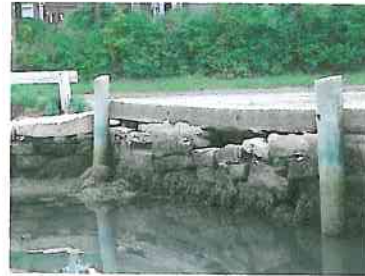
This structure is a bulkhead at the town pier in West Falmouth Harbor. The structure consists of a stone seawall with a concrete cap. There are some sections missing stones and there are spots where the cap has slumped. The central area beneath dock had no access for assessment.

**Condition****D****Rating****Poor****Level of Action****Major****Description**

Structure exhibits advanced levels of deterioration, section loss, cracking, spalling, undermining, and/or scour. Structure has strong risk of significant damage and possible failure during a major coastal storm. Structure should be monitored until repairs/reconstruction can be initiated. Actions taken to reconstruct structure to regain full capacity to resist a major coastal storm. Landform eroded, stability threatened. Landform not adequate to provide protection during major coastal storm. Actions taken to recreate landform to adequate limits for full protection from a major coastal storm.

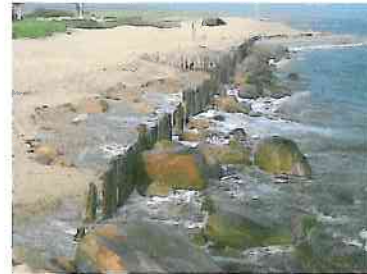
This structure is an abandoned wooden bulkhead fronted by armor stones. The structure runs parallel to Washburn Road. The bulkhead is just remnant timbers standing upright with a large majority of the wooden structure having been destroyed. The stones fronting the old piles are completely unraveled and the beach behind the structure is eroding.

*Condition***F***Rating***Critical***Level of Action***Immediate***Description*

Conditions of structure/landform may warrant emergency stabilization as failure may result in potential loss of property and/or life. Landform eroded, loss of integrity. Structure exhibits critical levels of deterioration, section loss, cracking, spalling, undermining, and/or scour. Structure provides little or no protection from a major coastal storm. Actions taken to totally reconstruct structure to regain full capacity. Landform stability is severely compromised, rate of erosion/material loss may be increasing, and landform does not provide adequate protection from a major coastal storm. Actions taken to recreate landform to adequate limits for full protection from a major coastal storm.

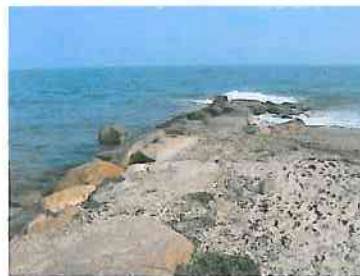
This structure is a field of 3 groins along the beach east of the entrance to Bournes Pond. The groins are seeing some loss of interlocking between armor stones. The stones at the head and the side slopes are becoming unraveled.

*Condition***C***Rating***Fair***Level of Action***Moderate***Description*

Structure is sound but may exhibit minor deterioration, section loss, cracking, spalling, undermining, and/or scour. Structure adequate to withstand major coastal storm with little to moderate damage. Actions taken to reinforce structure to provide full protection from major coastal storm and for extending life of structure. Moderate wind or wave damage to landform exists. Landform may not be sufficient to fully protect shoreline during a major coastal storm. Actions taken to provide addition material for full protection and extended life.

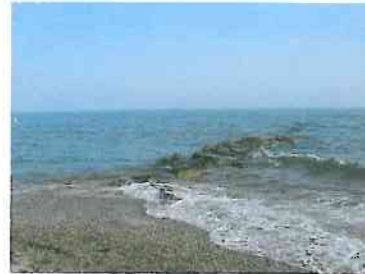
This structure is a pair of stone groins on the beach running east of Jewelers Road. The stones are unraveled and mostly submerged. The western groin is being flanked.

*Condition***D***Rating***Poor***Level of Action***Major***Description*

Structure exhibits advanced levels of deterioration, section loss, cracking, spalling, undermining, and/or scour. Structure has strong risk of significant damage and possible failure during a major coastal storm. Structure should be monitored until repairs/reconstruction can be initiated. Actions taken to reconstruct structure to regain full capacity to resist a major coastal storm. Landform eroded, stability threatened. Landform not adequate to provide protection during major coastal storm. Actions taken to recreate landform to adequate limits for full protection from a major coastal storm.

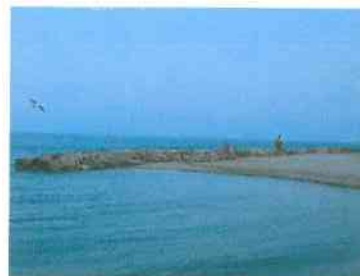
This structure is the terminal groin which serves as the western channel edge at the entrance to Eel Pond/Childs River in East Falmouth. The armor stones at the head are becoming unraveled and the center of the trunk is slumping. There is erosion adjacent to slumped areas where material is lost through the structure.

*Condition***D***Rating***Poor***Level of Action***Major***Description*

Structure exhibits advanced levels of deterioration, section loss, cracking, spalling, undermining, and/or scour. Structure has strong risk of significant damage and possible failure during a major coastal storm. Structure should be monitored until repairs/reconstruction can be initiated. Actions taken to reconstruct structure to regain full capacity to resist a major coastal storm. Landform eroded, stability threatened. Landform not adequate to provide protection during major coastal storm. Actions taken to recreate landform to adequate limits for full protection from a major coastal storm.

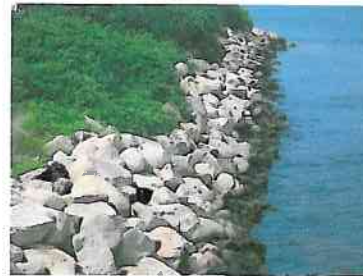
This structure is the channel protection along the west side of the entrance to Great Pond. The stones are becoming unraveled and some erosion of fill behind the structure is evident.

*Condition***C***Rating***Fair***Level of Action***Moderate***Description*

Structure is sound but may exhibit minor deterioration, section loss, cracking, spalling, undermining, and/or scour. Structure adequate to withstand major coastal storm with little to moderate damage. Actions taken to reinforce structure to provide full protection from major coastal storm and for extending life of structure. Moderate wind or wave damage to landform exists. Landform may not be sufficient to fully protect shoreline during a major coastal storm. Actions taken to provide addition material for full protection and extended life.

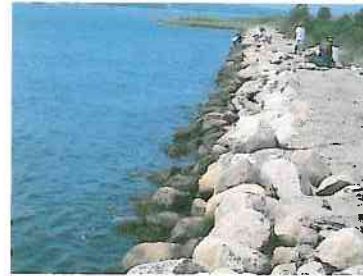
This structure is the channel protection along the east side of the entrance to Great Pond. The stones are becoming unraveled along the water line. There is a loss of interlocking between the toe stones and the side slopes.

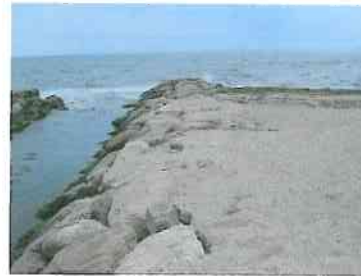
This structure is the west jetty at the entrance to Little Pond. The stone is weathered but solid. The side slopes and crest are generally in good condition.

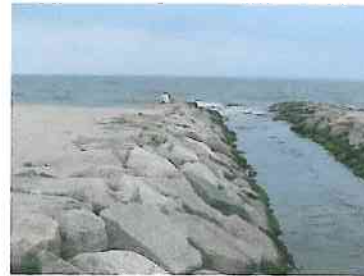
This structure is the east jetty at the entrance to Little Pond. The stone is weathered but solid. The side slopes and crest are generally in good condition. There is minor slumping along trunk of the structure.

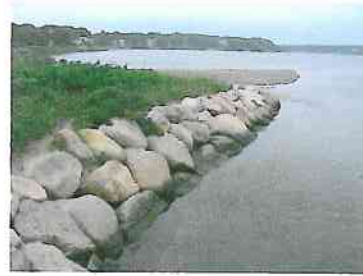
This structure is the stone revetment along the western channel side slope at the entrance to Little Pond. The stone is weathered but solid. The side slopes and crest are generally in good condition.

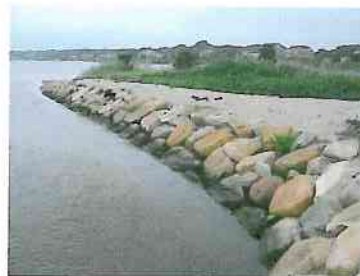
This structure is the stone revetment along the eastern channel side slope at the entrance to Little Pond. The stone is weathered but solid. The side slopes and crest are generally in good condition.

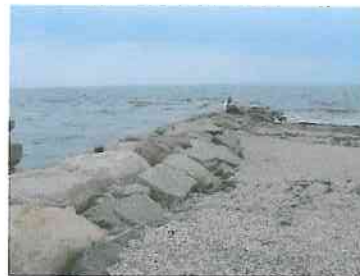
This structure is a single stone groin on the beach east of the inlet to Little Pond. The head of the structure is becoming unraveled. The groin is filled on the west side with an offset in the beach on the east side. The crest and side slopes along the groin trunk are in good condition.

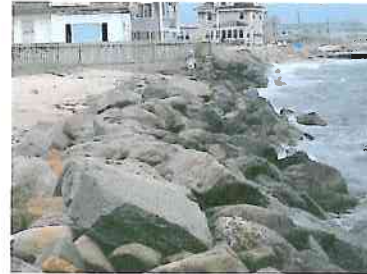
This structure is a revetment along the beach east of the entrance to Little Pond. The structure is fronting an empty lot and consists of dumped armor stones. The armor stones are unraveled and in a random pile exhibiting no crest or side slope.

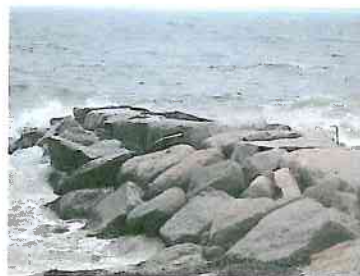
This structure is two stone groins on the beach west of the entrance to Great Pond. The sides and heads are beginning to unravel on both groins.

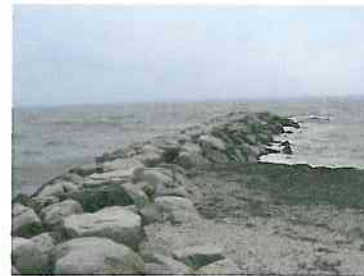
This structure is the west jetty at the entrance to Great Pond. The crest and side slopes are in fair condition. The head is beginning to unravel with a loss of interlocking between adjacent armor stones.

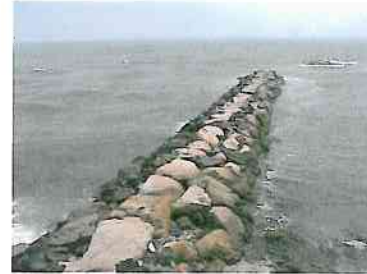
This structure is the east jetty at the entrance to Great Pond. The crest is in fair condition. There is some slumping of the side slopes. The head is beginning to unravel with a loss of interlocking between adjacent armor stones.

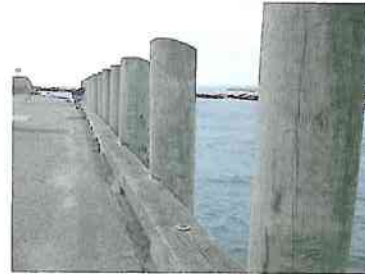
This structure is a wooden bulkhead along the southeast portion of Falmouth Harbor. The timbers and pilings are weathered but solid. The structure appears to be in good condition. The structure was not inspected below the water line.

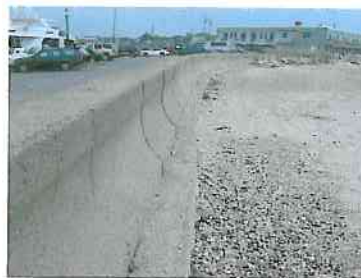
This structure is a recurved concrete seawall fronting a parking lot at the southeast corner of Falmouth Harbor. There is cracking and spalling evident throughout the structure. Some undermining of footing at the center is evident.

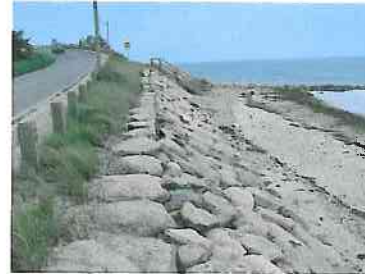
This structure is the western portion of the stone revetment fronting Grand Avenue at the base of Falmouth Heights. The sideslopes are intact but there is some small slumping in areas on the crest.

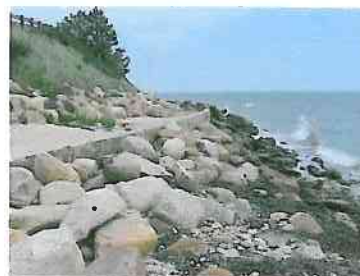
This structure is the eastern portion of the stone revetment fronting Grand Avenue at the base of Falmouth Heights. The structure is comprised of riprap fronting and backing an abandoned seawall. The seawall is completely failed in many sections. The riprap fronting the seawall is unraveled.

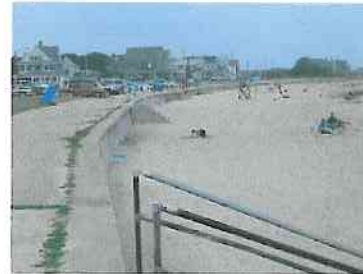
This structure is a concrete seawall backing Central Park Beach along Grand Avenue. There is some superficial cracking and spalling evident along the wall. There are multiple small patched areas evident on the wall face.

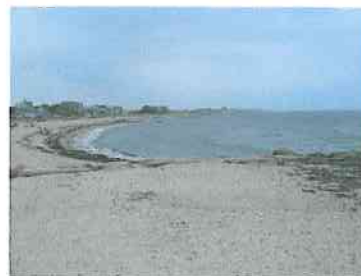
This structure is the 4 stone groins at Central Park Beach along Grand Avenue. The groins are low profile and are becoming unraveled with reduced interlocking between armor stones.

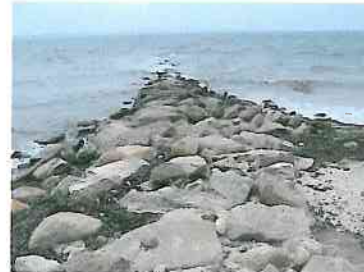
This structure is a single stone groin protruding from the revetment fronting Grand Avenue at the base of Falmouth Heights. It is just west of the terminus of Vernon Avenue. This is a low profile groin. The side slopes and head are unraveled.

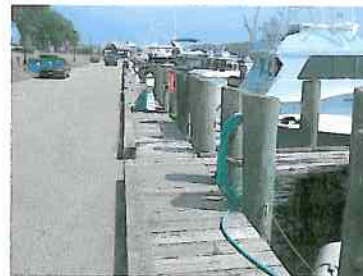
This structure is the wooden bulkhead for town marina along the western edge of Falmouth Harbor. The timbers and piles are weathered but solid.

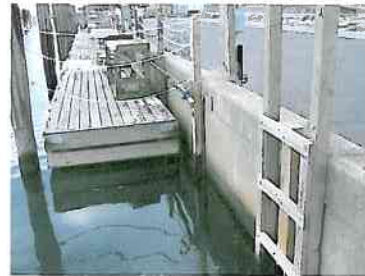
This structure is a concrete bulkhead immediately north of the town marina dockage on the west side of Falmouth Harbor. This is the section of dockage reserved for charter fishing boats. The bulkhead is weathered and discolored at sections. There are a few cracks visible on the face of the wall. There is some spalling of the concrete observed at the seams between the wall sections.

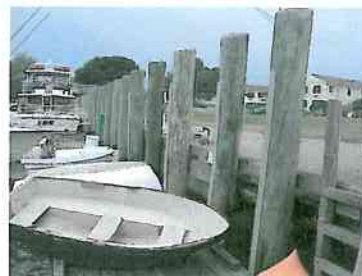
This structure is a timber bulkhead at the north end of Falmouth Harbor. The dockage and boats tied up make a detailed inspection impossible. The visible portions appear solid.

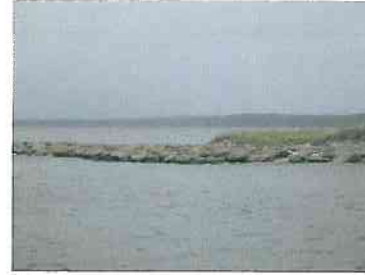
This structure is the west jetty at the entrance to Falmouth Harbor. There is some slumping and displacement of armor stones along the middle of structure. Aside from this section, the crest and side slopes are in good condition.

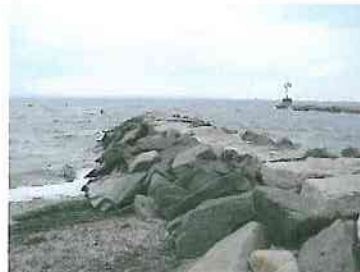
This structure is the east jetty at the entrance to Falmouth Harbor. There is a section at the head that is starting to unravel as well as a slumped section in the center. Aside from these areas, the crest and side slopes are in good condition.

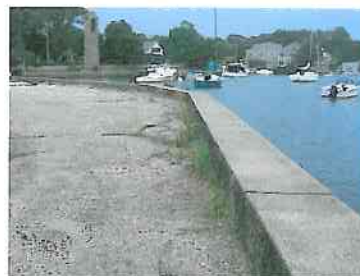
This structure is a stone seawall along the west side of Eel Pond. The wall has a concrete cap. The cap and face of the wall are weathered. There is slumping of the ground behind wall crest suggesting some fill loss out of the front and bottom of the wall.

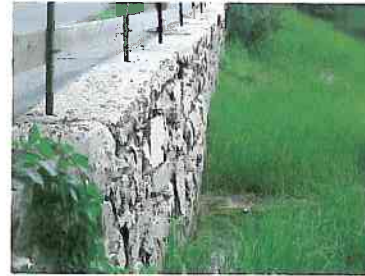
This structure is a stone wall fronting roadway School Street on the east side of Eel Pond. The wall has an iron railing along the top. The stone is weathered and discolored but the grout between stones is intact. There is marsh at the base of the wall.

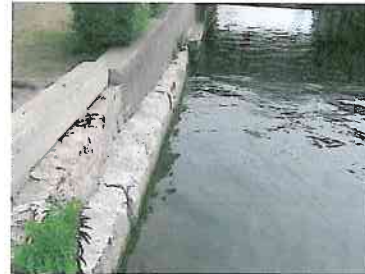
This structure is a seawall along the eastern side of the channel into Eel Pond. The wall is composed of rectangular granite blocks stacked atop each other. There is also a concrete section at the crest running back to the abutments of the bridge. The stone in the wall is weathered but solid. The concrete section is in good condition.

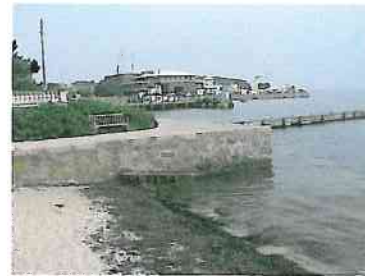
This structure is a stone seawall running parallel to Water Street. There is grout between the stones in the wall and evidence of sheetpile along toe. The stones are weathered but solid. The crest of the wall is level and even.

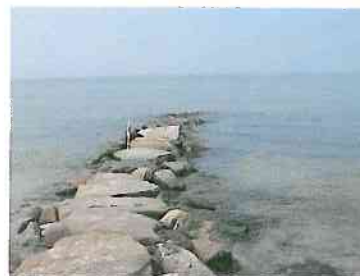
This structure is the 2 stone groins at Stoney Beach. Both groins are very low profile. There is some weathering of stone and displacement of the armor stone.

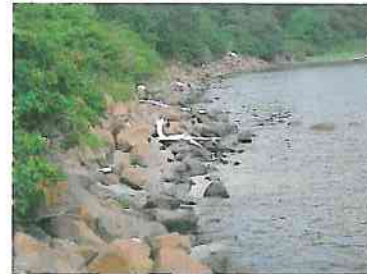
This structure is a dumped stone revetment fronting the bike path at the head of the Coast Guard Harbor. The stone is slumped and unraveled with no clear crest or side slopes. Some sections of the structure have slumped forward.
