2018 Triennial Inspection

REPORT OF CONDITIONS

December 19, 2018

HNTB Corporation
31 Saint James Avenue
Boston, MA 02116

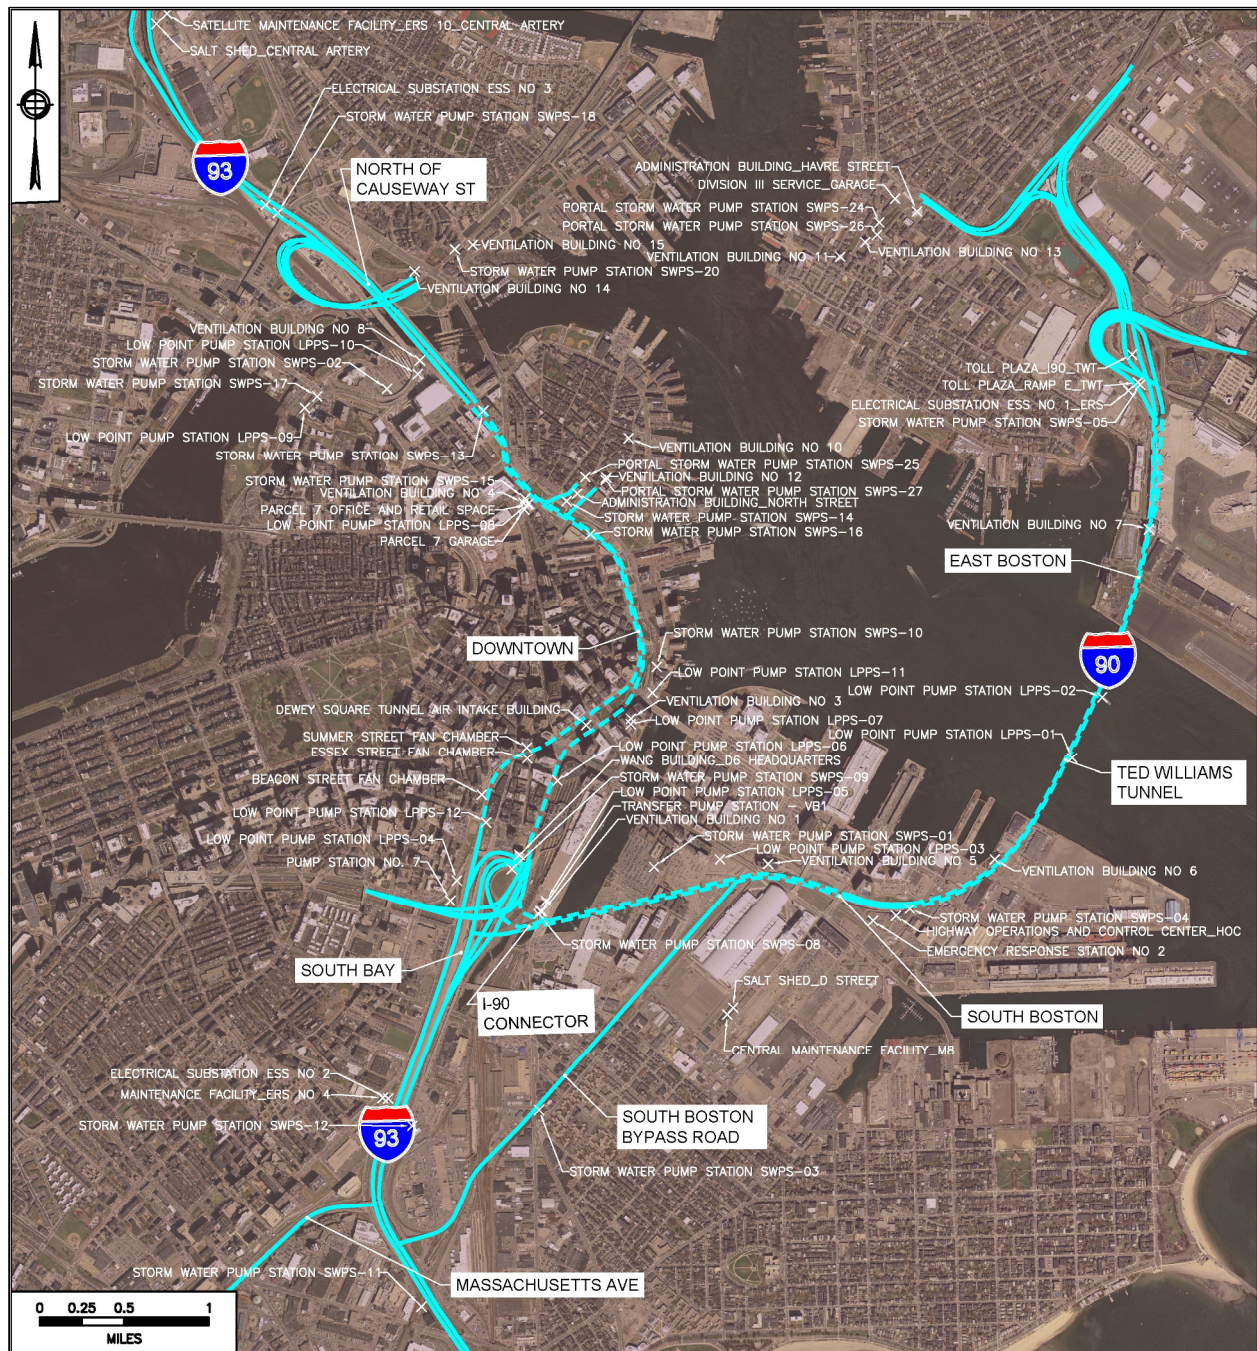
Figure 2: Central Artery/Tunnel

This network, shown in Figure 2, includes approximately 107 lane miles of roadway, primarily tunnels and bridges, of which approximately 35 lane miles are toll roads. The tunnels include eight ventilation buildings, three fan chambers, 29 pumping stations and approximately 90 utility rooms.

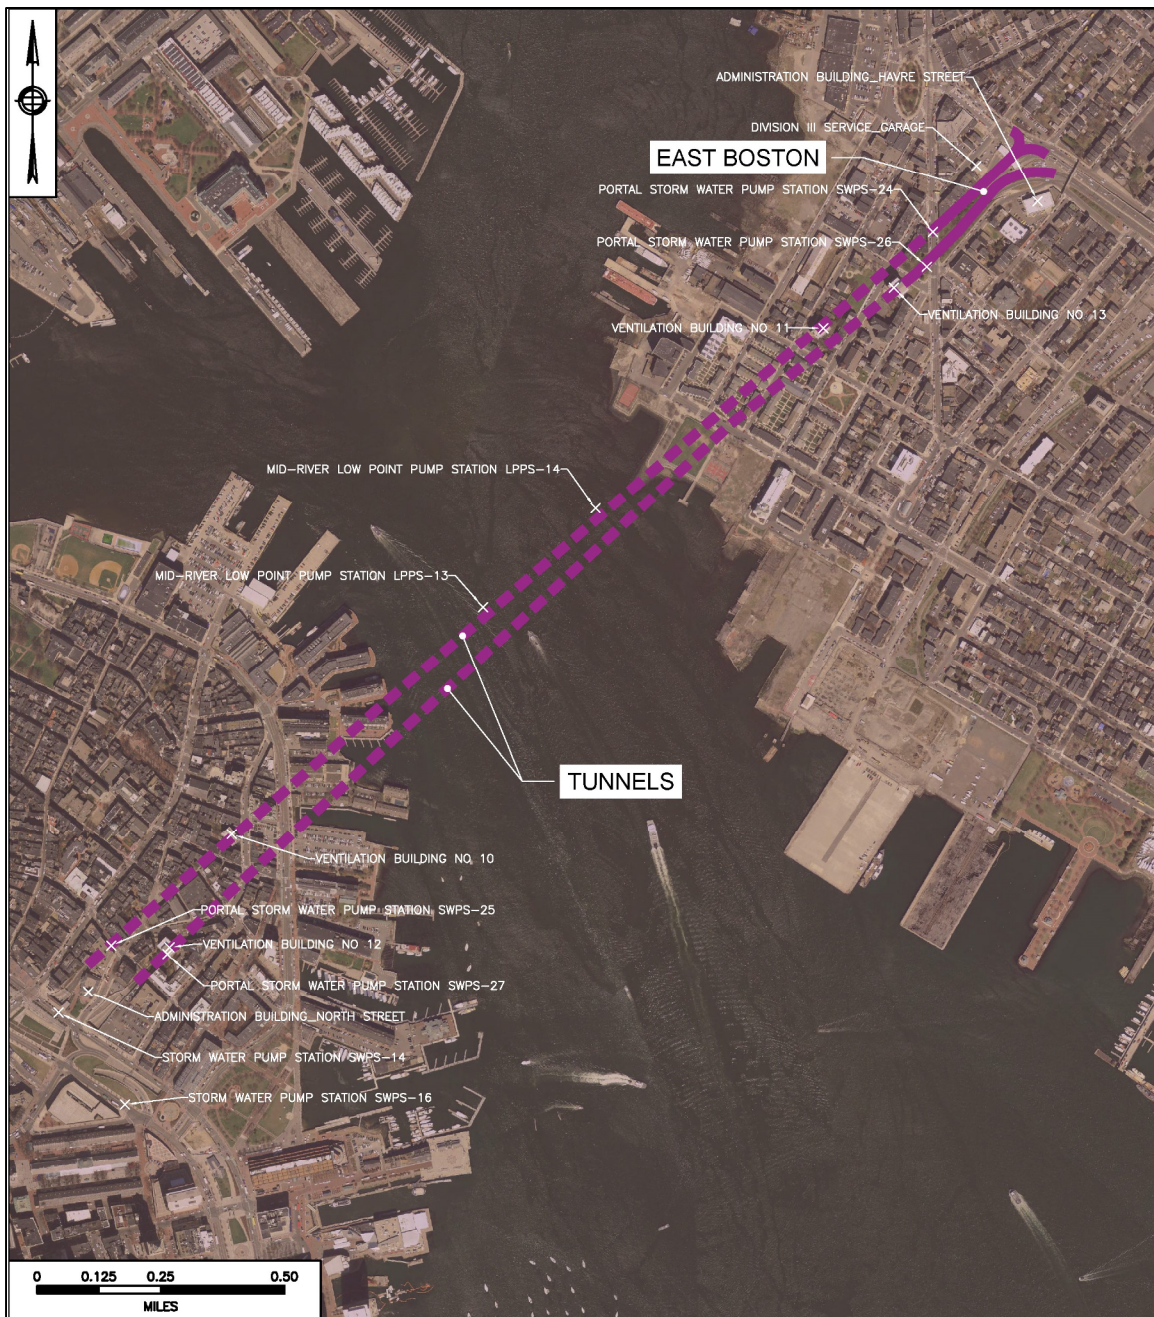
Figure 4: Sumner/Callahan Tunnels

The southerly ends of both tunnels connect into ramps that were constructed as part of the Central Artery/Tunnel Project. The limits of the Sumner/Callahan Tunnels are shown in Figure 4. The Sumner/Callahan Tunnels are 5,600 feet and 5,900 feet long respectively. This transportation network includes four ventilation buildings, six stormwater pumping stations and three administration buildings.
