Office of the
Inspector General
Commonwealth of Massachusetts

A Recommendation for
Cost Recovery Against the
Big Dig's Management
Consultant:

Grout Heave-Related Contractor Claims on the
C11A1 Contract

February 2003

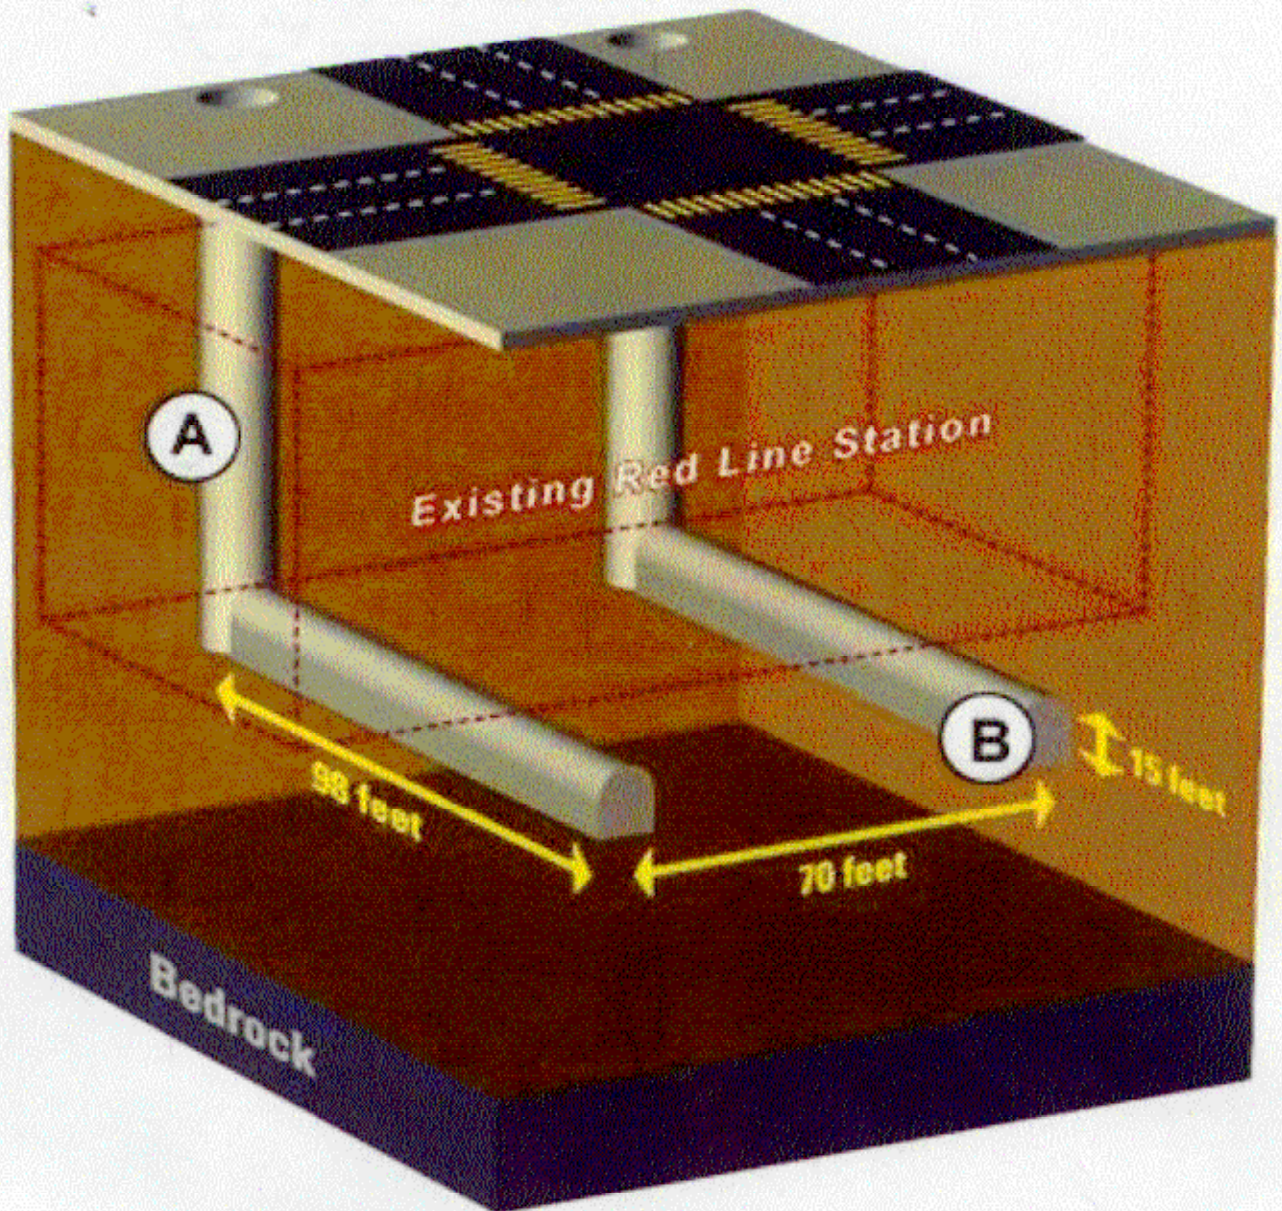
Step one was digging two shafts (A.), like elevator shafts, down to about 20 feet below the bottom of the subway tunnel. One shaft is on the Federal Reserve Bank corner across from South Station, the other on the old Peter Pan Bus Terminal corner across from One Financial Center. Next, horizontal tunnels (B.), called "grouting galleries," each about 15 feet high, were dug under the subway across Summer Street. The subway is only a few feet above the top of the tunnels; workers can hear the trains rumbling overhead.

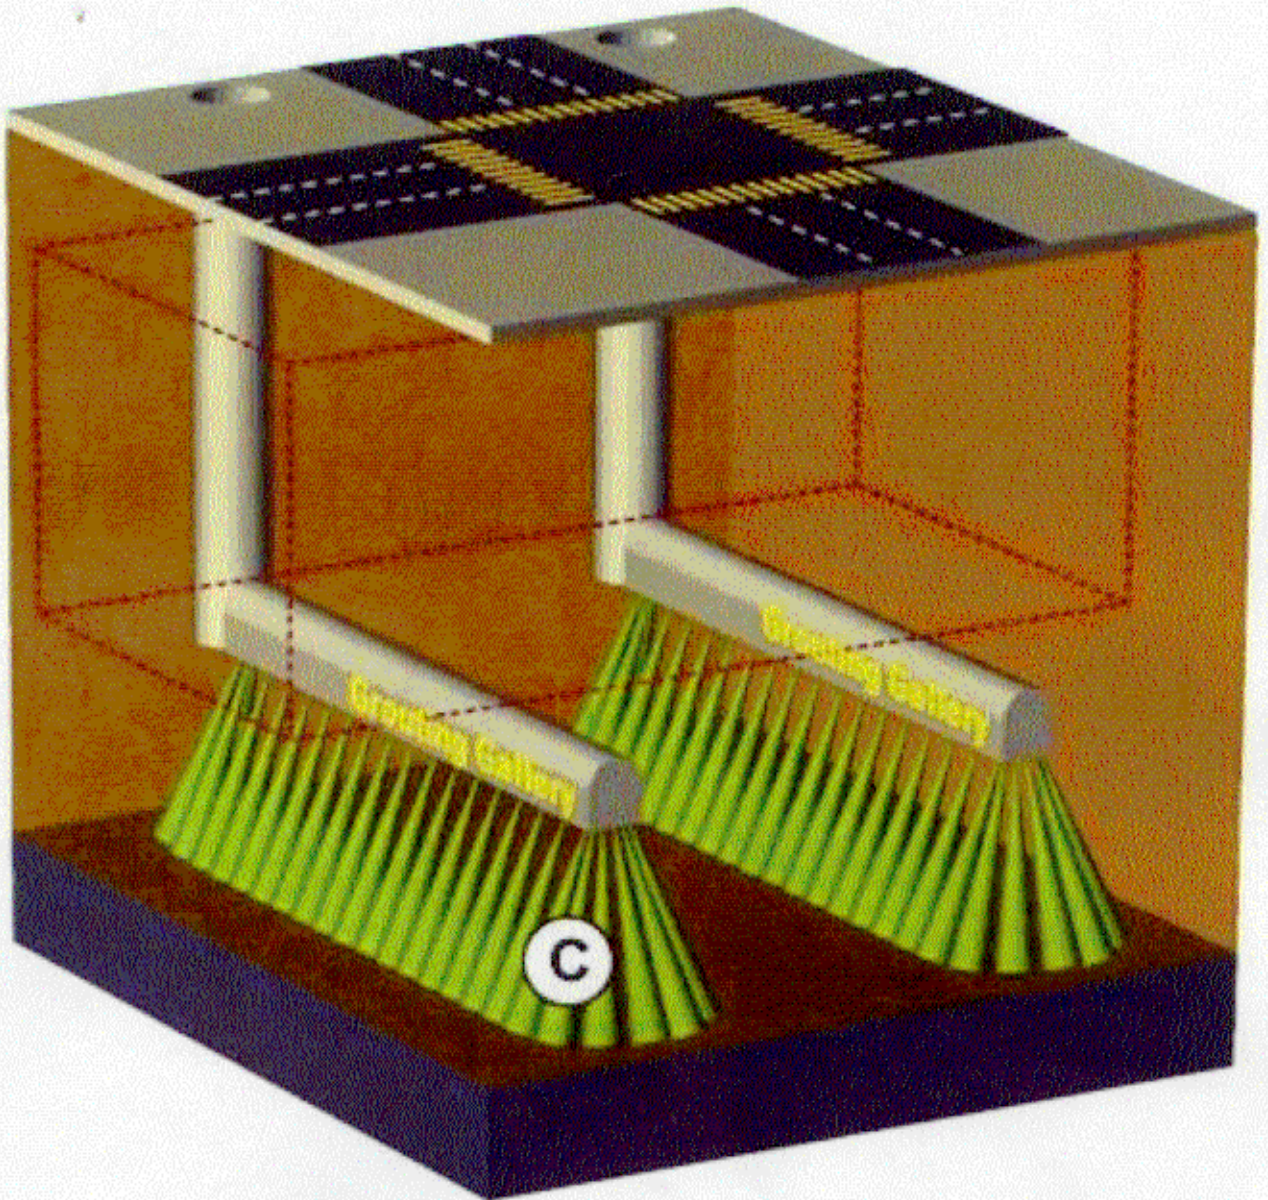
Then hundreds of small shafts just a few inches in diameter were drilled in a fan pattern (C.) from the horizontal grouting galleries down to bedrock about 50 feet below. Porous pipes were inserted into the shafts and a liquid material called "grout" - like the liquid component of concrete - pumped through the pipes. The grout flowed out the tiny holes in the pipes and permeated the soil. When dry the grout makes the soil impermeable to water; tunneling is impossible in water-soaked ground. In fact, to make the first grouting gallery tunnel possible, the entire water table in Dewey Square had to be temporarily lowered by sinking wells to pump out the groundwater.

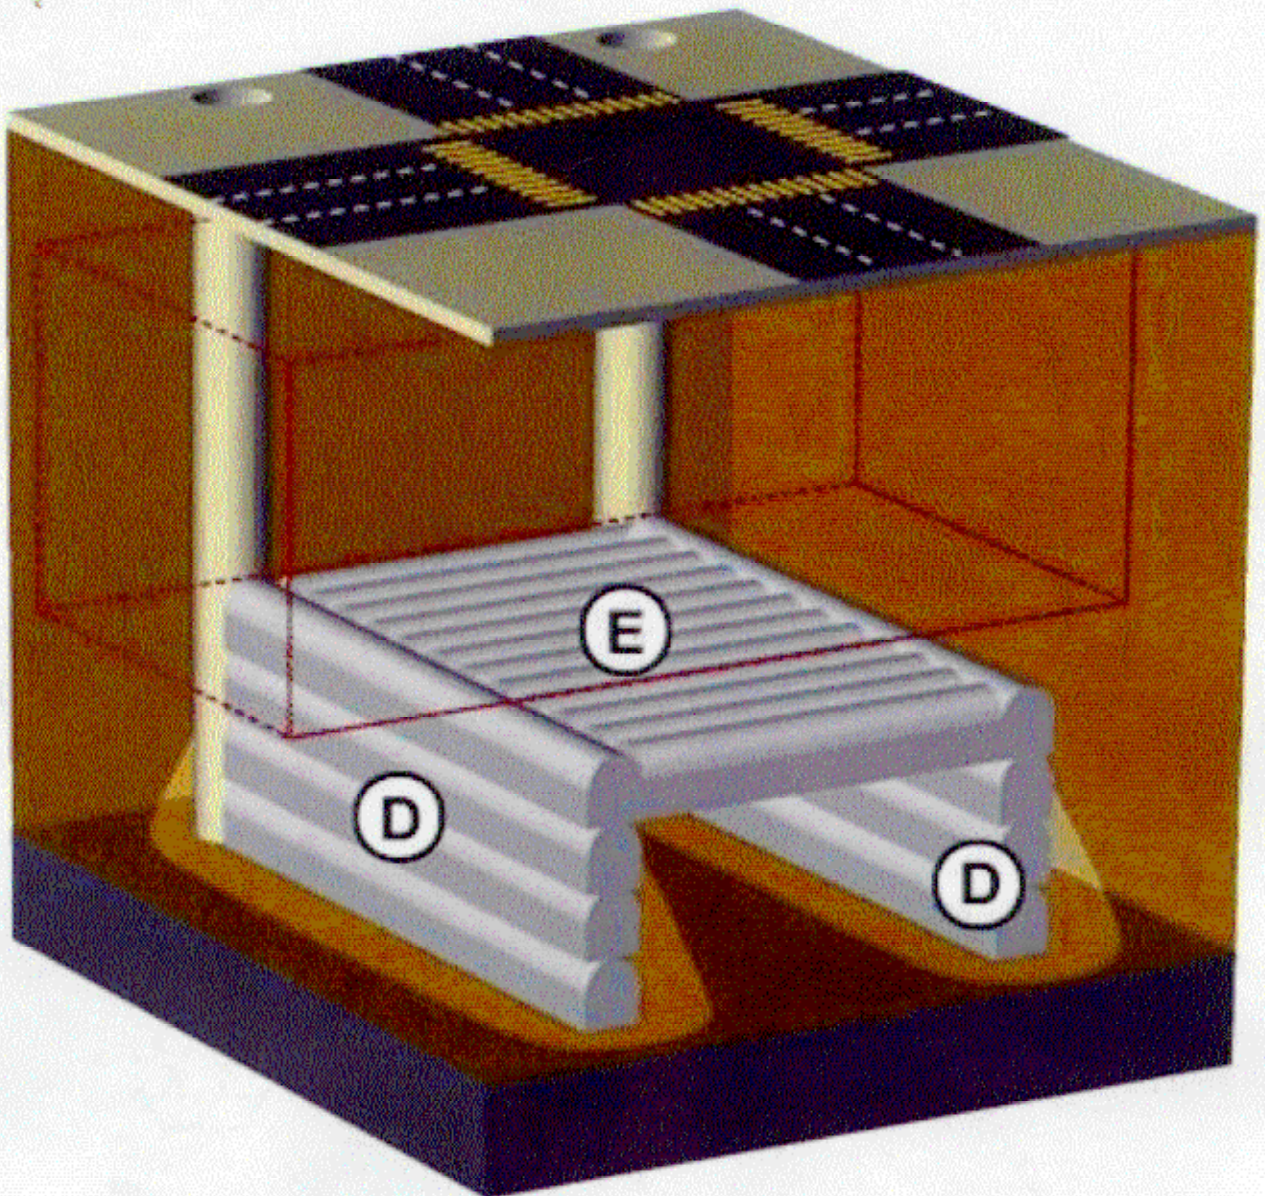
With the grout dry, the the vertical shafts could be sunk farther down to bedrock, so that a series of three more pairs of tunnels could be dug, one on top of the next, and filled with concrete (D), forming two massive concrete walls 100 feet long and 45 feet high underneath the grouting galleries and perpendicular to the subway. A series of small tunnels (E) between the grouting galleries atop the walls (all filled with reinforced concrete) will form the top of the table. Finally, the grouting galleries will be filled with concrete (leaving a duct for utilities) and the supporting structure will be finished.

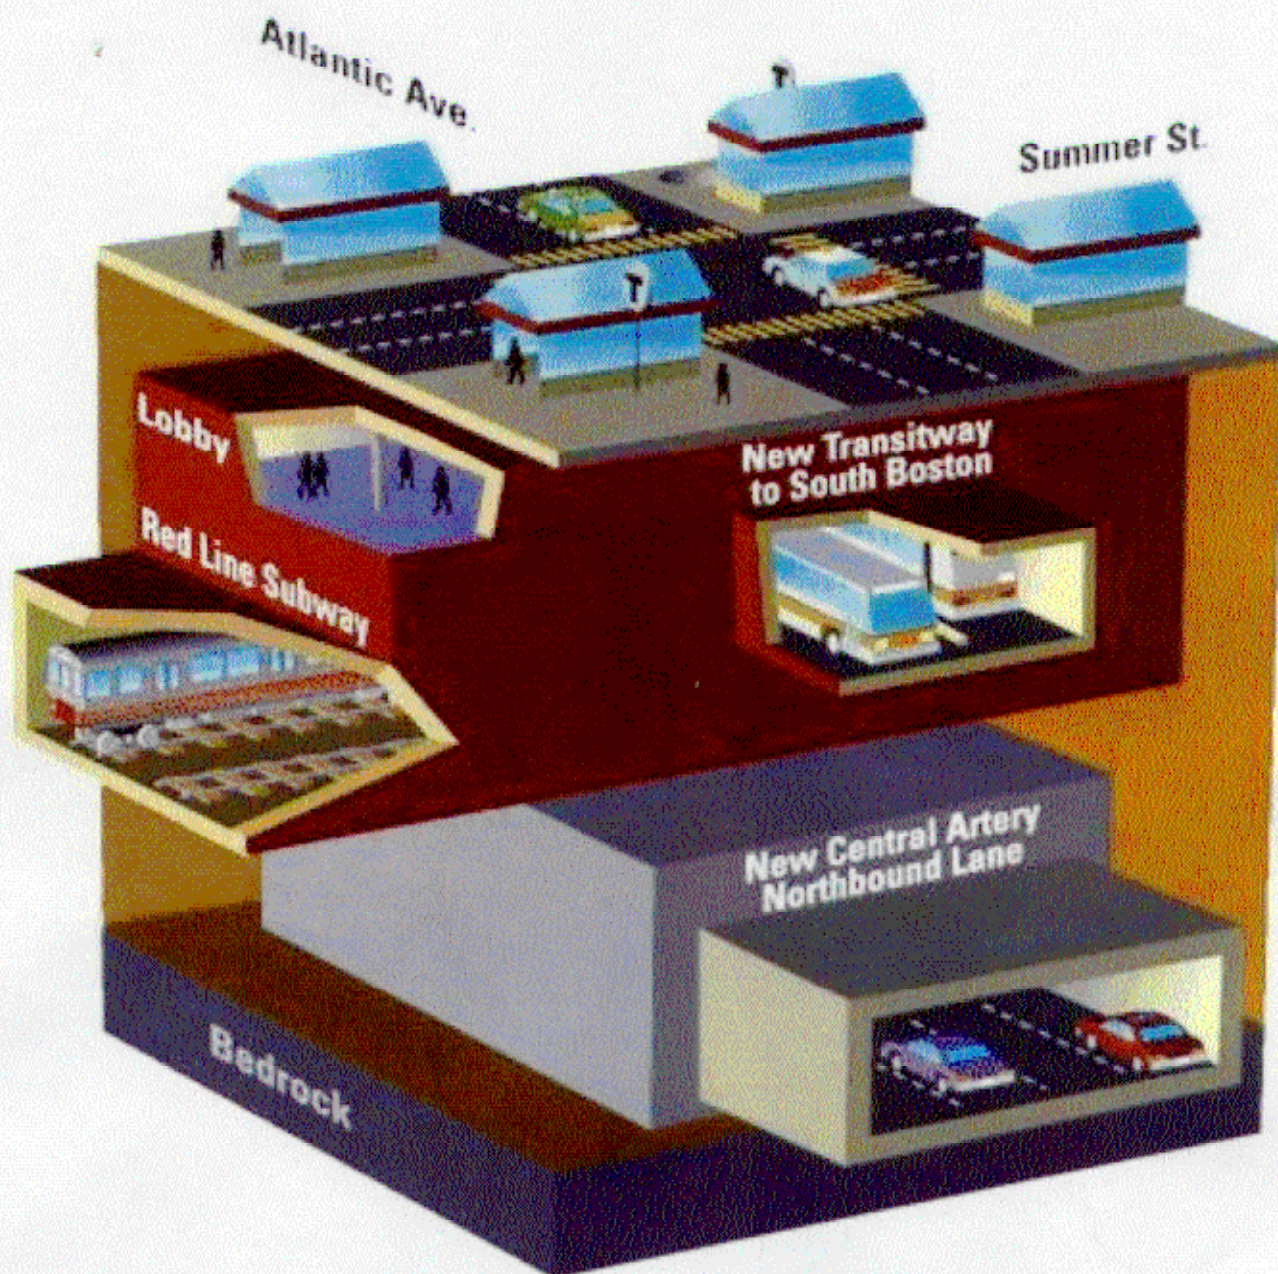
With the soil above the underpinning structure grouted and the structure itself resting on bedrock, the subway tunnel will be fully supported and the highway will be mined between the sides of the "covered bridge" beneath the Red Line.
