## 2 Program Purpose and Need

The purpose of the Program is to improve cross-canal mobility and accessibility between Cape Cod and mainland Massachusetts for all road users and to address the increasing maintenance needs and functional obsolescence of the aging Sagamore and Bourne Bridges.

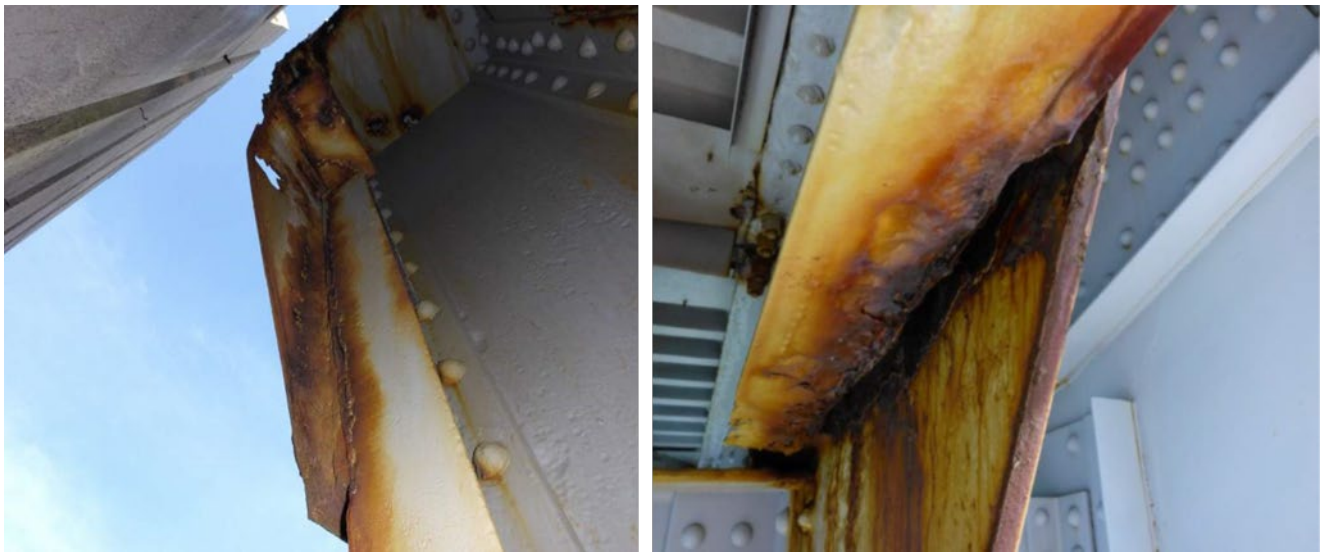
Exhibit 2-1. Truss Joint Gusset Plate Deterioration (Sagamore Bridge)

Sagamore Bridge was not considered to be “structurally deficient” as of the USACE inspection conducted in September 2021. The deck was in fair condition with an overall rating of 5. The superstructure and substructure were also in fair condition with overall ratings of 5. While Sagamore Bridge was not classified as “structurally deficient,” several gusset plates connecting the truss members within the superstructure exhibited advanced section loss and deformation due to corrosion. Severe deterioration or warping of gusset plates could lead to localized failures and, in extreme cases, a progressive collapse of the steel truss superstructure. [Exhibit 2-1](#) depicts the advanced deterioration of gusset plates based on the 2021 USACE Sagamore Bridge inspection.

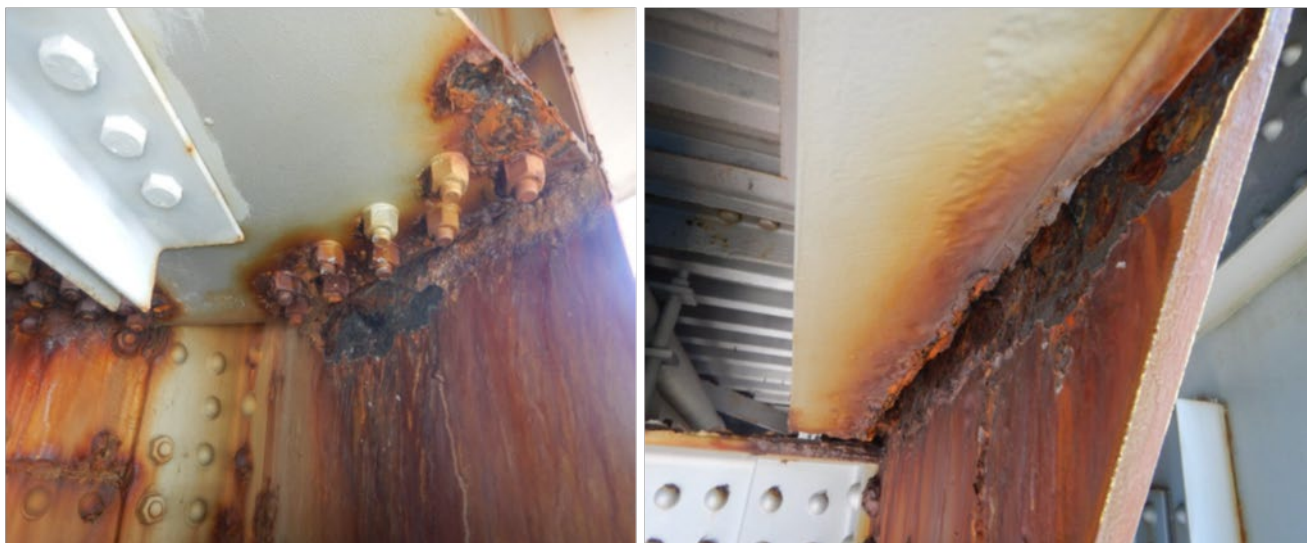
**Exhibit 2-2. Truss Joint Gusset Plate Deterioration (Bourne Bridge)**

substructure was in good condition with a rating of 7, although delamination and spalling were noted in the bridge abutment walls, and the deck joints received a rating of 4. [Exhibit 2-2](#) depicts advanced deterioration of gusset plates based on the 2022 USACE Bourne Bridge inspection. [Exhibit 2-3](#) depicts advanced deterioration of concrete T-beams based on the 2022 USACE Bourne Bridge inspection.

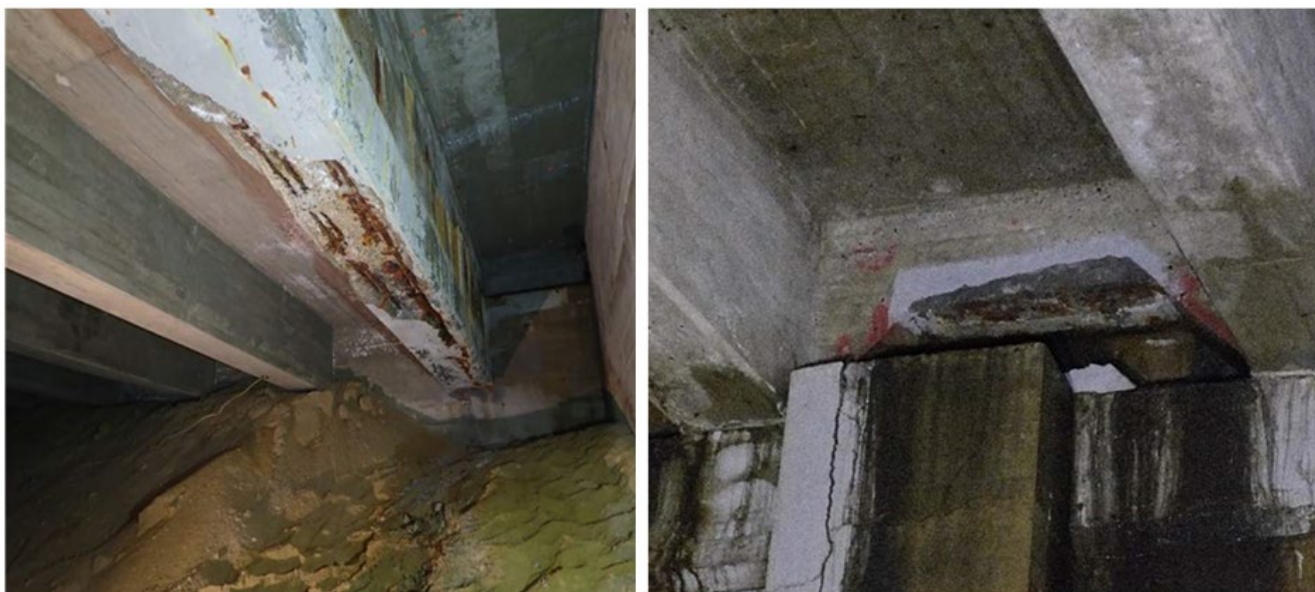
**Exhibit 2-3. Concrete T-Beam Deterioration (Bourne Bridge)**

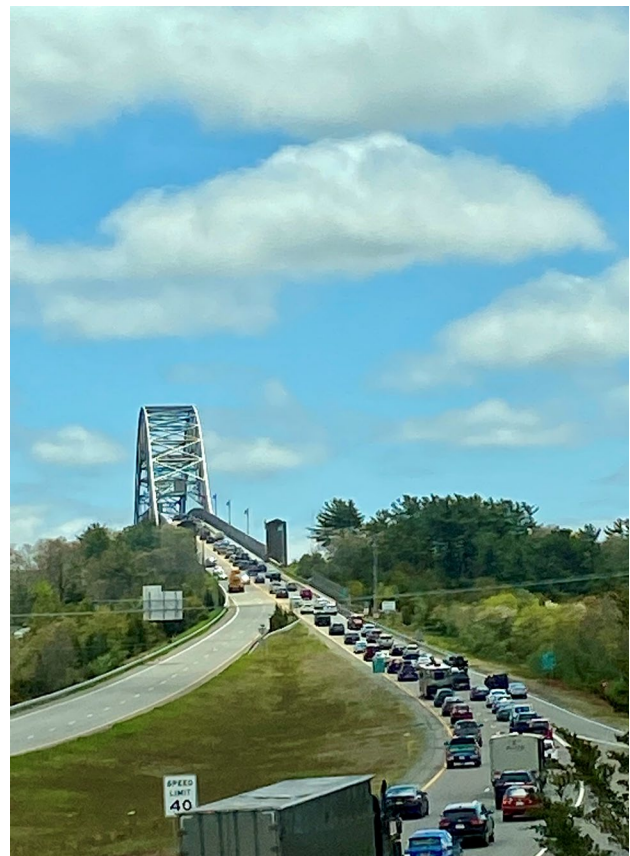
**Exhibit 2-4. Steep Roadway Grade Approaching Sagamore Bridge**

Sagamore and Bourne Bridges and their approaches have steep roadway profile grades of up to 6%, which gradually flatten as the roadway crests at the mid crossing point of the canal. [Exhibit 2-4](#) illustrates the steep grades approaching Sagamore Bridge. At a 6% grade, the vertical profiles of the bridges and their approaches are steeper than the 4% to 5% maximum grade typical for limited-access highways. Because of the steep roadway profile grades of the bridges and their approaches, it is difficult for vehicles, especially large trucks, to

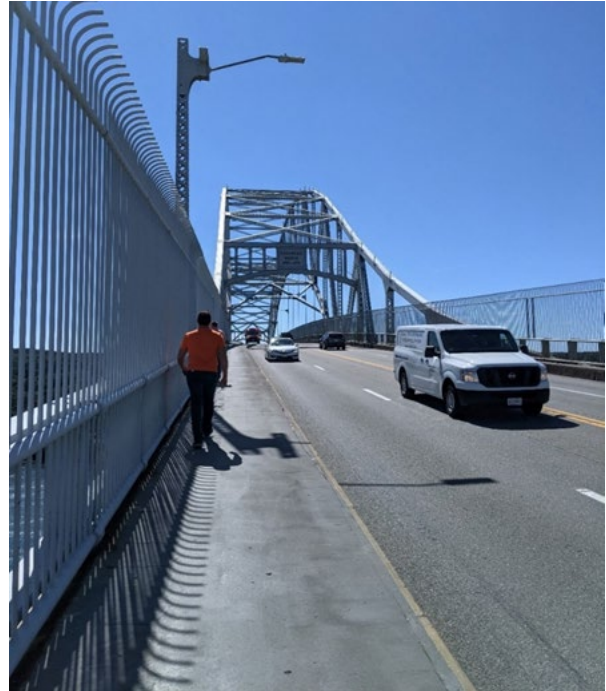
**Exhibit 2-5. Pedestrians Crossing Sagamore Bridge**

**Exhibit 2-5** illustrates the narrow width for pedestrian traffic on Sagamore Bridge.

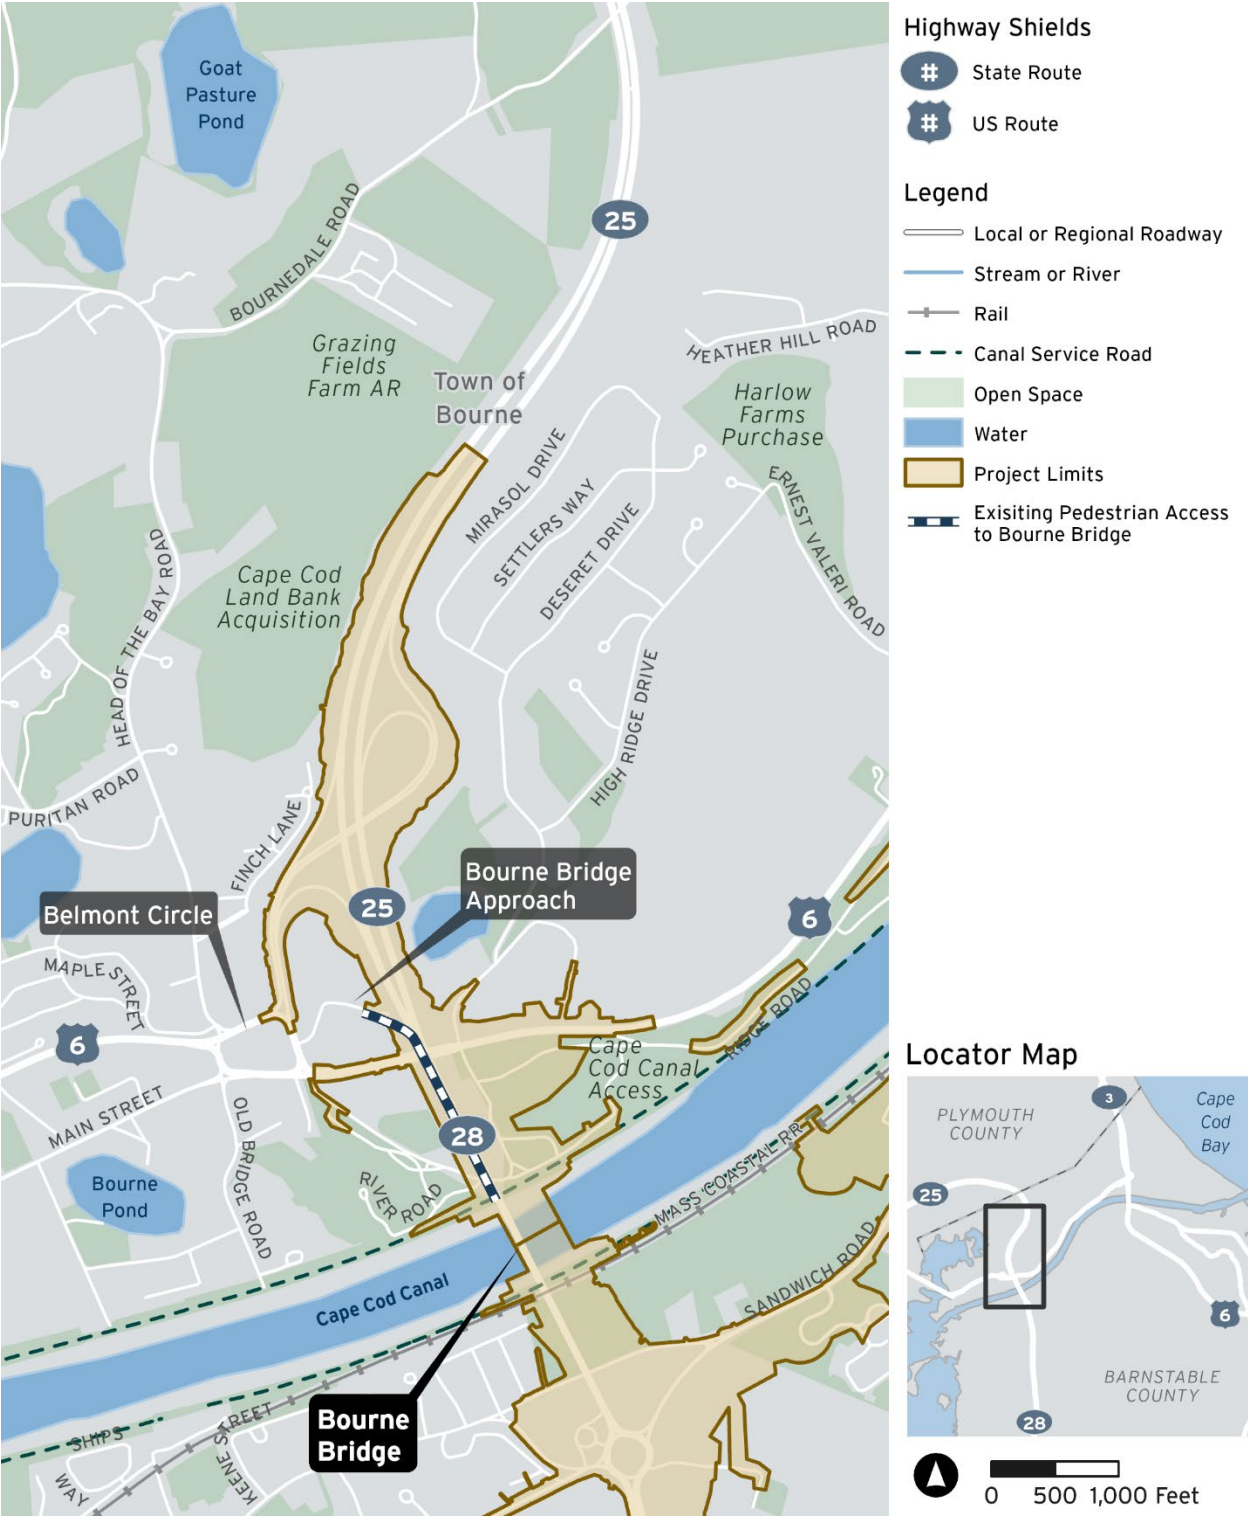
Figure 2-4. Pedestrian Access to Bourne Bridge via Sidewalk at Bridge Approach Street

At the approaches to both bridges, existing gaps in the sidewalk network pose access limitations for pedestrians to cross Cape Cod Canal. The only pedestrian access to Bourne Bridge from the north is via an unmarked sidewalk at the end of the Bourne Bridge approach (**Figure 2-4**). To access the sidewalk at the southern end of Bourne Bridge, pedestrians need to enter Bourne Rotary, a high-volume traffic circle that lacks sidewalks. No designated pedestrian facilities connect the southern end of Sagamore Bridge to Cranberry Highway or Sandwich Road.
