# Cape Cod Bridges Program

## Purpose and Need Statement

August 2022

Massachusetts Department of Transportation  
Highway Division  
10 Park Plaza  
Boston, MA 02116

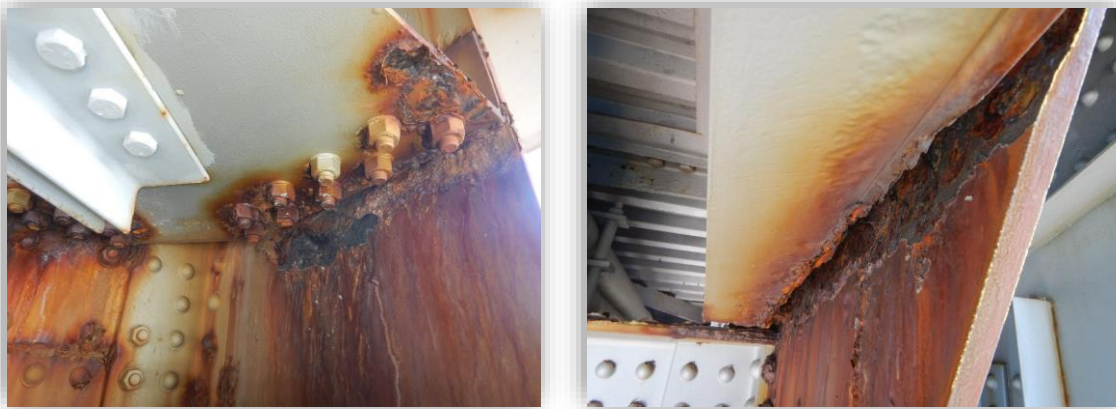
**Exhibit 1-1 Photos of Fracture Critical Gusset Plate Deterioration (Bourne Bridge 2020)**

Based on latest information available from a routine inspection conducted by USACE in October 2020, the Bourne Bridge was classified as structurally deficient. The deck was in fair condition with a condition rating of 5 due to continuing deterioration in the abutment spans. The superstructure was in poor condition with a rating of 4 due to continuing deterioration of the concrete T-beams, deterioration of gusset plates at truss joints and broken anchor bolts at truss expansion bearings. Gusset plates are considered fracture critical members (FCM), meaning the failure of one of these elements will likely lead to catastrophic failure of an entire span. The substructure was in good condition with a condition rating of 7, although delamination and spalling were noted in the bridge abutment walls. The “structurally deficient” classification does not imply that the bridge is unsafe for travel. However, the classification is an indication that the bridge requires maintenance and repair and eventual rehabilitation or replacement to address existing deficiencies.

Exhibit 1-1 Photos of Fracture Critical Gusset Plate Deterioration (Bourne Bridge 2020) .....	2
Exhibit 1-2 Photos of Fracture Critical Gusset Plate Deterioration (Sagamore Bridge 2021).....	3
Exhibit 1-3 Traffic Backup on Route 6 Westbound During Maintenance Work on the Sagamore Bridge ...	4
Exhibit 1-4 Vehicular and Pedestrian Traffic Crossing the Bourne Bridge .....	5
Exhibit 1-5 Historic Photo of Bourne Bridge Opening in 1935.....	6

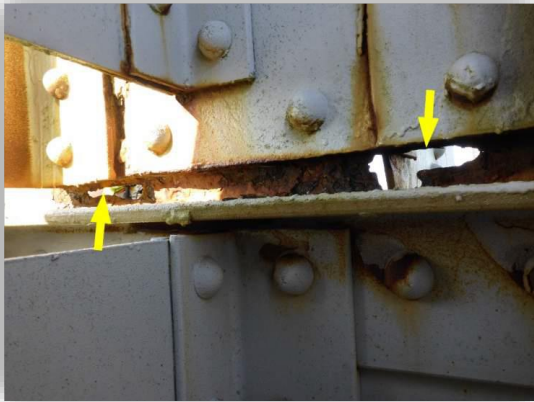
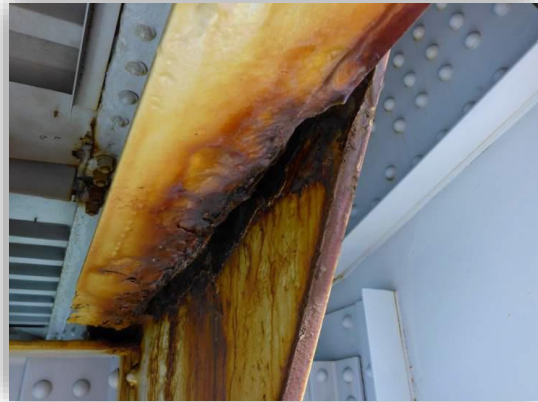
**Exhibit 1-2 Photos of Fracture Critical Gusset Plate Deterioration (Sagamore Bridge 2021)**

The Sagamore Bridge was not considered to be structurally deficient as of the latest available inspection conducted by the USACE in 2021. The deck was in fair condition with an overall rating of 5. The superstructure and substructure were also in fair condition with overall ratings of 5. Although the 2021 inspection findings warranted condition ratings of fair for the deck, superstructure and substructure, individual bridge components warranted overall ratings of poor, such as the fracture critical gusset plates and other connection plates.

There are several unrepaired truss joint gusset plates on three spans of the west truss and two spans of the east truss of the Sagamore Bridge that exhibit areas of advanced section loss and deformation due to pack rust. In addition to continuing deterioration, the Sagamore Bridge is vulnerable to fatigue. Fatigue, which is progressive in nature, refers to failure of structural steel members under repeated stress cycles such as traffic loading. The truss spans of the Bourne and Sagamore bridges are fracture critical.

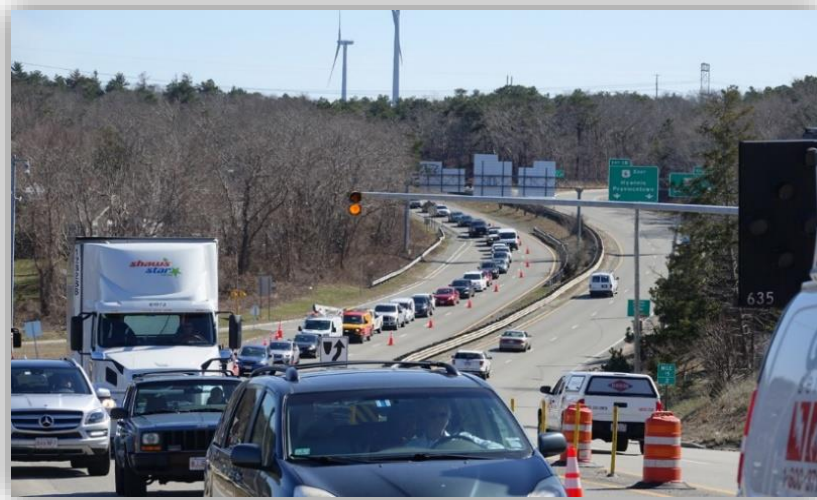
**Exhibit 1-3 Traffic Backup on Route 6 Westbound During Maintenance Work on the Sagamore Bridge**

The age of the Bourne and Sagamore bridges, combined with heavy vehicular demands and the corrosive saltwater environment of Cape Cod, necessitates frequent, costly, and escalating maintenance and repairs to maintain the structures in a state of good repair. All repair work on the superstructure and bridge deck requires vehicular lane closures to facilitate contractor activities. Typically, these lane closures restrict travel to one lane in each direction. Historically, temporary lane closures have been in effect for a minimum of approximately nine months during repair contracts. Full closure of the bridge would be required for shorter time periods (about 2 weeks) multiple times during a major rehabilitation to allow replacement of certain critical bridge components, such as interior gusset plates and floorbeams. These prolonged lane restrictions and full bridge closures likely would result in lengthy traffic delays, with congestion extending far beyond the project area.

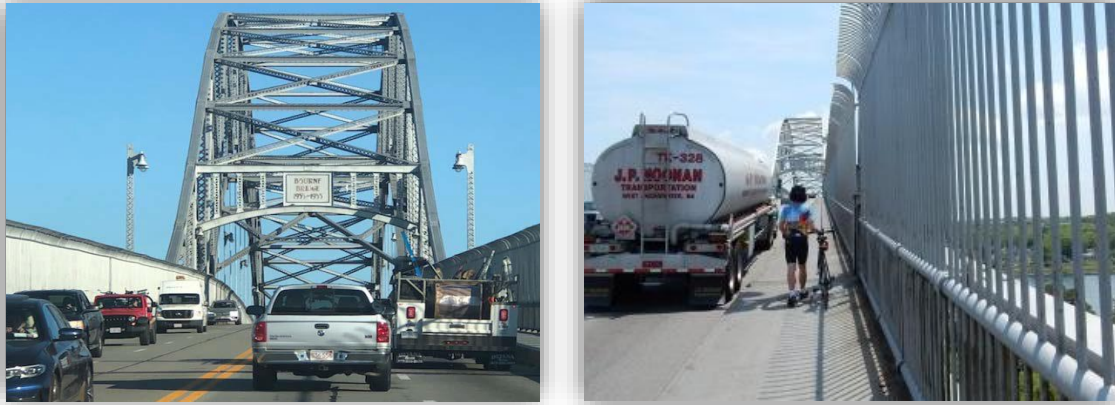
**Exhibit 1-4 Vehicular and Pedestrian Traffic Crossing the Bourne Bridge**

The Bourne and Sagamore bridges were constructed in the 1930s to standards that are not in use today. Identical in design, each highway bridge provides four 10-foot-wide vehicular travel lanes (two lanes in each direction) with a double yellow centerline, and a single 5-foot-wide sidewalk. A two-foot-wide safety curb is provided along the side opposite the sidewalk.

Based on roadway functional classification as limited access highways, the 10-foot-wide travel lanes along both bridges are two feet narrower than the 12-foot lane width standard specified by the American Association of State Highway and Transportation Officials (AASHTO). The bridges also lack physical separation between opposing traffic lanes and lack shoulder accommodation to provide refuge for drivers in the event of a vehicle breakdown, emergency, crash, or other incidents. Since the existing bridges do not have shoulders, stopped or disabled vehicles block one or both lanes of traffic, resulting in lengthy traffic delays and public safety concerns due to delayed emergency response. Narrow lanes and the lack of shoulders, and the absence of separation between opposing travel lanes result in frequent reports of sideswipe collisions between vehicles travelling in the same and opposite directions. The lack of shoulders presents additional safety concerns for bicyclists and the absence of barrier separation between the traffic lanes and the existing sidewalk on the Bourne and Sagamore bridges presents safety concerns for all non-motorized bridge users including pedestrians and bicyclists. The single raised 5-foot-wide shared pedestrian and bicycle sidewalks provided along the Bourne and Sagamore bridges do not conform to current Americans with Disabilities Act (ADA) and MassDOT geometric design standards, which limit

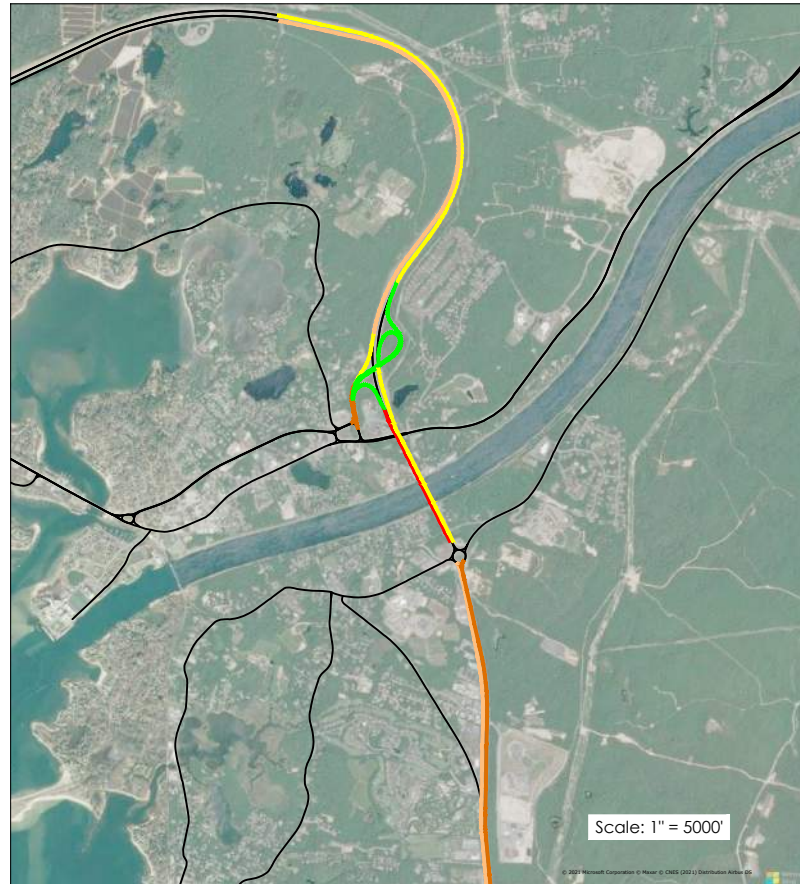
FALL SAT PEAK HOUR

Bourne Bridge and Sagamore Bridge Density,  
Fall and Summer SAT  
Peak Hour

2019 Baseline Conditions

The approaches to the Bourne and Sagamore bridges from both directions operate at poor LOS for all peak hours analyzed under 2019 base year conditions including the Weekday AM Peak Hour (Summer and Fall), the Weekday PM Peak Hour (Summer and Fall) and the Saturday Midday Peak Hour (Summer and Fall). The southbound side of the Bourne Bridge currently operates at LOS F during all peak hours analyzed due to congestion at the Bourne Rotary. Southbound Route 25 approaching the exit for Belmont Circle operates at LOS E and F during the Summer Weekday PM Peak Hour, Fall Saturday Midday peak hour and Summer Saturday Midday peak hour. Northbound Route 28 approaching the Bourne Rotary also operates at LOS F during the Fall and Summer Weekday PM peak hours, in addition to Fall and Summer Saturday Midday peak hours. Westbound Route 6 and Southbound Route 3 approaching the Sagamore Bridge operate at LOS E and F for all peak hours analyzed. Both directions of the Sagamore Bridge also operate at LOS F for all peak hours analyzed. Graphics illustrating LOS for all major freeway sections within the project area under 2019 Base Year conditions during all analyzed peak hours are presented in Appendix A. With projected growth in traffic volumes in future years, operating conditions are expected to worsen over time.
