Resource Management Plan

Chestnut Hill Reservation

Boston, Massachusetts

November, 2006

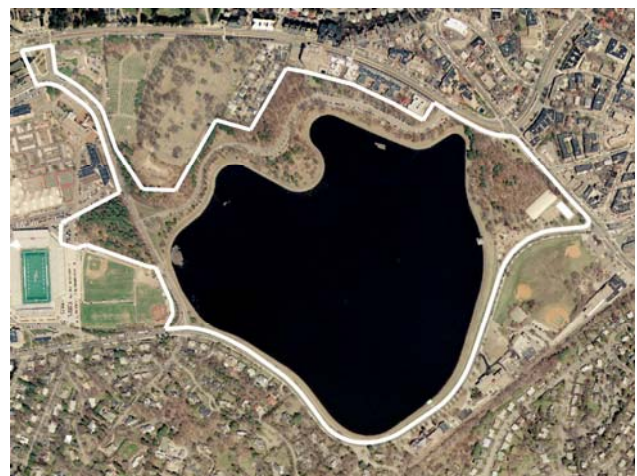
Figure 1.2: Property Line of the Chestnut Hill Reservation (2002 MassGIS Orthophoto)

The planning area includes the Bradlee Basin (reservoir) and surrounding landscape, pathways and woodland, Chestnut Hill Driveway, Saint Thomas More Road, and the Reilly Memorial Rink and Pool area. The Plan does not include recommendations for the operation of the Rink and Pool, nor does it address property under MWRA control per the 2002 Agreement (Shaft #7, Gatehouse #2, etc.). Please refer to Figure 1.2 for details.

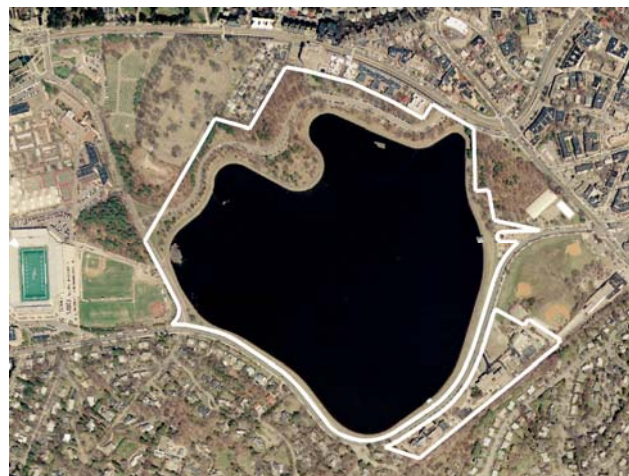
Figure 2.3: Boston Landmark boundary.

The exact boundaries of the Boston Landmark, National Register nomination, and RMP project area vary slightly from each other. For example, the eastern portion of the Reservation (containing the hill, the old playground, the parking area in front of Gatehouse #1, and the area around the Reilly Rink and Pool), the Intermediate Gatehouse and the northern stretch of Saint Thomas More Road are part of the RMP area but are not included within the Boston Landmark boundary. Neither the RMP nor the Boston Landmark designation include the small plot of land in Newton that houses the Sudbury terminal chamber, although it does appear to be included in the Chestnut Hill Reservoir Historic District (the exact boundaries of the National Register nomination are, however, difficult to interpret). The RMP project area also includes the MWRA-managed area to the west of the Reservoir (known as Shaft #7) although only to note its legal status and restrictions regarding its access and development.¹² Figure 2.3 shows the location of the boundary of the Boston Landmark designation.

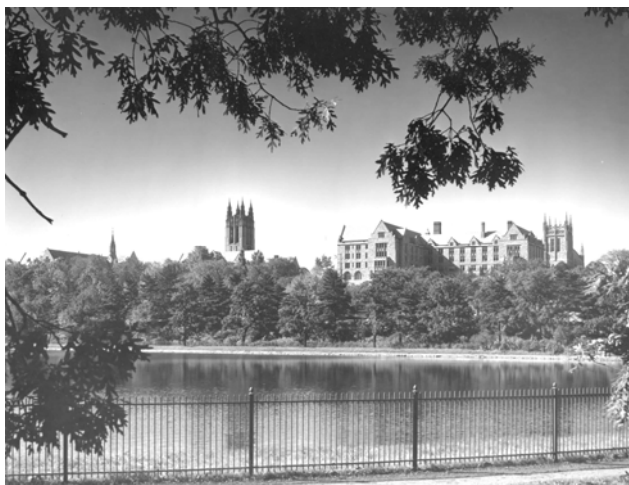
Figure 2.4: Photograph from the early 1930s showing the new fence around the Lawrence Basin (University Archives, John J. Burns Library, Boston College).

Another related historic context for the Chestnut Hill Reservation is its importance as part of the Metropolitan Park System. This context begins in 1919 when the MDC assumed responsibility for the Reservoir. This secondary period includes the erection of the decorative iron picket and chain link fence around both basins and its accompanying gates (1928-29), to protect the quality of the water supply. It also includes the creation of the new outer path around the water to allow continued public access to the site. This secondary period of significance comes to an end as the creation of the Quabbin Reservoir results in the Lawrence Basin being declared inactive in 1948. This smaller reservoir was sold to Boston College; the basin was filled in, the Influent Gatehouse razed, and the Driveway and its surrounding landscape became the site of the College's Lower Campus. Defining the end of the secondary period of significance for the Chestnut Hill landscape as c.1948 also reflects the National Park Service guidance that properties achieving significance within the past 50 years are not generally considered historic or eligible for inclusion on the National Register

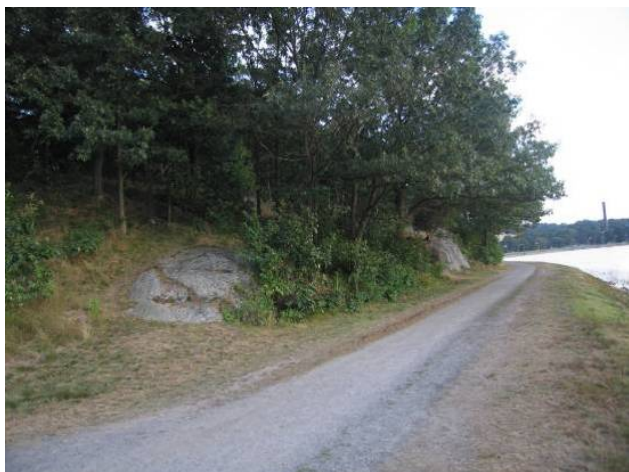
Figure 3.2: Rock outcropping on the west side of the drumlin (2005)

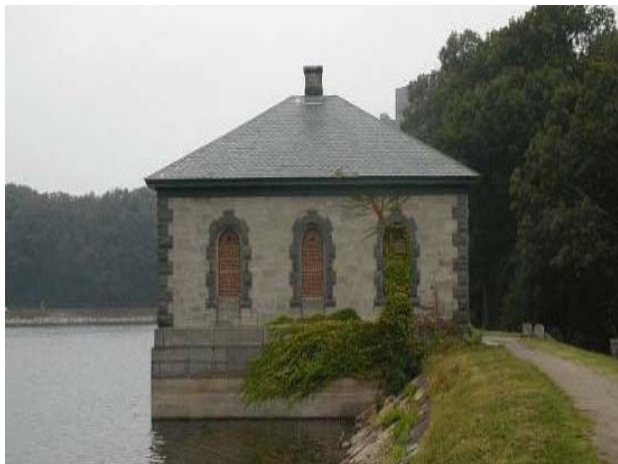
Figure 3.8: Gatehouse #1 upper structure (2005)

Gatehouse #1 was constructed between 1868 and 1870 and contained the major control gates for the Reservoir. Designed by Edward R. Brown in the Renaissance Revival style, it is located on the rim of the embankment or dam at the end of the original route of Beacon Street, and thus provided the first view of the new Reservoir complex for many visitors. It is a two-level granite structure, three bays wide, with a shingled, hipped roof. Originally built on quicksand, Gatehouse #1 has substantial foundations with rubble piers and brick arches that rested on bedrock. On the first level, the entrance to the gate chamber and two flights of stairs lead to an elevated pathway, which in turn provides access to a central set of steps up to the second story and the level of the Reservoir.

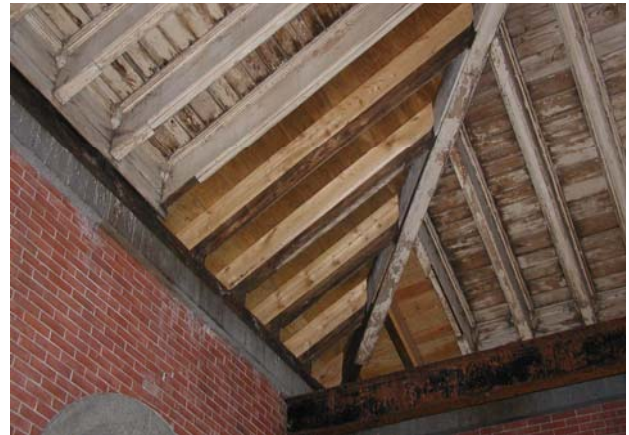
Figure 3.9: Modern materials in southwest corner of roof (2005)

roof structure would need to be repaired before the building could be designated for public use.

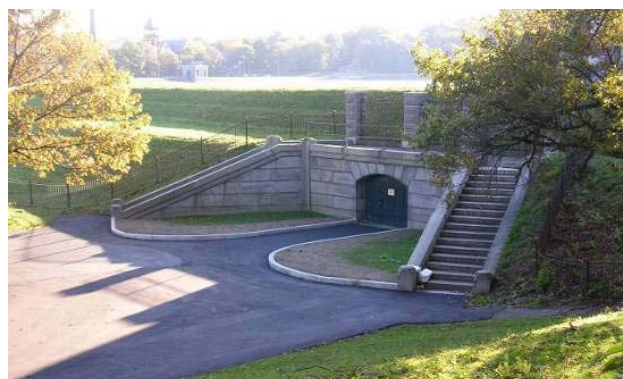
Figure 3.11: Gatehouse #1 lower structure and double stairs (2005)

Externally, two formal, angled stairs, constructed of granite, enclose a stone retaining wall. This wall and stair structure is integral to the Gatehouse and presents a grand entrance to the Reservation. At the center of the retaining wall, three cast iron doors lead into the underground chambers of the gatehouse. The large stone units of the wall are in good condition and in their original positions. Minor damage is present at the mortar joints, especially under a narrow coping or belt course at the top of the wall. The cast iron doors function and are in good condition.

Each stair consists of individual tread stone units and heavy side wall units. While the stairs appear to be in good condition, there is evidence of past movements among the various stone units. The side cheek walls appear to have tilted or shifted laterally, creating wide gaps between units that were subsequently filled with mortar. The wide mortared joints are generally intact but many are cracked. Although there are no immediate or major public safety concerns, some level of repair and stabilization of the steps and cheek walls is warranted.

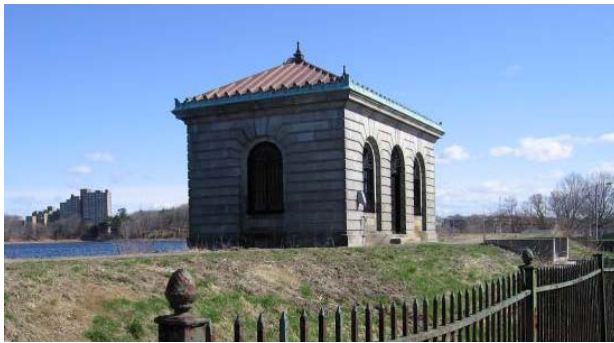
Figure 3.12: Gatehouse #2 (2005)

1898 when gravity was no longer sufficient to distribute water from Chestnut Hill) and took over the operations of the original Effluent Gatehouse #1. Built in the Renaissance Revival style, it is one-story in height, three window bays across and one window bay deep. The exterior is dressed granite ashlar and the windows are accented with iron grillwork. The roof has a shallow pitch and is clad with copper. Access to the structure is gained from the pedestrian path on top of the dam. There is a small flight of simple stone steps leading down to the Beacon Street sidewalk that are in fair condition.

A structural analysis for Gatehouse #2 was not conducted as a part of this Resource Management Plan. This gatehouse remains in operation and is under the control of the MWRA as the main outlet for discharge of the Reservoir's water to the water distribution system. It houses several five foot square gates used to maintain the water level. The MWRA has recently upgraded the equipment within the gatehouse and carried out repair and cleaning work to the inside and outside of the structure. Unlike Gatehouse #1, the windows are still glass and are covered with iron grille-work.

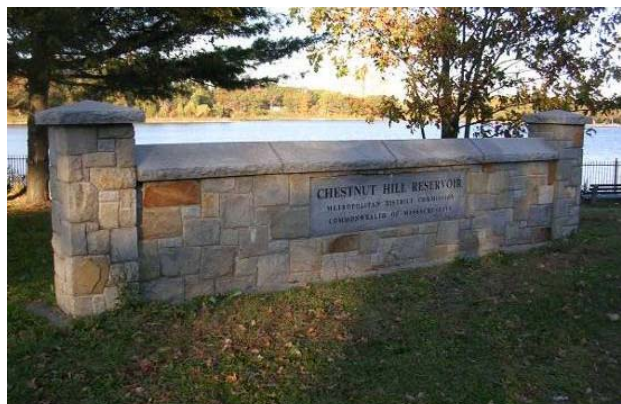
Figure 3.13: Freestanding stone wall at Beacon Street Entrance (2005)

improvements. These walls mark the Beacon Street entrance to Saint Thomas More Road and the Commonwealth Avenue entrance to the Chestnut Hill Driveway. These walls serve as the only formal signage for vehicles entering the Reservation and therefore function as vehicular gateways into the park. A granite plaque inserted in the center of two of the walls reads “Chestnut Hill Reservoir, Metropolitan District Commission Commonwealth of Massachusetts.” The letters are painted black for visibility. All fascia stones are rough granite. The three walls are typically four to eight feet high and terminate with a five to ten feet high stone masonry column. A cut tapered granite capstone runs along the top of the walls. The Beacon Street intersection wall is straight and twenty-five feet long. The west wall of the Commonwealth Avenue intersection is curved and approximately sixty-six feet long. The east wall is curved and one hundred and forty feet long.

Most of the mortar joints for all three walls are in good condition, but deterioration is starting to affect the masonry. Almost all of the capstone butt joints have small cracks and some moss is taking hold at the butt joints that absorb moisture and dry slowly. A few of the joints between the stone units show calcium carbonate deposits. Water infiltration is beginning to work into the wall but no significant damage has occurred yet. Repair work is warranted given the existing damage and in order to prevent any future deterioration.

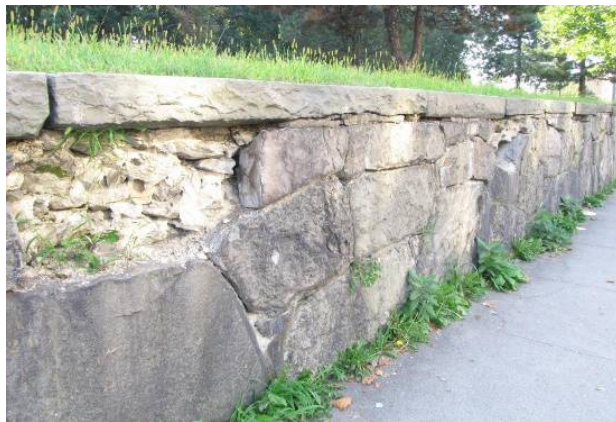
Figure 3.15: Stone retaining wall along Chestnut Hill Avenue (2005)

The Chestnut Hill Avenue walls are about two feet wide and vary in height, although three and a half feet is typical. These walls primarily serve as retaining walls, but in the area by the pool, a significant portion of the back side of the wall is exposed. The walls are capped with dressed stone slabs about six and half inches deep and four to five feet long. The wall is built mostly of large granite units that penetrate the full depth of the wall with smaller stones used to fill in the voids between the largest stones.

The stones are mortared together and the mortar between stone units is generally cracked, missing, disintegrated or is an inappropriate white mortar color used for a previous

re-pointing. In spite of the mortar deterioration, the large size of the stone units has ensured the stability of the wall, there being no significant displacement of the wall as a system or of most of the stone units individually. However, several cap stones at the curve in the retaining wall near Commonwealth Avenue have been displaced outward about six inches. Also, small stones at the surface have toppled out of the wall at roughly ten to fifteen foot intervals.

The deterioration is caused by moisture infiltrating the interior of the wall and freezing or dissolving the constituents of the mortar. In the retaining wall, moisture enters the back of the wall from the soil; in the freestanding wall, moisture enters initially through cracked butt joints between the cap stones and then later through cracked mortar joints in general. It is possible to make repairs at the freestanding wall that will last for some time but repairs at the retaining wall will need frequent maintenance, in the absence of a waterproof membrane on the earth side. Immediate repairs may be necessary to prevent future deterioration.

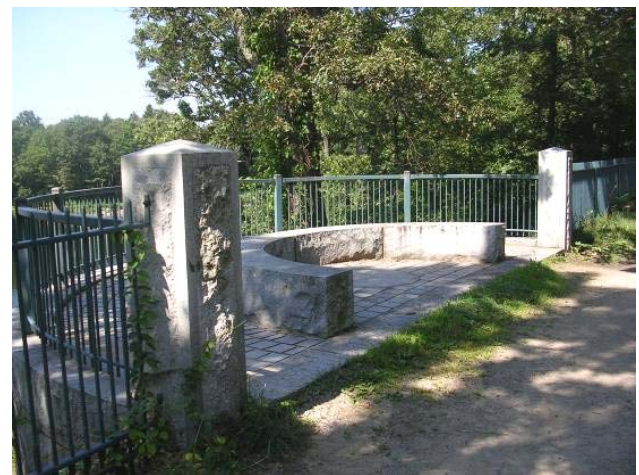
Figure 3.16: 1977 overlook (2005)

The overlook and all its associated features are in fair to good condition. However, there is a slight step-down to the adjacent packed dirt pathway that presents a tripping hazard as well as being aesthetically unattractive. This also effectively makes the overlook inaccessible to persons with physical disabilities.

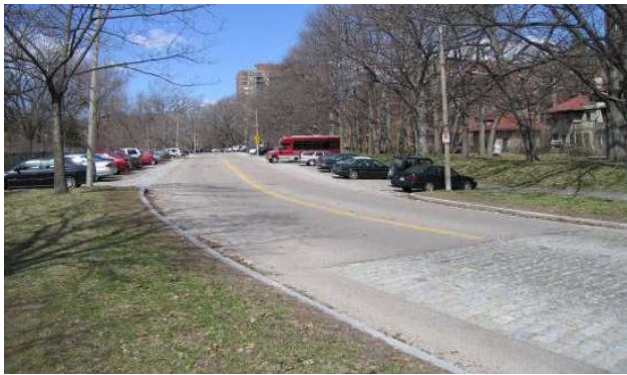
As described above, the Chestnut Hill Driveway was part of the historic design for the Reservoir landscape. To alleviate deteriorated conditions and unorganized shoulder parking, the MDC made substantial improvements to the roadway in 1977. This required first removing old catch basins and lights at the edges of the paving, followed by changes to the original alignment of the historic eighty foot-wide road to provide a pull-off

area south of the Driveway for parallel parking as well as head-in parking spaces on both sides of the road. Five feet-wide granite cobble paving strips were added at the back of the head-in parking spaces. This left a narrower central section for through traffic in which the MDC added granite cobble “rumble strips” on both sides of crosswalks. New cobra-head lighting, curbs, and catch basins were installed along the new edges of the road. The intersection of Chestnut Hill Driveway and Saint Thomas More Road was re-configured from a Y-intersection into a T-intersection.

Figure 3.19: Chestnut Hill Driveway (2005)

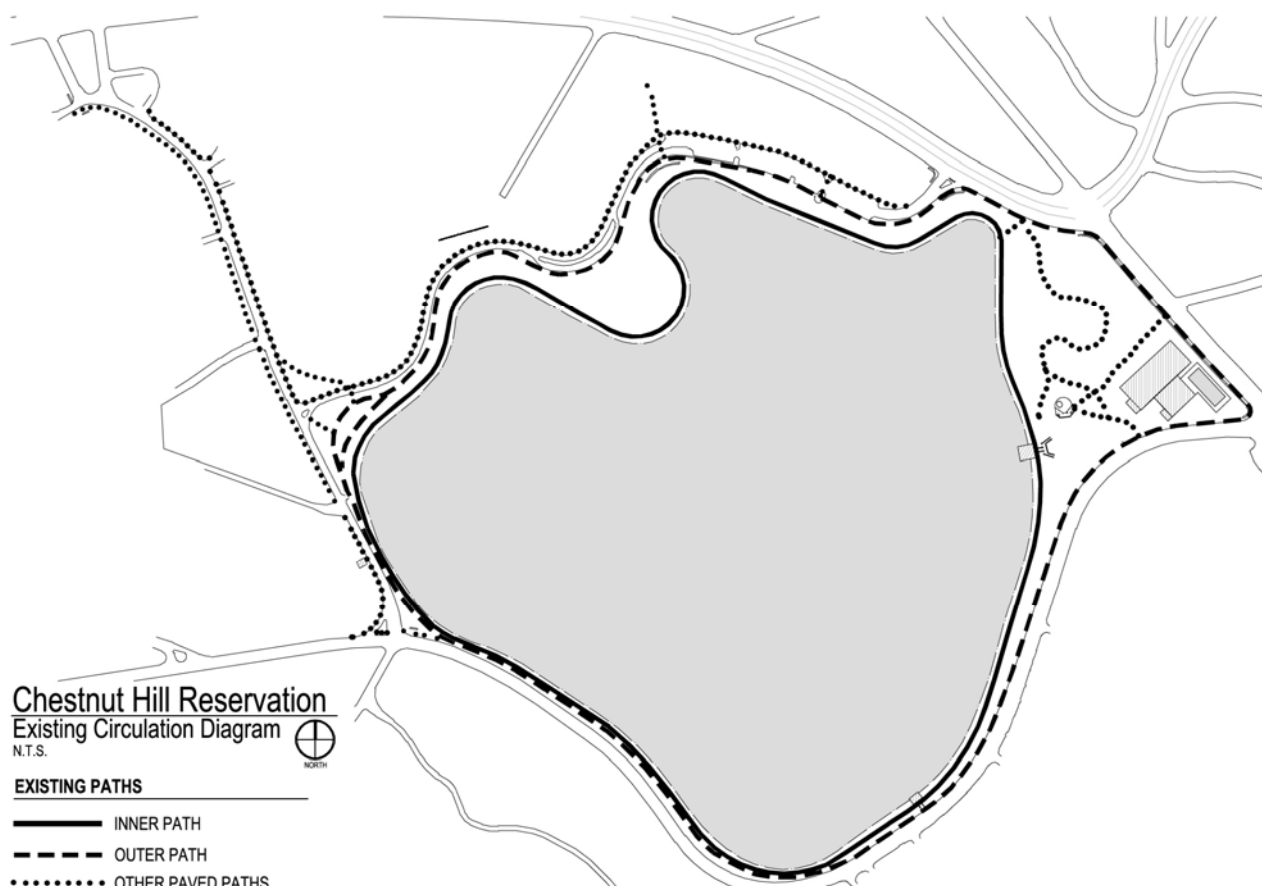
Figure 3.21: Existing circulation diagram

Pedestrians currently enter the Reservation at several locations, which are noted on the Existing Circulation Diagram (Figure 3.21). The primary pedestrian entrances are from the Beacon Street sidewalk into the Reilly Pool and Rink area, through the opening in the Chestnut Hill Avenue retaining wall, through three areas along Commonwealth Avenue, and from the Boston College campus across Saint Thomas More Road. These entrances provide access to the two main pedestrian paths systems, which encircle the Reservation, and to another smaller, more recent system around the hill parcel and Reilly Rink and Pool. The existing pedestrian entrances are not signed and in some cases are not visually obvious as entrances into the Reservation. Figure 3.21 shows the location of the existing paths.

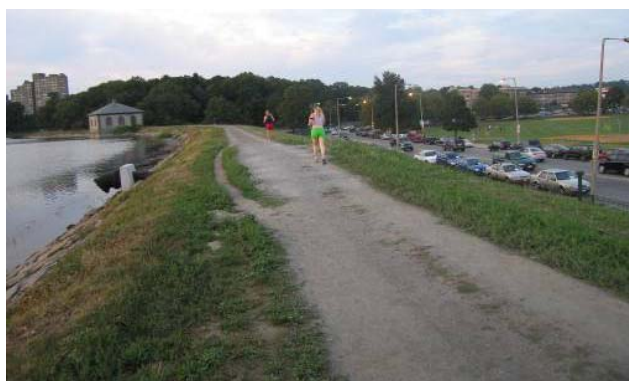
The original inner or perimeter path, now typically six to eight feet wide and surfaced in stone dust, still follows the shoreline of the Reservoir, with a section running along the top of the dam. This path is typically called the “inner” path, which is completely inside the perimeter steel picket fence, except in the southwest corner of the Reservation where the original stonedust path is located outside the fence and a narrow dirt path has been established inside the fence. This “inner” path is about 8,250 linear feet long (1.56 miles).

Figure 3.22: Stonedust path along top of Reservoir dam (2005)

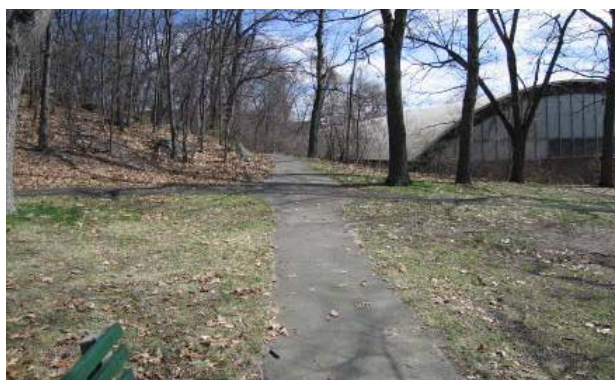
of the Reservation. These paths also connect to the old playground area and the Reilly Rink and Pool building. The paved portions of these paths were part of the 1977 MDC landscape improvements and are in varying conditions between fair to poor with the paved edges frequently crumbling. The typical paved path width is between four to five feet. Several “desire line” dirt paths also exist in this area. Some of these desire lines run straight up the slopes and are creating erosion problems. Since the Reservoir perimeter path system was re-opened, the paths on the hill parcel experience less pedestrian traffic. Given their poor condition and lack of use, these paths are candidates for reconfiguration, including enhancing access to some excellent views of the water.

Figure 3.24: Bituminous concrete path adjacent to 1977 playground (2005)

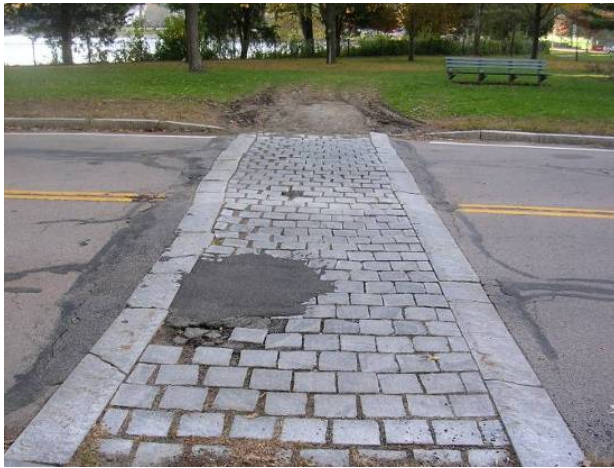
Painted crosswalks, outside the Reservation property, are provided at the intersections of all vehicular roads surrounding the Reservation. There are signalized crosswalks at Commonwealth Avenue and Chestnut Hill at Cleveland Circle. There are non-signalized, painted crosswalks within the Reservation at several points across Saint Thomas More Road and crosswalks paved with granite cobbles (rumble strips) at several points across the Chestnut Hill Driveway described above. These crosswalks serve to connect the outer pathway to a five foot wide bituminous concrete sidewalk running along the north side of the Driveway. The granite cobble crosswalks, part of the 1977 MDC improvements, are in fair to poor condition in many areas with loose and dislodged cobbles. Some areas of these crosswalks have been patched with bituminous concrete and may present tripping hazards to pedestrians.

Figure 3.26: Crosswalk across Chestnut Hill Driveway (2005)

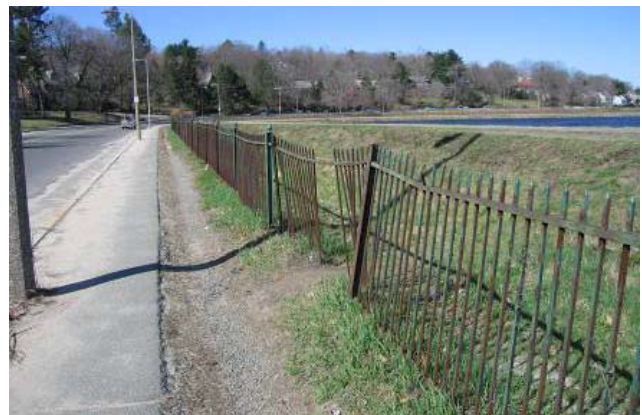
Figure 3.27: 1928-29 steel picket fence (2005)

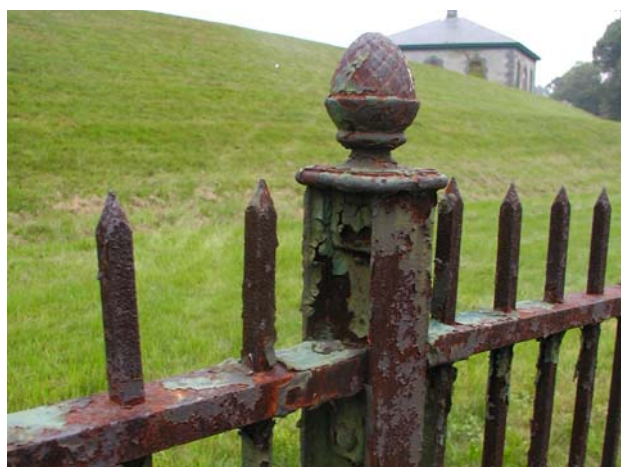
Figure 3.28: Post and rail detail (2005)

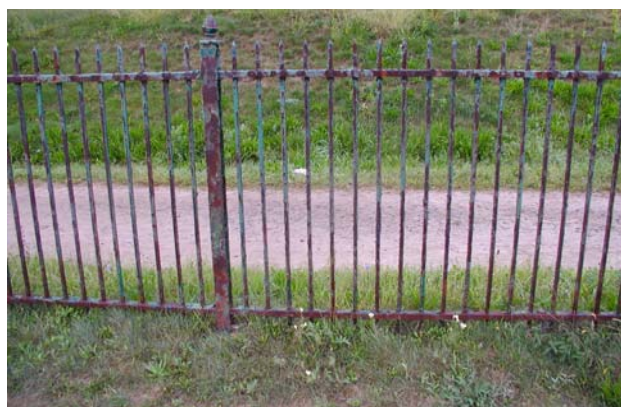
Figure 3.29: Typical intact 1928-29 panel (2005)

The 1928-29 fence design consists of panels of twenty-one square section balusters between I-section posts with acorn-styled finials and tied by two horizontal L-section bars. The panels are eight-four inches (seven feet) long. Each panel includes a top and bottom rail made of two inch wide channels laid flat and five-eighth of an inch square by fifty-four inch long pointed pickets spaced four inches apart. The ends of each top and bottom rail have an elongated hole where they are bolted to the posts, thereby allowing the panels to slip slightly as the fencing expands and contracts during temperature changes. Unlike many old iron and steel fences at cemeteries and other historic sites, only a few of the failed connections have been repaired with welds, which prevent slippage between each post. The 1977 fencing panels were designed in a similar style to the 1928-29 originals, but they are one hundred and twenty inches (ten feet) long and do not have the decorative acorn castings. The new 1977 metal fencing is green although most of the panels have severely peeling paint.

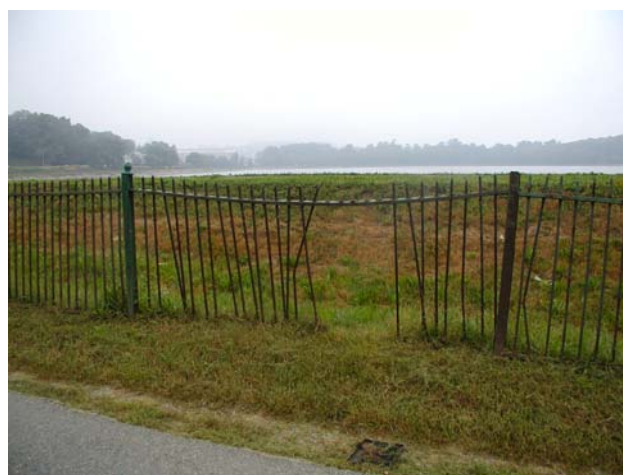
Figure 3.30: Typically damaged 1928-29 panels (2005)

The condition of the fence was analyzed in 2004 by DeAngelis Iron Works and, in 2005 as part of this RMP, Ocmulgee Associates performed a further inventory and evaluation. According to Ocmulgee, the 1928-29 steel

picket fences are extensively damaged, with many deteriorated and missing elements. In particular, the following items were noted:

- The paint is completely deteriorated and some of the pickets are pitted from corrosion;
- Ten percent of the top rails are bent;
- Fifty percent of the pickets are bent or corroded in some degree, with about ten percent severely bent, missing or corroded;
- Forty percent of the panels have bottom rails that are significantly corroded and unsalvageable because they are buried in earth or vegetation;
- Twenty-five percent of the panels are in reasonably good condition and can be easily repaired;
- Thirty-five percent of the panels are in mixed condition, with damage and deterioration that could be repaired with replacement components;
- The posts appear to be set in concrete but many are corroded to some extent near the ground. Less than ten percent of the posts have broken off at the ground.

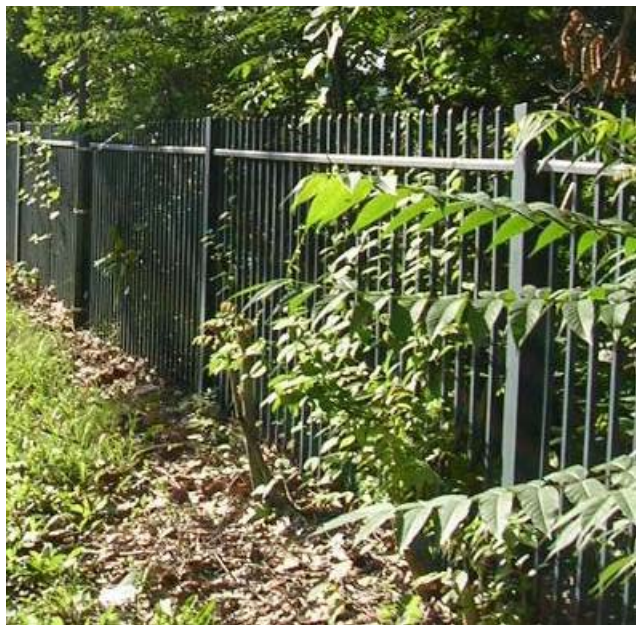
Figure 3.31: 1977 steel picket fence (2005)

The 1977 fencing panels are in fair to good condition except for some vine growth on certain sections, although preventative measures should be taken soon to ensure

they do not deteriorate. There is one panel near the 1977 overlook that appears to have had damage repaired by inserting a section of salvaged, unpainted 1928-1929 fencing.

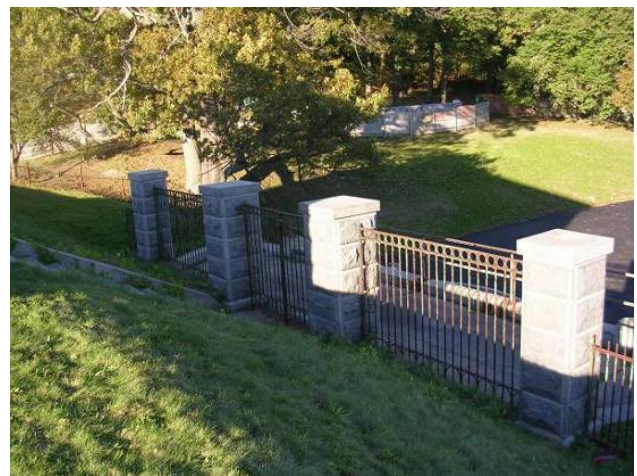
Two 1928-29 gates are located in front of the two gatehouses. The two forty-seven inch wide gate leaves and the ten foot six inch long fences on each side of the approach to Gatehouse #1 are about six feet high and are decorated more elaborately than the typical panel. Except for extensive paint loss and some corrosive pitting, they are in excellent condition. Most importantly, their hinges and anchors at the granite posts are intact and no spalling or deterioration was seen where the metal anchors are embedded in the stone. Similar gates without side fences are present at Gatehouse #2; some of the decorative circular elements are missing at these gates.

Figure 3.32: 1928-1929 entrance gate at Gatehouse #1 (2005)

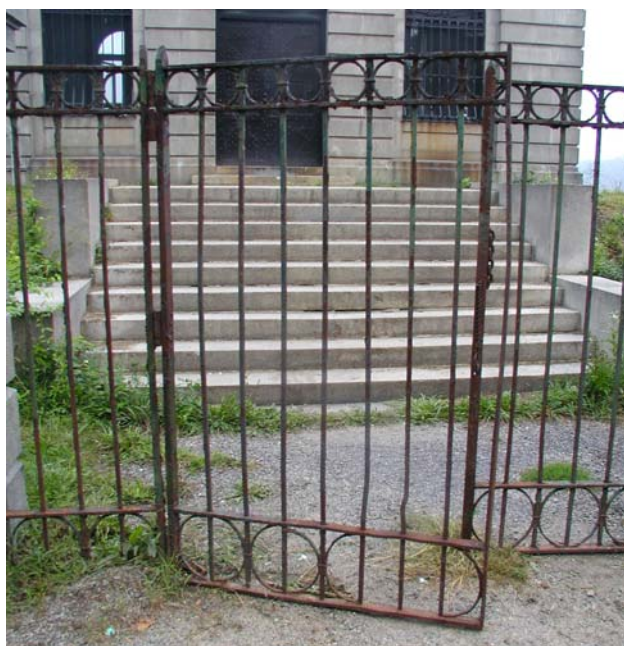
Figure 3.33: Gatehouse #2 gate with missing circular elements (2005)

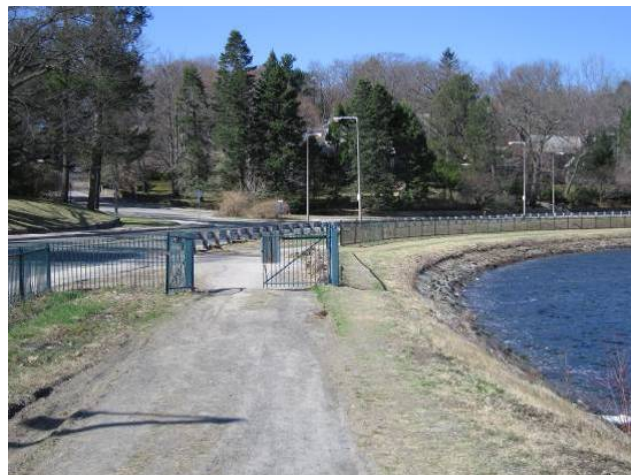
Figure 3.34: Entrance gate along Beacon Street (2005)

The MDC added two additional gates in 1977, one near the intersection of Saint Thomas More Road and Chestnut Hill Driveway, and the other near the intersection of Beacon Street and Reservoir Road. Both have double gates and are wide enough for vehicle access. In addition, as described in the section on circulation above, there are a total of seven openings in the fence where panels were removed in 2002 by the MDC to provide additional access points into the inner part of the Reservation.

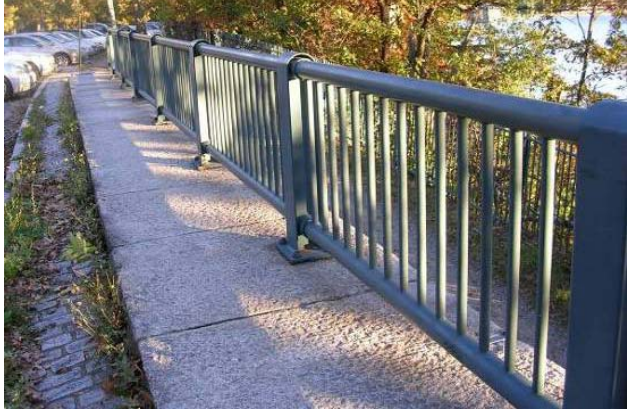
Figure 3.35: 1977 fence on top of Chestnut Hill Driveway retaining wall (2005)

A heavy-gauge pipe rail fence, installed in 1977, spans the top of the retaining wall along Chestnut Hill Driveway. Its design consists of panels of seventeen balusters attached to round horizontal bars at top and bottom between I-section posts with arched tops. It is painted green and remains in good condition.

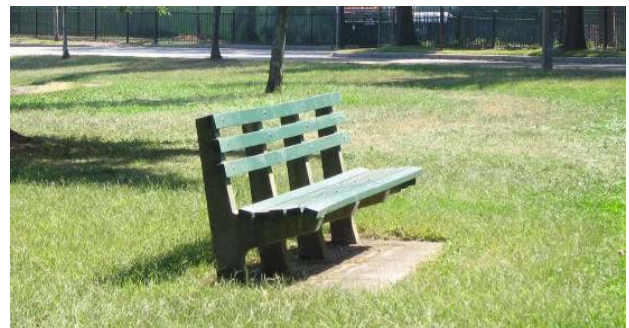
Figure 3.36: Type 1 bench (2005)

The first bench (Type 1) consists of wooden slats on a precast concrete frame. The concrete frame is attached to a below grade footer. The slats are painted green. These are a standard bench used by the former MDC throughout the metropolitan park system and thus are arguably the

These benches are generally in fair condition with mostly maintenance and small repairs needed such as painting the wood slats. The Type 1 benches are well-sited in the landscape and are directed toward views of the Reservoir, although a large grouping of benches is located in an unused area at the corner of Chestnut Hill Driveway and St. Thomas More Road.

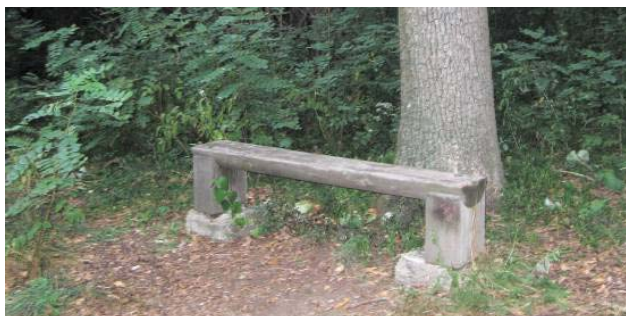
Figure 3.37: Type 2 bench (2005)

The second bench (Type 2) has a more rustic design and consists of a longitudinally cut log fixed on rectangular wooden legs. The legs are secured to concrete blocks, which are now exposed several inches above the grade of the soil. There are ten of these log benches in the Reservation:

Generally, the Type 2 benches are in poor to fair condition with some severely deteriorated and nearly falling over due to exposed footings. These benches are not visually attractive or appropriate for an urban park setting and are not sited to take advantage of the scenic views.

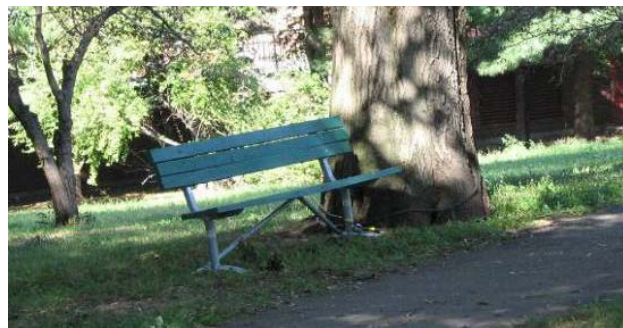
The third bench (Type 3) was installed as a temporary bench and consists of wooden slats on freestanding metal frames. These benches are set directly on the ground without footings or foundation. They are secured with locked steel cables to nearby trees or fence posts, which mean they can be dragged around and the cables cause damage to the trees. There are four of these benches:

Figure 3.38: Type 3 bench attached to tree (2005)

The Type 3 benches are in fair to good condition, but are not an appropriate style for the Reservation, because they are not permanent installations and as mentioned above, the security cables damage the trees and fence.

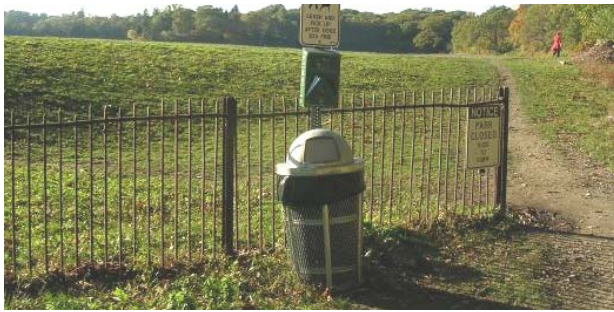
Two steel mesh trash receptacles are currently located at the entrance from the old playground and at the entrance near the intersection of Chestnut Hill Driveway and Saint Thomas More Road. Both are in relatively good condition. Adjacent to these two trash receptacles are dog scoop bag dispensers. A steel drum is located in front of the bituminous path to the Rink from Beacon Street that functions as a trash can. It may be that, for park users, a better location for trash receptacles would be at major entry or exit points to the Reservation. Certainly their current location means that DCR personnel must drive vehicles over pedestrian paths to access the receptacles for emptying; placing them at major gateways which are adjacent to roadways would result in less potential damage to pedestrian areas.

Figure 3.39: Trash receptacle and pet station (2005)

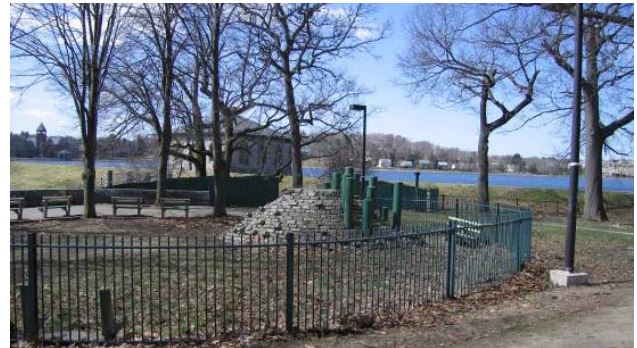
The 1977 MDC landscape improvements included the construction of a children's playground in the area between the Reilly Rink and the Reservoir. The play equipment has since been removed, although a stone mound remains that is a remnant of the slide play structure. The only remaining functioning feature is the semi-circular seating area with six benches facing the parking lot in front of Gatehouse #1. The stone retaining wall on the south side of the playground remains in good structural condition, although it is covered in graffiti. The original design of this playground does not meet current standards for children's play equipment and cannot safely be reused.¹⁶

Figure 3.40: 1977 playground (2005)

The dilapidated playground and graffiti-covered retaining wall are prominent eyesores in the landscape. The stone mound is a safety hazard for children tempted to play on it. There are similar children's playgrounds provided in nearby parks such as Boyden, Shubow, Joyce and elsewhere. Given the limited amount of land available at

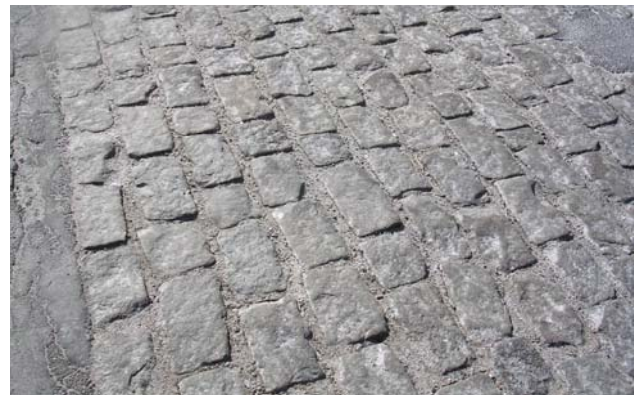
Figure 5.10: Cobblestone strips proposed to be removed along Chestnut Hill Driveway (2006)

- Removal of rumble strips
- Removal of existing street lights
- Repair and repave roadway
- New entry walls at Saint Thomas More Road (See recommendation below)
- Repair of existing Commonwealth Avenue freestanding walls
- New historic-style lighting
- Opening of scenic views and new landscaping
- Standard painted crosswalks

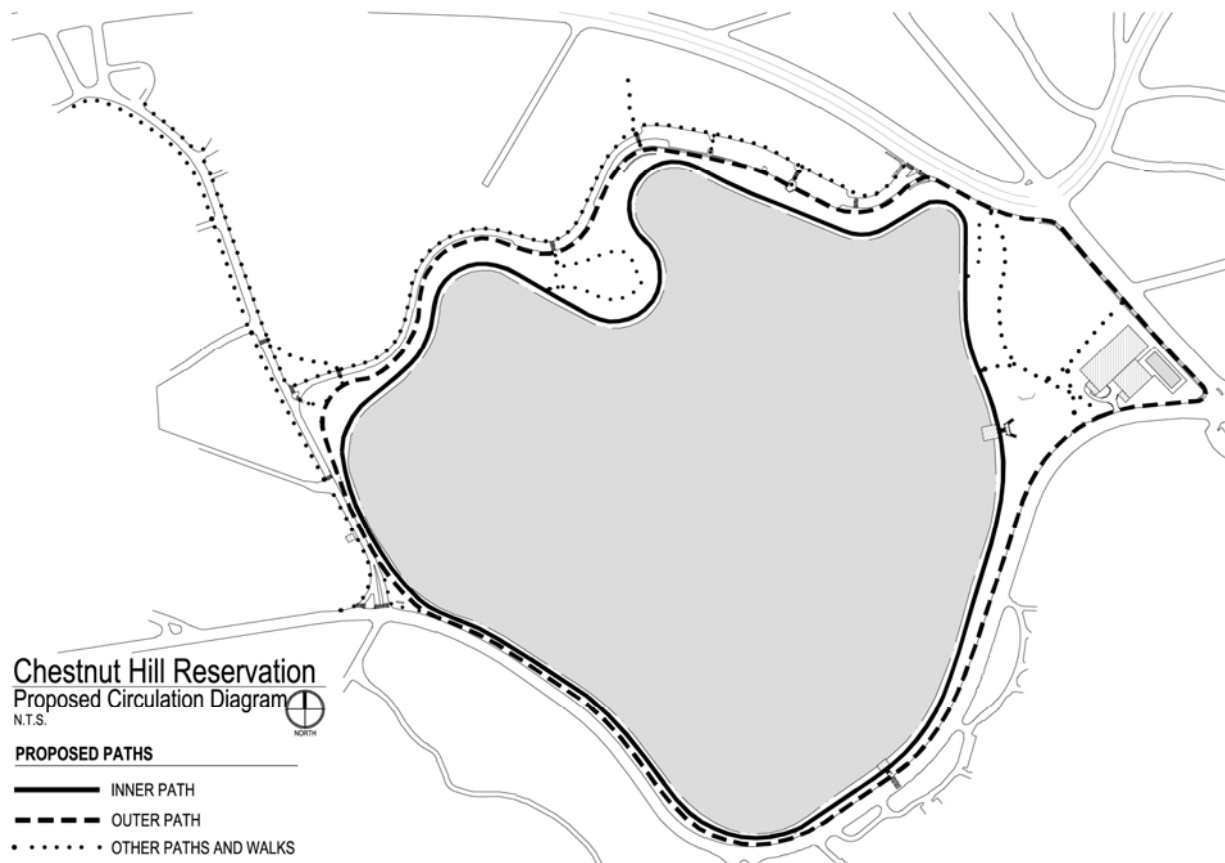
Figure 5.11: Proposed circulation diagram

The proposed pedestrian circulation recommendations below are based upon DCR maintenance issues, providing for the continuity and management of the perimeter (“inner”) and “outer” pathway systems, defining clear access points (gateways), modifying the existing paths to maximize universal accessibility, installing additional paths in needed areas, removing non-used paths and desire lines, DCR snow removal practices, and preserving the character defining qualities of the original Reservoir perimeter path. Figure 5.11 shows the recommended final path system.

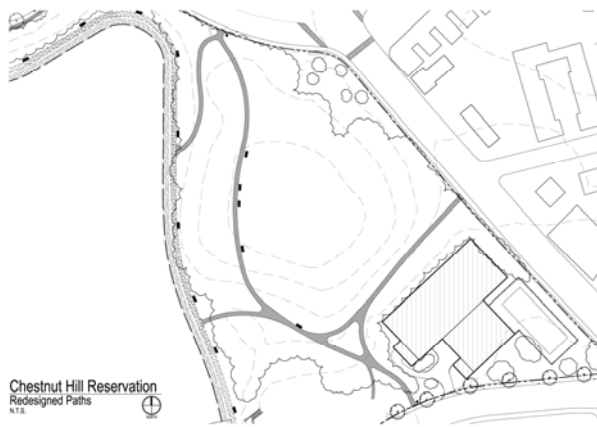
Figure 5.12: Redesigned paths behind Reilly Memorial Pool and Rink

A new path system should be designed to replace the existing path system and become a universally accessible route between Beacon Street, Commonwealth Avenue, the inner pathway, and the Reilly Memorial Pool and Rink area. The path should be designed to have no steps and a 5% or less grade which will meet accessibility guidelines. The existing paved loop path, which is not commonly used, should be removed and allowed to naturalize. The other “desire-line” dirt paths in this area, which are an erosion problem, should be filled and provisions made to limit continued pedestrian access to these dirt paths such as the installation of vegetation. There is also a good view of the Reservoir on top of the rock outcropping and provisions should be made to access this natural overlook area.

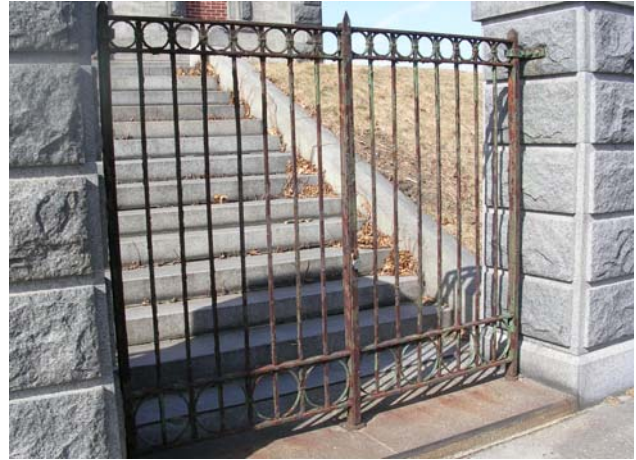
Figure 5.14: Gatehouse #2 fence gates proposed to be removed (2005)

In order to accurately portray the 1901 appearance of the Reservation within a distinct area from Gatehouse #1 to Gatehouse #2, the RMP recommends the removal of the later 1928-1929 fence. This creates an outdoor interpretive exhibit for a small section of the Reservoir perimeter that visually communicates the accurate historic character of the landscape during the primary period of significance. At Gatehouse #1 and #2, the 1928-1929 gates and columns should be removed as well.

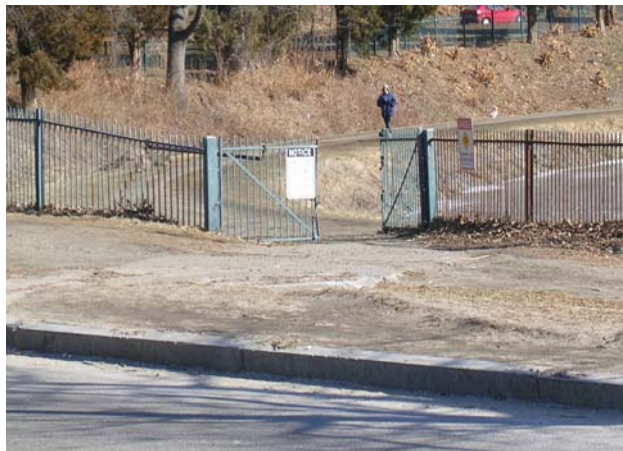
Figure 5.16: 1977 gate in the perimeter fence proposed to be removed (2006)

Recommendation: Replace and/or relocate the two 1977 vehicular gates with design that is compatible with landscape (after 1928-1929 fence removal).

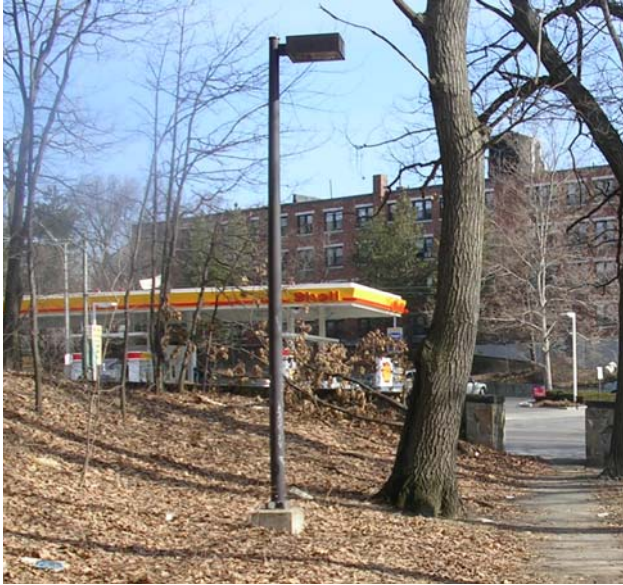
Figure 5.17: Park lights proposed to be removed on the hill behind Reilly Pool & Rink (2006)

The existing pedestrian lights no longer function and this area of the Reservation is closed after dusk.
