STATE BOARD OF BUILDING REGULATIONS AND STANDARDS

CODEWORD

October, 1989

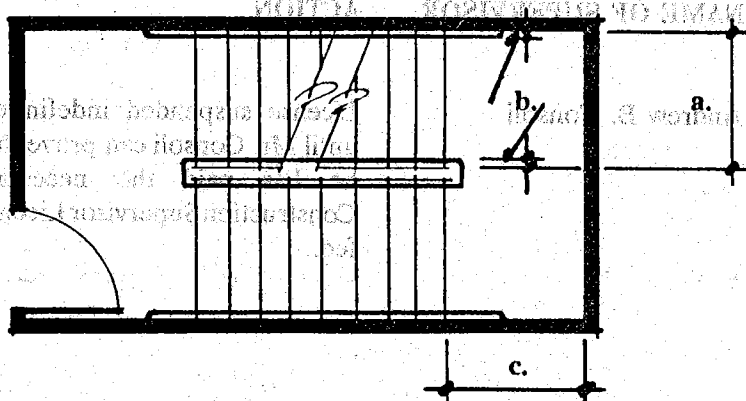
The following sketch illustrates a stair (including the landing) in conformance with these sections.

- a. Required Stair Width
- b. Allowable Handrail Projection
- c. Required Landing Width

Mistakenly, many believe the minimum required width is the result of the equation; required stair width (44") minus the seven (7) inch allowable projection ($3\ 1/2"$ on each side) which equals 37. This dimension is often termed, clear width between rails. The term, although technically accurate, does not bear any meaning within the Code. The required stair width remains as forty-four (44) inches, measured from wall to wall (or edge of stair pan in a reversing stair, as shown).
