2.3 | Arrival, Circulation and Parking

Getting to Herter Park and circulation within the park rank high among community's concerns and desires for improvement. The analysis of connectivity and internal circulation issues is highlighted in the Circulation Diagrams shown on the following pages. The most pertinent issues are summarized below.

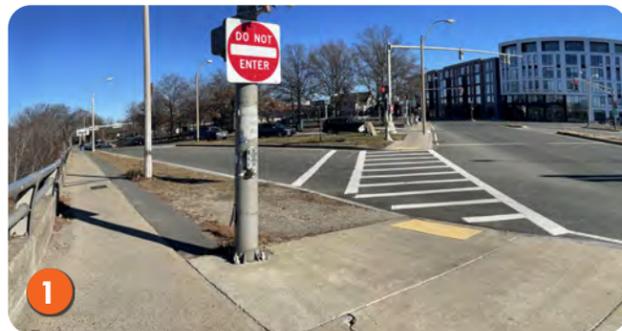
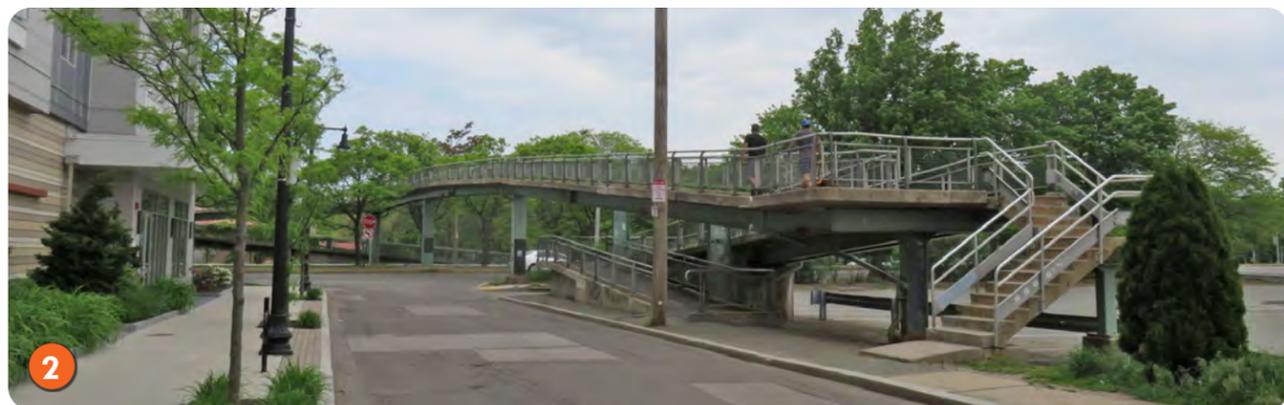
Figure 2-18. Currently there are only two safe pedestrian access points to Herter Park from the adjacent neighborhoods: (1) at the intersection of Soldiers Field Road at Arsenal Street Bridge, and (2) the Telford Street overpass.

Presently, there are only two pedestrian/ bicycle access point from the Allston / Brighton neighborhood:

- Signaled crossing at Arsenal Street Bridge intersection, which serves as a connection from Western Avenue and links to the Dr. Paul Dudley White Greenway to the west, but is far from the present core of activities located about 1/2 mile further east.
- Telford Street shared use overpass, which connects the neighborhood to the destination Artesani Playground, is narrow, does not meet ADA requirements, and in deteriorating condition.

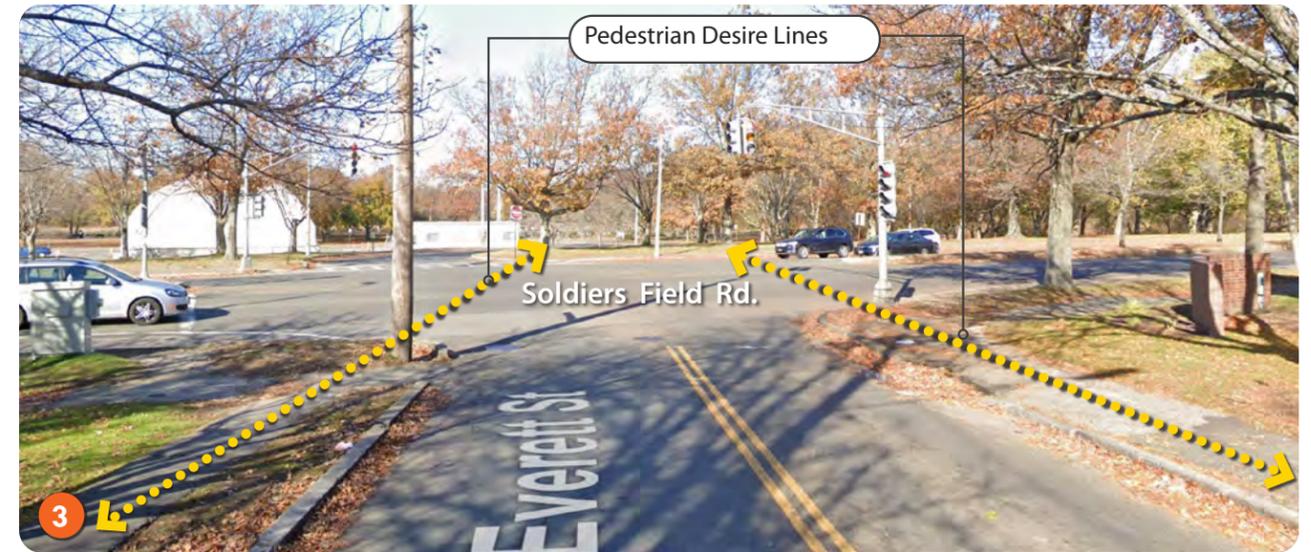
Figure 2-19. Crosswalk to Herter Park at Everett Street is proposed by several planning studies and is part of DCR's ongoing project for roadway improvements at the Everett / Soldiers Field Road intersection. Image credit: Google.

- The signalized Everett Street intersection, which is across from the main park entry, lacks a pedestrian crosswalk to the park. There is a strong pedestrian desire line to the park at this location, and it is recommended that a signalized crosswalk should be provided. (The DCR is developing a roadway improvements plan for Everett Street which includes a crossing that aligns with the west side of Everett Street.)

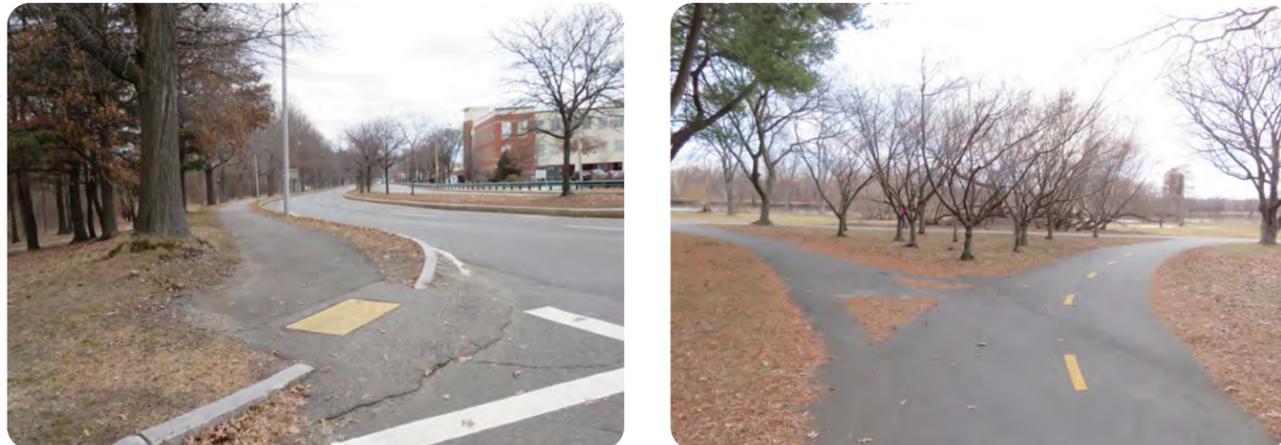
Figure 2-20. Left: Dr. Paul Dudley White Greenway ("winter path") is narrow and too close to the roadway, which encourages bicyclists to use the park paths instead. Right: Within the park, some paths are striped as a visual cue to guide bicyclists away from the more popular river-side paths.

- Its width of 5.5' to 6' does not meet the standards for a two-way shared-use path, which require 10-foot minimum width. The path is situated close to the fast moving traffic, which might discourage some bicyclists from using it and divert them to the park interior paths instead.
- Along the Herter Park frontage, the path crosses vehicular driveways 14 times, each of these requiring special attention to safety. The crossings have been equipped with detectable surfacing, however the few examples observed do not meet the ADA requirements for curb ramps.
- At Eliot Bridge, there is no at-grade crossing. Instead, the path circles down and under the bridge, and then back up via a non-ADA compliant segment.
- There is a lack of signage and wayfinding to inform the path users on directions, points of decision / park connections, and vehicular crossings.

- In an attempt to steer the bicyclists away from the more popular paths along the river, some paths were rebuilt wider (10-foot wide) and have been painted with striping as a visual cue of a shared-use path.

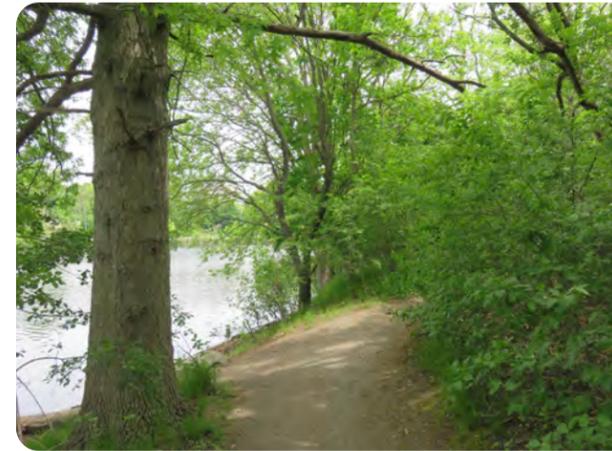
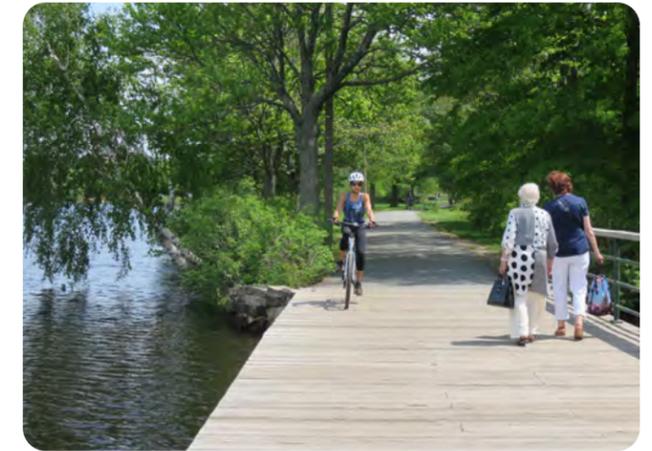
Figure 2-21. Left: Informal dirt paths along the woodland river edge are narrow, overgrown and not ADA accessible. Right: the boardwalk is too narrow for shared-use travel discouraging its desirable use as a sitting node.

- Signage and wayfinding is lacking that could help clarify direction, points of decision, or highlight conflict with other uses.
- The boardwalk is too narrow for its desirable use as a sitting node along with serving as a circulation path.

- At the west end of the park, the compacted dirt footpaths are not accessible and often get soggy due to the poor drainage in the area. Alternative paving materials, such as stabilized stone dust, wood chips trails, or boardwalks, would make this part of the park more user friendly while retaining its informal character.

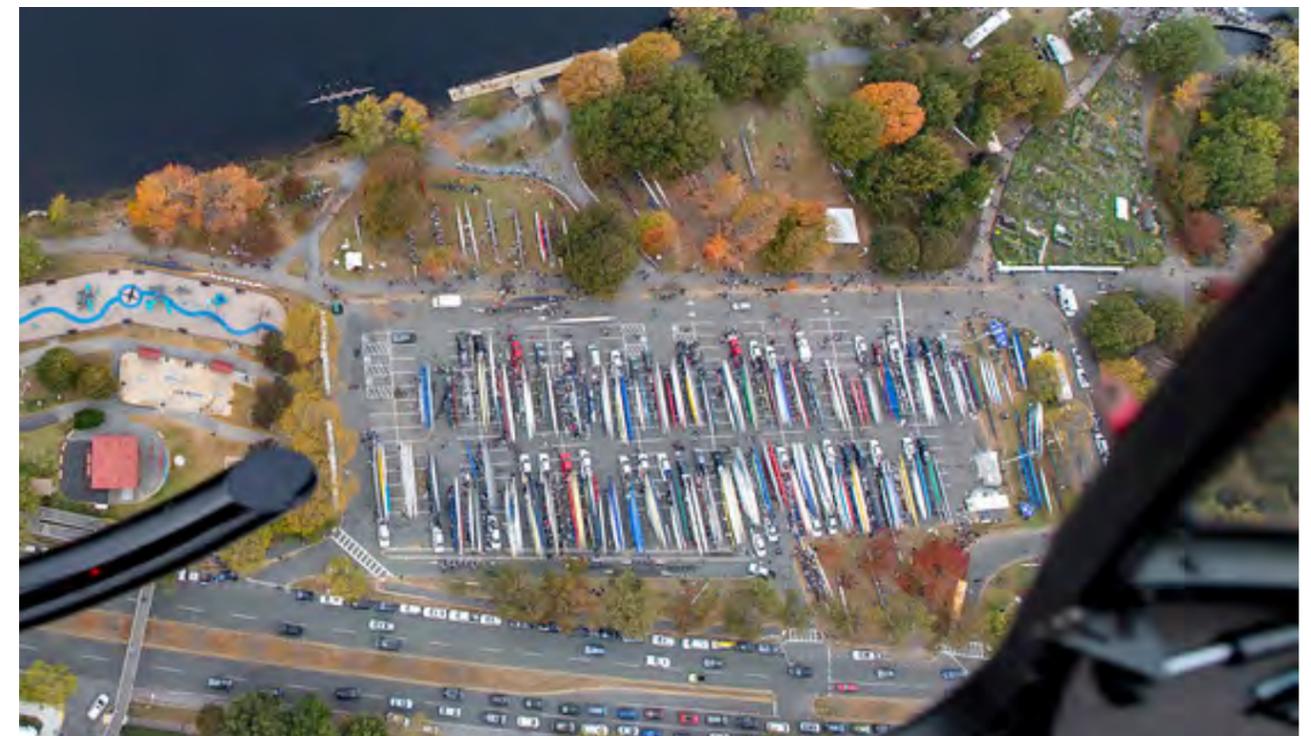
Figure 2-25. Artesani parking lot is essential for parking of rowing boat trailers during the Head of the Charles Regatta. Image credit: HOCR.

The vast Artesani Parking Lot is the “workhorse” of the park. It provides parking for 230 cars, some of which are reserved for Park & Ride users. The parking is currently free, which has led to some misuse by commuters and notably by BB&N students, who park here daily and are taken to their school across the river by the school’s shuttle bus. In addition to parking, the wide paved expanse is useful for staging of various organized events, parking of about 60 rowing boat trailers during the Head of the Charles Regatta (HOCR), and for snow storage in winter.

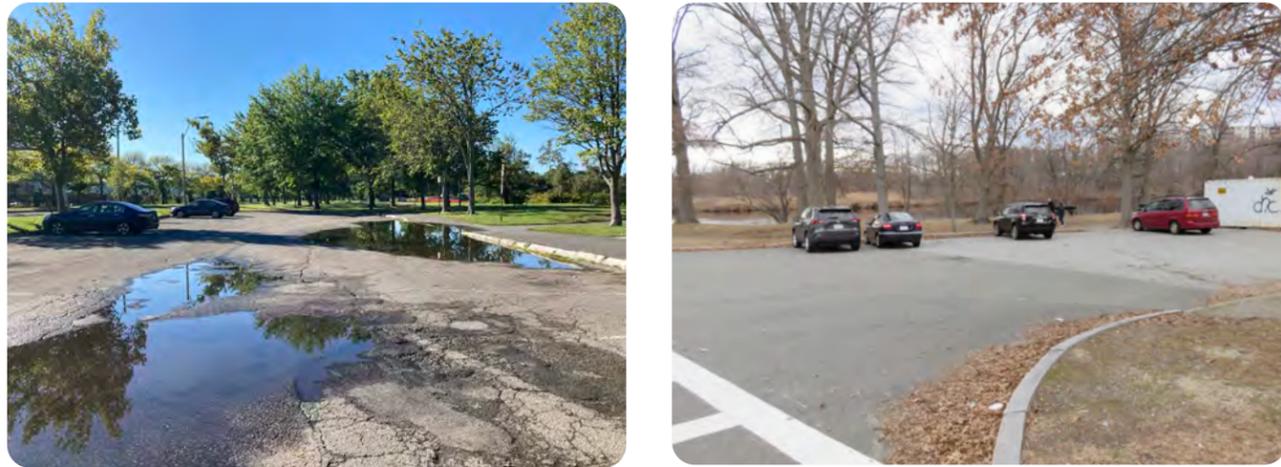
Figure 2-26. Flooding issues at Parking Lot #1 (left), and filtered river views at the West End parking (right).

- Each of these lots has drainage and flooding issues, as well as an inadequate number of accessible parking spaces.
- These parking lots (especially #2) are also used for trailer parking during Head of the Charles Regatta in addition to parking lot #4 (Artesani) as shown in the image. Small size and turning constraints make these lots unsuited for trailer access and adjacent parkland often gets damaged. Also, boat trailers attempting tight turns to park accelerate deterioration of parking lot surfaces and pavement markings.

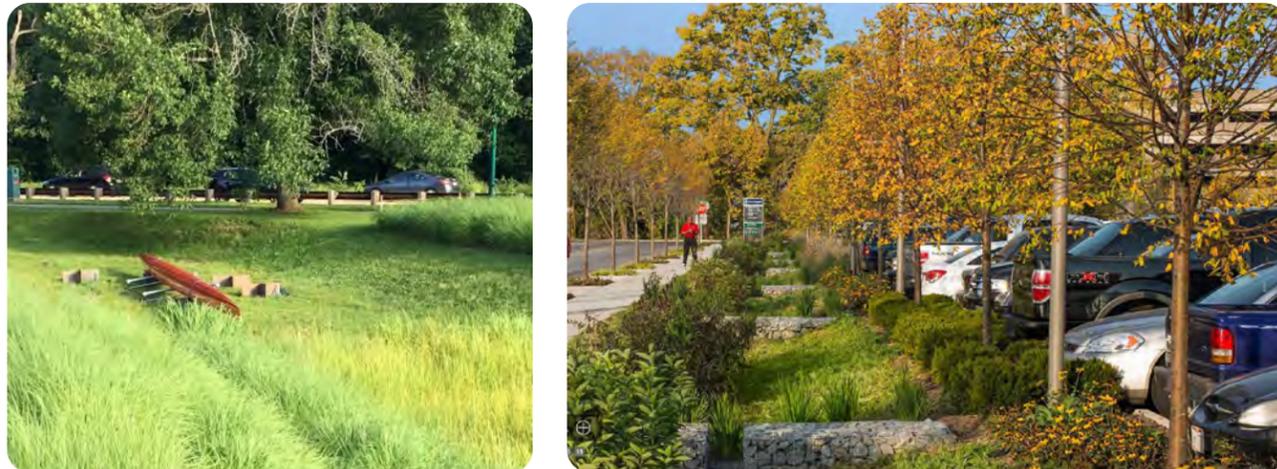
Figure 2-28. Examples of green infrastructure for treatment of parking stormwater runoff: Bioretention swales at Harry Parker Boathouse, Brighton, MA (left) and Christ Hospital, Cincinnati OH (right). Image credit (left): DCR, (right): www.OJB.com.

- Stormwater management for all parking lots:
 - Provide green infrastructure and nature-based solutions for stormwater treatment.
- Snow management plan: Follow *DCR's Snow Management Plan* that is posted on the DCR website.

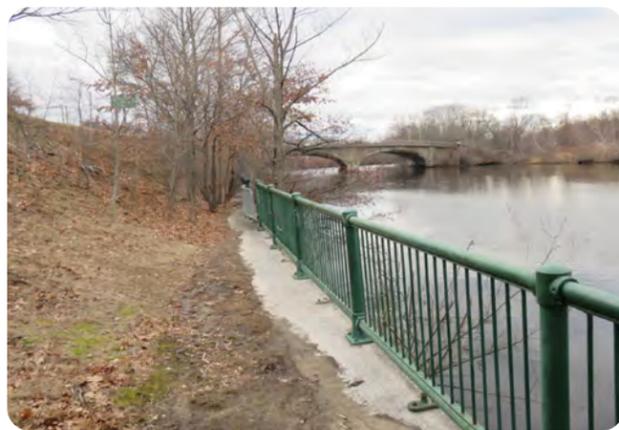
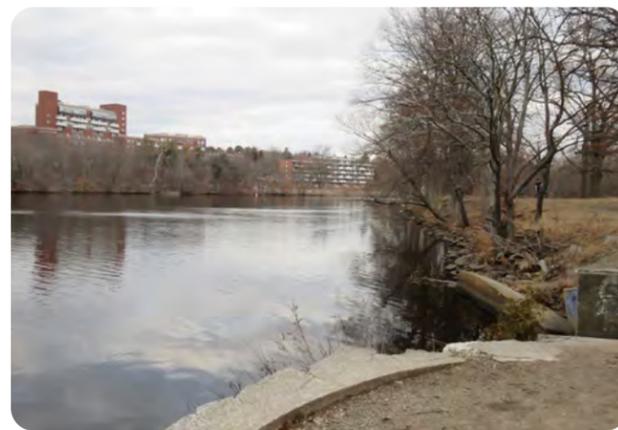
Figure 2-29. View west to Arsenal St. Bridge (left). View east showing a derelict outfall structure along with attractive river views.

Arsenal Street Bridge anchors the west end of the park. The sidewalk /shared use path from the Arsenal Street Bridge is one of the three main pedestrian access points to the park (the other two being the Telford Street Overpass, and the access from Eliot Bridge). The parkland east of the bridge is a narrow strip of wooded, steeply sloping terrain; at its base, along the river’s edge, is a concrete embankment wall with a metal guardrail. A paved area in the vicinity serves as parking for 8 cars; its layout coincides with the end of the former Charles River Speedway loop; the rest of the loop was long abandoned and any vestiges obliterated by successional vegetation.

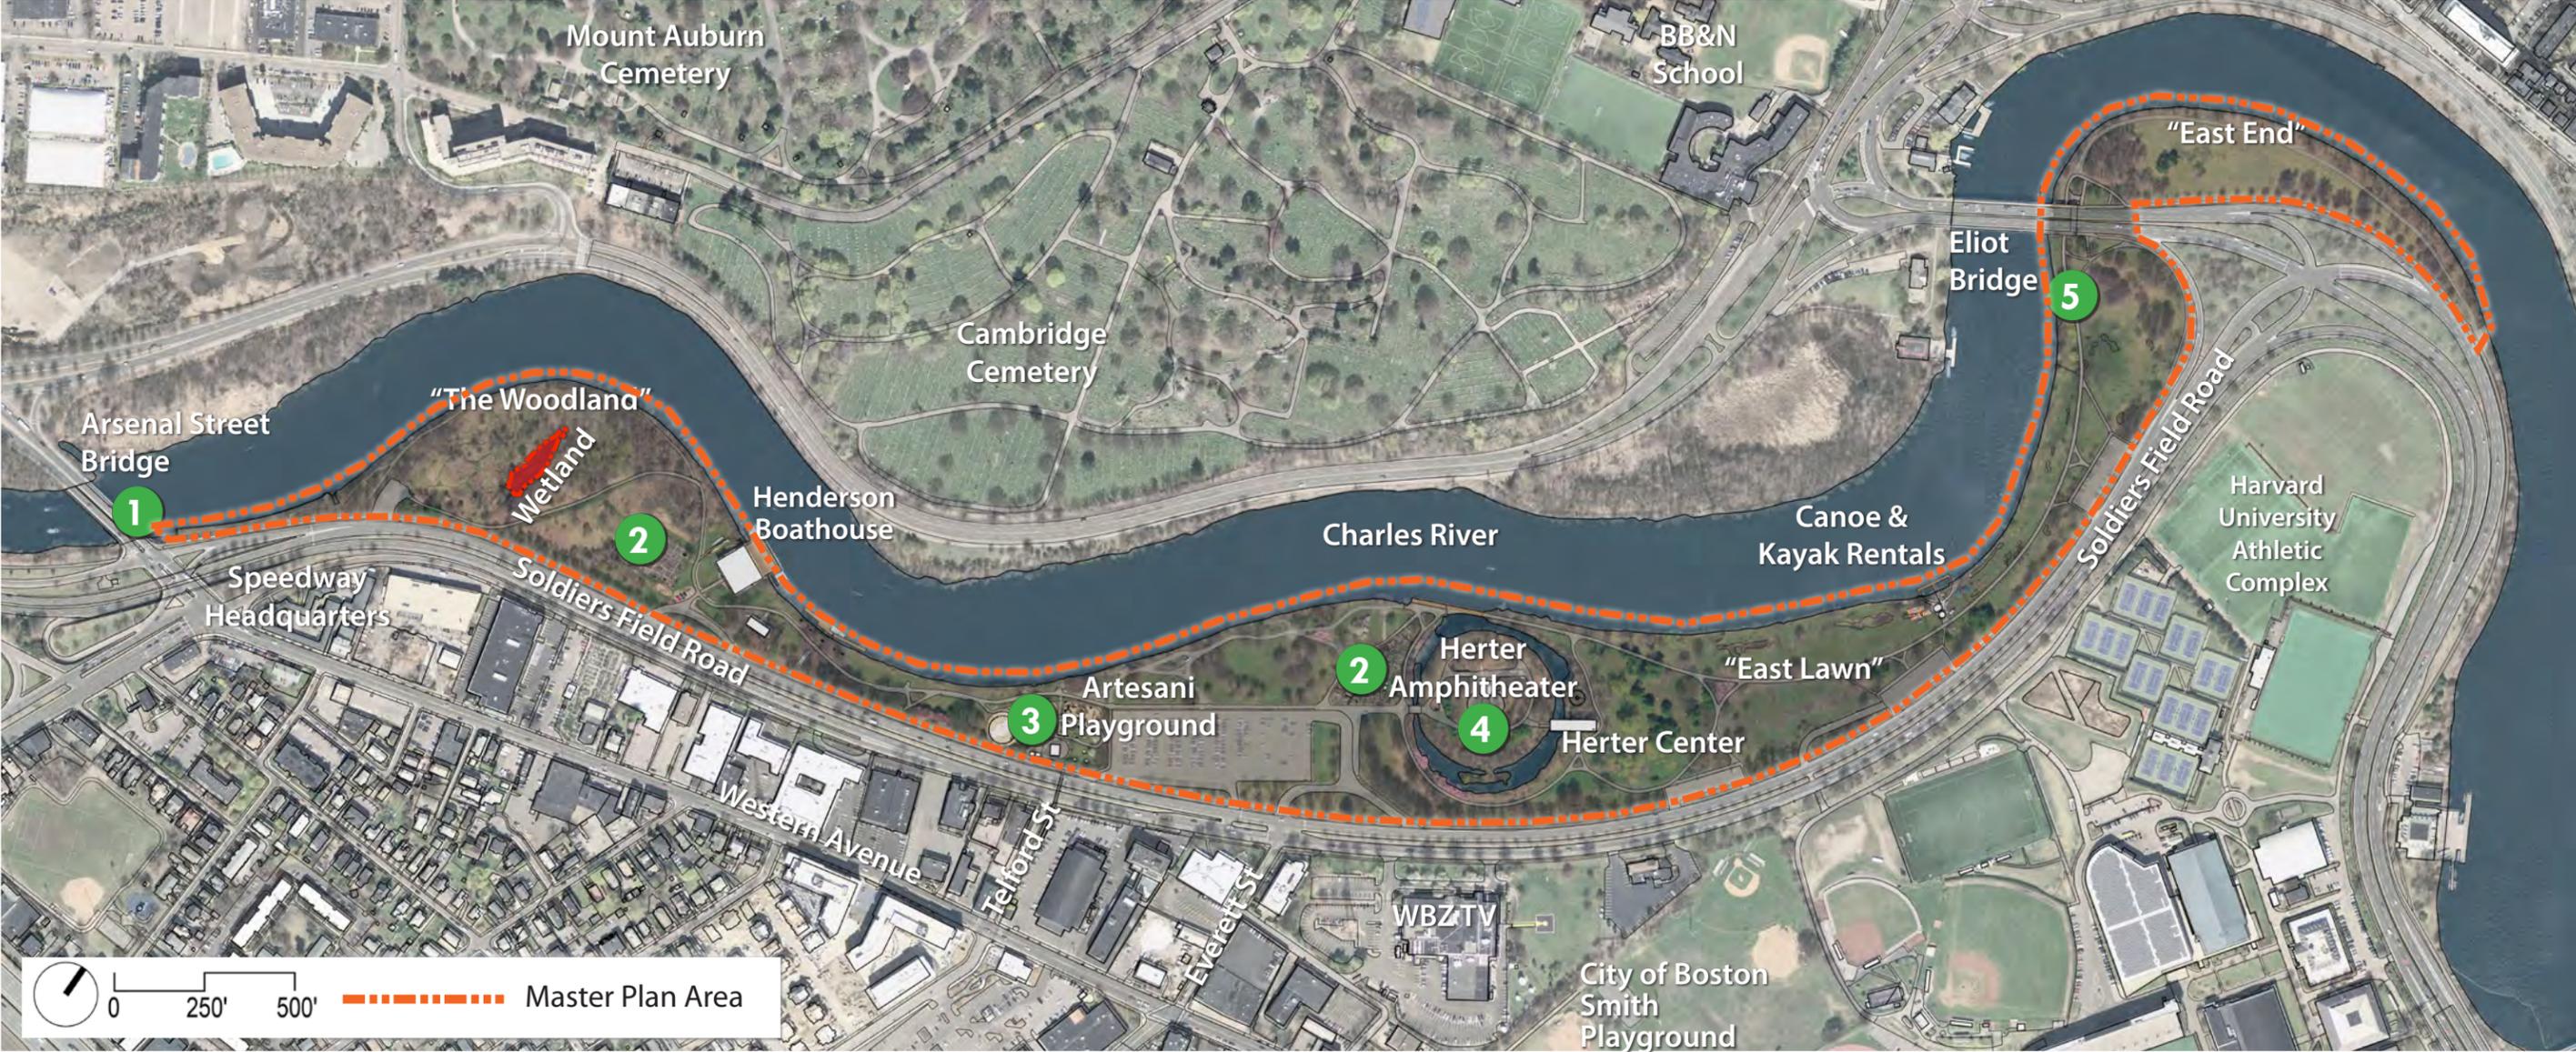
Figure 2-32. Existing prominent site features.

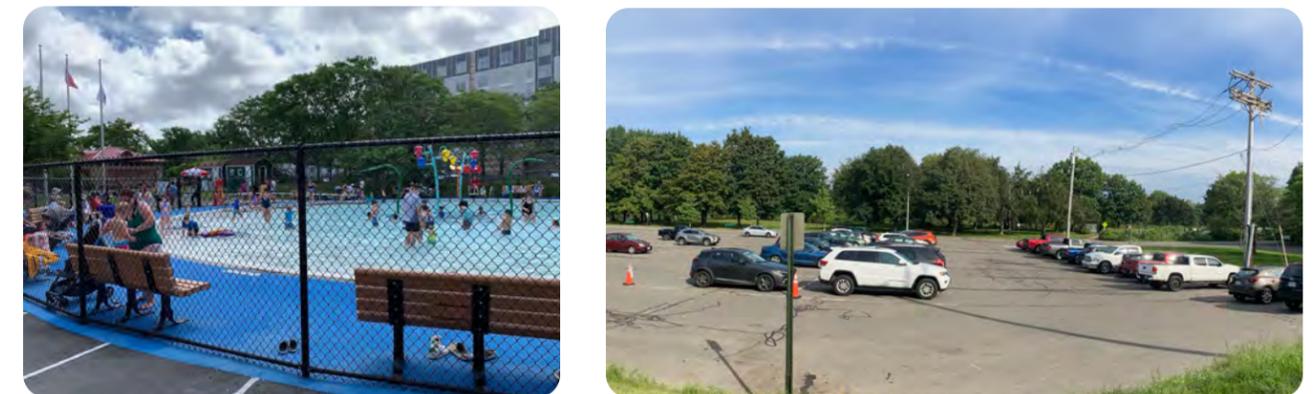
Figure 2-34. Wading pool at Artesani Playground (left)(Image credit: DCR) and the Artesani Parking Lot (right).
