MAYO CREEK SALT MARSH RESTORATION CULVERT DESIGN ALTERNATIVES

December 2016

Mayo Creek Salt Marsh Restoration Culvert Design Alternatives

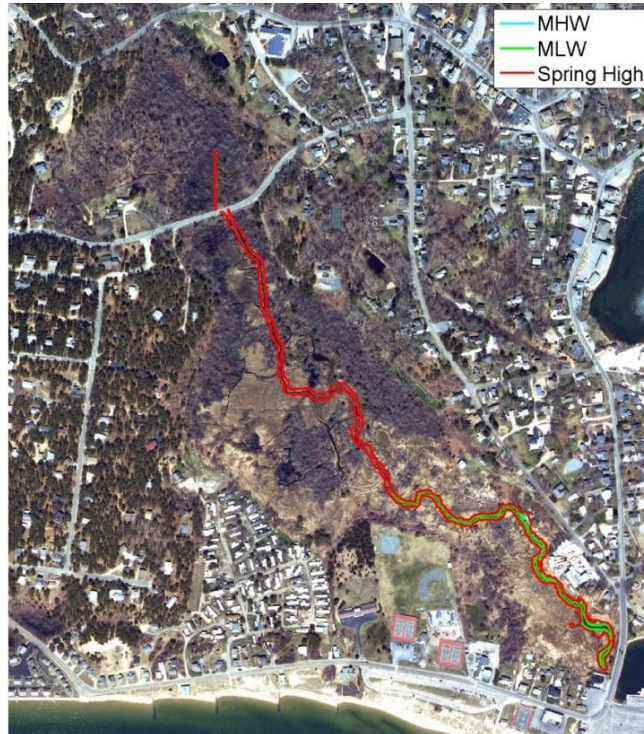
Figure 4. Mayo Creek Basin with contours of MHW, MLW, and Spring High tide under existing conditions (does not consider rainfall). From Woods Hole Group, 2011.

The ultimate goal of the restoration of the Mayo Creek system is to improve the health of the marsh by increasing the tide range and, therefore, the intertidal area within the marsh. As discussed in 2011 Woods Hole Group study, the current intertidal zone is limited to the banks of the perennial stream (Figure 4), and the tidal range is less than 2 feet (compared to nearly 10 feet in Wellfleet Harbor).
