Massachusetts Coastal Infrastructure Inventory and Assessment Project Massachusetts Department of Conservation and Recreation Office of Waterways

Boston Harbor - North

Nahant
Winthrop
Chelsea
Everett
Harbor Islands

July 6, 2009

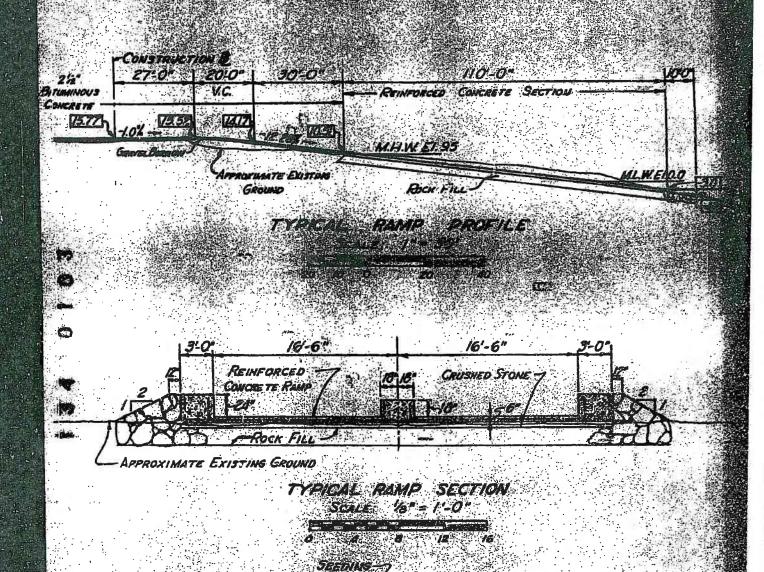
082-013-000-002-100

APPROXIMATE EXISTING GROUND PLASTIC STRIBUTY
FILTER

TYPICAL REVETMENT
SECTION
SCALE: 4/16"=1'-0"

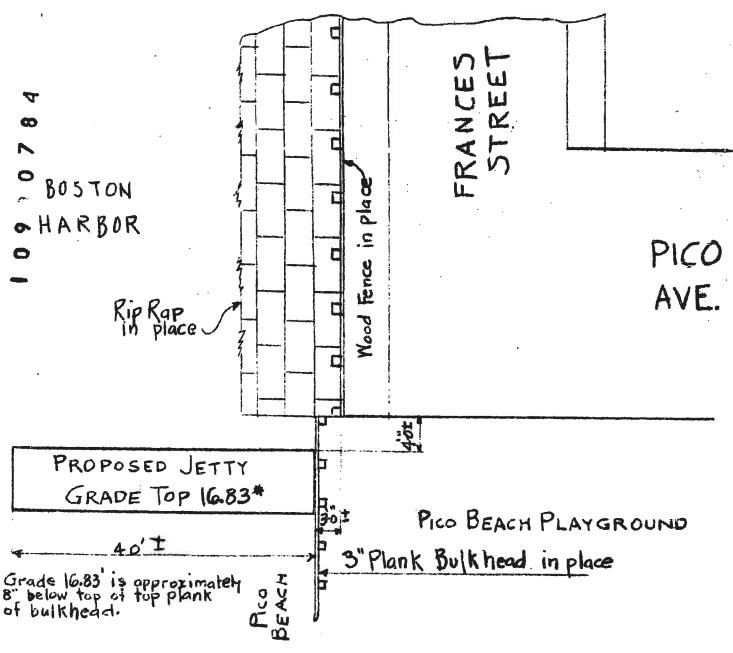
PROPOSED JETTY AT PICO BEACH, WINTHROP MASS.

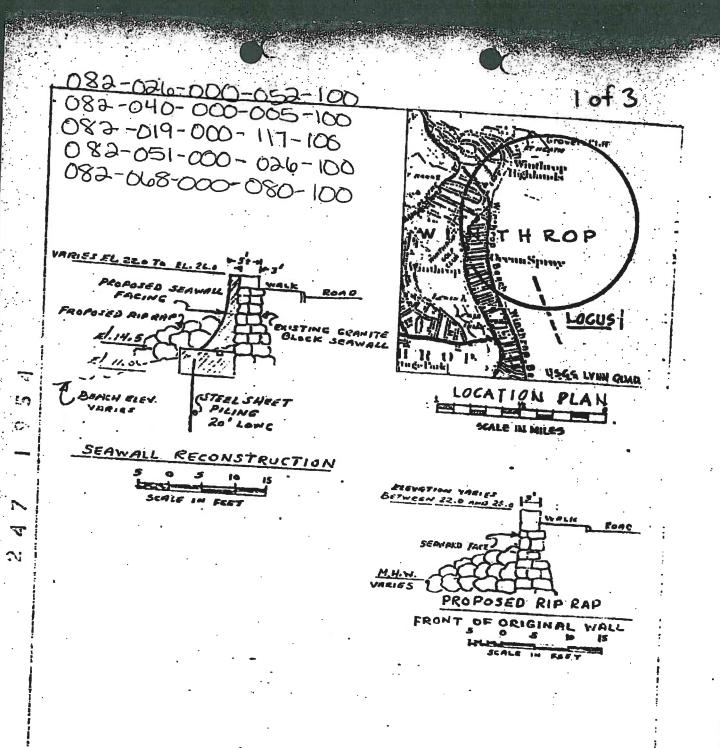
PROPOSED SEAWALL
REPAIRS
WINTHROP BEACH
AT WINTHROP
SUFFOLK COUNTY STATE MASS.
APPLICATION BY MET. DISTRICT COMM.
SHEET 1 OF 2 DATE

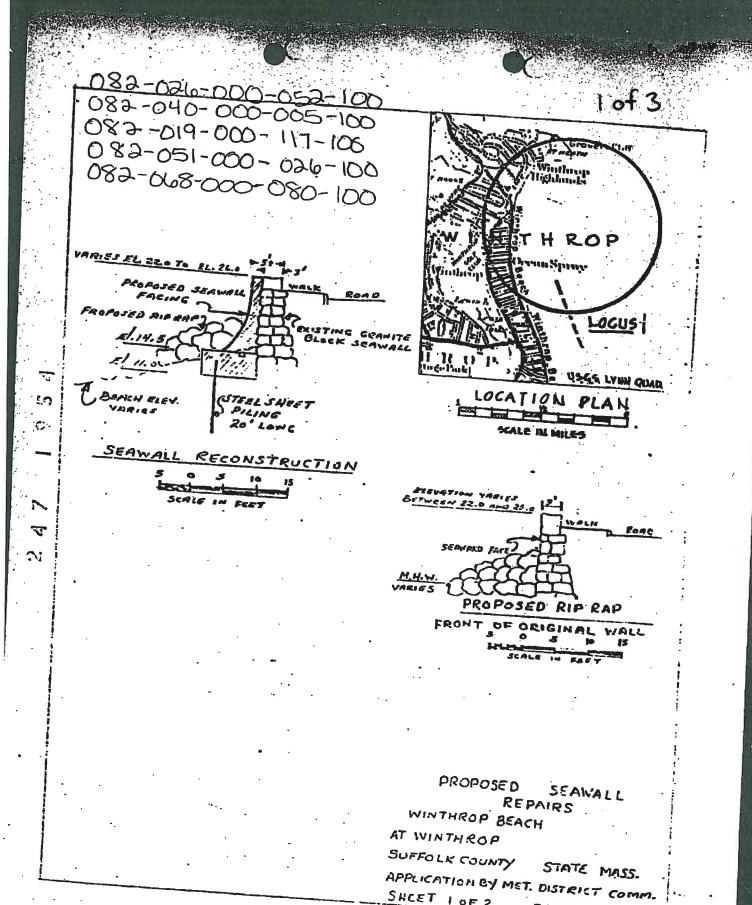
SHEET 10F2

CORPS OF ENGINEERS WINTHROP GROVERS EW PROPOSED CONCRETE SEAWALL FACING REPAIRED 089 089 689 689 NEW PROPOSED CONCRETE SEAWALL FACING EXISTING DINS TO BE REPAIRED WINTHROP HEAD NOTE: EXTENT OF RIP-RAP AT BASE OF SEAWALL FROM BEAGON ST. TO FORT HEATH, WINTHROP

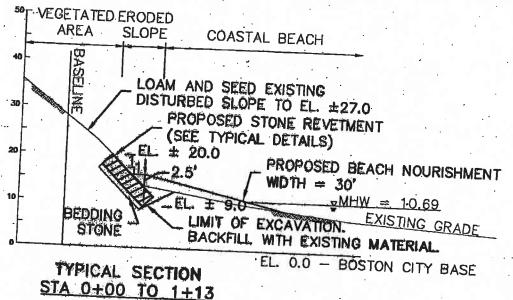
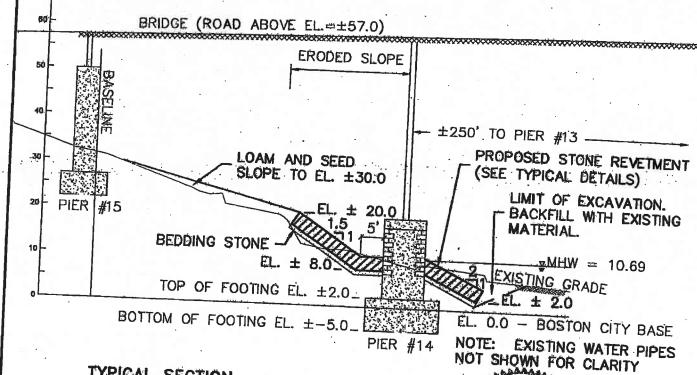
TYPICAL SECTION STA 1+13 TO 1+45

TYPICAL SECTIONS

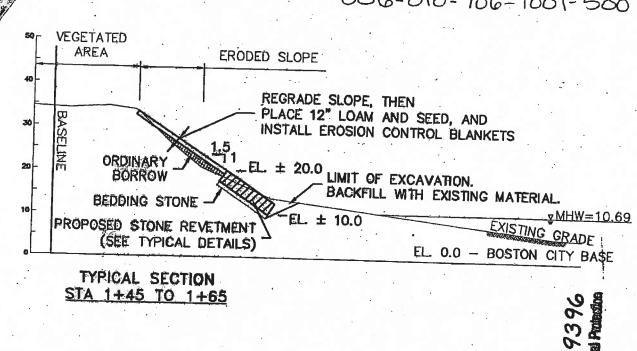
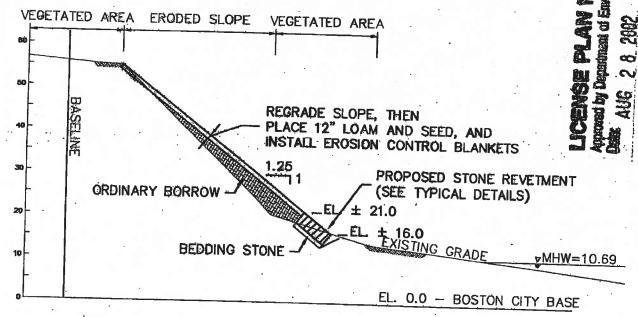
TYPICAL SECTION STA 1+65 TO 2+70

TYPICAL SECTIONS

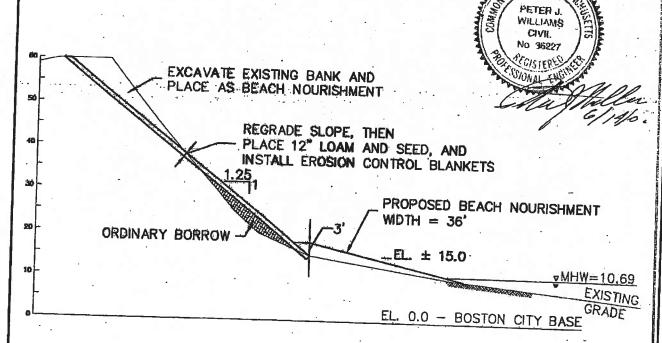
TOE OF REVETMENT DETAIL NTS

TO 2 TON ARMOR STONE 2 TO 3 TON MIN. TOE STONE BACKFILL WITH EXISTING BEACH MATERIAL TEXISTING GRADE (VARIES) MIN. BEDDING STONE 12" MIN. LIMIT OF FILTER FABRIC **EXCAVATION**

PLAN ACCOMPANYING PETITION OF: THE CITY OF BOSTON TO CONSTRUCT AND LICENSE STONE SLOPE PROTECTION AT THE LONG ISLAND BRIDGE ABUTHENTS PLAN NO.

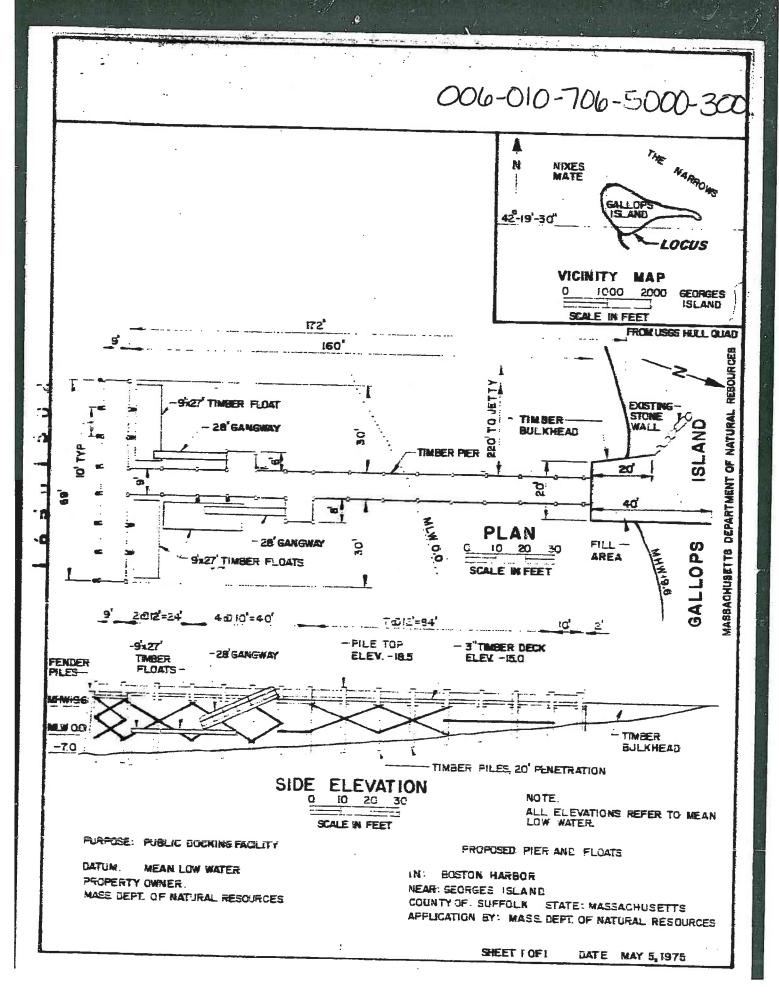
Description	Timber Bulkhead and Stone Wall
Location	Gallops Island Pler
Sheets	-
ТІВВ	Proposed Pier and Floats in Boston Harbor on Gallops Island, Suffolk County, Massachusetts
Date	May 5, 1975
Municipality	Boston
Entity	USACE
Contract/ Drawing Number	76-15
Document No	006-010-706-5000-300-COE3A
BCE Structure No	006-010-706-5000-300
