MODULE V: EMERGENCY OPERATIONS

TERMINAL OBJECTIVES

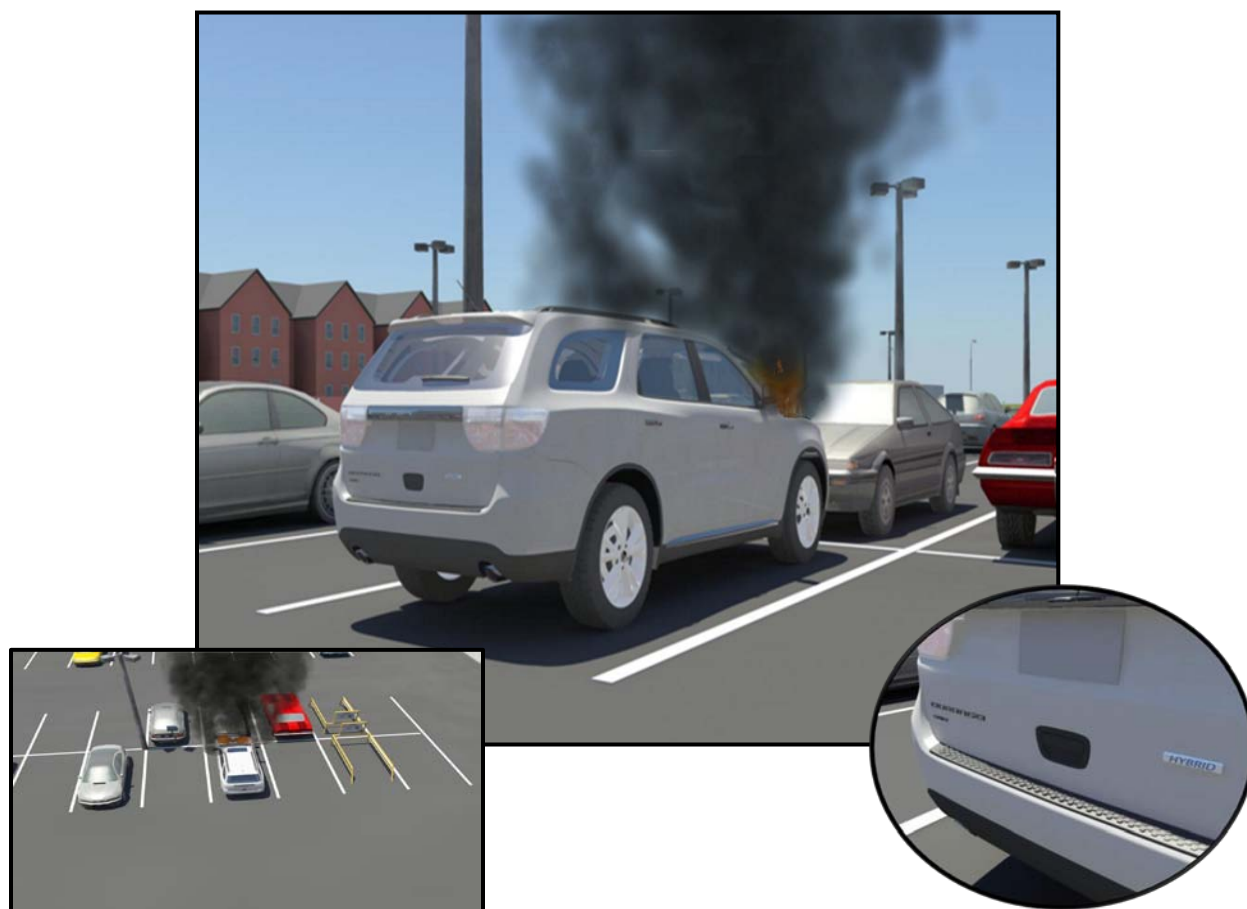
Scenario 3: Vehicle Fire in Engine & Passenger Compartment

You are dispatched to a reported vehicle fire in the parking lot of a local shopping mall. As you approach the parking lot you see a small column of smoke coming from a group of cars parked close to an entrance. It is Saturday at 11 am, 75°F, there is a mild breeze. On arrival, you find a hybrid Highlander SUV with smoke and flames coming from the engine compartment area and heavy smoke coming from the passenger compartment through the driver window. The parking spaces on both side of the vehicle are empty; however, the spaces immediately in front of the vehicle are filled. The owner meets you and tells you that no one is in vehicle.
