**FEASIBILITY REPORT  
RESERVOIR DAM MODIFICATIONS  
FOR HIGHER POND LEVELS  
FIRST HERRING BROOK FISH PASSAGE IMPROVEMENTS**

26 June 2013  
EA Project No. 62651.02

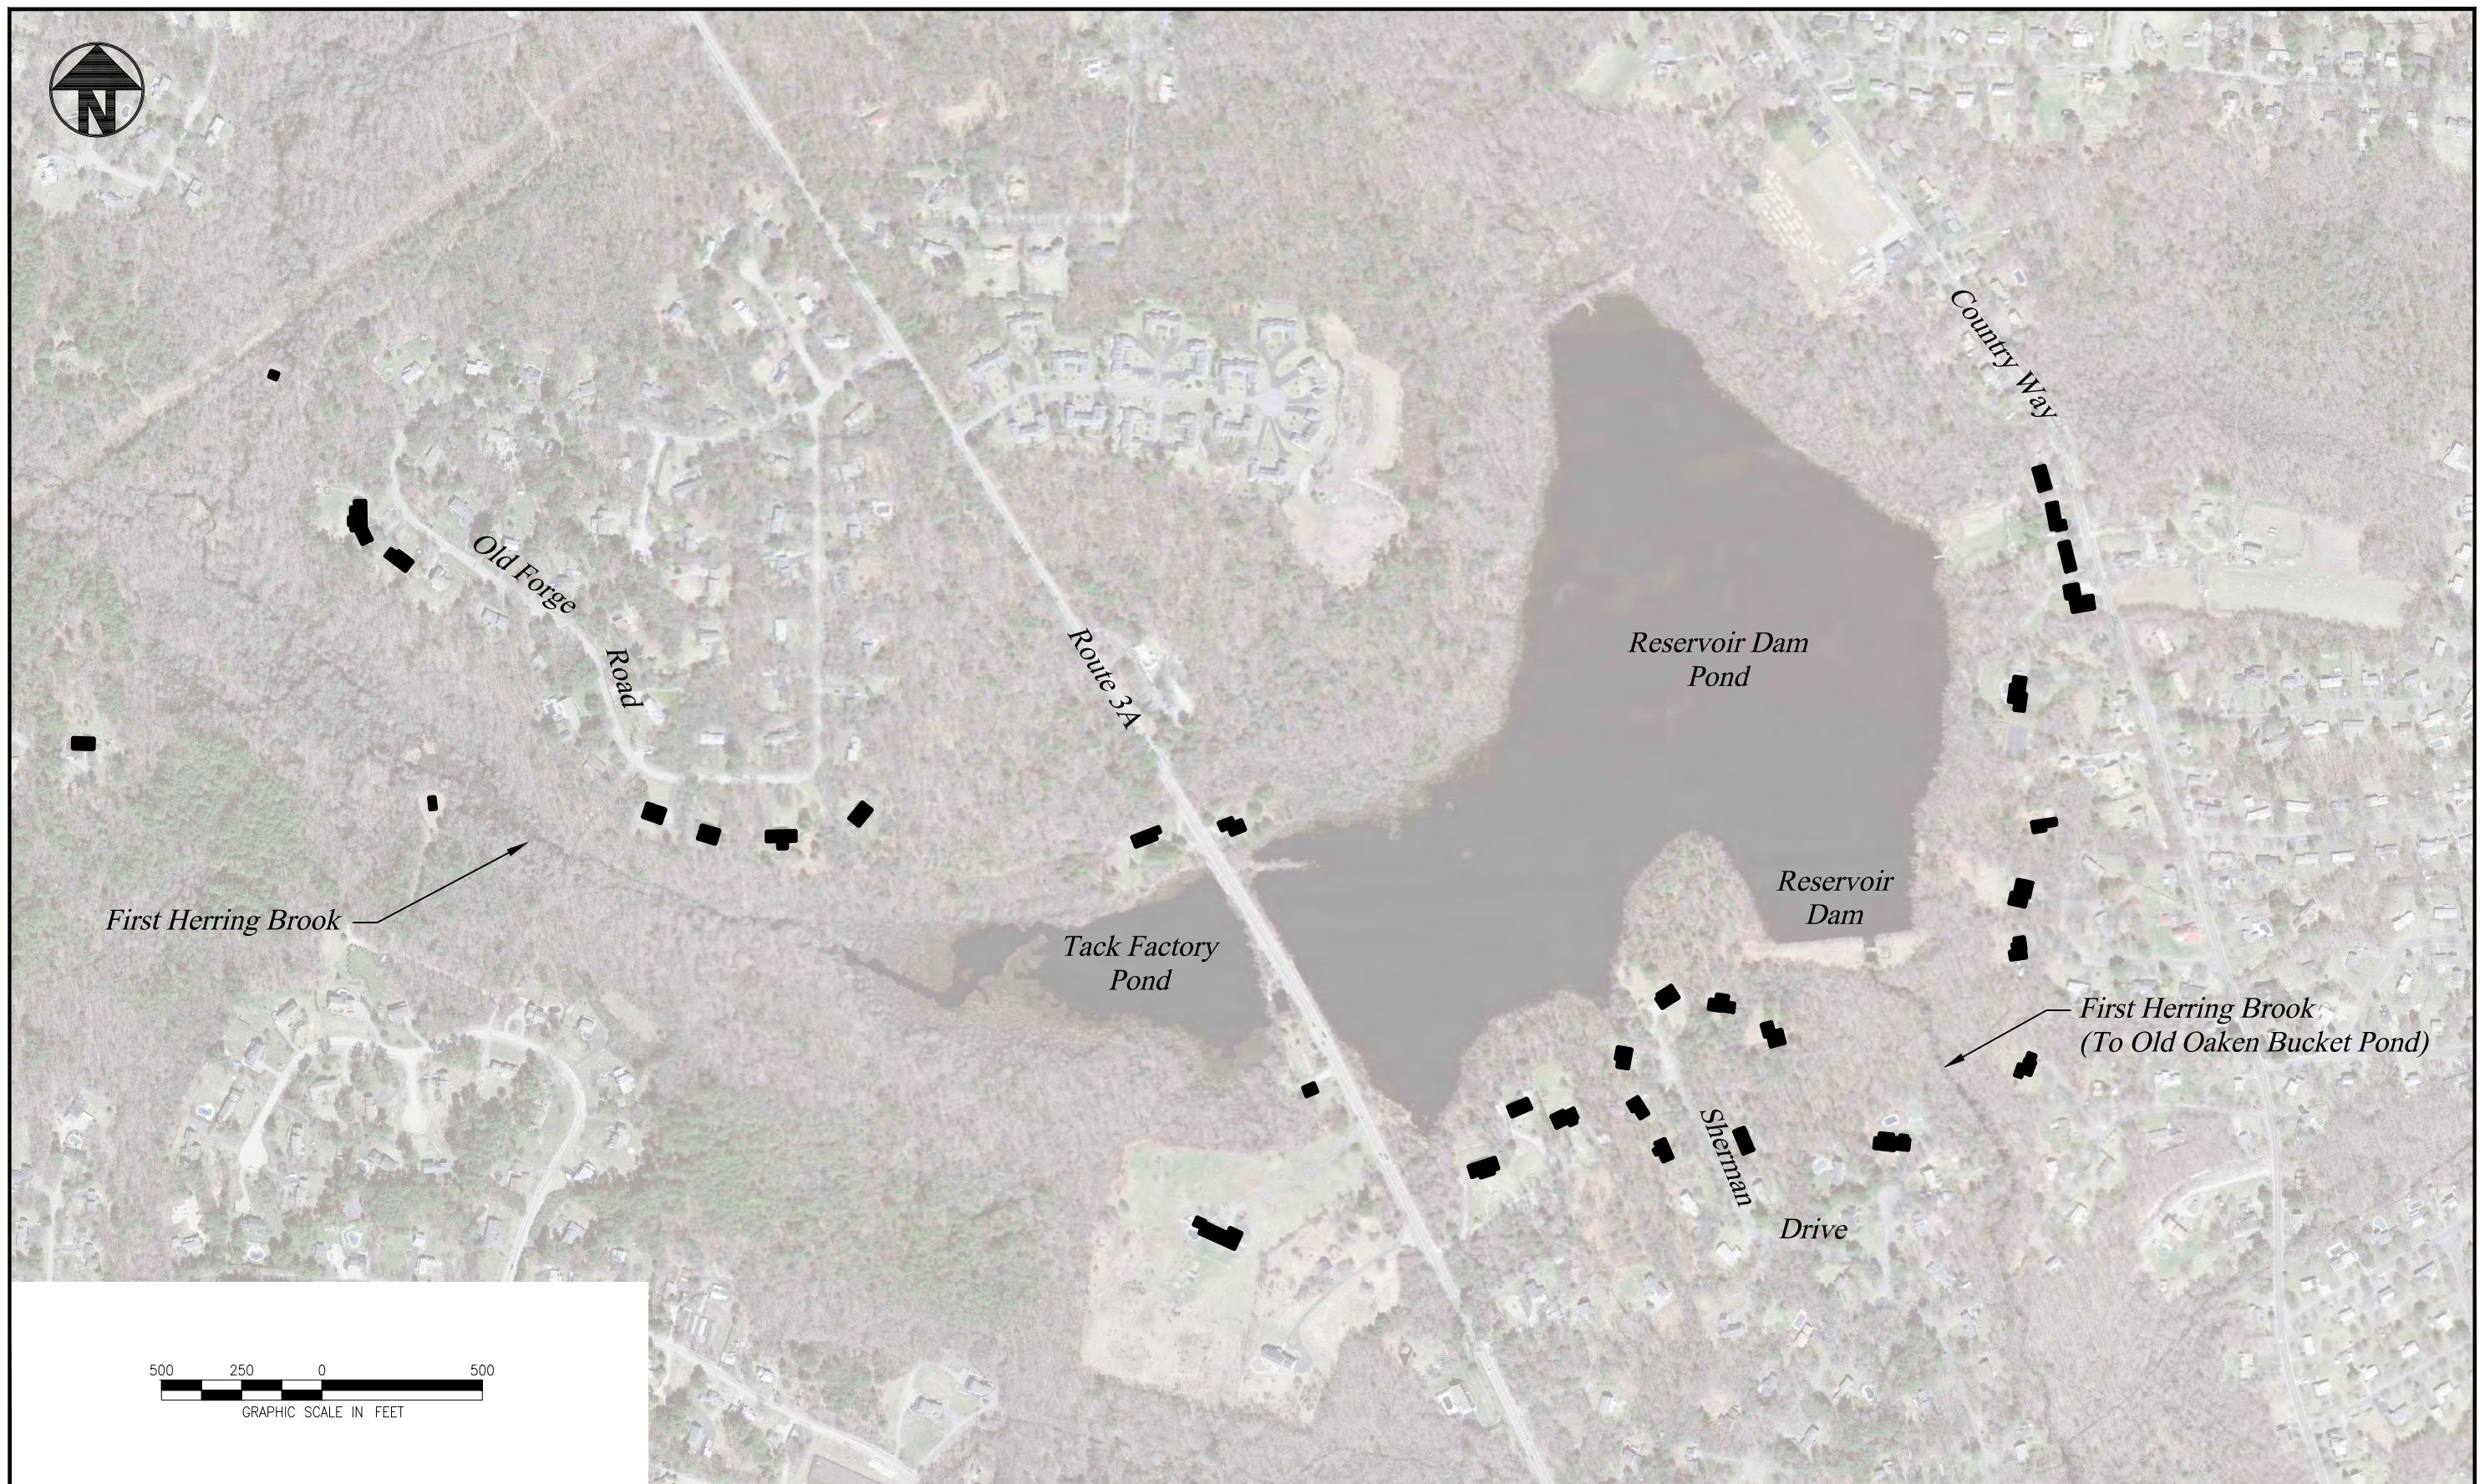
The Scituate DPW is currently implementing an Interim Operational Plan (IOP) recommended by the NSRWA and its partners. The IOP utilizes reservoir storage below the spillway crest (El. 40.0 ft) to meet water supply demands and environmental flow releases needed to maintain the habitat in First Herring Brook between Reservoir Dam and Old Oaken Bucket Pond, as shown on Figure 1, and downstream of Old Oaken Bucket Dam.

There are three (3) houses off from Route 3A that are very close to the Reservoir and Tack Factory Pond (See Figure 1). Ground level around these houses is generally at El. 43.0 ft to El. 45.0 ft. Higher pond levels could increase groundwater level and the yards for these houses may have to be raised to provide some dry yard area for the owners.

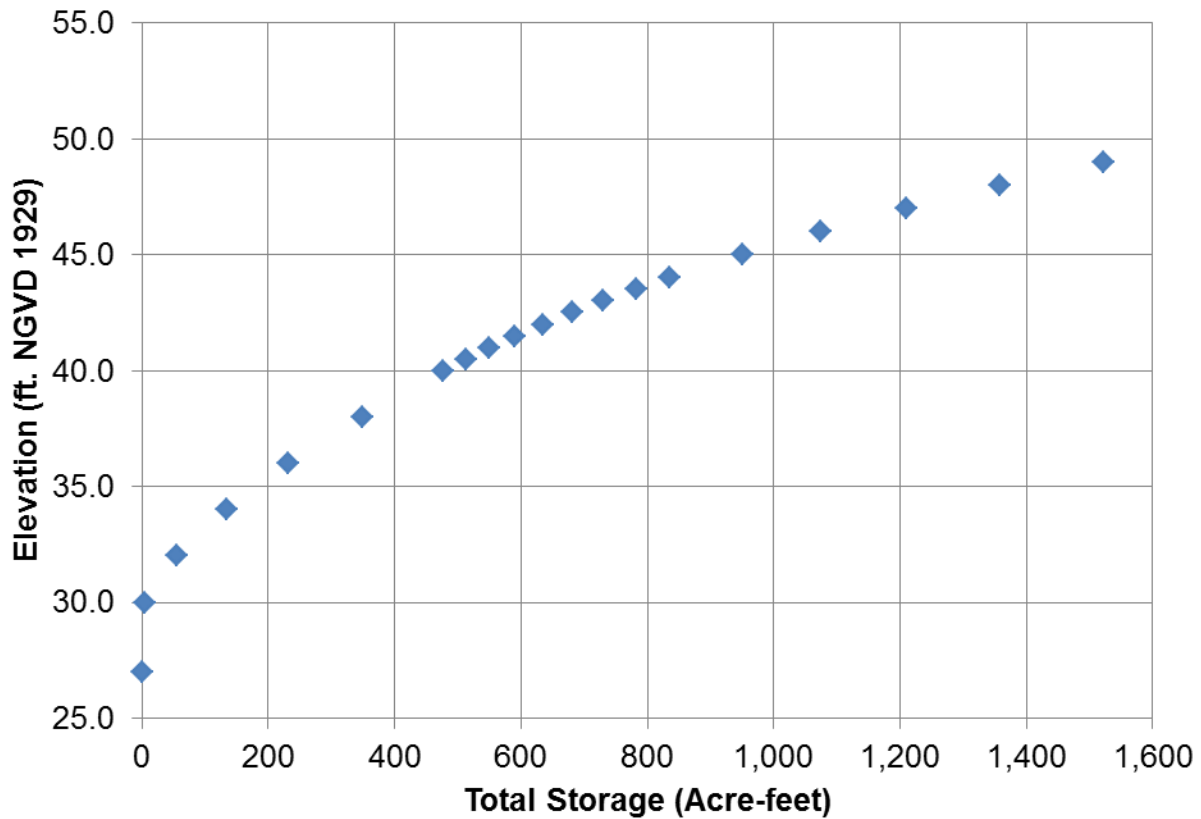
**Figure 2 Reservoir Dam Storage Rating Curve**

The storage rating curve for Reservoir Dam is presented in Table 1 and illustrated in Figure 2.

For pond levels at El. 40.0 ft and lower, EA used the reservoir storage rating curve presented in the 2003 Town of Scituate Drinking Water Supply and Demand Analysis (CEI 2003). This storage rating curve was also used for the 2012 Water Evaluation and Planning (WEAP) model (Kearns 2012).

Reservoir Dam has a storage volume of 476.6 ac-ft at the spillway crest El. 40.0 ft according to these data. The LIDAR data indicates that Reservoir Dam has a surface area of approximately 69.5 acres. Raising normal pond to El. 41.0 ft would increase the storage volume by 73.3 ac-ft to 549.9 ac-ft. Similarly, raising the storage elevation to EL 43.0 ft would increase the storage volume by 254.6 ac-ft (53%) to 730.2 ac-ft.

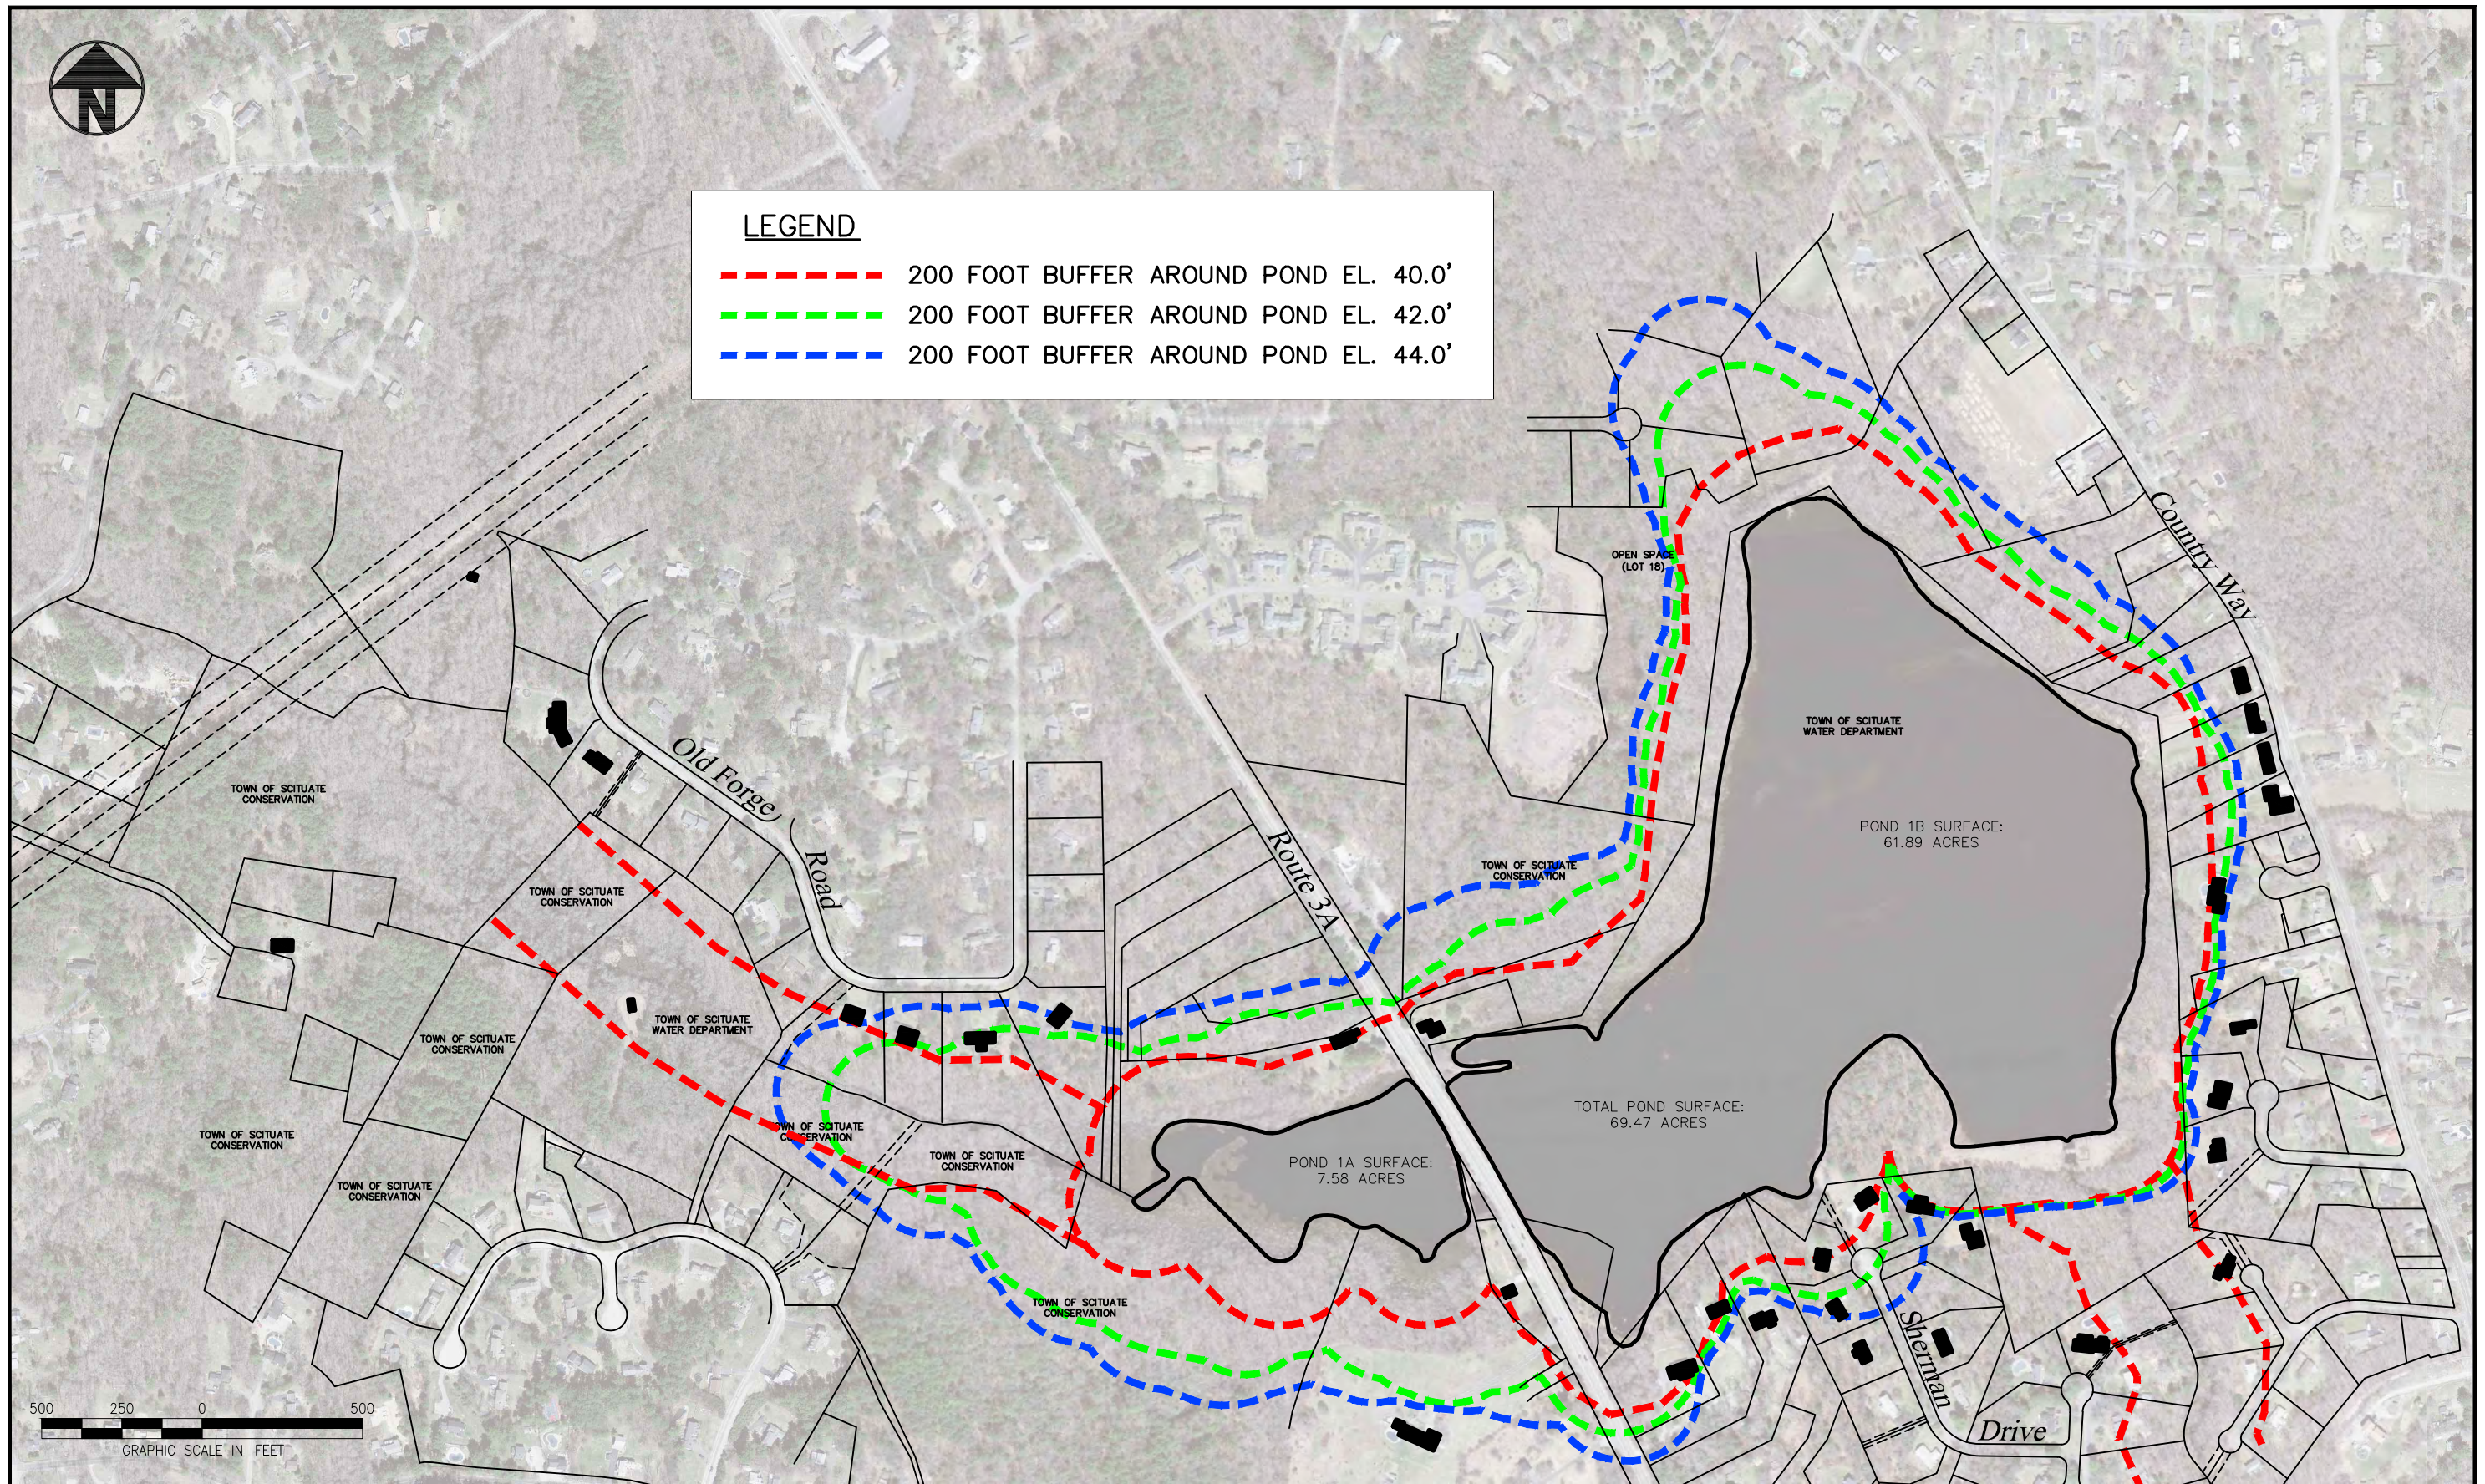
Figure 5 illustrates the 200 ft buffer zone around Reservoir Dam Pond for the normal water level at El. 40.0 ft, El. 42.0 ft, and El. 44.0 ft. The total buffer zone area around Reservoir Dam Pond is 52.5 acres above normal pond El. 40.0 ft, 84.7 acres above El. 42.5 ft, and 107.3 acres above El. 43.5 ft. Deducting Town owned land from these acreages, private land impacted by this 200 ft buffer zone would be approximately 18.4 acres, 24.0 acres, 29.7 acres, 31.7 acres, and 37.5 acres for El. 40.0 ft, El. 41.0 ft, El. 42.0 ft, El. 42.5 ft, and El. 43.5 ft pond levels, respectively.

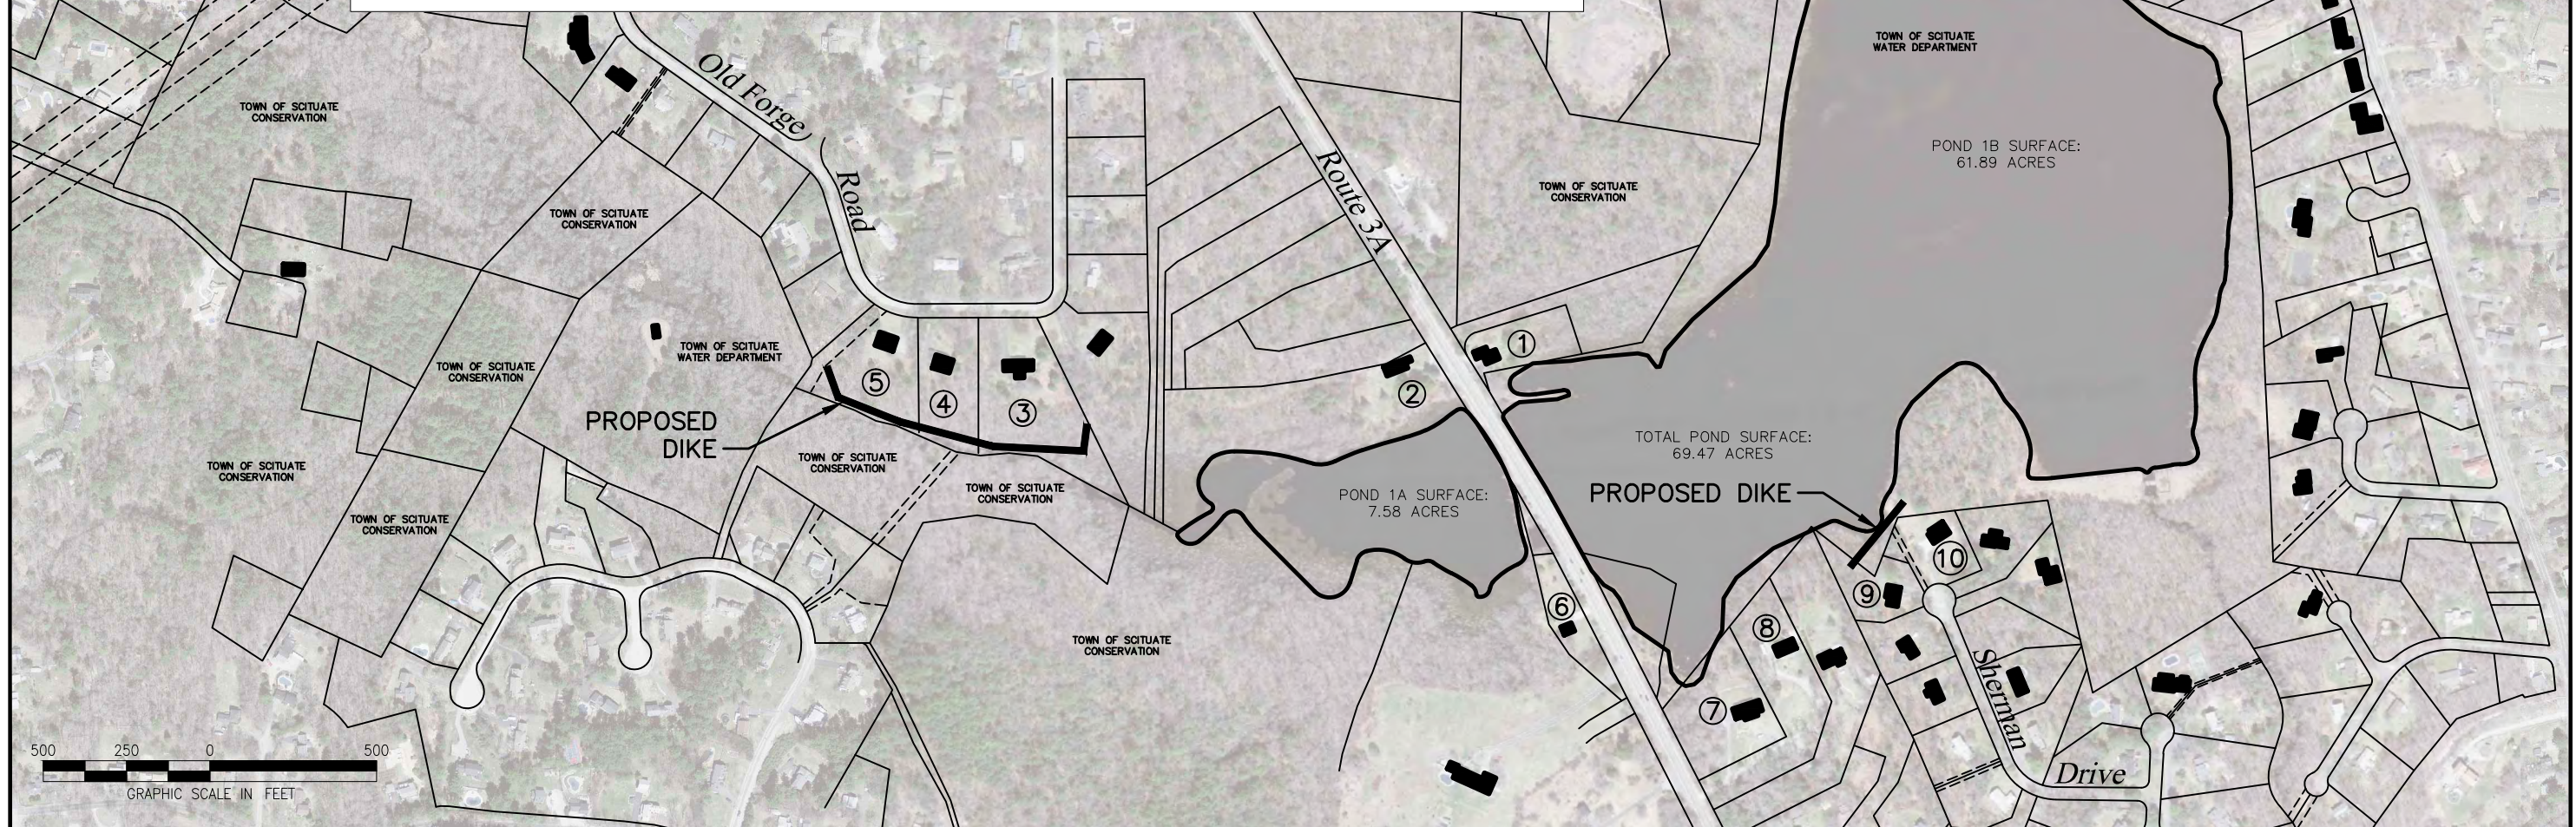
1. POTENTIAL IMPACTED PROPERTY DESIGNATED BY #
2. OPTION A – POND EL. 42.0 FT MITIGATION MEASURES
  - RAISE HOUSE, CONSTRUCT NEW FOUNDATION, AND FILL YARD FOR ①,②, AND⑥ .

- RAISE HOUSE, CONSTRUCT NEW FOUNDATION, AND FILL YARD FOR ①,②, AND⑥ .
  - EXTEND SEWER LINE FOR ①,②, AND⑥ .
  - UPGRADE SEPTIC SYSTEMS FOR ③,④, AND⑦ .

- CONSTRUCT FLOOD PROTECTION DIKES FOR ③ AND ⑨ .
4. OPTION C – POND EL. 43.5 FT MITIGATION MEASURES
  - RAISE HOUSE, CONSTRUCT NEW FOUNDATION, AND FILL YARD FOR ①,②, AND⑥ .

- EXTEND SEWER LINE FOR ①,②, AND⑥ .
  - UPGRADE SEPTIC SYSTEMS FOR ③,④,⑤,⑦, AND ⑧ .
  - CONSTRUCT FLOOD PROTECTION DIKES FOR ③,④,⑤,⑨, AND ⑩ .
5. OPTION D – POND EL. 40.0 FT MITIGATION MEASURES

- EXTEND SEWER LINE FOR ①,②, AND ⑥ .

In addition to the properties identified above that would have shoreline impacts, there are five (5) houses that could be impacted by higher water levels in Reservoir Dam Pond and Tack Factory Pond. These houses, which are shown on Figure 6 and identified as #3, #4, #5, #9, and #10, could be protected by earthen dikes. The earthen dikes would be sized to prevent overtopping during normal conditions would assure that the property would be useable except during flood conditions. If normal pond level is limited to El. 41.0 ft or lower, no dikes would be required to protect these houses and property.

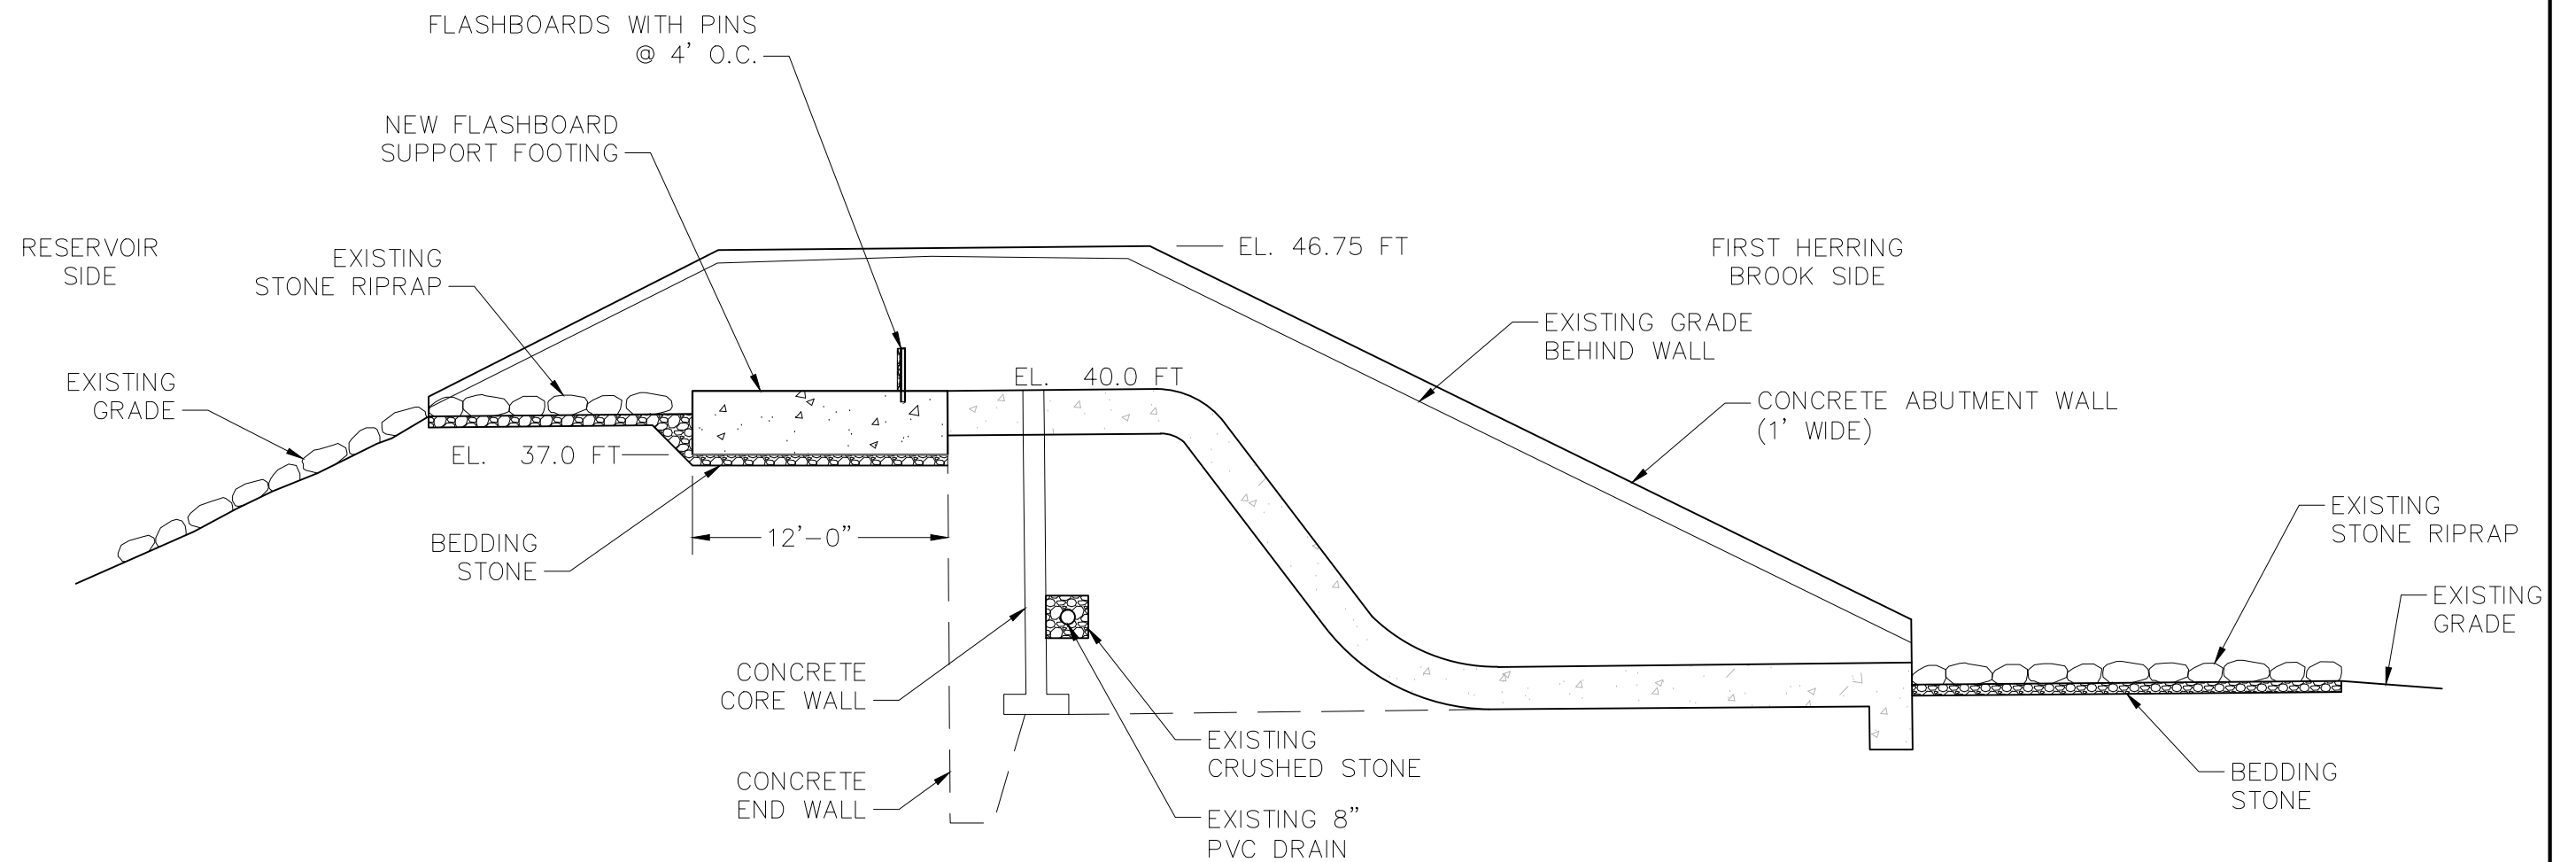
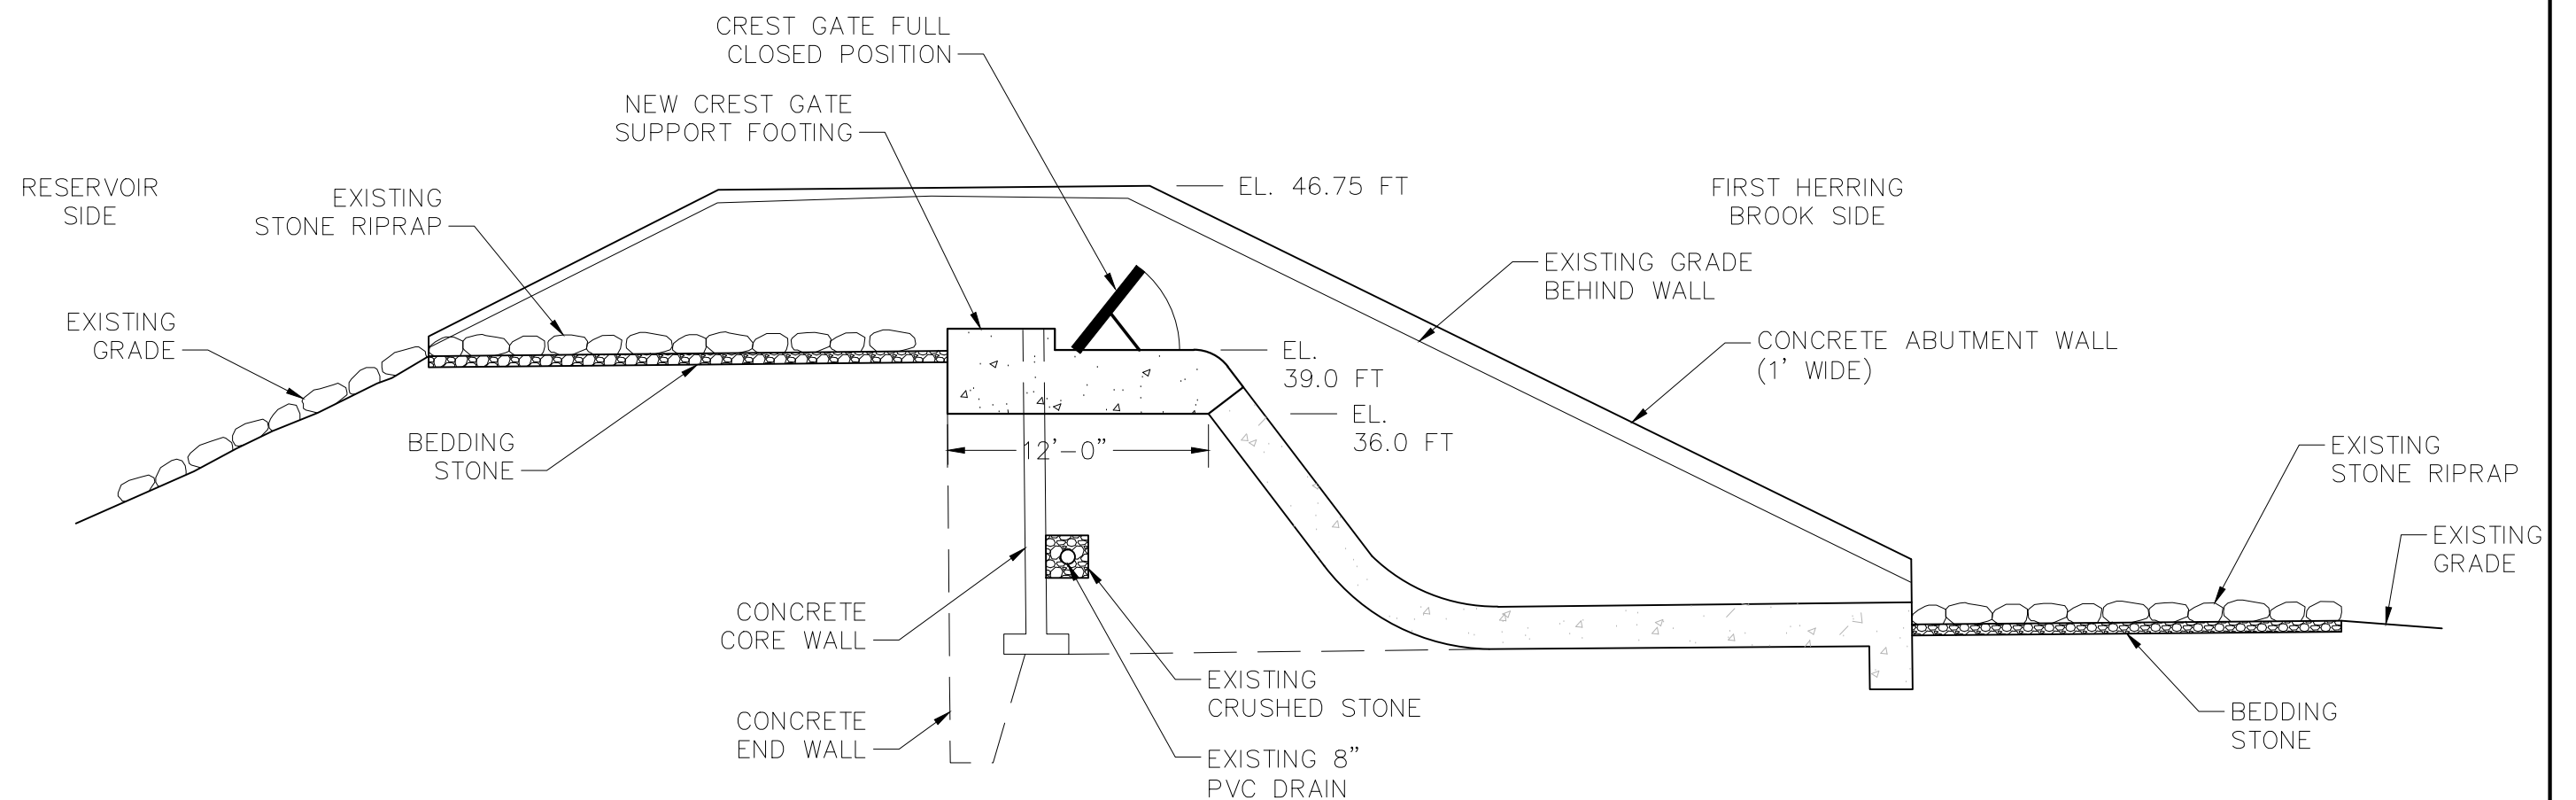
A bottom-hinged crest gate could be installed on the Reservoir Dam Spillway as shown on Figure 8. The spillway crest would have to be modified to incorporate a concrete footing sized to resist the hydrostatic forces on the gate without jeopardizing the stability of the spillway.

The new gate support would be doweled to the existing concrete core to eliminate a potential seepage flow path. The footing would be recessed such the face of the gate in the open position would be below the existing spillway crest to maintain the existing spillway discharge capacity. The actual gate height assumed for this study would be 6 inches higher than the height of the pond elevation above the spillway crest (i.e., a 2 ft increase in normal pond to El. 42.0 would require a 2.5 ft high crest gate).

The gate would have a single operator on the west side of the spillway to facilitate access by DPW personnel. The gate could have a manual, electric motor, or hydraulic operated. A motor or hydraulic operator would require the existing underground electric service to the low-level outlet control valve to be upgraded operated for the new electric load. An electric motor or hydraulic system would both have 5 HP motors. For this study, the power line on Sherman Drive has been assumed to be adequate for the additional load and the underground cable would only be changed out from the Sherman Drive cul-de-sac.

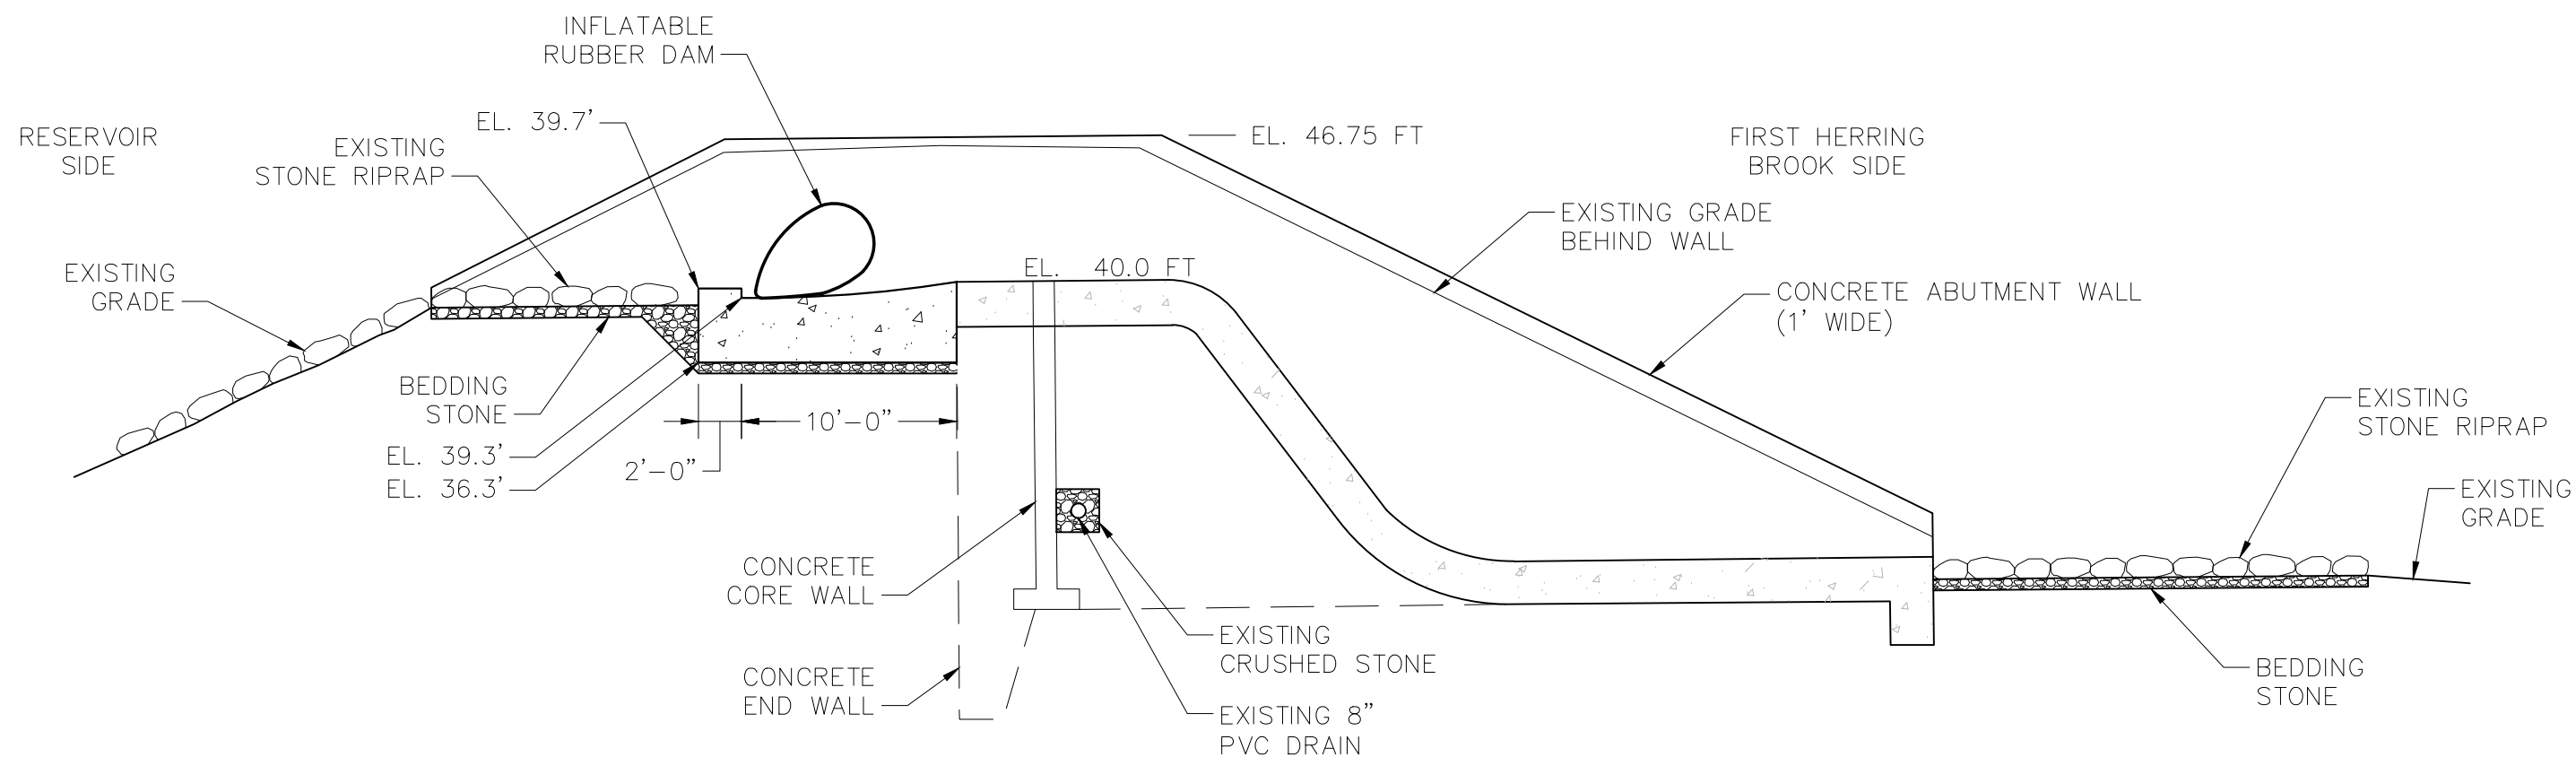
An inflatable rubber dam could be installed on the Reservoir Dam Spillway as shown on Figure 9. The spillway crest would be modified to incorporate a concrete footing sized to resist the hydrostatic forces on the inflatable dam without jeopardizing the stability of the spillway. The inflatable dam footing would be similar to the flashboard footing, but could be similar to the crest gate footing. The actual inflated dam height would be 6 inches higher than the height of the pond elevation above the spillway crest similar to the crest gate option.

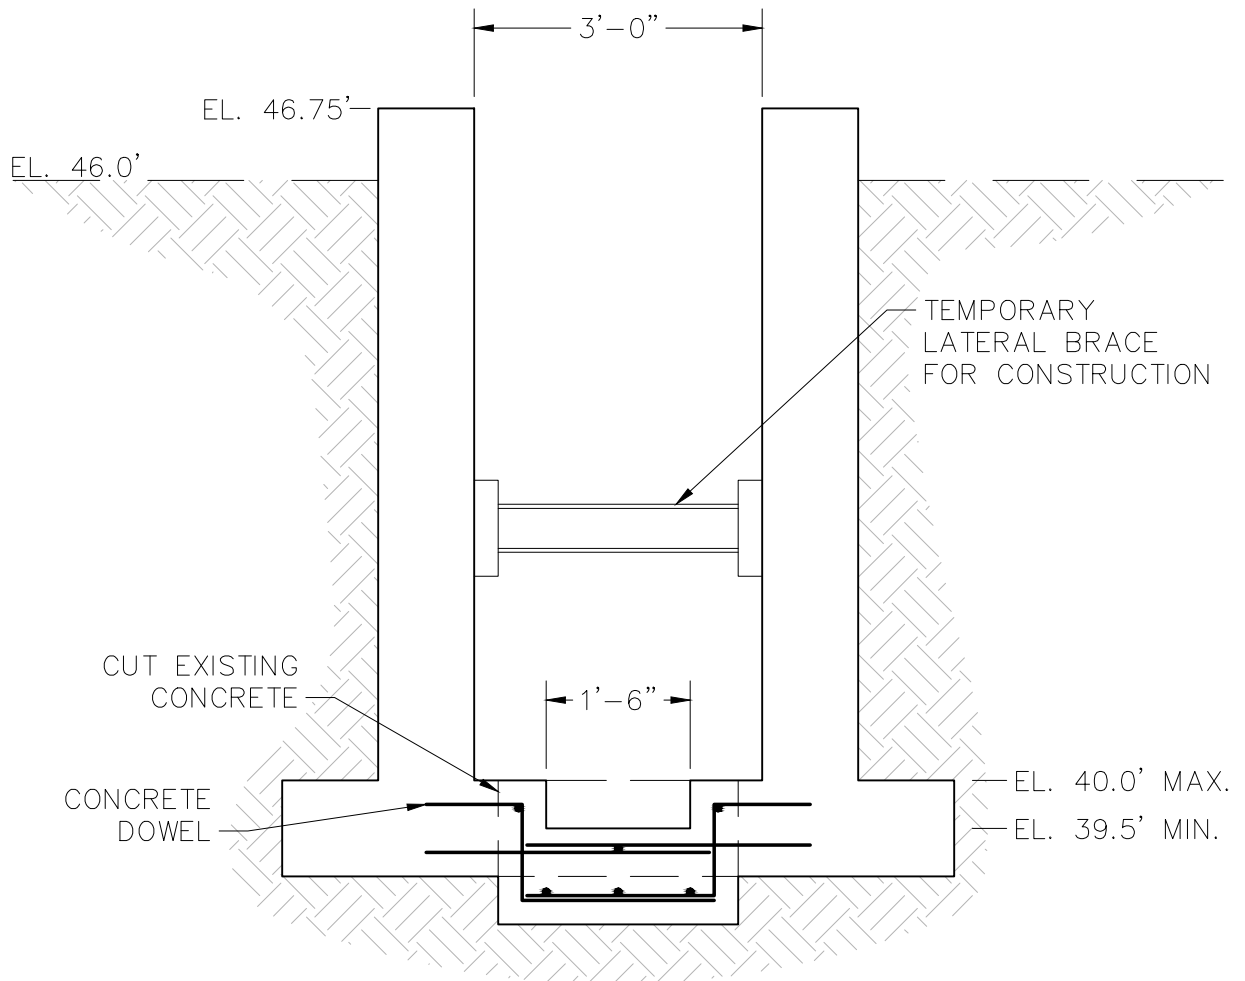
FISHWAY MODIFICATIONS FOR  
EXIT CHANNEL NOTCH  
FIGURE 10

The fishway exit channel would be modified to incorporate a 6 inch deep, 18 inch wide notch in the concrete bottom as shown on Figure 10. The modifications could be completed without excavation of dam embankment; however, lateral braces between exit channel walls would have to be installed with sawcutting of the exit channel bottom slab completed around the braces. The construction contractor would be required to submit a stability analysis of the fishway walls during construction of the notch prior to initiating any the work. The analysis should be stamped by a licensed Geotechnical Engineer.

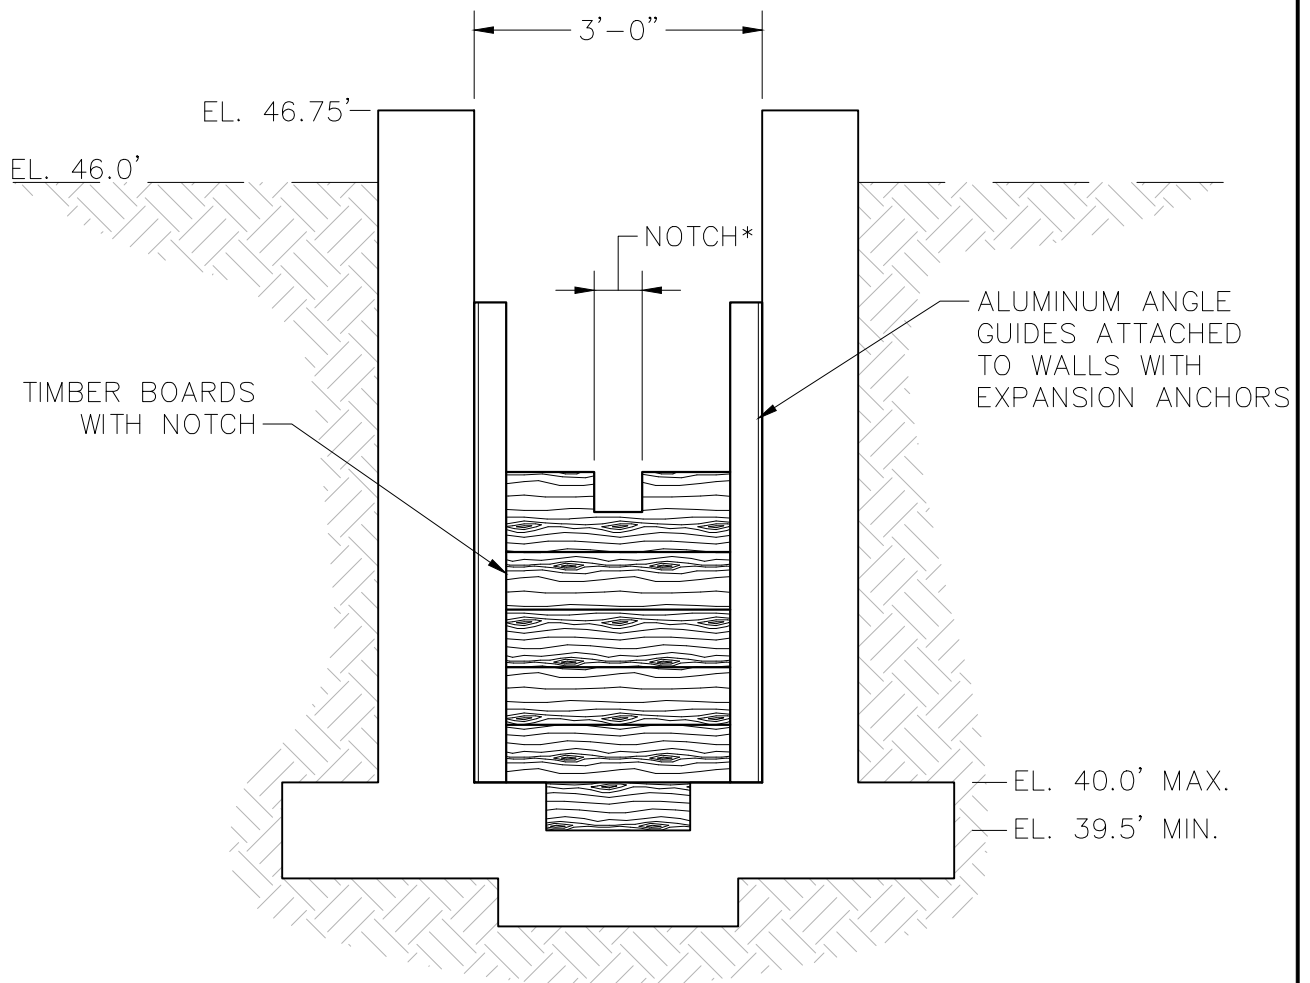
FISHWAY MODIFICATIONS FOR  
 EXIT CHANNEL REMOVABLE WEIRS  
 FIGURE 11

Seven (7) Removable weirs as shown on Figure 11 would be installed in the existing fishway exit channel to meet USFWS criteria for upstream and downstream fish passage (USFWS 2010). The removable weirs would extend the operating range for the fishway from El. 40.0 ft up to El. 43.0 ft with the notches ranging between El. 39.5 ft up to El. 42.0 ft. Aluminum angles would be installed on the fishway exit walls to form support slots for the removable weirs. Slots would be incorporated in the channel bottom notch to support stoplogs in the notch at pond levels higher than El. 40.5 ft. The removable weirs would extend to El. 43.5 ft (6 inches above the maximum pond level with the spillway flashboards in place) and would have an 18 inch wide notch for upstream passage. A second set of removable weirs would have a 6 inch wide notch for downstream passage similar to the removable weirs installed at the Old Oaken Bucket Dam fishway. In addition, the removable weirs at the Old Oaken Bucket fishway would be retrofitted with new notched weirs matching the Reservoir Dam fishway weirs to reduce fishway flow during the spring migration.

\*NOTCH NOTE:  
 6" WIDE X 5" DEEP NOTCH  
 FOR DOWNSTREAM PASSAGE

18" WIDE X 8" DEEP NOTCH  
 FOR UPSTREAM PASSAGE
