**FEASIBILITY REPORT  
RESERVOIR DAM MODIFICATIONS  
FOR HIGHER POND LEVELS  
FIRST HERRING BROOK FISH PASSAGE IMPROVEMENTS**

26 June 2013  
EA Project No. 62651.02

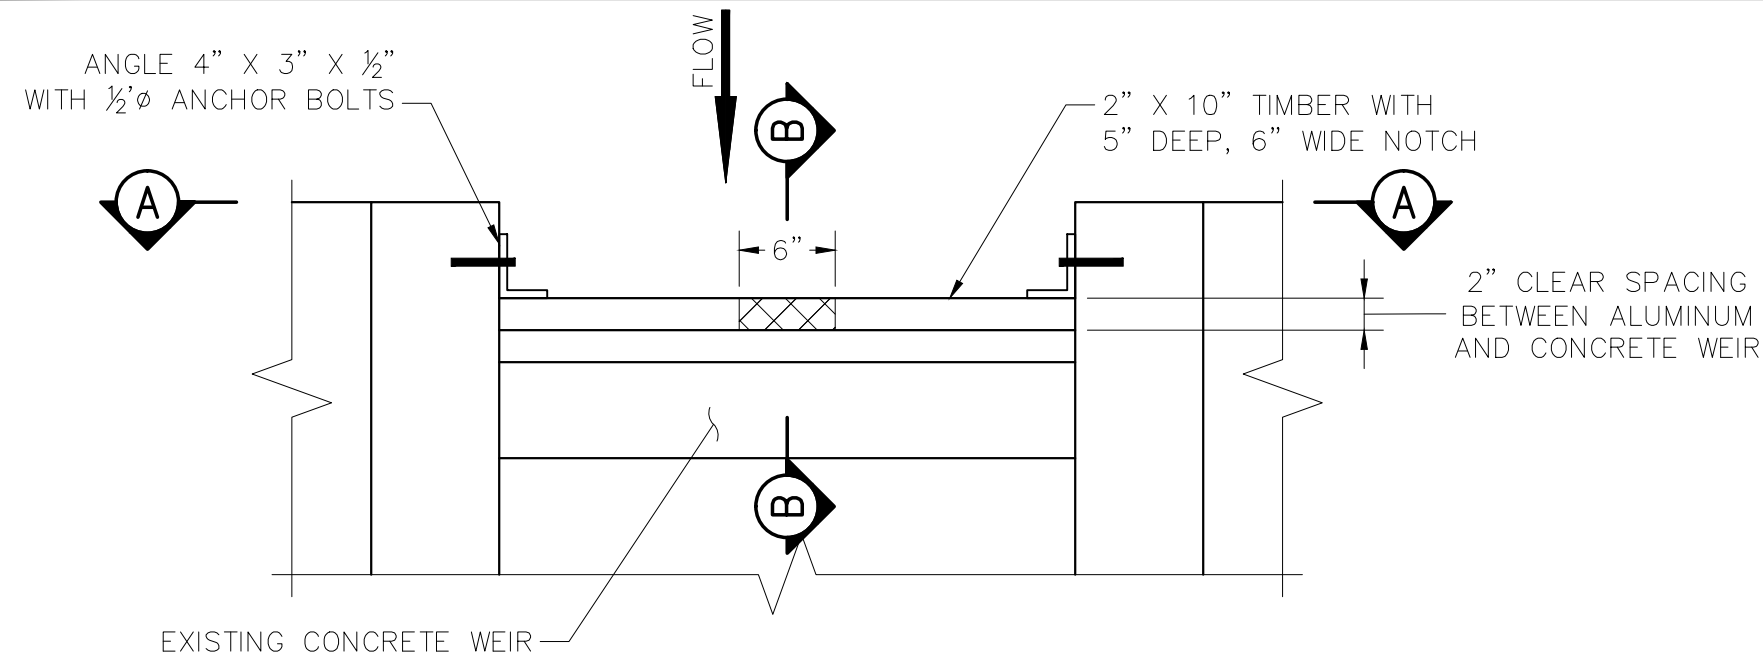
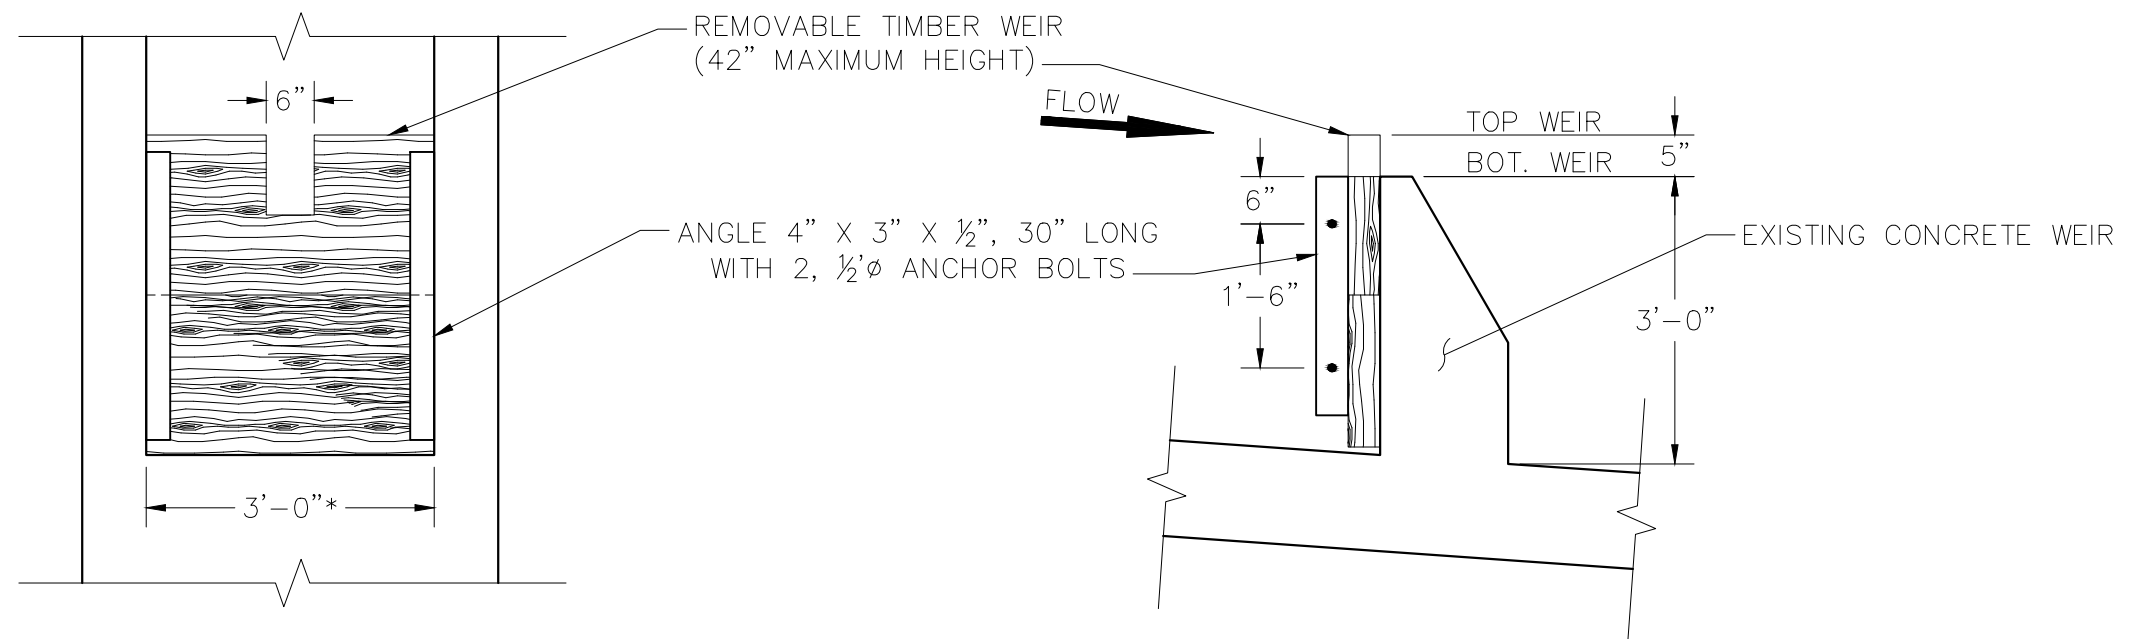
TYPICAL FISHWAY CONCRETE WEIR MODIFICATIONS  
FIGURE 12

The existing fishway weirs at Reservoir Dam would be modified to incorporate removable weirs similar to the Old Oaken Bucket removable weirs as shown on Figure 12. The removable weirs would reduce the fishway flow with an 18 inch notch width providing an 8 inch minimum depth during the upstream migration period and a 6 inch notch width with a 5 inch minimum depth during the downstream migration period. In addition, removable weirs with an 18 inch notch would be installed in the Old Oaken Bucket Fishway for upstream passage.

**WEIR PLAN**  
SCALE: 1" = 1'-0"

**SECTION A-A**  
SCALE: 1/2" = 1'-0"

**SECTION B-B**  
SCALE: 1/2" = 1'-0"

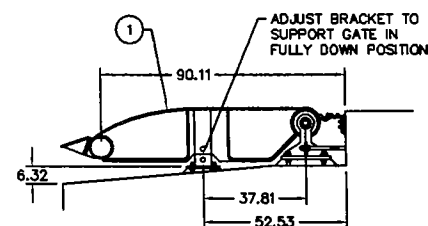
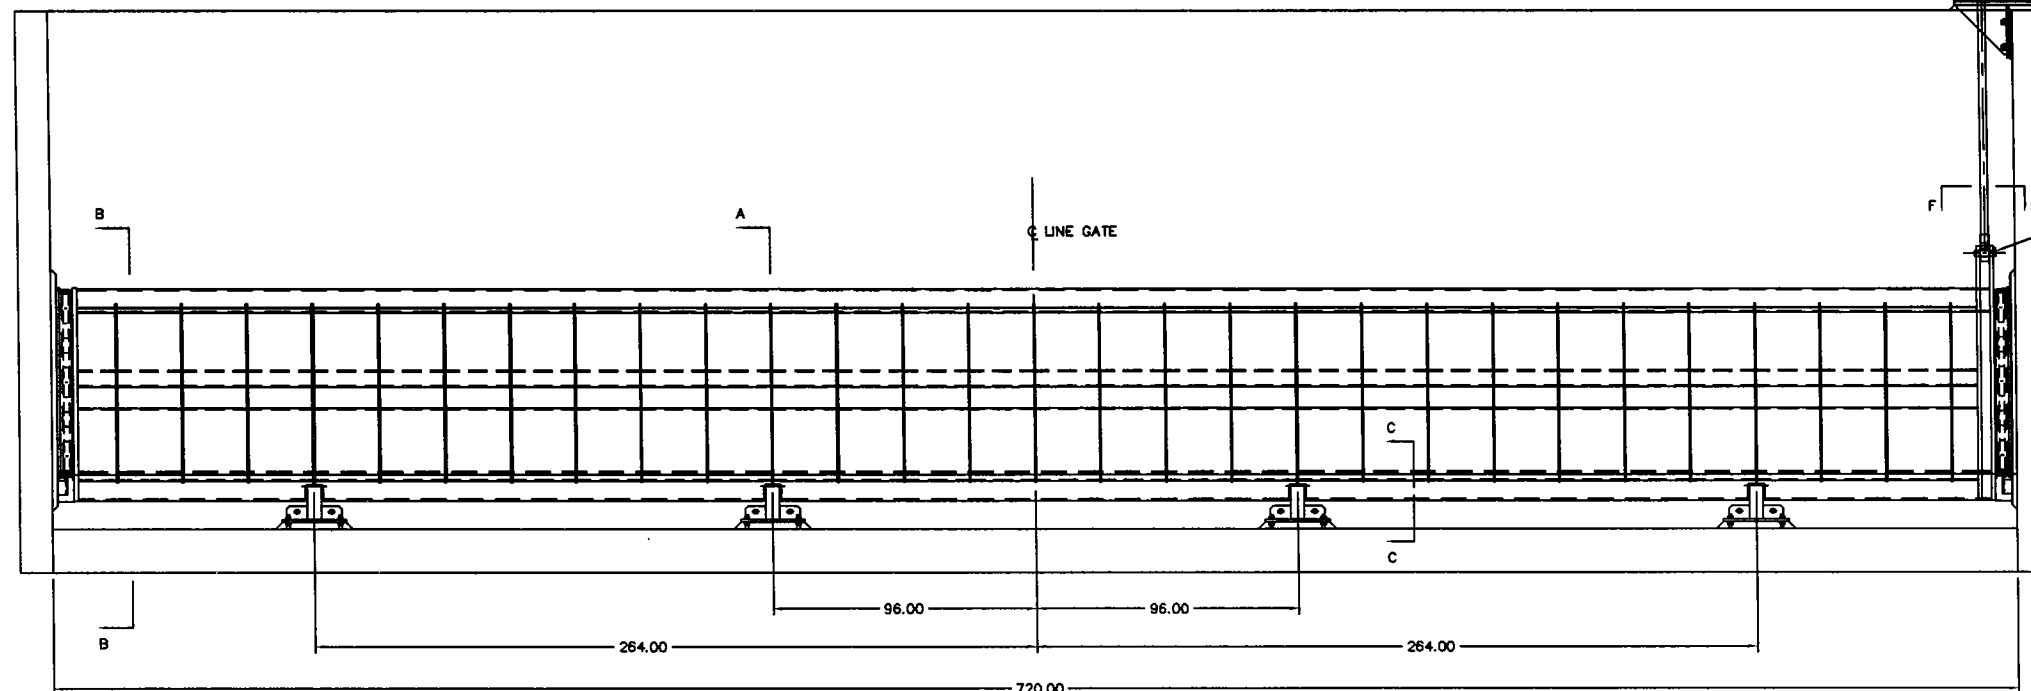
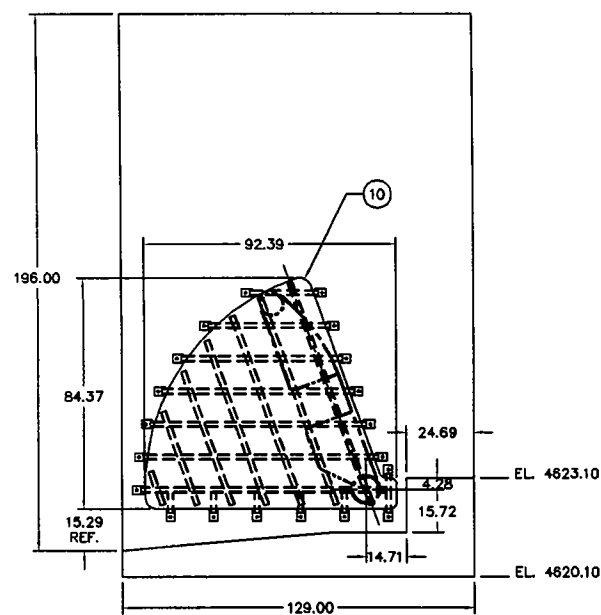
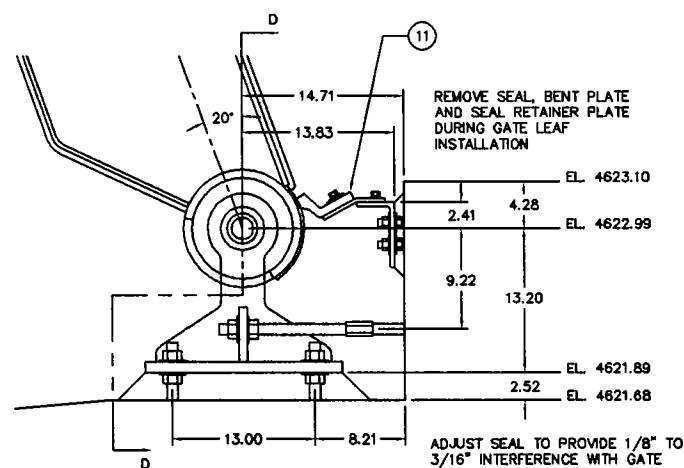
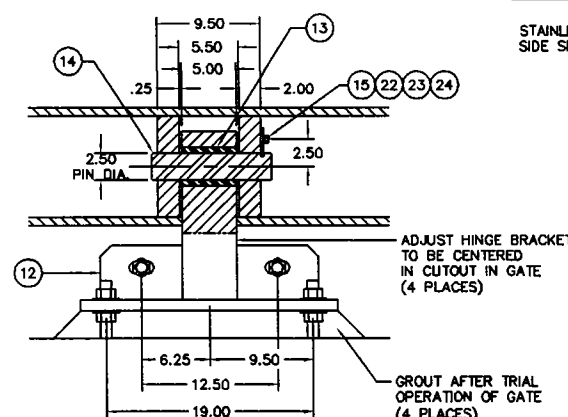
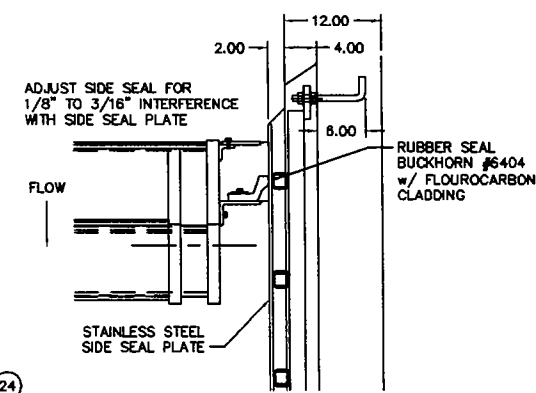
# **REPRESENTATIVE SPILLWAY CREST GATE INSTALLATION**

SECTION A-A  
(WITH GATE FULL UP)

**SECTION A-A**  
**(WITH GATE FULL DOWN)**

VIEW LOOKING UPSTREAM

SECTION B-B  
GATE LEAF NOT SHOWN FOR CLARITY

SECTION C-C

**SECTION D-D**
