Route 114 Safety Improvements Project Danvers/Peabody

*MassDOT in collaboration with Representative
Tom Walsh's Office, Representative Sally
Kerans' Office, and Senator Lovely 's Office*

Peabody Municipal Safety Committee | October 27 | 6pm

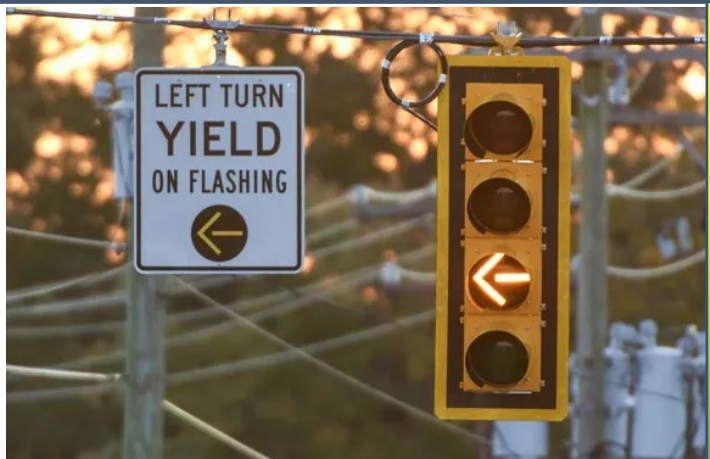
Existing

- STOP.** Left-turning drivers must stop and wait.
- WARNING / CAUTION.** The left turn signal is changing to red.
- CAUTION.** You may cautiously turn left **after** yielding to oncoming traffic and to pedestrians (similar to a green ball). Oncoming traffic will typically have a green light.
- GO.** Left-turning drivers have the right of way.

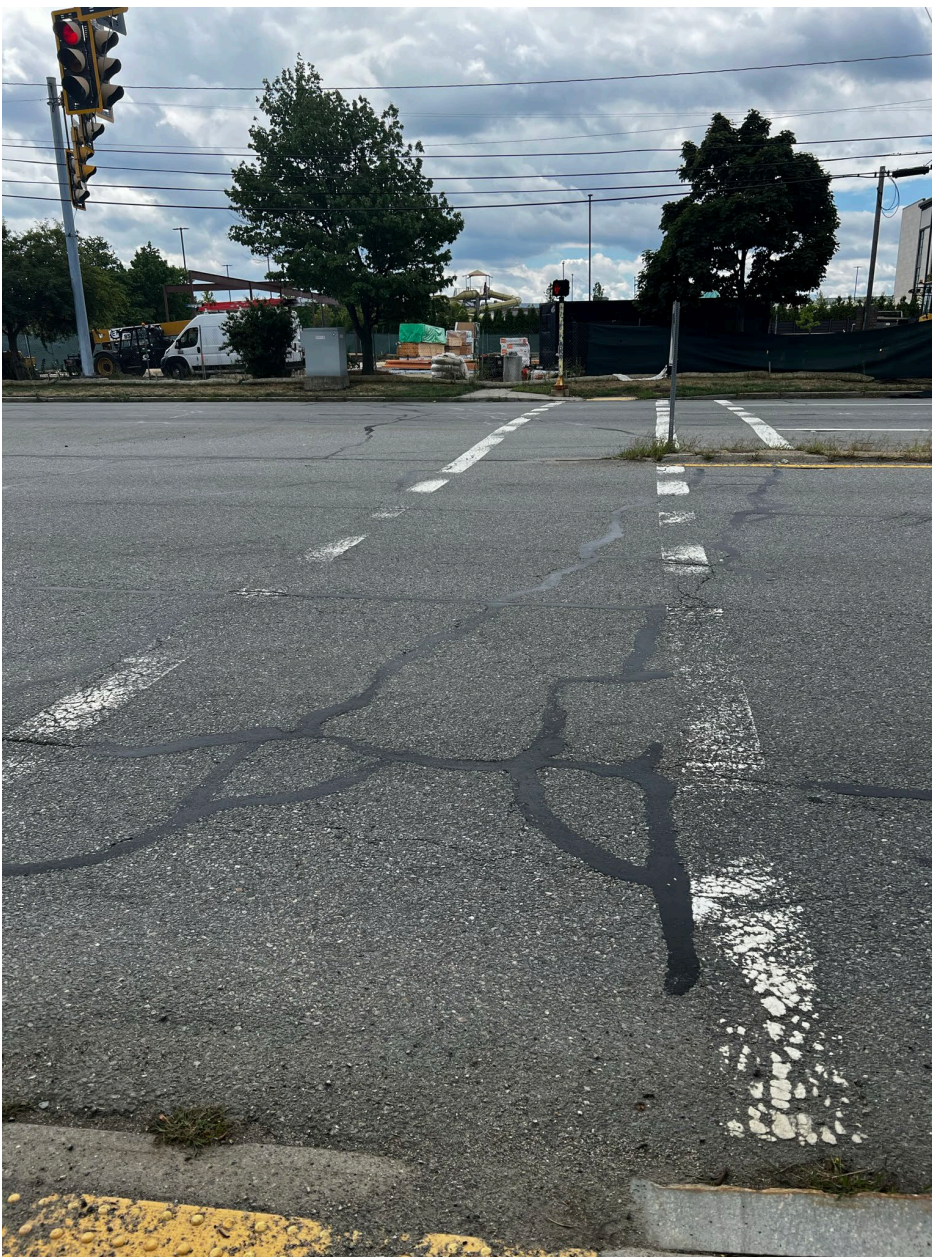
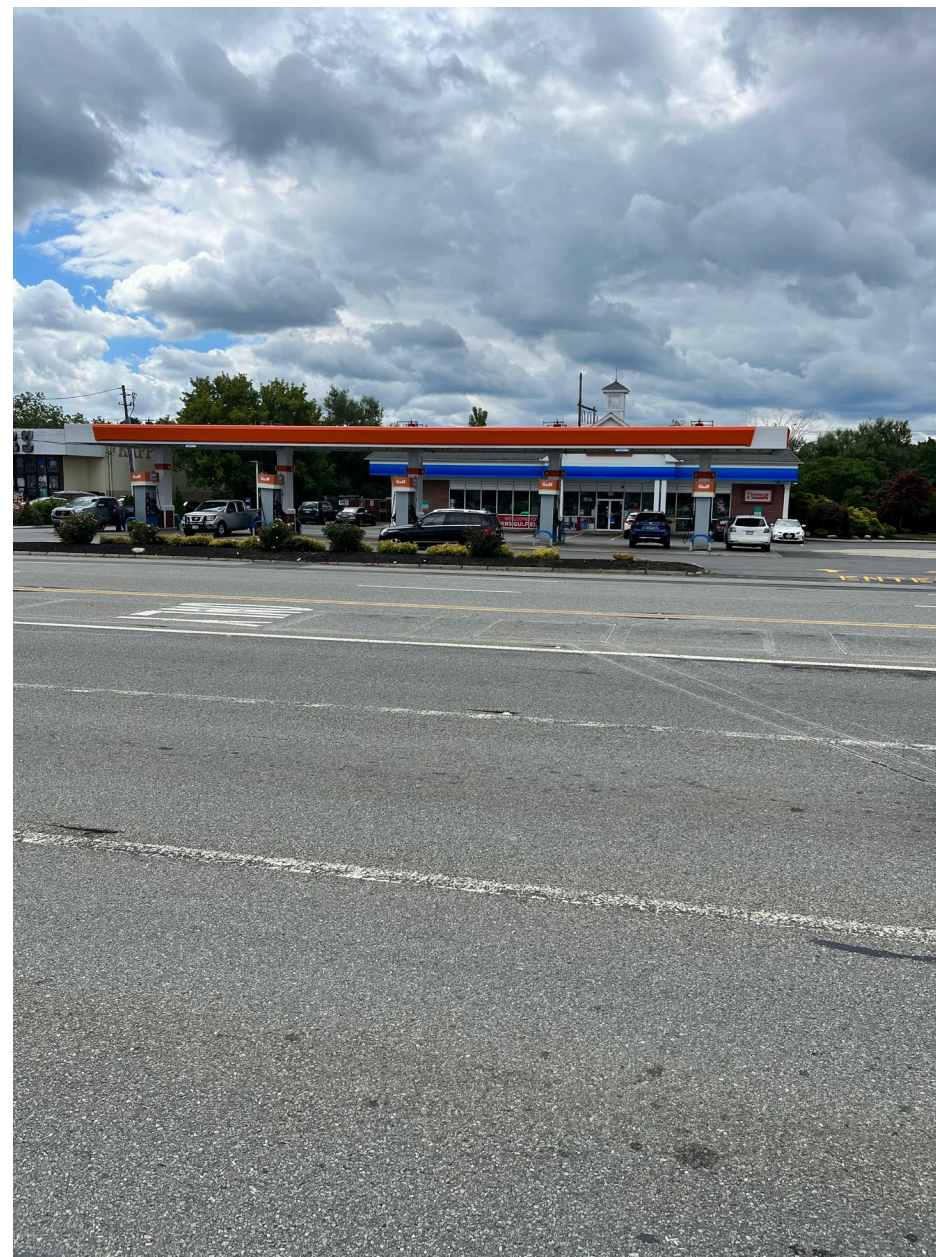
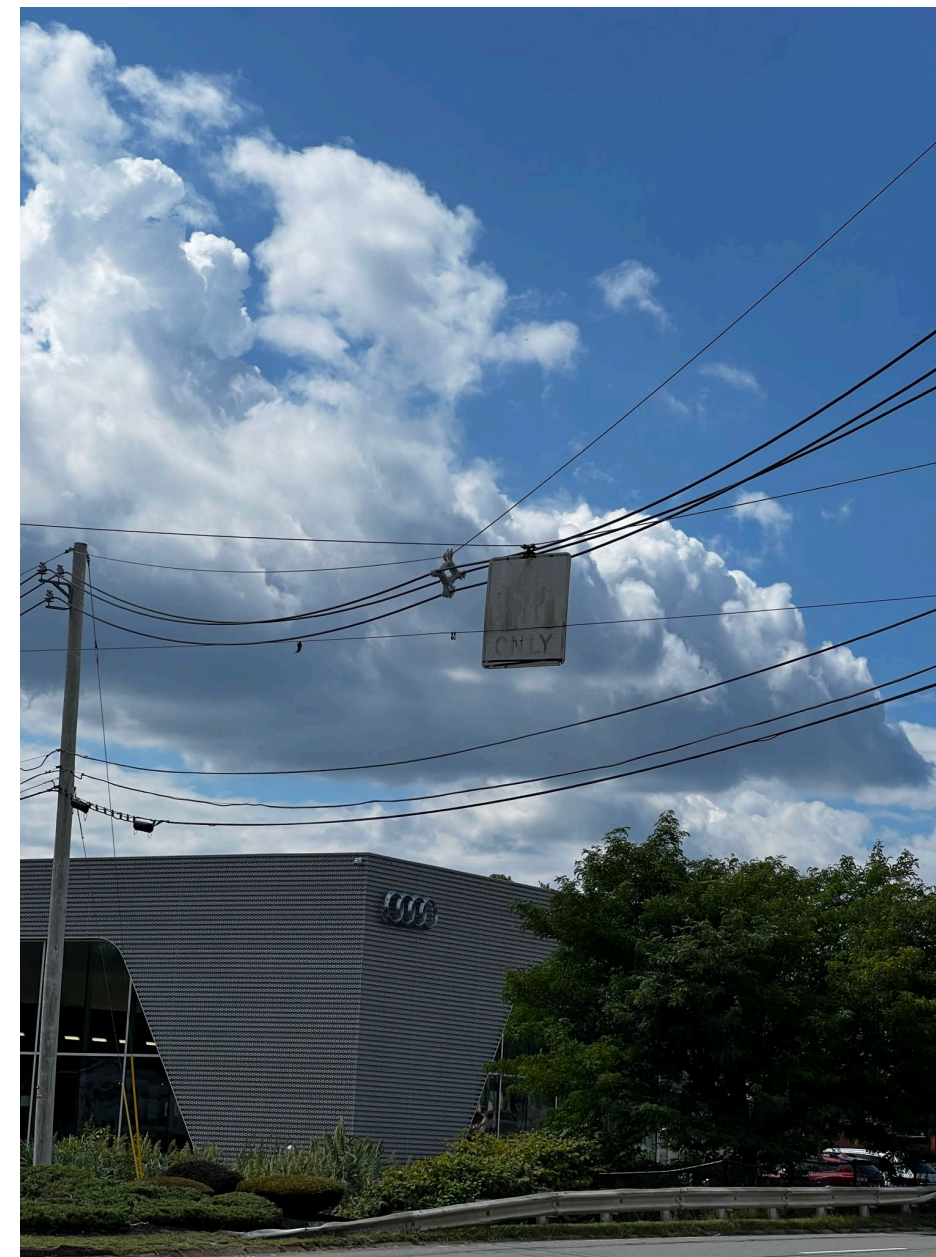
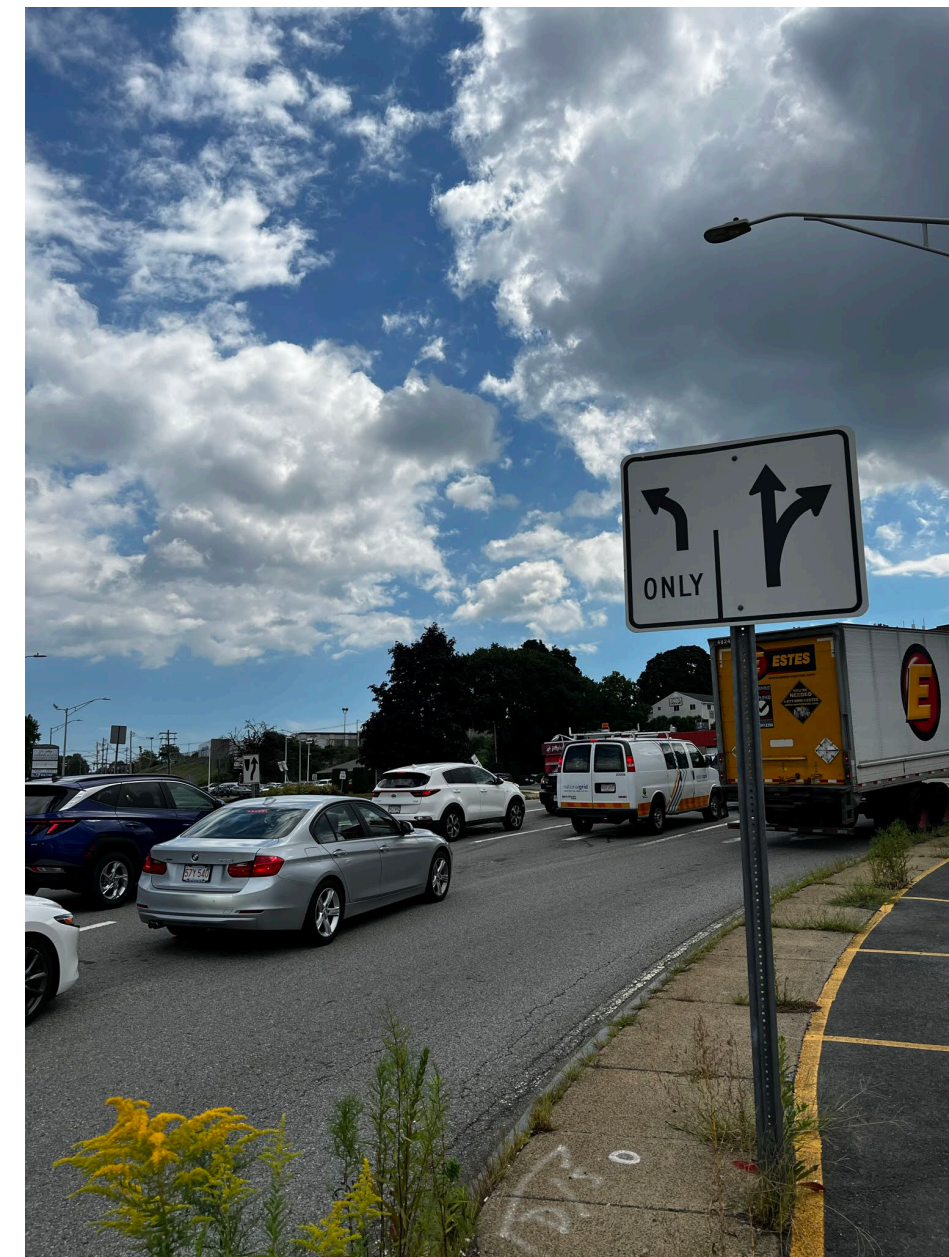
Design Development: Pavement Markings & Signage

- Pavement markings are faded or missing in some locations, especially problematic at crosswalks
- Some existing signs are damaged, faded, or missing

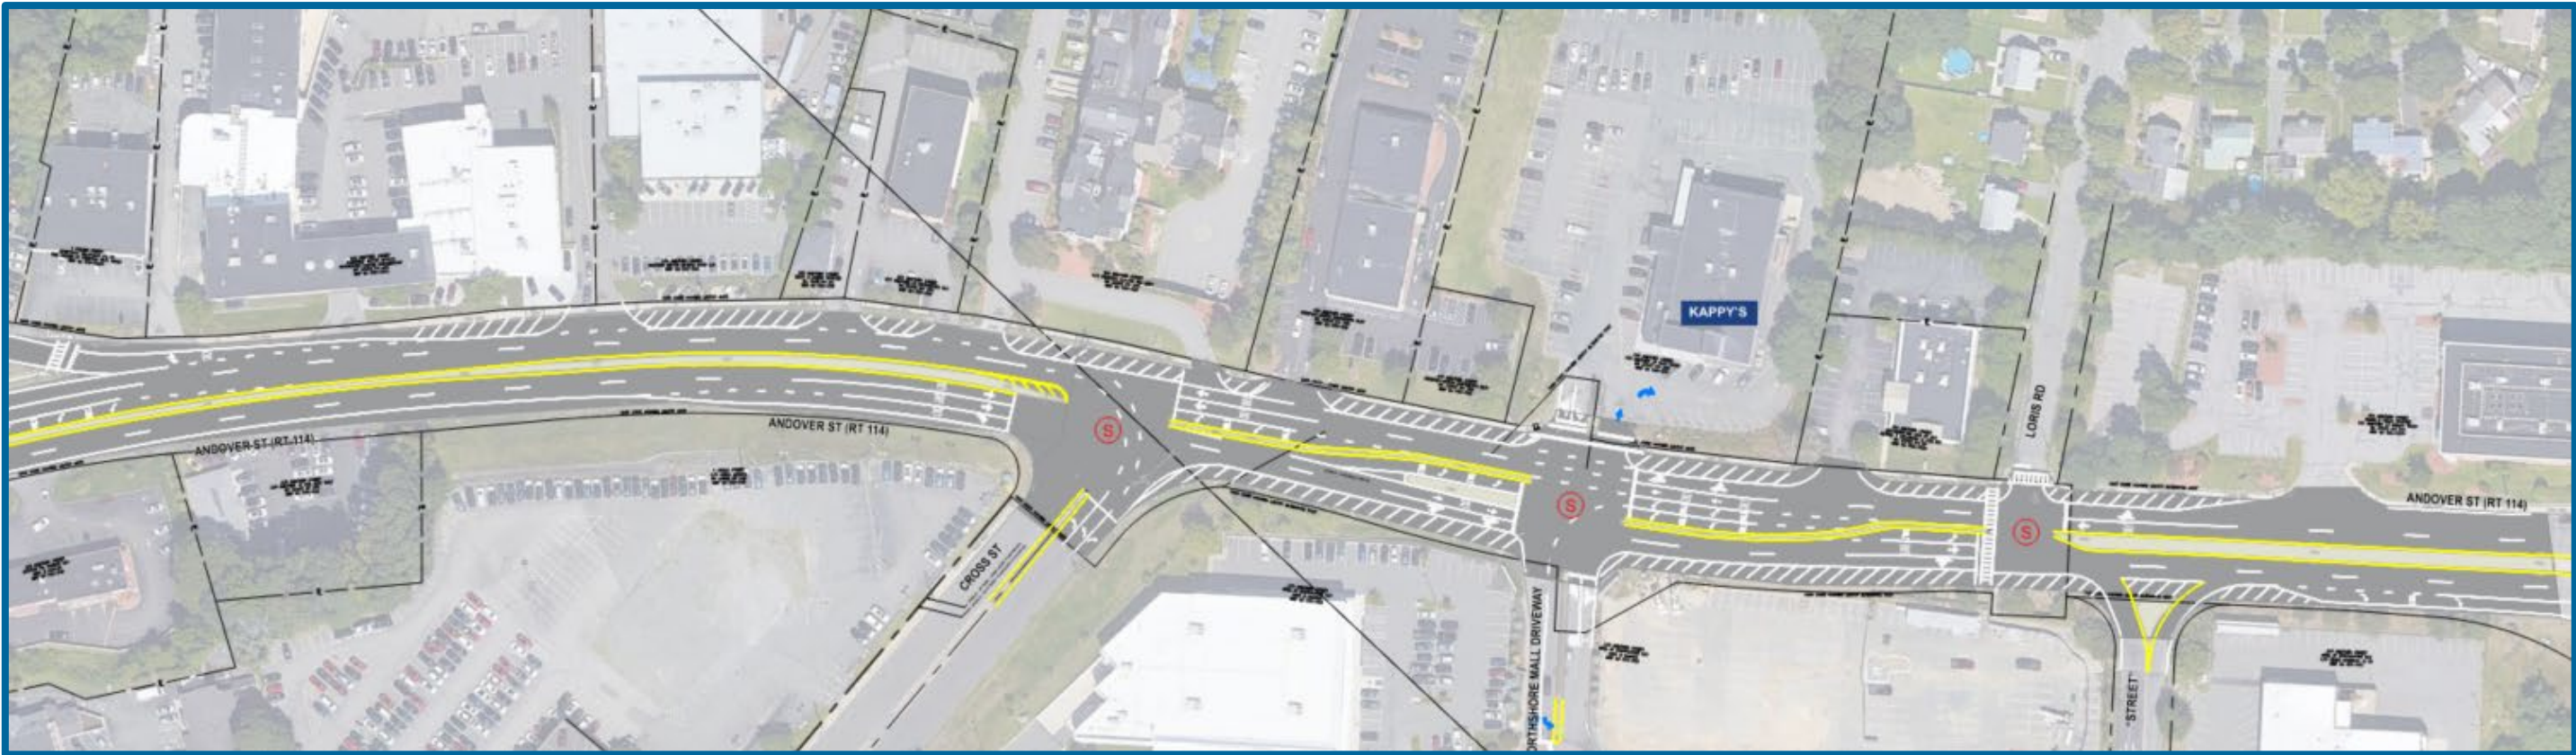
Design Development: Remove Extra Travel Lane

Reduces crashes related to weaving and merging

Improve sight distance of Route 114 drivers of Loris Road to reduce red-light running here

Reduces speeds and conflicts

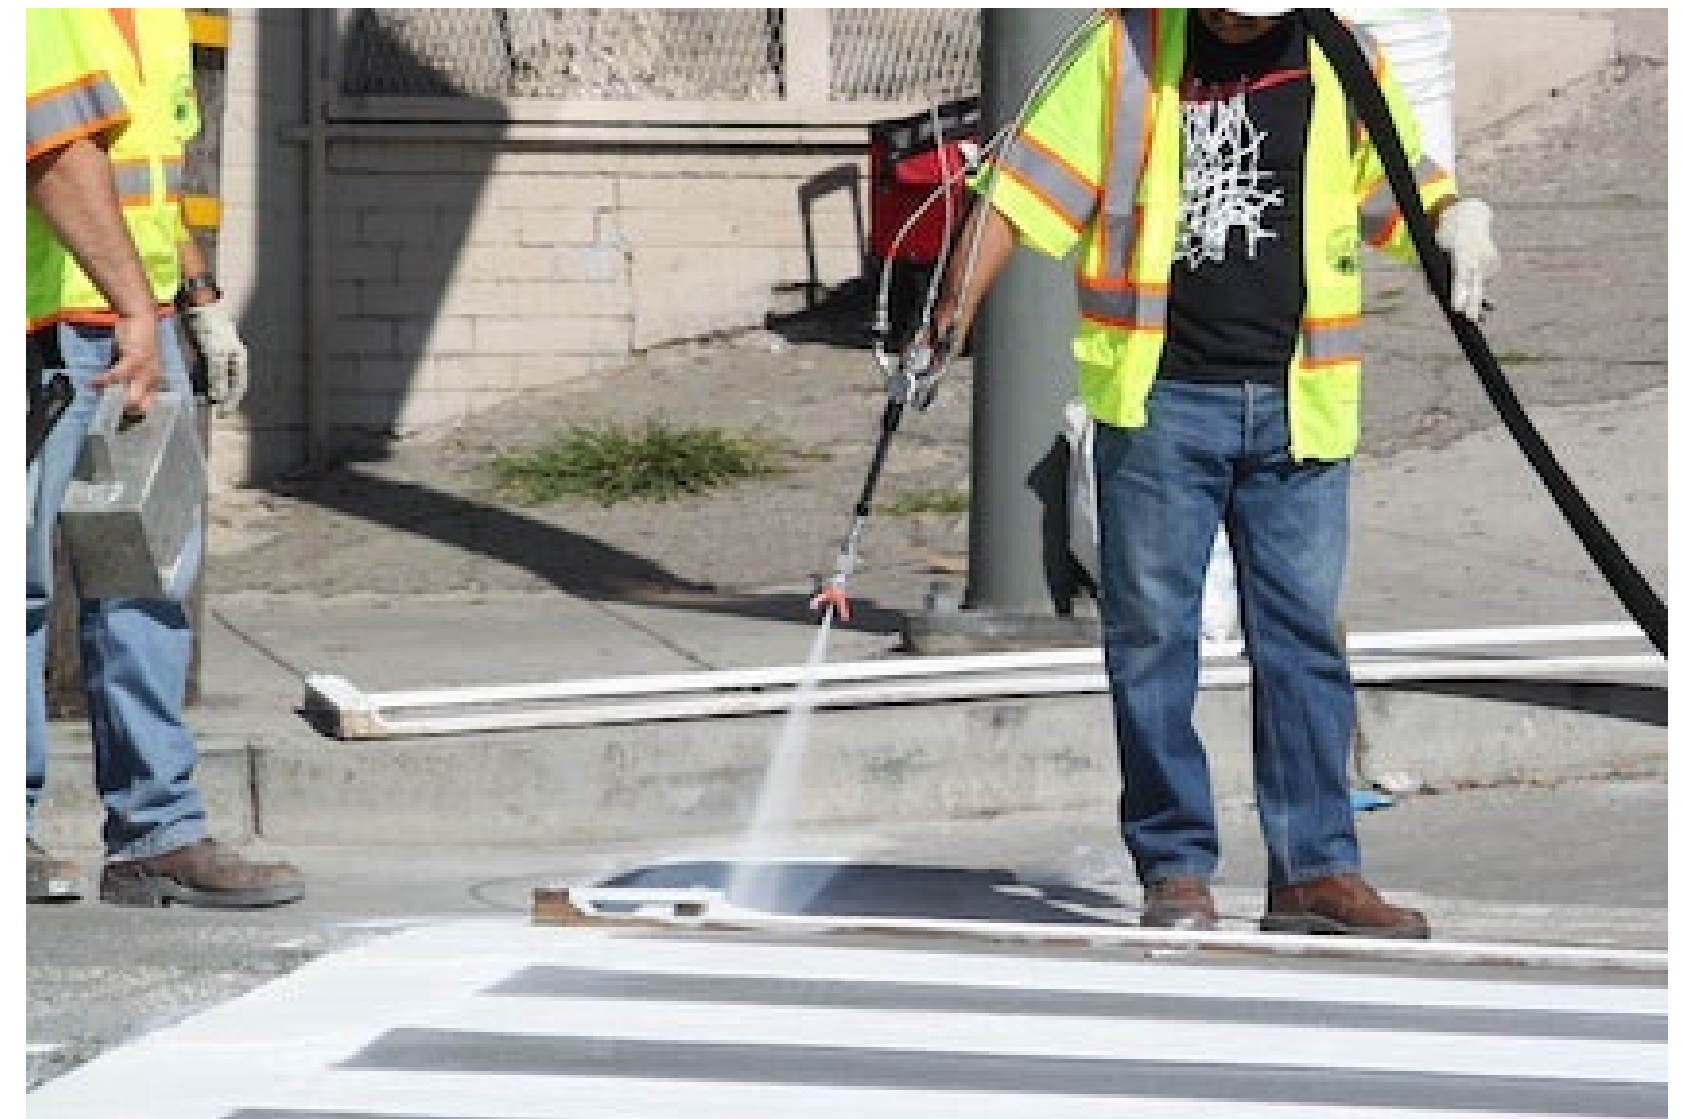
Next Steps: Tier 1 Implementation Update

- 🚦 Signal work: Mostly complete; pending pedestrian equipment
- 🚶 Pavement markings: white markings done, yellow and crosswalk pending
- 🚶 Curb ramps: anticipated this week
