Massachusetts Coastal Infrastructure Inventory and Assessment Project Coastal Hazards Commission

Cape Cod Islands

Massachusetts Department of Conservation and Recreation Hingham, Massachusetts

Bourne Consulting Engineering Franklin, Massachusetts

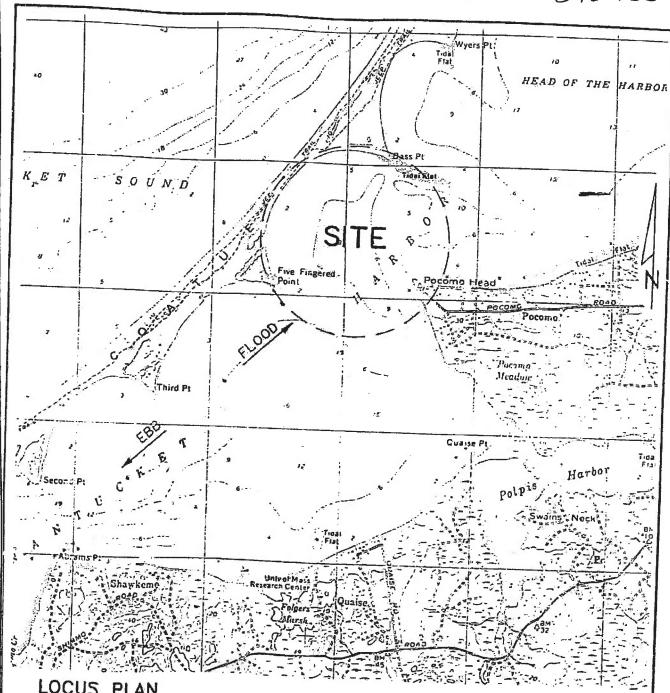
LOCUS PLAN

NANTUCKET HARBOR DREDGING NANTUCKET, MASSACHUSETTS NANTUCKET COUNTY

PLAN FROM U.S.G.S. MAP "SIASCONSET, MA" 1972, UPDATED 1977

SCALE: 1" = 2083" ELEVATIONS IN FEET ABOVE NGVD 1929 SOUNDINGS IN FEET BELOW MLW

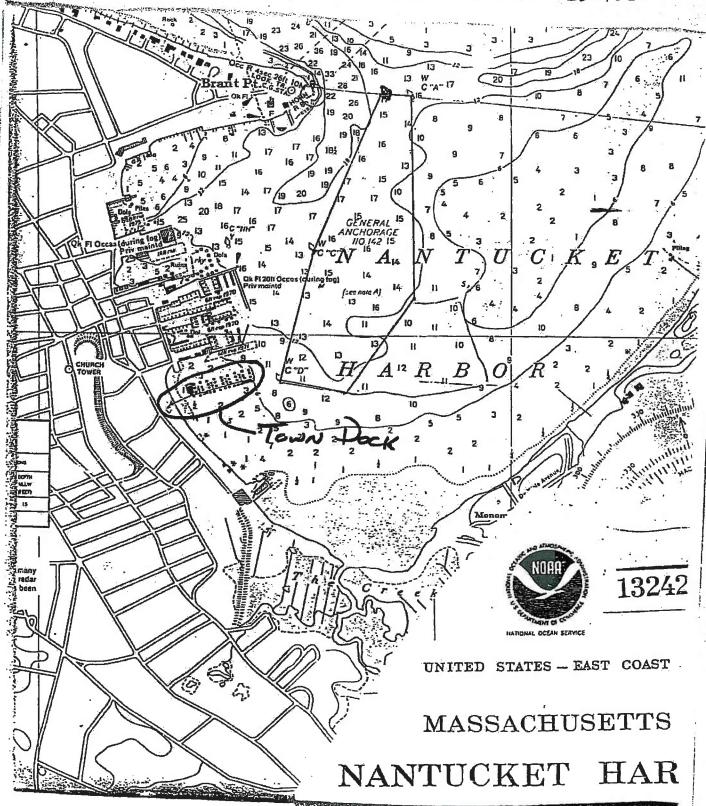
048-042-004-029-100

Town of Nantucket, MA Rental Moorings U.S. Coast Guard General Anchorage Sheet 2 of 5

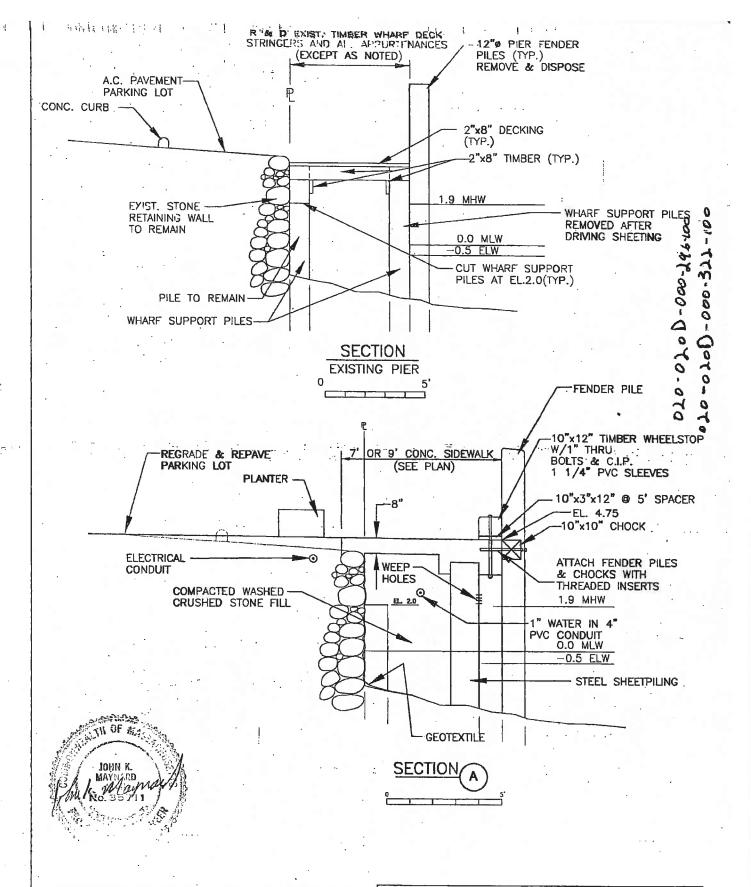
License Plan no. 5403 Approved by Department of Environmental Frotection

- 1. ELEVATIONS REFER TO MEAN LOW WATER (MLW) DATUM.
 2. APPROXIMATELY 320 CU. YDS. OF COMPACTED CRUSHED STONE FILL WILL BE PLACED BEHIND THE PROPOSED STEEL SHEETPILE BULKHEAD.
 3. EXCEPT WHERE ELW IS SHOWN ON PLANS,
- MEAN HIGH WATER LEVEL (MHW) AND EXTREME LOW WATER (ELW) LEVEL ARE ALONG FACE OF EXISTING STONE RETAINING WALLS.
- 4. FLOOD PLAIN BOUNDARIES BEYOND PROJECT AREA.
- 5. NO EXISTING OR PROPOSED EASEMENTS.

020-020D-000-322-100	020-020D-000-322-100 020-020D-000-322-100-LIC1B	1242	DEP	Edgartown	May 23, 1985	Plan Accompanying Petition of the Town of Edgartown to Construct and Maintain Sheet Pile Bulkhead	-	Dock Street	Sheet Pile Bulkhead
020-020D-000-322-100	020-020D-000-322-100 020-020D-000-322-100-LIC1C	5403	DEP	Edgartown	February 12, 1996	Plan Accompanying Petition of Town of February 12, 1996 Edgartown, Ma Wharf Replacement with Steel Sheetpile Bulkhead and Fill	5	Wharf Near Dock Street	Bulkhead
020-020D-000-337-100	020-020D-000-337-100 020-020D-000-337-100-LIC1A	9272	DEP	Edgartown	May 10, 2002	Chappaquiddick Ferry Slip for the Town of Edgartown, Martha's Vinyard Massachusetts	2	Edgartown Harbor	Bulkhead/Seawall

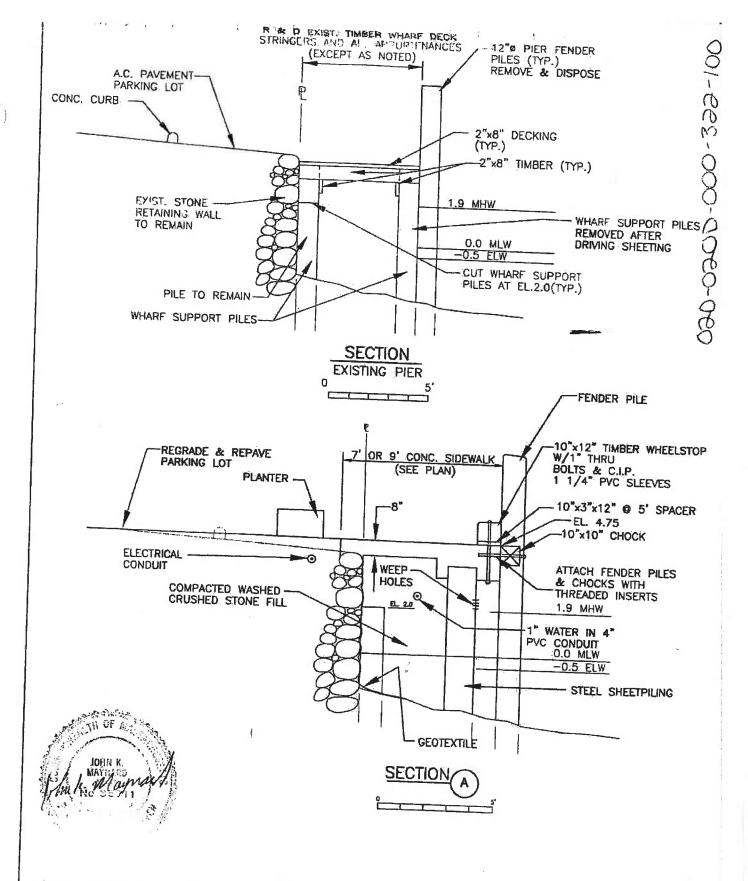
1. ELEVATIONS REFER TO MEAN LOW WATER (MLW) DATUM.
2. APPROXIMATELY 320 CU. YDS. OF COMPACTED
CRUSHED STONE FILL WILL BE PLACED BEHIND THE PROPOSED STEEL SHEETPILE BULKHEAD.

3. EXCEPT WHERE ELW IS SHOWN ON PLANS MEAN HIGH WATER LEVEL (MHW) AND EXTREME LOW WATER (ELW) LEVEL ARE ALONG FACE OF EXISTING STONE RETAINING WALLS.

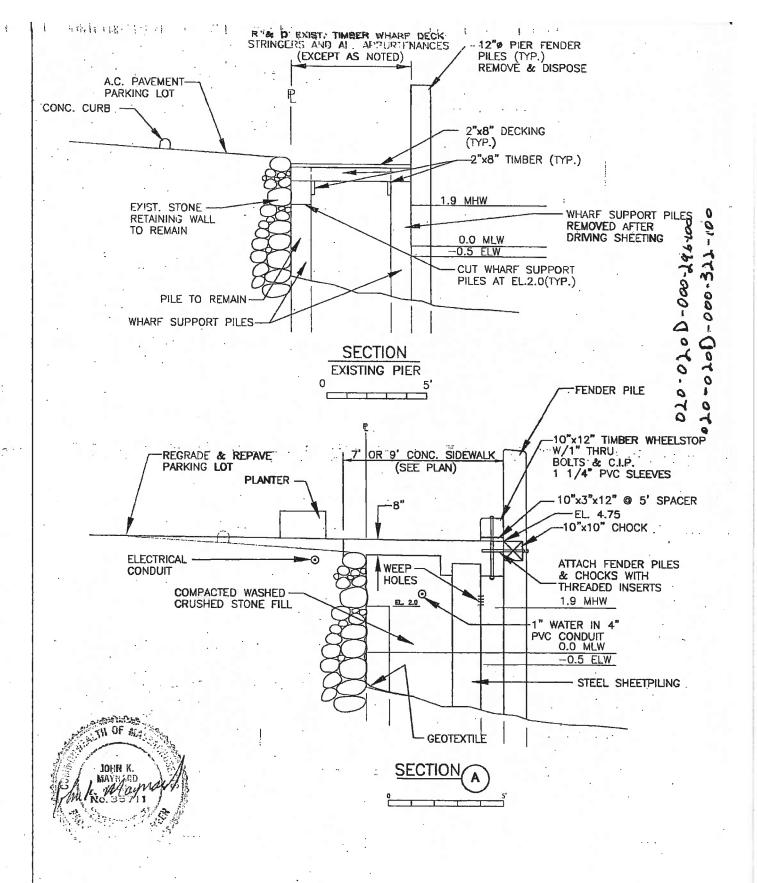
1. ELEVATIONS REFER TO MEAN LOW WATER (MLW) DATUM.
2. APPROXIMATELY 320 CU. YDS. OF COMPACTED CRUSHED STONE FILL WILL BE PLACED BEHIND THE

PROPOSED STEEL SHEETPILE BULKHEAD.

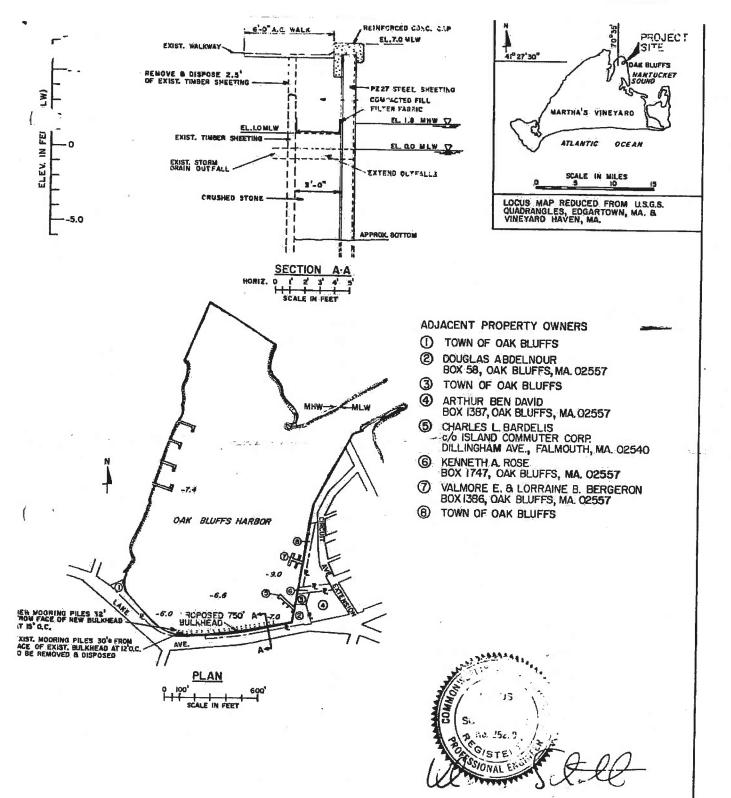
PLAN ACCOMPANYING PETITION OF TOWN OF OAK BLUFFS, MA.

D CONSTRUCT AND MAINTAIN FILL, STEEL SHEET PILE JLKHEAD, TIMBER MOORING PILES & EXTENSION OF SISTING STORM DRAINAGE OUTFALLS WITHIN OAK BLUFFS ARBOR ALONG LAKE AVE.

1. ELEVATIONS REFER TO MEAN LOW WATER (MLW) DATUM
2. APPROXIMATELY 400 CU. YDS. OF COMPACTED FILL 8. 880 CU. YDS. OF
CRUSHED STONE FOR BEHIND THE PROPOSED BULKHEAD WILL BE
TRUCKED ONTO THE SITE.

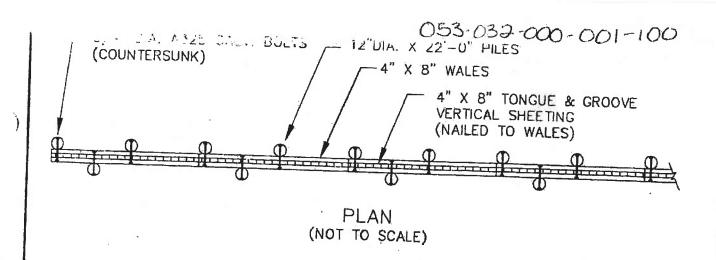
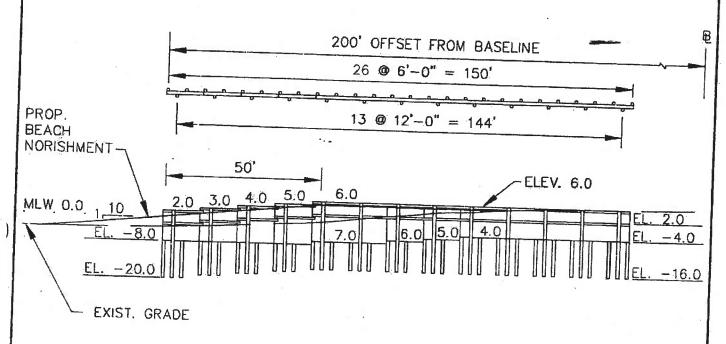
ELEVATION

(TYPICAL FOR ALL PROPOSED GROINS)
SCALE 1" = 30'

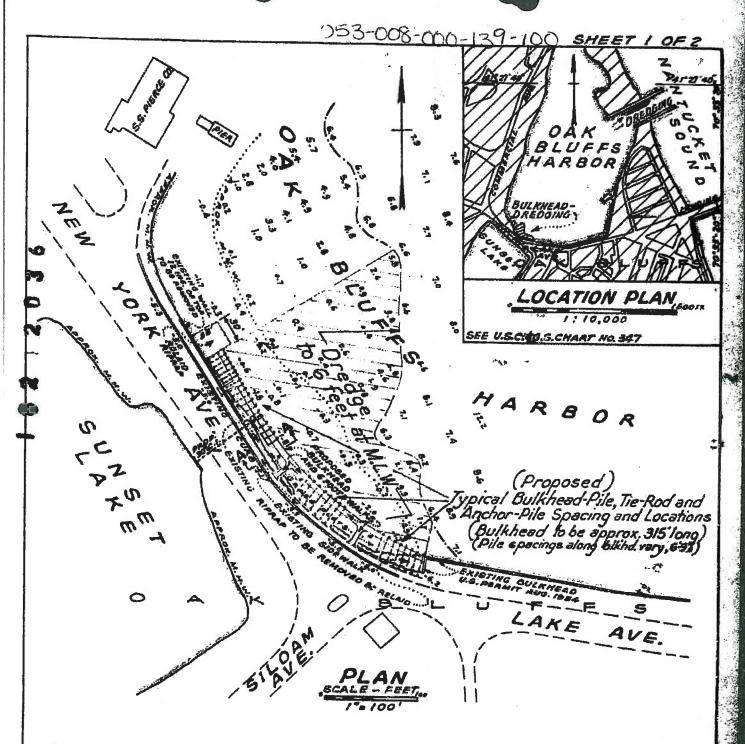
SOUNDINGS ARE IN PEET AND TENTHS BELOW PLANE OF MEAN LOW WATER MINUS FIGURES SHOW ELEVATIONS ABOVE THE SAME PLANE, PROPOSED DREDGING IS IN TWO LOCATIONS, A-MOUNTING TO 10,500 CY. THIS SHEET, AND 1,100 CY, SHEET 2. DREDGED MATERIAL TO BE DISPOSED OF ON BEACH TEAST CHOP BEACH CLUB PROPERTY, ABOVE MEAN HIGH WATER. ALL TIMBER CONSTRUCTION, HARDWARE, ETG. TO BE IN ACCORDANCE WITH CURRENT STANDARD USAGE.

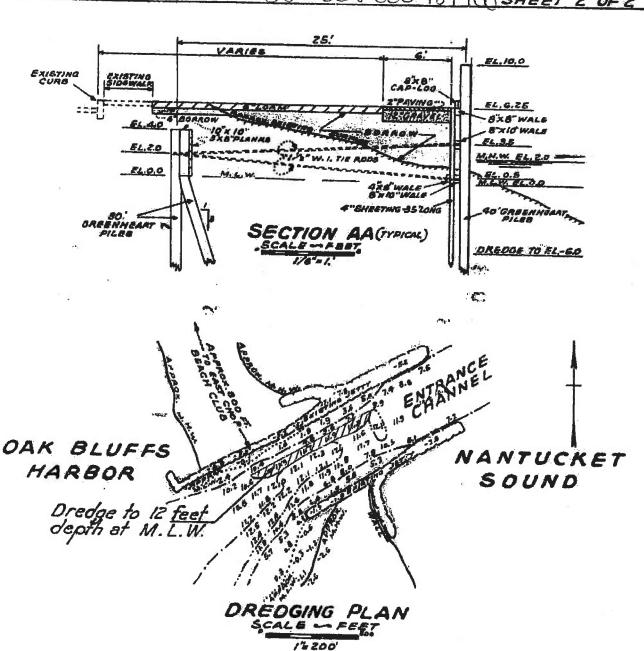
SOUNDINGS ARE IN EAST AND TENTHS AND SHOW DEPTHS BELOW PLANE OF MEAN LOW WATER, MINUS FIGURES SHOW ELEVATIONS ABOVE THE SAME PLANE.

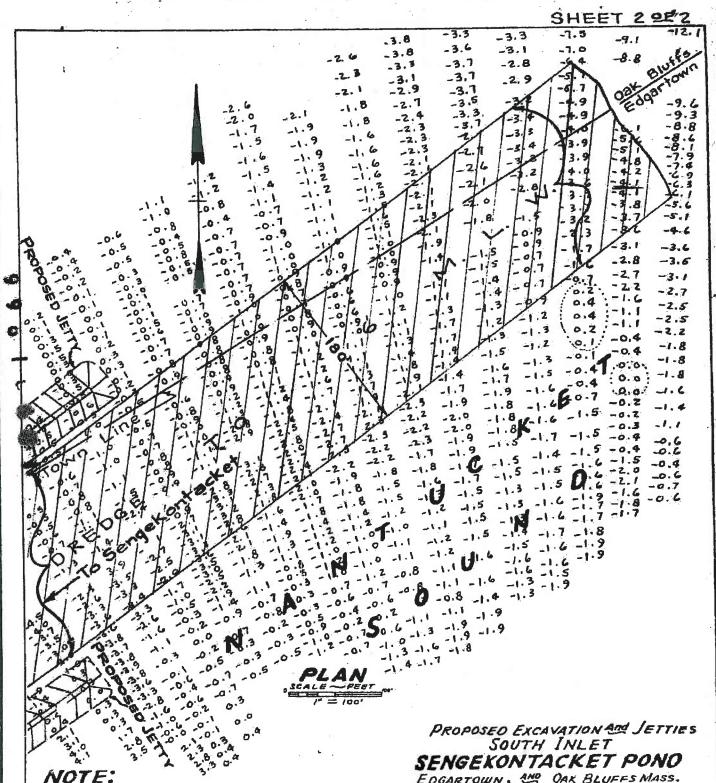
ENEVATIONS ARE IN FEET AND TENTES AND REFER TO THE PLANE OF MEAN LOW WATER MINUS FIGURES DENOTE BEPTHS BELOW THE SAME PLAND. LUCATION OF PROPOSED WORK SHOWN IN KED. DRIFUED MATERIAL APPROX, 43, 600 G.Y. TO AT DISPOSED OF ALONG BEASURS ARM THE TO DECIGING AKEAS.

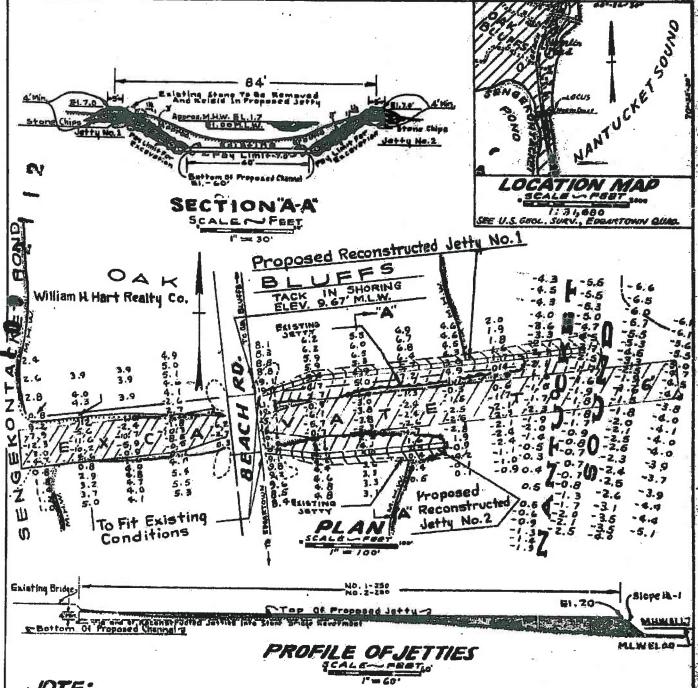
ELEVATIONS ARE IN FEET AND TENTHS AND CLEVATIONS MELINIEST AND TONTHS AND REFER TO THE PLANE OF MEAN LOW WATER, MINUS FIGURES DENOTE DEPTIS BELOW THE SAME PLANE LOCATION OF PROPOSED WORK SHOWN IN RED. EXCAVATED MATERIAL APPROX.8600 C.Y. TO DE DISPOSED OF ALONG SHORE ADMICENT TO EXCAVATED AREAS.

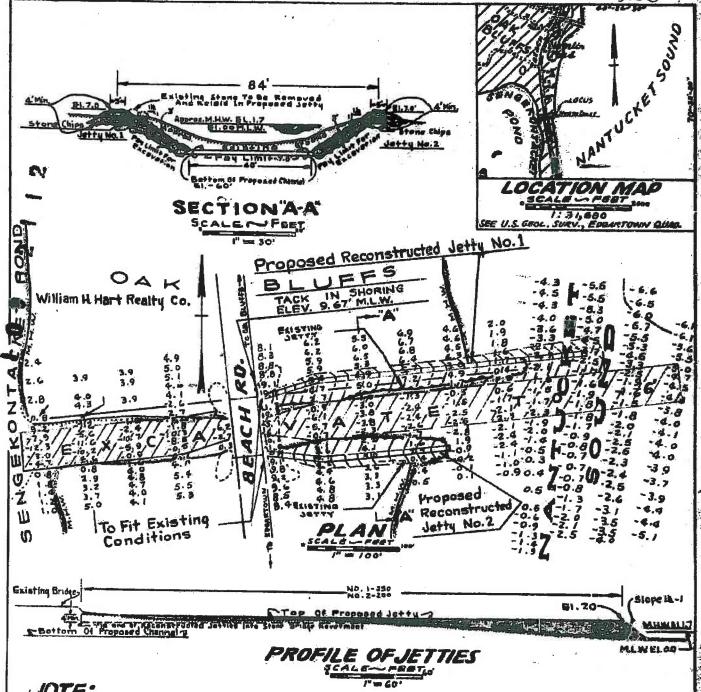
ELEVATIONS ARE IN FEET AND TENTHS AND CLEVATIONS MEET NEET AND TONINS AND REPER TO THE PLANE OF MEAN LOW WATER. MINUS FIGURES DENOTE DEPTHS BELOW THE SAME PLANE LACATION OF PROPOSED WORK SHOWN IN RED. ENCAVATED MATERIAL APAROX.8500 C.Y. TO BE DISPOSED OF ALONG SHORE
ADMIENT TO EXCAVATED AREAS.

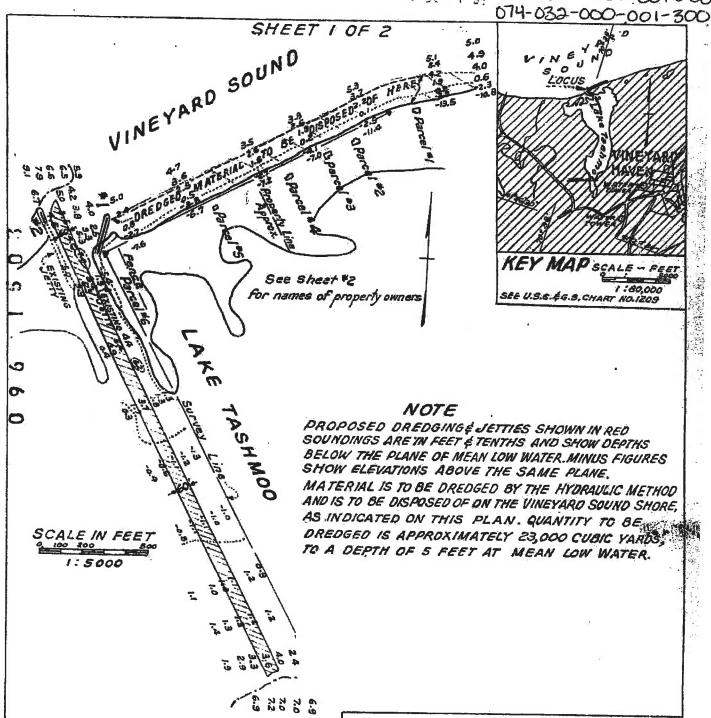
PROPOSED STONE JETTIES & DREDGING
IN VINEYARD SOUND & LAKE TASHMOO
TISBURY, MASS.
APPLICATION BY

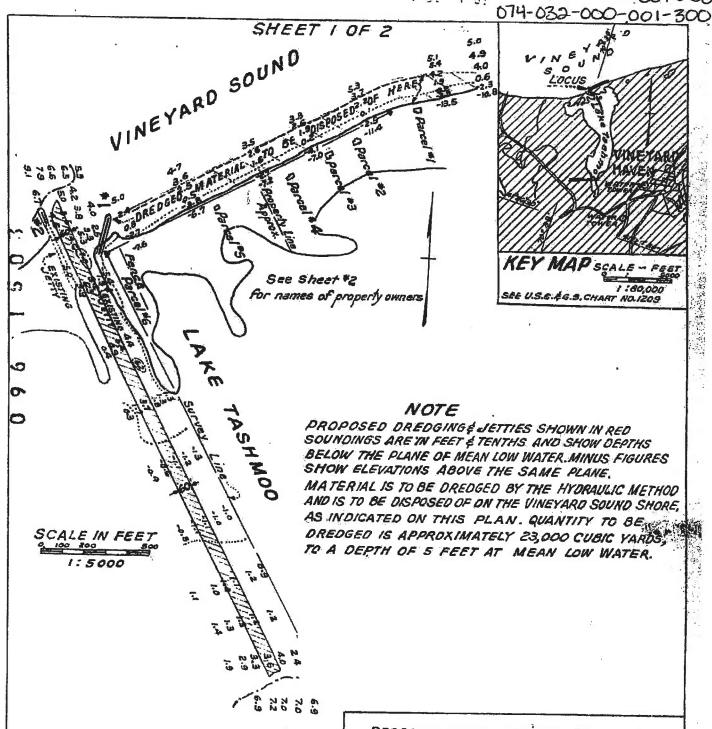
PROPOSED STONE JETTIES & DREDGING IN VINEYARD SOUND & LAKE TASHMOO TISBURY, MASS.

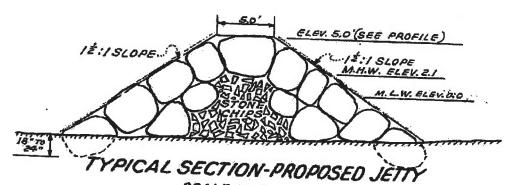
JETTY NO.2 & PROFILE OF PROPOSED JETTIES

SCALE IN FEET HOR 1"-20"

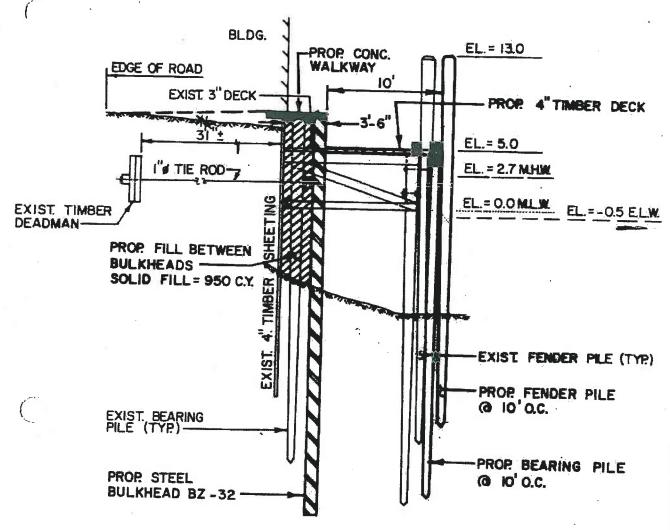
TYPICAL SECTION SCALE: |" = 8'

PLAN ACCOMPANYING PETITION OF THE COMM OF MASSACHUSETTS DEPT OF ENVIRONMENTAL MANAGEMENT

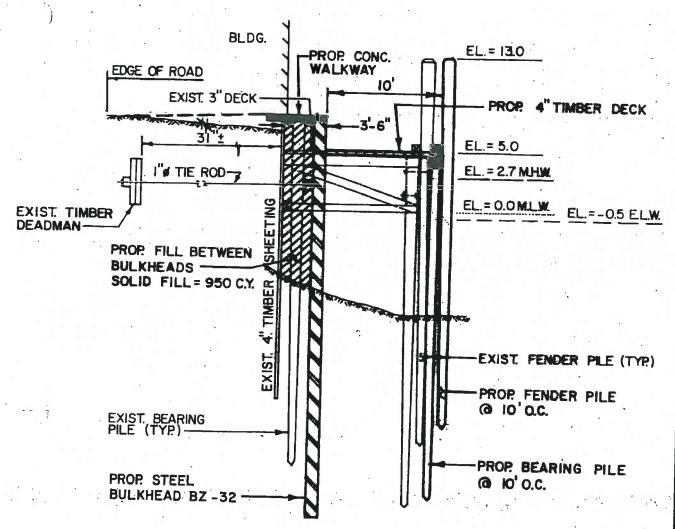
TYPICAL SECTION
SCALE: I"= 8'

PLAN ACCOMPANYING PETITION OF THE COMM. OF MASSACHUSETTS DEPT. OF ENVIRONMENTAL MANAGEMENT

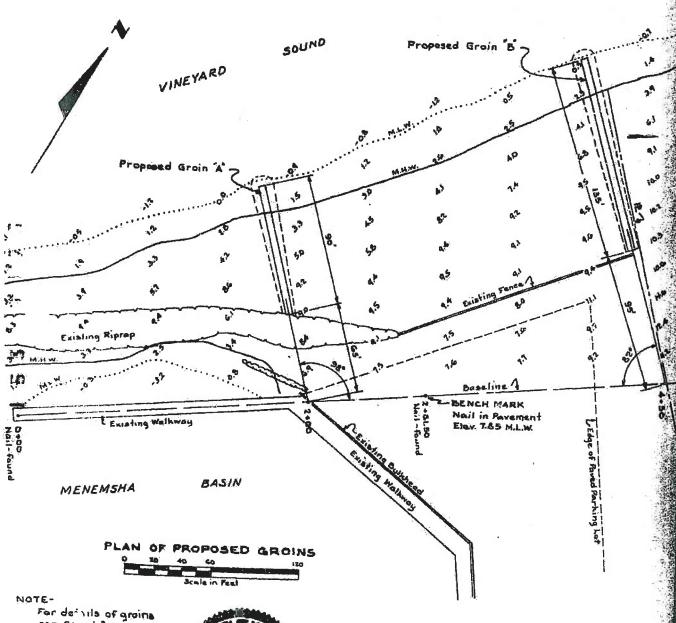
For definits of groins see Sheet 3.

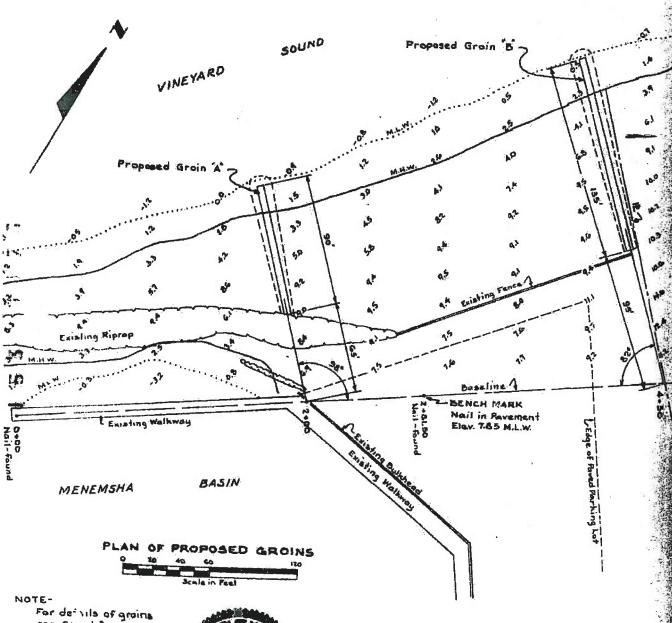
For defines of grains see Sheet 3.
