Impaired Waters Assessments – Final Reports (IC/TMDL)

Impaired Waters Assessment for Lake Como (MA52010)

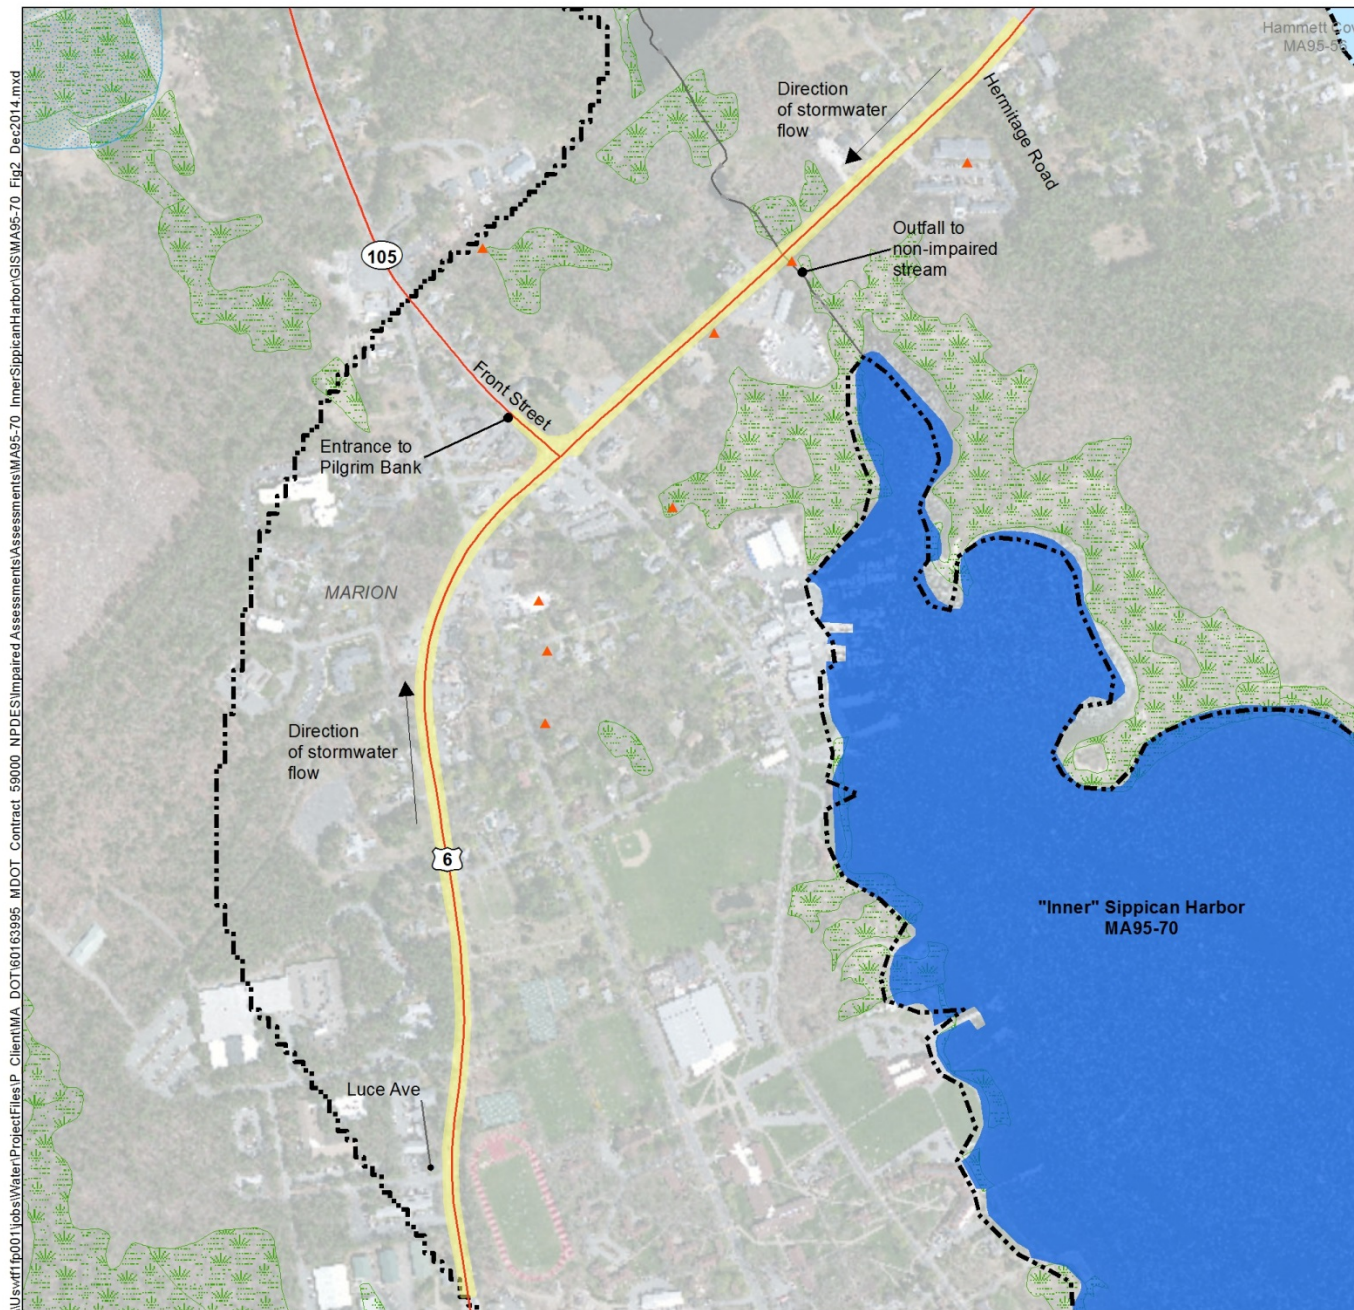
- ▲ MassDOT Outfalls
- MassDOT Roadways in Urban Area
- Total and Subwatershed
- Assessed Segment
- Impaired Lakes
- Non-Impaired Streams
- MassDOT Directly Discharging Area
- Zone II Wellhead Protection Areas
- DEP Wetlands
