Attachment 5:

Pathogen Only

Attachment 5 includes 31 assessments for water bodies impaired only for pathogens which were evaluated using either MassDOT's Pathogen TMDL or Non-TMDL Method.

Impaired Waters Assessment for Hoosic River (MA11-04)

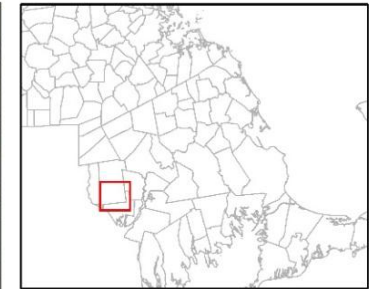
Figure 1A
Rocky Run (MA53-18)
Watersheds
June 2015

- MassDOT Roadways in Urban Area
- MassDOT Roadways
- Total and Subwatershed
- Assessed Segment
- Impaired Lakes
- Impaired Streams
