Technical Manual for Dam Owners

Impacts of Plants on Earthen Dams

FEMA 534 / September 2005

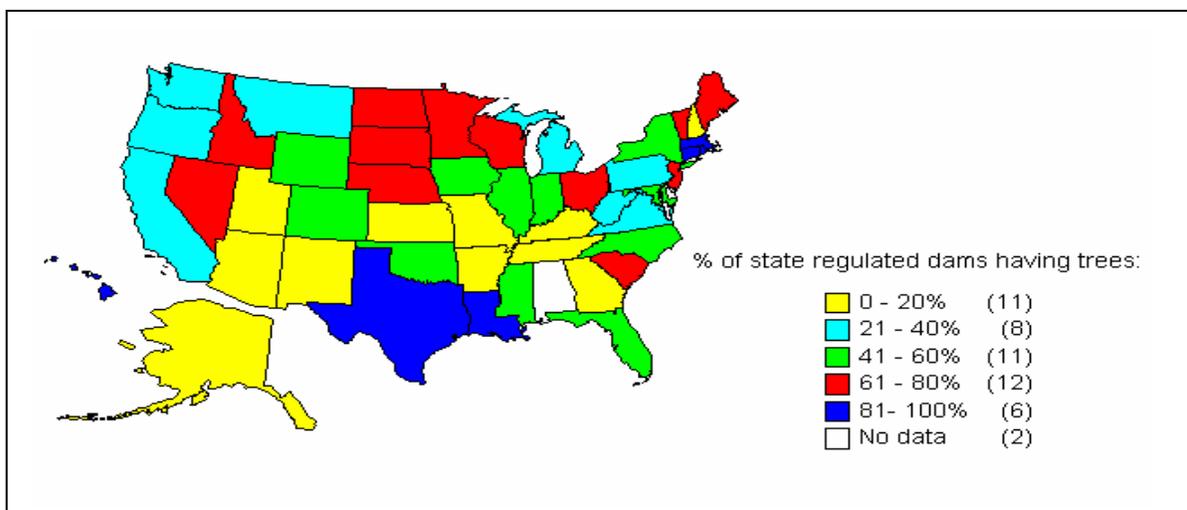
Figure 1. Estimated percentages of state-regulated dams having trees.

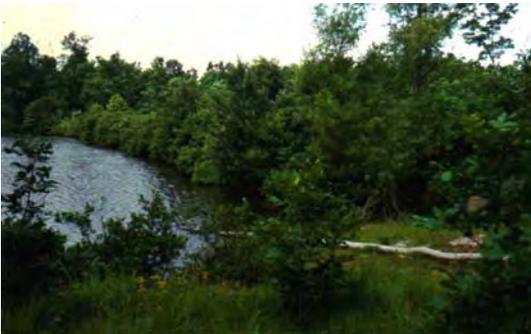
Figure 3. Example dam with inspection-hindering trees in Tennessee.

The problem most commonly noted by state officials is that trees, woody vegetation, briars, and vines interfere with effective safety inspections. Figure 3 illustrates this problem for a dam located in Tennessee.

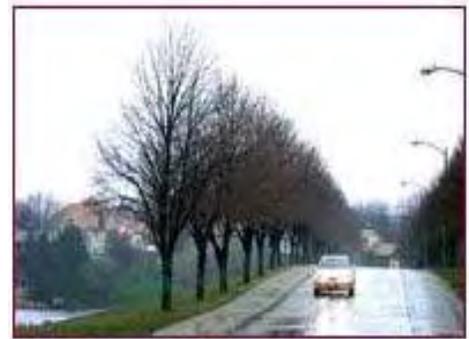
Figure 2. Example dam with problematic trees in Nebraska.

Of the 48 states that responded to the above seven questions (Alabama and Delaware did not reply), all state dam safety officials indicated that they consider trees and plant growth on dams to be a safety problem. One eastern state dam safety engineer goes so far to say that trees are probably the major problem that he has to deal with. He notes further that most of the trouble occurs because owners (and some engineers) do not recognize trees as problems and become complacent as trees slowly grow into serious problems. Both state and federal officials agree that trees have no place on dams. Federal agencies like the Corps of Engineers, U. S. Bureau of Reclamation, and TVA, which own, operate and maintain their own dams, do not allow trees to grow on their structures. Figure 2 shows a problem dam in Nebraska where tree roots have been reported to penetrate the chimney drain and thus affect the

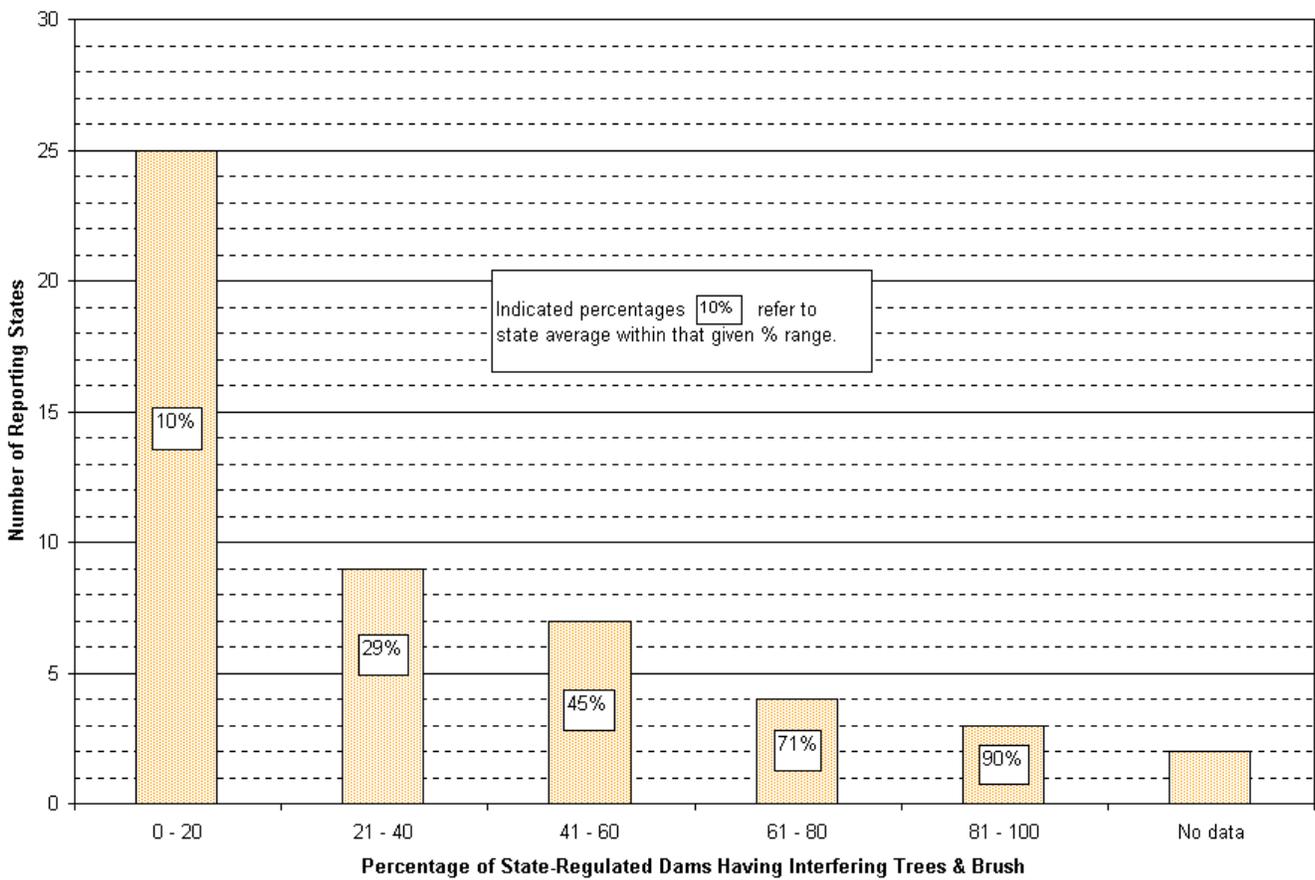
Figure 4. Estimated percentages of state-regulated dams where trees and brush are considered a deterrent to effective safety inspections.

Figure 4 gives a breakdown of the percentage ranges of regulated dams where the 48 reporting state dam safety officials shown in Figure 1 estimate that trees and brush hinder safety inspections in their respective states (ASDSO, 1999). While half the states report having only 20 percent or fewer dams with significant trees and woody vegetation that hinder inspections, vegetation on an estimated 30,000 or nearly a third of the collective state-regulated dams, is reported to obstruct effective dam safety inspections.

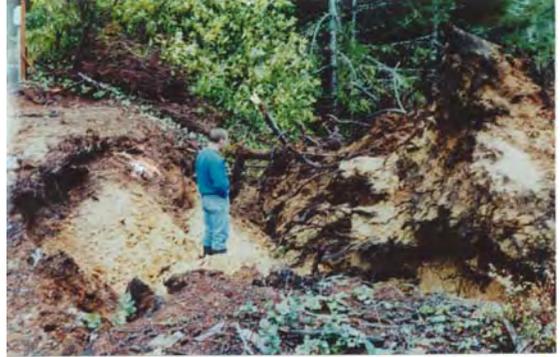
Figure 5. Serious damage by uprooted tree to embankment stability at a dam in Oregon.

- Uprooted trees that produce large voids and reduced freeboard; and/or reduced x-section for maintaining stability as shown in Figure 5.
- Decaying roots that create seepage paths and internal erosion problems.
- Interfering with effective dam safety monitoring, inspection and maintenance for seepage, cracking, sinkholes, slumping, settlement, deflection, and other signs of stress
- Hindering desirable vegetative cover and causing embankment erosion
- Obstructing emergency spillway capacity
- Falling trees causing possible damage to spillways and outlet facilities
- Clogging embankment underdrain systems
- Cracking, uplifting or displacing concrete structures and other facilities

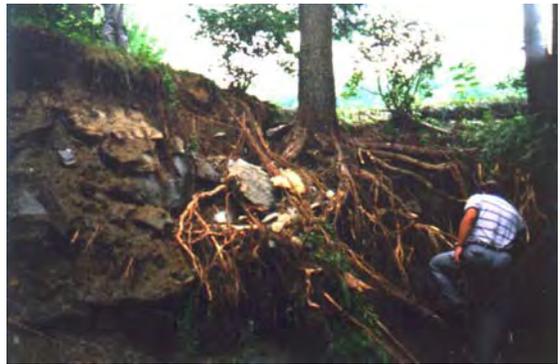
Figure 6. Tree root induced scouring on crest and downstream face of Coffey dam in Kansas.

- Inducing local turbulence and scouring around trees in emergency spillways and during overtopping as shown in Figure 6.

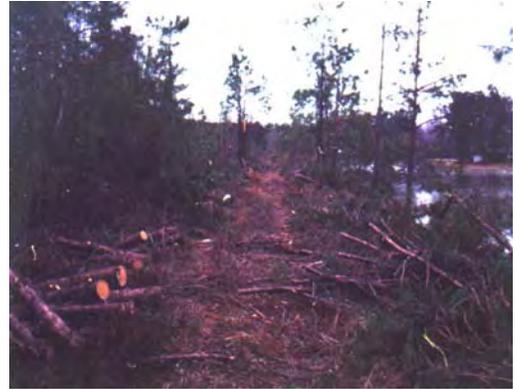
Figure 6. Trees cut prior to removing stumps and roots from dam.

Figures 6 and 7 illustrate extensive efforts necessary to restore a heavily wooded earthen dam to a desirable vegetated and maintained condition.

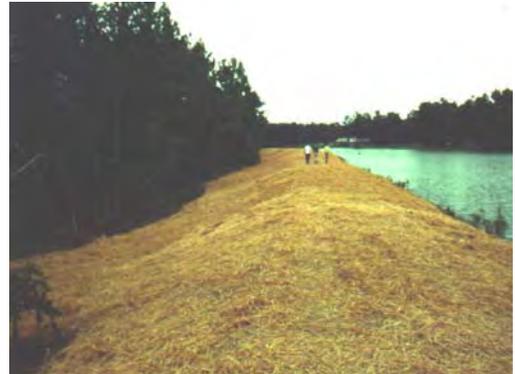
Figure 7. Completed remediation job after removing stumps, seeding, fertilizing & mulching.

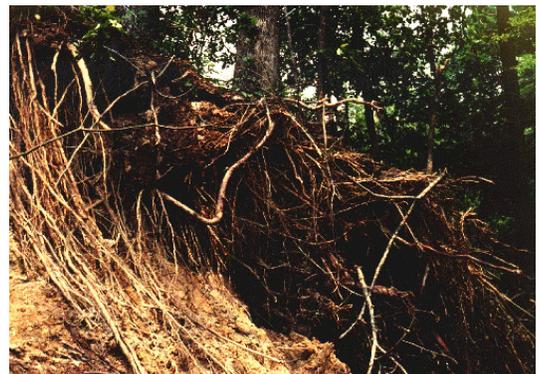
Figure 8. Exposed tree roots in overtopped dam.

Twenty-nine states indicated documented evidence where vegetation on dams has either caused dam failure or negatively affected their safe operation. Sixteen states had no documented evidence and five states had no response. Several states provided photos (Figure 8) and information on tree caused failures or dam

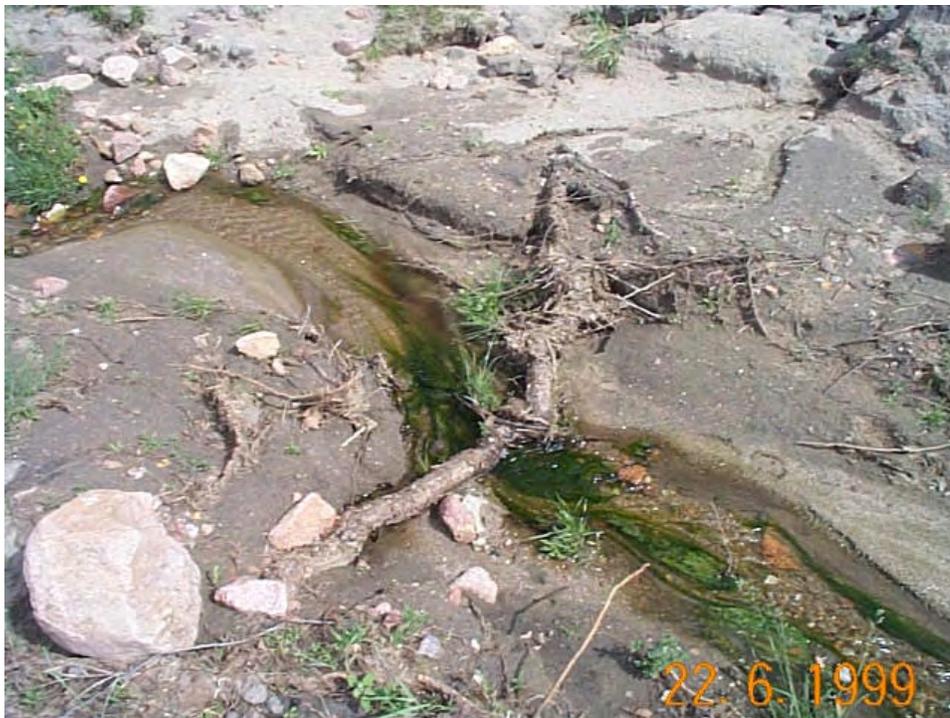
Figure 9. Large pine tree root located in the channel of the breach opening of a failed Air Force Academy waste lagoon pond dam (David Eyre, Senior Civil Engineer, Air Force Academy, Colorado, 1999).

safety problems. The most recent documented dam failure due to tree root penetration occurred in May 1999 at an unnamed Air Force Academy dam near Colorado Springs. Here, an approximately 13-ft. high dam with a pond capacity of less than 5 acre-feet of horse stable waste water failed, releasing its contents and injuring a horse in a stable located about 100 yards downstream. The failure occurred after more than 7 inches of rain had fallen in the previous 72 hours. The dam had several pine trees on its crest and faces, and the breach opening exposed an extensive, deep root system. Roots up to 4 inches in diameter were found in the breach area. Figure 9 shows an example of a large root exposed in the bottom of the channel at the breach. The dam had not overtopped, and the failure was attributed to internal erosion of the decomposed granite embankment material along the roots. A tree had been located directly over the breach.

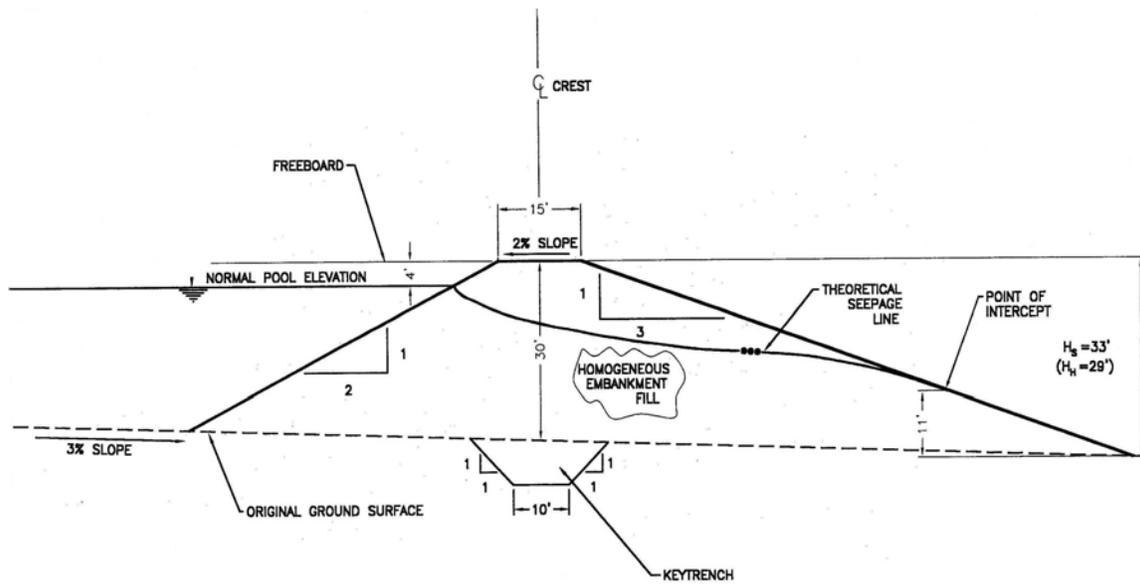
**TYPICAL EMBANKMENT SECTION
WITHOUT TOE DRAIN SYSTEM**

The configuration of the example earthen dam consists of an upstream slope of 2:1 (horizontal to vertical), a crest width of fifteen feet, and a 3:1 (horizontal to vertical) downstream slope. The dam has a freeboard of four feet making the hydraulic height of the dam about 29 feet. The dam is founded on relatively impervious (compared to the embankment fill soil) material with a down gradient slope of about three percent. The example earthen dam section has a key trench directly below the centerline of the dam crest that has a bottom width of ten feet and side slopes of 1:1 (horizontal to vertical). The dam crest has a two-percent slope toward the impounded lake and the upstream slope has no protection system against tree and woody vegetation growth or wave erosion. The embankment of the example earthen dam is assumed to be homogeneous. Figure 1 is a representation of the example earthen dam configuration with the theoretical seepage line intercepting the downstream slope at about one-third the hydraulic height of the dam.

Rule-of-Thumb: *The phreatic surface intercepts the downstream slope of a homogeneous earthen dam at a vertical distance of about one-third the hydraulic height above the toe of the downstream slope, provided there is no internal drainage system in the dam embankment.*

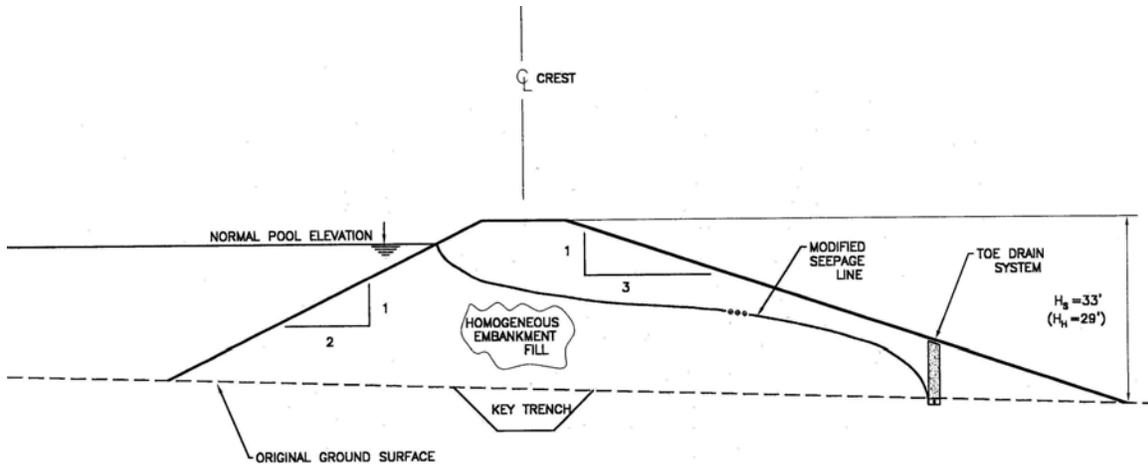
TYPICAL EMBANKMENT SECTION
WITH TOE DRAIN SYSTEM

Figure 2 illustrates the example earthen dam with an embankment subdrain system located within the downstream embankment slope. The subdrain or embankment drain system is located at about the point of interception of the seepage line with the downstream slope if there was no embankment toe drain system within the downstream slope. As a result of the presence of the embankment subdrain system, the seepage line through the dam embankment has been modified (lowered) from the location of the theoretical seepage line for a homogeneous earthen dam embankment. The seepage line within an earthen dam is often mistakenly considered to have a permanent location.

However, the location of the seepage line is continually changing as a result of many influential factors. Fluctuations in the pool elevation, seasonal and long-term climatological conditions, and the growth of trees and woody vegetation in close proximity to the seepage line are some of the factors that influence changes in the location of the phreatic surface within an earthen dam embankment.

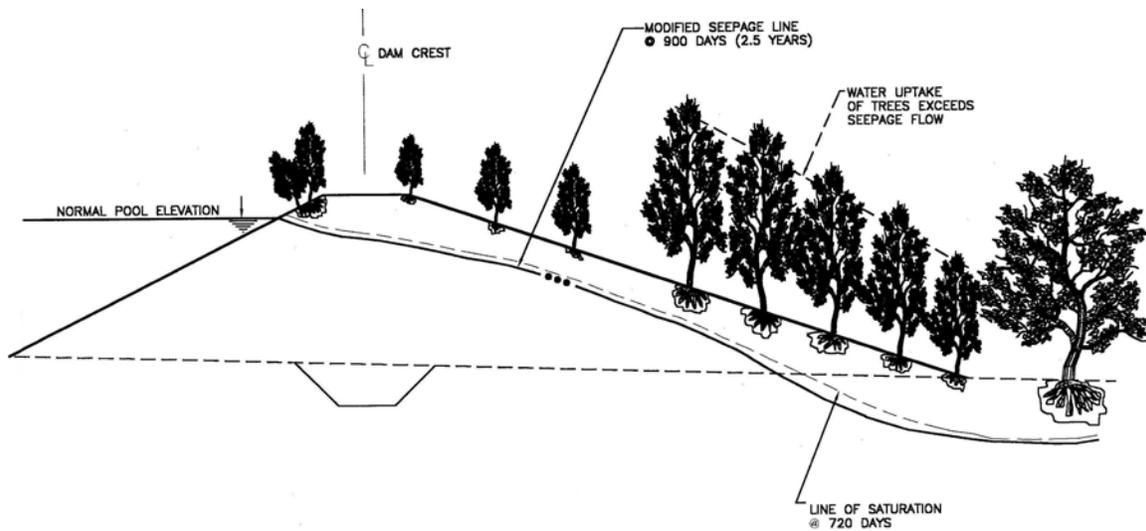
MODIFICATION OF SEEPAGE LINE
WITH TREES & WOODY VEGETATION

The initiation of tree and woody vegetation growth on the downstream slope begins the soil moisture uptake cycle so that the line of saturation and the seepage line may never completely develop and intercept the downstream slope. The condition represented by Figure 6 might initially be considered to be beneficial to the stability of the dam embankment. However, one must understand that as the tree and woody vegetation growth continues compacted soils of the dam embankment are continually loosened by the penetration of major tree and woody vegetation root systems. Furthermore, trees that might appear healthy to an untrained inspector may be an unhealthy specimen and have a premature death leaving penetrating root systems to rot inside the dam embankment. Additionally, soil nutrients in the compacted soil embankment of an earthen dam may not be sufficient for development of growth beyond which the tree cannot be properly sustained without premature death. Regardless of the cause, trees and woody vegetation do die and cease to uptake soil moisture that they previously used. This change in soil moisture uptake will affect the zone of aeration, zone of saturation, and the location of the seepage line in the vicinity of the unhealthy or dead trees and woody vegetation.

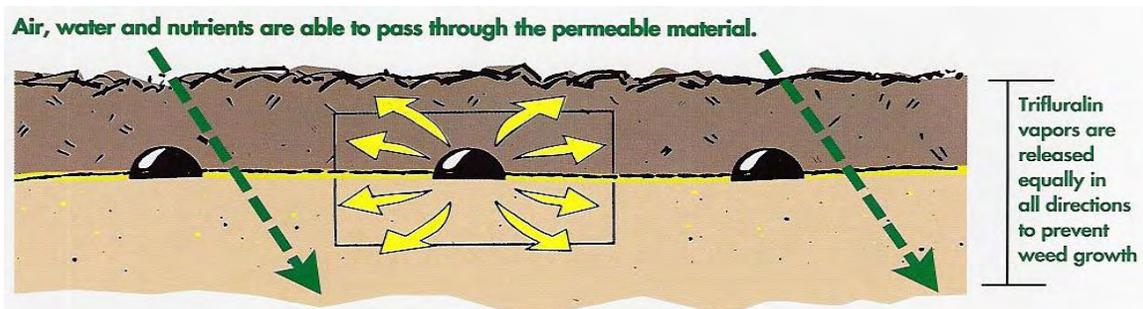
Figure 1. Chemical biocide barrier installation showing slow-releasing biocide nodules attached in a woven fabric matrix and installed under a cover of soil, mulch, gravel or stone (Biobarrier©).

One typical biocide product, called “Biobarrier©” is marketed and promoted, among other applications such as sidewalk and landfill cap protection, to prevent tree and plant roots from penetrating dams. The product consists of long-term, slow release nodules containing Trifluralin herbicide, that are bonded to a geotextile fabric as shown in Figure 1.

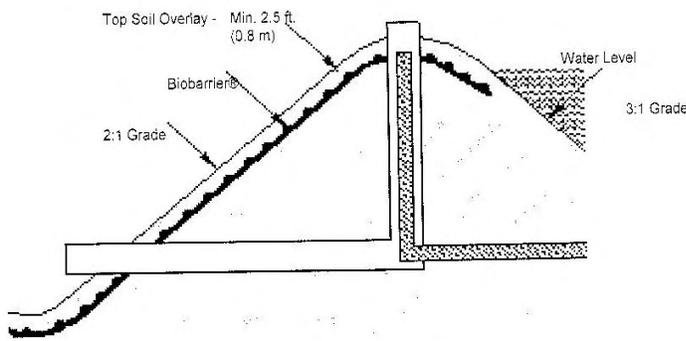
Figure 2. Earth dam installation of chemical

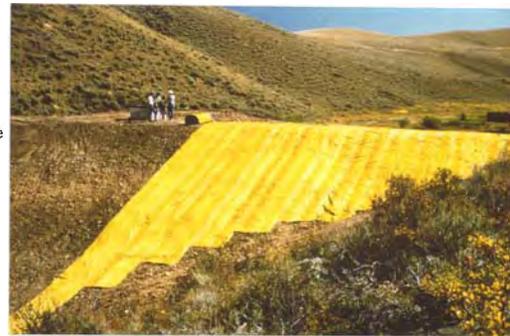
Figure 3. Installed chemical barrier on a dam in Montana (Kershner, 1992)

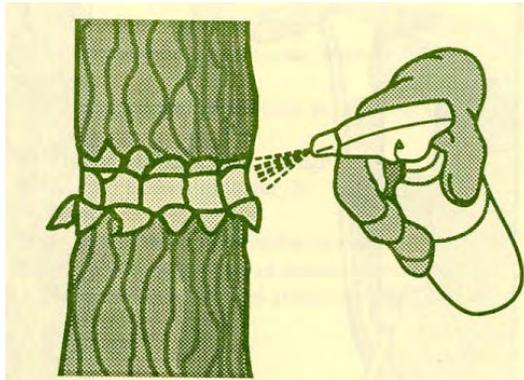
Vanquish
Weedone
Chopper
Pathway
Tordon
Arsenol

Figure 5a. Frill cut application.

Some of these techniques and herbicides used are illustrated in Figures 5a – 5f. The U. S. Department of Agriculture (SCS, now NRCS) published a useful methods, treatment points, and time of treatment guidelines for controlling trees and brush on dams, including some of the applications listed in Figure 4 (USDA, 1988). Table 4 summarizes the USDA recommendations. With the exception of Krenite, which is applied to the foliage, 2,4-D is the only approved herbicide for poisoning trees on dams. 2, 4-D is manufactured by several companies and is sold under several trade names. In all cases, the user is cautioned again to follow the manufacturer’s instructions and should consider the manufacturer’s label instructions to supercede recommended instructions in the USDA table.

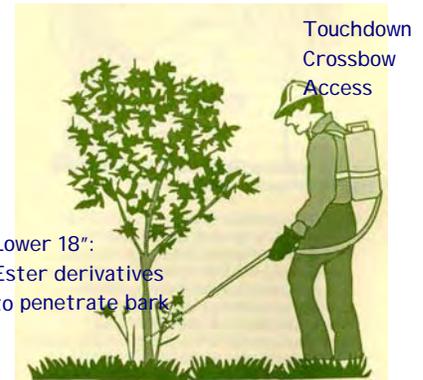
Touchdown
Crossbow
Access

Lower 18":
Ester derivatives
to penetrate bark

Figure 5b. Basal bark spraying.

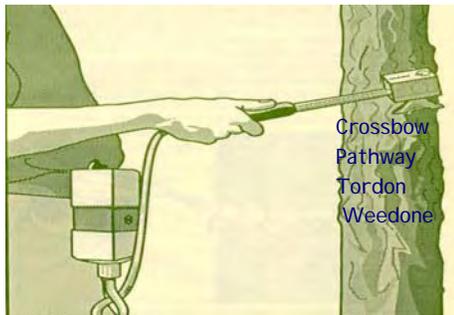
Crossbow
Pathway
Tordon
Weedone

Figure 5c. Hypohatchet application.

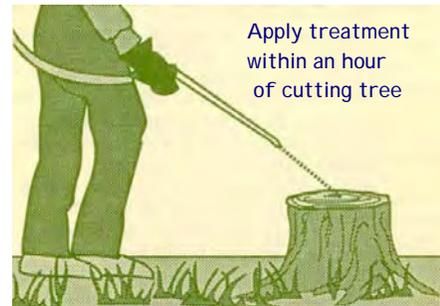
Apply treatment
within an hour
of cutting tree

Figure 5d. Cut-stump application.

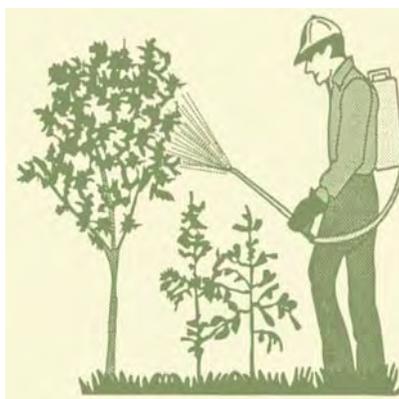
Vanquish
Weedone
Weedmaster
Crossbow
Banvel
Roundup
Accord
Arsenol
Chopper
Pathway
Tordon
Touchdown
Spike
Garland

Figure 5e. Backpack foliar application on dam.

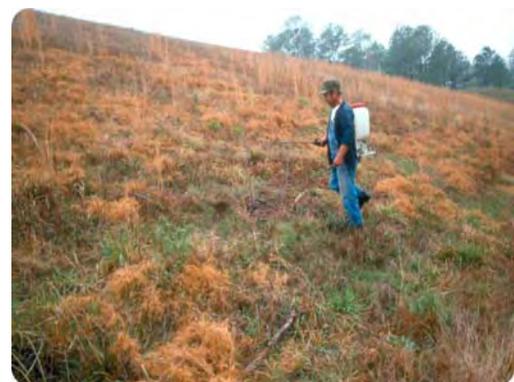
Figure 5. Applications and techniques for different herbicidal deliveries to trees and brush, with example commercially-available herbicides listed.

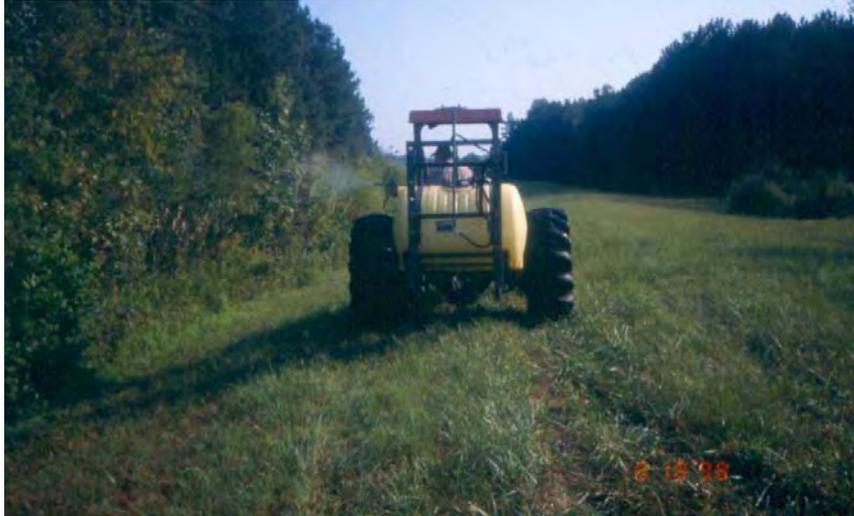
Figure 5f. Tractor spraying application on dam.

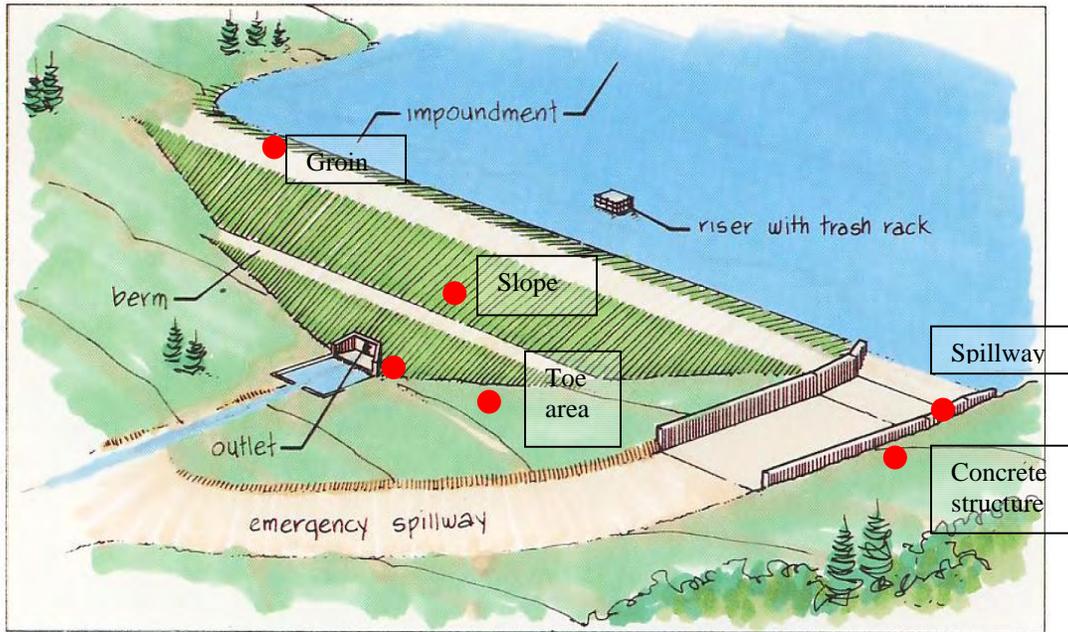
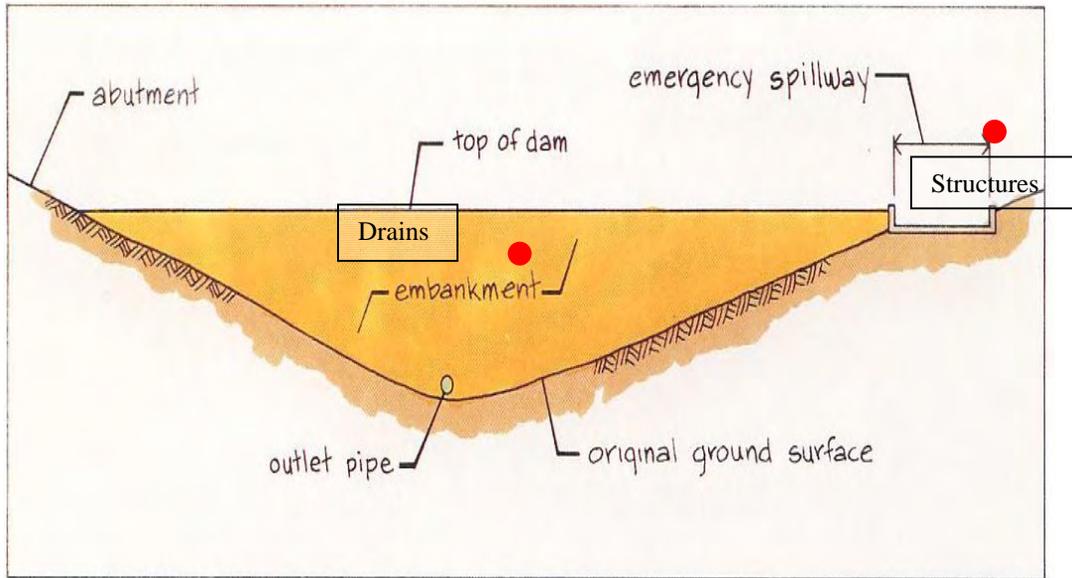
Figure 6. Tree clearance zones for embankment dams and dikes.

3. **Root exclusion zones** utilizing soil structure changes, soil compaction, water/aeration, stress, anaerobic conditions, soil injections and slurries, soil additives, and chemicals to prevent roots from colonizing the soil structure areas due to applied physical or chemical changes to the soil. Changing the soil structure, pore space volume or drainage/aeration matrices can generate a soil environment that roots cannot effectively grow and sustain. A variety of physical- or chemical-based soil altering materials (i.e., soil injected clay slurry or cement solutions) can be effective, at least over the short term if adequate soil volume is treated. Compacting soils appear to be a very good way to prevent root colonization. High density soils increase the resisting strength of these soils to root penetration and deprive the roots from needed oxygen and available water. Certain types of clay soils, freeze-thaw cycles, biological activity, and poor soil compaction can, over time, produce root-accessible pore space. Soil or infrastructure building material additives that neutralize or sterilize the available minerals and nutrients such as nitrogen gas, sulphur, sodium, zinc, borate, salts, or herbicides may produce serious environmental consequences, short-lived results, and non-targeted damage potential. Other methods or additives may be cost-prohibitive. See Figure 6 at end of chapter for root clearance zones.

8. **Creating avoidance zones** to separate tree growth from earthen dam embankments and dam appurtenances where root damage may be critical thus establishing biological-free zones that reduce potential problems. This method simply recognizes that there are places where trees are acceptable and other places, namely dams, where they are not (see Figure 6).

The reader is referred to the USDA guideline for detailed discussion on each of the six treatment methods listed in the above table. These methods can be applied to establish tree and woody plant clearance or avoidance zones on and around dams as illustrated in Figure 6.

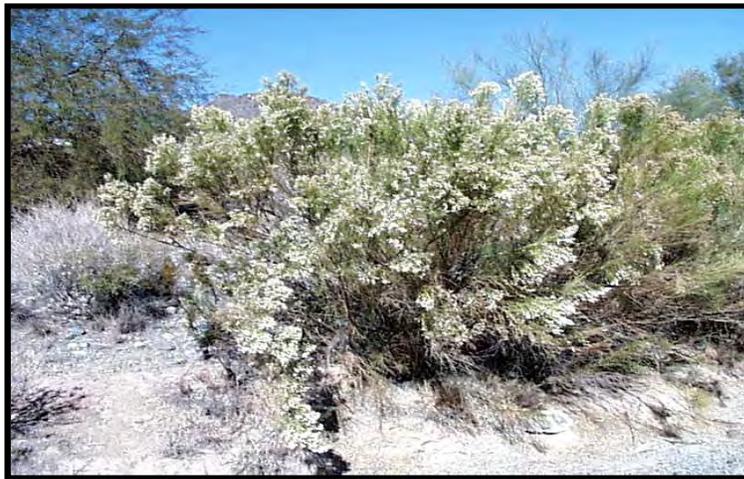
Figure 7. Deep-rooting Desert Broom Plant

Deep-rooted desert plants, when left unchecked, can propagate rapidly on earthen dams located in arid and semi-arid regions of the U. S. Some of these deep-rooted plants include Desert Broom shown in Figure 7, Salt Cedar, Mesquite, Cypress, Cottonwood and Paloverde. All of these species require considerable effort to control and should not be allowed to become established anywhere on dams. Palm trees can be a problem in that they are shallow-rooted, but develop a large root ball that can produce large cavities when toppled during high winds. Upstream and downstream access roads, in place at many dams, should be utilized to create a buffer zone between these species and the toe of dams.

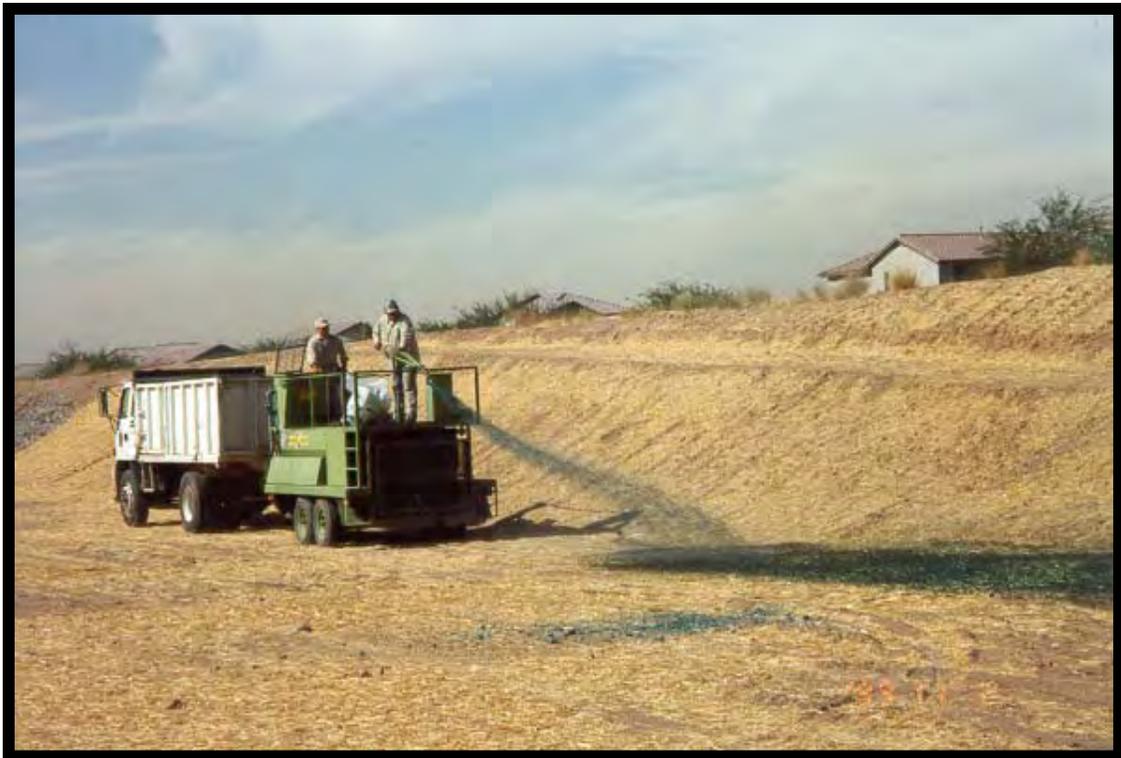
Figure 8. Hydro-seeding operations on a floodway dam in Maricopa County, Arizona (Renckly & Drake, 1999).

Revegetation on earthen dams is recommended to minimize erosion on the embankment slopes and to provide natural landscaping for earthen dams. MCFCD recommends hydro-seeding over labor-intensive hand-seeding to revegetate dam embankments. Figure 8 illustrates hydro-seeding operations on a floodway dam. Seed, water, tack material and a wood fiber or paper mulch are mixed in a hydro-seeder and sprayed directed onto the slopes. The seeds are encapsulated in the mulch and tack material until enough moisture is present to begin the germination process.

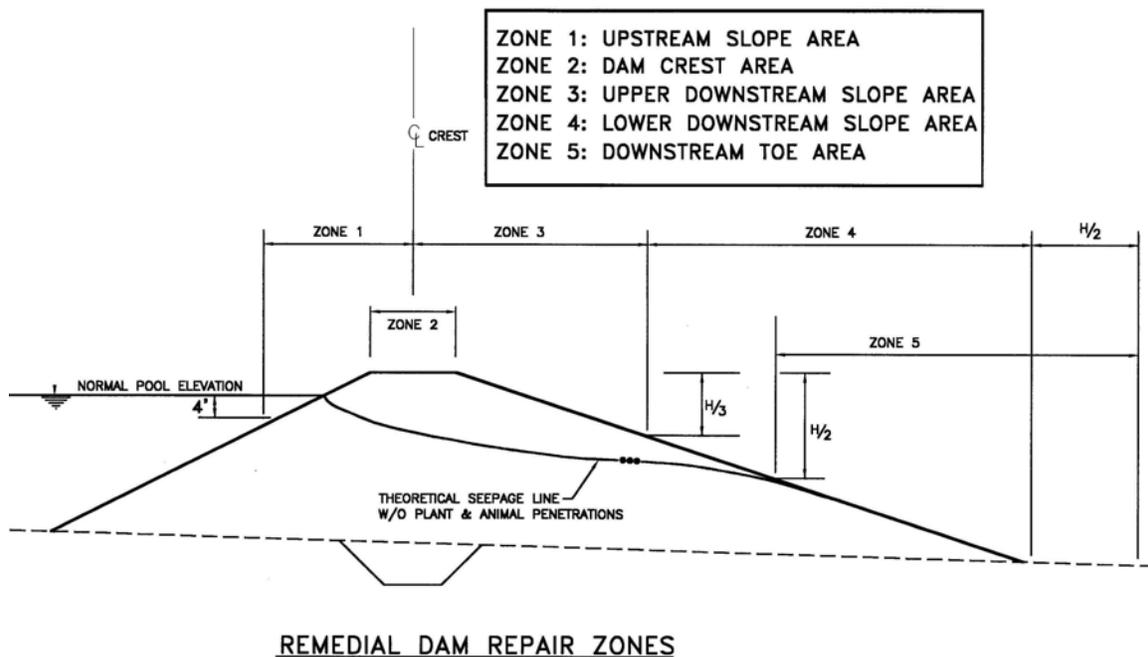
Specific dam remediation design considerations, procedures, and techniques will be considered for each of the previously identified dam safety inspection and evaluation zones. Figure 1 presents these zones as a review prior to discussion of potential dam remediation design considerations for each zone. Dam remediation design alternatives presented herein should be considered examples. These remediation design examples should not be considered the only alternatives for use in dam remediation design to correct deficiencies associated with tree and woody vegetation growth on earthen dams. Some additional dam remediation design alternatives presented for correction of tree and woody vegetation growth related deficiencies also provide positive correction of other deficiencies and protection against other types of earthen dam deterioration.

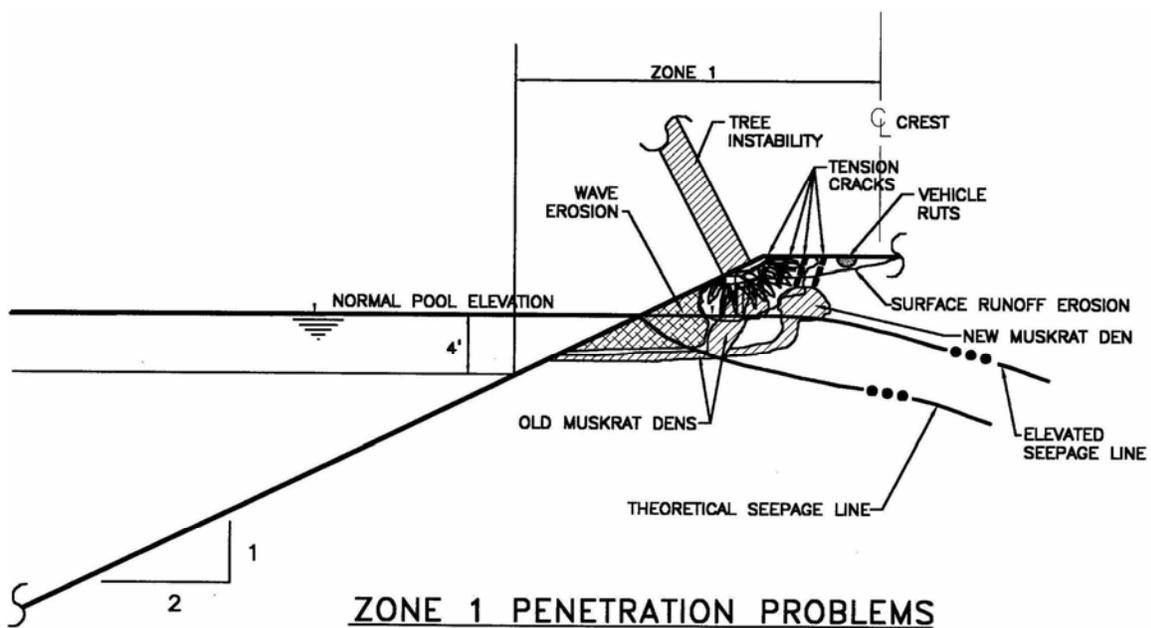
Figure 2 illustrates potential problems that can occur in Zone 1 with respect to tree and woody vegetation growth on earthen dams. This illustration also depicts the occurrence of wave erosion, vehicle access, and surface runoff erosion. Potential problems illustrated include instability of relatively large trees on the upstream slope and dam crest, and alteration of the seepage line as a result of wave erosion.

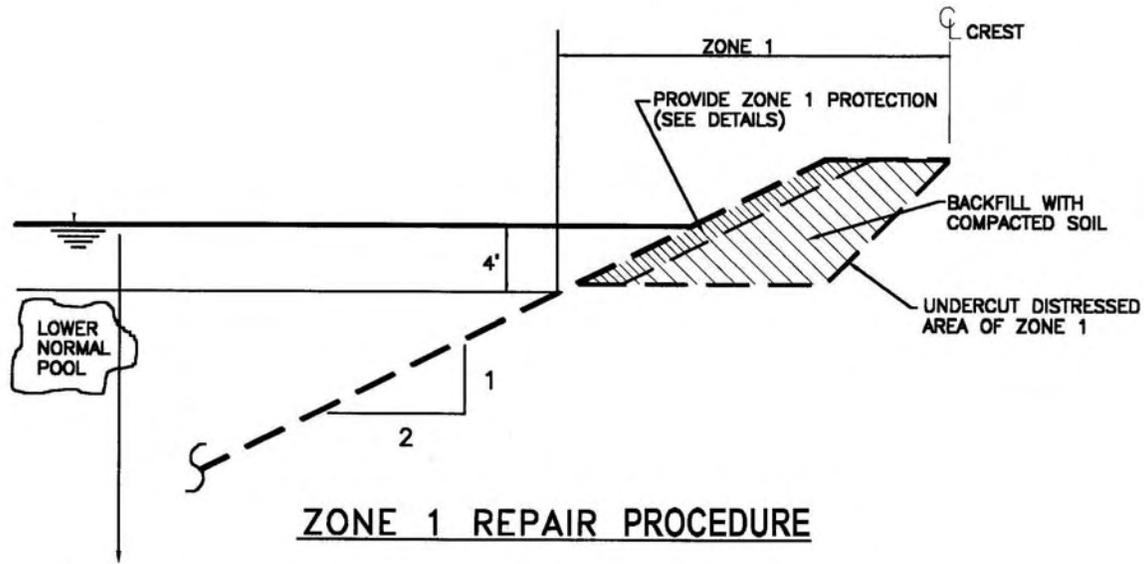
Figure 3

Tree and woody vegetation growth in Zone 1 must be undercut to remove all stumps, rootballs, and root systems developed by tree penetrations as illustrated in Figure 3. The required depth of undercutting typically extends to near the limits of Zone 1, which is about four feet below normal pool elevation. In the case of earthen dams with narrow crest widths, the backslope of the undercut area will typically extend to near the centerline of the dam crest or the downstream limits of Zone 1. Subsequent to undercutting affected areas of Zone 1, the undercut area must be thoroughly inspected to confirm that all major root systems (greater than about one-half inch in diameter) have been removed during the undercutting operation. Following inspection and approval of the undercut area by the engineer, suitable backfill should be placed in the excavation and properly compacted to the dam remediation design limits. Backfill should consist of approved embankment fill material and should be compacted to a minimum of 95 percent of the maximum dry density of the fill soil as determined by the standard Proctor compaction test (ASTM D-698). In conjunction with the undercutting and backfilling, the dam remediation design should include a slope protection system to deter future tree and woody vegetation growth and reduce the potential for wave and surface runoff erosion.

Dam remediation design techniques necessary to address potential problems illustrated in Figure 2 are illustrated in Figures 3 and 4. Dam remediation construction typically requires lowering of the normal pool elevation and/or complete drawdown of the retained reservoir. This is particularly true for dam remediation construction in Zone 1. The normal pool elevation should be lowered as far ahead of the scheduled dam remediation construction as practicable.

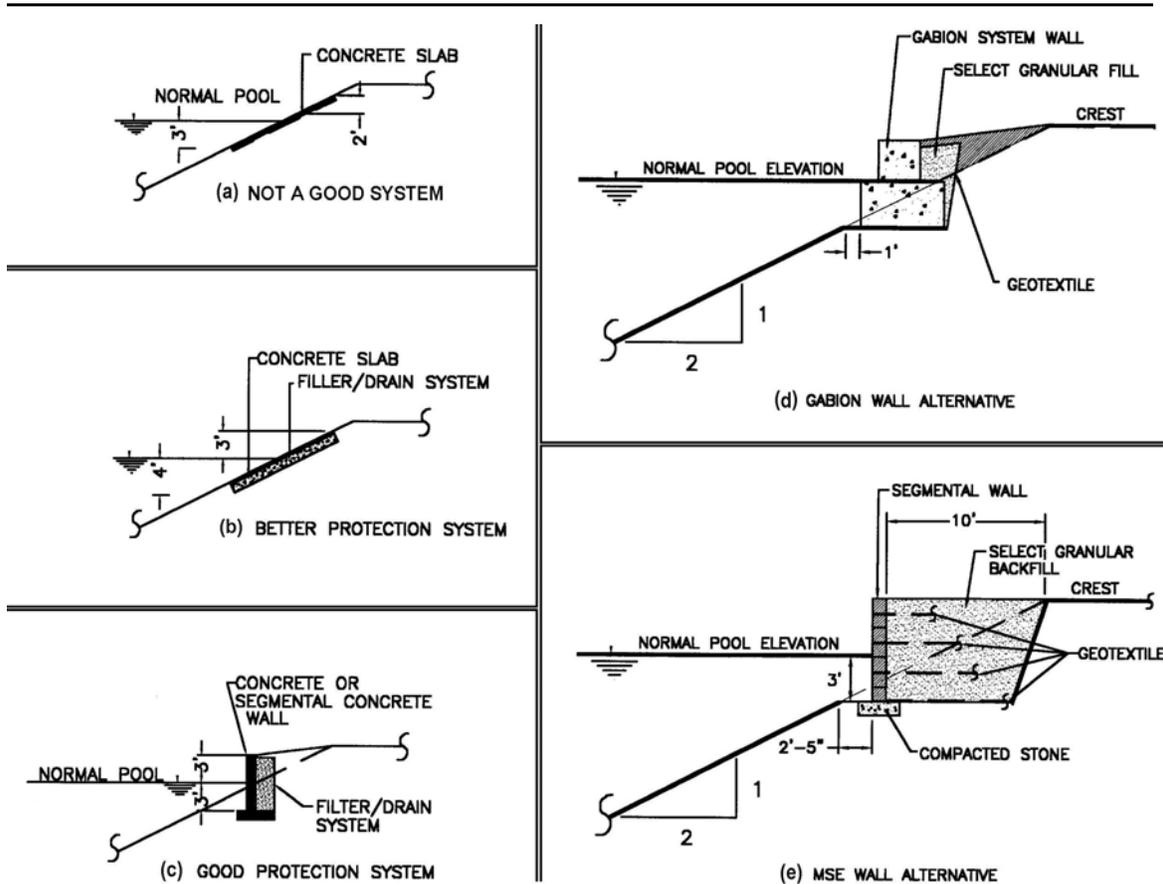
Figure 4

Figures 4(a) through 4(c) illustrate various configurations of rigid (concrete) upstream embankment slope protection systems. Figure 4(a) illustrates a concrete slab being placed directly on the upstream slope from about three feet below to about two feet above normal pool elevation. While this system is somewhat limited relative to the area of protection, the most critical aspect of this system is that it provides no filtration and/or drainage system beneath the concrete slab. Continual wave action and the buildup of hydrostatic pressures beneath the concrete slab will eventually result in downward movement of the slab. Figure 4(b) illustrates a better dam remediation design utilizing a concrete slab slope protection system. This slope protection system has been improved over the original system by covering a larger area of the upstream slope and by providing a filter system beneath the concrete slab protection system. The author is of the opinion

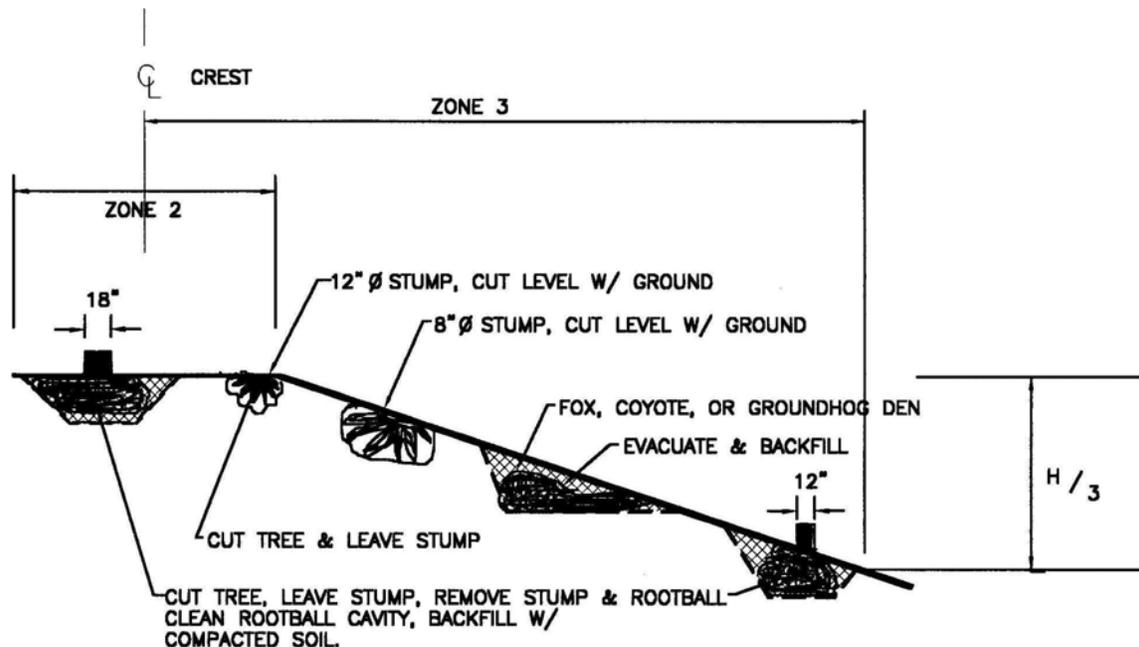
Potential problems associated with tree and woody vegetation growth on earthen dams in identified Zones 2 and 3 are illustrated with dam remediation design procedures in Figure 5. Potential problems illustrated for Zone 2 include the growth of mature trees having stump diameters greater than twelve inches. Mature trees having stump diameters greater than eight inches are illustrated at various locations throughout Zone 3 and in the overlap area of Zones 2 and 3.

ZONE 2 & 3 REPAIR PROCEDURES

Two dam remediation design procedures are illustrated in Figure 5 for removal of trees of various sizes. This illustration implies that trees located in the overlap area of Zones 2 and 3 having stump diameters less than about twelve inches could be cut flush with the ground and left in place for future treatment of the decayed stump and rootball system. However, removal of all stumps, rootballs and root systems is always the better and more conservative approach to removal of mature trees. Subsequent to cutting of trees having stump diameter less than about twelve inches in the overlap area of Zones 2 and 3, the surface of the stump can be treated with a protective coating similar to polyurethane that will prolong the decaying process. Conversely, the referenced illustration indicates that any trees in Zone 2 upstream of the overlap area of Zones 2 and 3 having stump diameters of twelve inches or greater should be treated by total removal of the tree, stump, rootball, and root system. The suggested dam remediation design and construction procedure suggested for complete removal of trees, stumps, rootballs, and root systems in Zones 2 and 3 consists of the following activities:

Figure 5 further illustrates that trees located in Zone 3 that have stump diameters greater than about eight inches should be treated by total removal. The removal procedure should be the same as previously described for larger trees in Zone 2. Trees having stump diameter of less than about eight inches could be cut flush with the ground and treated with a waterproofing sealant similar to polyurethane to prolong the stump and rootball decaying process. Again, complete removal of the stumps, rootballs, and root systems of all mature trees is a better and more conservative method of remediation.

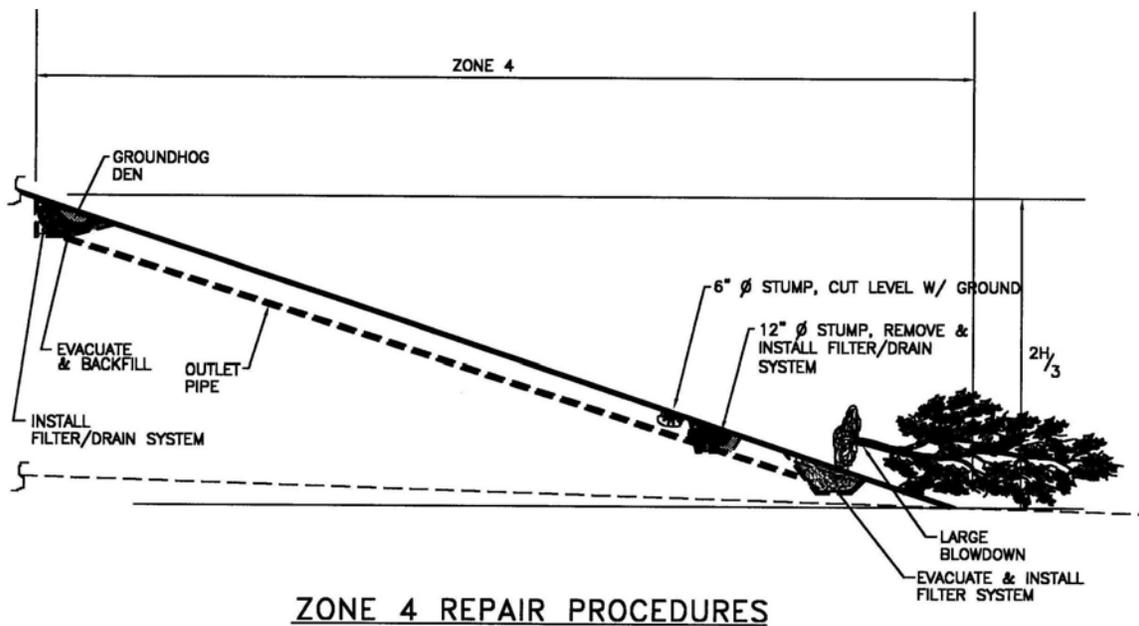
Figure 6 illustrates potential problems associated with tree and woody vegetation growth in Zone 4 of an earthen dam with suggested dam remediation design and construction procedures.

Young immature trees having stump diameters less than about six inches can be removed by cutting flush with the ground and treating the stump with a wood preservative and/or sealant to prolong the decaying process. This procedure is based upon the fact that immature trees of this size typically have not developed a rootball and/or root system that will significantly impact the zone of saturation or the seepage line in Zone 4.

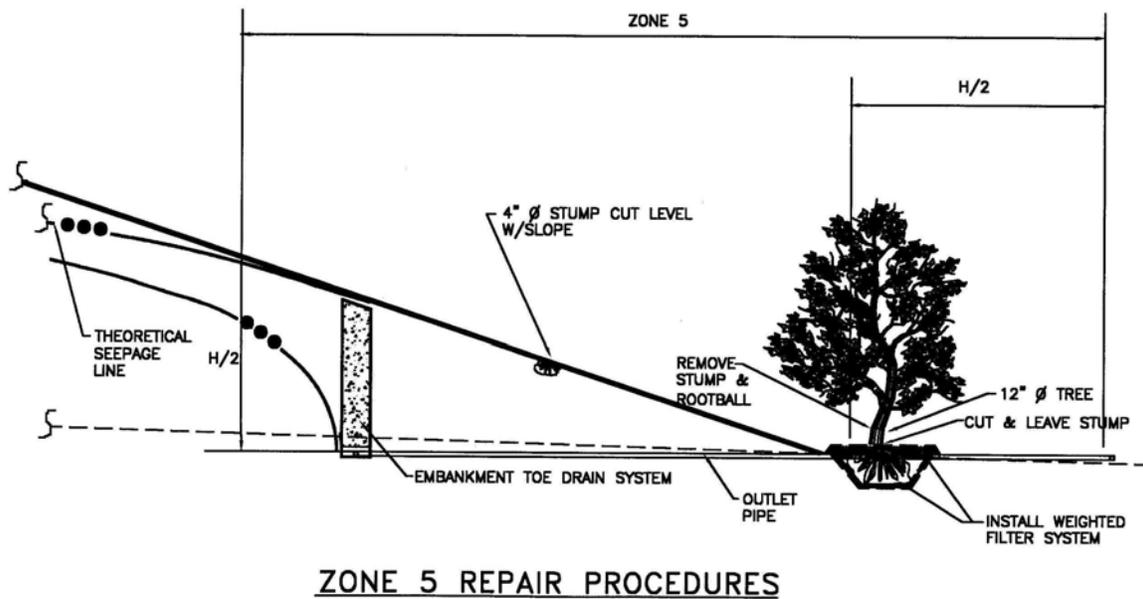
The author identified Zone 5 as one of the two most critical zones for tree and woody vegetation growth on an earthen dam. Figure 7 illustrates some of the problems that can occur with tree and woody vegetation growth in Zone 5. The major adverse feature in Zone 5 is typically the interception of the downstream embankment slope by the seepage line. The author is a strong advocate of the installation of embankment subdrain systems during dam remediation design and construction even though the earthen dam may have been provided with an embankment subdrain system during original design and construction.

One must understand the impact of tree removal in Zone 5 on the seepage line and the quantity of seepage that will occur subsequent to dam remediation in this zone. As indicated by Figure 7, trees in Zone 5 having stump diameters less than about four inches can be cut flush with the ground and the stump treated with a waterproof sealant to

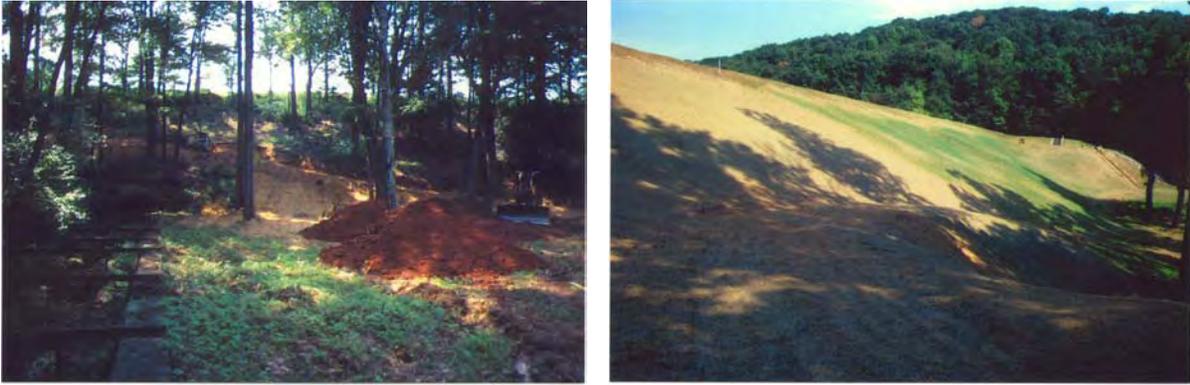
Figure 1. Restored Downstream Slope on Fishing Creek Dam, Maryland (1991-92)

State and federal dam safety officials and other dam safety experts agree that trees have no place on dams. Federal agencies and some states do not allow trees to grow on dams. However, it is estimated that about a third of the nation's 77,000 inventoried dams have sufficient woody vegetation to hinder effective dam safety inspections (ASDSO, 2000; Tschantz, 2000). Most states require dam owners to remove trees and undesirable vegetation, but the cost of clearing and grubbing trees and restoring the dam embankment slopes and crest is often cost prohibitive for many dam owners, usually running into thousands of dollars. It would seem that regular control of woody vegetation and maintaining the surface on an earthen is relatively inexpensive, compared to removing trees on and repairing damage from neglected dams such as shown in Figure 1.
