Technical Manual for Dam Owners

Impacts of Plants on Earthen Dams

FEMA 534 / September 2005

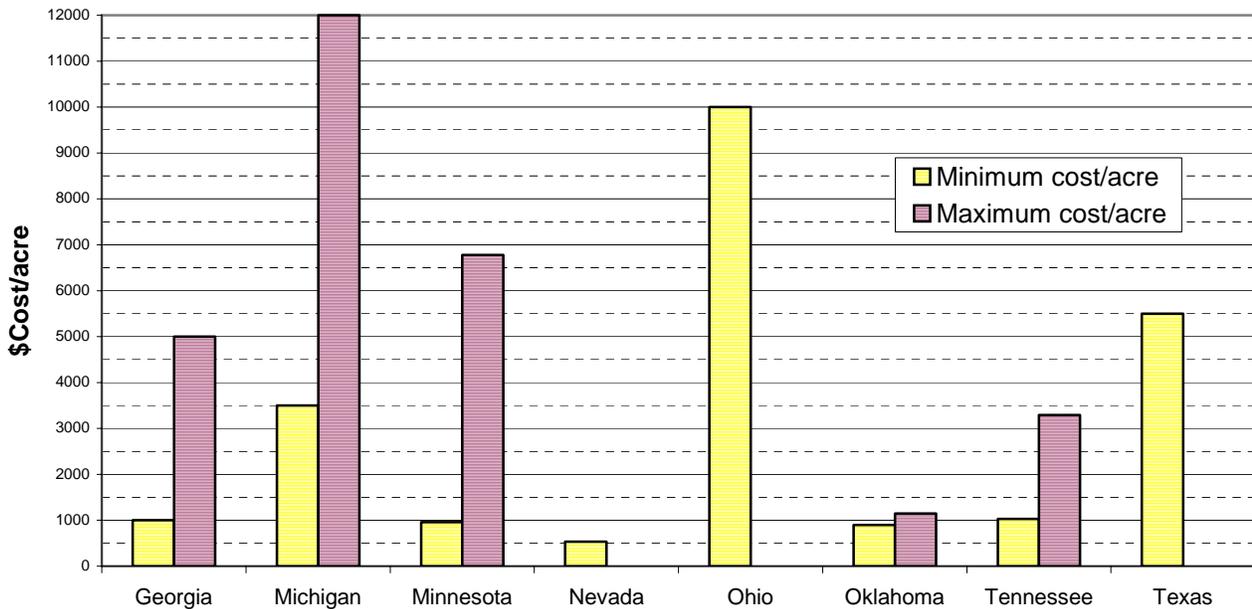
Figure 2. Comparison of tree removal costs per acre of dam surface area reported by 8 states.

The reader is referred to Table 1 in Chapter 2 and Figure 2 below for unit area tree removal cost comparison experiences reported in a survey by eight state dam safety officials in different regions of the country. The survey data shows that the cost of clearing and grubbing trees and other woody vegetation varies widely within and among states, but generally ranges from about \$1000 to \$5000 per acre, depending on site-specific conditions (Tschantz, 2000).

These data compare favorably with the \$1500 - \$3000 bid price data for three Southeastern states discussed earlier in Chapter 2 for cutting trees, removing stumps and rootballs, and grubbing the area to remove roots for different dam conditions. While not included in the above Figure 2 chart data, Massachusetts’ dam safety personnel reported in 2000 that, based on its own in-house experience, some local consultants and other sources, “broad area” tree removal costs ranged from \$5000 and \$6000 per acre or from about \$800 to \$1000 for individual 18-24 inch trees in their region. One dam safety official, from Tennessee, provided detailed cost data for clearing trees from seven dams in that state from 1995-1999. The cost for clearing and grubbing trees and for reseeding for one typical dam in 1998 is described for the reader in Table 1.

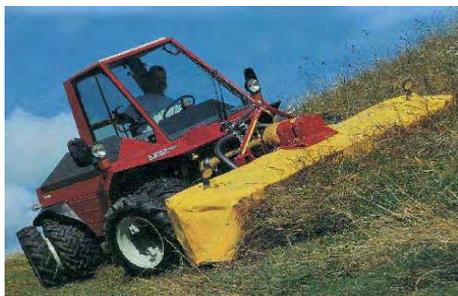
Figure 3. Example of slope mower (Terratrac© photo used with permission from AEBI North America, Inc.)

Figure 3 illustrates the use of a slope mower for easing the burden of maintenance for state and federal agencies and for other multiple or large dam owners.

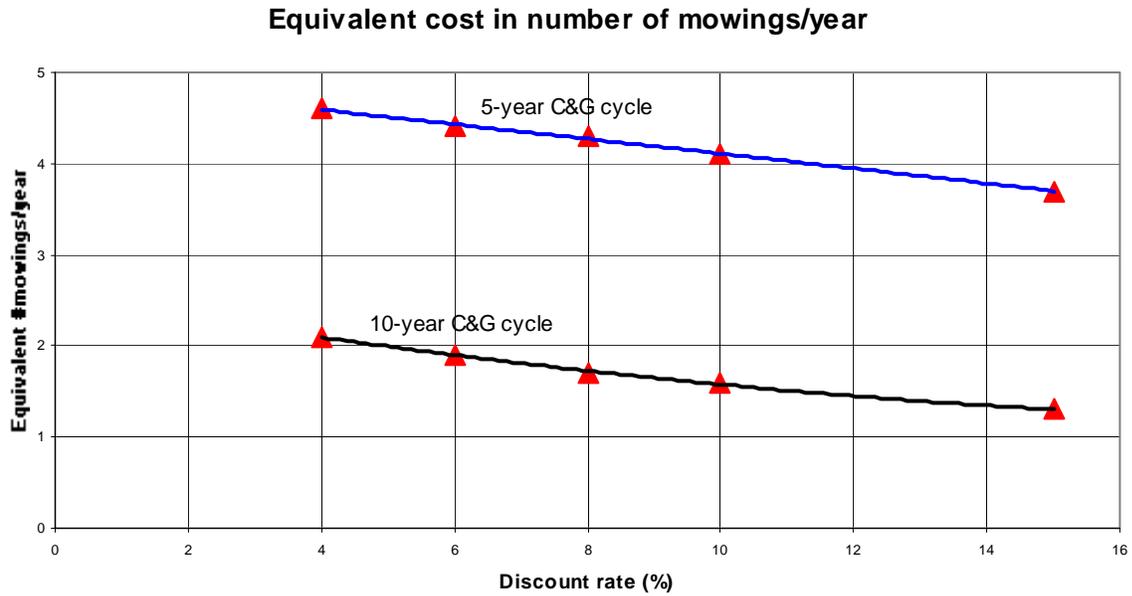
Figure 4. Comparison of Annual Tree Clearing and Grubbing Costs for 5 and 10-Year \$2500/acre payouts.

For a more conservative 5-year tree growth cycle and a \$2500 clearing and grubbing cost assumption, the annualized clearing and grubbing costs would be \$1523, \$1464, \$1406, \$1351, and \$1224 for the same discount rates, respectively. The corresponding justifiable mowings would be 4.6, 4.4, 4.3, 4.1, and 3.7 per year. Similarly, justifiable mowings for an assumed \$5000 clearing and grubbing cost would double the justifiable mowings to 9.2, 8.9, 8.6, 8.2, and 7.4 per year. Figure 4 compares 5 and 10-year annualized costs for \$2500/acre clearing and grubbing payouts.

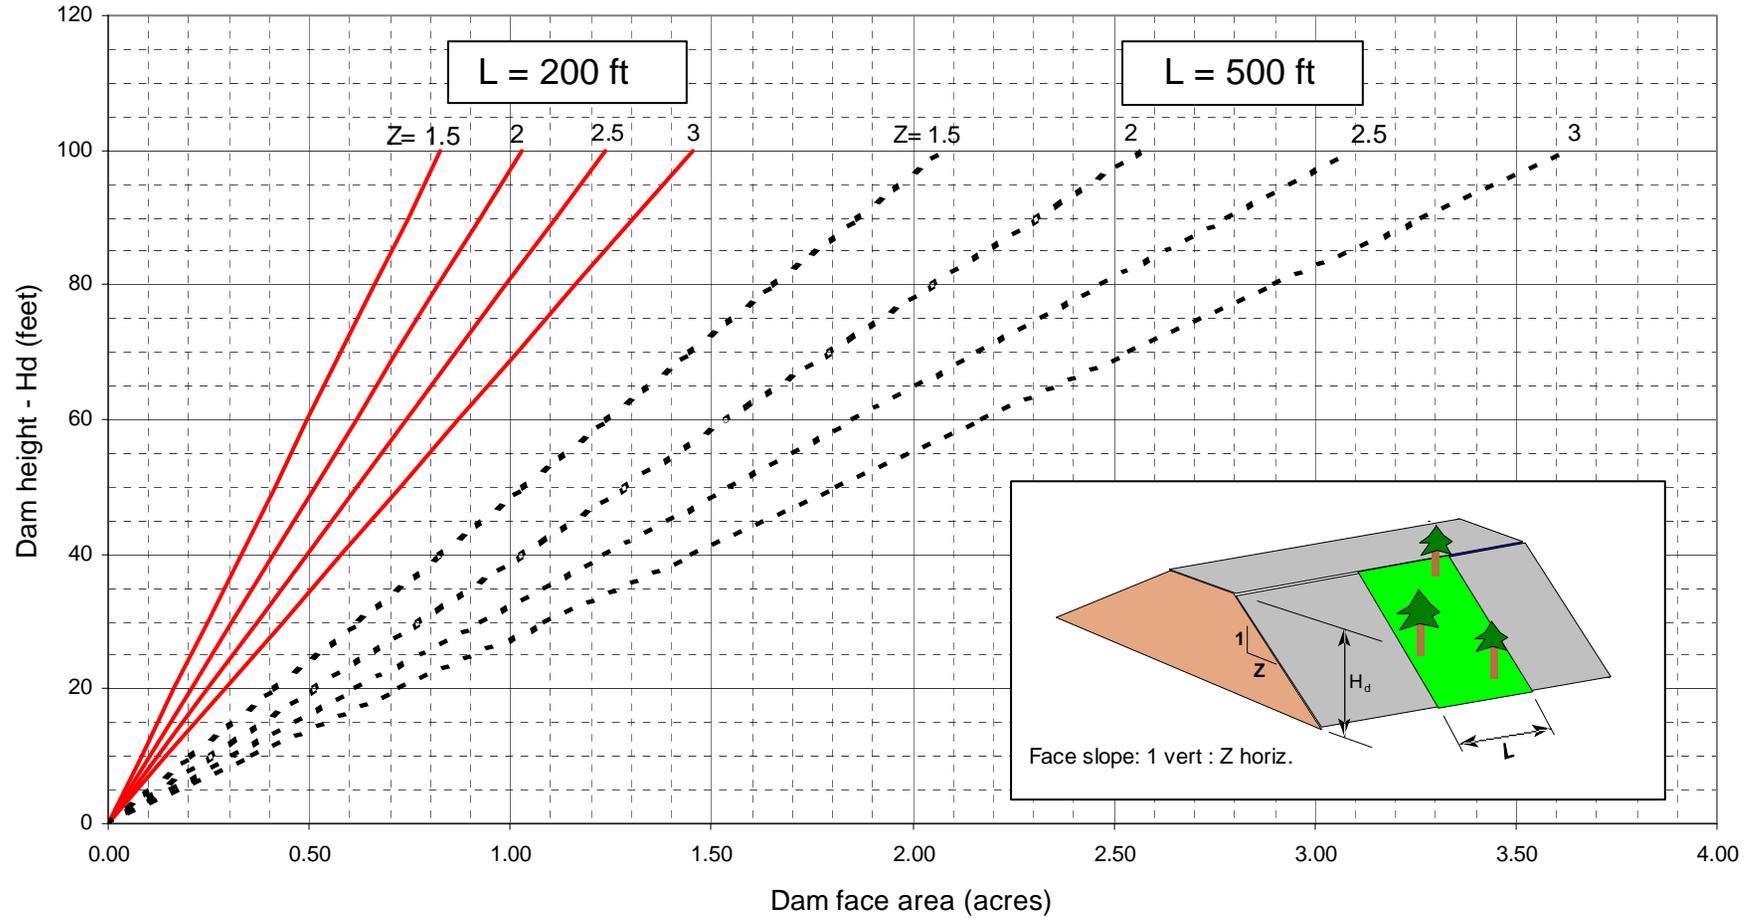
Chart 1. Dam face area for different geometries

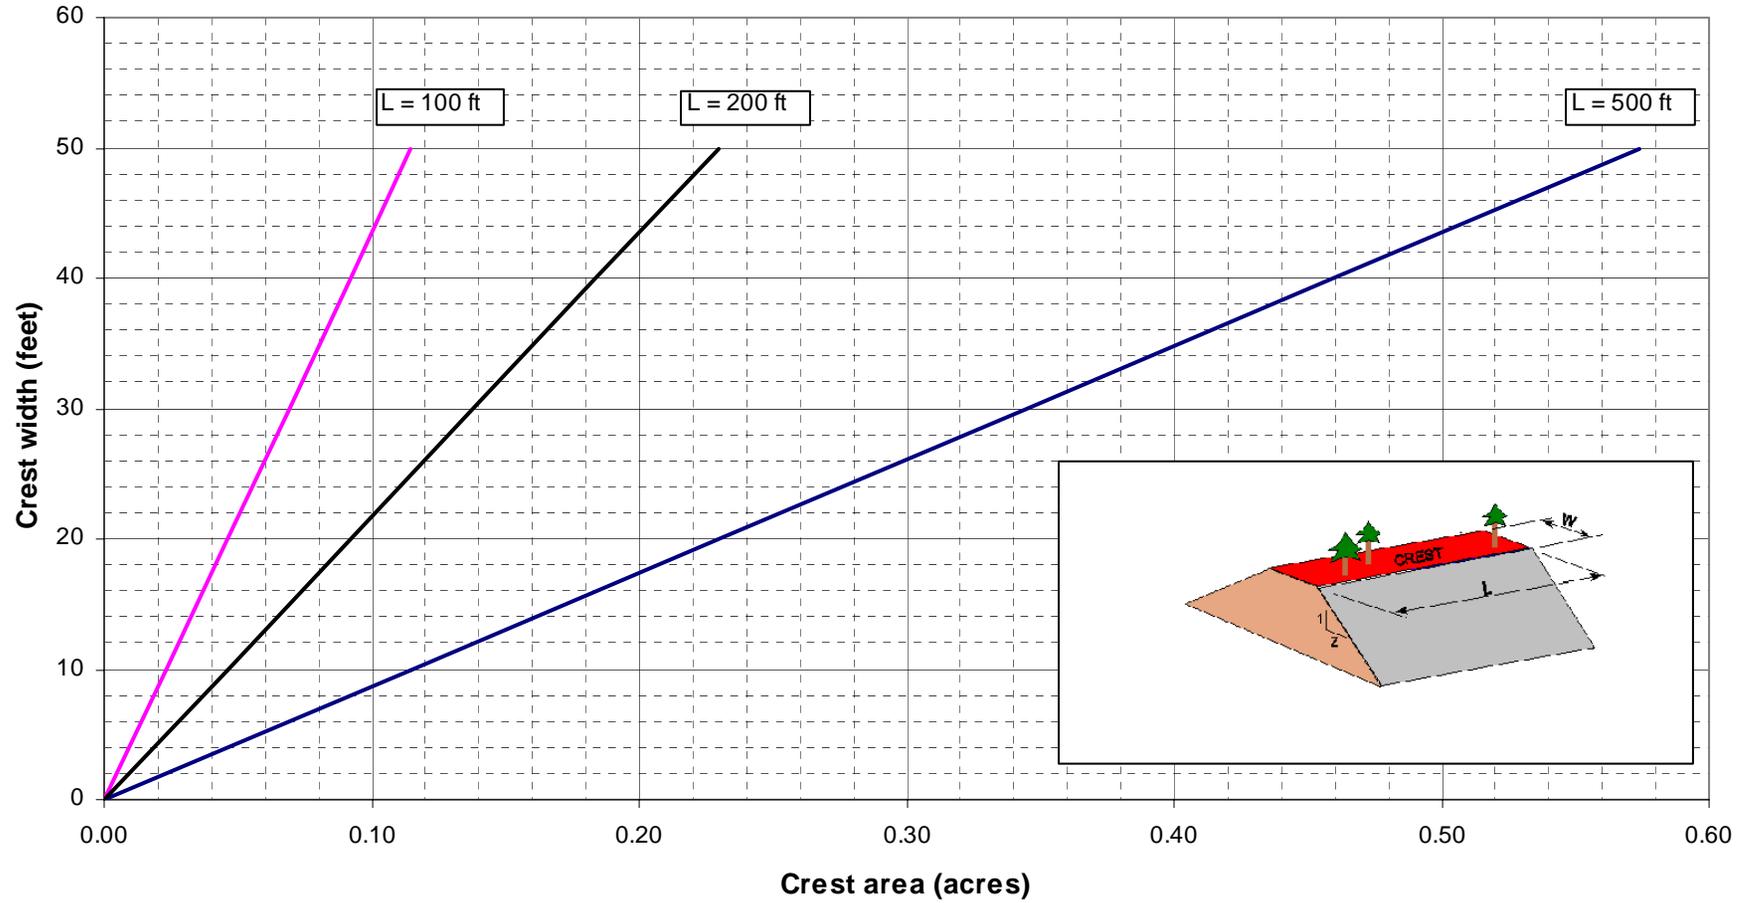
Chart 2. Dam crest area by width and length

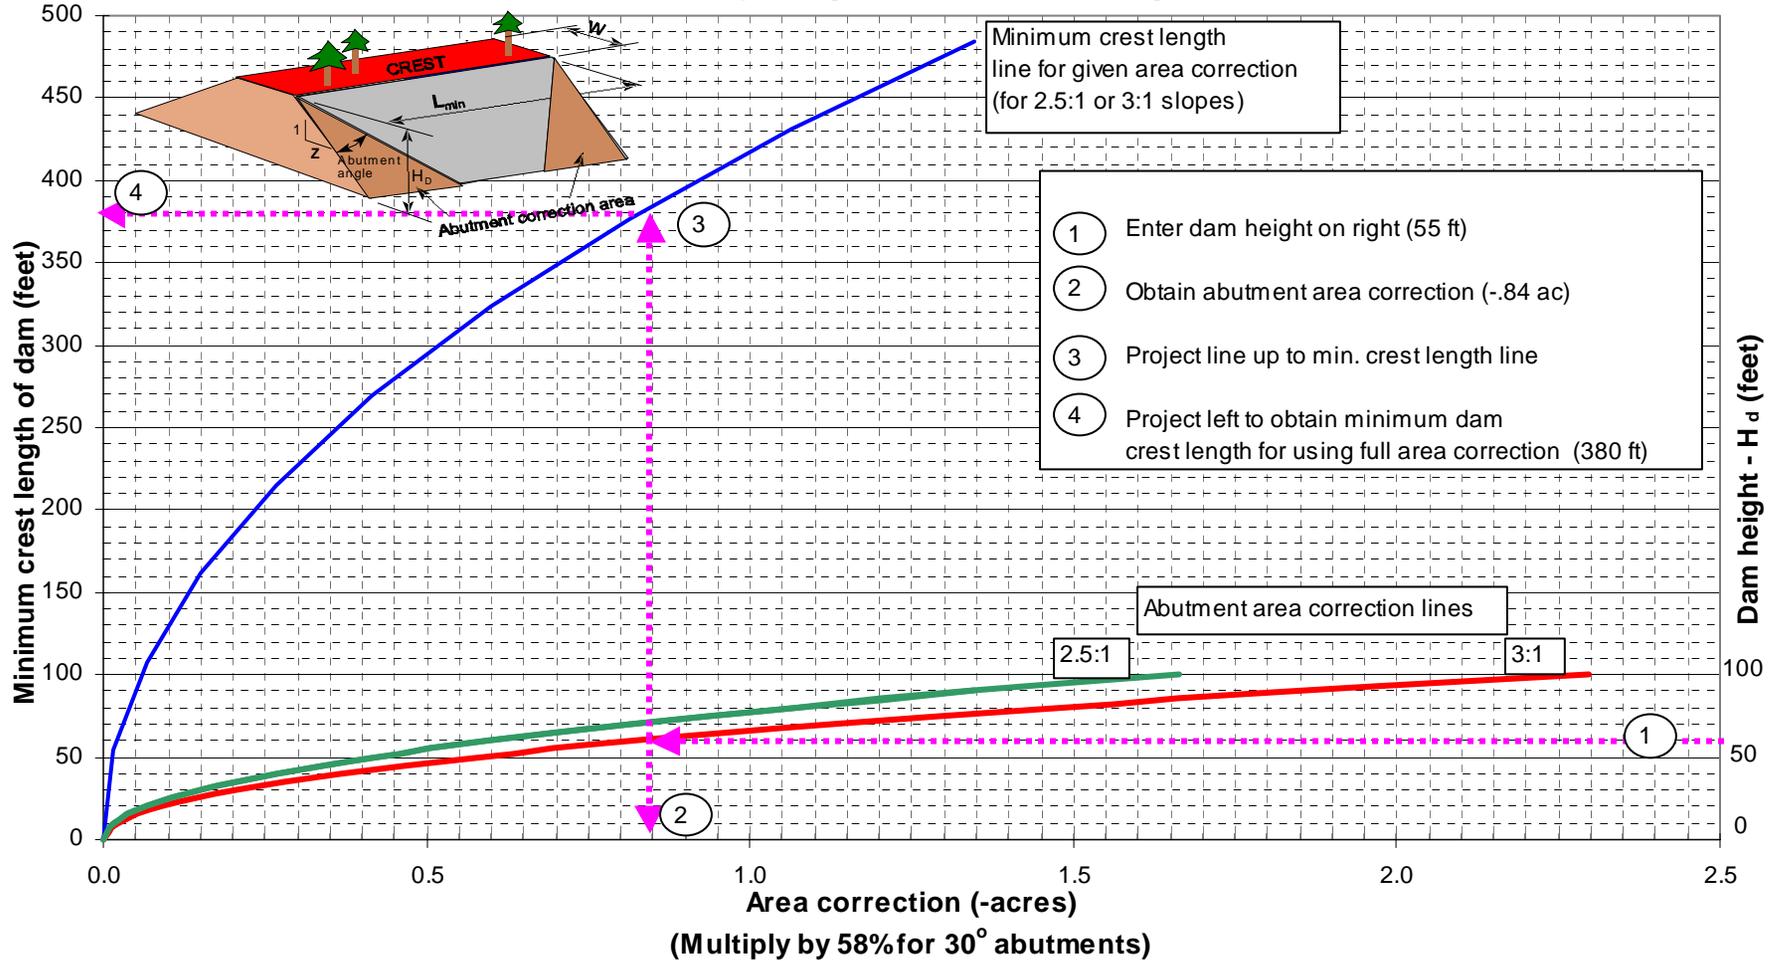
Chart 3. Abutment area corrections vs. dam height for 2.5H:1V & 3H:1V side slopes, with 45° abutment angle and corresponding minimum dam crest length
