Massachusetts Department of
Environmental Protection

The Occurrence and Sources of Perchlorate in Massachusetts

August 2005

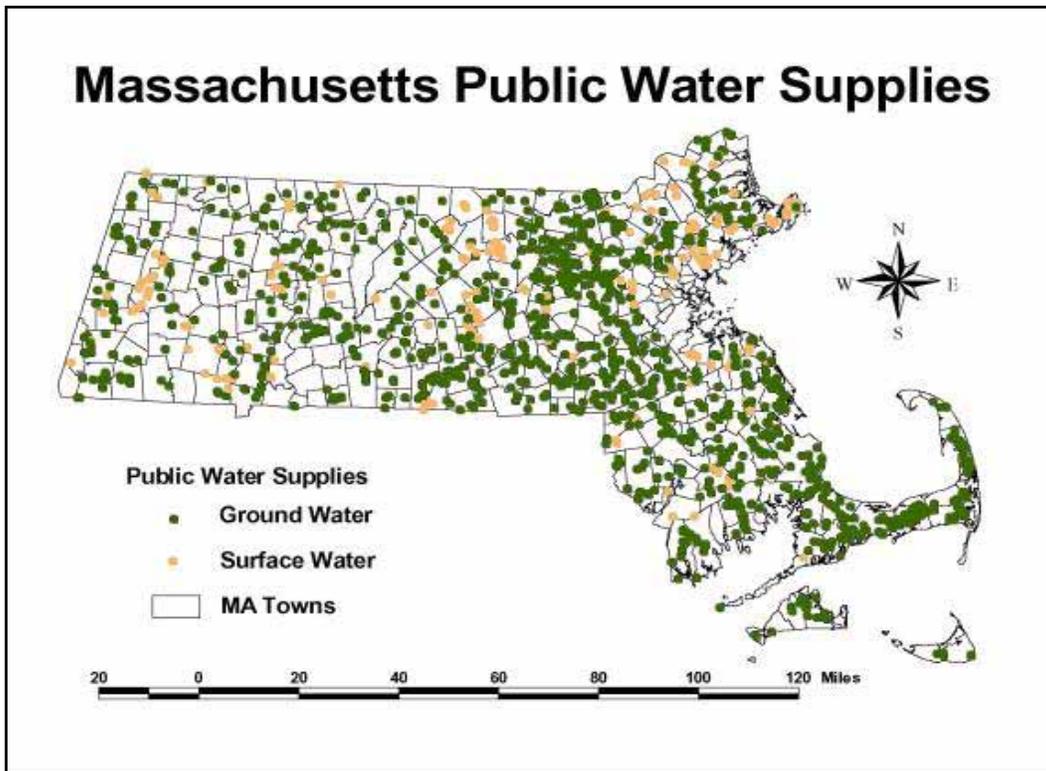
Figure 1 - Public Water Supplies in Massachusetts

There are approximately 450 community and 250 non-transient/non-community public water supply systems in Massachusetts, as plotted in Figure 1. The majority (89%) of these systems obtain water exclusively from groundwater aquifers. Collectively, this infrastructure constitutes a large, geographically and geologically diverse universe of water quality indicators.

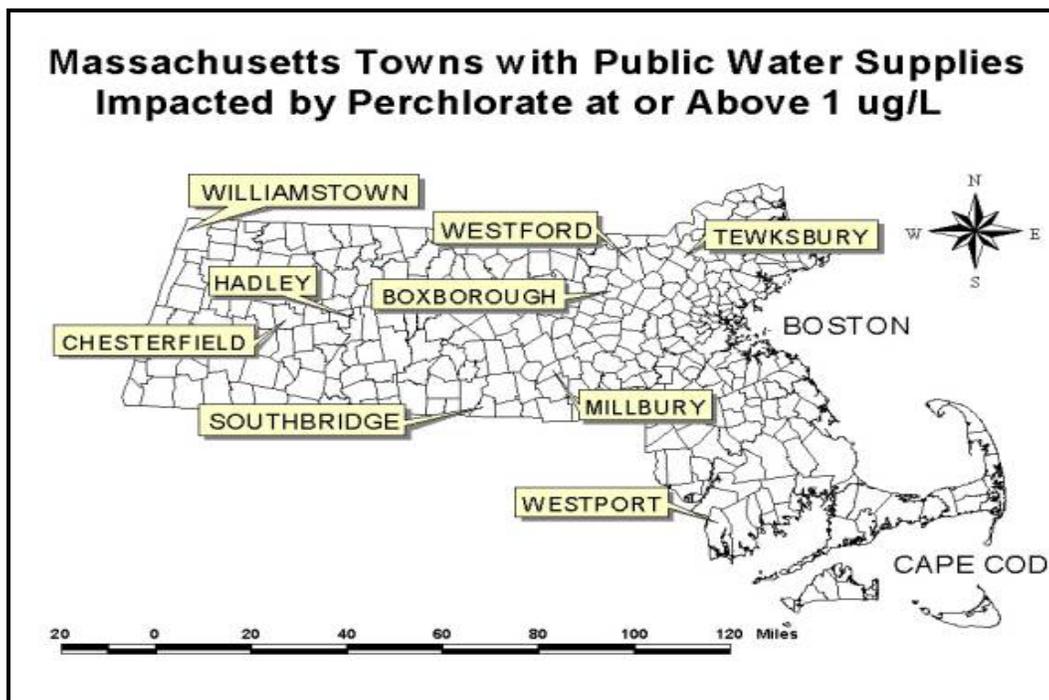
Figure 2 - Impacted Public Water Supplies in Massachusetts

In the last year, 85% (379) of the community and 86% (212) of the non-transient/non-community public water supplies in Massachusetts (groundwater and surface waters) have been tested for the presence of perchlorate, using analytical methodologies and laboratories capable of achieving a 1 $\mu\text{g/L}$ Reporting Limit. *Of these 591 water supplies, only 12 sources in 9 water supply systems have detected perchlorate above 1 $\mu\text{g/L}$ (some systems have multiple groundwater production wells in close proximity).* The communities where these 9 water supply systems are located are illustrated in Figure 2.

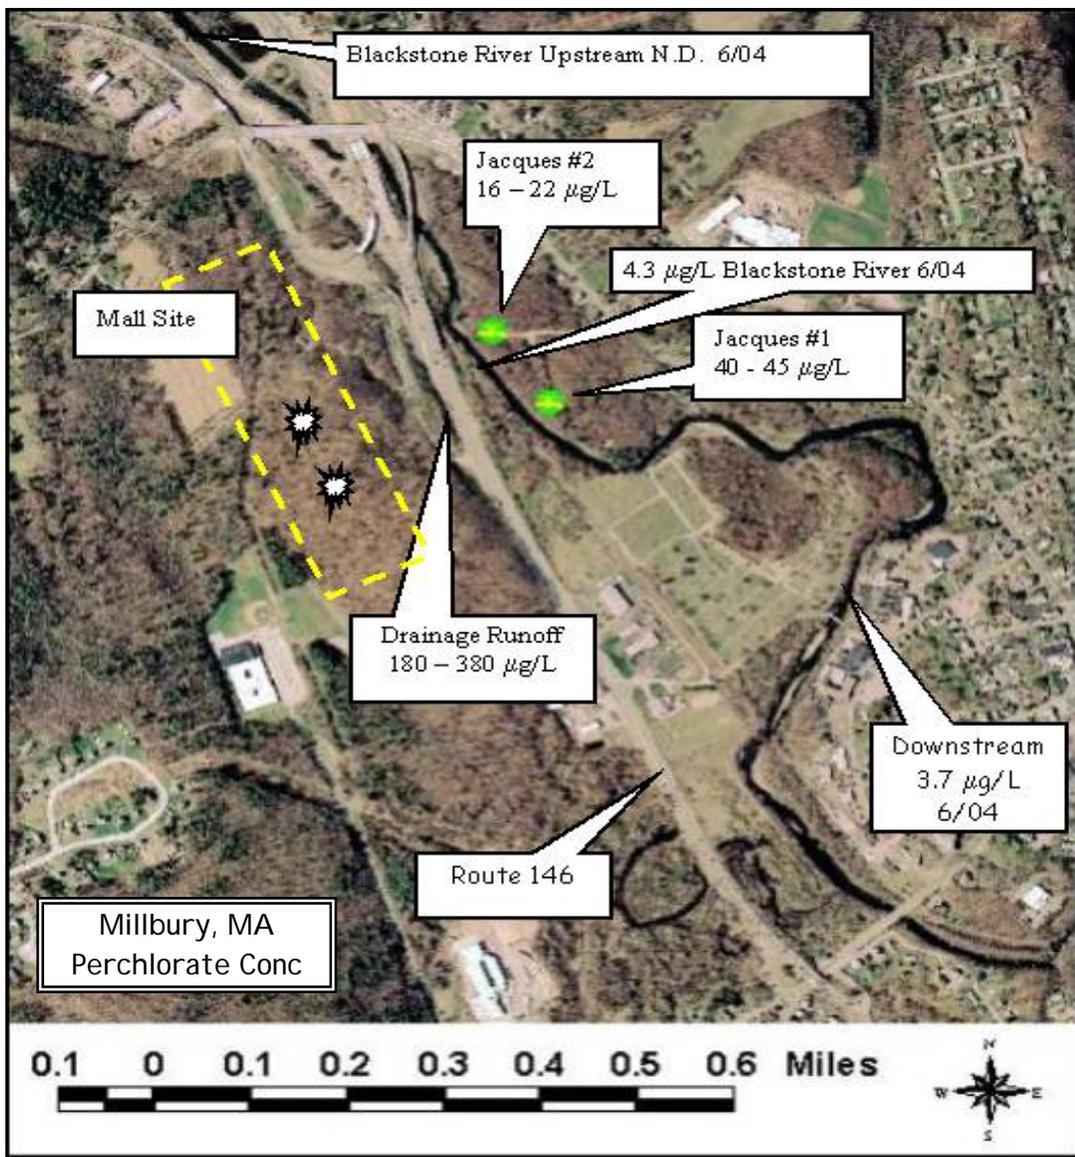
Figure 3: Millbury, MA Blasting Site

Blasting operations occurred at the Millbury site from July 10, 2002 through January 6, 2004. Much of the blast rock was reused at the site to facilitate construction of a large shopping mall, which was essentially constructed on the side of a bedrock hill (see Figure 3). Importantly, runoff from the roof drains of the mall buildings are discharged to the subsurface; in some cases into areas where blast-rock has been deposited.

To date, assessment efforts have disclosed tens to hundreds of $\mu\text{g/L}$ of perchlorate in surface water runoff systems, overburden monitoring wells, and bedrock monitoring wells on the mall property. In total, 9 private drinking water wells have been tested, though none appear to be directly downgradient of the mall area. None of these wells were found to contain perchlorate above 1 $\mu\text{g/L}$.

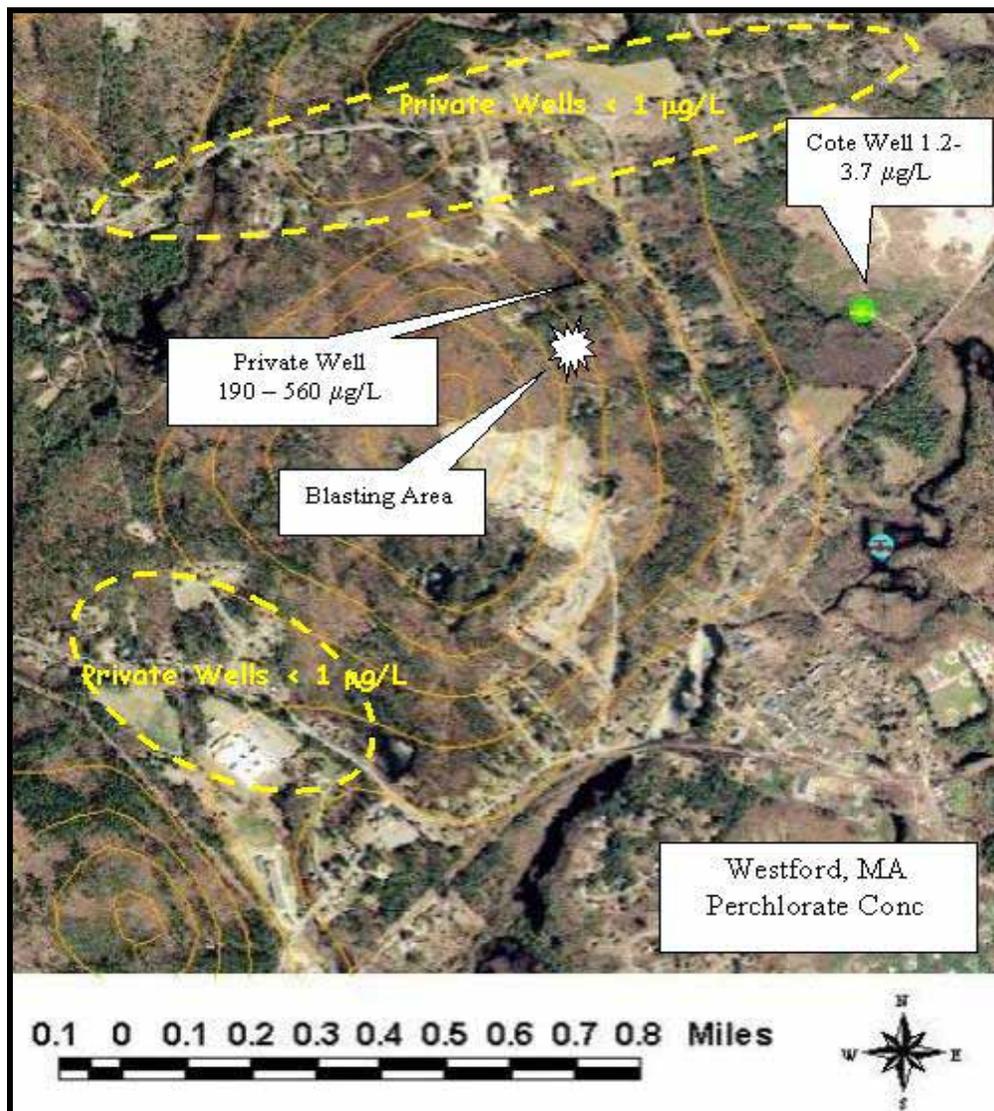
Figure 4: Westford, MA Blasting Site

In July 2004, 2 $\mu\text{g/L}$ of perchlorate was detected in the Cote Well, a municipal water supply located approximately one-half mile northeast of the highway garage site (see Figure 4).

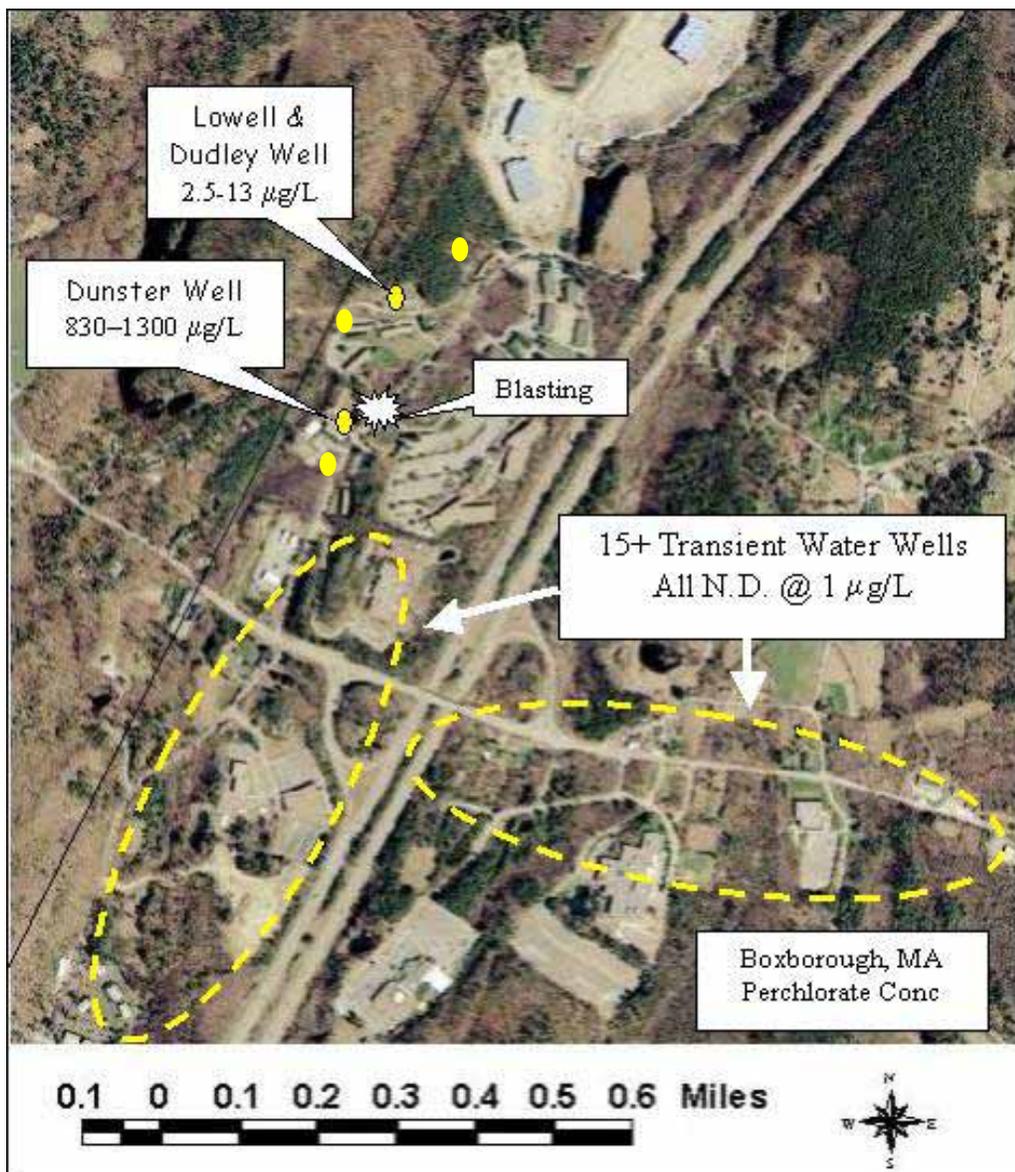
Figure 5: Boxborough, MA Blasting Site

In April 2004, 4.87 $\mu\text{g}/\text{L}$ of perchlorate was detected in one of 5 on-site production wells. The other 4 wells reported N.D. In September, however, testing of a second well (Dunster House) identified 791 $\mu\text{g}/\text{L}$ of perchlorate; a re-test two weeks later indicated 1080 $\mu\text{g}/\text{L}$. A peak concentration of 1300 $\mu\text{g}/\text{L}$ was reported for this well in November 2004. (See Figure 5)

All five production wells are believed to be bedrock wells, spaced about 200 - 500 feet from each other. The most impacted well is located within several hundred feet of the blasting operations.

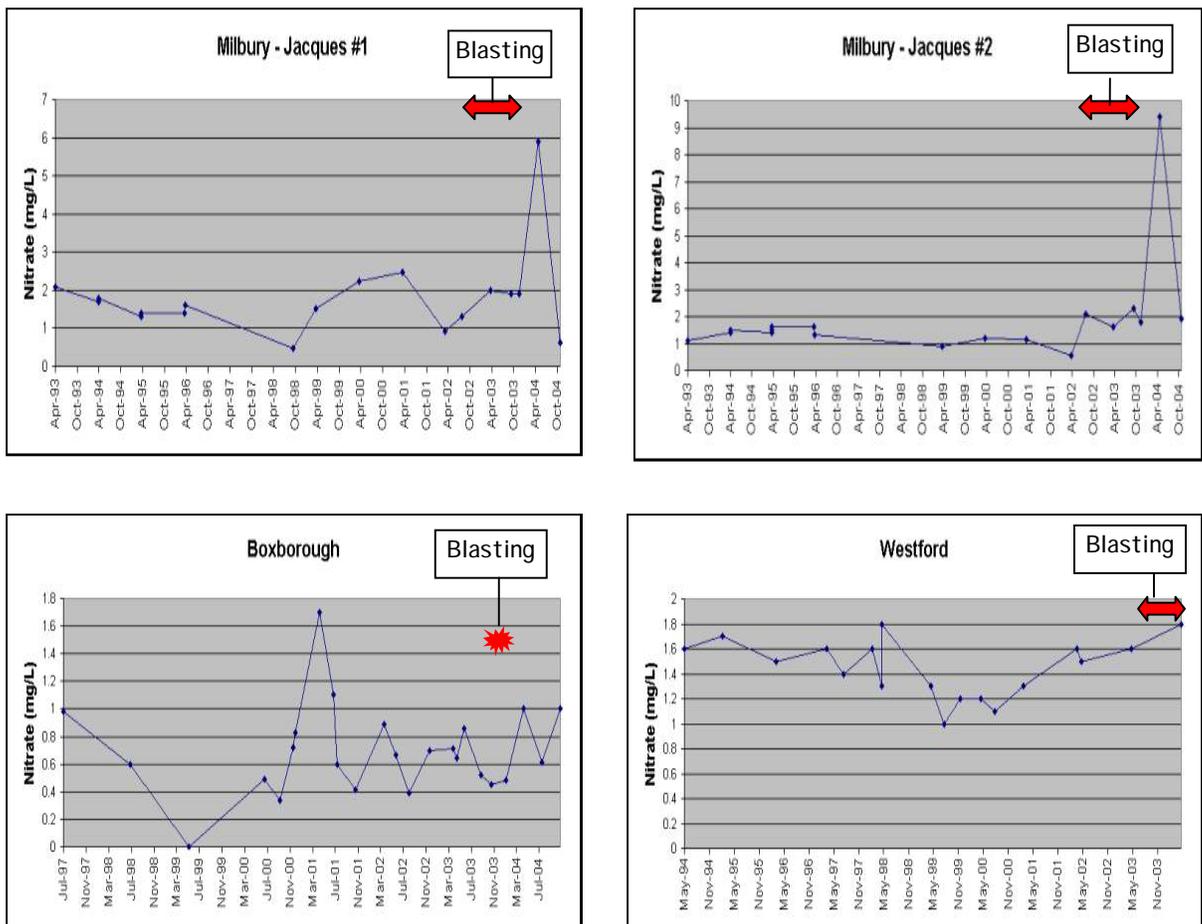
Figure 6
Nitrate Levels in Wells Impacted by Perchlorate from Suspected Blasting Sources

Figure 6 plots the last 10 years of routine nitrate monitoring data for the 3 blasting-related impacted water supplies.

The above data suggest the possibility of a relationship between nitrates and perchlorate at the Millbury site, given the 5-10 fold increase in nitrates in Jacques Wells #1 and #2, located 800 - 1000 feet to the east of the mall construction site, approximately 18 months after the start of blasting activities. This is also the site where large amounts of ANFO were used (621,000 pounds).

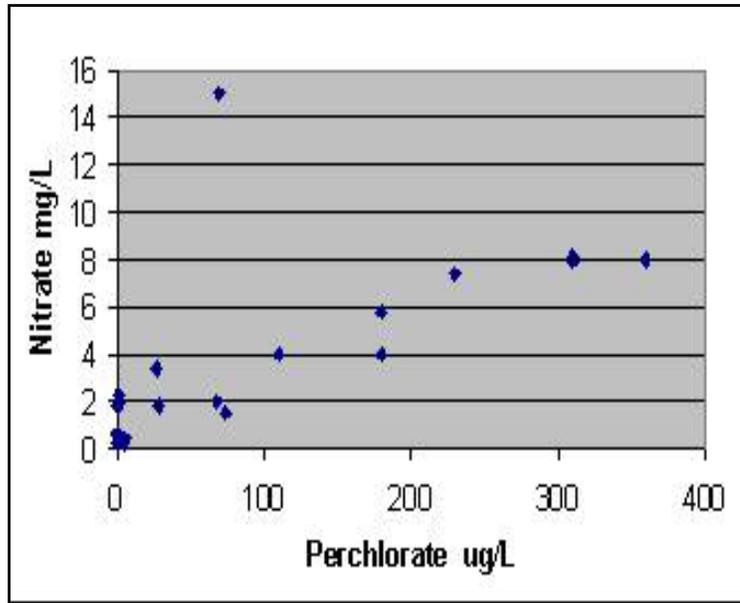
Figure 7
Millbury, MA Perchlorate vs Nitrate
(GeoSyntec, 2005)

This relationship was further explored by the consulting firm overseeing work at the Millbury site, during a series of sampling events in February 2005, where split samples were analyzed for perchlorate and nitrates (NO₃-N). In total, 22 samples were synoptically analyzed in this manner, including 8 drainage/surface water samples, 8 overburden groundwater samples, and 6 bedrock groundwater samples. The results of all data are plotted in Figure 7. Once again, the possibility of a general correlation is suggested, though more evaluation of variables (e.g., site-wide explosive materials usage, precipitation events, groundwater elevations, etc.) would be needed to draw more definitive conclusions.

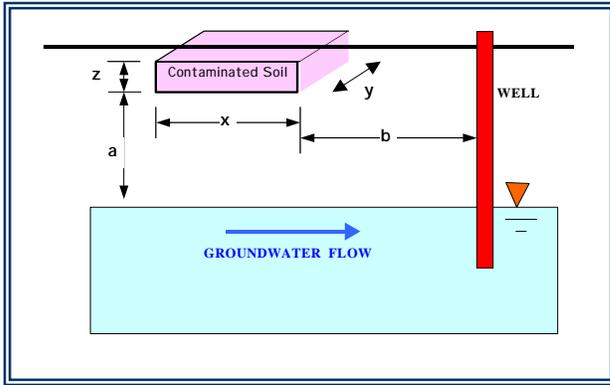
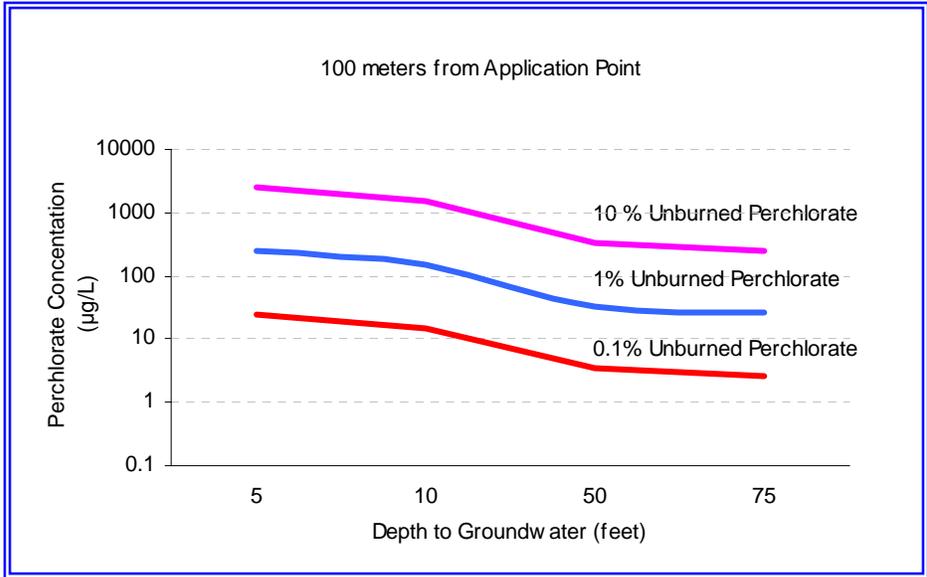
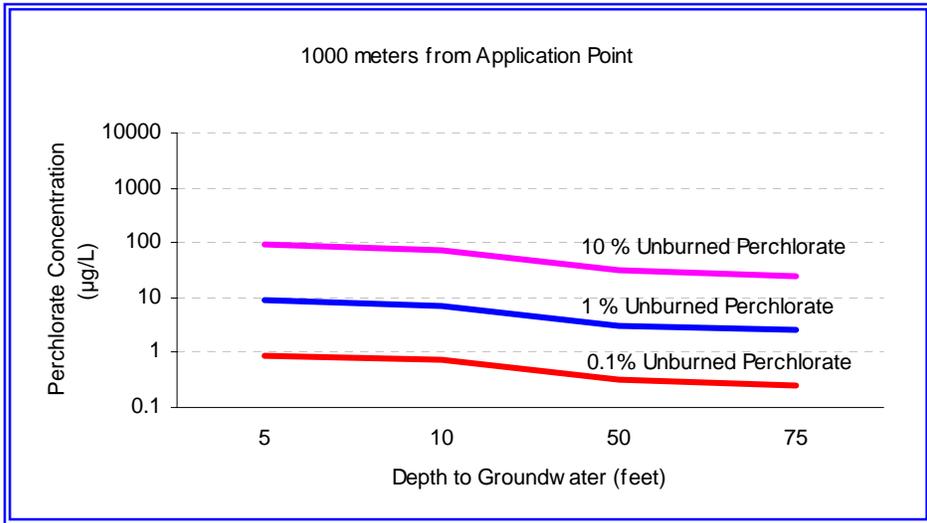
Figure 8: Modeled Perchlorate Impacts to Groundwater from Fireworks Display

Model = SESOIL/AT123D
 Assumptions:
 3000 lbs fireworks (1000-2000 shells)
 Average perchlorate content = 40%
 x = 60 meters
 y = 60 meters
 z = 6 inches
 a = variable from 5 to 75 feet
 b = variable from 100 to 1000 meters

Additional Model Inputs:

- 44 inches of precipitation per year (Massachusetts)
- Solubility of Potassium Perchlorate = 1.5×10^7 µg/L
- Hydraulic Conductivity = 4.583 m/hr (sand)
- Hydraulic Gradient = 0.0031

MassDEP has conducted limited modeling efforts of hypothetical fireworks displays, in order to better define the scope and range of potential groundwater impacts and concerns. The details and results of this modeling effort are contained in Figure 8, which assumes a mid-sized "July 4th community display" of 1000 to 2000 aerial shells, with a total weight of 3000 pounds.

While the 40% perchlorate figure may be high, it is being used in the absence of anything more definitive from the pyrotechnics industry. On the basis of this analysis, even with 99.9% destruction of perchlorates, tens of $\mu\text{g}/\text{L}$ of perchlorate could be expected immediately (100 meters) downgradient of the fallout area, with trace amounts ($1 \mu\text{g}/\text{L}$ +/-) further downgradient. Higher concentrations could be expected with larger displays, use of pyrotechnics with higher amounts of perchlorates, less complete combustion, improper disposal of duds and misfires, excessive debris fallout and/or lack of post-display cleanup.

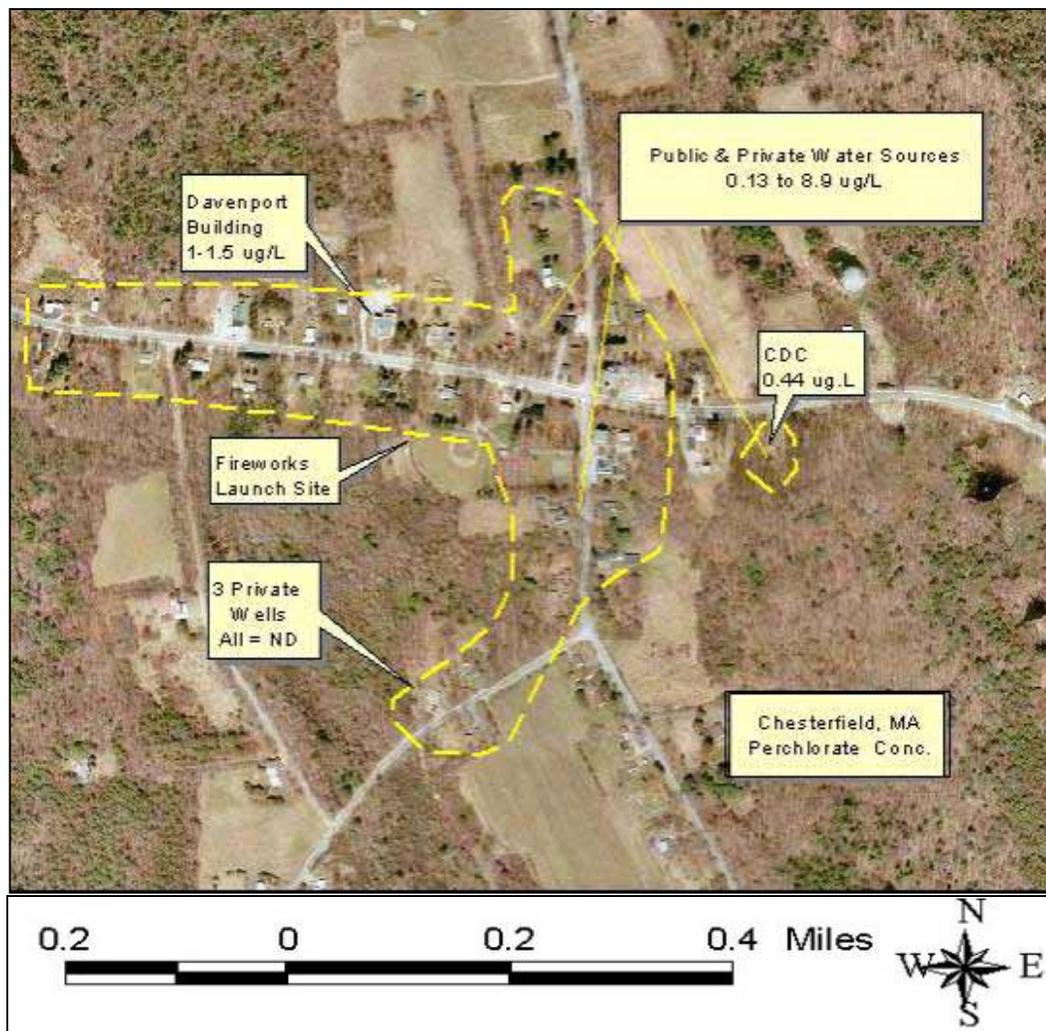
Although detailed records have not as yet been obtained, fireworks were reportedly launched from a municipal ball field located across the street from the Davenport Building, with the last event occurring on July 4, 2002 (see Figure 9).

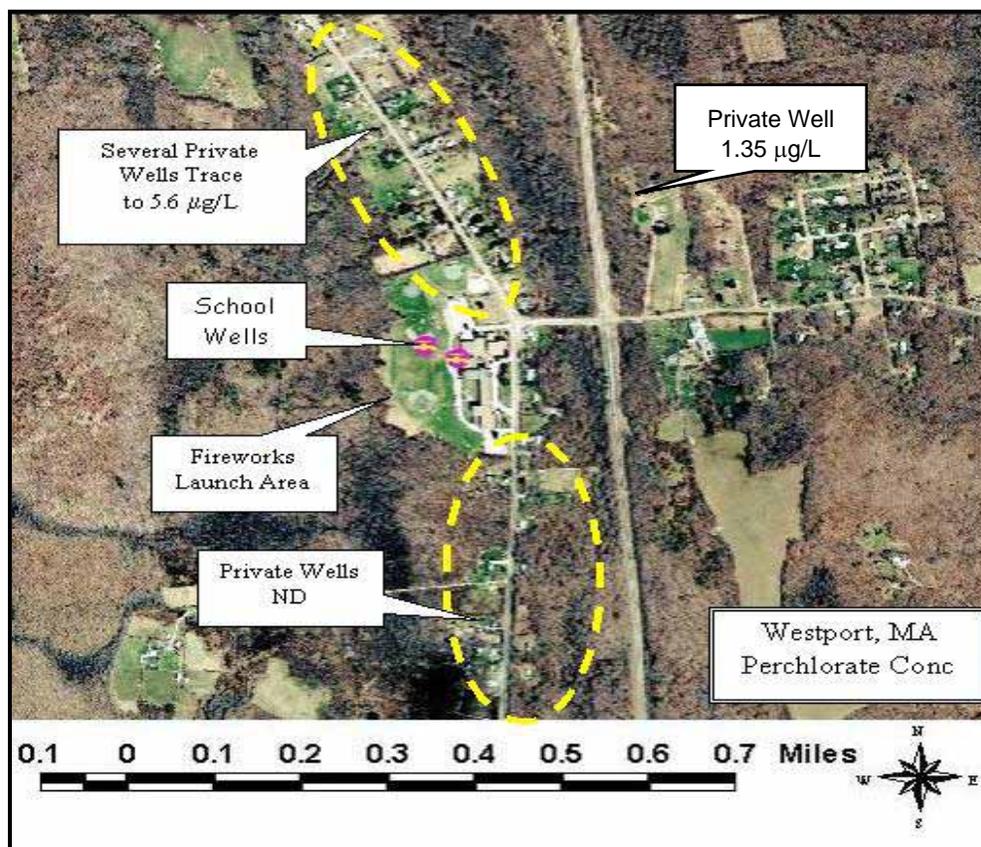
Figure 10: Westport, MA Fireworks Site

the High School, and located about 600 feet northeast of the former fireworks launch area (see Figure 10). Shortly thereafter, one well was taken out of service, and the remaining well has consistently reported perchlorate in the range of 1 to 2 $\mu\text{g/L}$.

Groundwater movement in the area of the school is not known, but, based upon topography, is believed to be towards the south/southeast. Depth to groundwater is relatively shallow throughout the area (i.e., 10-15 feet below grade). The geology is expected to consist of glacial till overlying bedrock, with bedrock likely present 30 to 40 feet below grade. Importantly, the direction of wind during fireworks launching events is not known, though prevailing winds in this area are from the southwest.

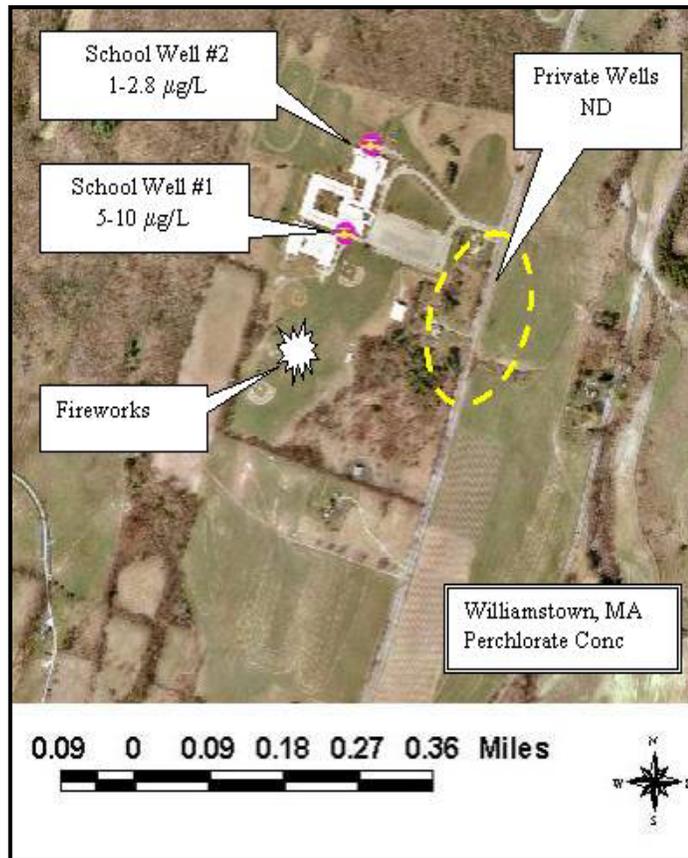
Figure 11: Williamstown, MA Fireworks Site

Fireworks were launched from the Mount Greylock School in Williamstown between 1989 and 1992, and from 1999 to 2003. In April of 2004, two (bedrock) wells servicing the school were found to contain concentrations of perchlorate at 1.0 and 5.1 $\mu\text{g/L}$ (see Figure 11).

Bedrock is believed to be present within 10 to 15 feet of the ground surface, and the groundwater table is believed to be in the bedrock. Investigations are continuing.

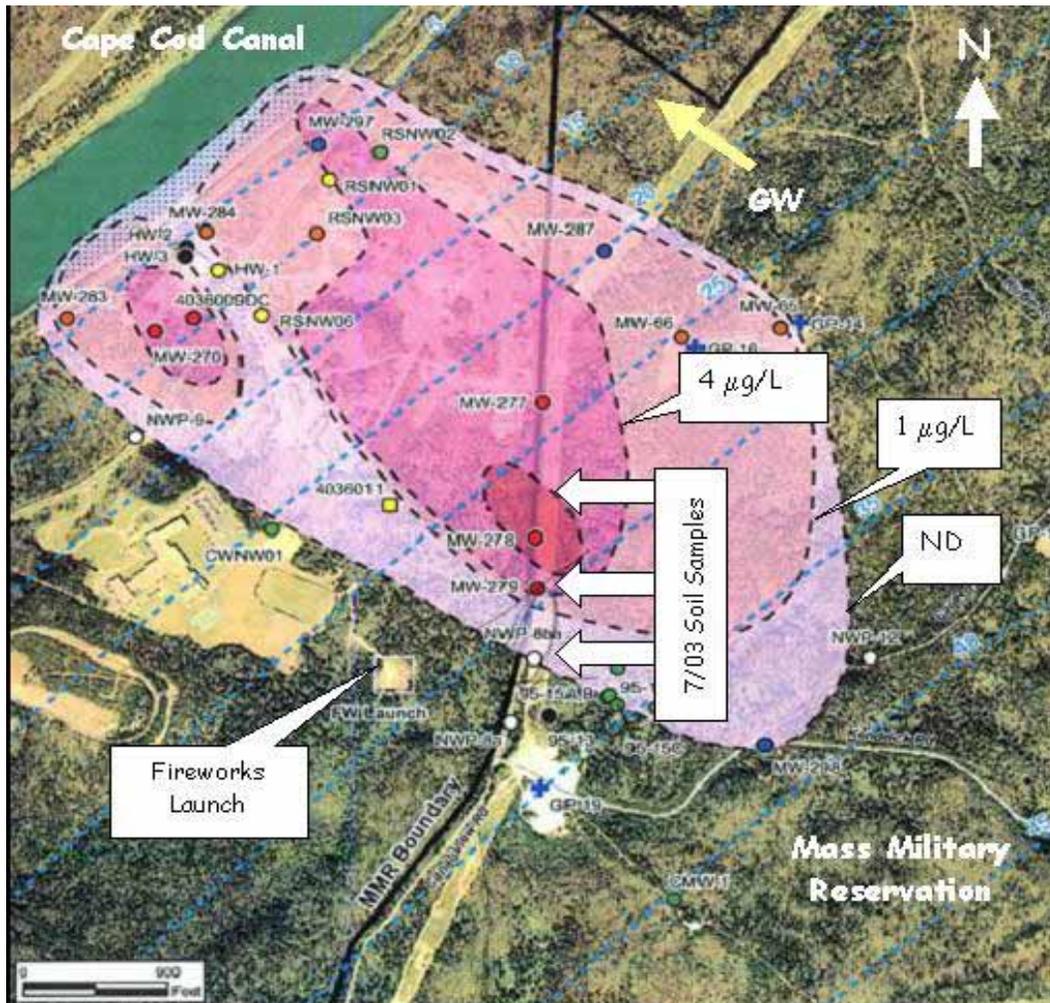
Figure 12: Bourne, MA Fireworks Site

Between 1997 and 2004, fireworks were launched during July 4th celebrations at the Upper Cape Cod Regional Technical School in Bourne. This launch area is located approximately 700 feet westerly of the Massachusetts Military Reservation, and 400 feet southwest of a groundwater contaminant plume containing explosive constituents, including perchlorate. One of 4 major perchlorate contamination areas under study at the 15,000-acre military installation, this 4500-foot, 318 acre plume contains predominantly single-digit concentrations of perchlorate, flowing in a northwest direction towards the Cape Cod Canal. The highest concentration of perchlorate in the plume is approximately 19 $\mu\text{g/L}$ (see Figure 12), as opposed to higher perchlorate levels (several hundred $\mu\text{g/L}$) in other areas of the base.

In July 2003, a military contractor collected soil samples along the western border of the base before and after the annual July 4th fireworks display at the Technical School. At 3 locations 1000 - 2000 feet northwest and downwind from the launch site, in an area containing fireworks paper debris, post-event surficial soil samples were found to contain 1330, 1260, and 7560 µg/kg of perchlorate, compared to a pre-fireworks level of N.D. Two of these locations were re-sampled 2 months later, on 9/18/03 and 9/23/03, and were found to have gone from 1330 µg/kg to 5.3 µg/kg, and from 7560 µg/kg to 15 µg/kg perchlorate. The fireworks paper debris was also analyzed, and found to contain between 302 and 34,200 µg/kg of perchlorate. (AMEC, 2004)

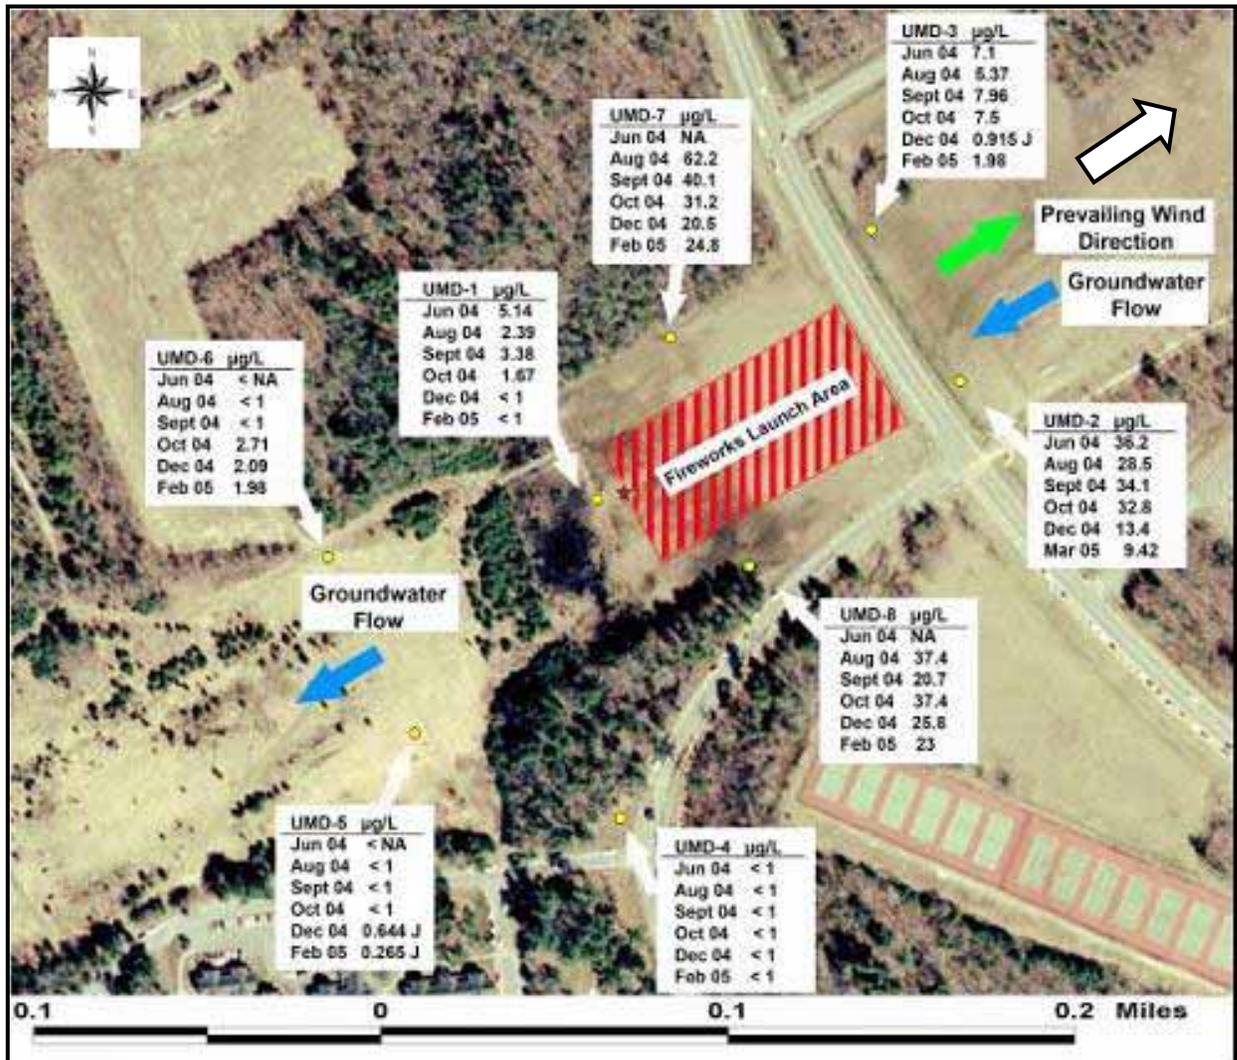
Figure 13
Fireworks Study Area, University of Massachusetts at Dartmouth

groundwater samples were obtained from all 8 monitoring wells. Additional rounds of groundwater samples were obtained in October and December of 2004, and February of 2005. The location of key site features and monitoring points, along with all groundwater data, is provided in Figure 13.

- A likely (and perhaps most significant) pathway for perchlorate introduction to the groundwater from fireworks events is via fallout of aerial debris (e.g., pieces of un-combusted aerial shells). The predominant wind direction at this site is to the north/northeast, counter to the direction of groundwater flow. This could explain the elevated perchlorate concentration in the upgradient wells: the remnants of 10 years of fallout and surficial deposition.

- Based upon slug testing of wells UMD-5, 6, and 7, and consistent with the observed and expected geologic conditions, the hydraulic conductivity of site soils (at the water table interface) was calculated to be in the range of 10^{-3} to 10^{-4} cm/sec. Given the average hydraulic gradient across the site of 0.0167 ft/ft, groundwater velocity is expected to be in the range of 0.04 to 0.4 ft/day, or about 15 to 150 feet per year. This means that groundwater is moving relatively slowly, and would explain why the heart of the perchlorate plume has not yet moved beyond the launch area (i.e., still moving downgradient from the up-wind deposition areas).

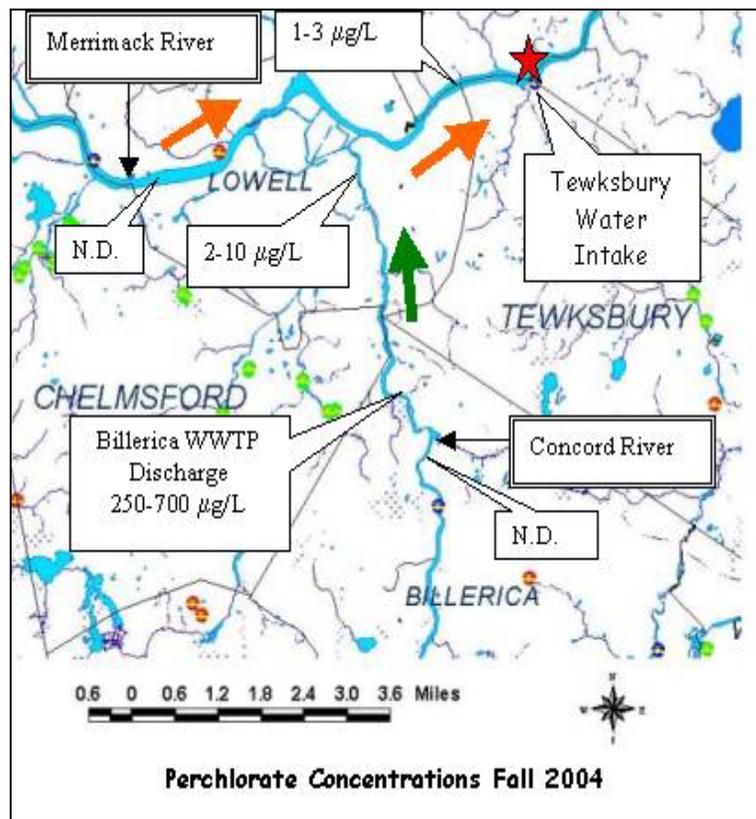
Figure 14: Perchloric Acid Discharge Concord and Merrimack Rivers, MA

This finding precipitated an effort by MassDEP to locate the source of perchlorate discharge to the river, involving a systematic and iterative sampling program tracking the contaminant upstream of the Tewksbury water intake. Eventually, the source was traced to the discharge from the Town of Billerica Wastewater Treatment Plant, which discharged into the Concord River, a tributary of the Merrimack, over 5 miles upstream of the Tewksbury intake (see Figure 14).

Monitoring of the effluent from the Billerica wastewater plant during September and October 2004 showed consistent levels of perchlorate in the range of 250 to 700 $\mu\text{g/L}$. The Billerica plant is a secondary treatment system servicing a community of 50,000, with an average daily flow of 3.1 million gallons/day (MGD), including 0.40 MGD of industrial wastewaters. At this average flowrate, approximately 6-10 pounds per day of perchlorates were being discharged from the plant. This was consistent with the 2-4 $\mu\text{g/L}$ concentrations of perchlorate that were being detected in the Concord River downstream of the discharge, where river flowrates varied in the range of 250 to 600 CFS. The highest level detected was 10.3 $\mu\text{g/L}$ of perchlorate on September 7, 2004, when the Concord River flowrate was at its lowest at 142 CFS.
