Massachusetts College of Art and Design Tower Building Assessment

Commonwealth of Massachusetts
Division of Capital Asset Management and Maintenance

14 November 2013

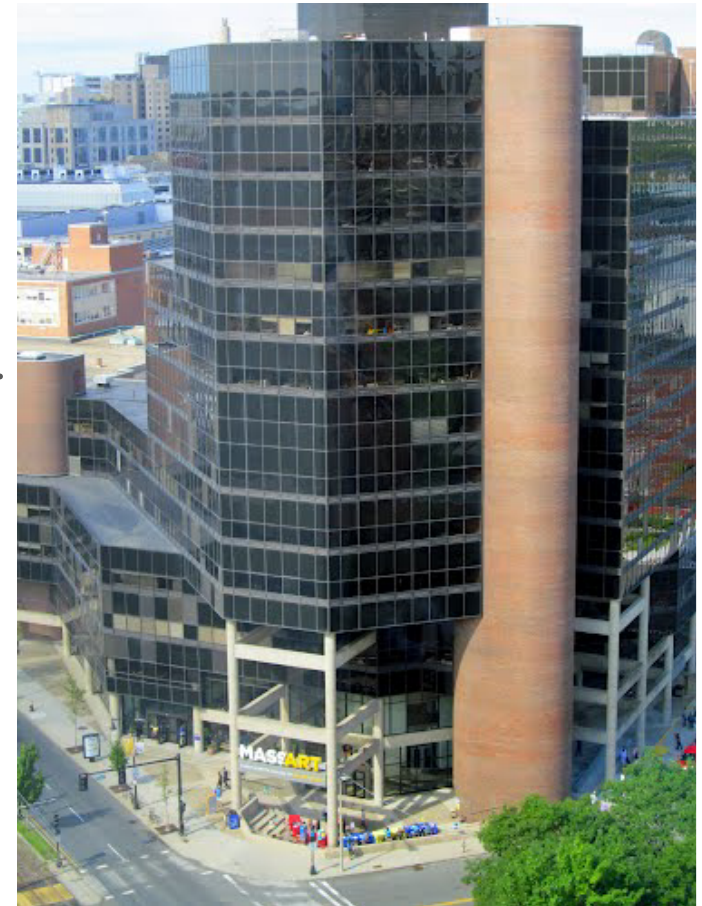
MCAD Tower Building Overview

- Located at 621 Huntington Ave. in Boston
- 14 stories tall and ~ 318,300 GSF
- Original construction documents dated May 1972 but identified as built in 1977
- Major renovation and upgrade completed in 1999.
- The Tower houses an auditorium, classrooms, offices, lecture halls, galleries and studio spaces
- Holds 60% of MCAD's classrooms, 22 of 37.
- 2013 CAMIS value \$98,127,074.00
