DIVISION OF
CAPITAL ASSET
MANAGEMENT &
MAINTENANCE

MASSART
MASSACHUSETTS COLLEGE
OF ART AND DESIGN

BUROHAPPOLD
ENGINEERING

- 0- Summary Tower Study (this document)
- 1- Kickoff Meeting PPT and Meeting Minutes
- 2- Brainstorming PPT
- 3- April 5, 2018 Trustees Meeting PPT and Meeting Minutes
- 4- May 3, 2018 Trustees Meeting PPT and Meeting Minutes
- 5- July 10, 2018 Final Trustees Meeting PPT
- 6- July 10, 2018 Implementation Schedules
- 7- July 10, 2018 Cost Analysis
- 8- MassArt Logistics Analysis (Cam Roberts)
- 9- Sketchup Model of Tower

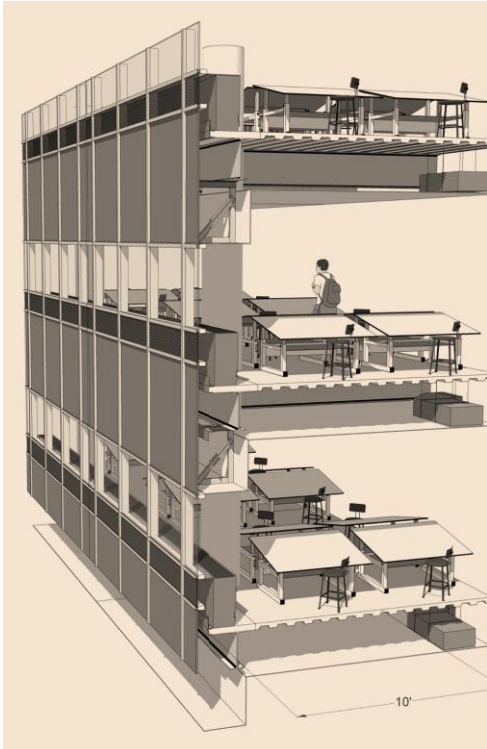
Unitized Curtainwall

Top reasons for recommendation:

- **Speed On-Site:** Units assembled and glazed in shop under controlled conditions ahead of time allows crews to work quickly on site to install units
- **Less Space Required on-site:** Units assembled in shop, brought to site and hoisted up to the building face from the exterior, reducing space needed on-site and on the interior.
- Unitized frames **accommodates existing building conditions:** building movements, high floor to floor heights and existing slab edge conditions.

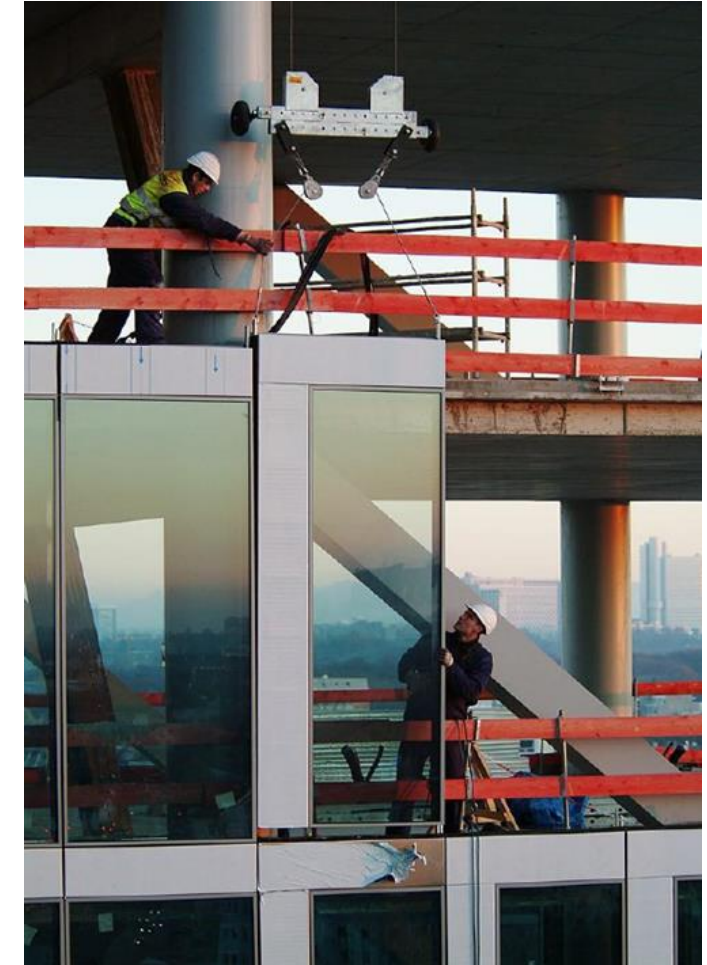
Replacement of Ventilators

Given integration of the HVAC (ventilators) into the existing curtainwall, Ventilators **must** be replaced

Given integration of the HVAC into the Curtainwall, Ventilators need to be replaced with new FCUs in ceiling

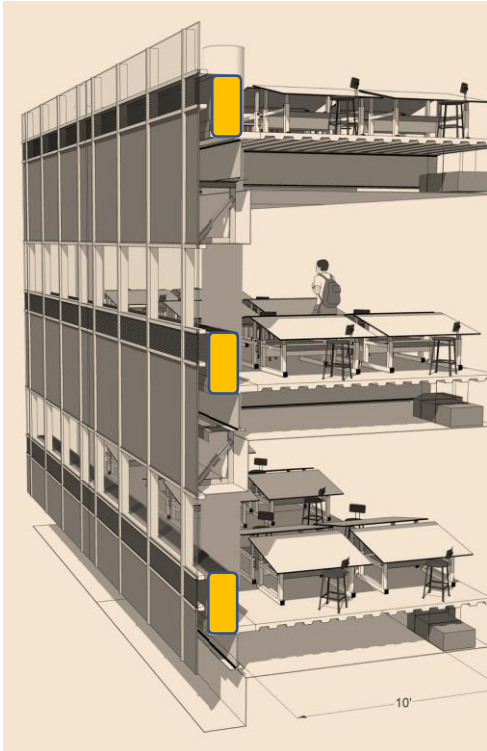
Ceiling Fan Coil Units (FCU)

Top reasons for recommendation:

- **High Cooling and Heating Capacities:** A proven and well known system with good local and individual room control
- **Can cater to variable load conditions:** Existing building presents different conditions per floor and per exposure
- **Low Capital Cost**

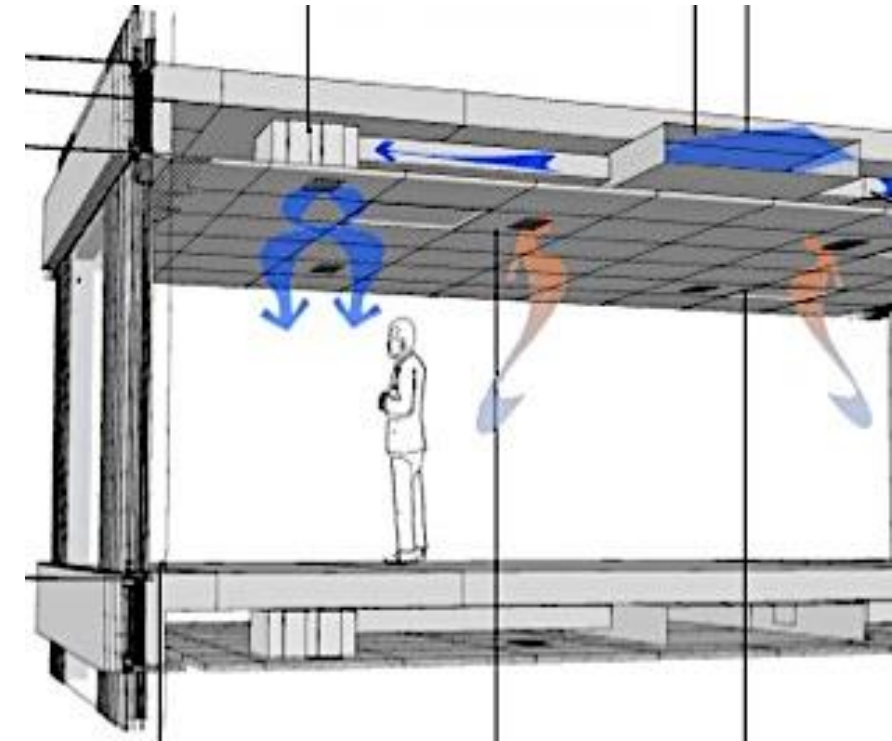
Replacement of Systems Feeding New FCUs

AHUs and Piping risers feeding new FCUs must be upgraded and replaced

Air Handling Units (AHU) & Piping Risers

Reasons for recommendation:

- **Additional AHU:** Existing ventilators took air directly from outside, new FCUs require new AHUs at roof
- **Replacement AHUs at Floors:** Existing AHUs are past their serviceable life
- **Piping Risers:** Existing piping risers feeding new FCUs and AHUs are in poor condition and need to be replaced

New/ replacement AHUs and replacement of associated piping risers for FCUs and AHUs

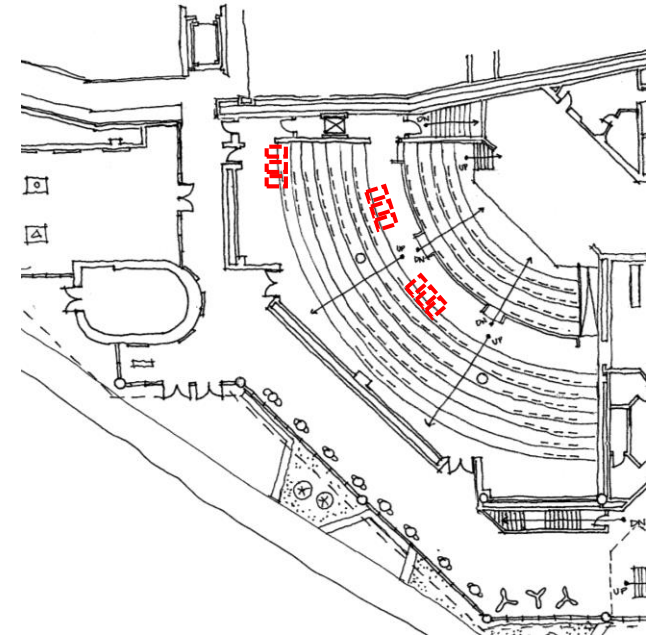
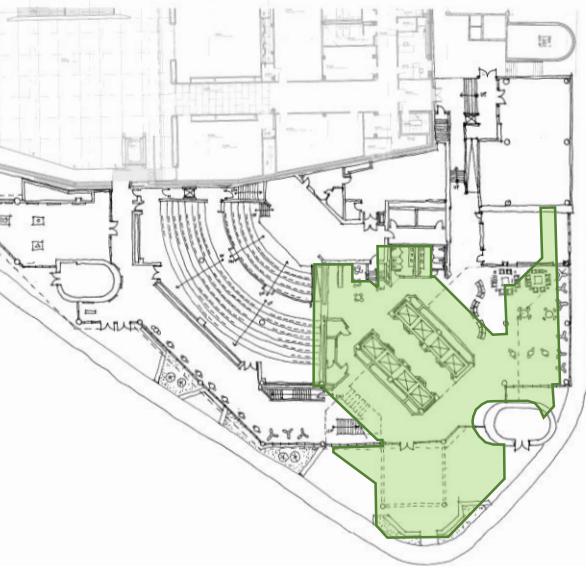
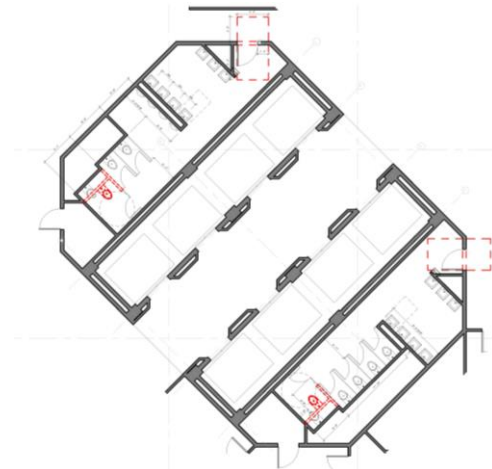
Main Entry, Toilet Rooms, Auditorium, Others

Recommendations:

- **Main Entry:** At a minimum, a lift must be provided to connect Lower, 1st and 2nd floor levels; a full infill of the area is a cleaner solution, as an alternate
- **Auditorium:** Ramps and Lift to an enlarged central aisle for HC seating
- **Toilet Rooms:** Handicap Stall is enlarged and door clearance is addressed
- **Other Areas:** Sinks in classrooms, door clearances, door hardware, drinking fountains all need to be addressed

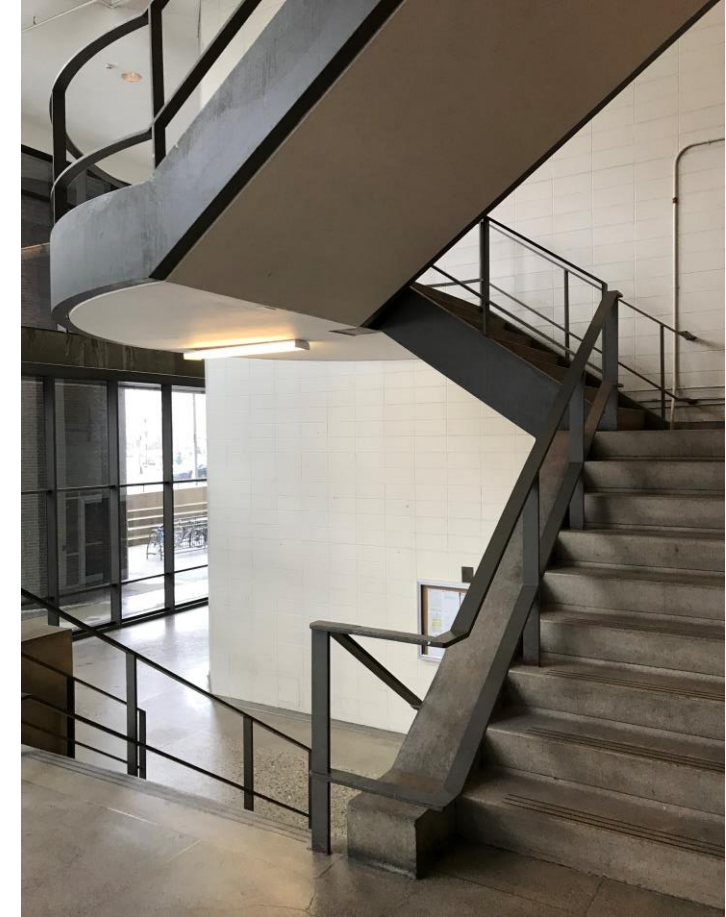
Code and Life Safety Upgrades

Reasons for recommendation:

- **Stair Pressurization:** New ductwork and fans to pressurize egress stairs
- **Open Stair Railings:** Railings at open stair need to be replaced
- **Structural Beam Repairs:** Structural beam identified in Arup Report as damaged needs repair
- **Detail Fireproofing Survey:** A survey to identify deficiencies in coverage
