*Massachusetts Coastal Infrastructure  
Inventory and Assessment Project*  
*Massachusetts Department of Conservation and Recreation*  
*Office of Waterways*

## Middle Cape Cod

Barnstable  
Yarmouth  
Dennis

**MASSACHUSETTS COASTAL INFRASTRUCTURE INVENTORY AND ASSESSMENT PROJECT**

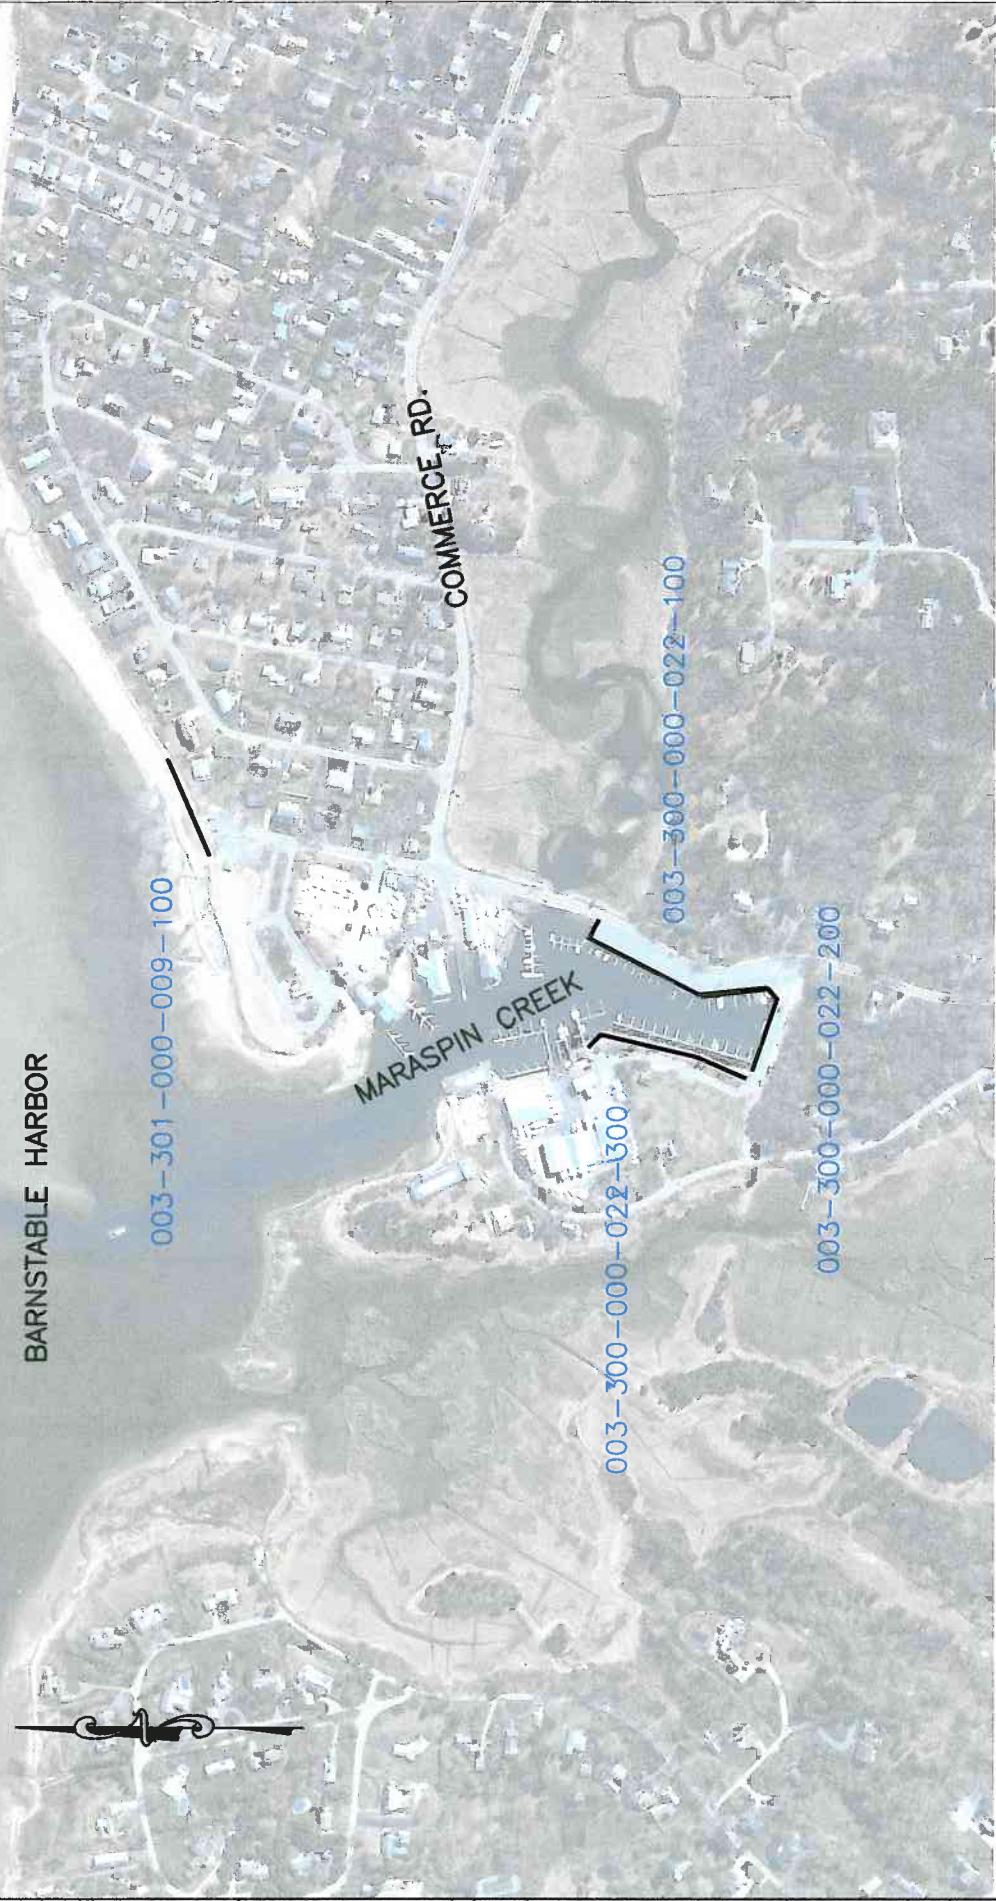
## COASTAL STRUCTURE LOCATION PLAN

BARNSTABLE HARBOR

TOWN OF BARNSTABLE  
COASTAL INFRASTRUCTURE INVENTORY  
AND ASSESSMENT PROJECT  
DECEMBER 2007

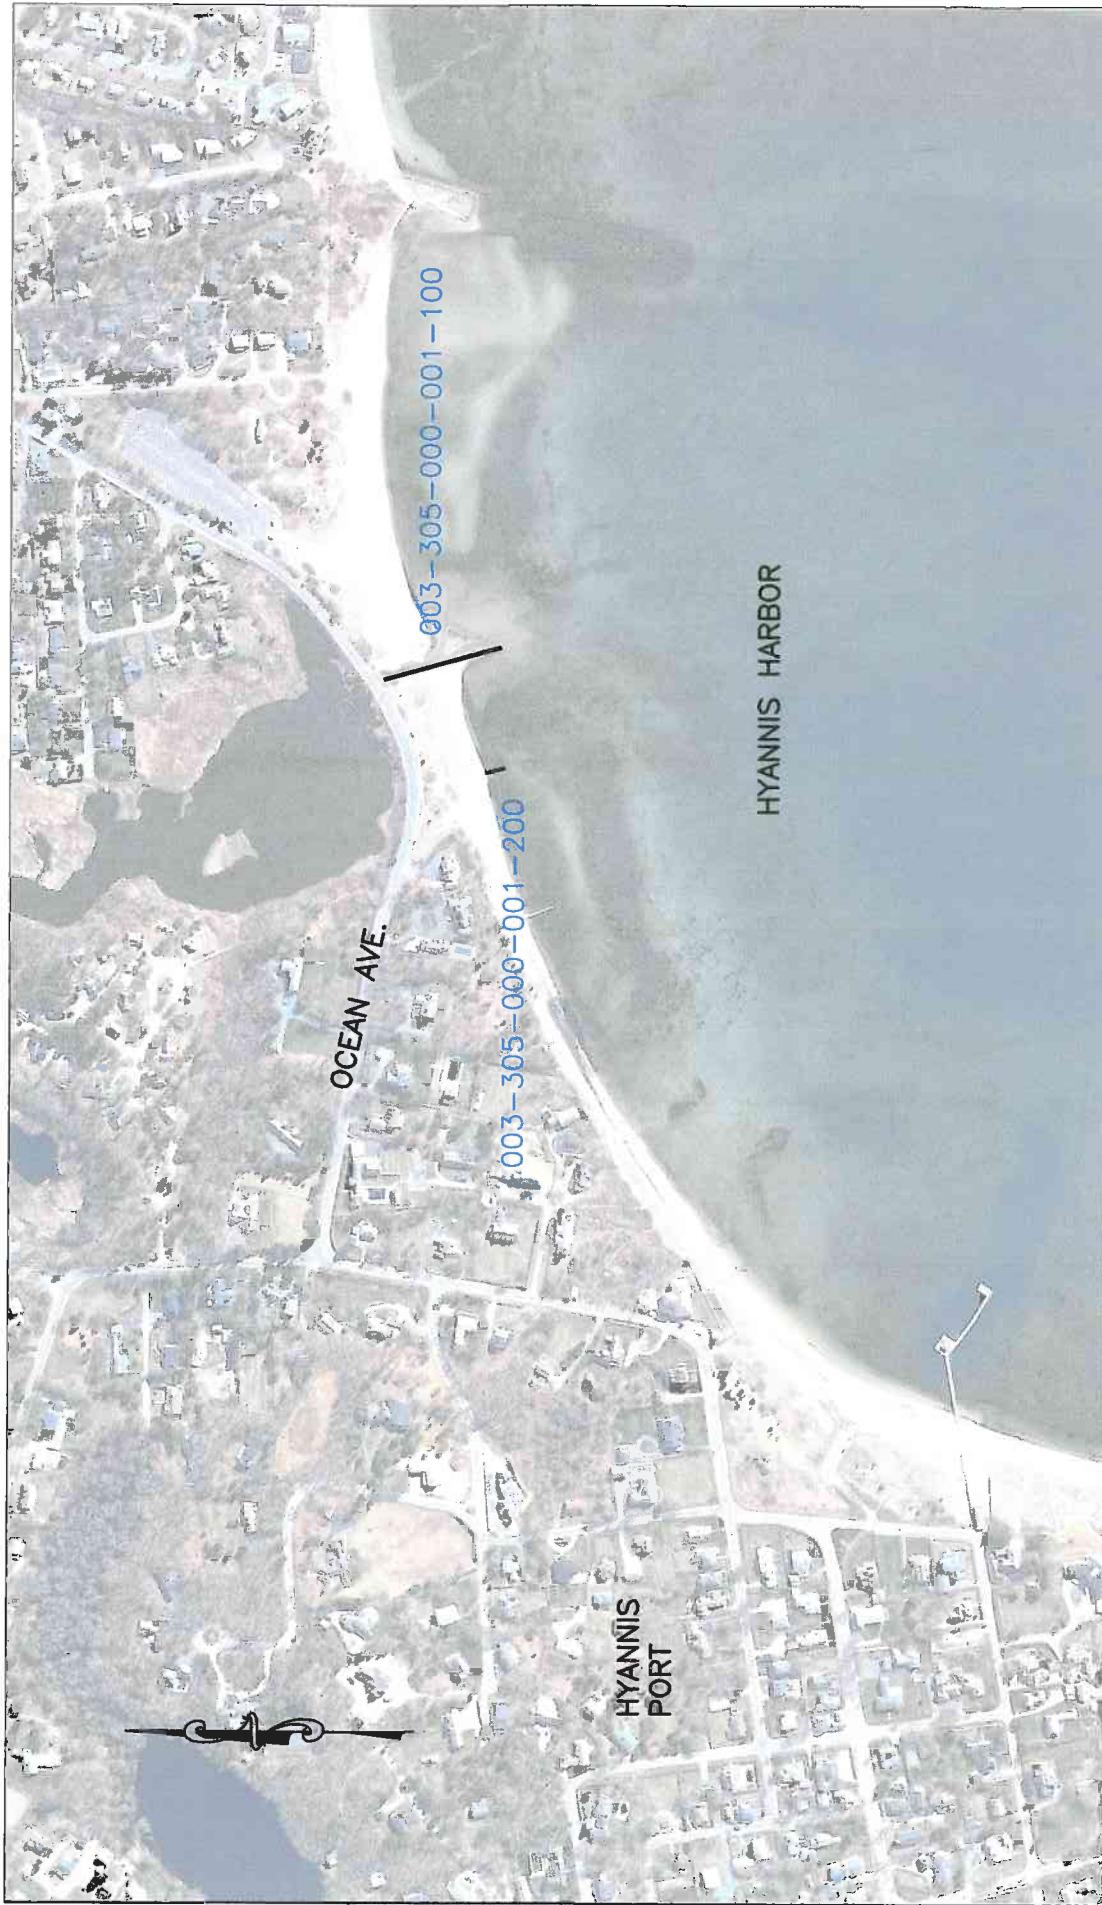
## COASTAL STRUCTURE LOCATION PLAN

HYANNIS  
HARBOR

TOWN OF BARNSTABLE  
COASTAL INFRASTRUCTURE INVENTORY  
AND ASSESSMENT PROJECT  
DECEMBER 2007

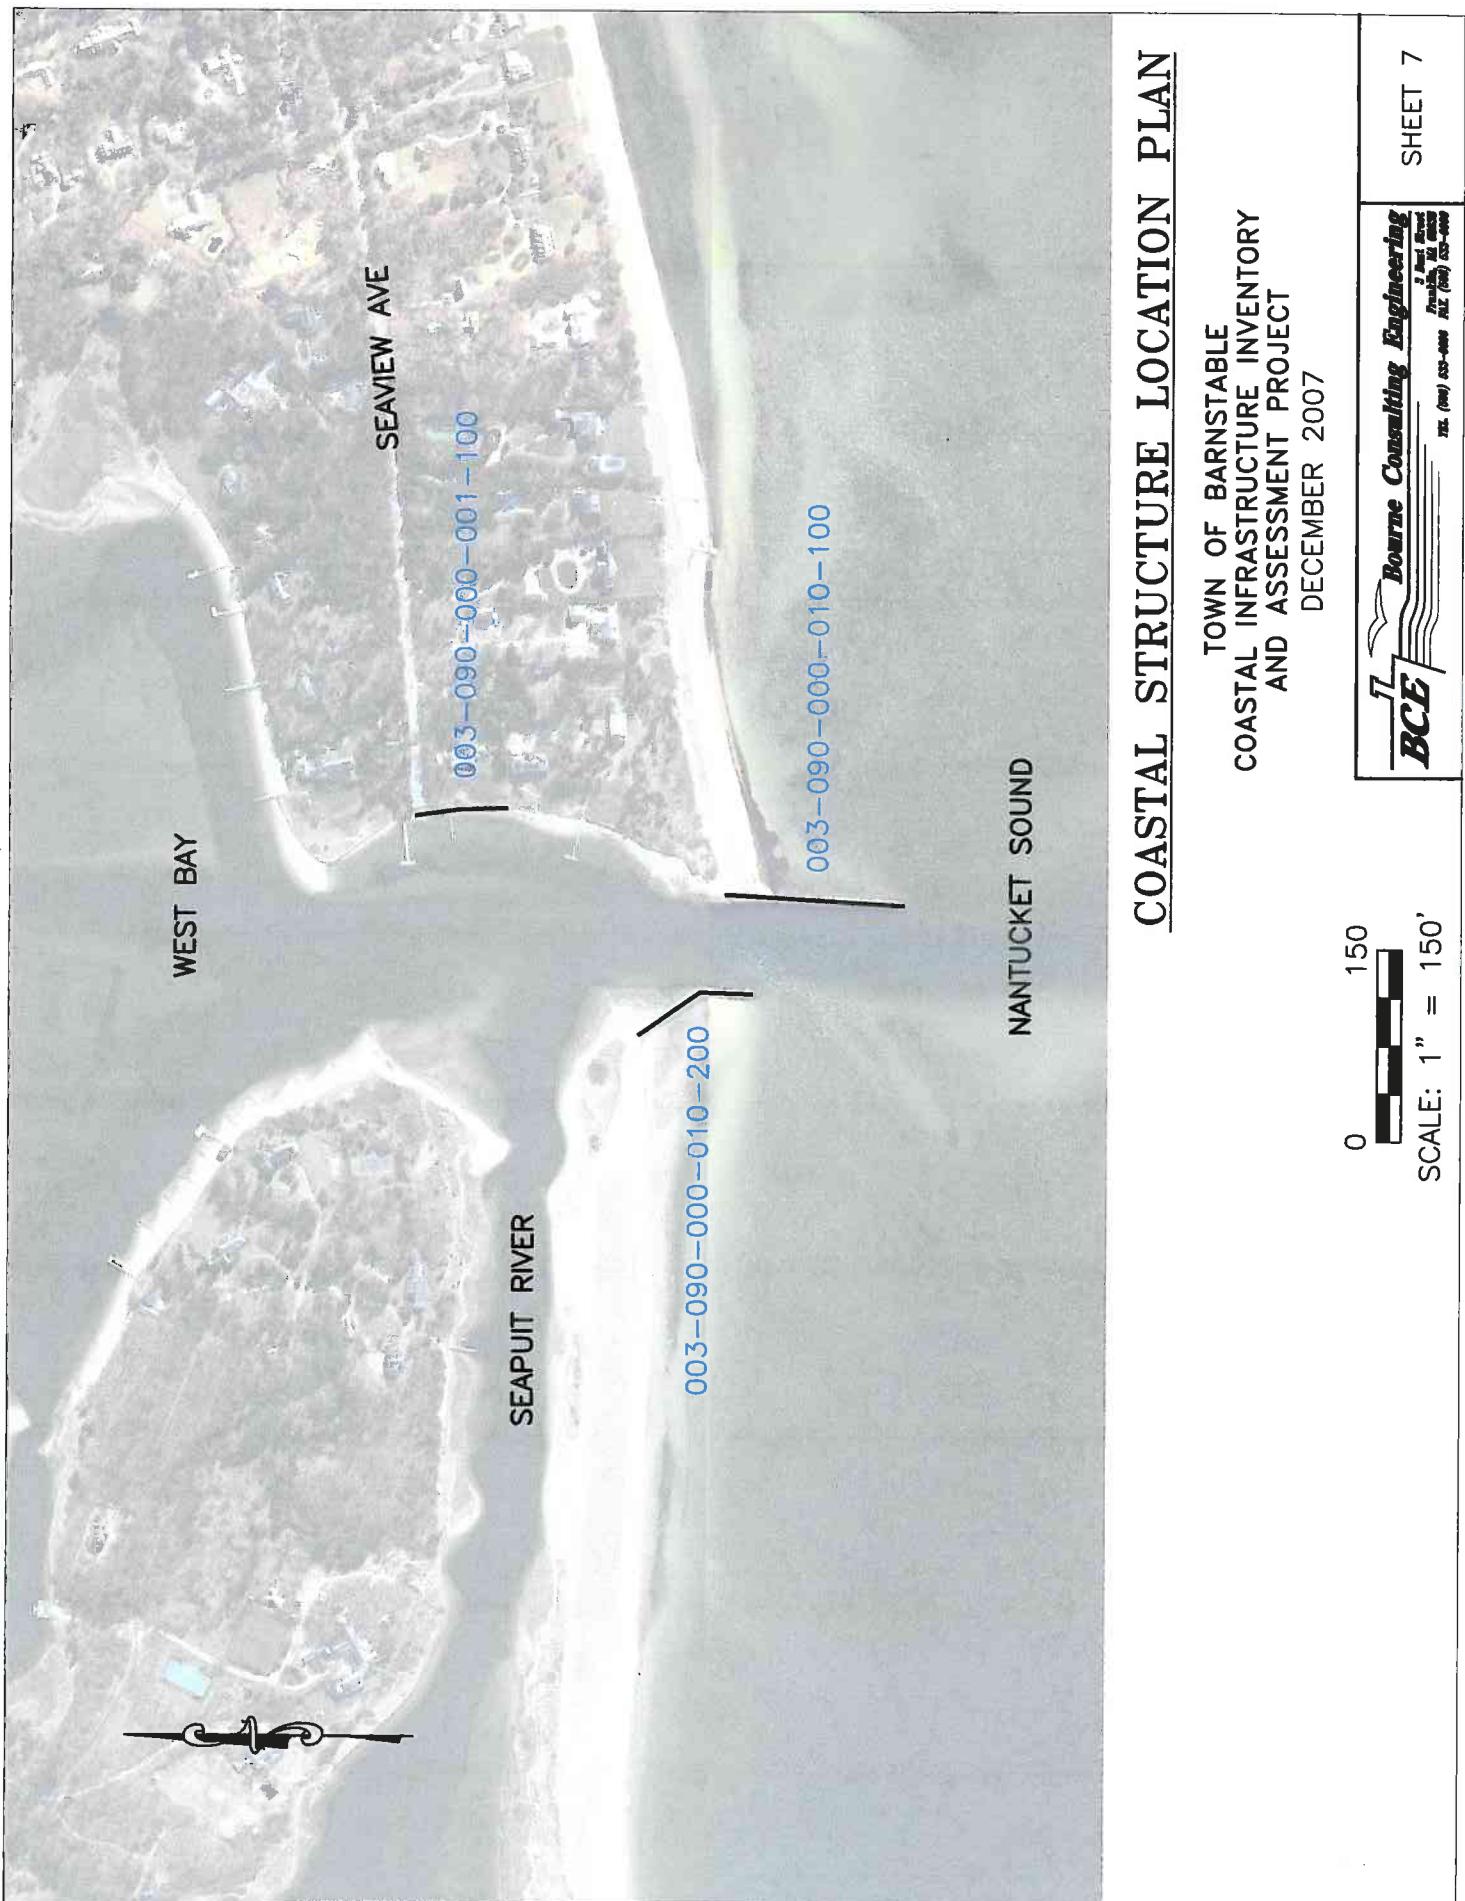
# COASTAL STRUCTURE LOCATION PLAN

TOWN OF BARNSTABLE  
COASTAL INFRASTRUCTURE INVENTORY  
AND ASSESSMENT PROJECT  
DECEMBER 2007

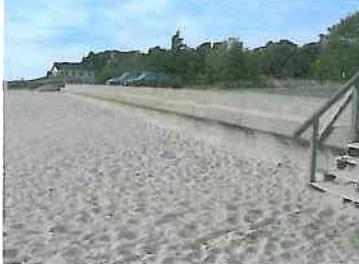
Property Owner:	Location:	Date:
Local	Ocean View Avenue	10/31/2007
Presumed Structure Owner:	Based On Comment:	
Local		
Owner Name:	Earliest Structure Record:	Estimated Reconstruction/Repair Cost:
Barnstable	1937	\$68,006.00

Length: 160 Feet	Top Elevation: Feet NAVD 88	FIRM Map Zone: V11	FIRM Map Elevation: 19 Feet NGVD
Primary Type: Bulkhead/ Seawall	Primary Material: Concrete	Primary Height: Under 5 Feet

Secondary Type:	Secondary Material:	Secondary Height:

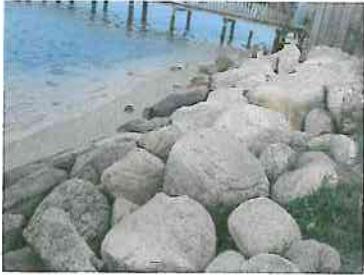
Property Owner:	Location:	Date:
Local	Sea View Avenue	10/31/2007
Presumed Structure Owner:	Based On Comment:	
Local		
Owner Name:	Earliest Structure Record:	Estimated Reconstruction/Repair Cost:
Barnstable	Unknown	\$144,144.00

Length:	Top Elevation:	FIRM Map Zone:	FIRM Map Elevation:

240 Feet	Feet NAVD 88	V17	14 Feet NGVD	
Primary Type:	Primary Material:	Primary Height:		
Revetment	Stone	5 to 10 Feet		
Secondary Type:	Secondary Material:	Secondary Height:

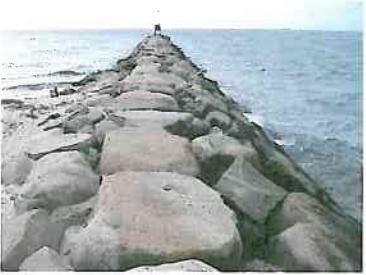
Property Owner:	Location:	Date:
Local	Dead Neck	10/31/2007
Presumed Structure Owner:	Based On Comment:	
Local		
Owner Name:	Earliest Structure Record:	Estimated Reconstruction/Repair Cost:
Barnstable	1947	\$1,105,104.00

Length:	Top Elevation:	FIRM Map Zone:	FIRM Map Elevation:

460 Feet	Feet NAVD 88	V17	16 Feet NGVD	
Primary Type:	Primary Material:	Primary Height:		
Groin/ Jetty	Stone	5 to 10 Feet		
Secondary Type:	Secondary Material:	Secondary Height:

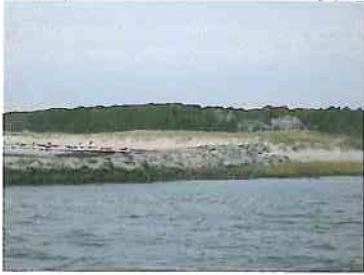
Property Owner:	Location:	Date:
Local	Dead Neck	10/31/2007
Presumed Structure Owner:	Based On Comment:	
Local		
Owner Name:	Earliest Structure Record:	Estimated Reconstruction/Repair Cost:
Barnstable	1953	\$792,792.00

Length: 330 Feet	Top Elevation: V17 Feet NAVD 88	FIRM Map Zone: V17	FIRM Map Elevation: 16 Feet NGVD

Primary Type: Groin/ Jetty	Primary Material: Stone	Primary Height: 5 to 10 Feet		
Secondary Type:	Secondary Material:	Secondary Height:

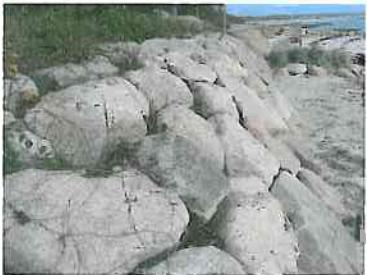
Property Owner:	Location:	Date:
Local	Wianno Avenue	10/31/2007
Presumed Structure Owner:	Based On Comment:	
Local		
Owner Name:	Earliest Structure Record:	Estimated Reconstruction/Repair Cost:
Barnstable	1955	\$7,808.00

Length:	Top Elevation:	FIRM Map Zone:	FIRM Map Elevation:

65 Feet	Feet NAVD 88	V11	18 Feet NGVD	
Primary Type:	Primary Material:	Primary Height:		
Revetment	Stone	5 to 10 Feet		
Secondary Type:	Secondary Material:	Secondary Height:

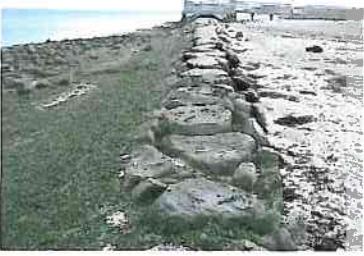
Property Owner:	Location:	Date:
Local	Dowses Beach	10/31/2007
Presumed Structure Owner:	Based On Comment:	
Local		
Owner Name:	Earliest Structure Record:	Estimated Reconstruction/Repair Cost:
Barnstable	1948	\$858,715.00

Length:	Top Elevation:	FIRM Map Zone:	FIRM Map Elevation:

715 Feet	Feet NAVD 88	V16	15 Feet NGVD	
Primary Type:	Primary Material:	Primary Height:		
Groin/ Jetty	Stone	5 to 10 Feet		
Secondary Type:	Secondary Material:	Secondary Height:

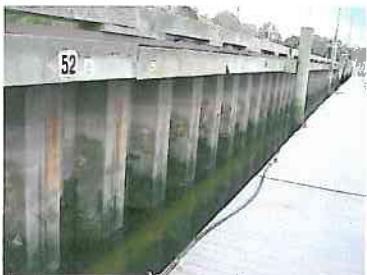
Property Owner:	Location:	Date:
Local	Barnstable Marina	10/31/2007
Presumed Structure Owner:	Based On Comment:	
Local		
Owner Name:	Earliest Structure Record:	Estimated Reconstruction/Repair Cost:
Barnstable	1949	\$463,980.00

Length: 370 Feet	Top Elevation: Feet NAVD 88	FIRM Map Zone: V4	FIRM Map Elevation: 15 Feet NGVD

Primary Type: Bulkhead/ Seawall	Primary Material: Steel	Primary Height: 10 to 15 Feet		
Secondary Type:	Secondary Material:	Secondary Height:

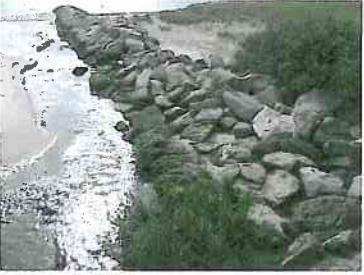
Property Owner:	Location:	Date:
Local	Ocean Avenue at Stewarts Creek	10/31/2007
Presumed Structure Owner:	Based On Comment:	
Local		
Owner Name:	Earliest Structure Record:	Estimated Reconstruction/Repair Cost:
Barnstable	1956	\$378,315.00

Length:	Top Elevation:	FIRM Map Zone:	FIRM Map Elevation:

315 Feet	Feet NAVD 88	V16	15 Feet NGVD	
Primary Type:	Primary Material:	Primary Height:		
Groin/ Jetty	Stone	5 to 10 Feet		
Secondary Type:	Secondary Material:	Secondary Height:

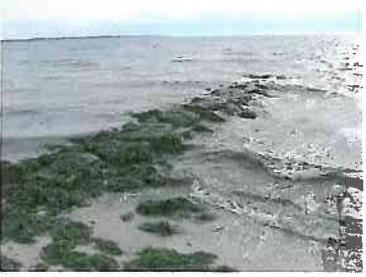
Property Owner:	Location:	Date:
Local	Stewarts Creek at Ocean Avenue	10/31/2007
Presumed Structure Owner:	Based On Comment:	
Local		
Owner Name:	Earliest Structure Record:	Estimated Reconstruction/Repair Cost:
Barnstable	Unknown	\$66,396.00

Length:	Top Elevation:	FIRM Map Zone:	FIRM Map Elevation:

50 Feet	Feet NAVD 88	V16	15 Feet NGVD	
Primary Type:	Primary Material:	Primary Height:		
Groin/ Jetty	Stone	Under 5 Feet		
Secondary Type:	Secondary Material:	Secondary Height:

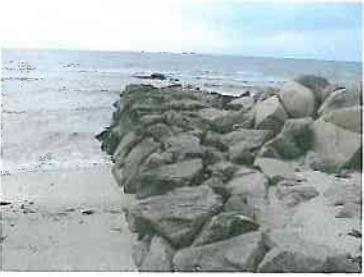
Property Owner:	Location:	Date:
Local	Kalmus Beach	10/31/2007
Presumed Structure Owner:	Based On Comment:	
Local		
Owner Name:	Earliest Structure Record:	Estimated Reconstruction/Repair Cost:
Barnstable	1950	\$139,440.00

Length:	Top Elevation:	FIRM Map Zone:	FIRM Map Elevation:

210 Feet	Feet NAVD 88	V15	15 Feet NGVD	
Primary Type:	Primary Material:	Primary Height:		
Groin/ Jetty	Stone	Under 5 Feet		
Secondary Type:	Secondary Material:	Secondary Height:

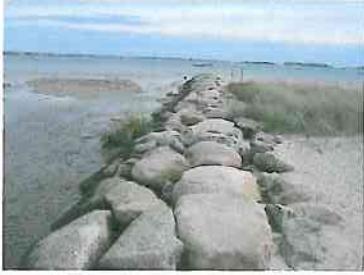
Property Owner:	Location:	Date:
Local	Veteran's Memorial Beach	10/31/2007
Presumed Structure Owner:	Based On Comment:	
Local		
Owner Name:	Earliest Structure Record:	Estimated Reconstruction/Repair Cost:
Barnstable	1954	\$192,560.00

Length:	Top Elevation:	FIRM Map Zone:	FIRM Map Elevation:

290 Feet	Feet NAVD 88	V15	15 Feet NGVD	
Primary Type:	Primary Material:	Primary Height:		
Groin/ Jetty	Stone	Under 5 Feet		
Secondary Type:	Secondary Material:	Secondary Height:

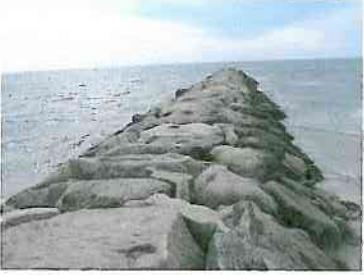
Property Owner:	Location:	Date:
Local	Kalmus Beach	10/31/2007
Presumed Structure Owner:	Based On Comment:	
Local		
Owner Name:	Earliest Structure Record:	Estimated Reconstruction/Repair Cost:
Barnstable	1951	\$1,182,985.00

Length:	Top Elevation:	FIRM Map Zone:	FIRM Map Elevation:

985 Feet	Feet NAVD 88	V15	15 Feet NGVD	
Primary Type:	Primary Material:	Primary Height:		
Groin/ Jetty	Stone	5 to 10 Feet		
Secondary Type:	Secondary Material:	Secondary Height:

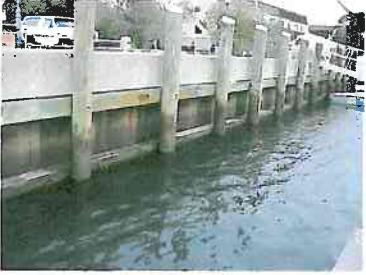
Property Owner:	Location:	Date:
Local	Hyannis Inner Harbor	10/31/2007
Presumed Structure Owner:	Based On Comment:	
Local		
Owner Name:	Earliest Structure Record:	Estimated Reconstruction/Repair Cost:
Barnstable	Unknown	\$37,950.00

Length:	Top Elevation:	FIRM Map Zone:	FIRM Map Elevation:

230 Feet	Feet NAVD 88	A9	10 Feet NGVD	
Primary Type:	Primary Material:	Primary Height:		
Bulkhead/ Seawall	Steel	5 to 10 Feet		
Secondary Type:	Secondary Material:	Secondary Height:

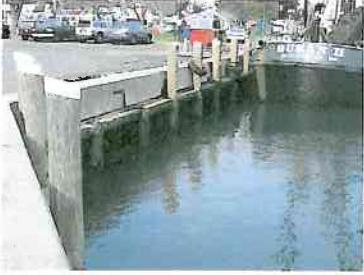
Property Owner:	Location:	Date:
Local	Hyannis Inner Harbor	10/31/2007
Presumed Structure Owner:	Based On Comment:	
Local		
Owner Name:	Earliest Structure Record:	Estimated Reconstruction/Repair Cost:
Barnstable	1962	\$846,450.00

Length:	Top Elevation:	FIRM Map Zone:	FIRM Map Elevation:

675 Feet	Feet NAVD 88	A9	10 Feet NGVD	
Primary Type:	Primary Material:	Primary Height:		
Bulkhead/ Seawall	Steel	10 to 15 Feet		
Secondary Type:	Secondary Material:	Secondary Height:		
I

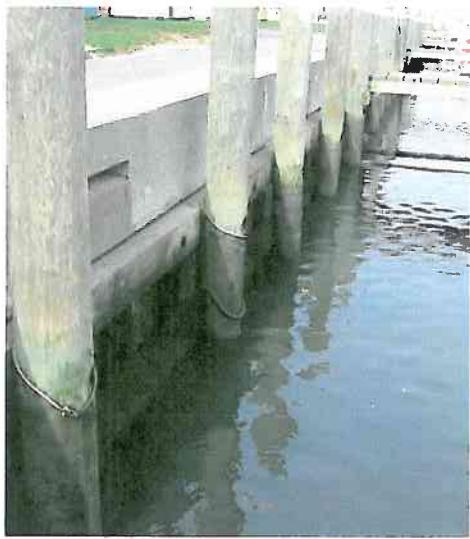
003-326-000-068-100-PHO1B

This structure is a steel sheetpile bulkhead with a concrete cap along the western side of Hyannis Inner Harbor. The sheetpile appears rusted in sections. The timber whaling are weathered but solid. The concrete cap is in good condition.

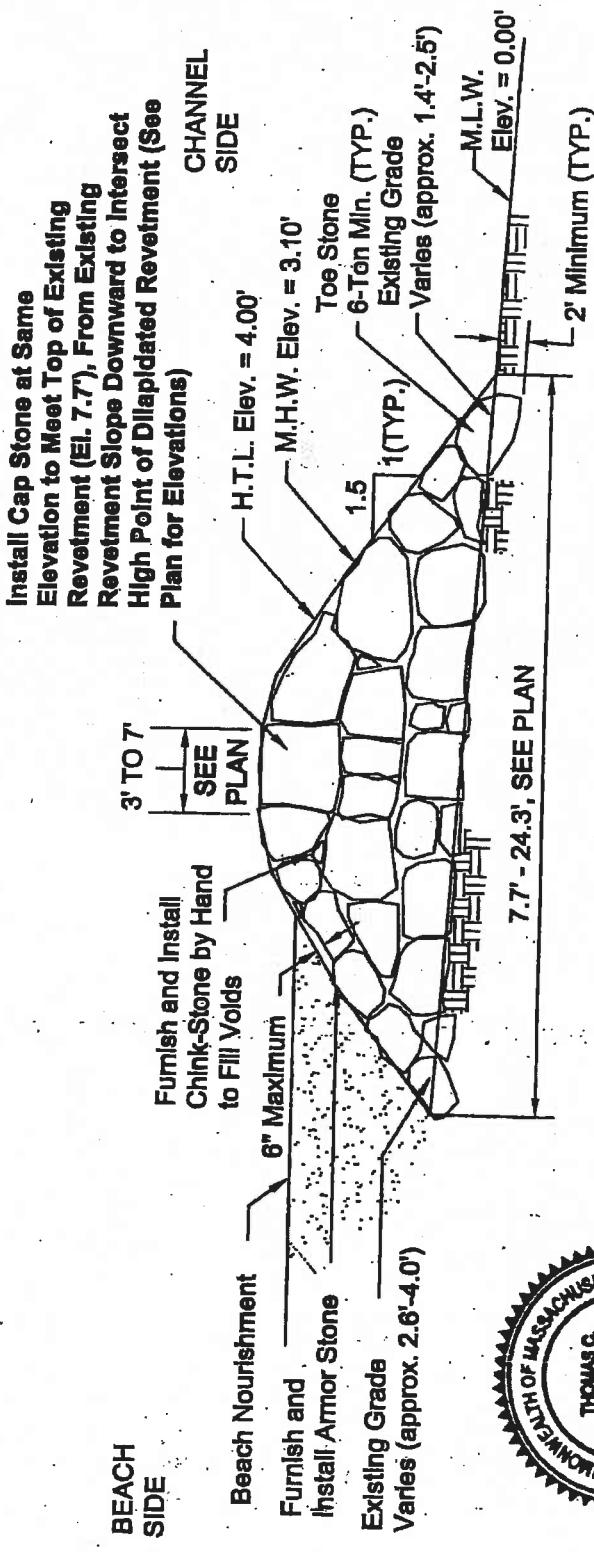
### Typical Revetment Section A-A

Not to Scale

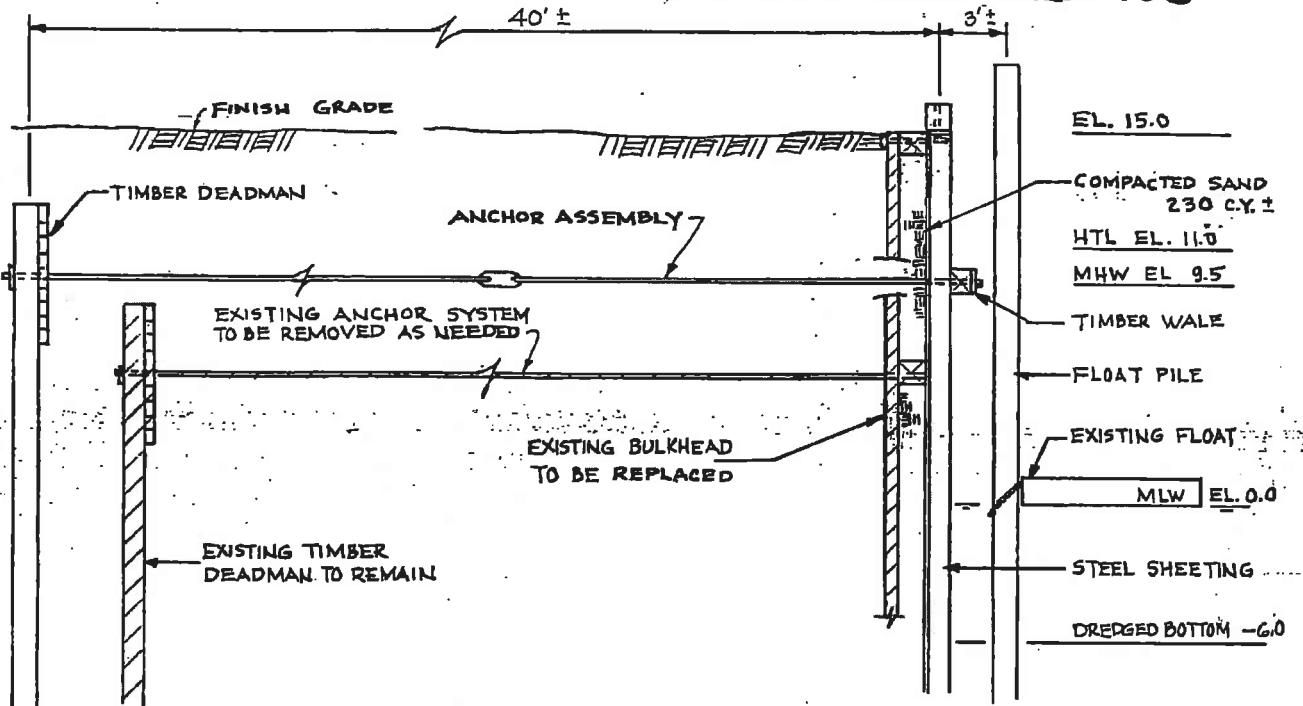
TYPICAL BULKHEAD SECTION

SCALE:  $\frac{1}{8}$ " = 1'-0"

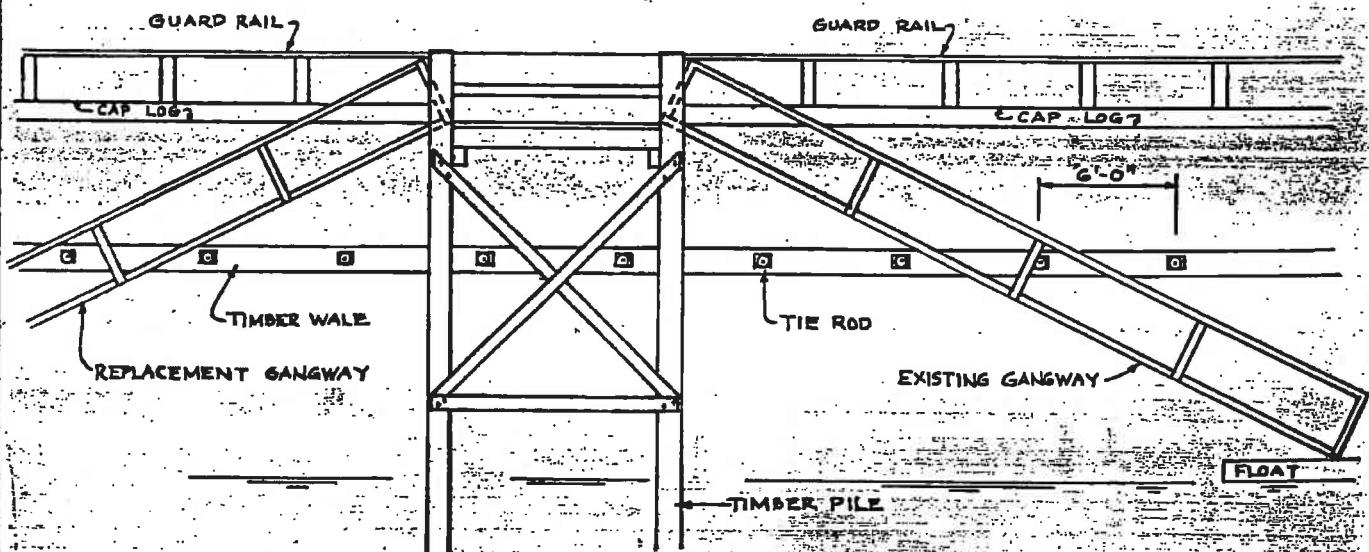
TYPICAL REPLACEMENT PLATFORM ELEVATION

SCALE:  $\frac{1}{8}$ " = 1'-0"

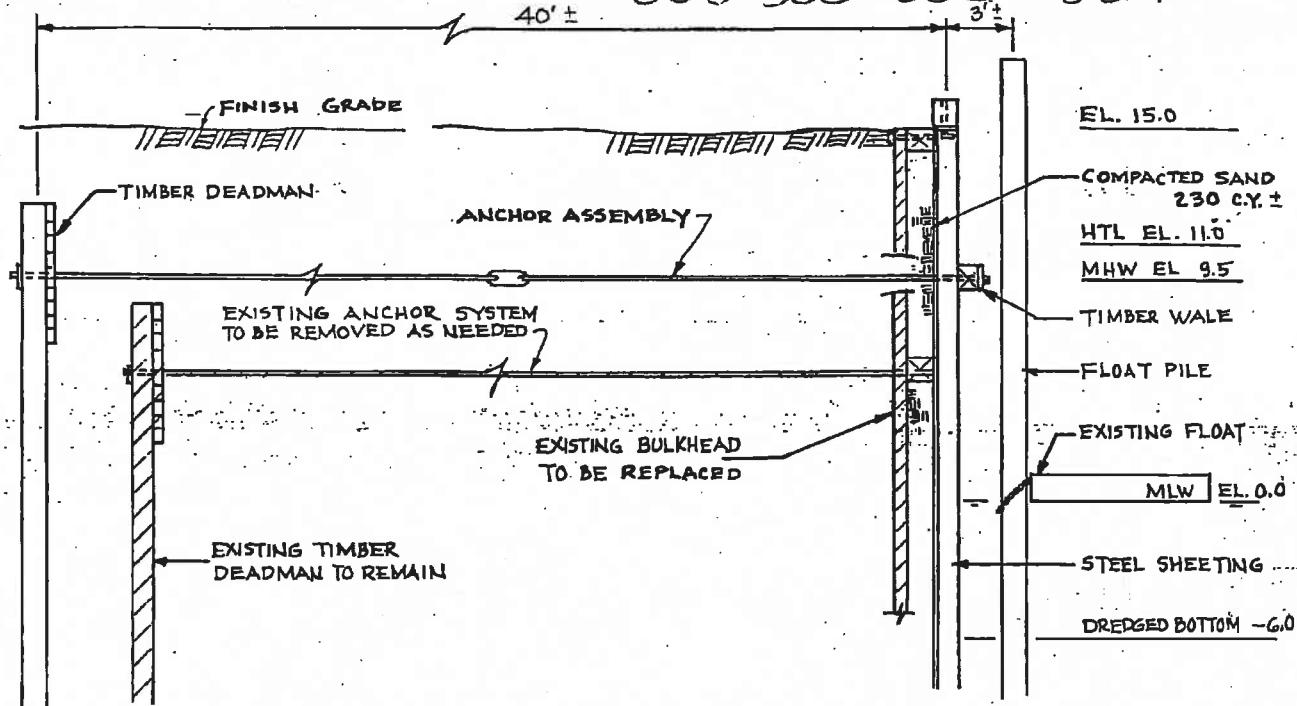
TYPICAL BULKHEAD SECTION

SCALE:  $\frac{1}{8}$ " = 1'-0"

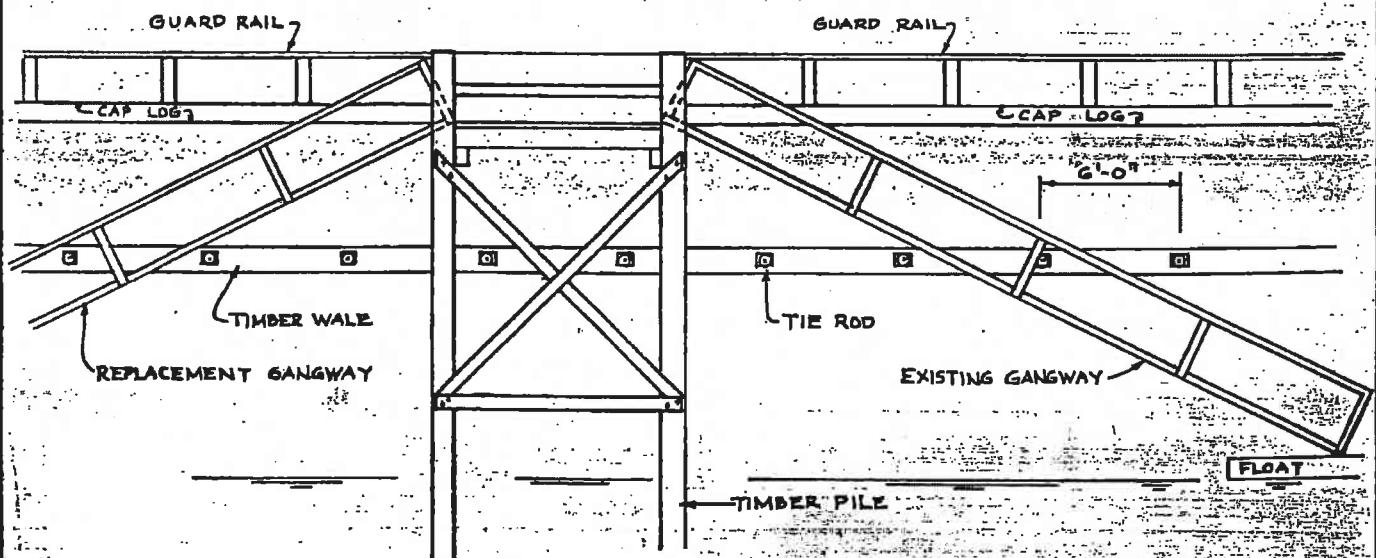
TYPICAL REPLACEMENT PLATFORM ELEVATION

SCALE:  $\frac{1}{8}$ " = 1'-0"

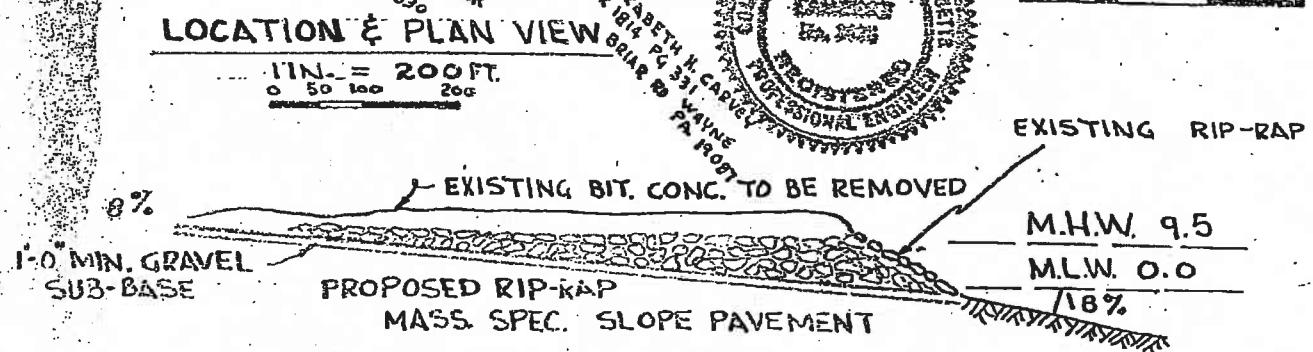
**LONGITUDINAL X-SECTION**

SCALE 1 IN. = 40 FT.  
0 10 20 30 40

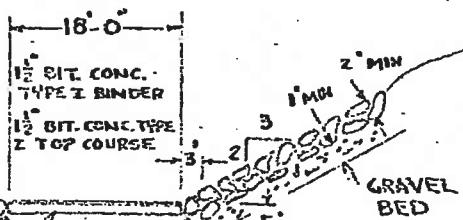
**TYPICAL TRANSVERSE X-SECTION**

SCALE: 1 IN. = 20 FT  
0 5 10 20

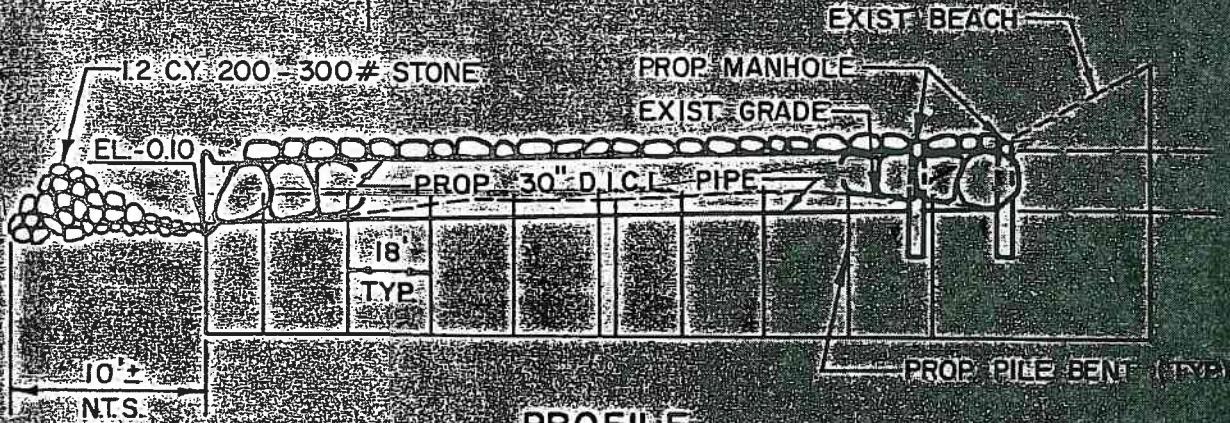
**PROFILE**

SCALE: 1"-40 HORIZ  
1"-8 VERT

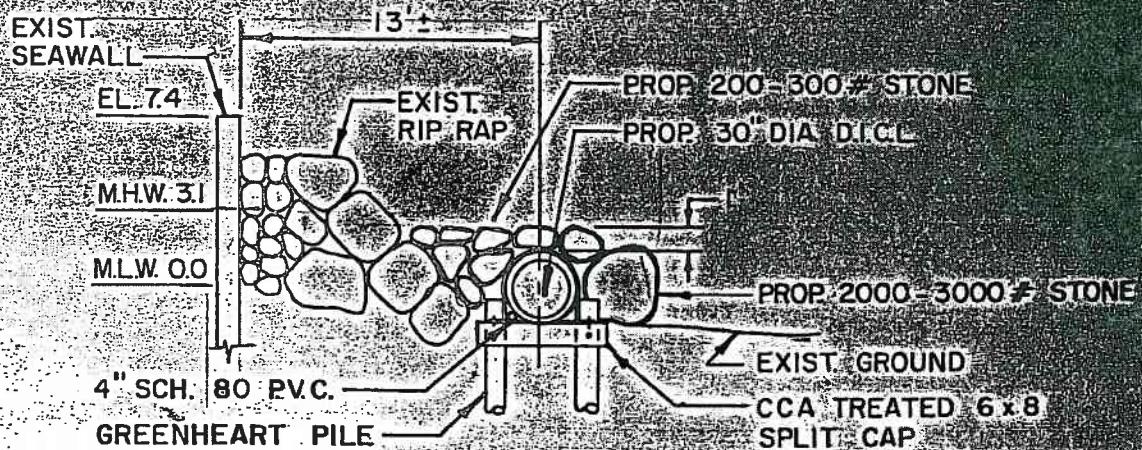
**CROSS SECTION**

SCALE: 1/8" = 1'-0"

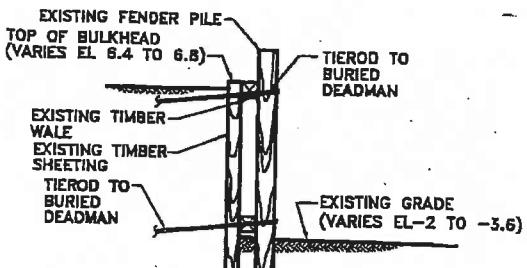
### EXISTING TIMBER BULKHEAD

SCALE: 1" = 10'  
SCALE IN FEET

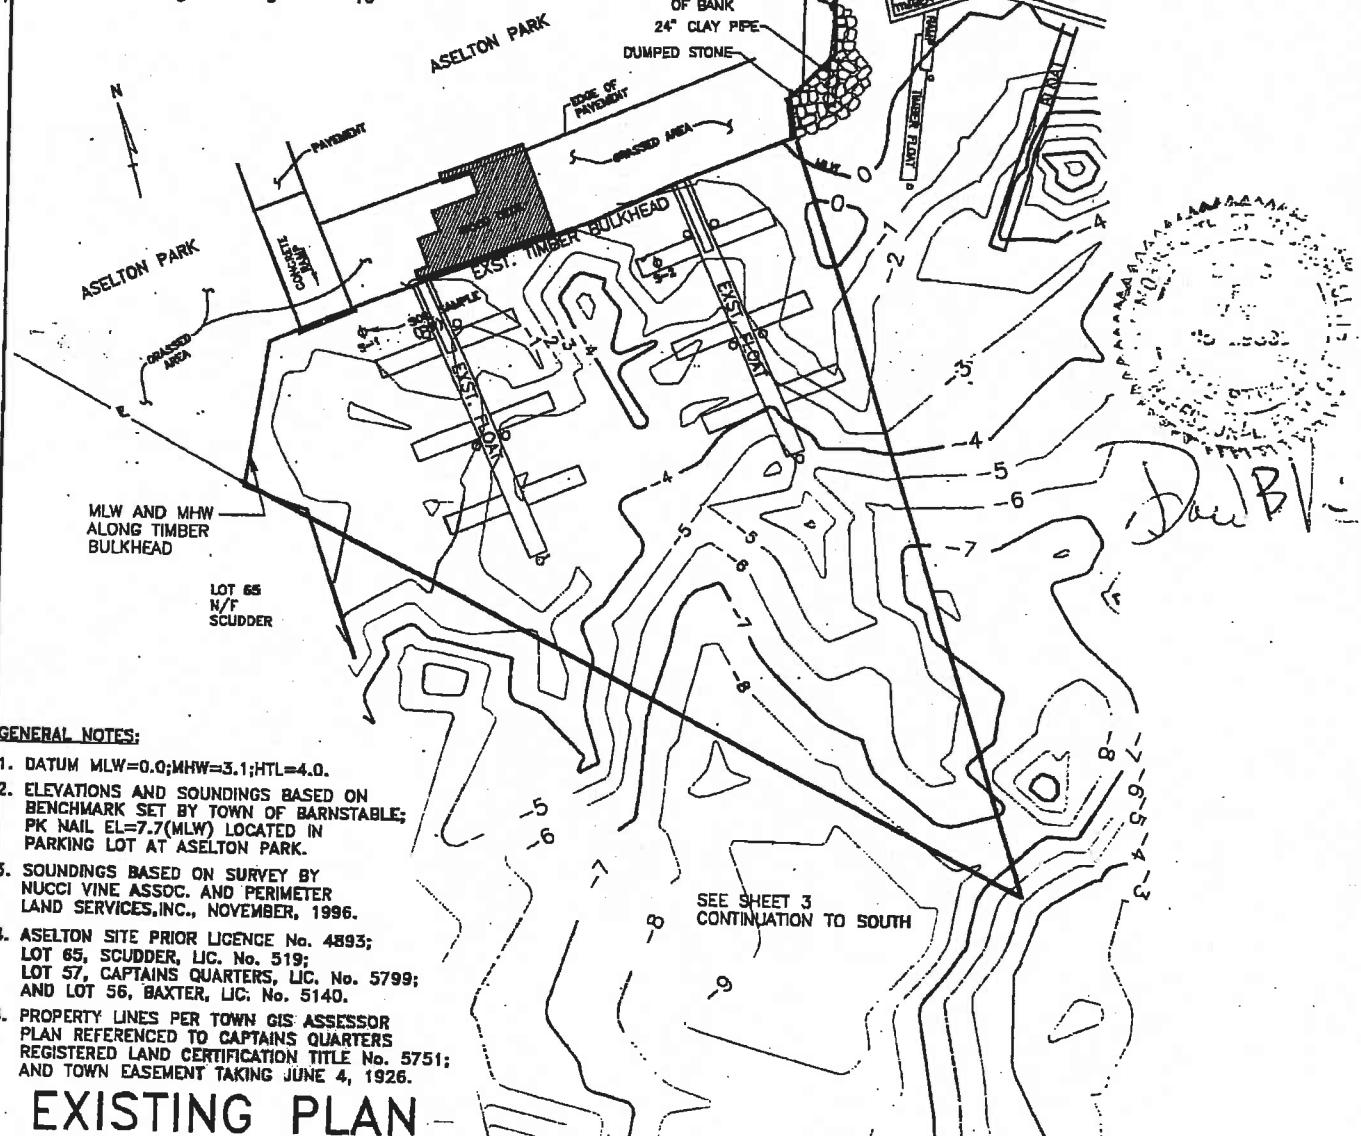
## EXISTING PLAN ASELTION PARK

1" = 50'  
SCALE IN FEET

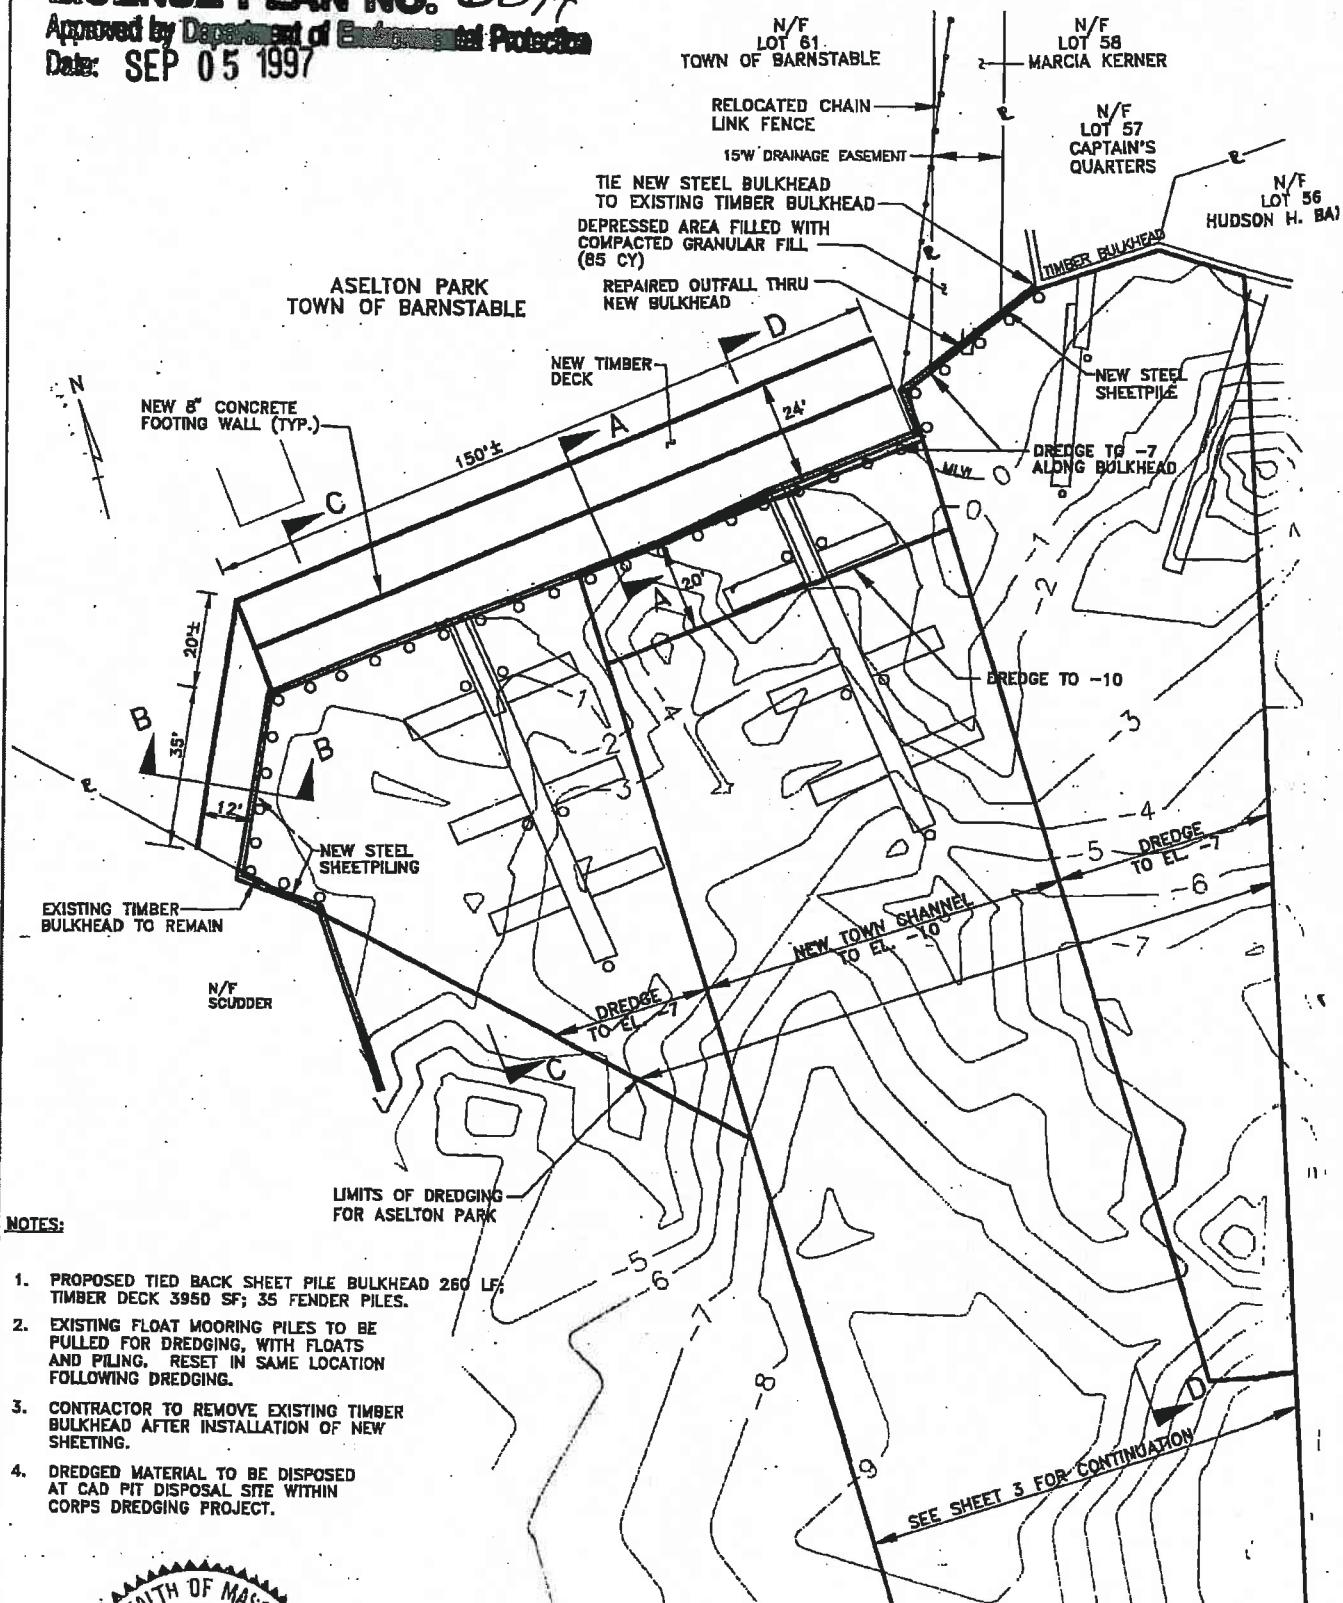
## PROPOSED WORK ASELTON PARK

1" = 40'  
SCALE IN FEET  
0 20' 40'

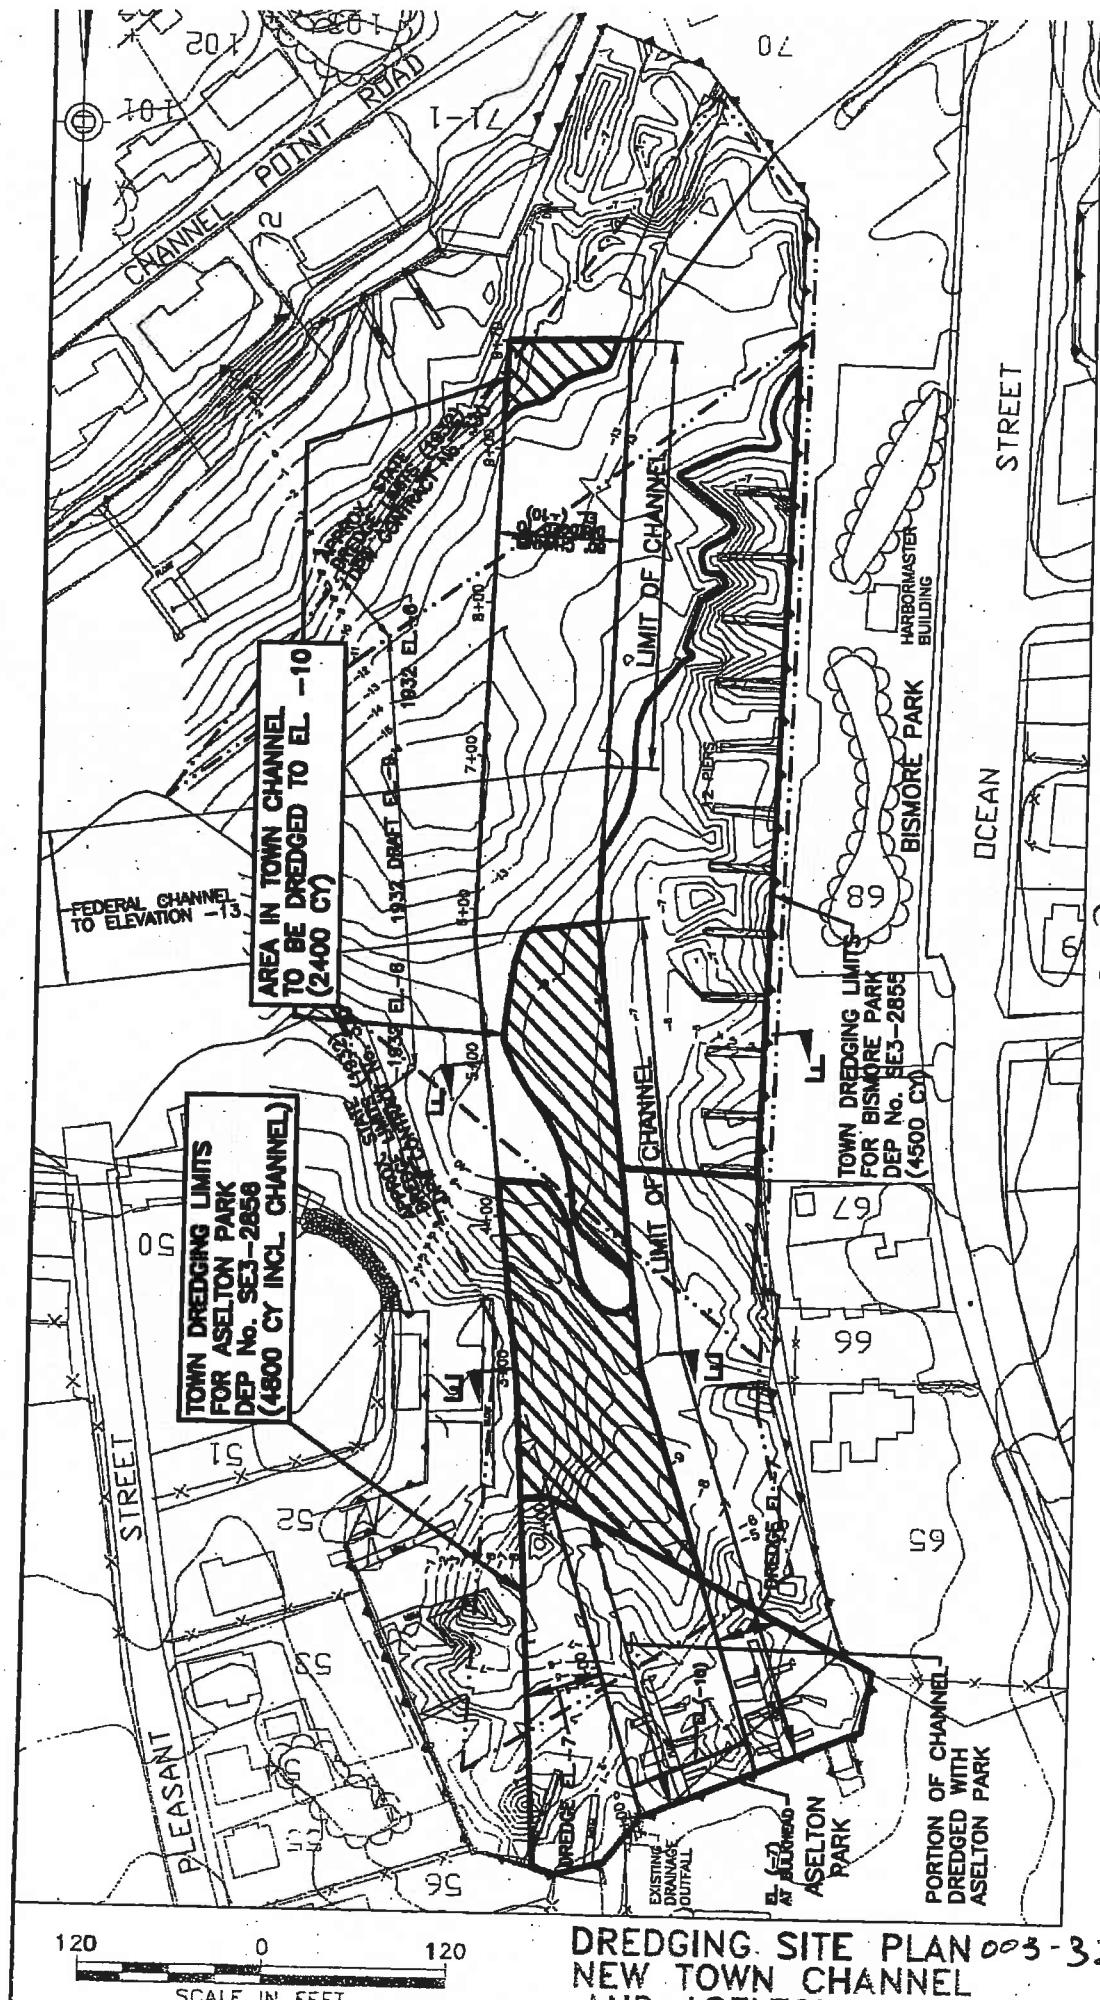
- NOTES:
1. TOTAL DREDGE VOLUME TOWN CHANNEL AND PARK AREA = 7200 CY.
  2. DREDGED SEDIMENT TO BE DISPOSED OF AT ABANDONED CHANNEL CAD PIT.
  3. PRIOR STATE DPW CONTRACT No. 330-1932 PERFORMED DREDGING TO THE LIMITS INDICATED.

NEW TOWN CHANNEL  
AND ASELTION PARK
