*Massachusetts Coastal Infrastructure  
Inventory and Assessment Project*  
*Massachusetts Department of Conservation and Recreation*  
*Office of Waterways*

## Middle Cape Cod

Barnstable  
Yarmouth  
Dennis

**MASSACHUSETTS COASTAL INFRASTRUCTURE INVENTORY AND ASSESSMENT PROJECT**

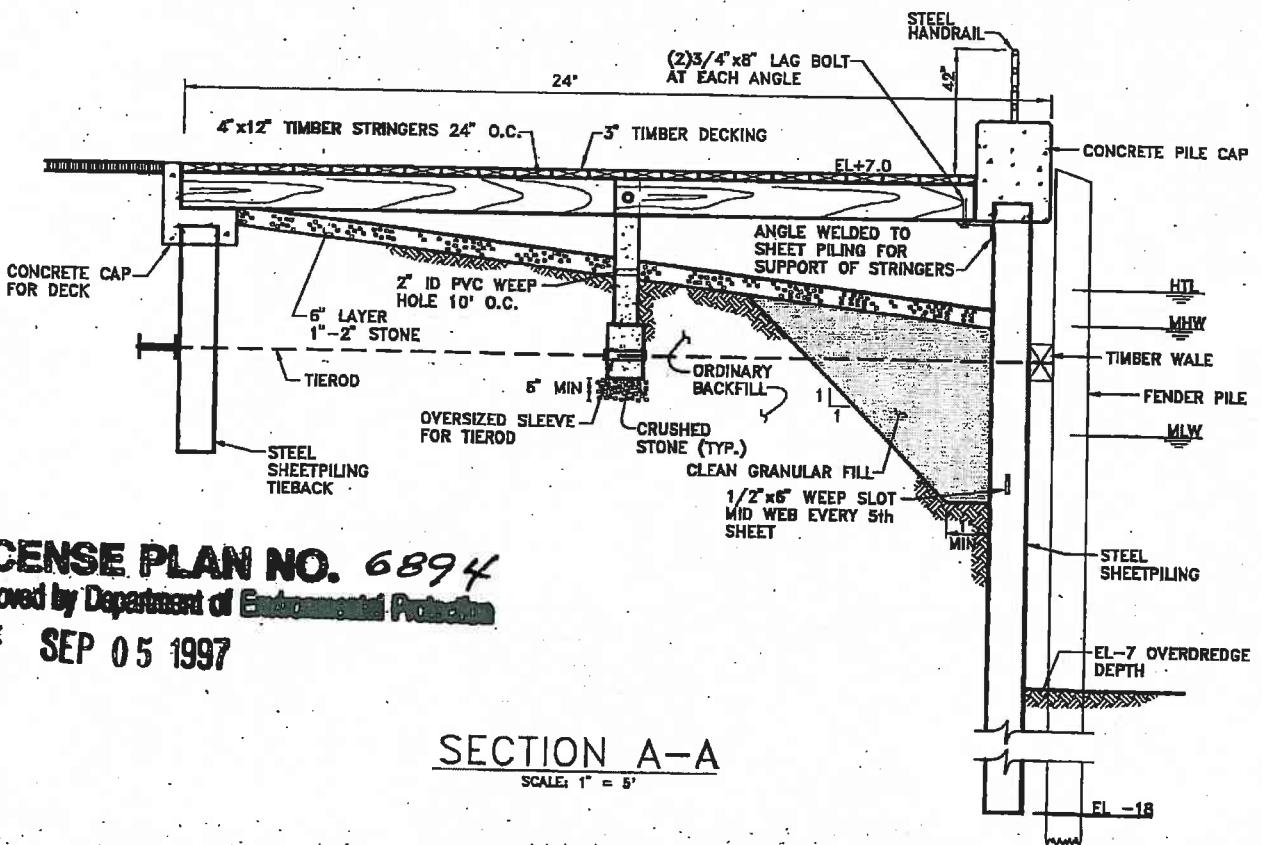
### SECTION A-A

SCALE: 1" = 5'

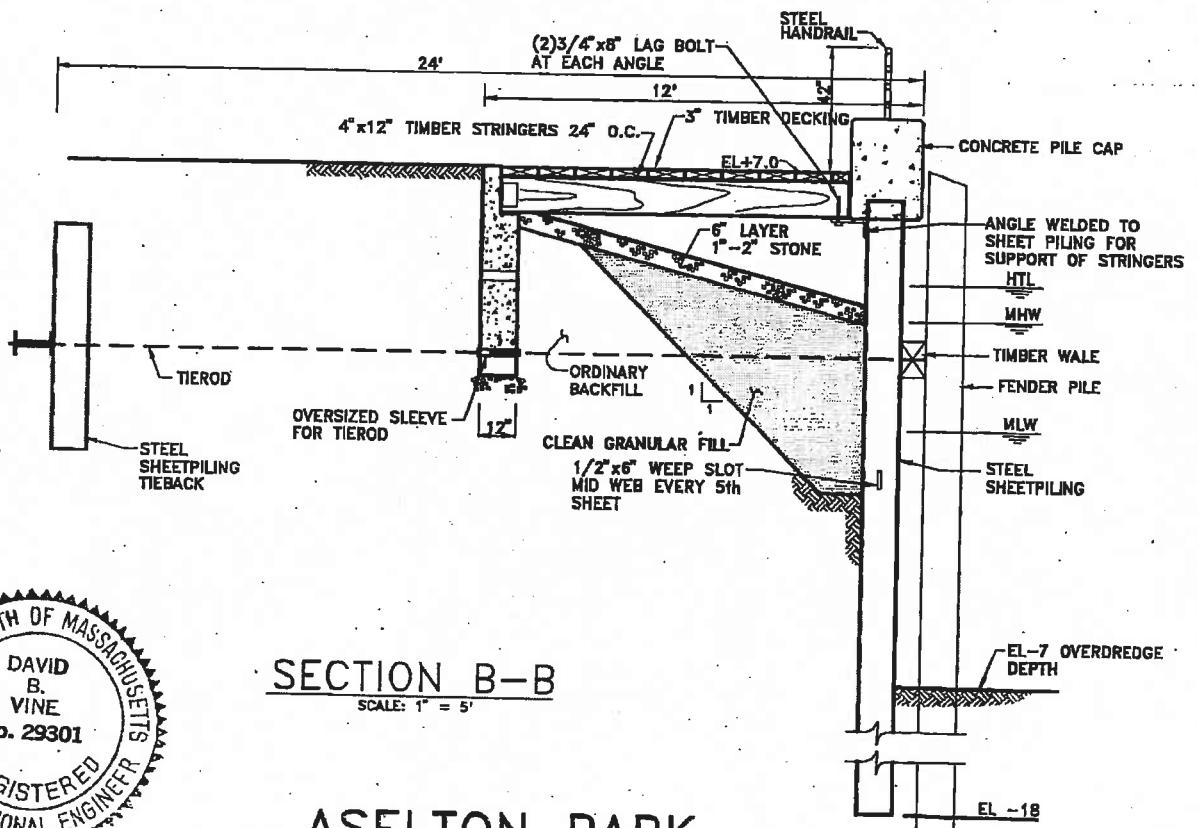
**ASELTON PARK**  
**PROPOSED BULKHEAD**  
**AND DECK SECTIONS**

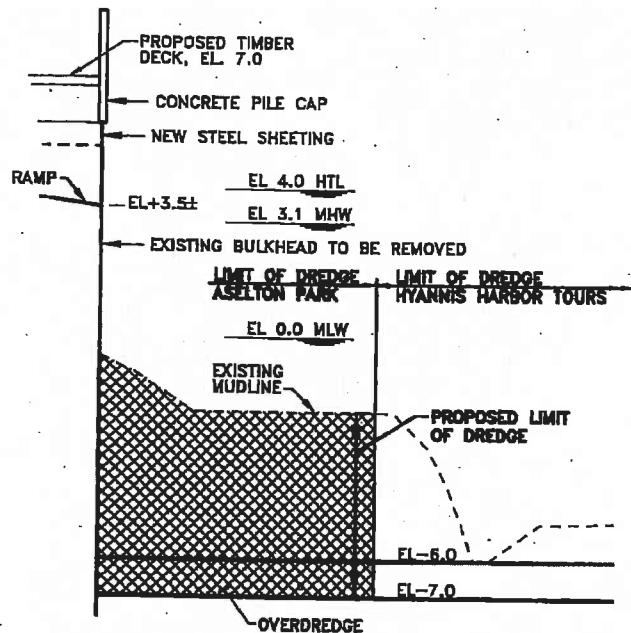
### SECTION C-C

SCALE: 1" = 50' HOR.  
1" = 5' VERT.

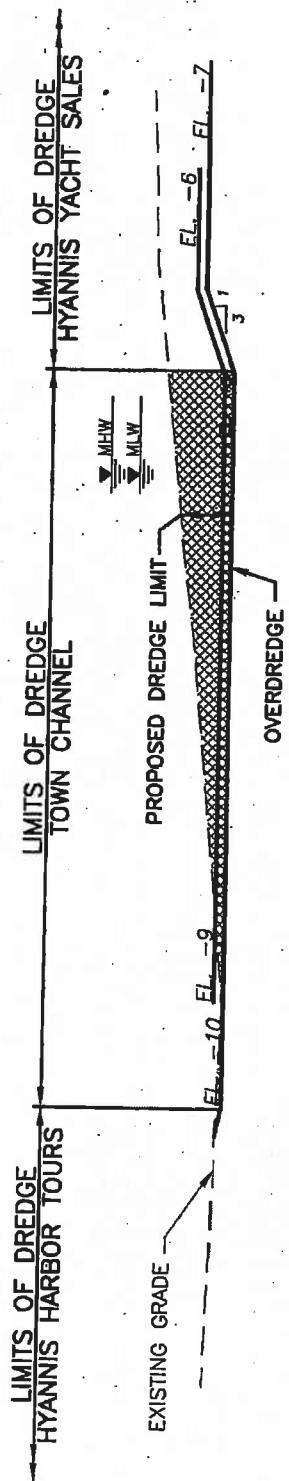
SECTION E-E  
 $1'' = 20'$

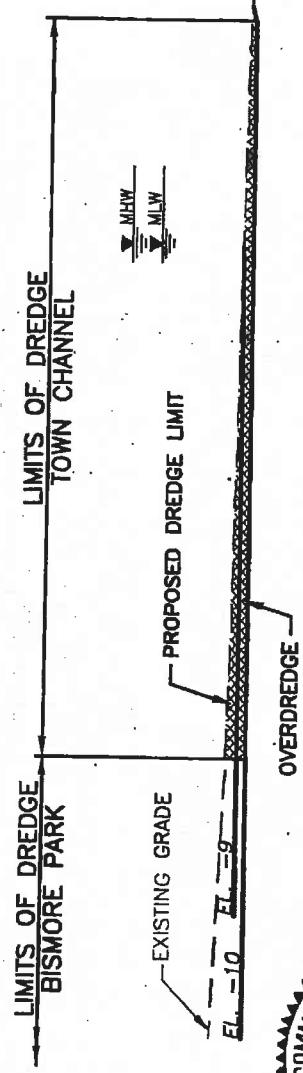
SECTION F-F  
 $1'' = 20'$

PROPOSED DREDGING  
TOWN CHANNEL

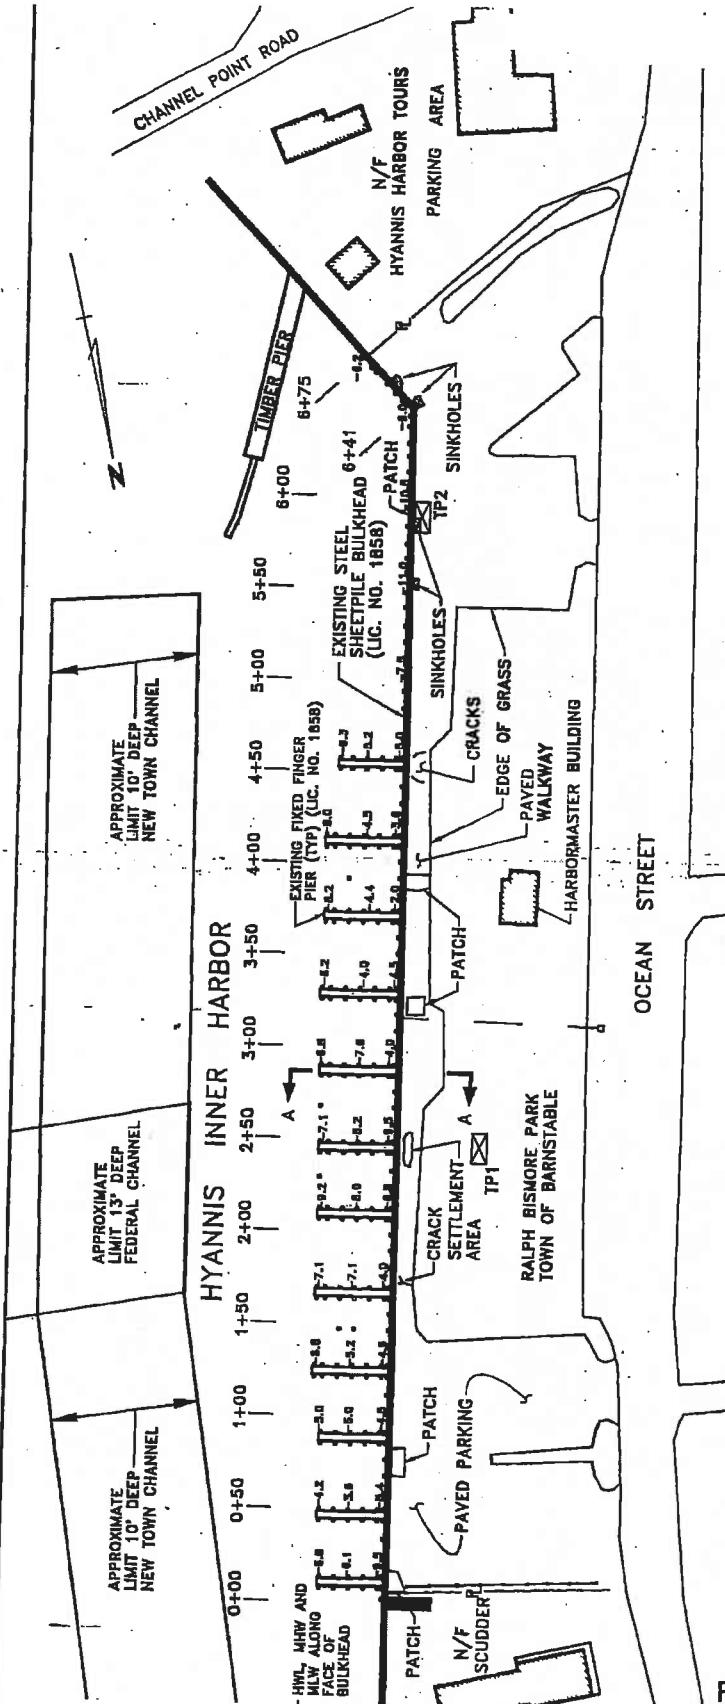
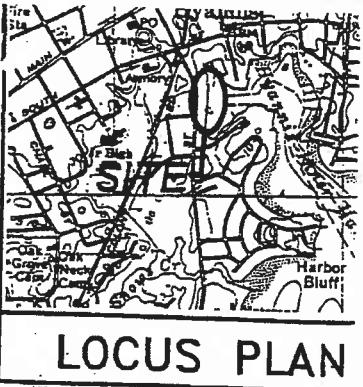
### RALPH BISMORE PARK EXISTING SITE PLAN

SCALE: 1" = 100'  
SCALE IN FEET

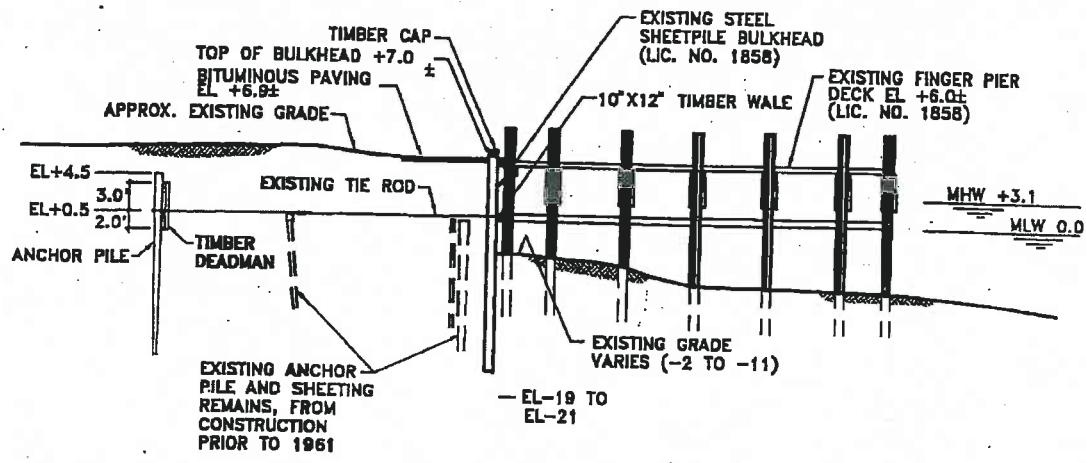
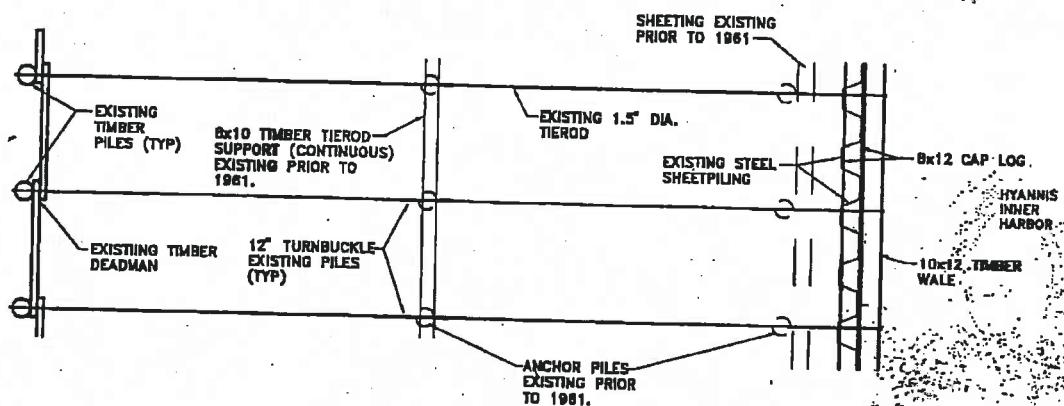
PLAN VIEW  
EXISTING TIEROD AND DEADMAN SYSTEM

EXISTING CONDITIONS

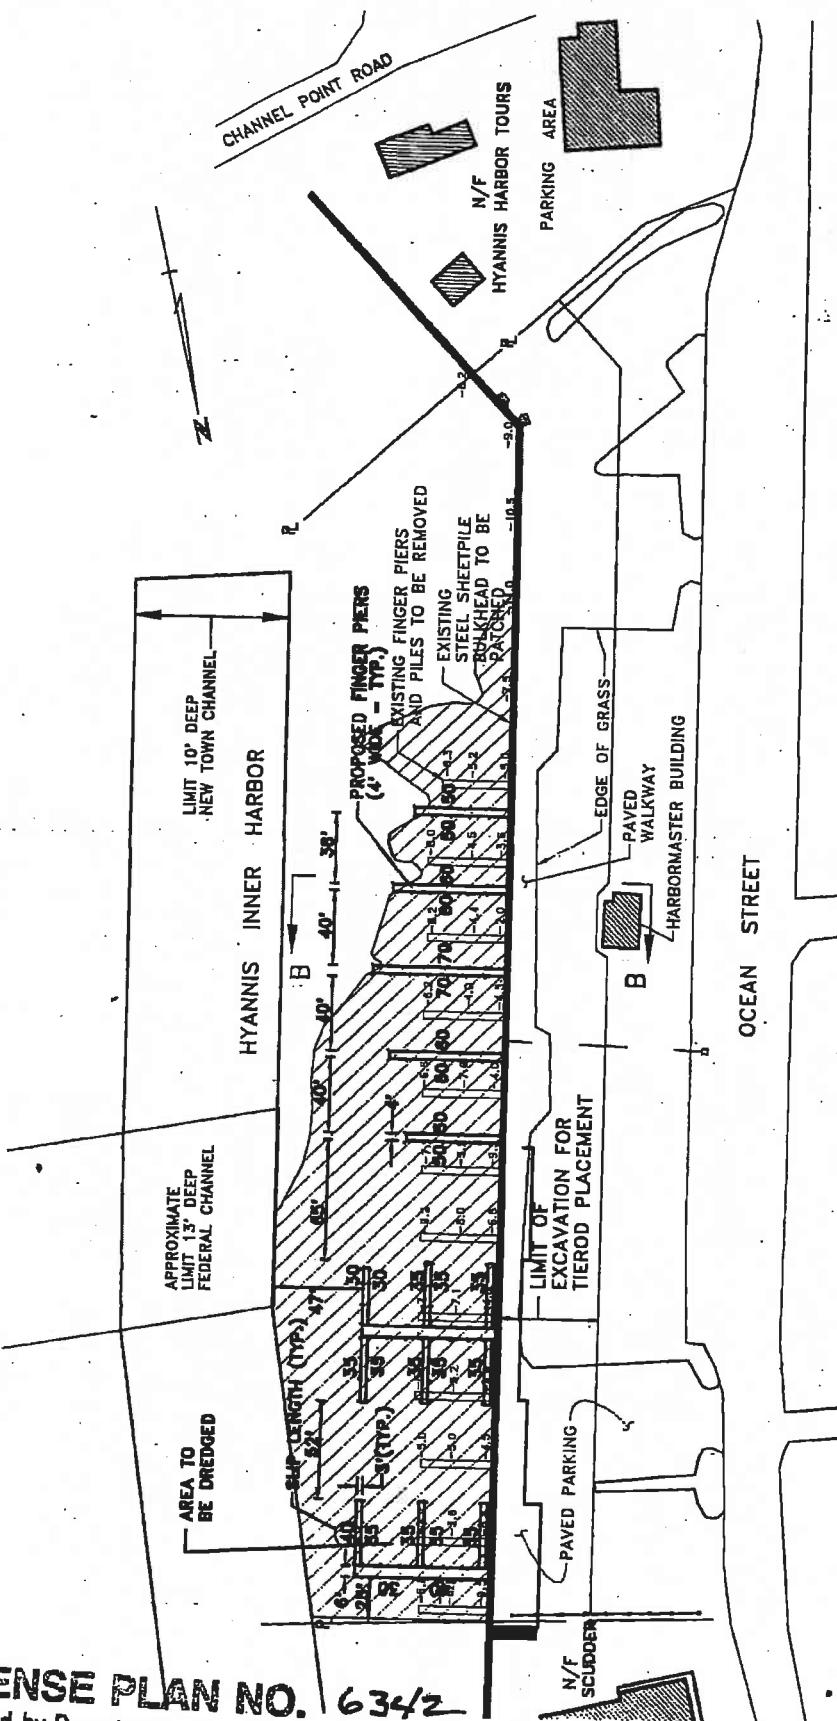
## PROPOSED WORK PLAN

1. PROPOSED DREDGING WITHIN 20' OF BULKHEAD DREDGE TO EL. -8 (WITH 1 FT. OVERDUDGE TO -7), BEYOND TO EL. -8 (WITH 1' OVERDUDGE TO EL. -10). AREA = 1,000 SF; VOLUME = 4500 CY.
2. DREDGED MATERIAL TO BE DEPOSITED AT CAD PIT WITH CORPS DREDGING PROJECT.
3. AREA OF PROPOSED FINGER PIERS IS 2950 SF. PIERS TO UTILIZE 172-172" Dia. TIMBER PILES. EXISTING FENDER PILES TO BE REPLACED AND/OR RELOCATED AS REQUIRED.
4. VOLUME OF FILL BELOW MHW = 50± CY.
5. NUMBER OF SLIPS = 27.

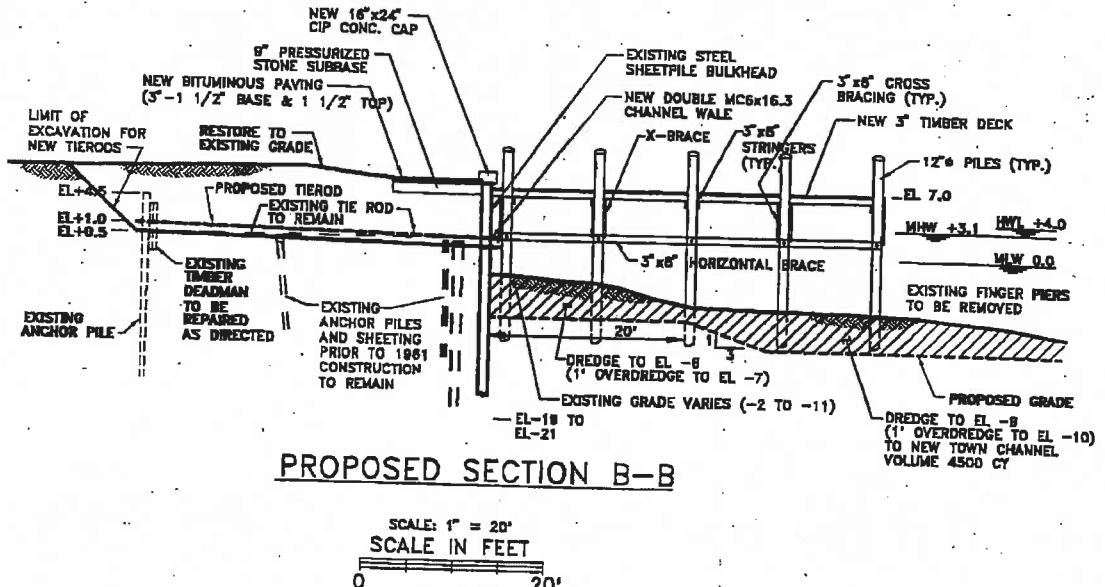
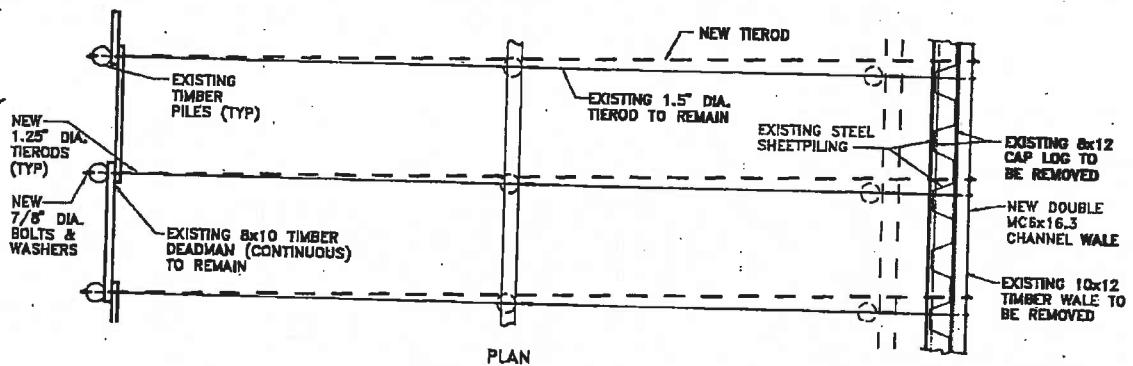
PROPOSED TIEROD REPLACEMENT

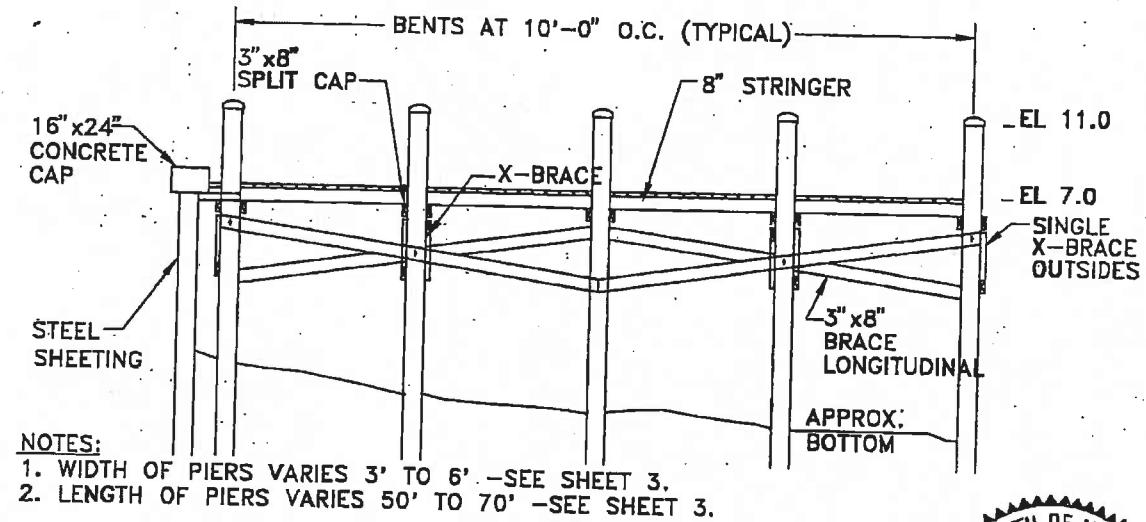
003-326-000-068-100  
**PROPOSED FINGER PIERS**

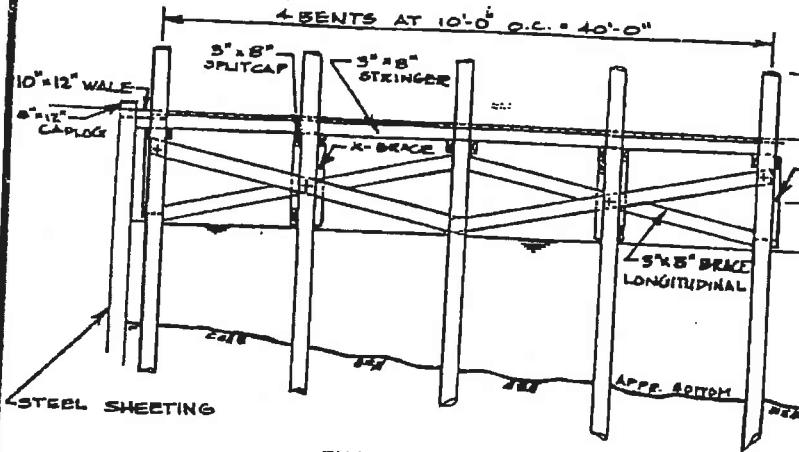
FINGER PIER PROFILE

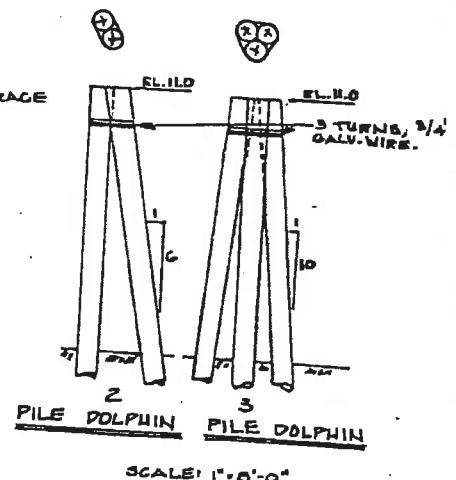
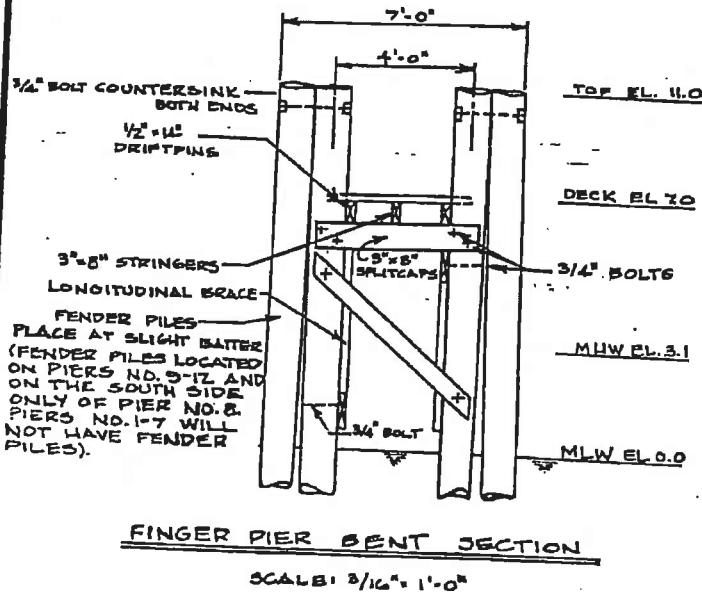
FINGER PIER BENT SECTION

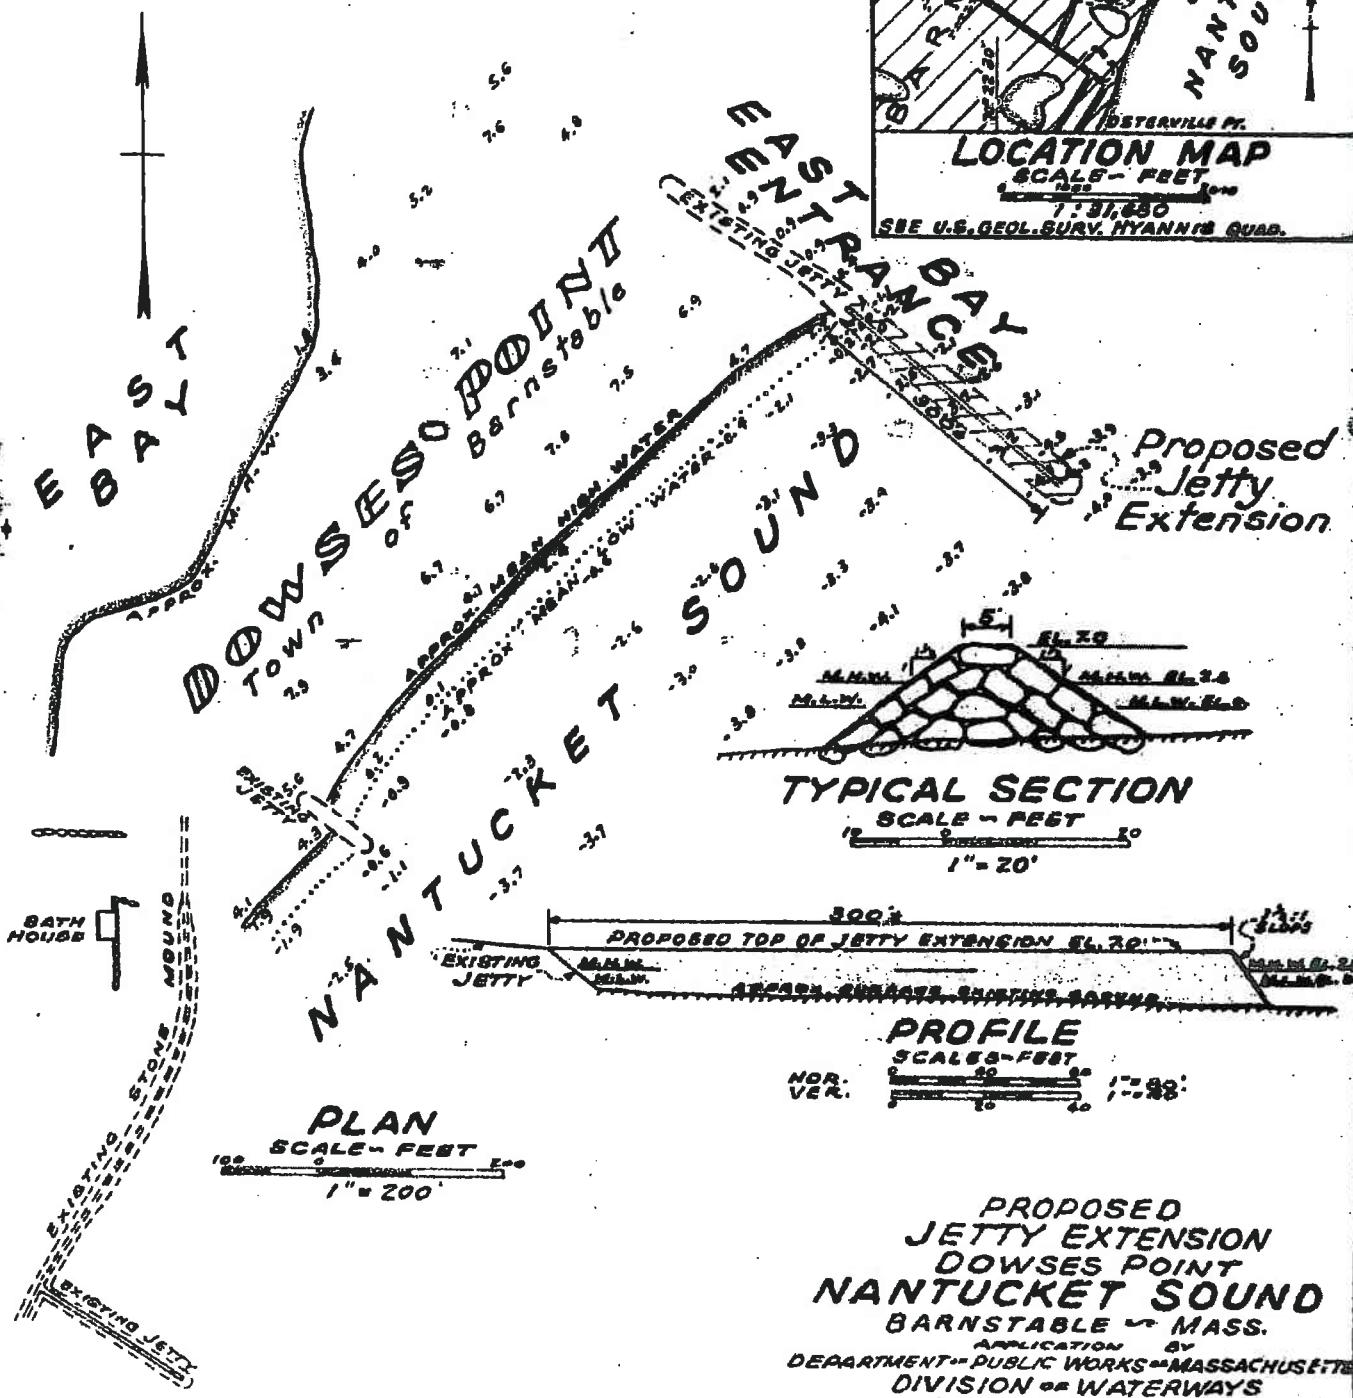
PROPOSED  
JETTY EXTENSION  
DOWSES POINT  
NANTUCKET SOUND  
BARNSTABLE - MASS.  
DEPARTMENT OF PUBLIC WORKS - MASSACHUSETTS  
DIVISION OF WATERWAYS  
DECEMBER 1955  
Robert B. MacKinnon

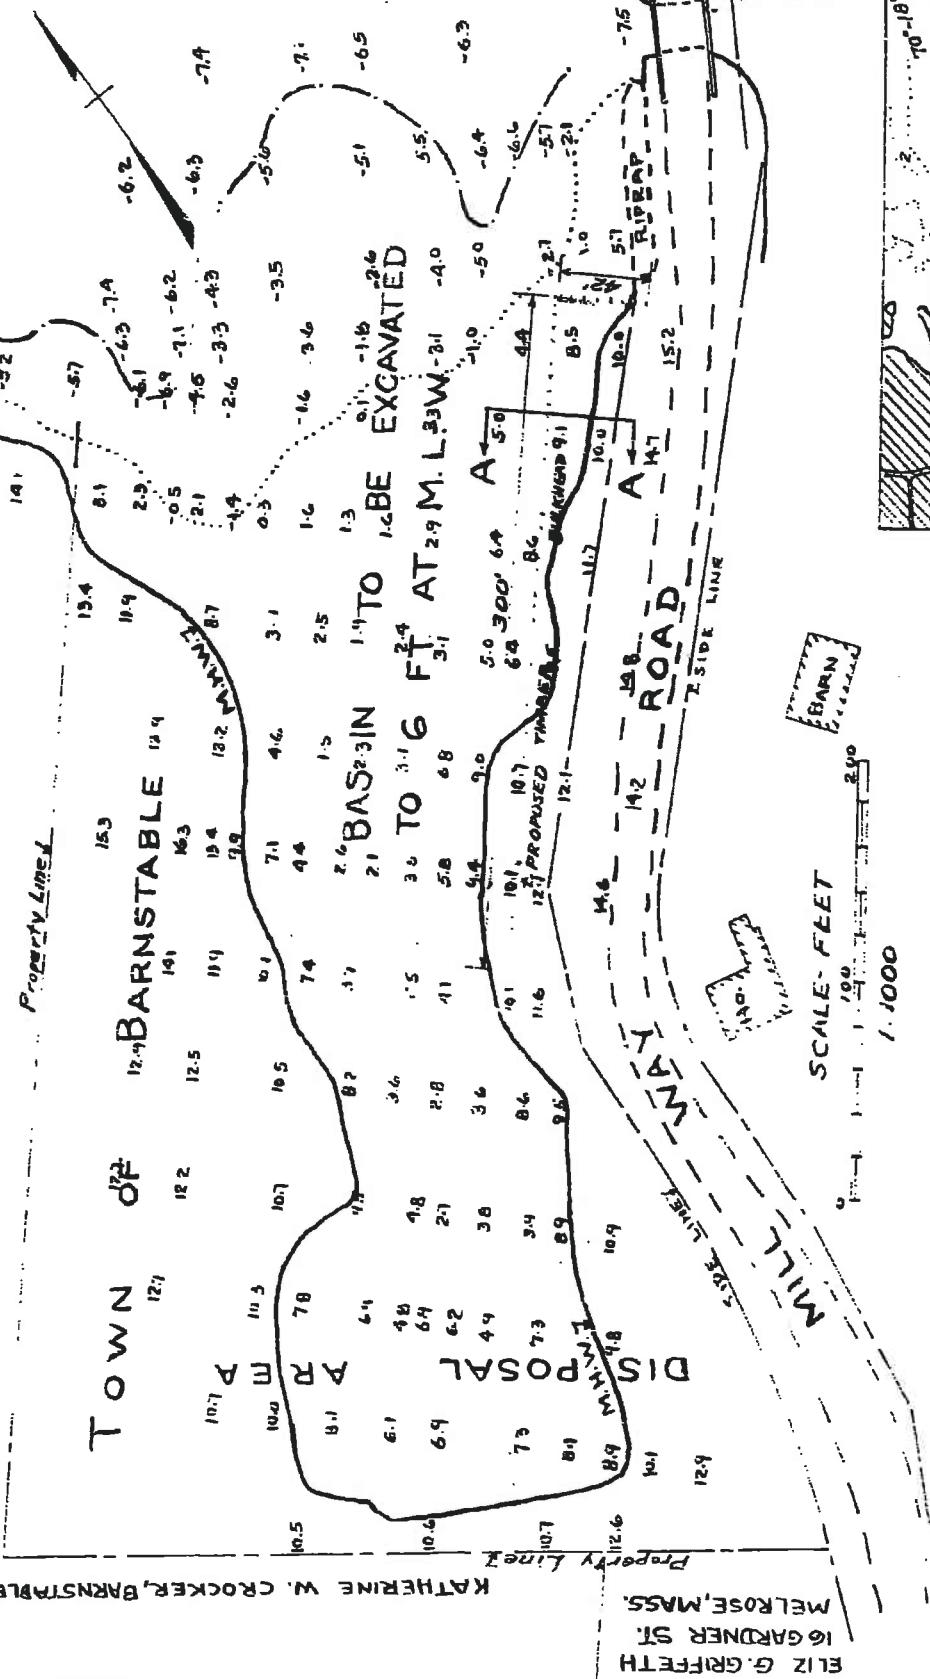
ELEVATIONS ARE IN FEET & TENTHES  
ABOVE THE PLANE OF M.L.W. MINUS  
FIGURES SHOW DEPTHS BELOW THE SAME  
AREA OUTLINED IN RED IS OF EXCAVATED  
TO A DEPTH OF 6 FT. AT M.L.W.  
EXCAVATED MATERIAL TO BE DISPOSED  
OF IN DISPOSAL AREA SHOWN HATCHED  
IN RED, ALSO IN HORN OF PROPOSED  
BULKHEAD UP TO ELEVEN FEET

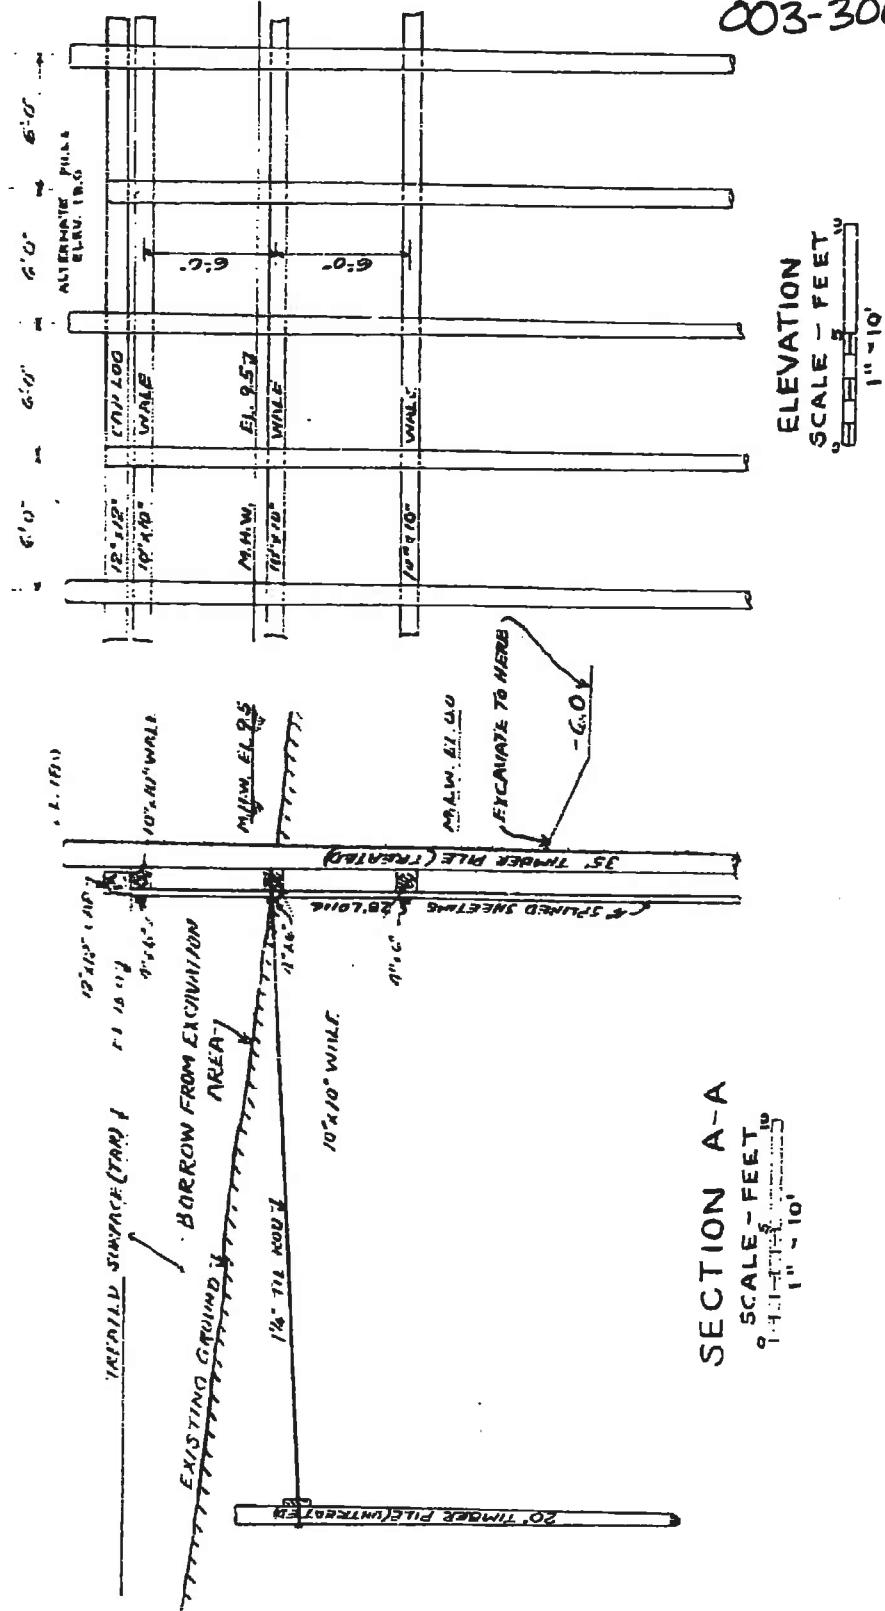
## **PROPOSED TIMBER BULKHEAD & EXCAVATION**

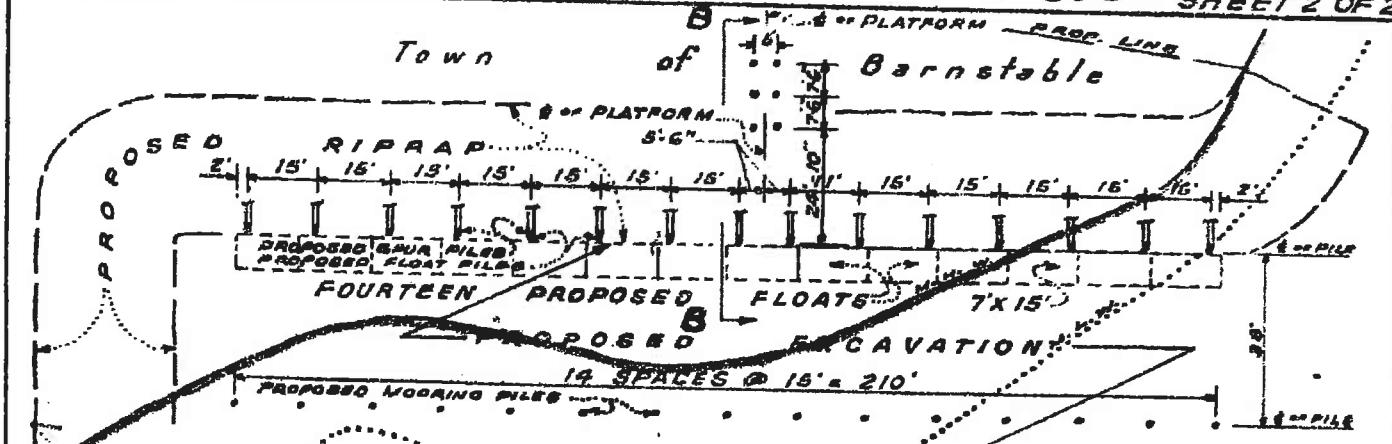
**PILE LAYOUT PLAN**

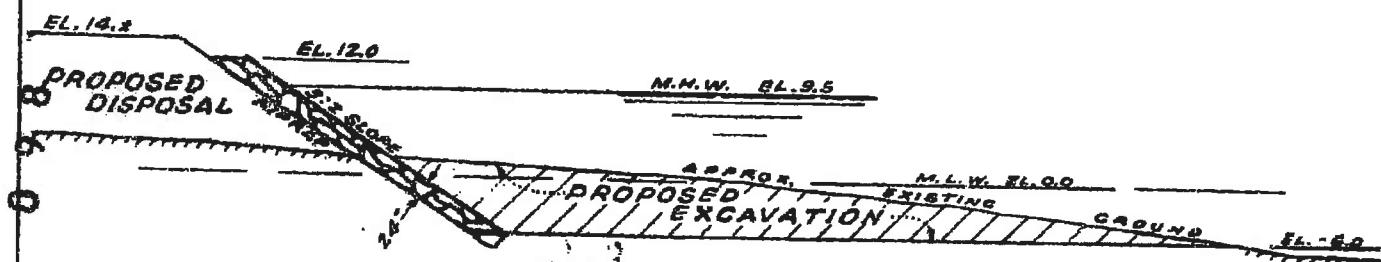
**SECTION AA**  
SCALE - FEET - BOTH SECTIONS  
1" = 20'

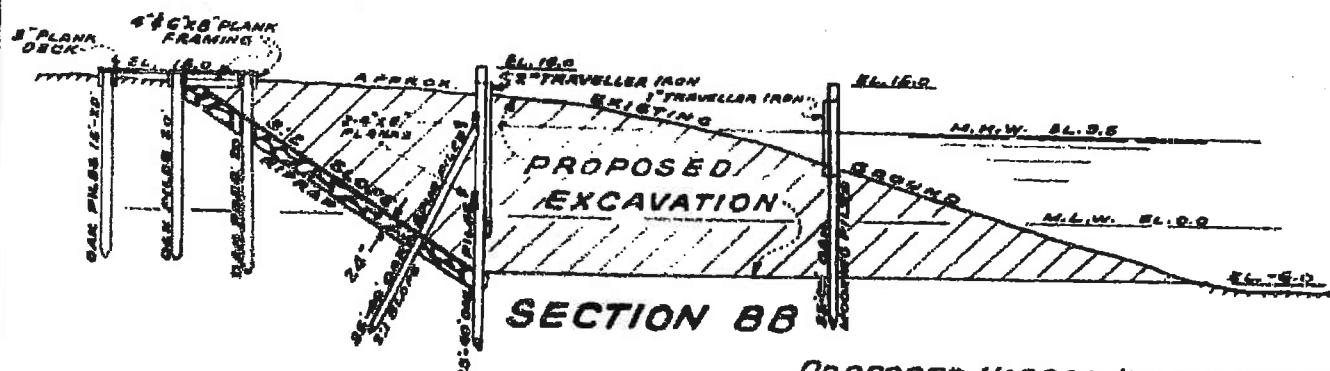
**SECTION BB**

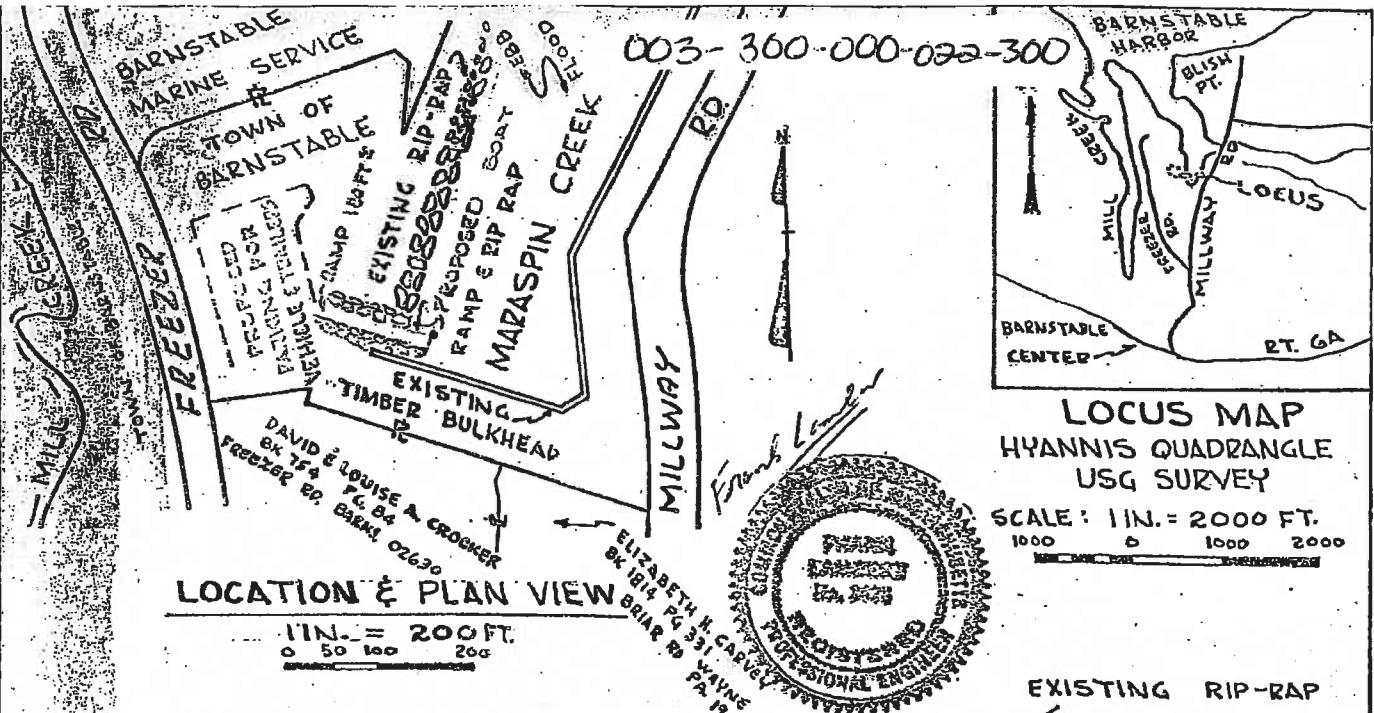
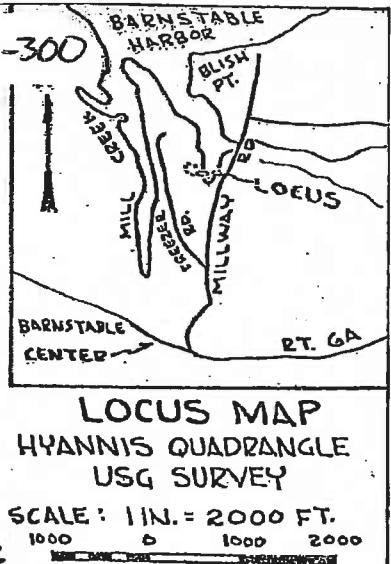
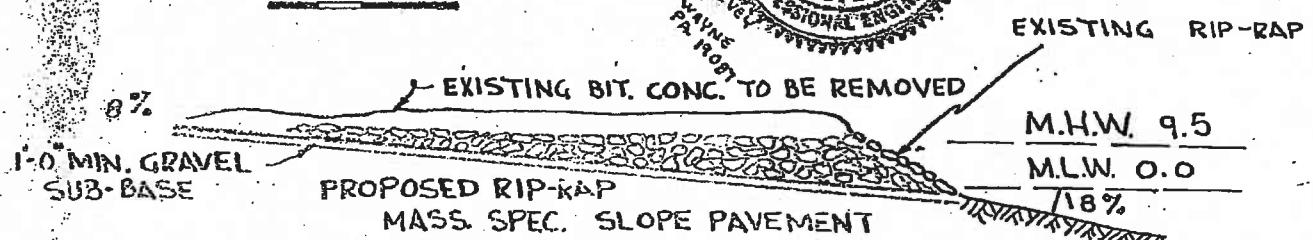
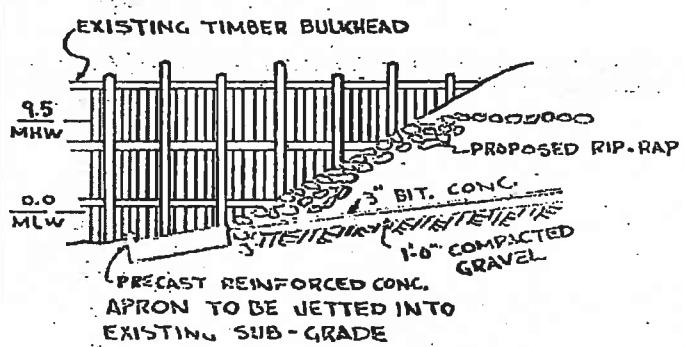
PROPOSED HARBOR IMPROVEMENT'S  
TIMBER PILES, EXCAVATION & RIPRAP  
**MARASPIN CREEK**  
BARNSTABLE HARBOR  
BARNSTABLE, MASS.  
APPLICATION BY  
DEPARTMENT OF PUBLIC WORKS - MASSACHUSETTS  
DIVISION OF WATERWAYS  
MARCH 1954

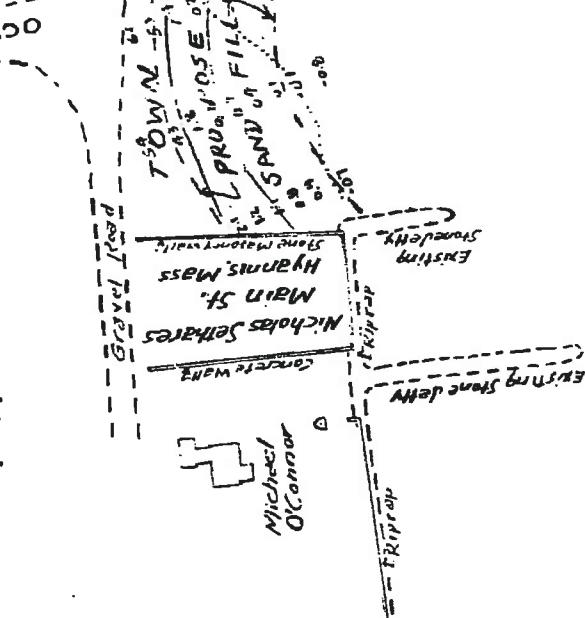
## PLAN

PROPOSED JETTIES & FILL SHOWN IN RED.  
APPROXIMATELY 6,000 C.Y. OF SAND  
FILL TO BE PLACED AS SHOWN.

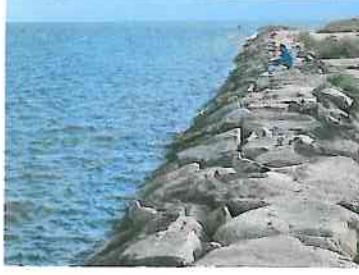
Property Owner:	Location:	Date:
Local	Parker's River	10/26/2007
Presumed Structure Owner:	Based On Comment:	
Local		
Owner Name:	Earliest Structure Record:	Estimated Reconstruction/Repair Cost:
Yarmouth	1951	\$1,225,020.00

Length:	Top Elevation:	FIRM Map Zone:	FIRM Map Elevation:
1020 Feet		V15	16 Feet NGVD
Primary Type:	Primary Material:	Primary Height:	
Groin/ Jetty	Stone	5 to 10 Feet	
Secondary Type:	Secondary Material:	Secondary Height:

This structure is the West jetty at Parker's River. The side slopes and crest are generally in good condition. There is some slumping evident in a small area in the central section of the jetty

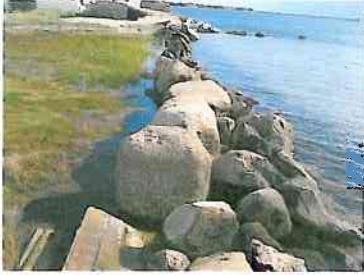
Property Owner:	Location:	Date:
Local	Webster Street	10/26/2007
Presumed Structure Owner:	Based On Comment:	
Local		
Owner Name:	Earliest Structure Record:	Estimated Reconstruction/Repair Cost:
Yarmouth	Unknown	\$91,245.00

125 Feet	Feet NAVD 88	V15	16 Feet NGVD	
Primary Type:	Primary Material:	Primary Height:		
Revetment	Stone	Under 5 Feet		
Secondary Type:	Secondary Material:	Secondary Height:

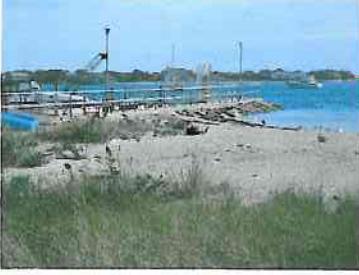
Property Owner:	Location:	Date:
Local	Englewood beach	10/26/2007
Presumed Structure Owner:	Based On Comment:	
Local		
Owner Name:	Earliest Structure Record:	Estimated Reconstruction/Repair Cost:
Yarmouth	1956	\$205,840.00

310 Feet	Feet NAVD 88	V15	13 Feet NGVD	
Primary Type:	Primary Material:	Primary Height:		
Breakwater	Stone	Under 5 Feet		
Secondary Type:	Secondary Material:	Secondary Height:

This structure is a breakwater which is impounding sand at Englewood beach. The stones at the toe have slumped and become unlocked from the stones above. The structure crest is in fair condition.

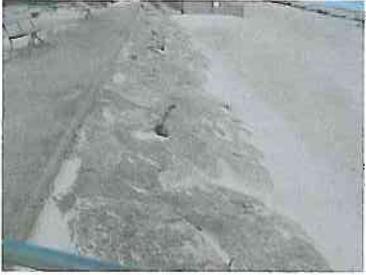
Property Owner:	Location:	Date:
Local	Seaview Beach	10/26/2007
Presumed Structure Owner:	Based On Comment:	
Local		
Owner Name:	Earliest Structure Record:	Estimated Reconstruction/Repair Cost:
Yarmouth	Unknown	\$16,817.00

140 Feet	Feet NAVD 88	V15	16 Feet NGVD	
Primary Type:	Primary Material:	Primary Height:		
Revetment	Stone	5 to 10 Feet		
Secondary Type:	Secondary Material:	Secondary Height:

This structure is the revetment fronting the parking lot at Seaview Beach. The armor stone is grouted and the sideslopes are in good condition. Toe is buried in beach and not visible for inspection.

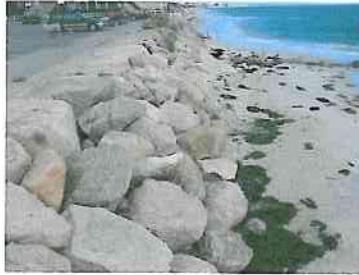
Property Owner:	Location:	Date:
Local	Thacher's Beach	10/26/2007
Presumed Structure Owner:	Based On Comment:	
Local		
Owner Name:	Earliest Structure Record:	Estimated Reconstruction/Repair Cost:
Yarmouth	1956	\$117,117.00

195 Feet	Feet NAVD 88	V15	16 Feet NGVD	
Primary Type:	Primary Material:	Primary Height:		
Revetment	Stone	5 to 10 Feet		
Secondary Type:	Secondary Material:	Secondary Height:

This structure is the revetment fronting the parking lot at Thacher's Beach. The revetment is generally in good condition. The armor stone is beginning to slump at the west end.

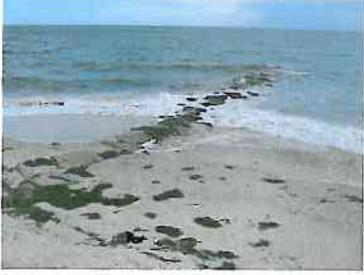
Property Owner:	Location:	Date:
Local	Thacher's Beach	10/26/2007
Presumed Structure Owner:	Based On Comment:	
Local		
Owner Name:	Earliest Structure Record:	Estimated Reconstruction/Repair Cost:
Yarmouth	Unknown	\$99,594.00

75 Feet	Feet NAVD 88	V15	16 Feet NGVD	
Primary Type:	Primary Material:	Primary Height:		
Groin/ Jetty	Stone	Under 5 Feet		
Secondary Type:	Secondary Material:	Secondary Height:

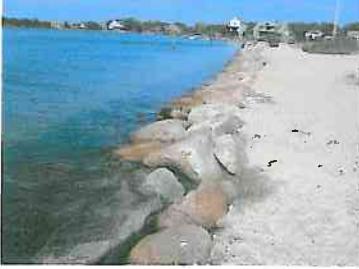
Property Owner:	Location:	Date:
Local	Mill Creek	10/26/2007
Presumed Structure Owner:	Based On Comment:	
Local		
Owner Name:	Earliest Structure Record:	Estimated Reconstruction/Repair Cost:
Yarmouth	1951	\$134,719.00

405 Feet	Feet NAVD 88	V15	16 Feet NGVD	
Primary Type:	Primary Material:	Primary Height:		
Revetment	Stone	Under 5 Feet		
Secondary Type:	Secondary Material:	Secondary Height:

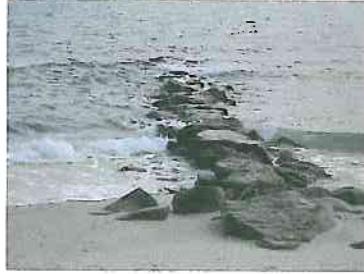
Property Owner:	Location:	Date:
Local	Beachwood Road	10/26/2007
Presumed Structure Owner:	Based On Comment:	
Local		
Owner Name:	Earliest Structure Record:	Estimated Reconstruction/Repair Cost:
Yarmouth	Unknown	\$398,376.00

Length:	Top Elevation:	FIRM Map Zone:	FIRM Map Elevation:
300 Feet	Feet NAVD 88	V15	18 Feet NGVD
Primary Type:	Primary Material:	Primary Height:	
Groin/ Jetty	Stone	Under 5 Feet	
Secondary Type:	Secondary Material:	Secondary Height:

This is the 3 groins at the terminus of Beachwood road and eastward. There are few stones serving as side slopes. As a result there is little interlocking between adjacent stones. The groins are very low profile.

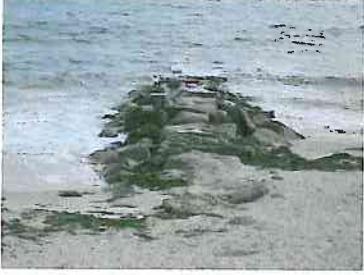
Property Owner:	Location:	Date:
Local	Parkers River Beach	10/26/2007
Presumed Structure Owner:	Based On Comment:	
Local		
Owner Name:	Earliest Structure Record:	Estimated Reconstruction/Repair Cost:
Yarmouth	1935	\$119,520.00

180 Feet	Feet NAVD 88	V15	16 Feet NGVD	
Primary Type:	Primary Material:	Primary Height:		
Groin/ Jetty	Stone	Under 5 Feet		
Secondary Type:	Secondary Material:	Secondary Height:

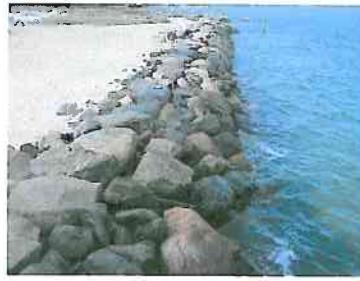
This structure is the revetment at Bass River Beach. The crest has settled to the point where there is little distinction between the crest stones and the side slope stones. The interlocking between armor stones is still good however.

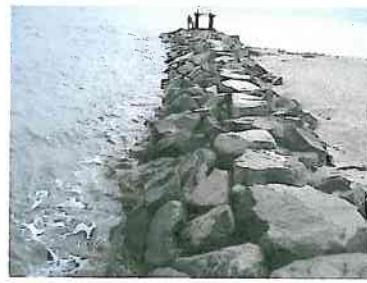
Property Owner:	Location:	Date:
Local	Bass River Beach	10/26/2007
Presumed Structure Owner:	Based On Comment:	
Local		
Owner Name:	Earliest Structure Record:	Estimated Reconstruction/Repair Cost:
Yarmouth	1945	\$204,170.00

Length:	Top Elevation:	FIRM Map Zone:	FIRM Map Elevation:
170 Feet	V13 Feet NAVD 88		16 Feet NGVD
Primary Type:	Primary Material:	Primary Height:	
Groin/ Jetty	Stone	5 to 10 Feet	
Secondary Type:	Secondary Material:	Secondary Height:

This structure is the jetty at Bass River Beach. The side slopes have begun to slump away from the crest, creating a gap between the sides and crest. There is some evidence of erosion along the back of the jetty crest, along the beach.

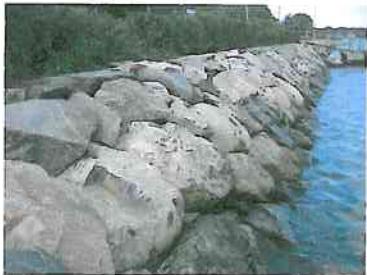
Property Owner: Local	Location: River Street	Date: 10/26/2007
Presumed Structure Owner: Local	Based On Comment:	
Owner Name: Yarmouth	Earliest Structure Record: 1994	Estimated Reconstruction/Repair Cost: \$78,078.00

Length: 130 Feet	Top Elevation: V13 Feet NAVD 88	FIRM Map Zone: V13 FIRM Map Elevation: 13 Feet NGVD

Primary Type: Revetment	Primary Material: Stone	Primary Height: 5 to 10 Feet	
Secondary Type:	Secondary Material:	Secondary Height:

This structure is the revetment at the turn in River Street. The structure toe is slumping somewhat at the south end. The remainder of the structure is in good condition, with level crest and side slopes.

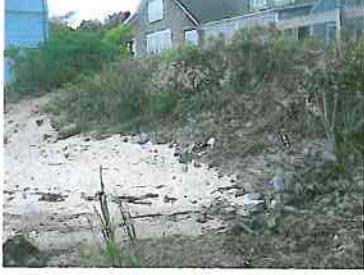
15 Feet	Feet NAVD 88	A8	9 Feet NGVD	
Primary Type:	Primary Material:	Primary Height:		
Revetment	Stone	5 to 10 Feet		
Secondary Type:	Secondary Material:	Secondary Height:

This structure is a revetment of dumped riprap at the terminus of North Cove Landing. Inspection was difficult due to vegetation overgrown across the entire structure. The riprap is quite small and appears to be loosely piled together.

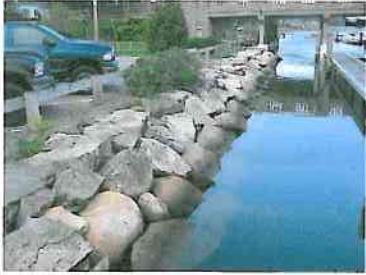
125 Feet	Feet NAVD 88	A8	9 Feet NGVD	
Primary Type:	Primary Material:	Primary Height:		
Revetment	Stone	5 to 10 Feet		
Secondary Type:	Secondary Material:	Secondary Height:

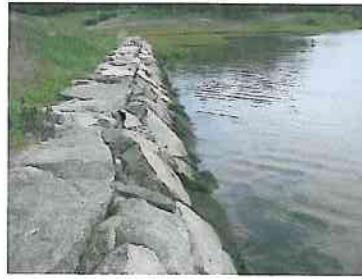
Primary Type: Revetment Primary Material: Stone Primary Height: 5 to 10 Feet  
 Secondary Type: Secondary Material: Secondary Height:

This structure is a revetment fronting a golf course green at Bass River. The crest and side slopes are level. The structure is in good condition.

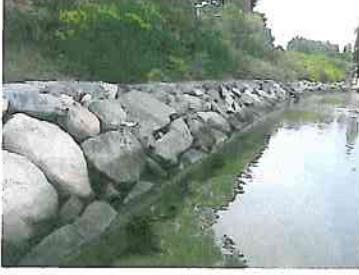
195 Feet	Feet NAVD 88	A5	7 Feet NGVD	
Primary Type:	Primary Material:	Primary Height:		
Revetment	Stone	5 to 10 Feet		
Secondary Type:	Secondary Material:	Secondary Height:

This structure is a revetment at Wilbur Park, fronting a dirt parking lot. The crest and side slopes are level and straight. The structure is in good condition.

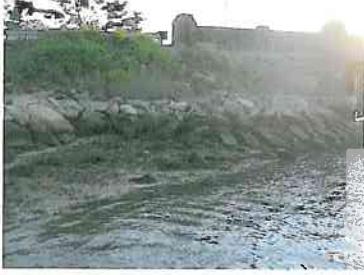
475 Feet	Feet NAVD 88	A4	6 Feet NGVD	
Primary Type:	Primary Material:	Primary Height:		
Revetment	Stone	5 to 10 Feet		
Secondary Type:	Secondary Material:	Secondary Height:

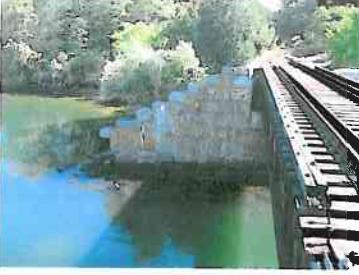
30 Feet	Feet NAVD 88	A4	6 Feet NGVD	
Primary Type:	Primary Material:	Primary Height:		
Bulkhead/ Seawall	Stone	10 to 15 Feet		
Secondary Type:	Secondary Material:	Secondary Height:

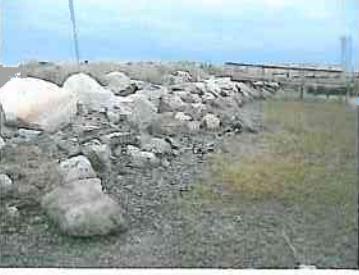
125 Feet	Feet NAVD 88	A5	13 Feet NGVD	
Primary Type:	Primary Material:	Primary Height:		
Revetment	Stone	Under 5 Feet		
Secondary Type:	Secondary Material:	Secondary Height:

This structure is the stone revetment at the parking lot at Bass Hole. The armor stone is generally in good condition. The eastern end of the structure is becoming unraveled.
