*Massachusetts Coastal Infrastructure  
Inventory and Assessment Project*  
*Massachusetts Department of Conservation and Recreation*  
*Office of Waterways*

## Middle Cape Cod

Barnstable  
Yarmouth  
Dennis

**MASSACHUSETTS COASTAL INFRASTRUCTURE INVENTORY AND ASSESSMENT PROJECT**

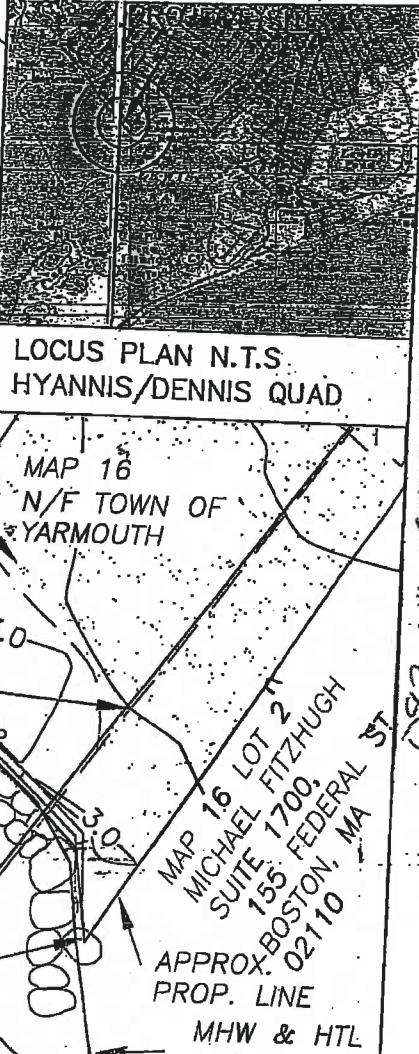
083-O16-000-003-100

EXISTING BROKEN 15" RCP TO BE  
REPLACED WITH 18" HDPE PIPE

APPROX. BURIED BROKEN 15"  
RCP. INV. APPROX. -2.5

PLAN ACCOMPANYING PETITION OF:  
TOWN OF YARMOUTH  
114 ROUTE 28  
SOU... YARMOUTH, MA 02664  
TO LICENSE EXISTING STONE GROIN AND TO  
REPLACE EXISTING  
5" CULVERT TO RESTORE TIDAL  
FLUSHING TO SALT MARSH  
LEWIS BAY, WEST YARMOUTH, MA

PROPOSED OUTLET 18"  
HDPE CULVERT  
INV. EL -2.0  
SEE DETAIL

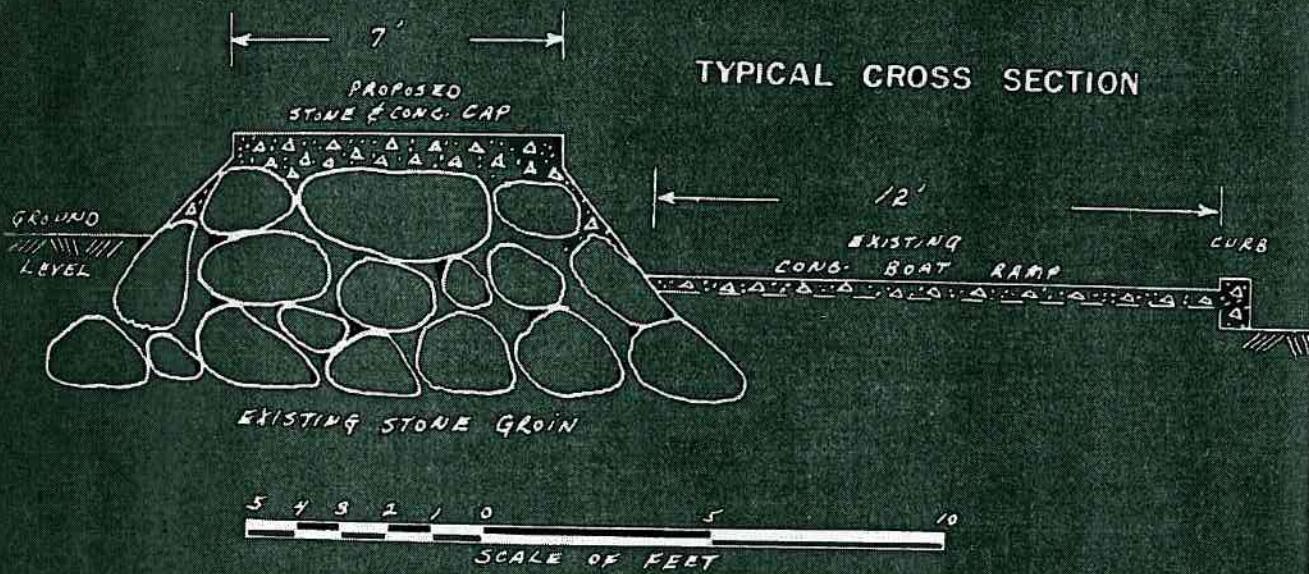
TYPICAL CROSS SECTION

PLAN FOR THE TOWN OF  
YARMOUTH TO MAINTAIN THE EXISTING CONC.  
BOAT RAMP AND TO CAP AND MAINTAIN THE  
EXISTING STONE GROIN IN LEWIS BAY AT  
(ENGLEWOOD) WEST YARMOUTH, MASS. AND TO  
BUILD A TIMBER PIER WITH FLOAT  
JULY 23, 1963  
SHEET 2 OF 2 SHEETS

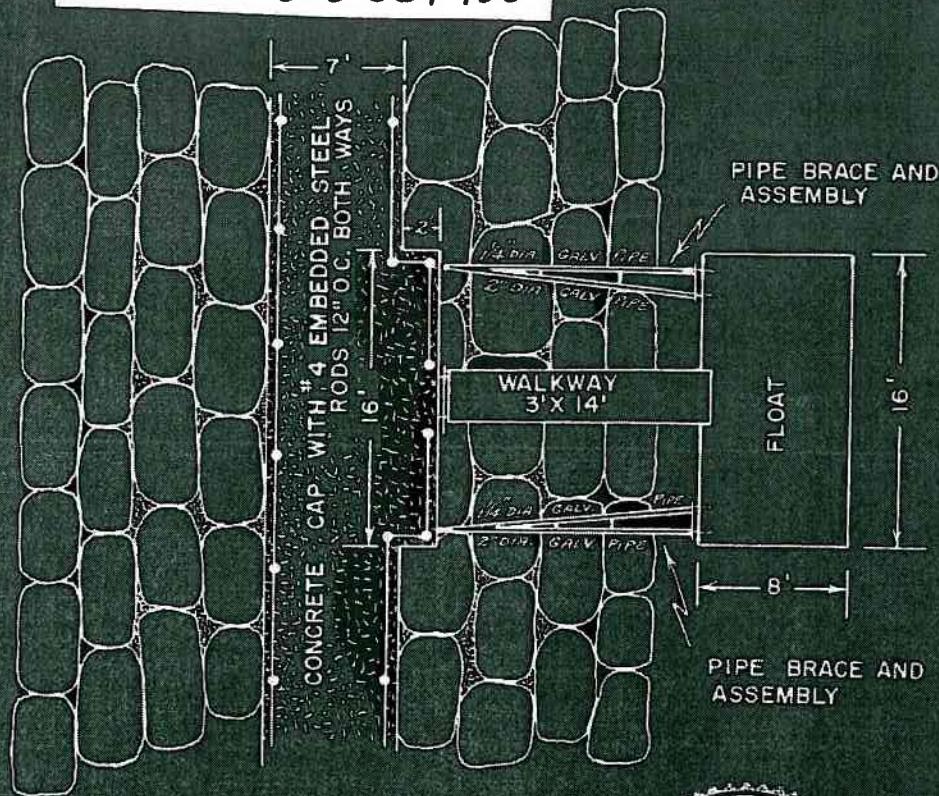
DETAIL CONCRETE CAP &amp; FLOAT

2 1/2" DIA. GALV. POST AND RAIL  
6' 0" ON CENTER

HANDRAIL ELEV. = 10.00

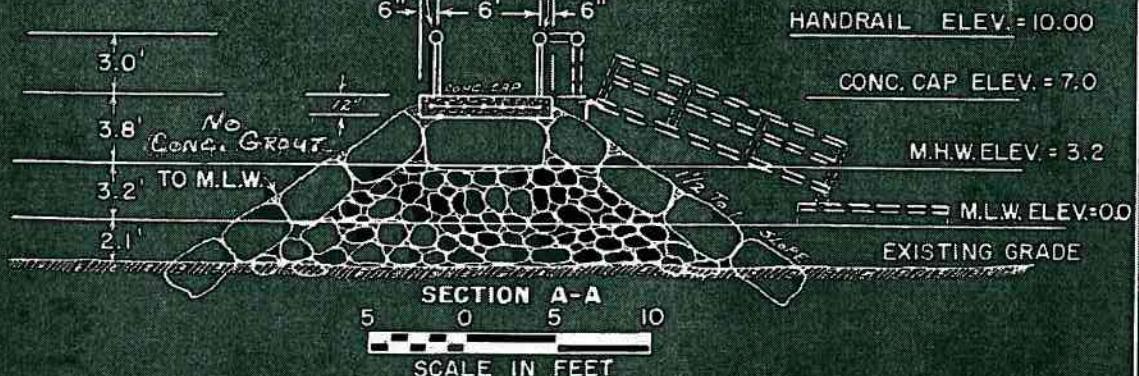
SECTION A-A

PLAN ACCOMPANYING PETITION OF  
THE TOWN OF YARMOUTH  
TO BUILD AND MAINTAIN A STONE PIER WITH  
A CONCRETE CAP AND ATTACHED FLOAT IN  
LEWIS BAY  
AT WEST YARMOUTH  
TOWN OF YARMOUTH  
MASSACHUSETTS  
SCALE AS SHOWN AUGUST 11, 1970

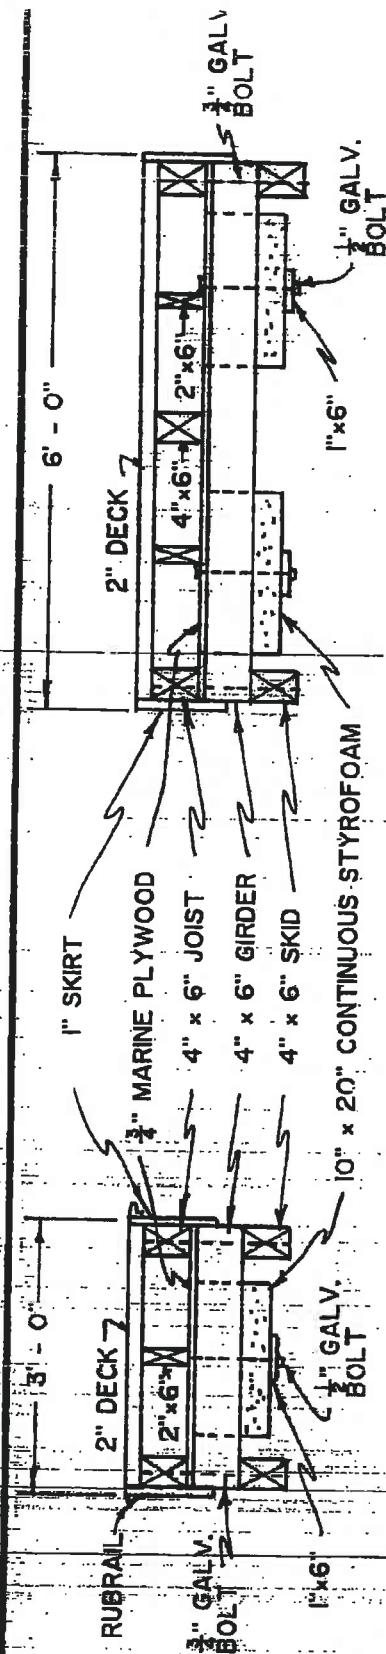
TIMBER FLOAT SECTIONS.

SCALE: 1" = 2'.

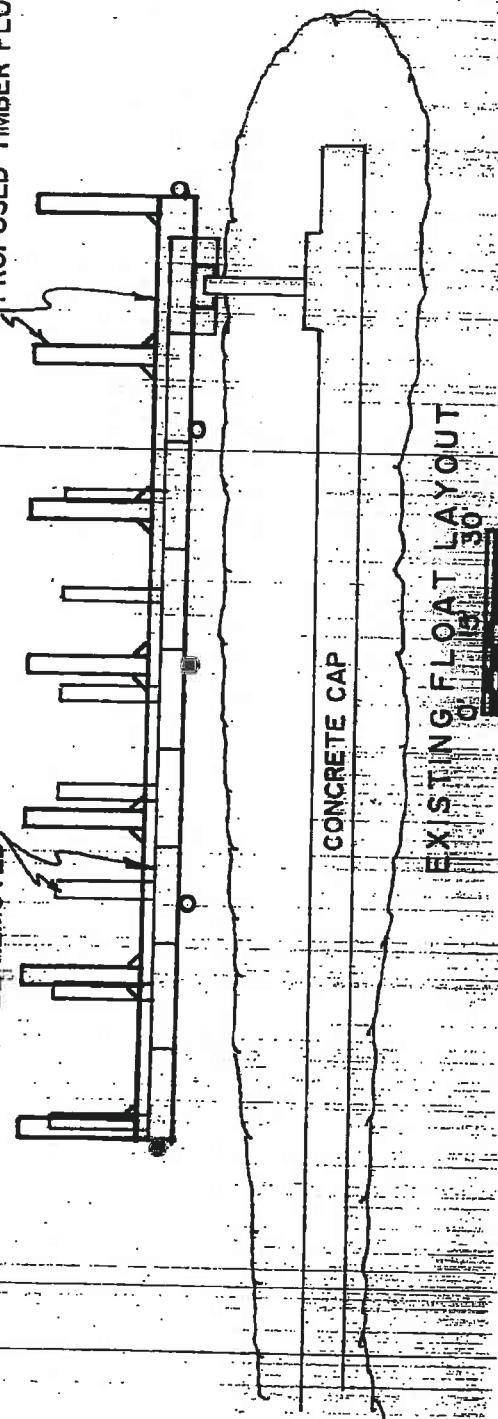
PROPOSED TIMBER FLOAT SYSTEM

EXIST. TIMBER FLOATS,  
TO BE REMOVED,

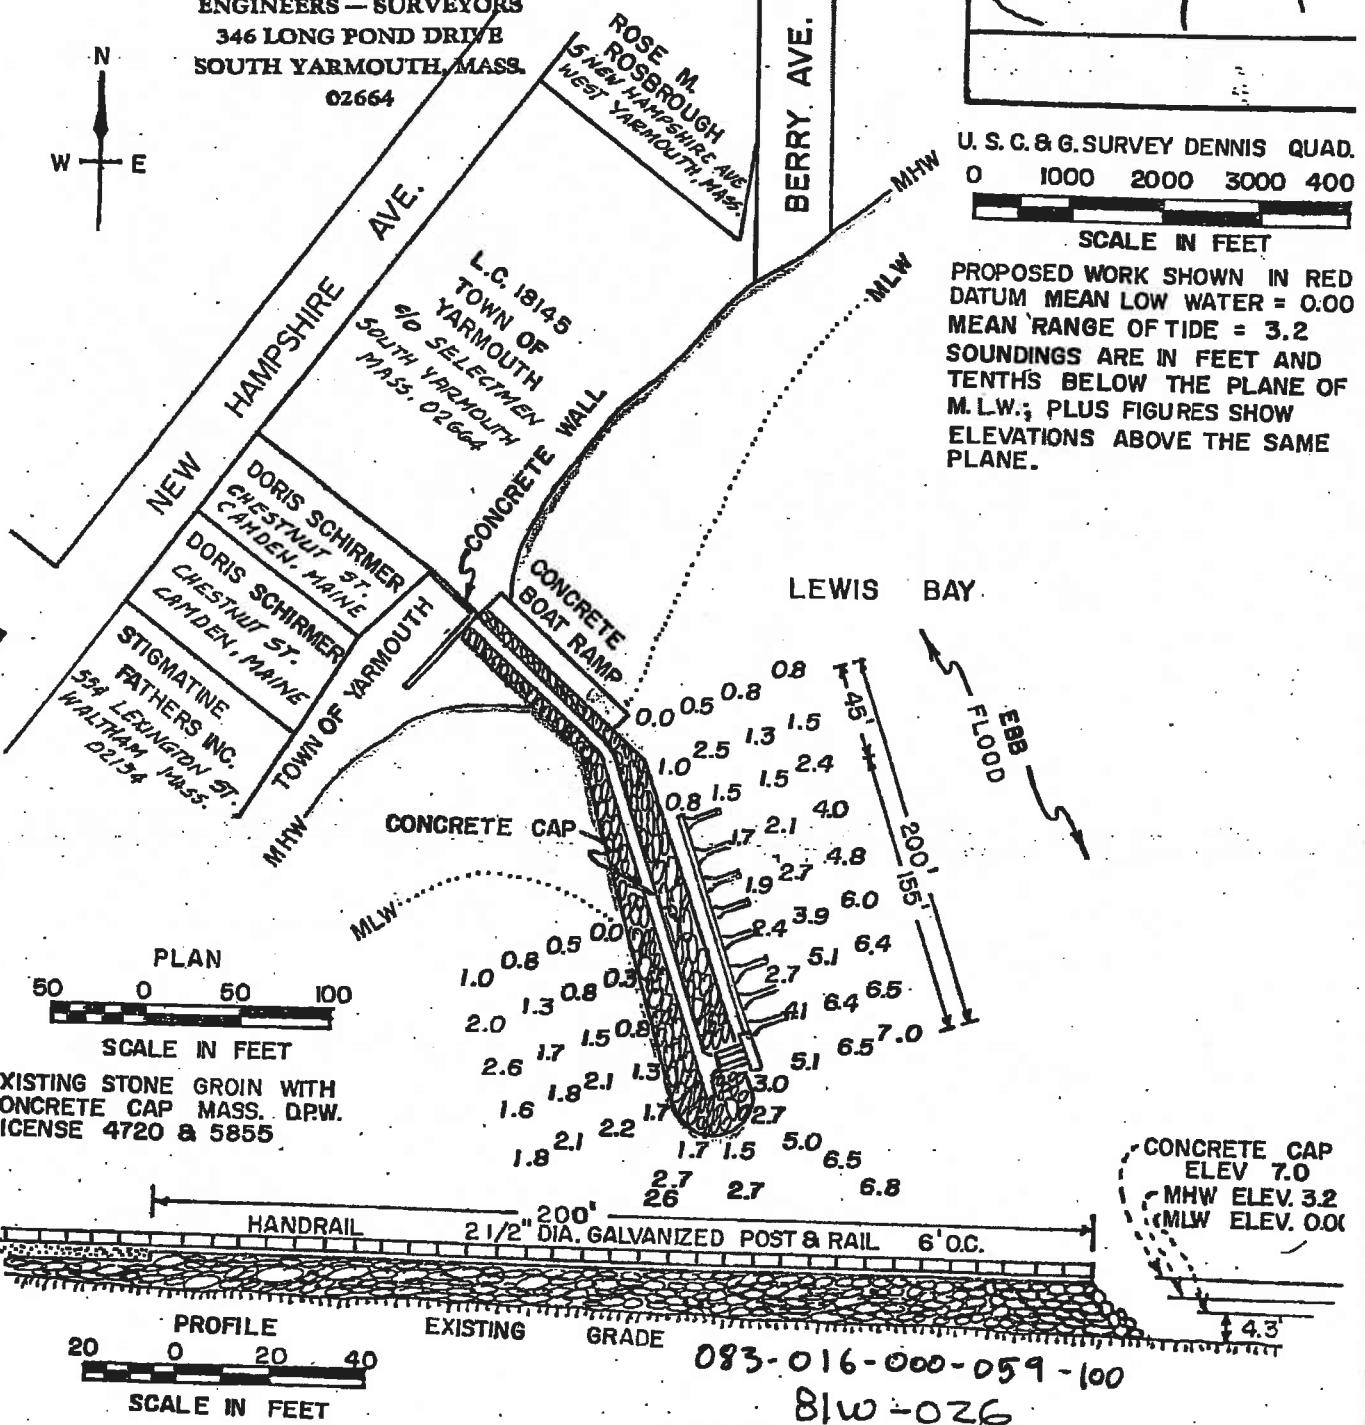
PLAN ACCOMPANYING PETITION OF  
THE TOWN OF YARMOUTH  
TO MAINTAIN A STONE PIER WITH  
A CONCRETE CAP AND ATTACHED FLOATS IN  
LEWIS BAY  
AT WEST YARMOUTH  
TOWN OF YARMOUTH  
MASSACHUSETTS

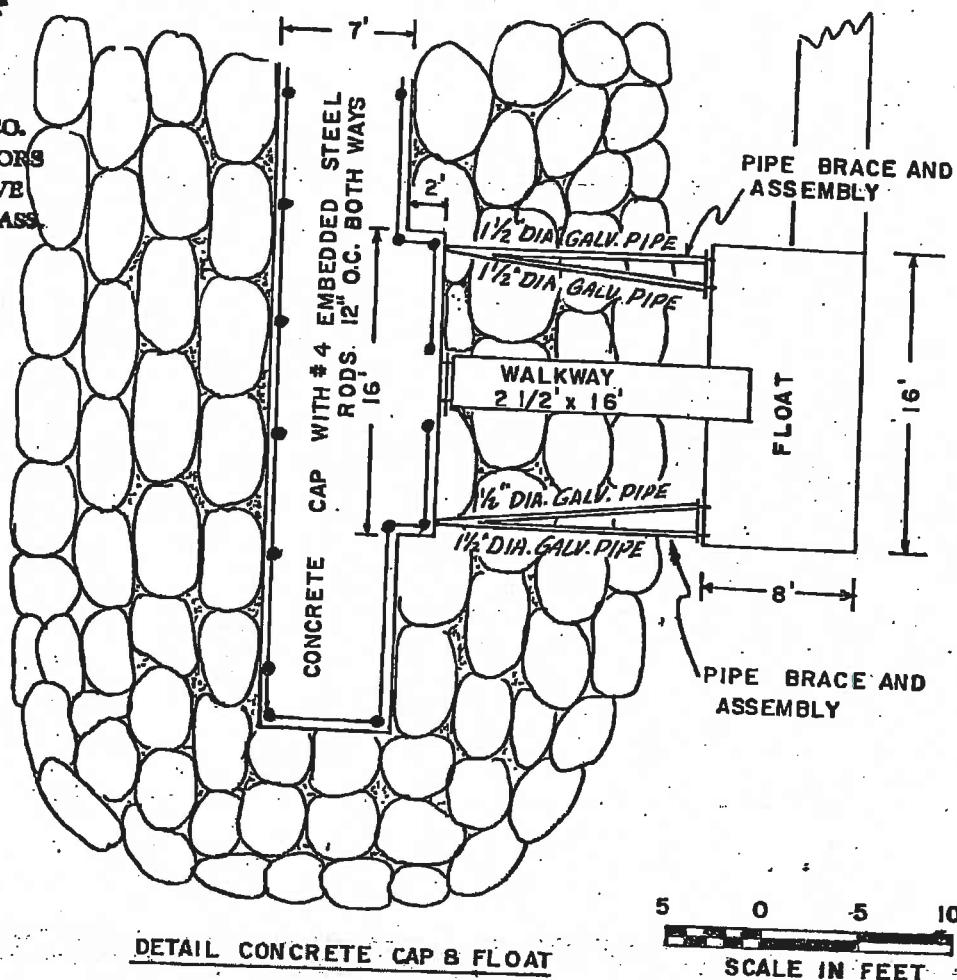
DETAIL CONCRETE CAP & FLOAT

2 1/2" DIA. GALV. POST AND RAIL  
6'-0" ON CENTER

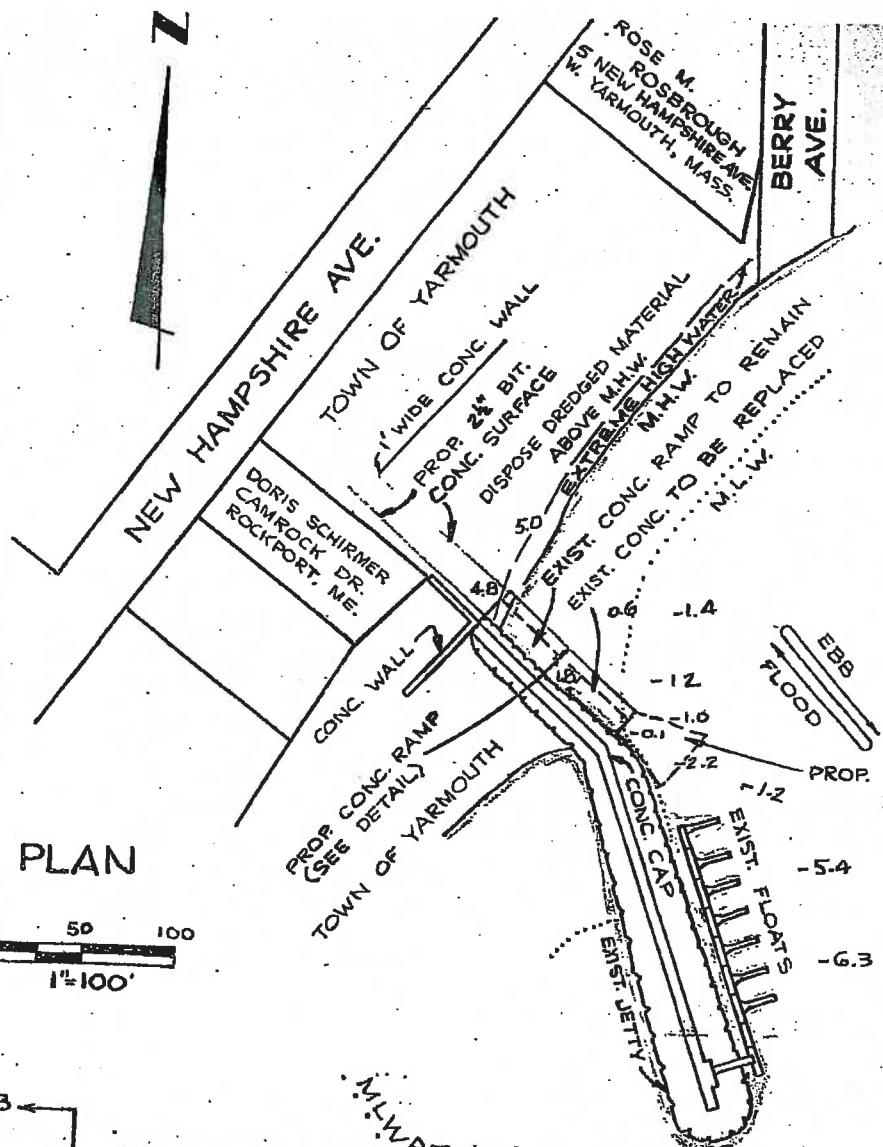
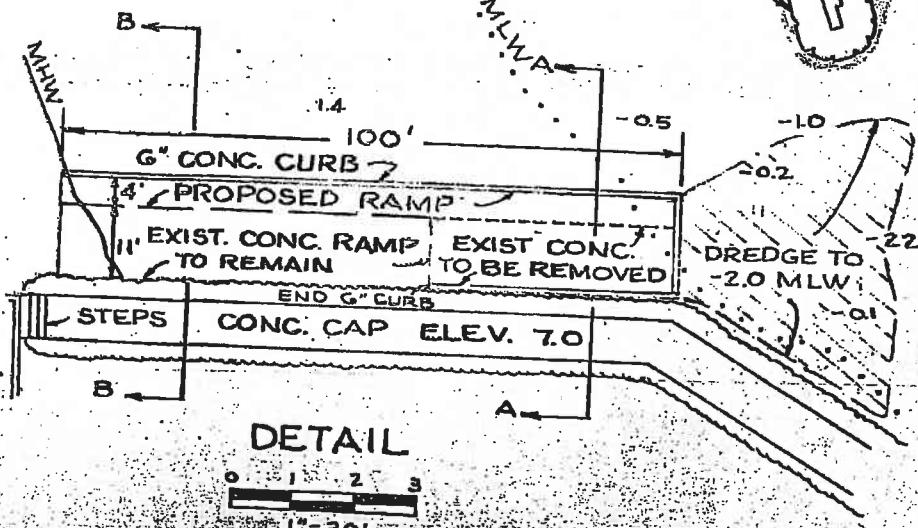
82w-094  
PLAN ACCOMPANYING PETITION OF  
TOWN OF YARMOUTH  
PROPOSED BOAT RAMP & DREDGING  
LEWIS BAY  
YARMOUTH, MASS.

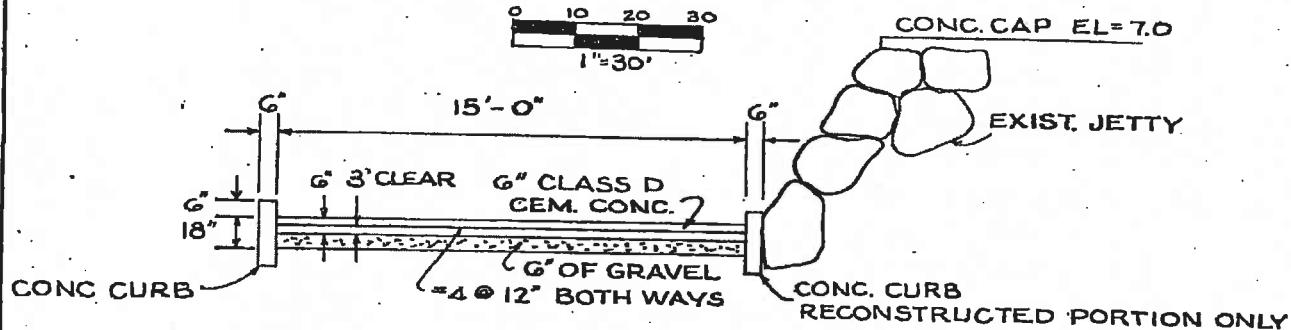
### SECTION A-A

NOTE: PORTION OF RAMP TO REMAIN SHALL BE DRILLED TO ALLOW REINFORCEMENT STEEL MAT TO SECURE JOINT.

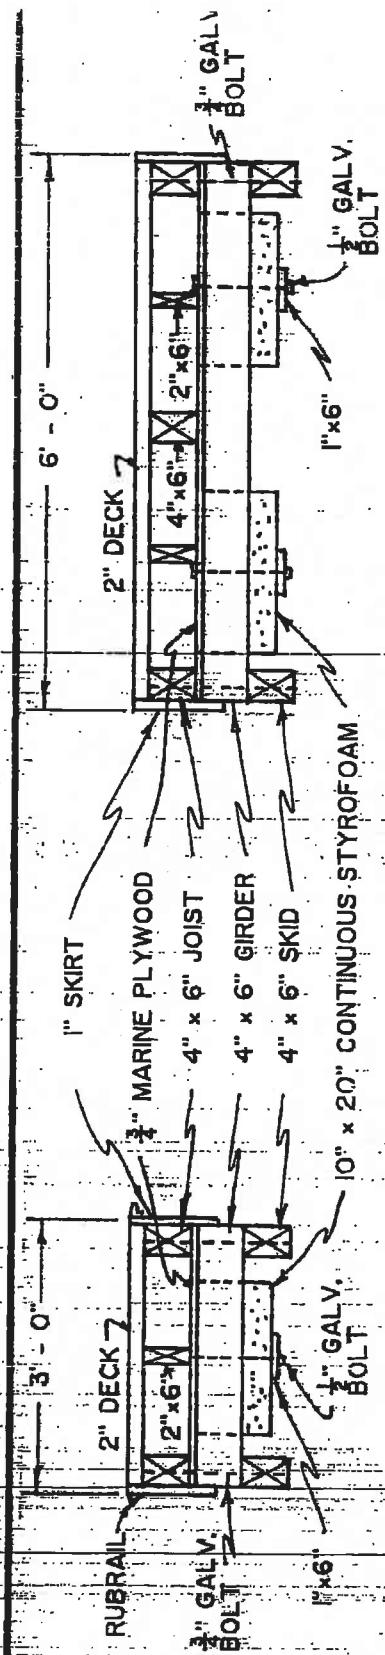
TIMBER FLOAT SECTIONS.

EXIST. TIMBER FLOATS,  
TO BE REMOVED

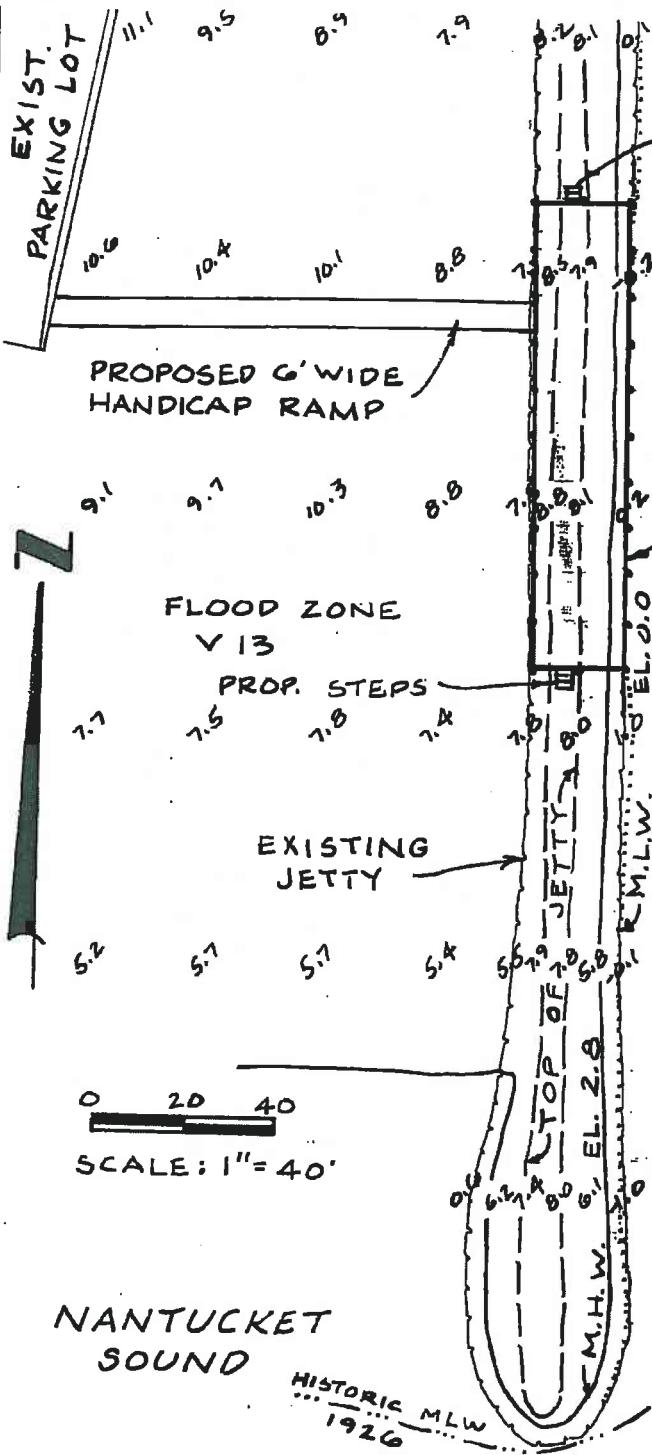
PROPOSED 19' x 99' HANDICAPPED ACCESSIBLE FISHING PLATFORM

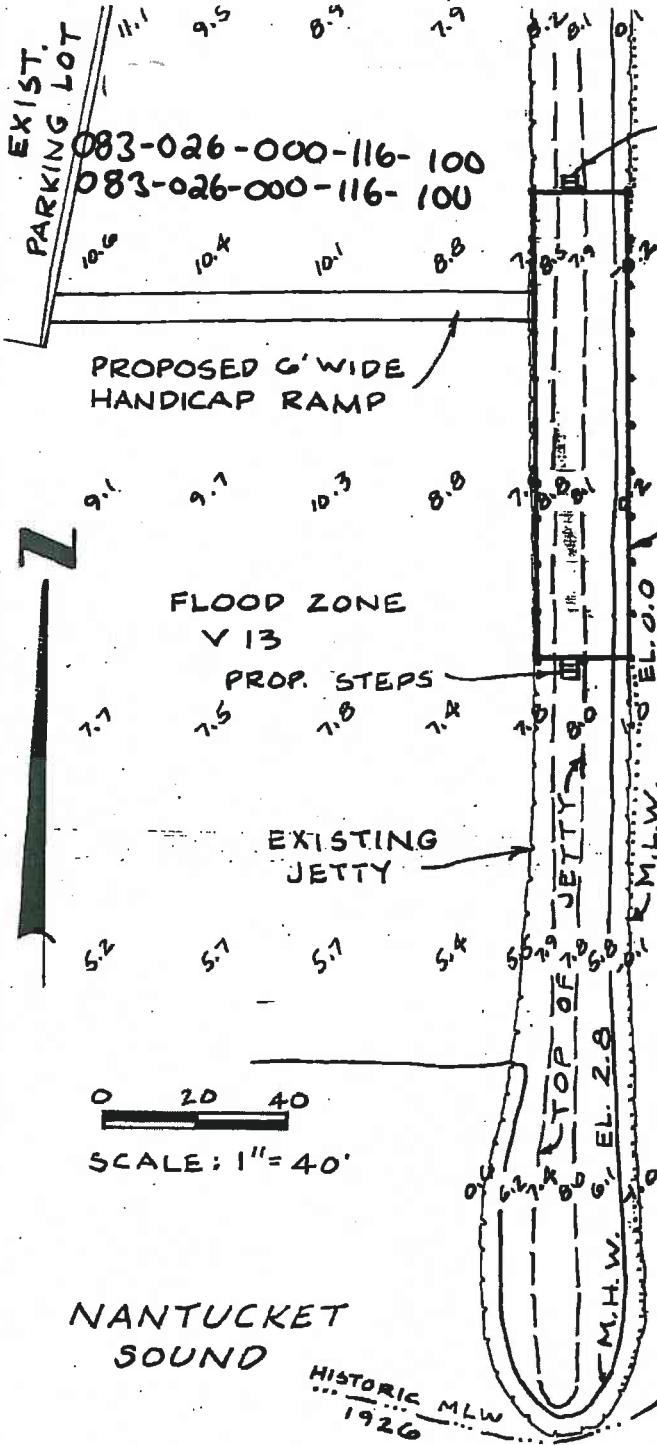
PROPOSED 19' x 99' HANDICAPPED ACCESSIBLE FISHING PLATFORM

PLAN ACCOMPANYING PETITION OF  
TOWN OF YARMOUTH  
TO CONSTRUCT A HANDICAPPED  
ACCESSIBLE FISHING PLATFORM IN  
BASS RIVER  
YARMOUTH, MA.

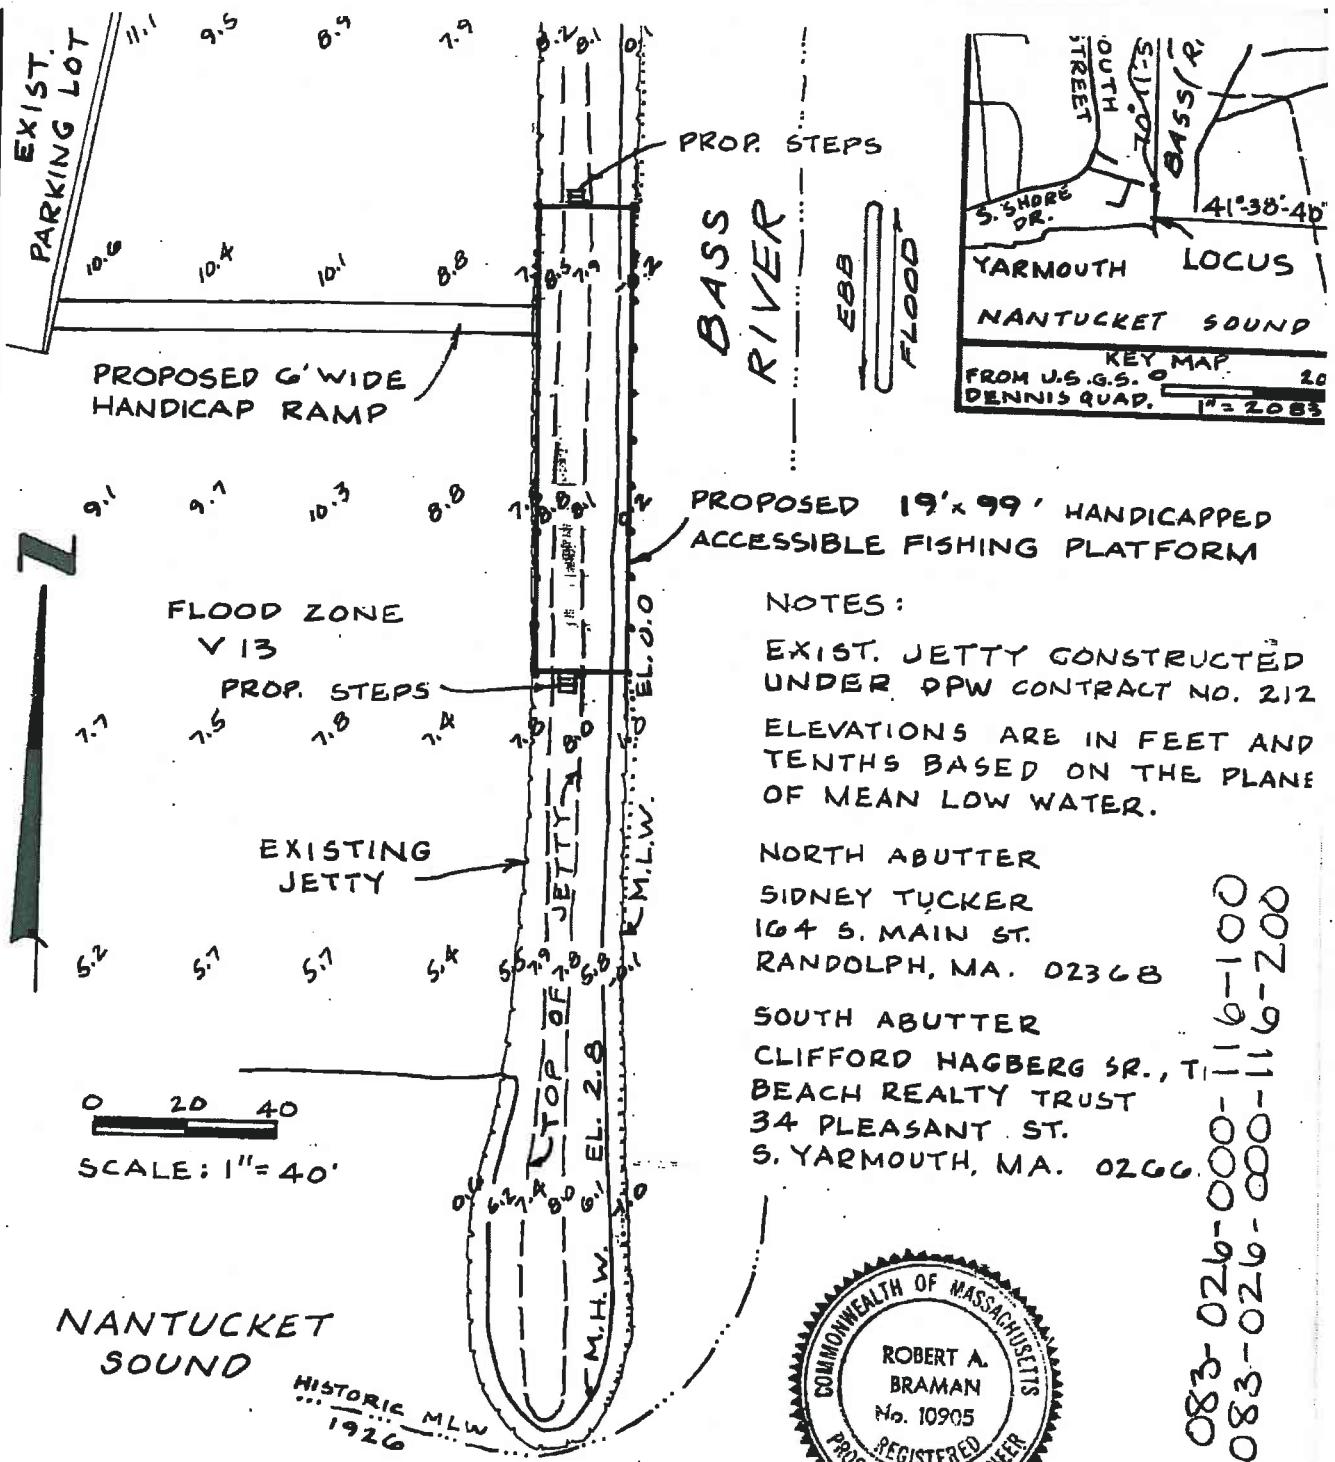
EXIST. JETTY CONSTRUCTED UNDER DPW CONTRACT NO. 212

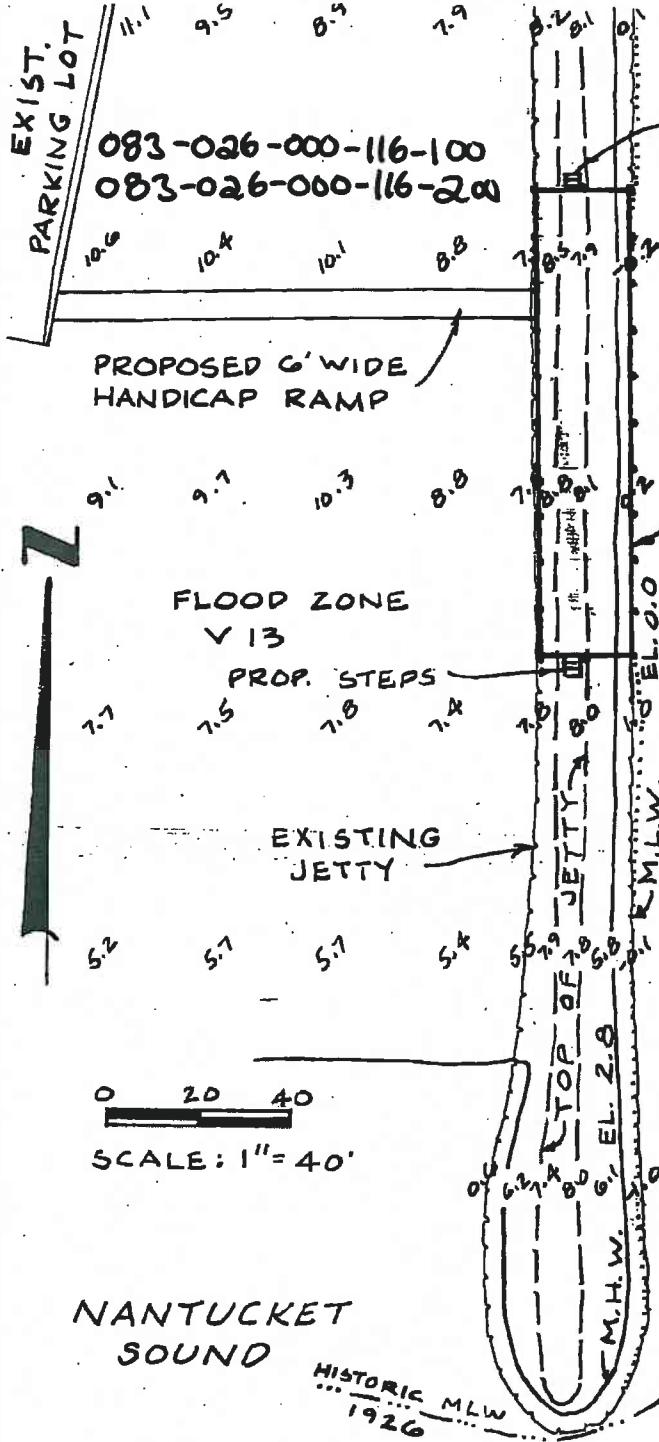
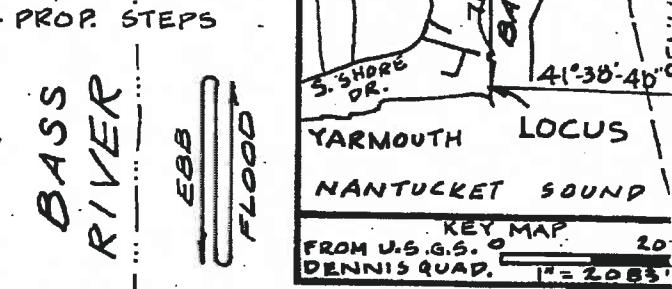
PLAN ACCOMPANYING PETITION OF  
TOWN OF YARMOUTH  
TO CONSTRUCT A HANDICAPPED  
ACCESSIBLE FISHING PLATFORM IN  
BASS RIVER  
YARMOUTH, MA.

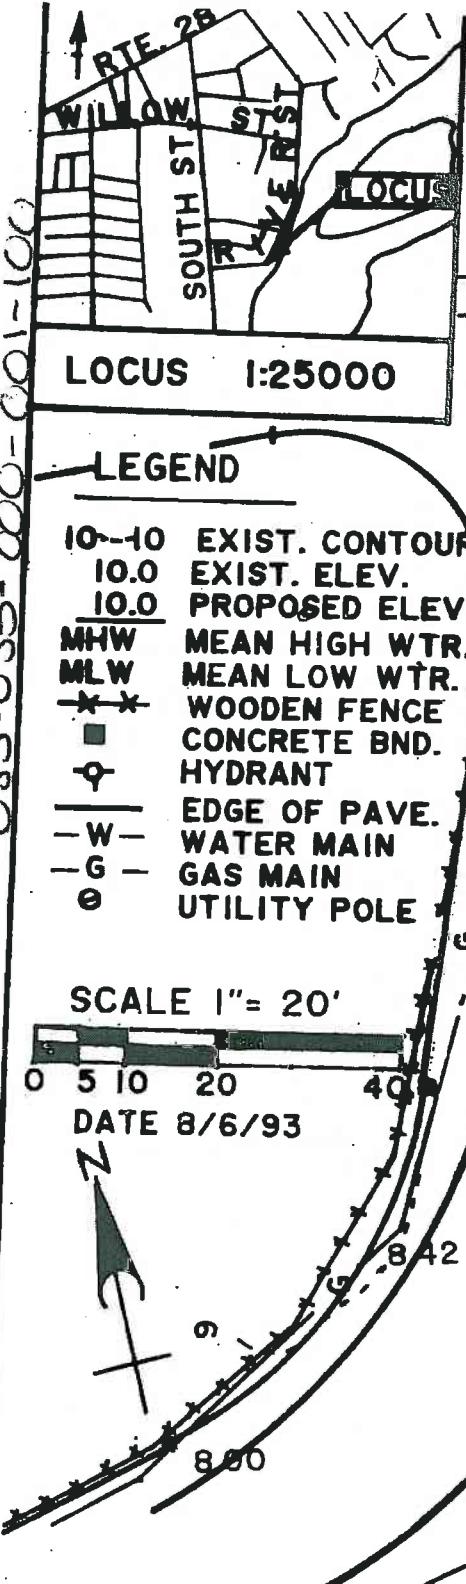
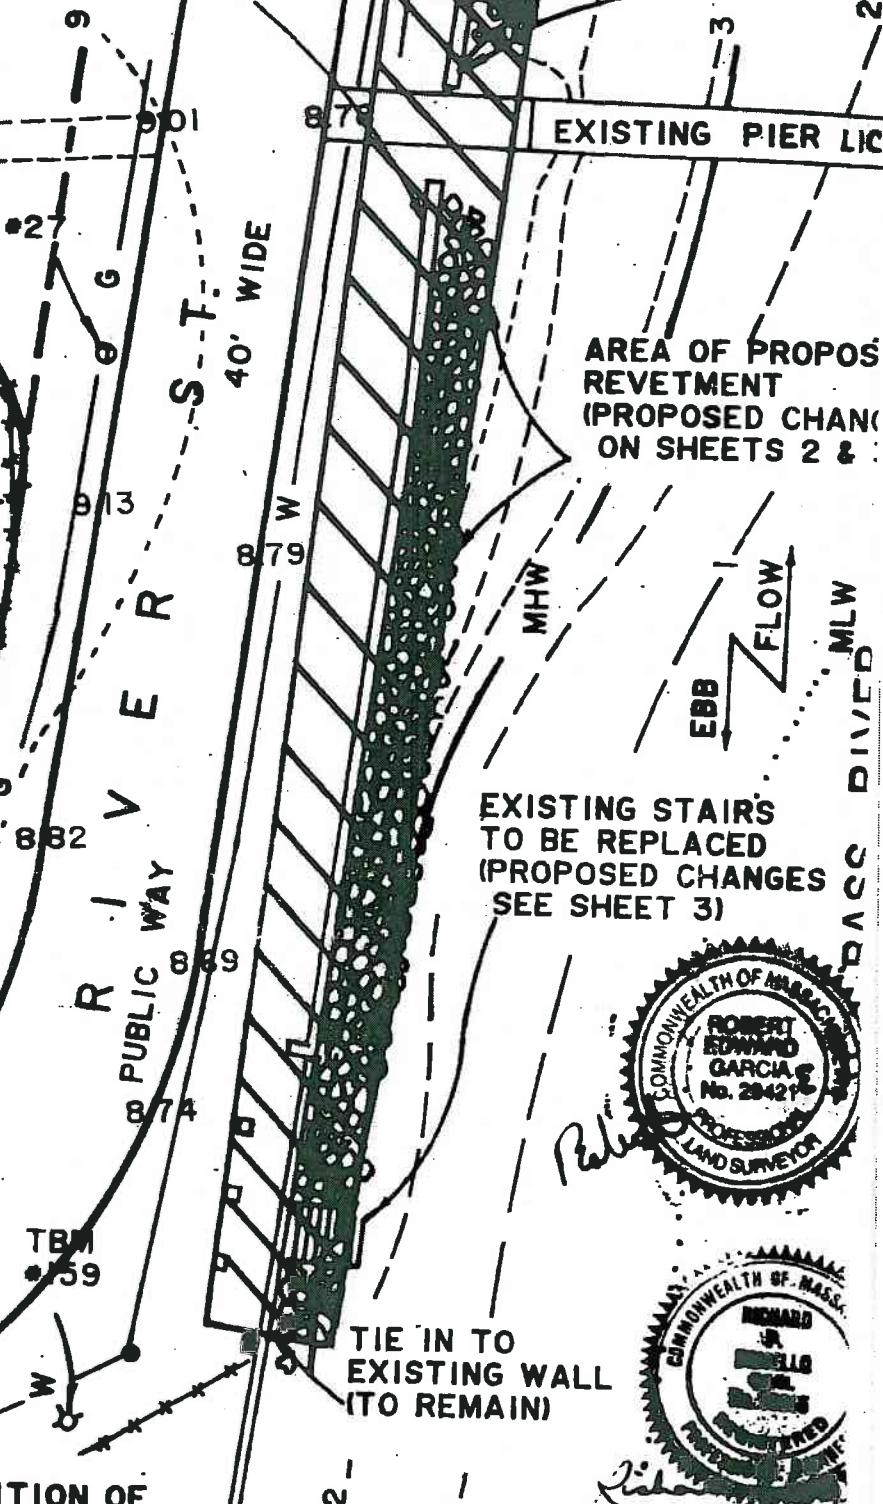
EXISTING RETAINING  
WALL TO BE REPLACED  
(PROPOSED CHANGES  
SEE SHEET 2)

PLAN TO ACCOMPANY PETITION OF  
TOWN OF YARMOUTH  
TO CONSTRUCT AND MAINTAIN  
A STONE REVETMENT  
IN  
BASS RIVER  
SOUTH YARMOUTH, MASS  
TOWN OF YARMOUTH ENGINEERING  
1146 ROUTE 28

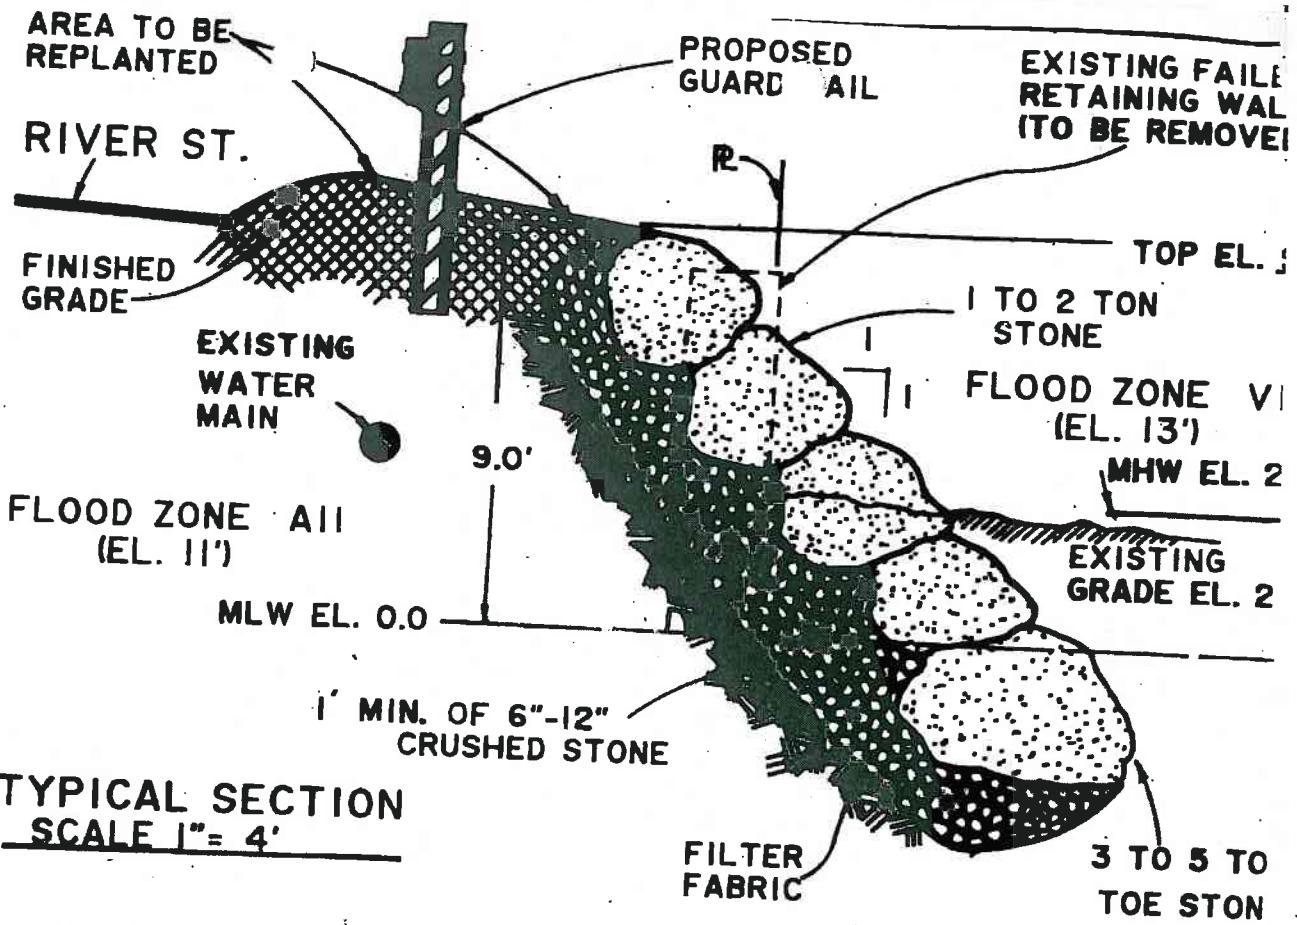
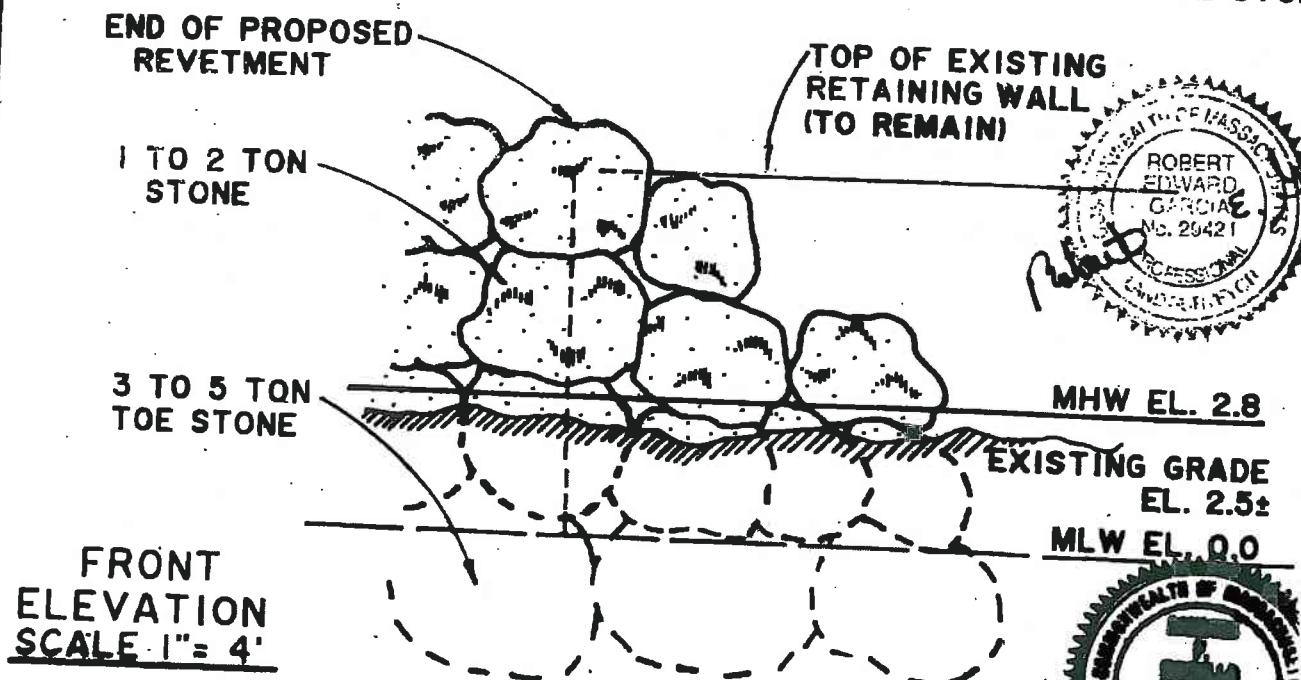
PLAN TO ACCOMPANY PETITION OF  
TOWN OF YARMOUTH  
TO CONSTRUCT AND MAINTAIN  
A STONE REVETMENT  
IN  
BASS RIVER  
SOUTH YARMOUTH, MASS.  
TOWN OF YARMOUTH ENGINEERING  
1145 ROUTE 28

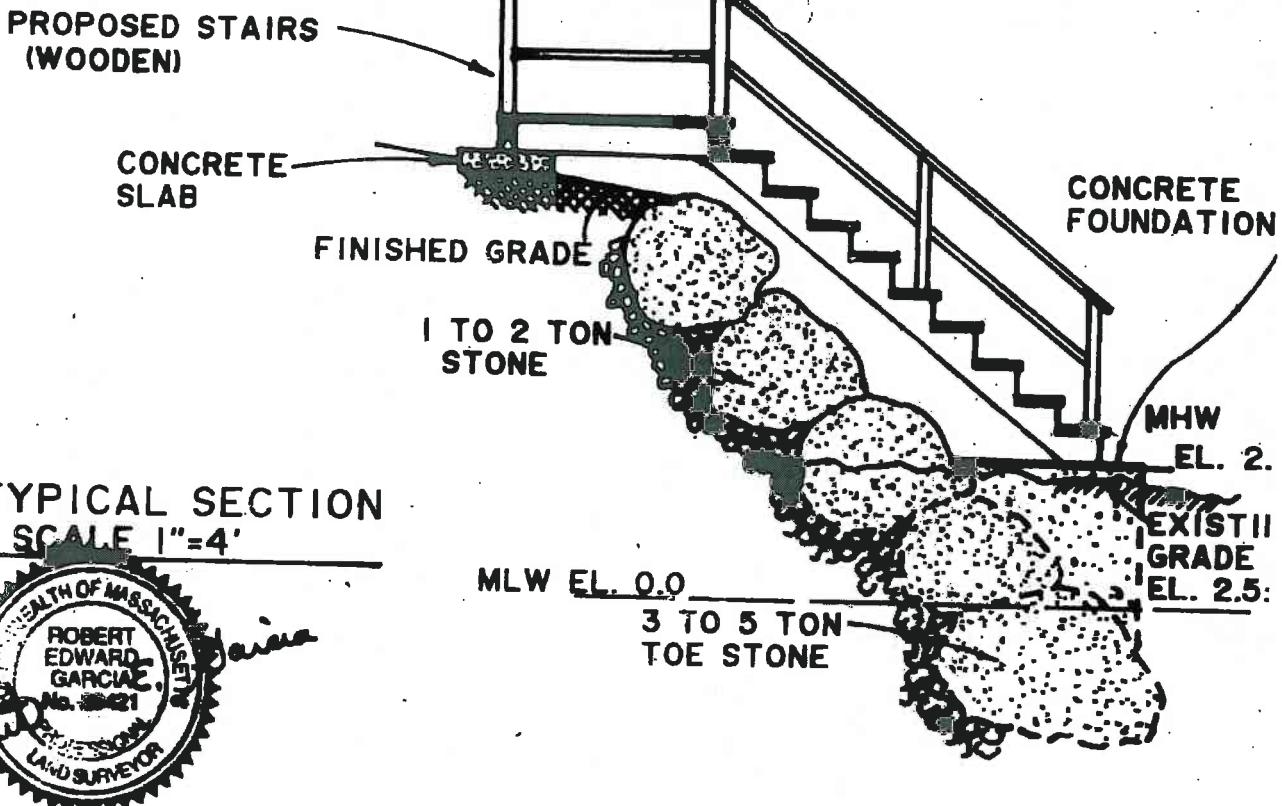
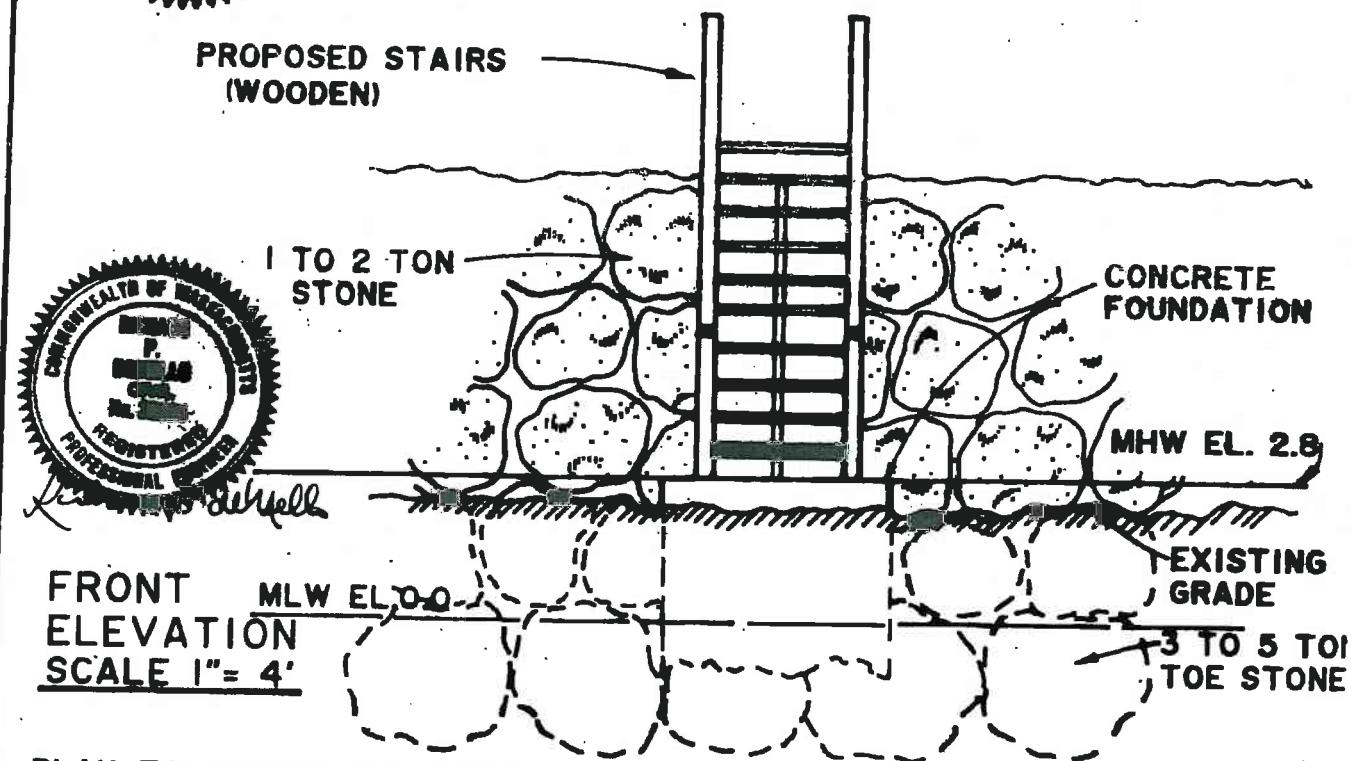
083-035-000-001-100

PLAN TO ACCOMPANY PETITION OF  
TOWN OF YARMOUTH  
TO CONSTRUCT AND MAINTAIN  
A STONE REVETMENT

IN  
BASS RIVER  
SOUTH YARMOUTH MASS.  
TOWN OF YARMOUTH ENGINEERING  
1146 ROUTE 28  
SOUTH YARMOUTH MASS

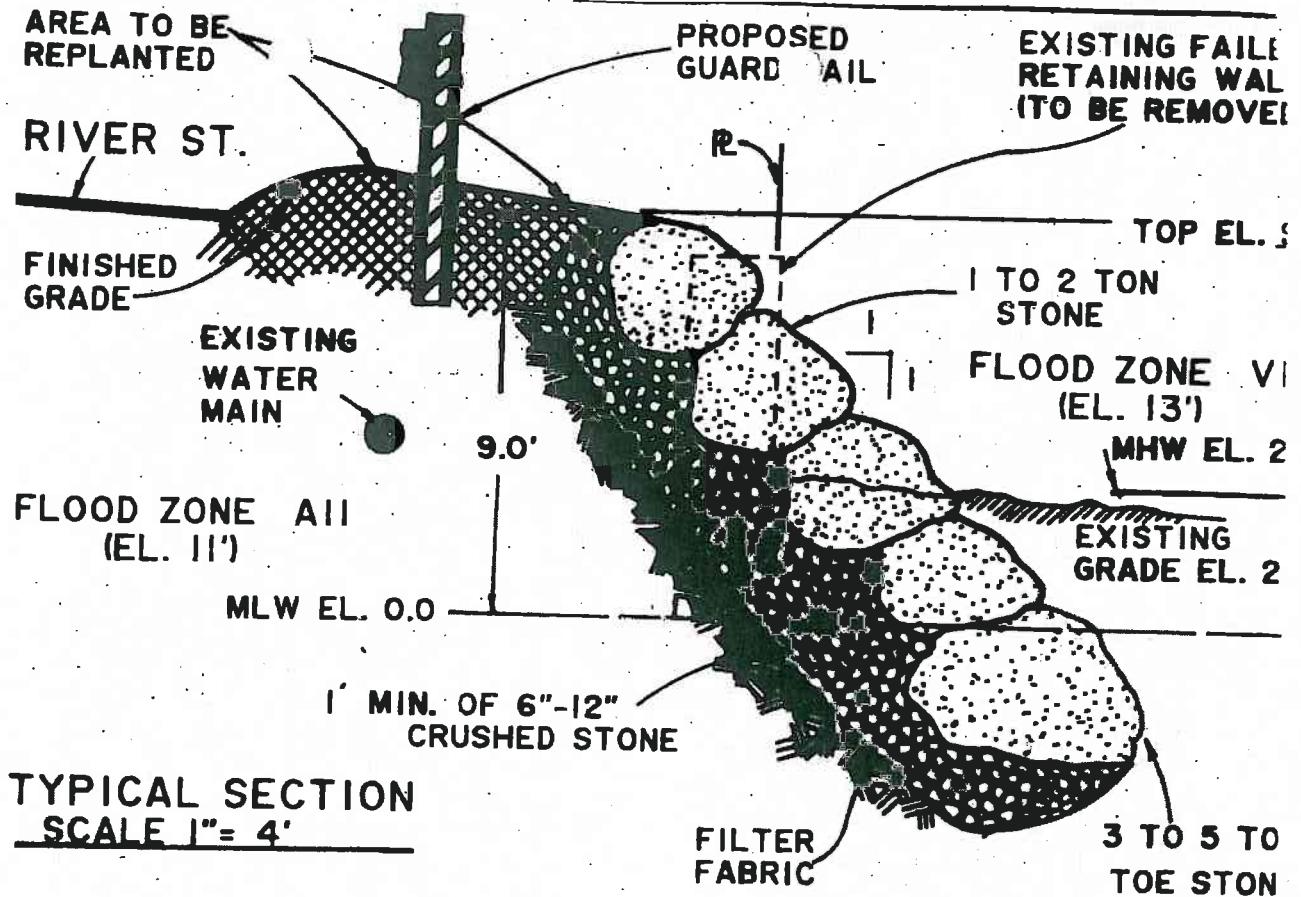
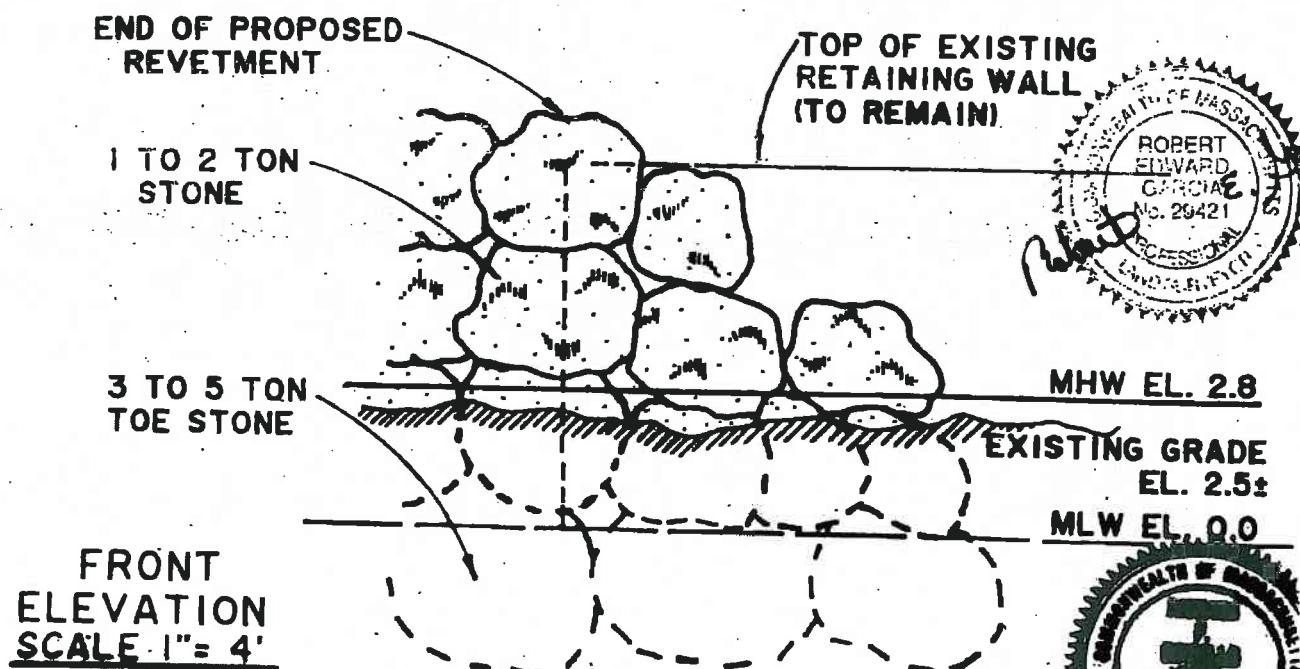
LICENSE PLAN NO. 3760  
Approved by Department of Environmental Protection  
Date APR 15 1994

PLAN TO ACCOMPANY PETITION OF  
TOWN OF YARMOUTH  
TO CONSTRUCT AND MAINTAIN  
A STONE REVETMENT  
IN  
BASS RIVER  
SOUTH YARMOUTH, MASS.  
TOWN OF YARMOUTH ENGINEERING  
1146 ROUTE 28
